MINERALS PROGRAM INSPECTION REPORT
PHONE: (303) 866-3567

MINE NAME: Gold Hill Mill	MINE/PROSPECTING ID#: M-1994-117	MINERAL: Gold and silver	COUNTY: Boulder
INSPECTION TYPE: Monitoring	WEATHER: Clear	INSP. DATE: May 16, 2025	INSP. TIME: 10:30
OPERATOR: Colorado Milling Company, LLC	OPERATOR REPRESENTATIVE: Mark Steen and Ben Langenfeld	TYPE OF OPERATION: 110d - Designated Limited Impact	
REASON FOR INSPECTION: Normal I&E Program	BOND CALCULATION TYPE: None	BOND AMOUNT: \$110,697.00	
DATE OF COMPLAINT: NA	POST INSP. CONTACTS: None	JOINT INSP. AGENCY: None	
INSPECTOR(S): Patrick Lennberg	INSPECTOR'S SIGNATURE:

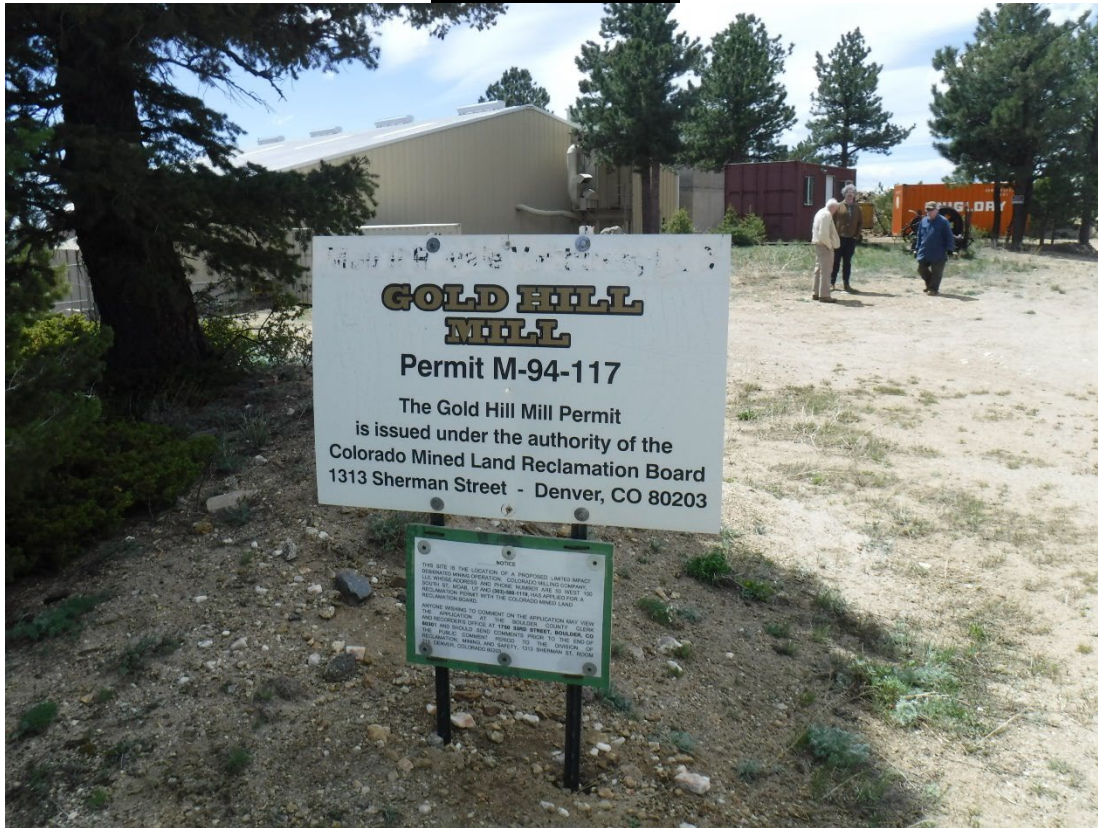
The Gold Hill Mill is located approximately 10 miles northwest of Boulder, CO in Boulder County. Access to the site is off Sunshine Canyon Drive. A mine sign was observed at the entrance to the mine as required by Rule 3.1.12.

Photo 1: Mine sign at primary mine entrance

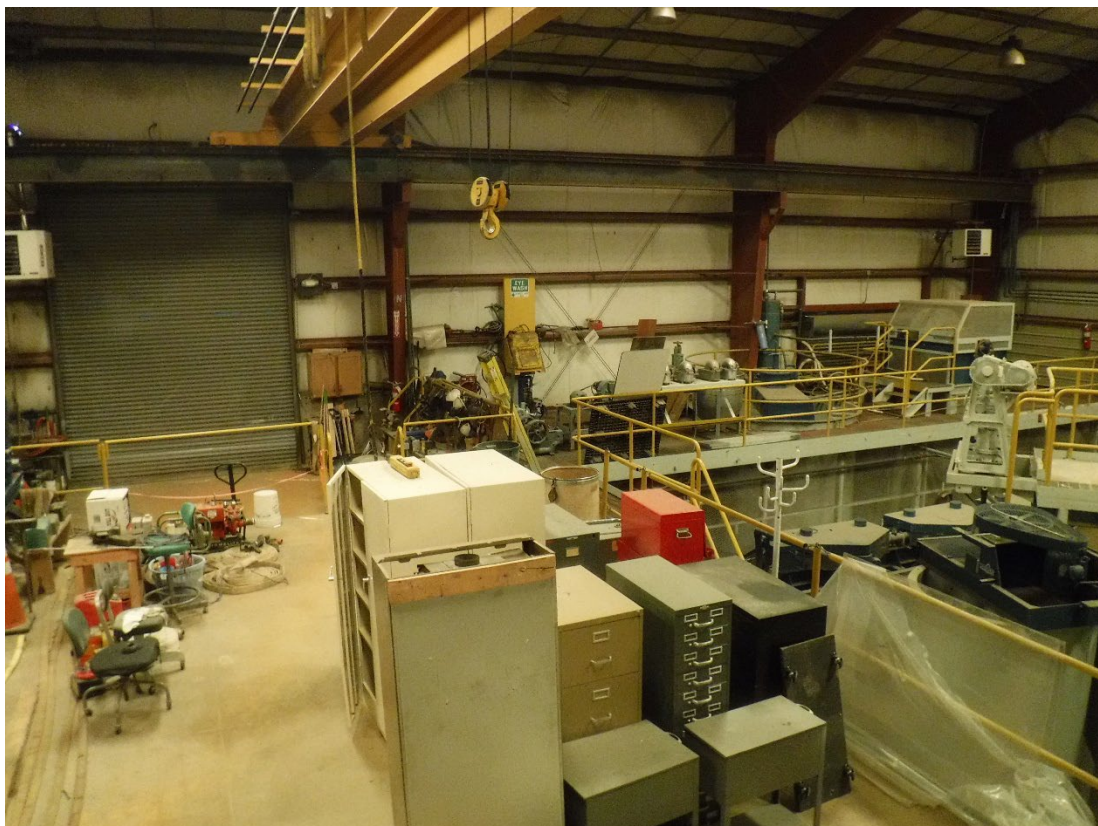
Photo 2: Conditions within the Mill Building

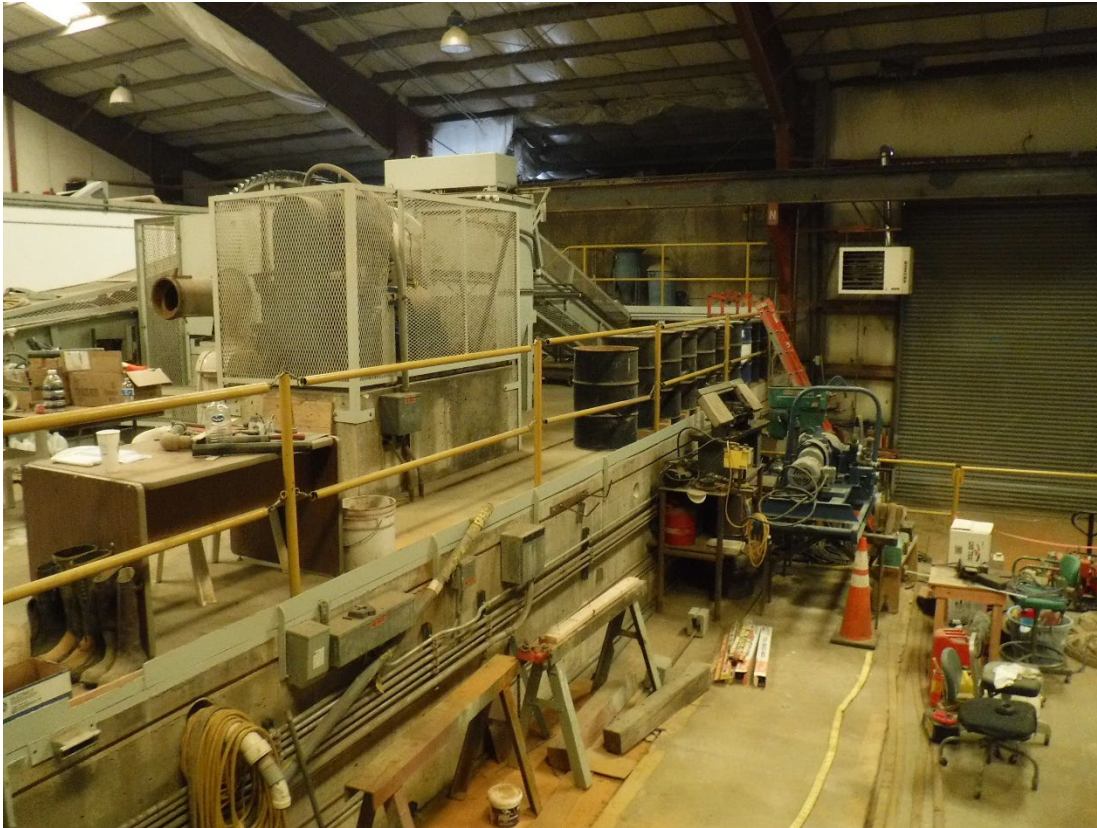
Photo 3: Conditions within the Mill Building

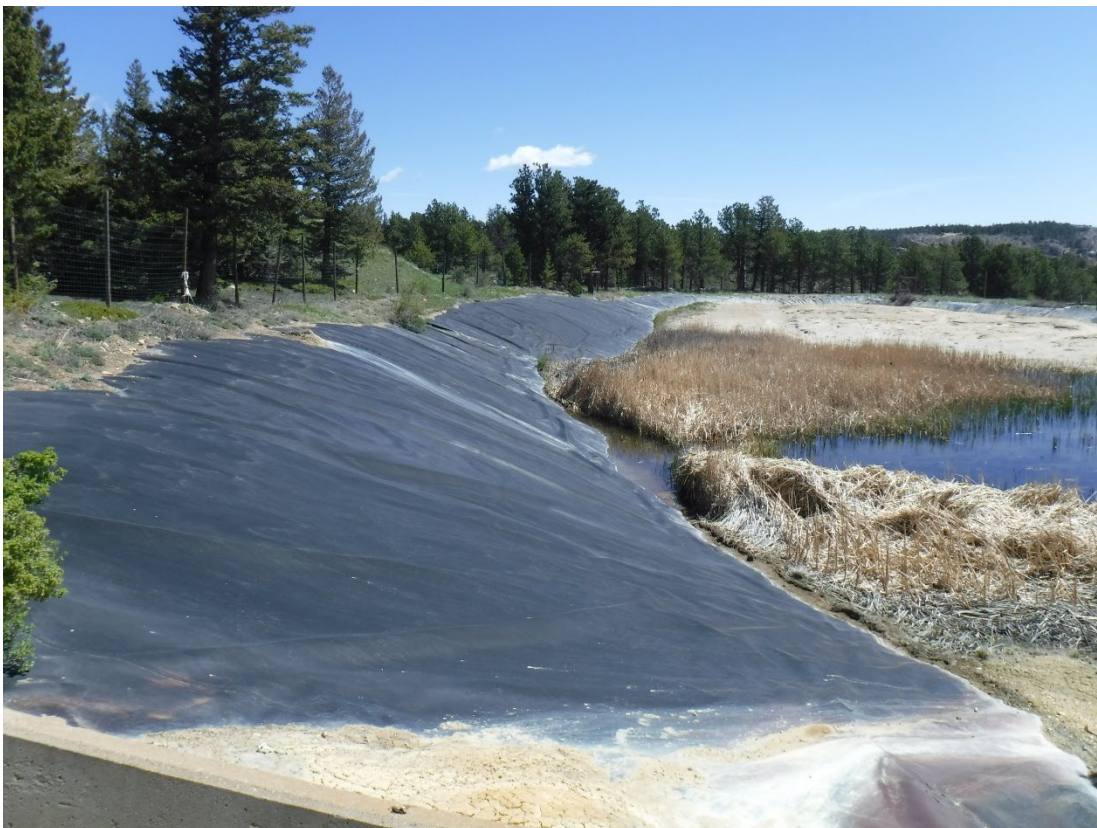
PROBLEM: As approved with CN-1, the TSF is a designated Environmental Protection Facility containing tailings material requiring recertification or final reclamation. During the October 2023 pre-operation inspection of the site, the Division noted several issues with the liner of the TSF, including, but not limited to, holes in the liner and animal burrows in the embankments. In adequacy review response no. 4, dated January 26, 2024, the Operator committed to providing an evaluation as to whether the TSF can be recertified. If not, or if there is insufficient capacity for further use, then closure would take place. The Operator committed to providing this evaluation no later than August 1, 2024. This commitment was part of the Division's rationale for approval of the conversion application. To date this item remains outstanding.

Photo 4: Looking east along the northern embankment of TSF

CORRECTIVE ACTIONS: The date for satisfying the TSF commitment by submitting the required evaluation is due within sixty (60) days from the signature date of this inspection report, July 20, 2025.

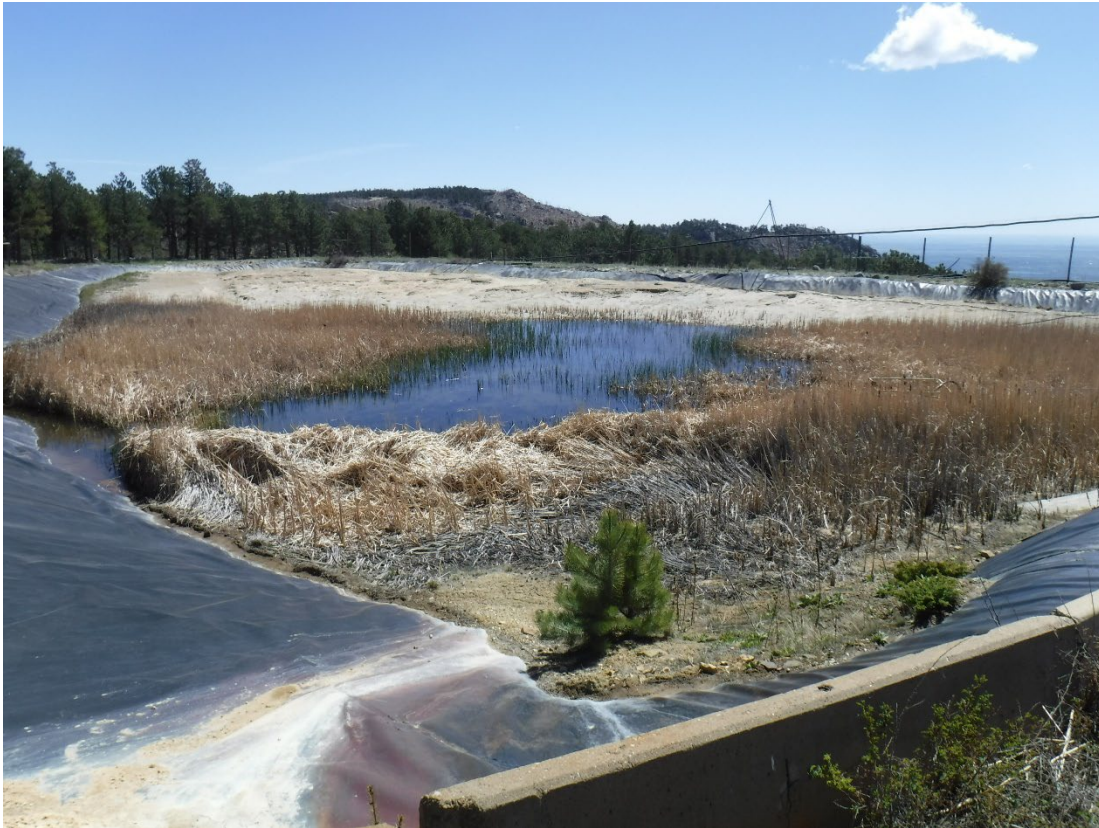
Photo 5: Looking across the TSF

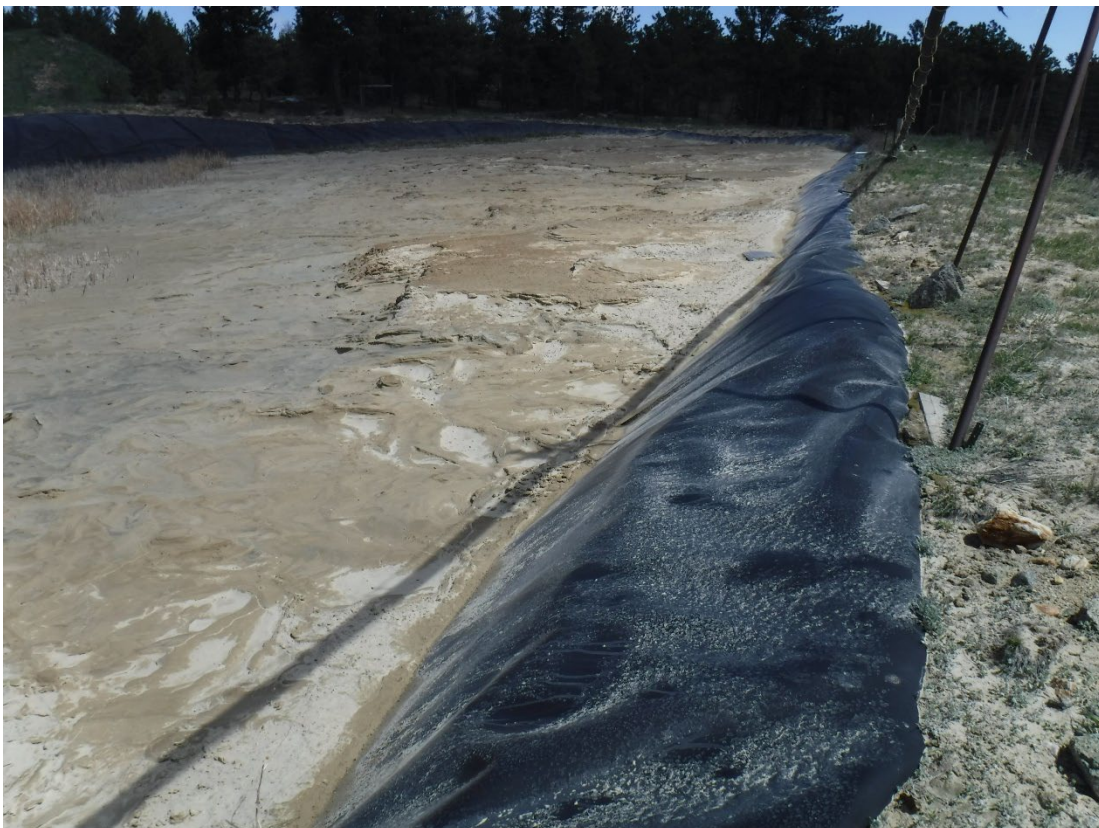
Photo 6: Looking east along the southern embankment of the TSF

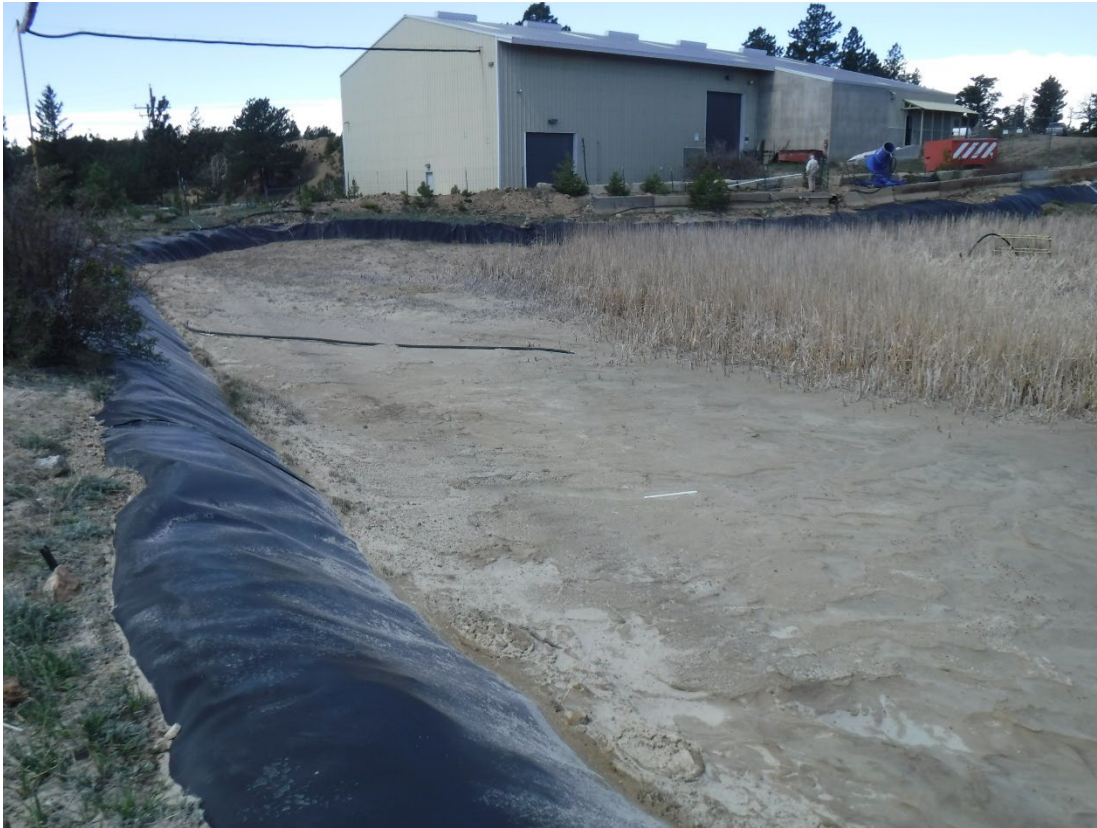
Photo 7: Looking west along the southern embankment of the TSF

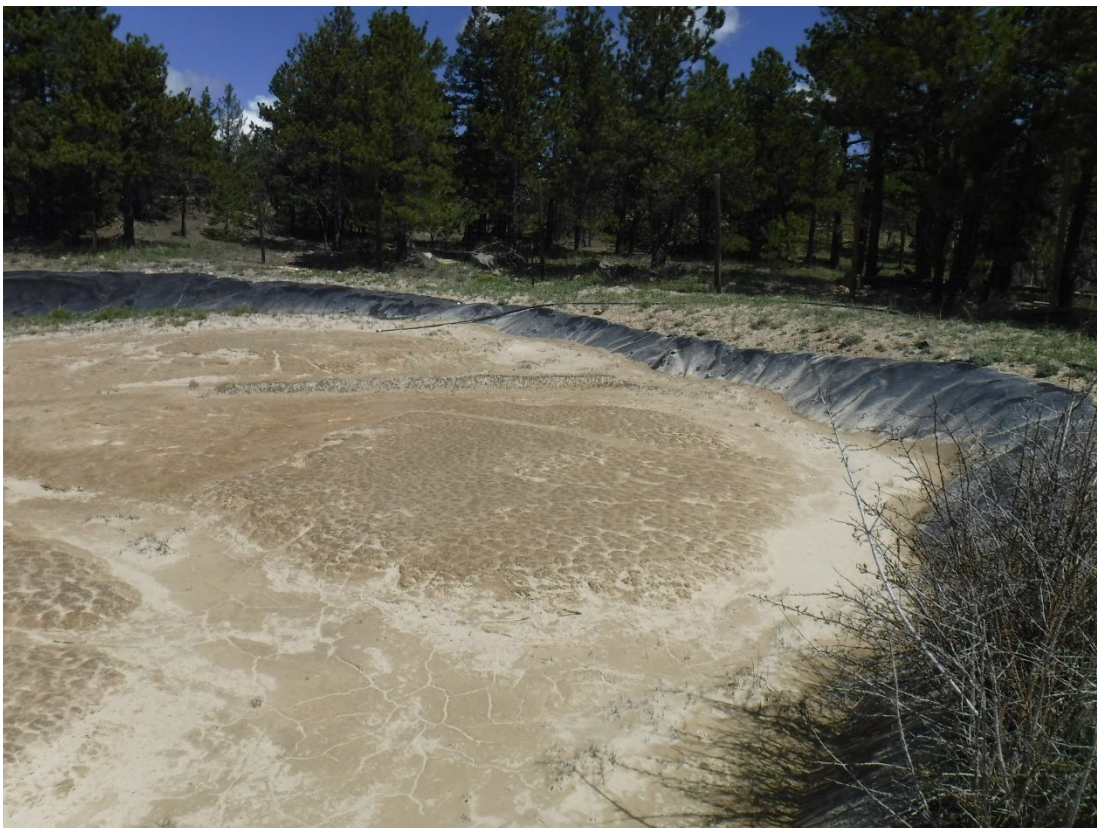
Photo 8: Eastern embankment of the TSF

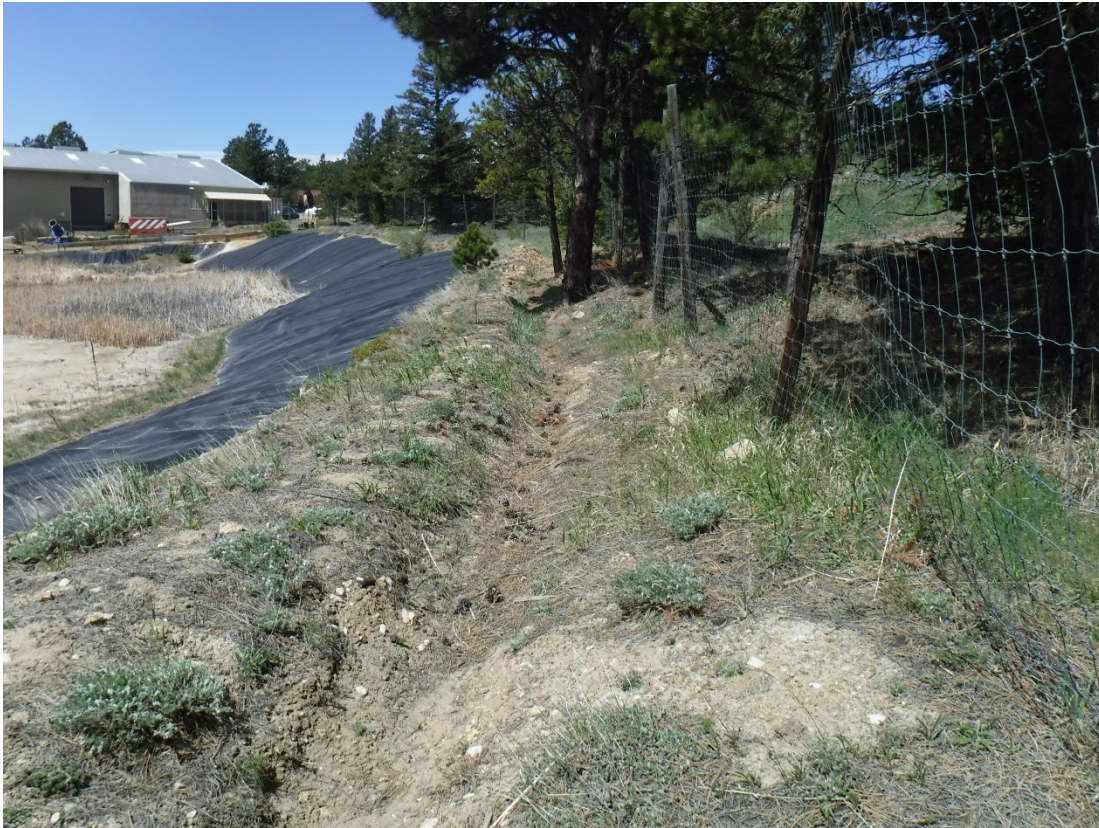
Photo 9: Run on/off control ditch along northern boundary of the TSF

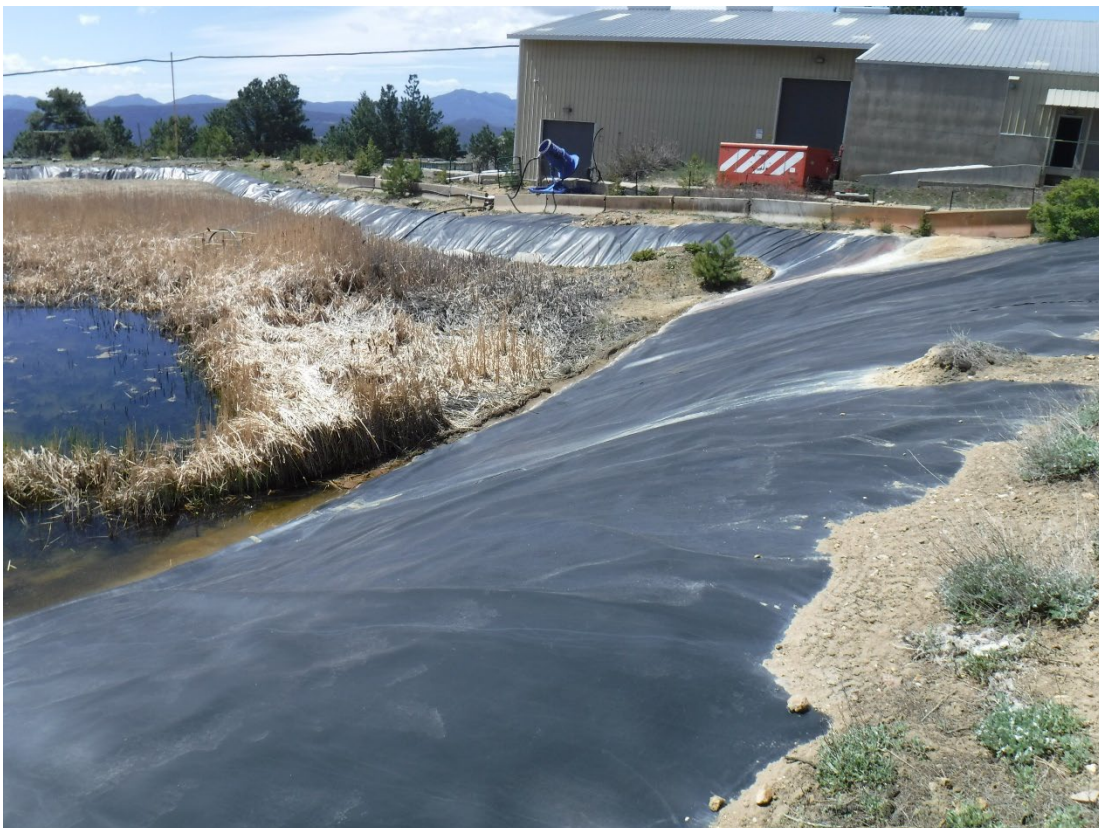
Photo 10: Western embankment of the TSF

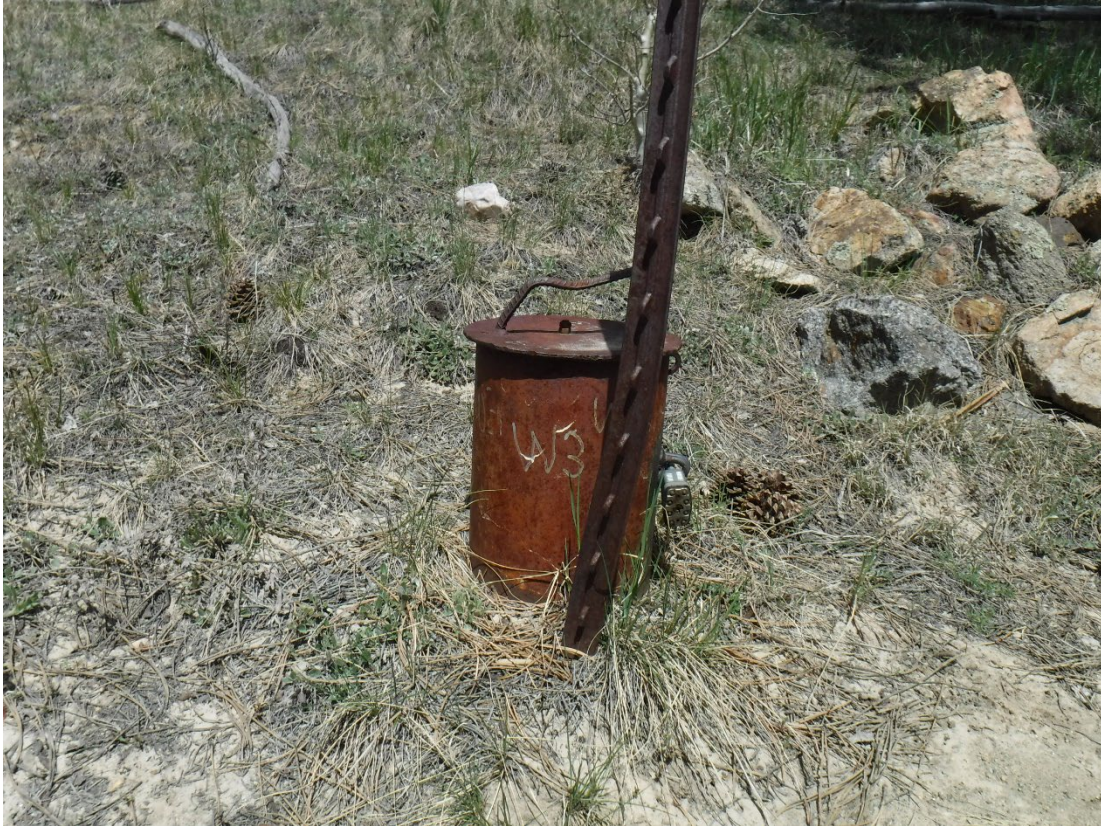
Photo 11: Monitoring Well W-3 south of TSF

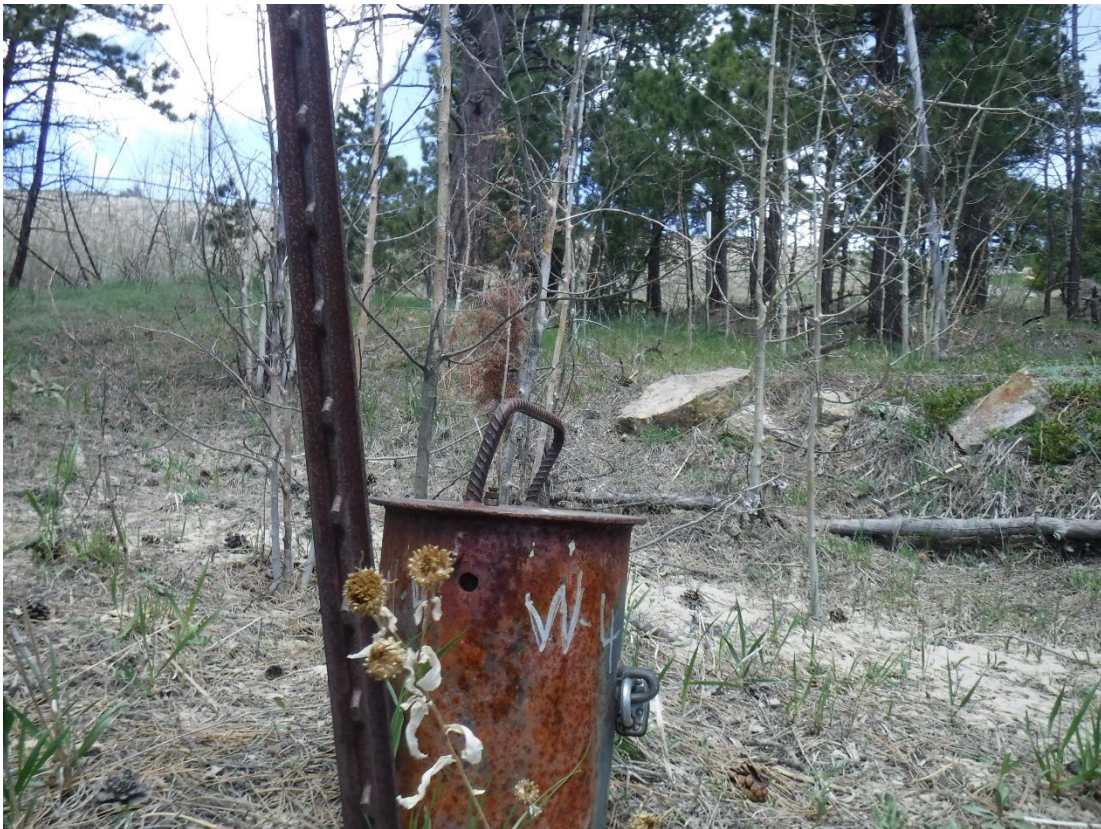
Photo 12: Monitoring Well W-4 south of TSF

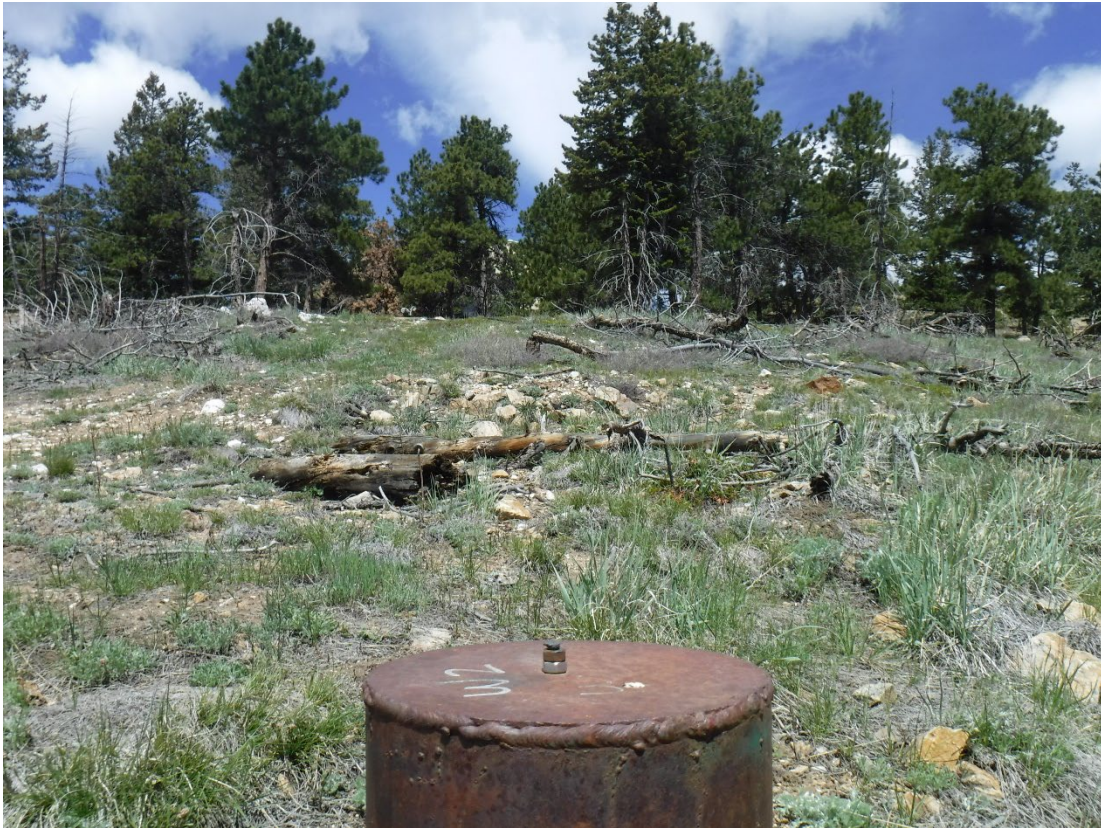
Photo 12: Monitoring Well W-2 south of Mill Building

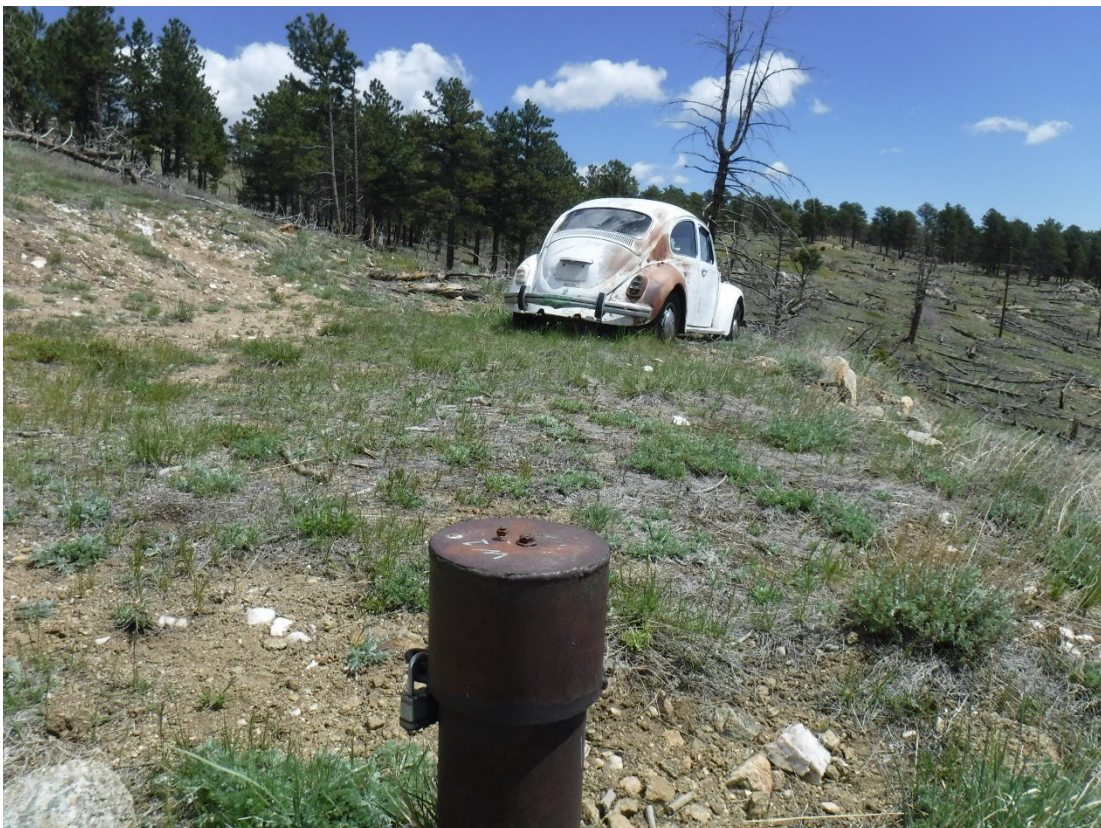
Photo 12: Monitoring Well W-1 west of W-2 located on the other side of Beetle
