MINERALS PROGRAM INSPECTION REPORT
PHONE: (303) 866-3567

MINE NAME: AZCO Pit	MINE/PROSPECTING ID#: M-2004-029	MINERAL: Sand and gravel	COUNTY: Fremont
INSPECTION TYPE: Monitoring	WEATHER: Clear	INSP. DATE: April 16, 2025	INSP. TIME: 09:00
OPERATOR: AZCO Construction, Inc.	OPERATOR REPRESENTATIVE: Mr. Ronald Walker	TYPE OF OPERATION: 110c - Construction Limited Impact

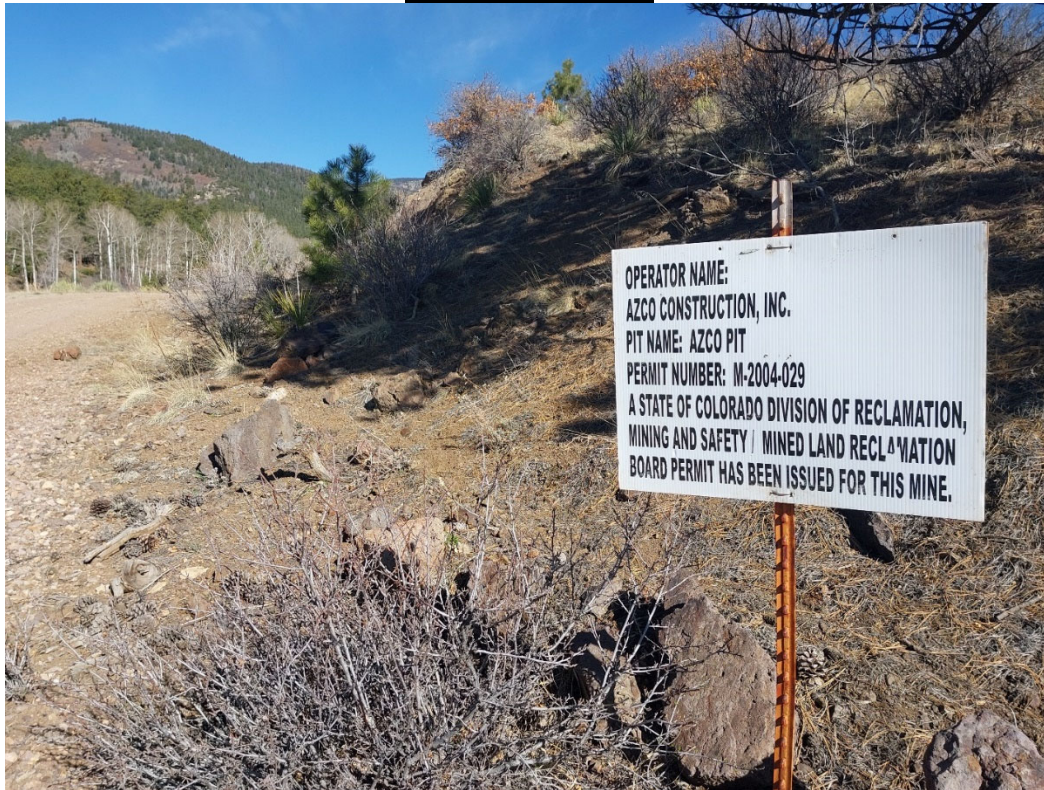
A mine sign is posted in accordance with Rule 3.1.12(1), see Photo #1. The permit boundary is marked with orange T-posts, see Photo #2.

Photo #1: Mine sign posted near the entrance of the pit on Walker Road.

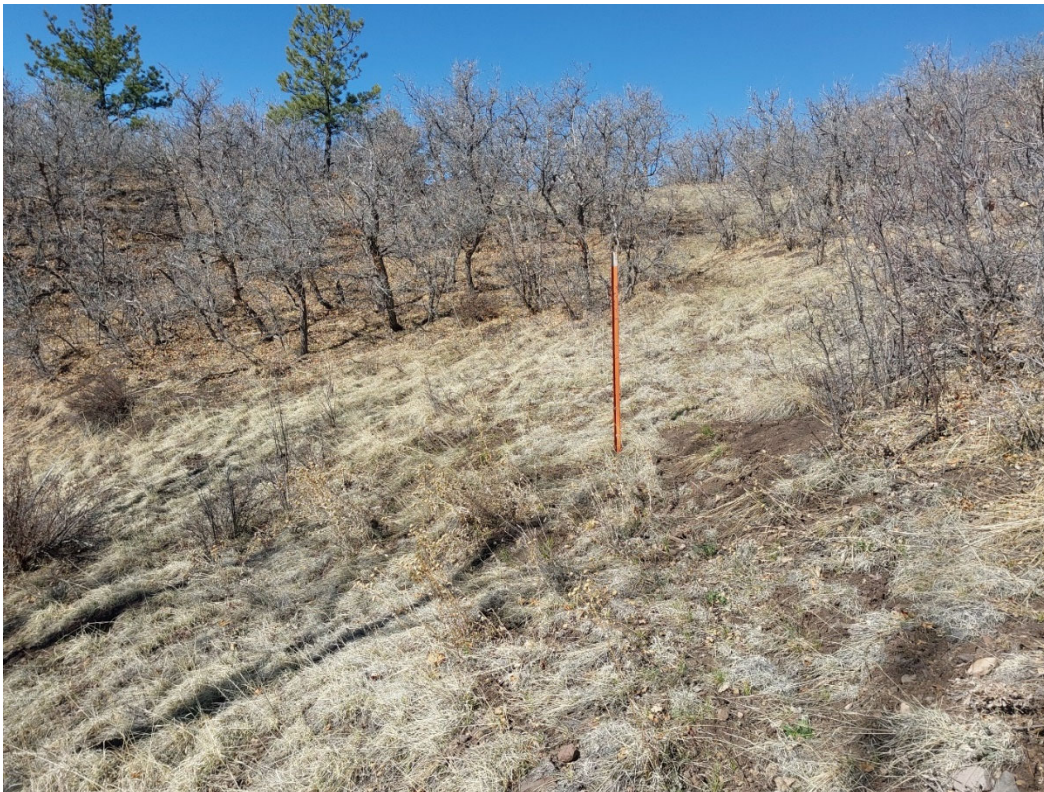
Photo #2: A permit boundary marker, located on the northwest corner, looking to the north.

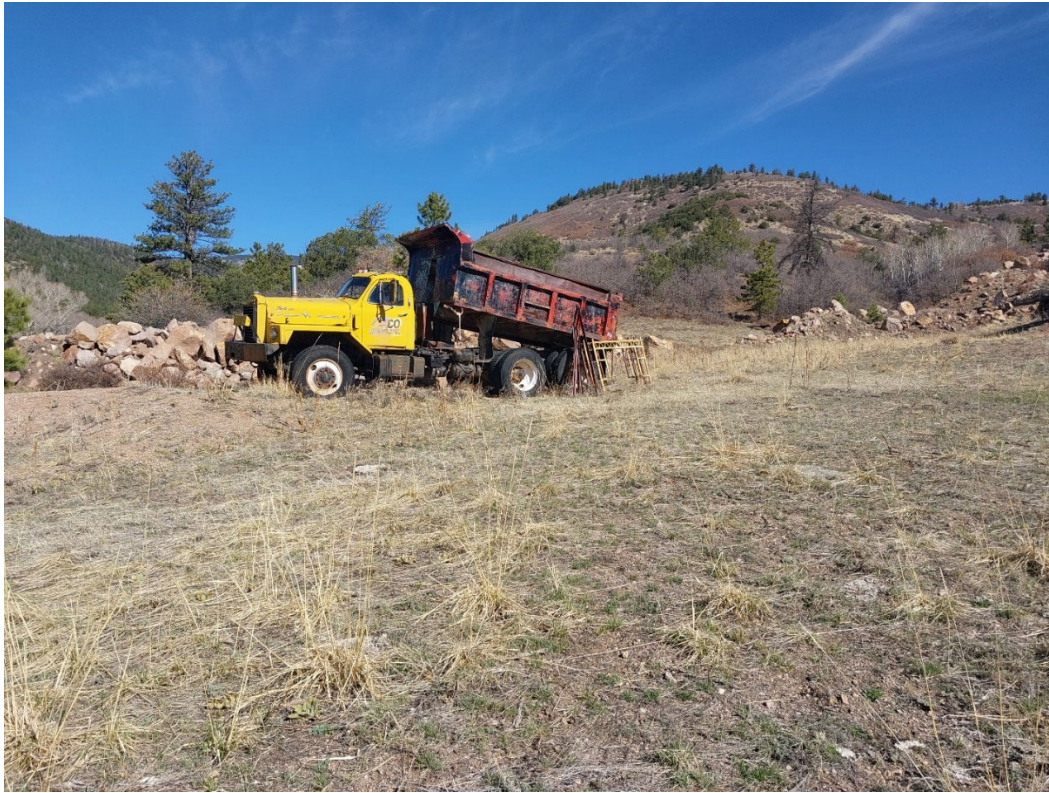
Photo #3: The dump truck kept on site, in front of a stockpile of material.

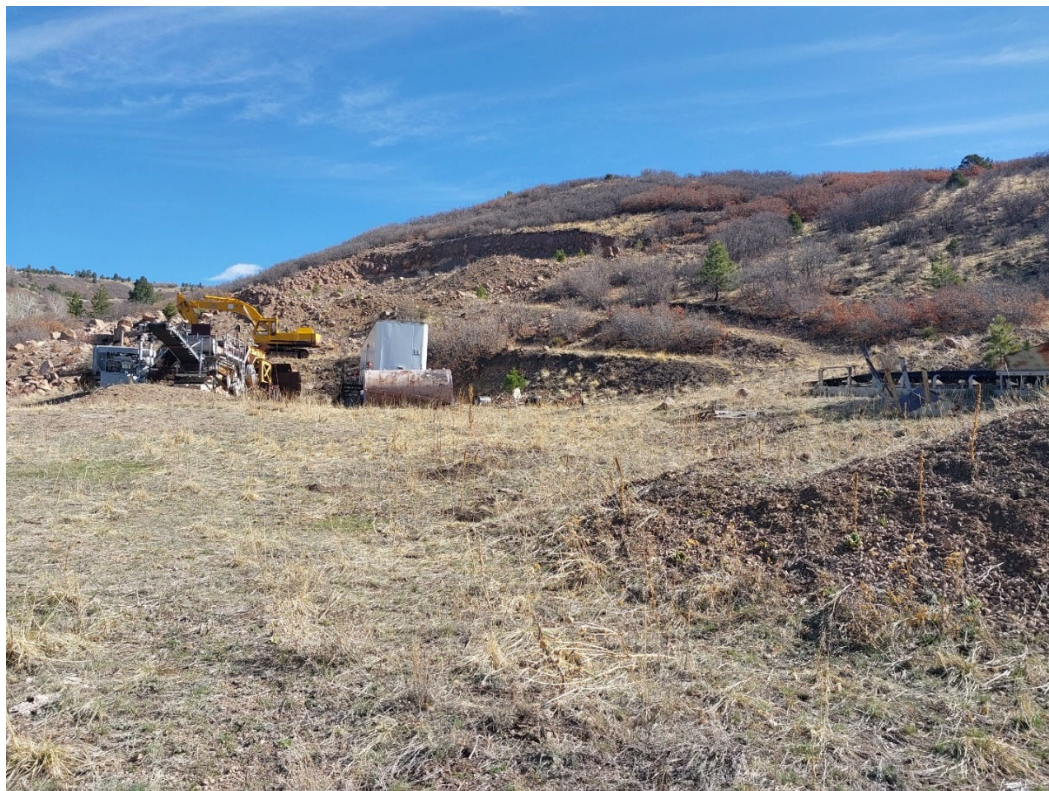
Photo #4: The excavator, processing plant, generator, trailer and fuel tank can be seen on the left side of the photo. The equipment parts can be seen on the right side of the picture. The two benches leading up to the working area and the high wall can be seen in the background.

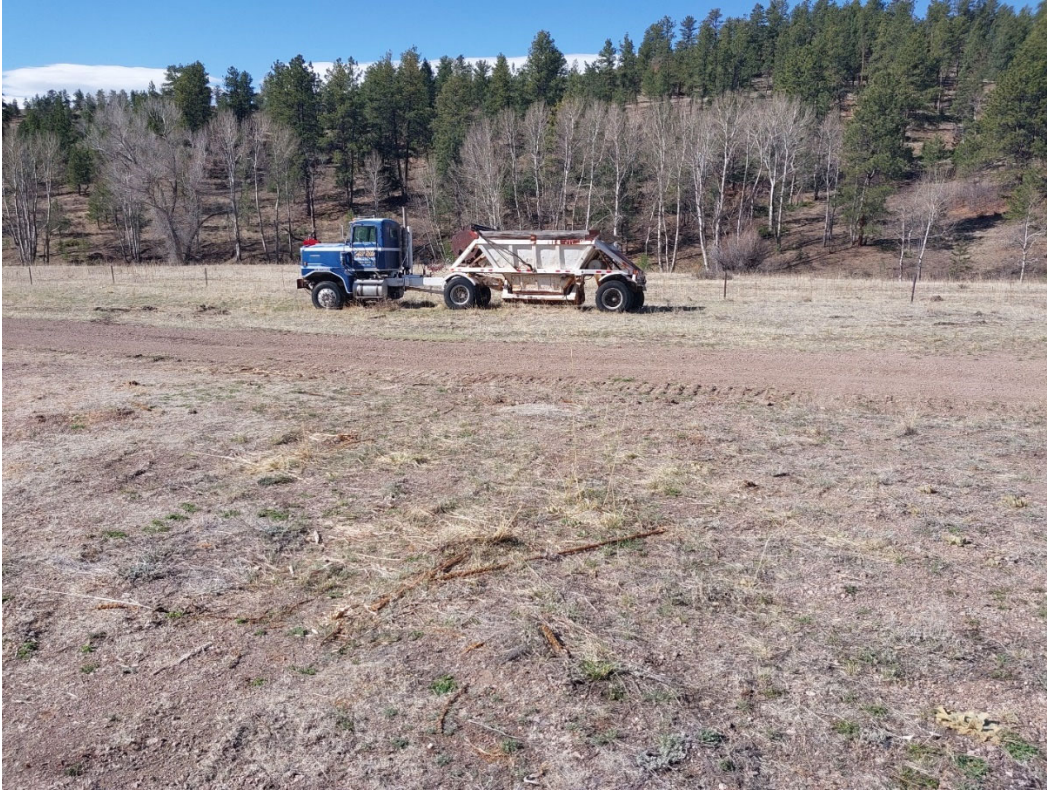
PROBLEM #2: A rock truck and processing plant appear to be stored just outside the permit boundary. According to Rule 1.3, this use of the land can be attributed to mining activity and is considered affected lands. This is a possible violation at this time pursuant to C.R.S. 34-32.5-116(4)(i) for failure to protect areas outside of the affected land from slides or damage occurring during the mining operation.

There is a dump truck and a processing plant that has been kept on the southwest side of Walker Road, outside the permit boundary, see Photos #5 and #6. This equipment is associated with mining activities and should be kept within the permit boundary or removed from the area. This is cited as Problem #2, see the above citation for the corrective action information and due date.

Photo #5: The rock truck sitting on the southwest side of Walker Road, outside the permit boundary that needs to be moved.

CORRECTIVE ACTIONS: Option 1) The rock truck and processing plant need to be moved into the approved permit boundary or removed from the area. Photographs of the removed rock truck and processing plant shall be sent to the Division by the corrective action due date. Option 2) Provide a letter to the Division from the landowner stating that the equipment is their personal property that is being stored in that area and no longer used for the mining operation by the corrective action due date.

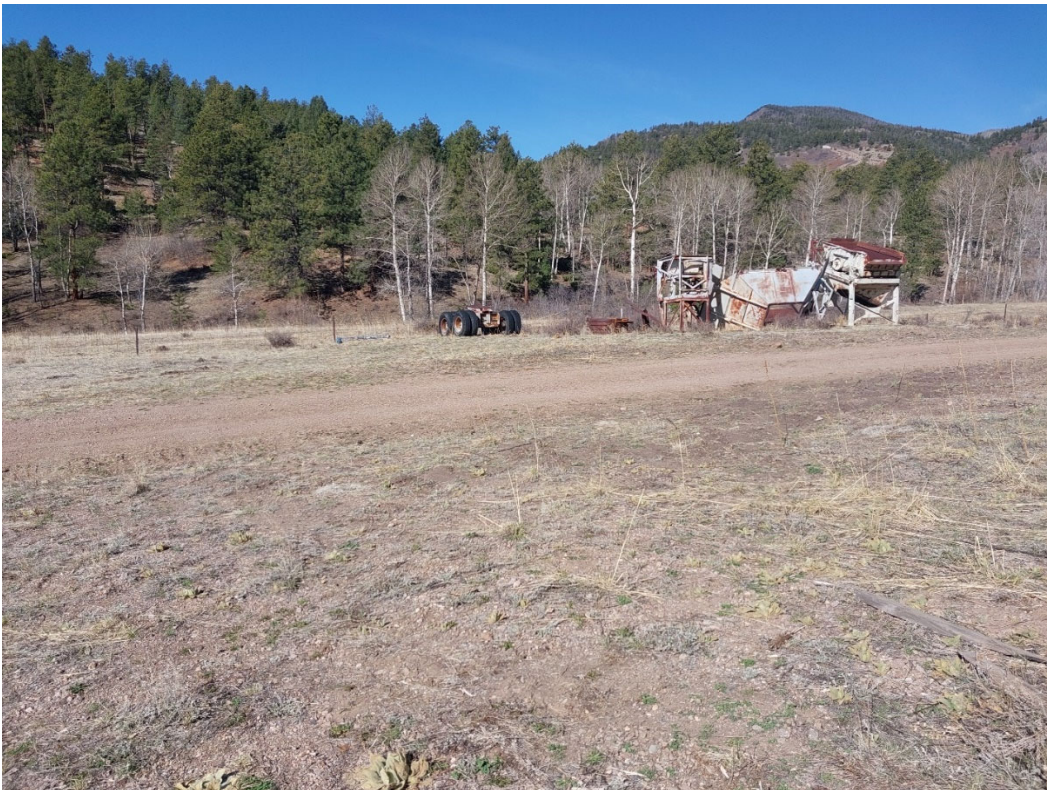
Photo #6: The processing plant sitting on the southwest side of Walker Road, outside the permit boundary that needs to be moved.

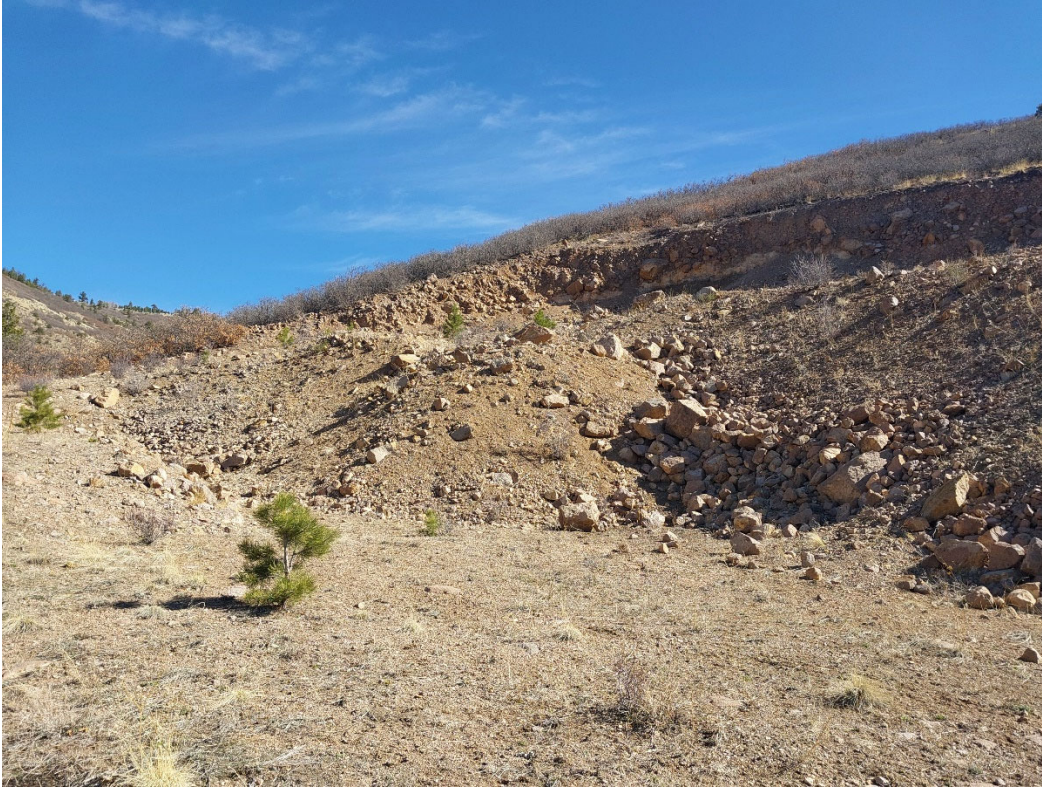
The technical revision TR-1, approved by the Division on March 10, 2020, gave approval of the benches to remain and the slopes to be left at 2H:1V. This reclamation task has not been performed.

Photo #7: View of the upper bench and base of the highwall from the middle bench, looking north. The slope needs to be graded and stabilized. Vegetation, including trees and shrubs, that have voluntarily established can be seen.

Voluntary vegetation has established on the benches of the affected area, including numerous pine trees. It is recommended that the operator preserve the trees prior to beginning reclamation tasks in effort to re-establish them in the affected area.

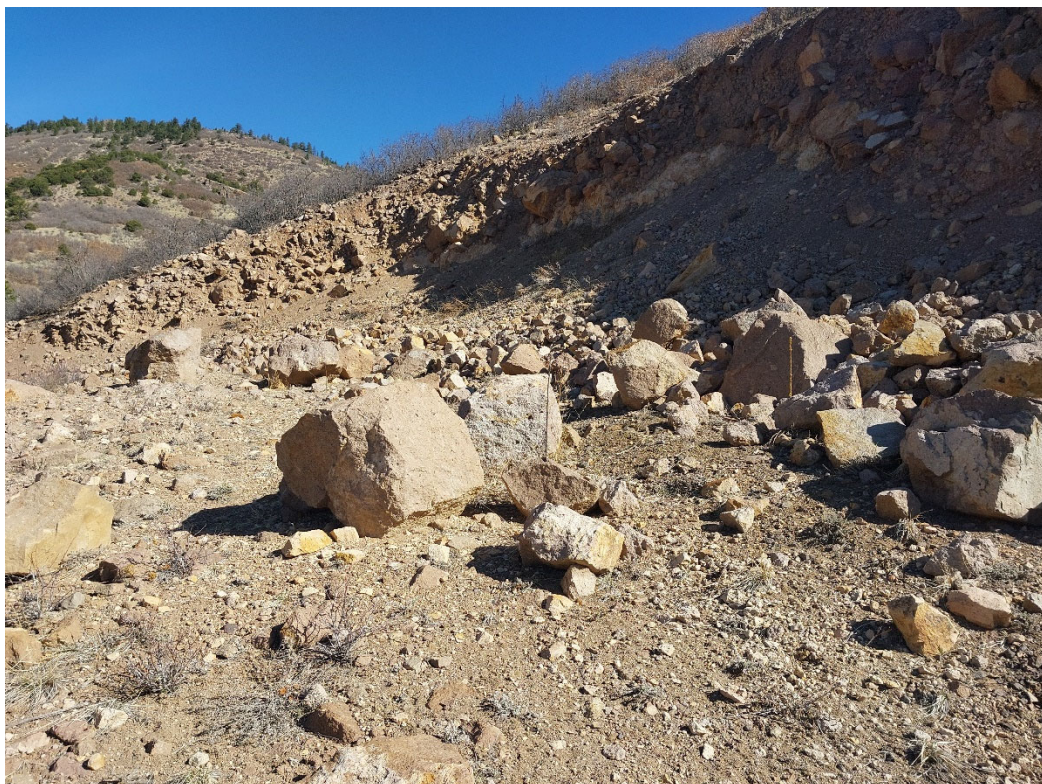
Photo #8: View of the upper bench with the highwall seen to the right, looking north.
