**MINERALS PROGRAM INSPECTION REPORT**  
**PHONE: (303) 866-3567**

| <b>MINE NAME:</b><br>Climax Mine | <b>MINE/PROSPECTING ID#:</b><br>M-1977-493 | <b>MINERAL:</b><br>Molybdenum | <b>COUNTY:</b><br>Lake |
| <b>INSPECTION TYPE:</b><br>Monitoring | <b>WEATHER:</b><br>Clear | <b>INSP. DATE:</b><br>May 14, 2025 | <b>INSP. TIME:</b><br>12:30 |

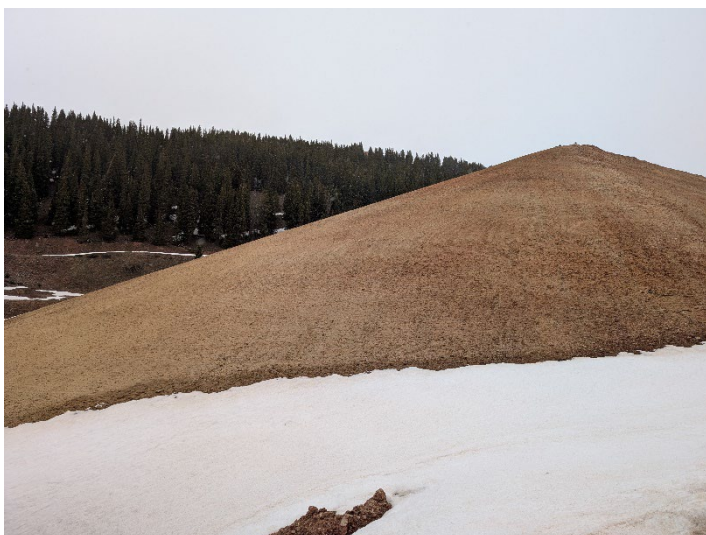
McNulty Topsoil Stockpile

Topsoil stockpiles in the OSF area appeared to be stored in stable configurations adequate to minimize loss due to wind or erosion, and to be preserved in a usable condition for reclamation.
