MINERALS PROGRAM INSPECTION REPORT
PHONE: (303) 866-3567

MINE NAME: Tomichi Pit	MINE/PROSPECTING ID#: M-2013-081	MINERAL: Gravel and sand	COUNTY: Gunnison
INSPECTION TYPE: Monitoring	WEATHER: Clear	INSP. DATE: April 29, 2025	INSP. TIME: 09:00
OPERATOR: Tomichi Materials, LLC	OPERATOR REPRESENTATIVE: Dean Rogers	TYPE OF OPERATION: 112c - Construction Regular Operation	
REASON FOR INSPECTION: Normal I&E Program	BOND CALCULATION TYPE: Complete	BOND AMOUNT: \$269,536.10	
DATE OF COMPLAINT: NA	POST INSP. CONTACTS: None	JOINT INSP. AGENCY: None	
INSPECTOR(S): Dustin Czapla	INSPECTOR'S SIGNATURE:

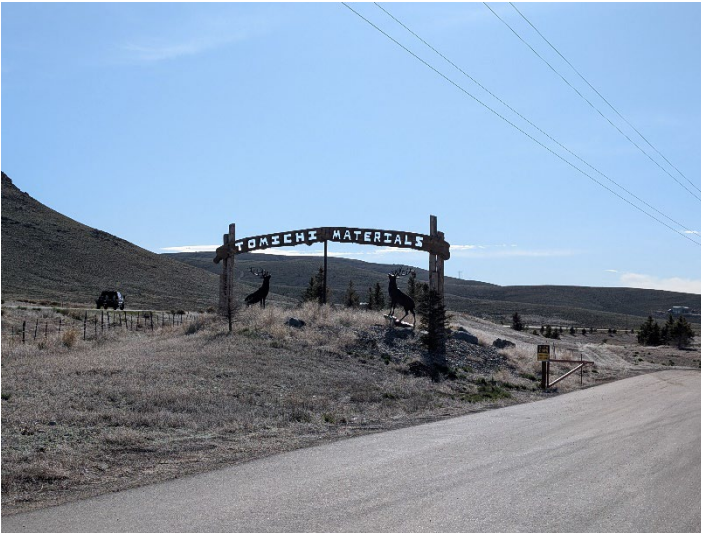
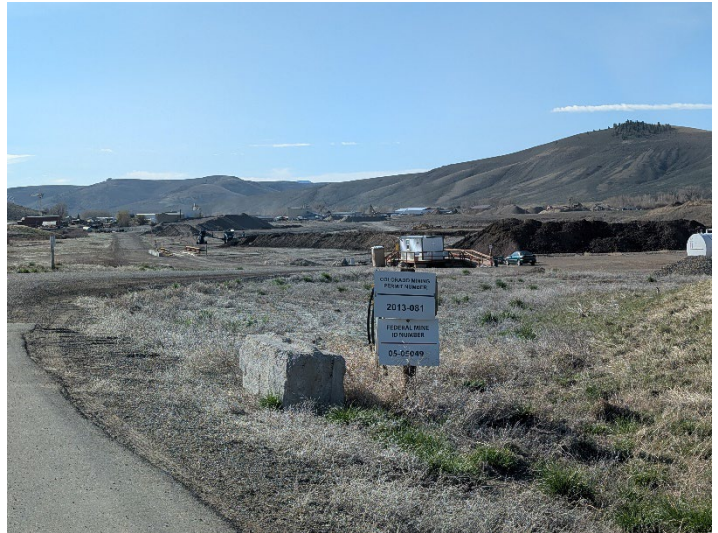
Adequate mine identification signage was noted at the entrance to the site.

Sign at entrance

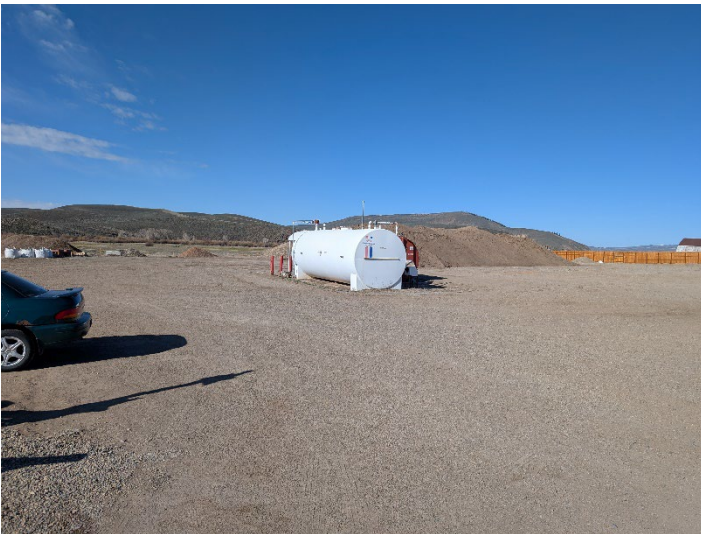
A scale and scalehouse are located near the entrance to the site. Fuel is stored in this area in a double walled container.

Fuel storage near scalehouse

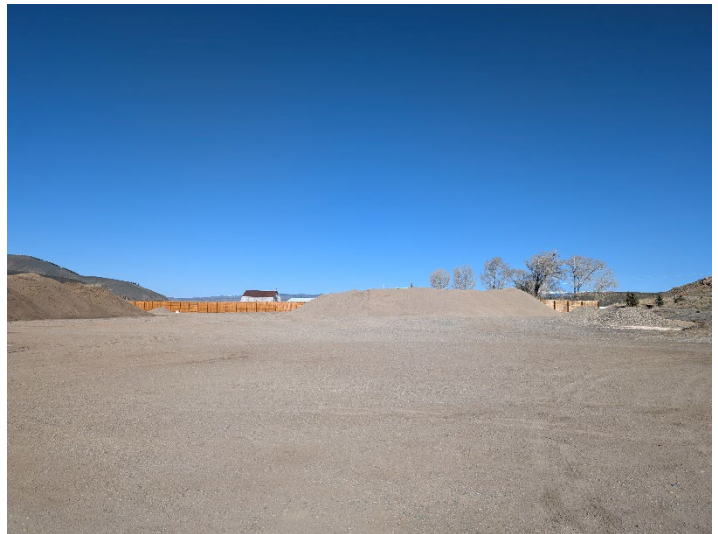
Stockpile area near scalehouse

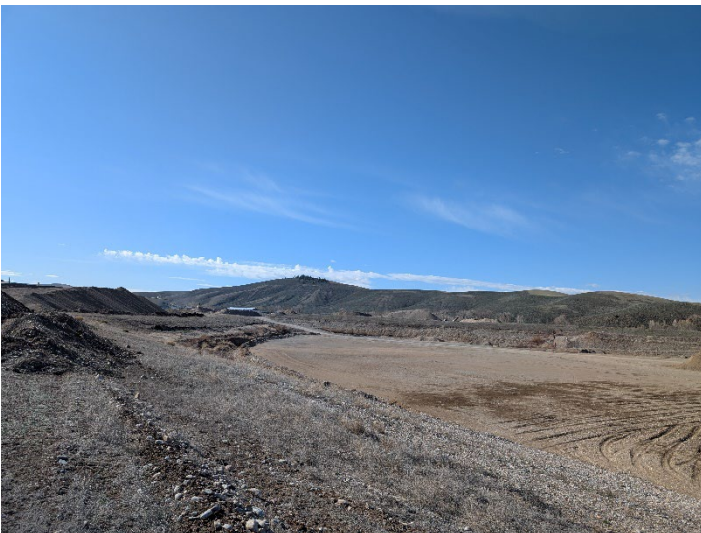
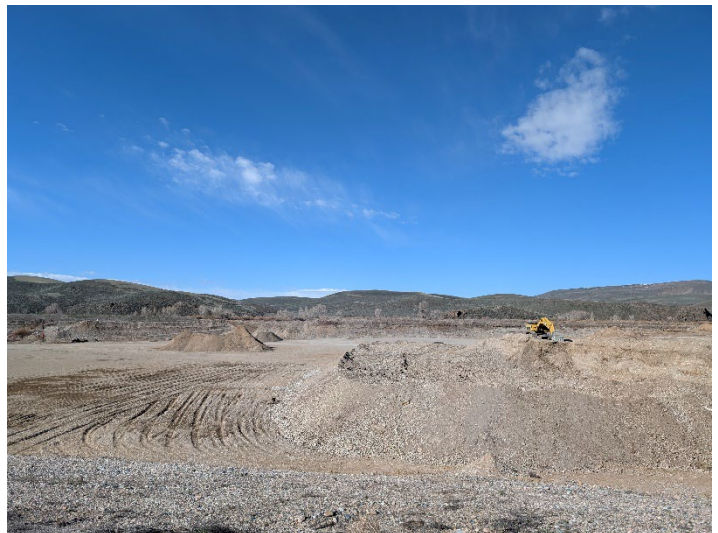
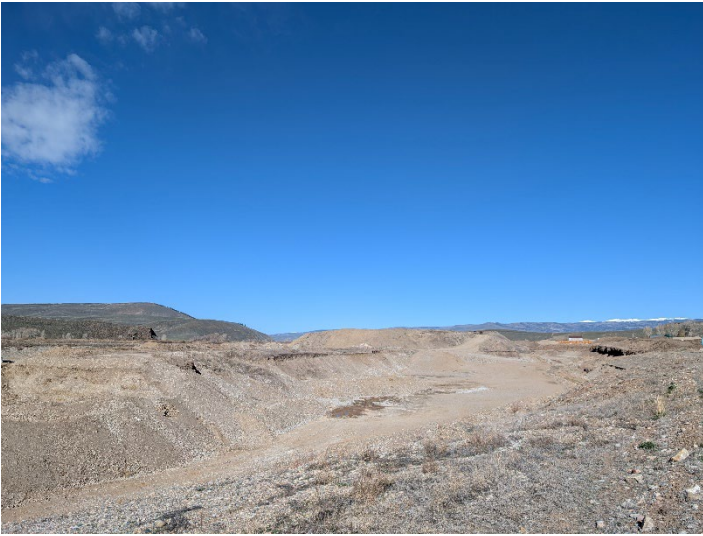
The pit area is located in the north part of the Stage 1 area. The pit has been mined from east to west and is nearing its western limit. The pit has been mined to a depth of approximately 20 feet. Highwalls have been mined to an approximate 1:1 slope. A dewatering trench has been constructed around the pit. Topsoil is stockpiled on the west side of the pit in a stable configuration.

Pit viewed from northeast end

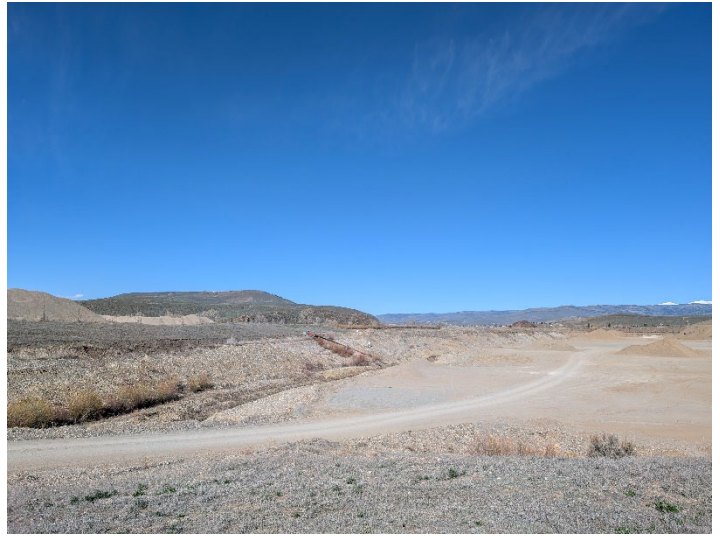
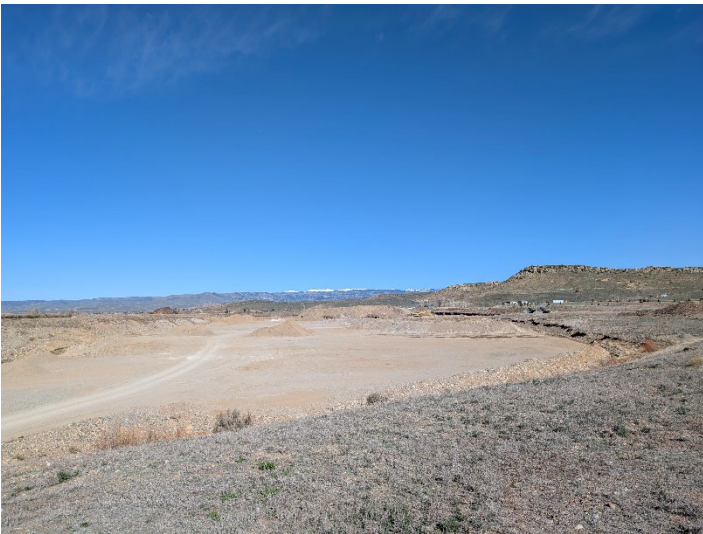
Pit viewed from east side

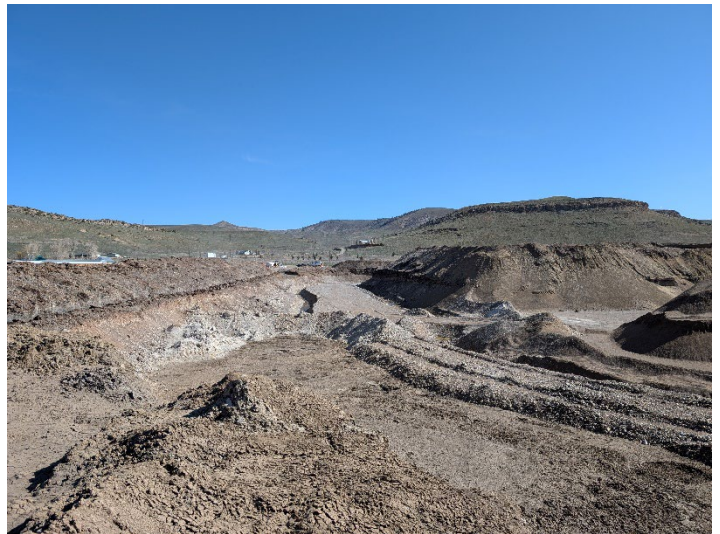
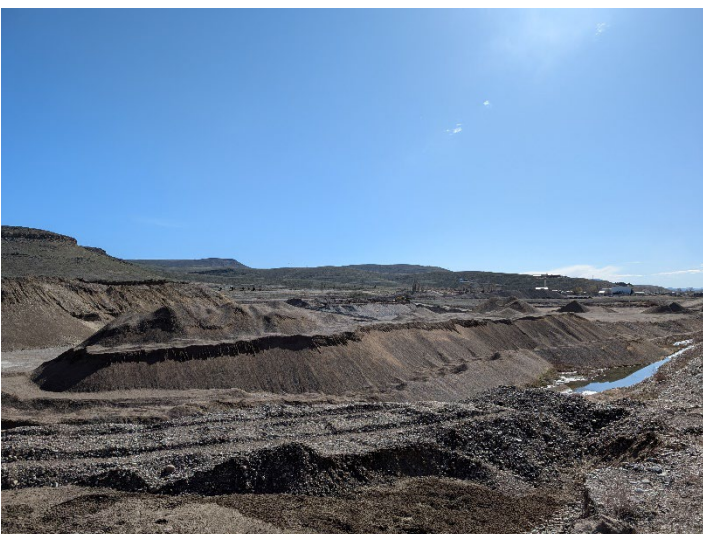
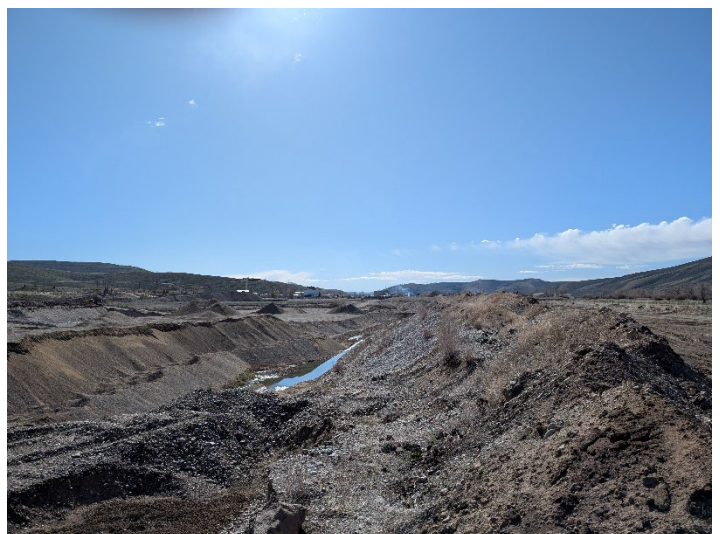
Pit viewed from southwest end

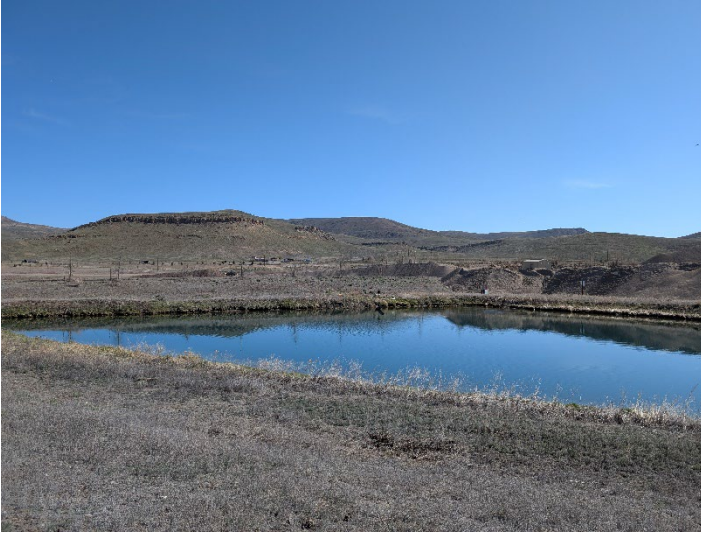
Wash pond near crusher

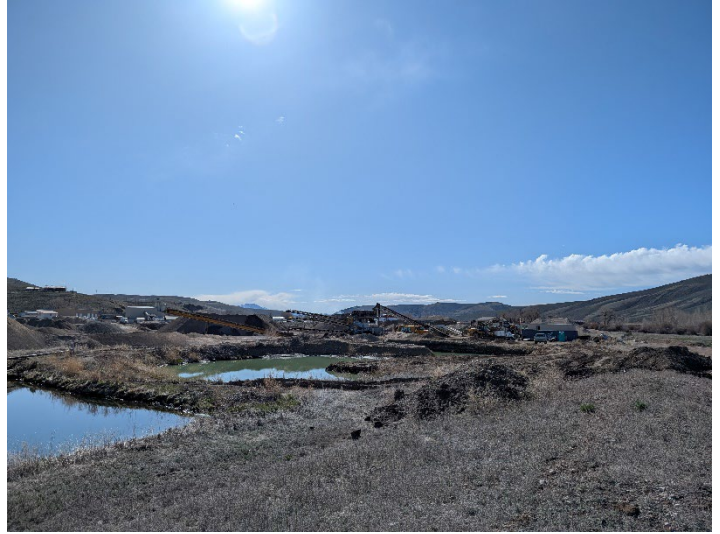
The site is still mining in the Stage 1 area. Approximately 68 acres are currently disturbed at the site. A processing plant and stockpile area are set up in the southeast part of the permit area. This area is still above the water table at an elevation of approximately 7,720'. Wash ponds are located on the west side of the crusher. The processing area is orderly. Stormwater berms are in place and appear well maintained.

Wash ponds and crushing area
