**MINERALS PROGRAM INSPECTION REPORT**  
**PHONE: (303) 866-3567**

| <b>MINE NAME:</b><br>Henderson Mine | <b>MINE/PROSPECTING ID#:</b><br>M-1977-342 | <b>MINERAL:</b><br>Molybdenum | <b>COUNTY:</b><br>Clear Creek |
| <b>INSPECTION TYPE:</b><br>Monitoring | <b>WEATHER:</b> Clear | <b>INSP. DATE:</b><br>May 12, 2025 | <b>INSP. TIME:</b><br>09:00 |

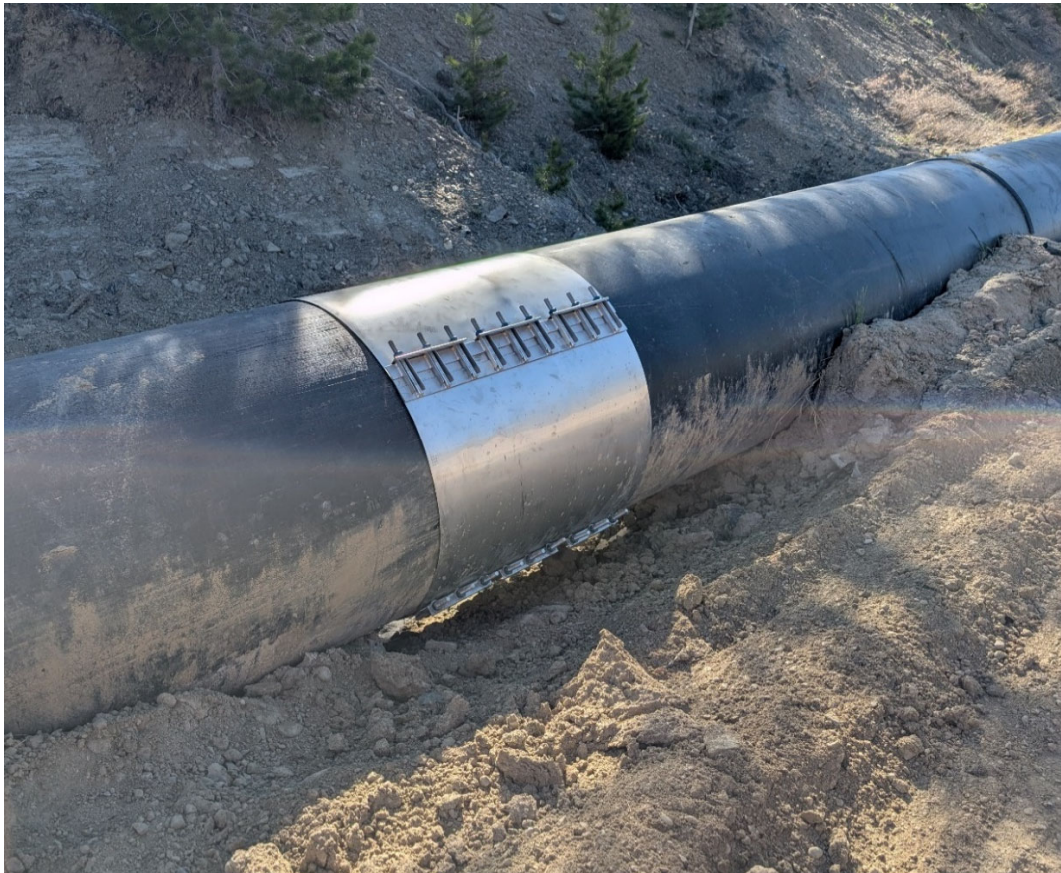
During the inspection, the Division observed a section of 42" HDPE pipeline that conveys tailings slurry from the Mill to the TSF. The leak occurred at a joint where two sections of HDPE pipeline are fused together. Mr. Hickman informed the Division that approximately 200 gallons of slurry leaked from the pipeline over the course of 30 minutes. The tailings slurry was rerouted to the No. 1 Cutout and the pipe was repaired using a metal band (Photos 1-3). The spilled tailings slurry around the pipeline will be placed into the tailings impoundment as practicable.

Photo 1: Looking at a section of the HDPE tailings delivery line where the leak occurred. A metal banded clamp was used to repair the pipe.

The Operator explained the cause of the leak was likely scouring at the joint. In the steeper sections of HDPE, the fused bead around the connecting joints causes eddy erosion in the pipeline over time (Photo 4). The pipelines are inspected daily for leaks and ultrasonic NDT (non-destructive testing) is completed near flanges and fuses each year to evaluate wear and erosion. Based on the data collected, sections of pipeline are rotated to prevent scouring on one side and replaced as needed. According to the Operator, the section of pipeline where the leak occurred will be replaced during the summer of 2025. The metal band will remain in place until then.

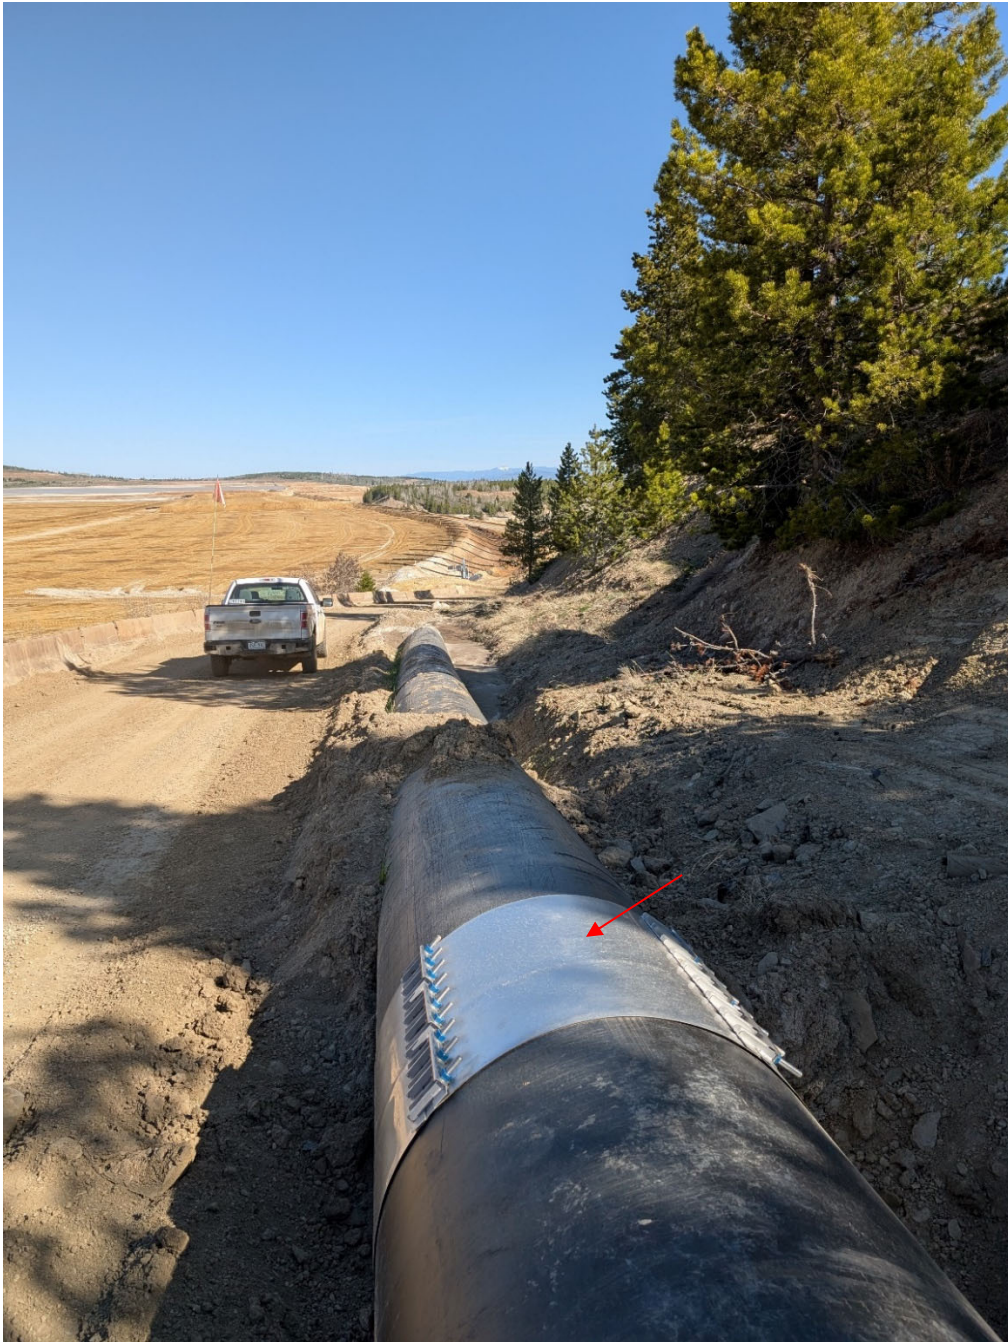
Photo 2: View looking northeast at the Tailings Delivery line, adjacent access road, and beginning of 3-Dam. The banded section is where the leak occurred (red arrow). Tailings flowed along the access road and the spill was contained in this area.

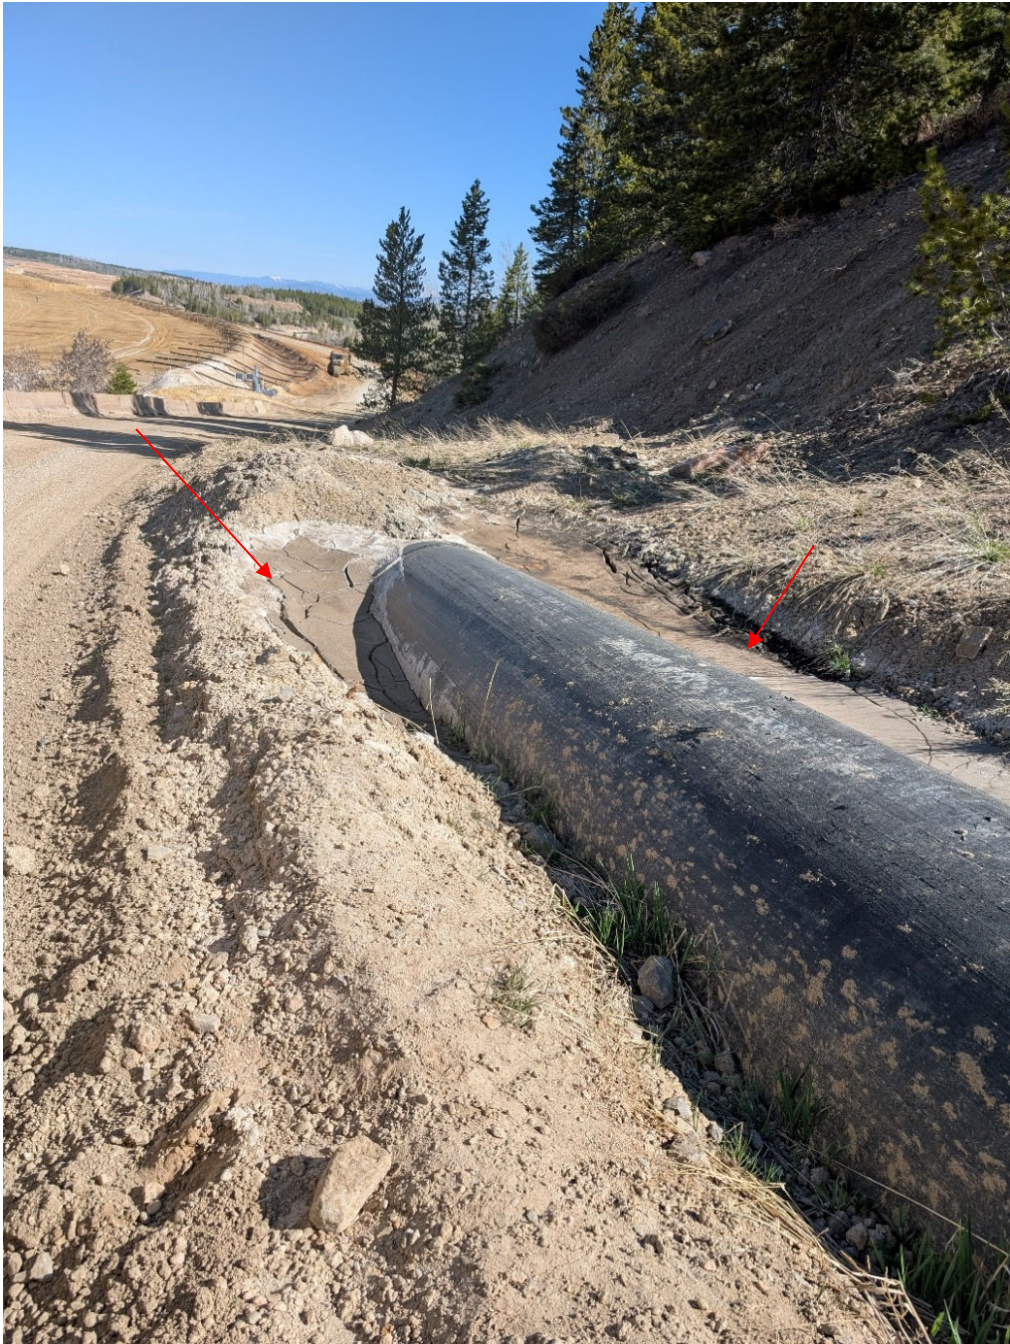
Photo 3: Looking at the area where the spilled tailings slurry accumulated when it leaked out of the HDPE pipe.

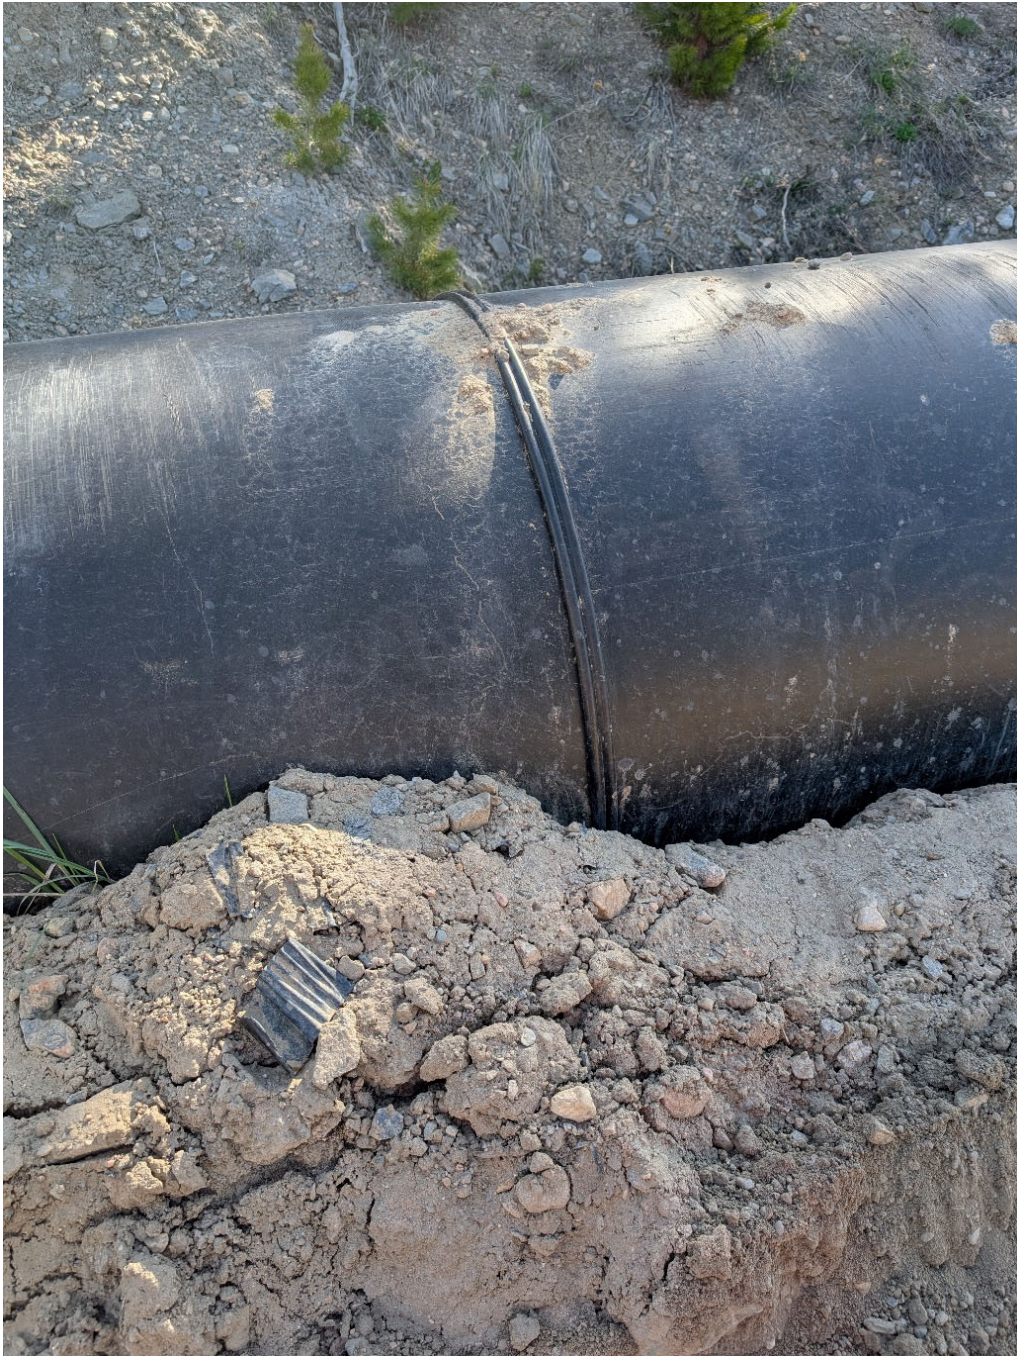
Photo 4: Connecting joint along the HDPE tailings line. Over time, the pipe tends to scour at these joints, especially in steeper sections.

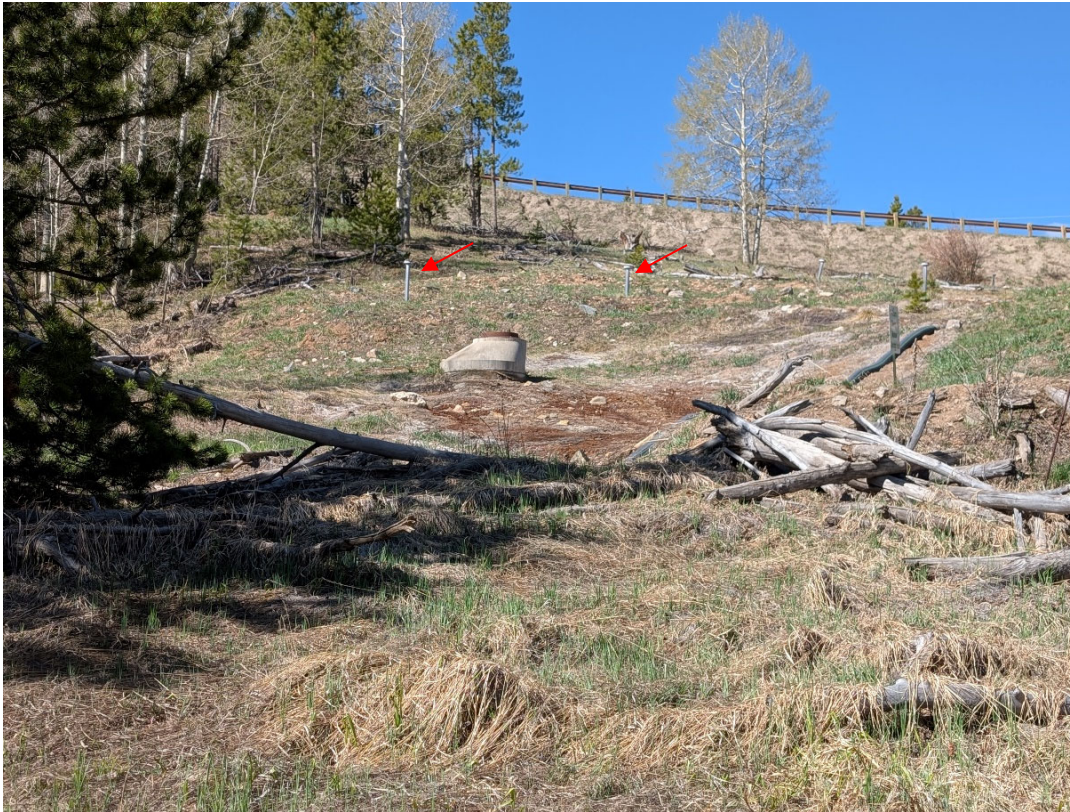
During this inspection, the Division observed the seepage collection area below 3-Dam (Photo 5). Mr. Hickman stated that during a routine inspection, staff observed seep water flowing from an overflow pipe (Photo 9). They determined that the pipeline was clogged between two cleanout ports, diverting flow to the overflow pipeline. Generators were brought in and used to pump water from the vault and the clogs were flushed out (Photo 7). Overflow water was contained in the seepage area below the dam. The Division did not observe any evidence of seep water flowing outside the immediate collection area. Mr. Hickman informed the Division that the pipelines clog due to precipitate formation in the lines and staff conduct routine inspections of the collection area daily and clean out the lines in the spring. Following the incident, Henderson implemented additional preventive maintenance measures which include entering the upper dosing vault in the spring for cleaning and they plan to evaluate the system for improvements that require less maintenance.

Photo 5: Looking up at the seepwater collection area below 3-Dam. French drains (red arrows) collect seep water and funnel it to the collection system vaults to the pipelines.

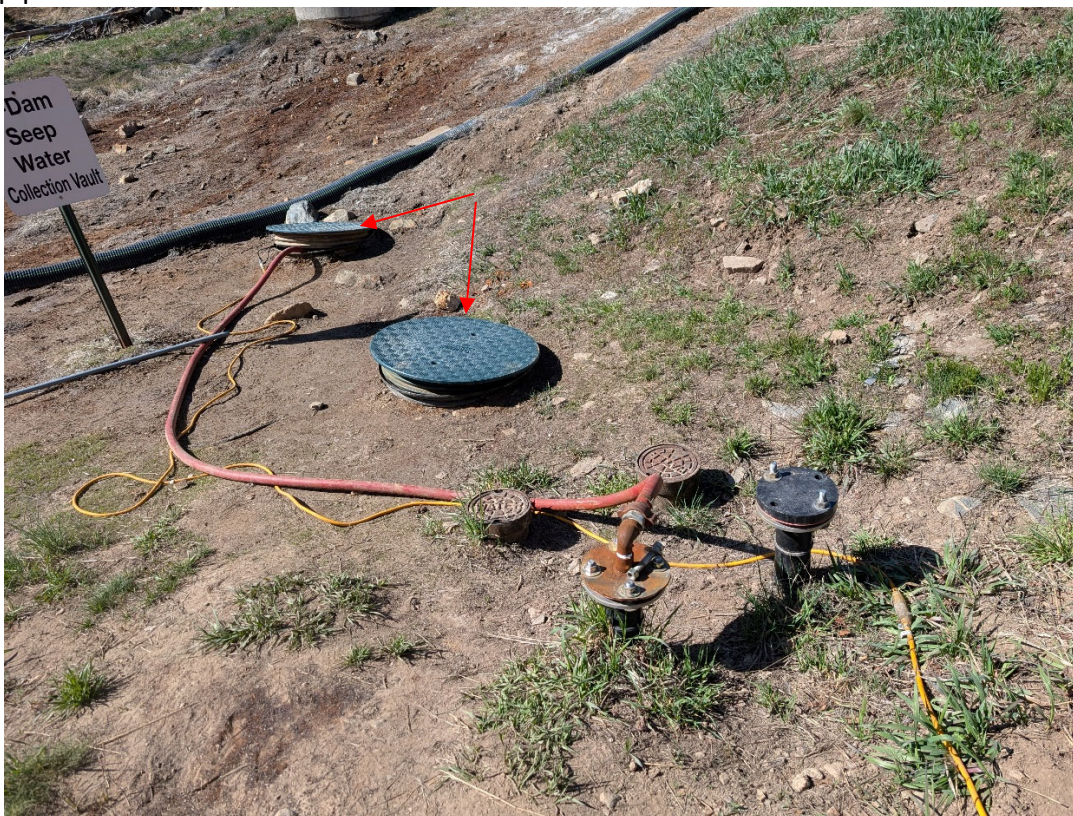
Photo 6: 3-Dam seepwater collection vault covers.

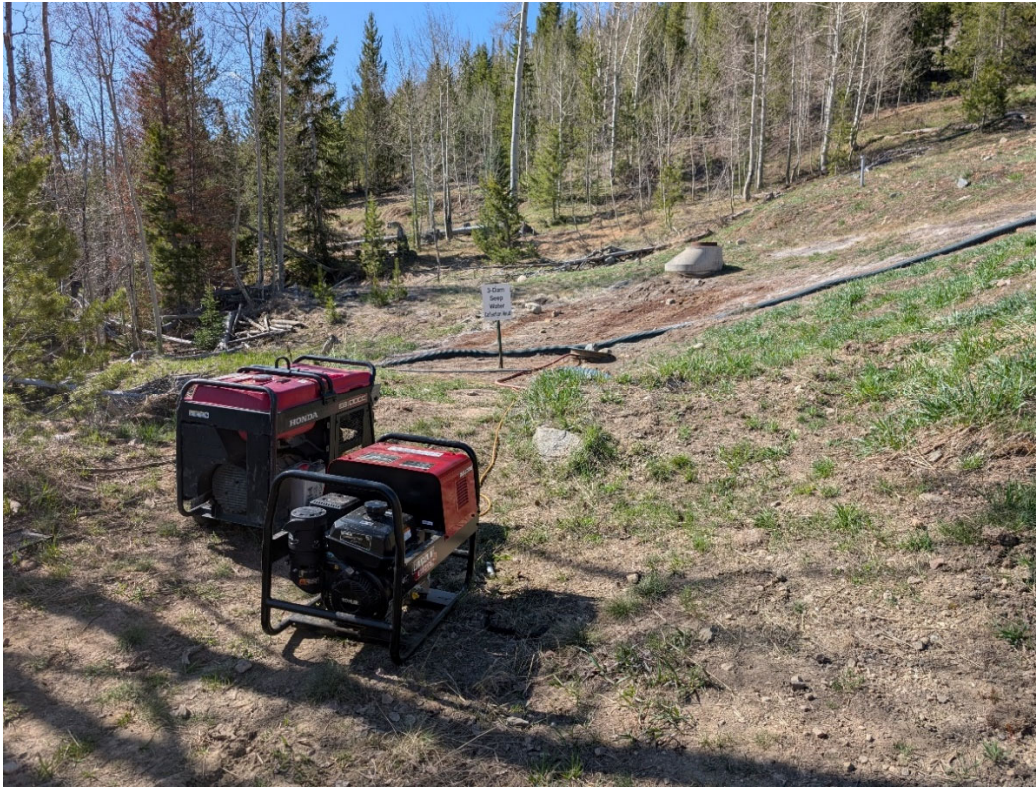
Photo 7: Generators observed in the area of the containment area.

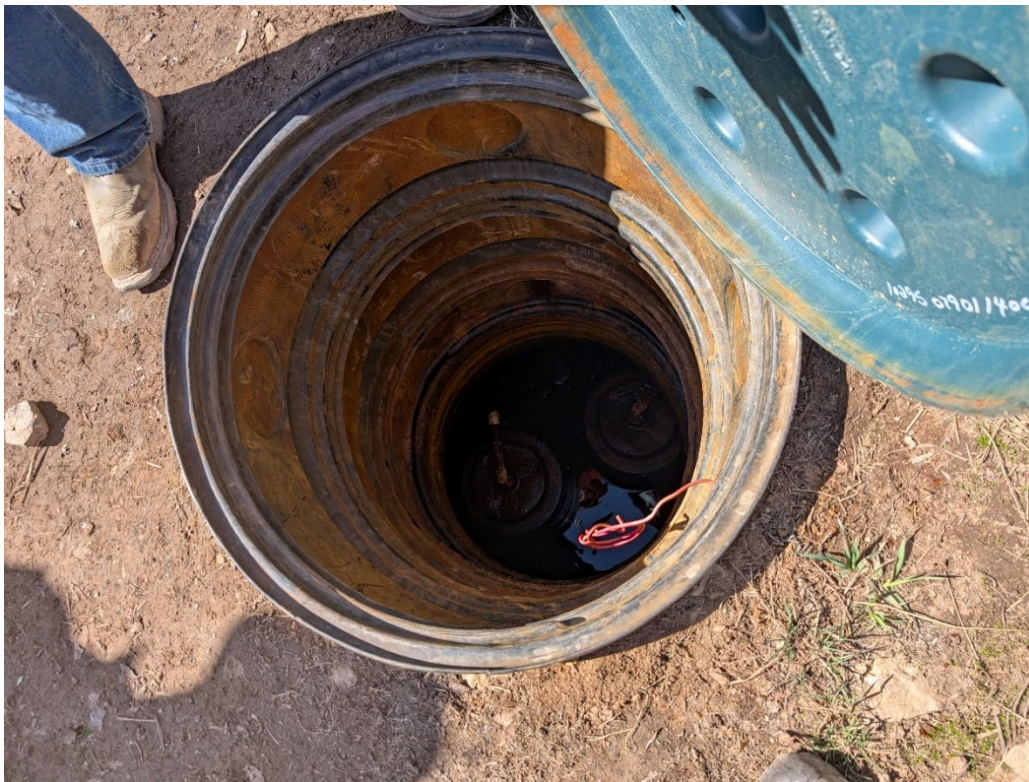
Photo 8: Looking down at siphon valves within a seep water vault.

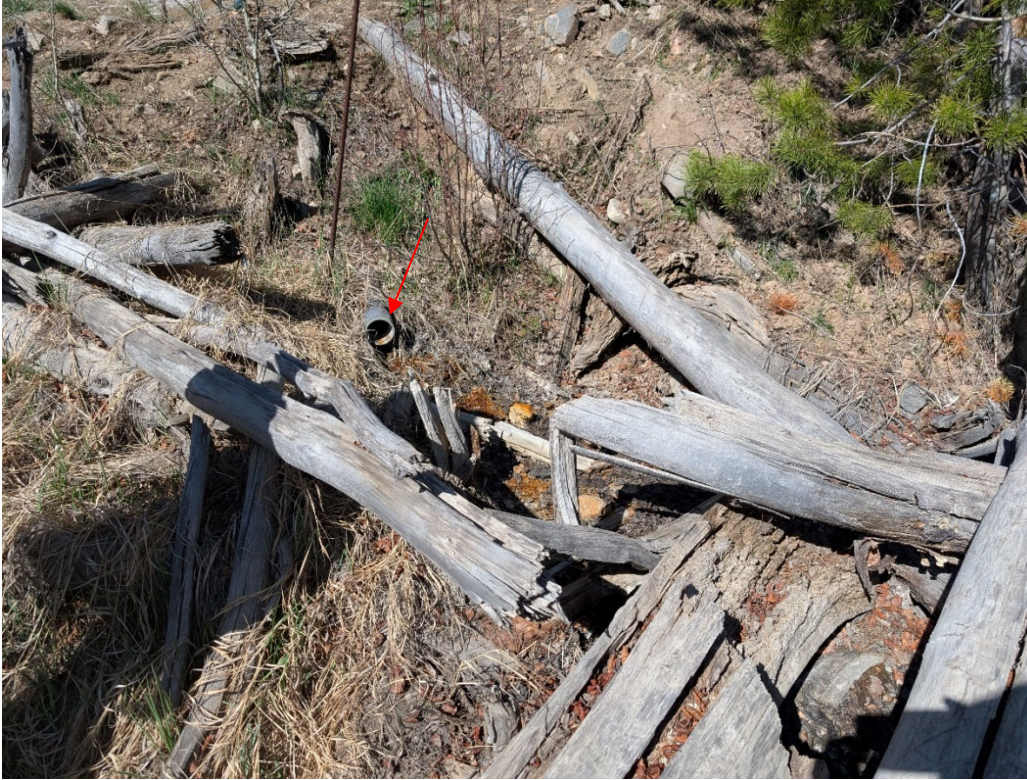
Photo 9: Looking at the overflow pipe for the seepage collection system below the engineered spillway.

Henderson will evaluate the collection system for improvements that would require less maintenance and submit a revision if necessary. Additionally, two groundwater wells (MLGW-17 and MLGW-20) located downgradient of the seepage collection area were observed during the inspection. Henderson monitors the groundwater for any evidence of seepage reaching the wells and submits a groundwater report to the Division annually.

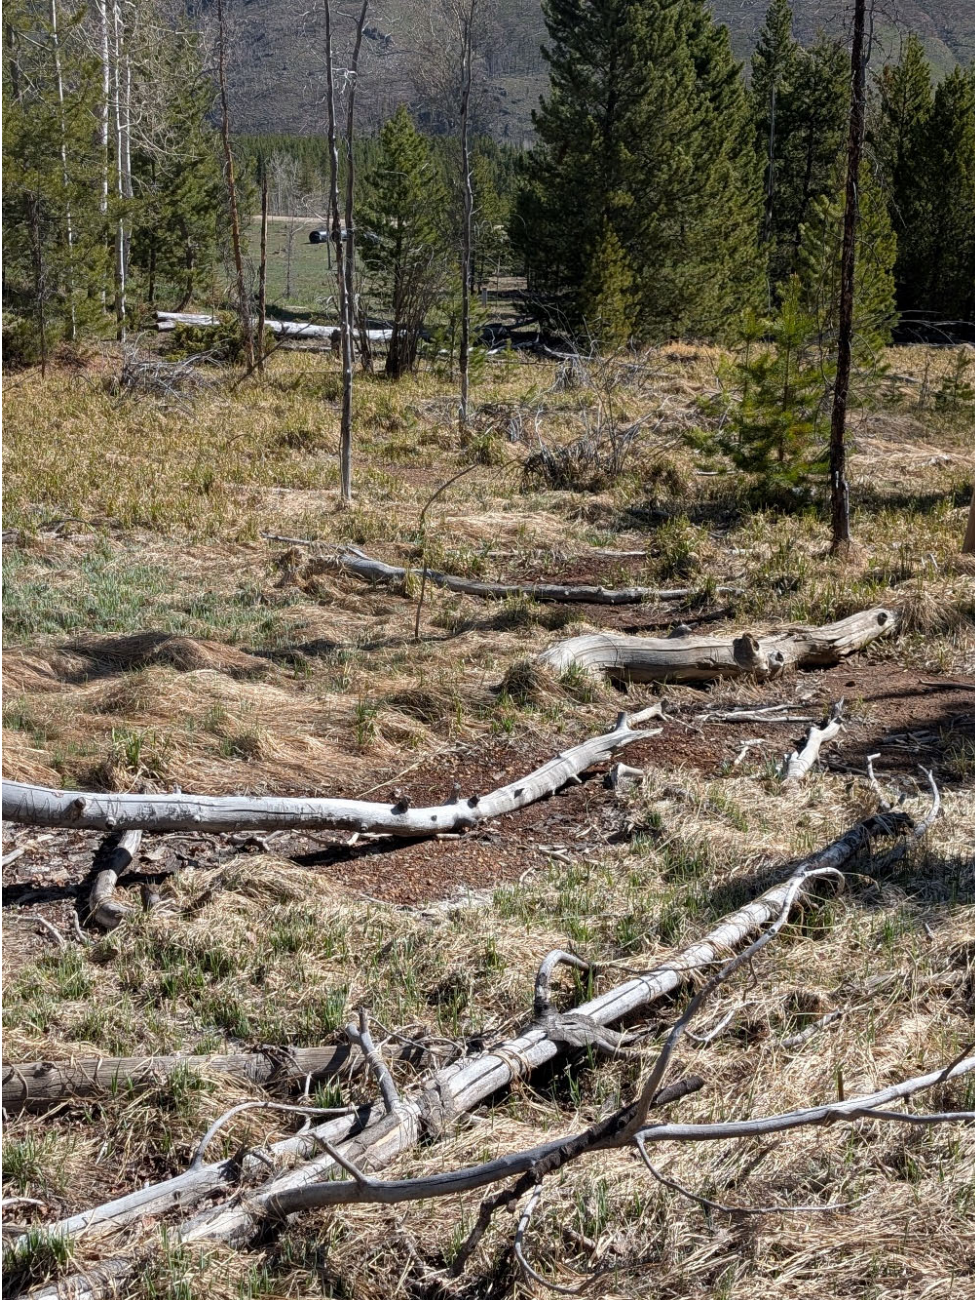
Photo 10: Looking north down the seepage collection area below 3-Dam. Overflow water appeared to infiltrate into the ground here. No evidence of water leaving the permit area was observed.

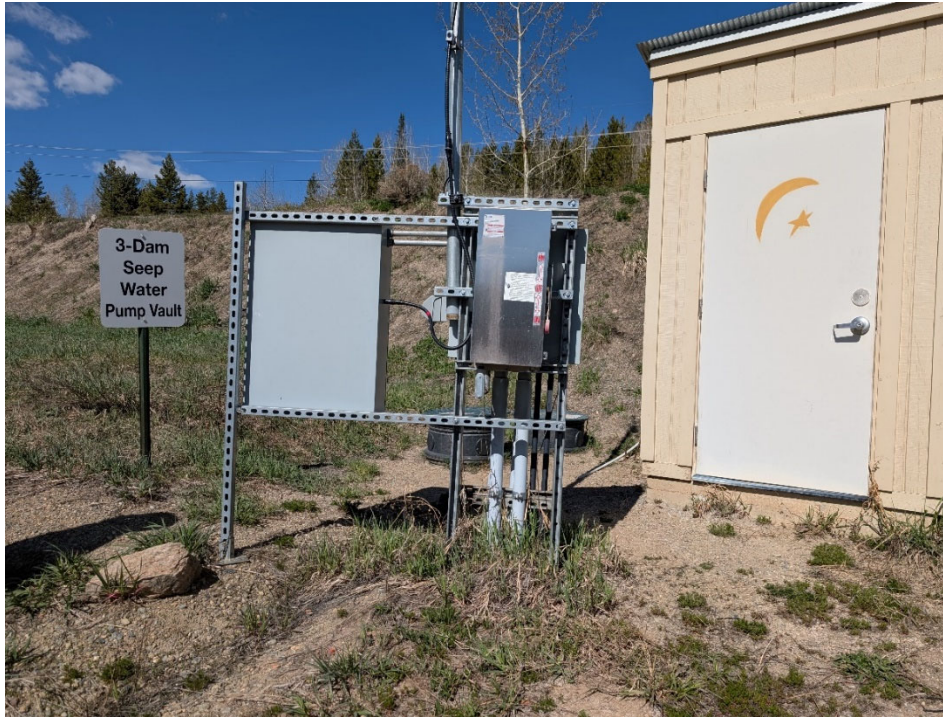
Photo 11: Control station and pump house for the seepwater collection system below 3-Dam.

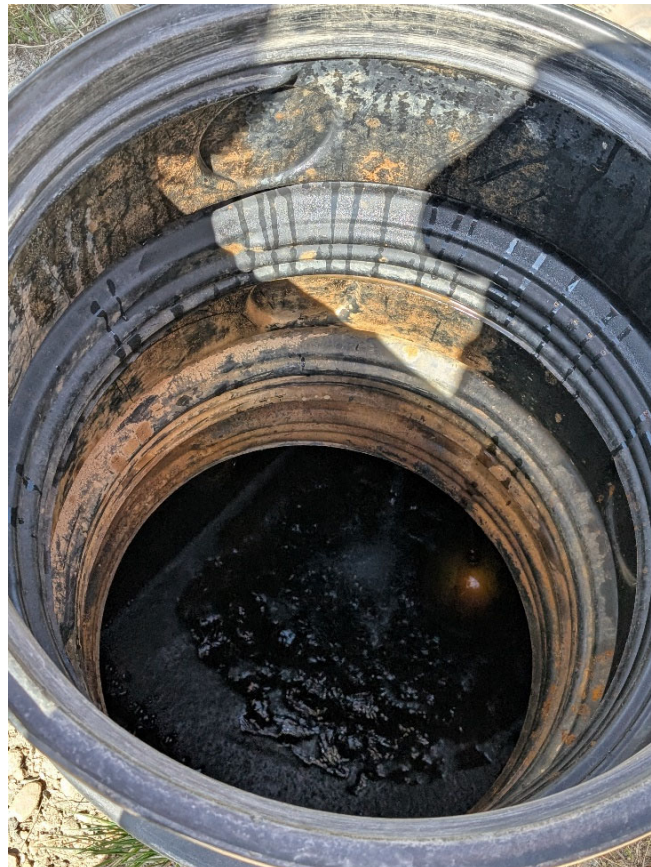
Photo 12: Looking down into the 3-Dam seepwater pump vault. Water is pumped to the main return pipeline.

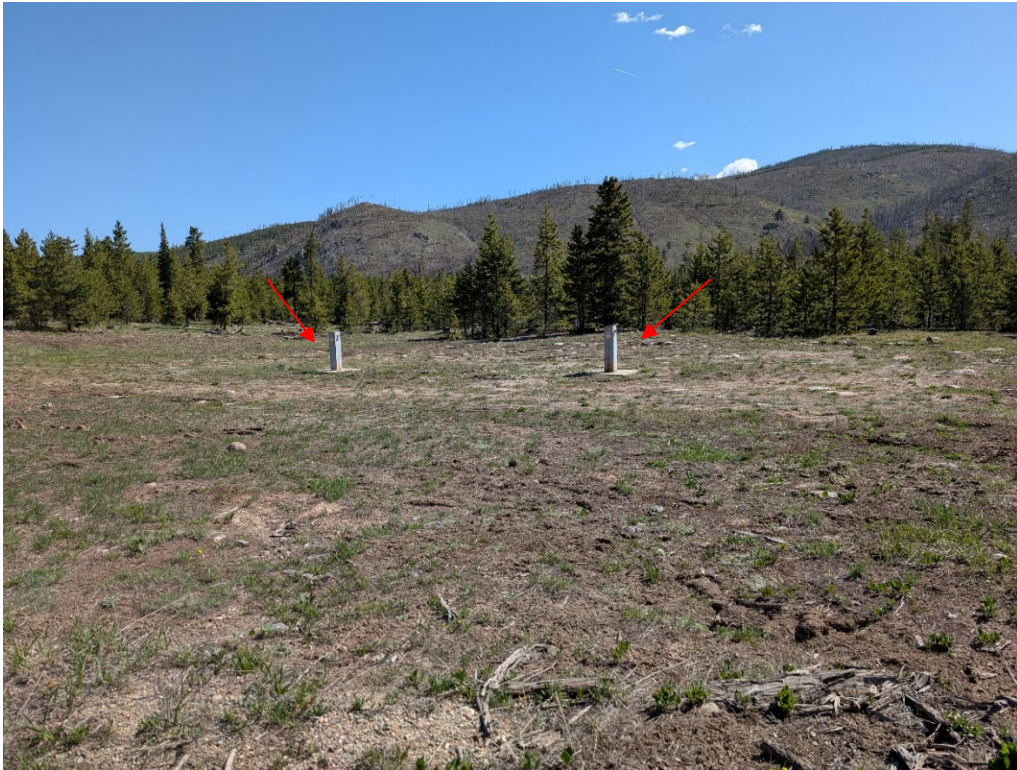
Photo 13: Looking east at two groundwater wells (MLGW-17 and MLGW-20) downgradient from the seepwater collection area.

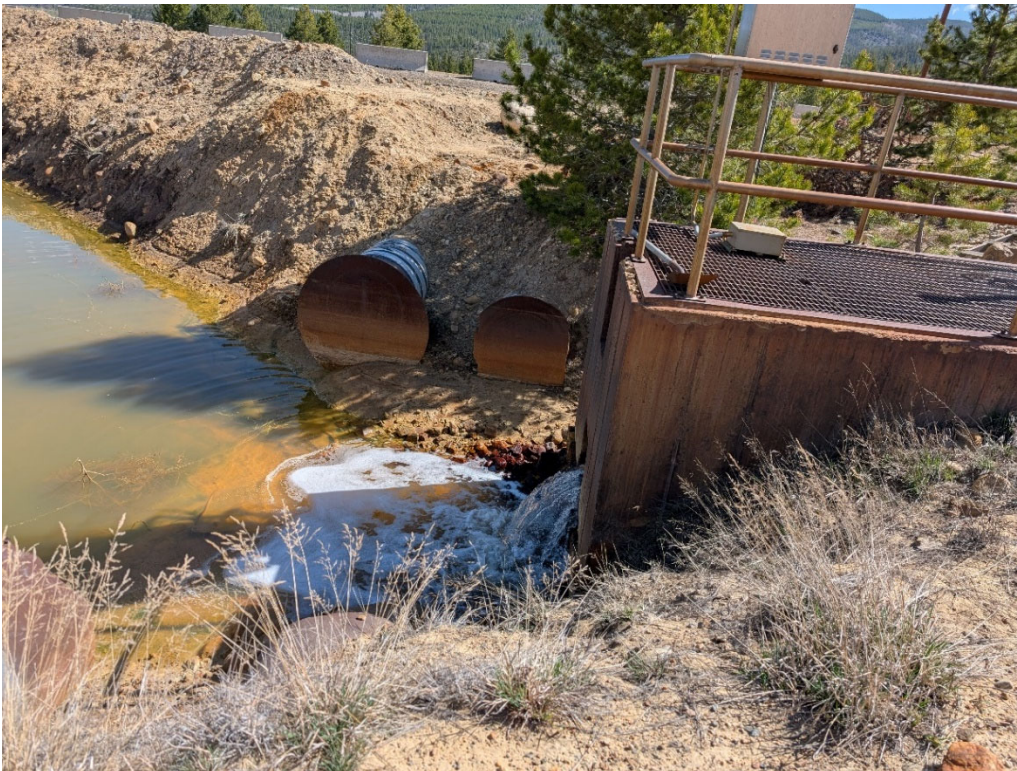
Photo 14: Looking at the outlet for the main seepwater return pipeline located at the base of 1-Dam near the Ute Park Pump station.

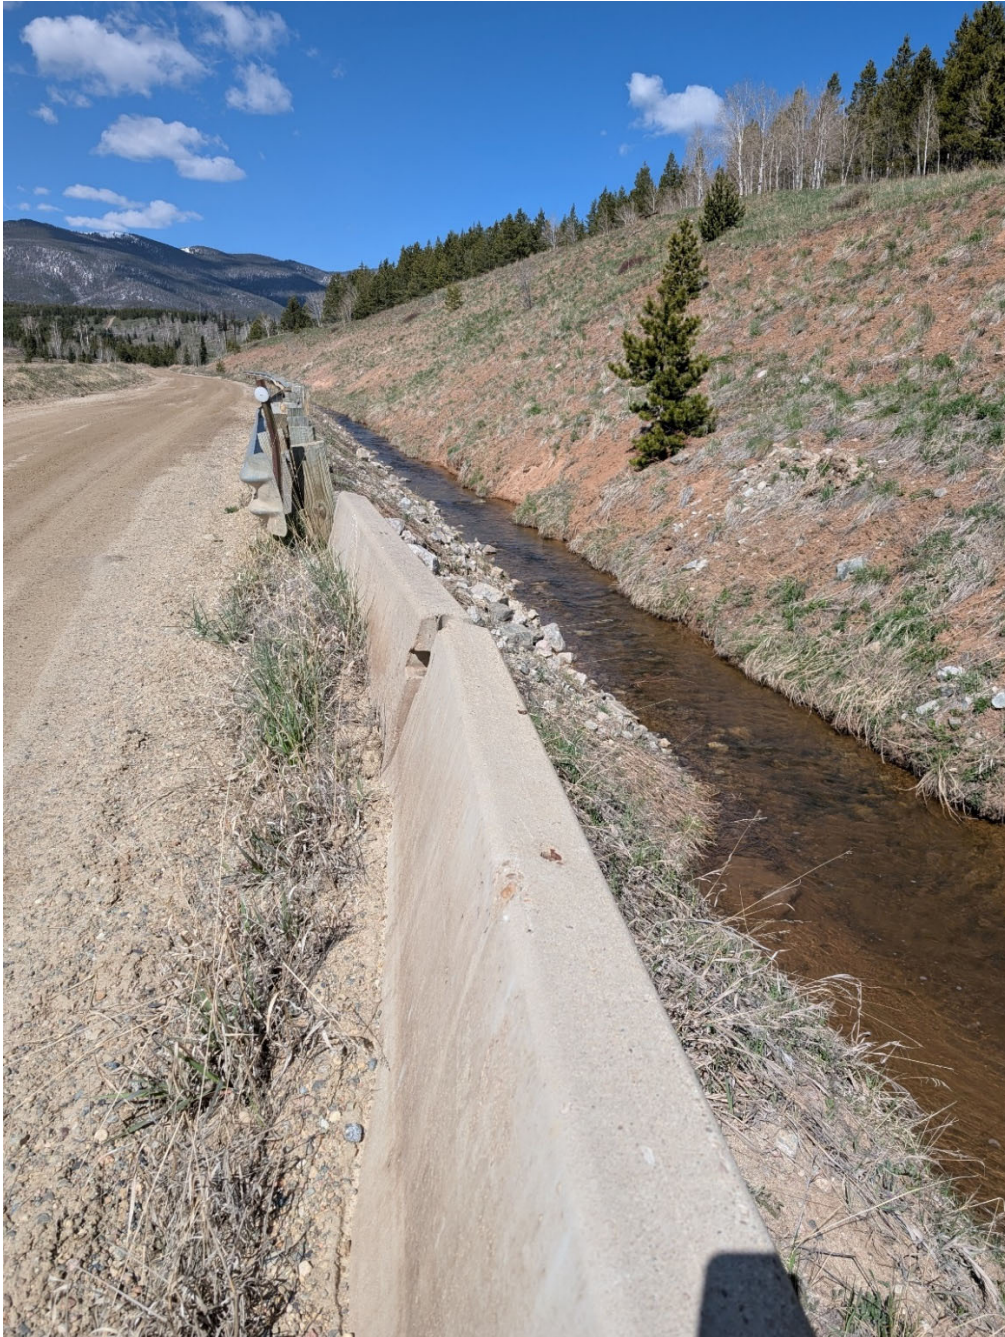
Photo 15: Looking west at the ultimate canal on the north end of the TSF where a pipeline is proposed to be installed.

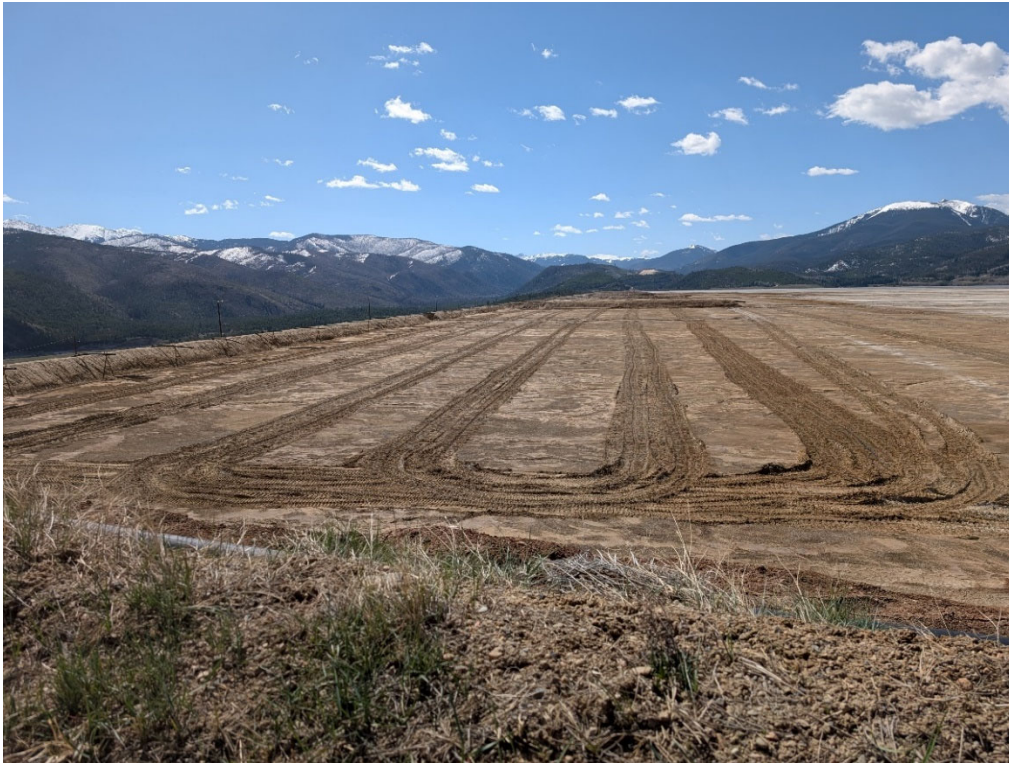
Photo 16: Looking south across the Tailings Storage Facility from the north end of 1-Dam. The tire tracks are associated with the use of Coherex for dust suppression which was recently spread across the tailings deposition area.

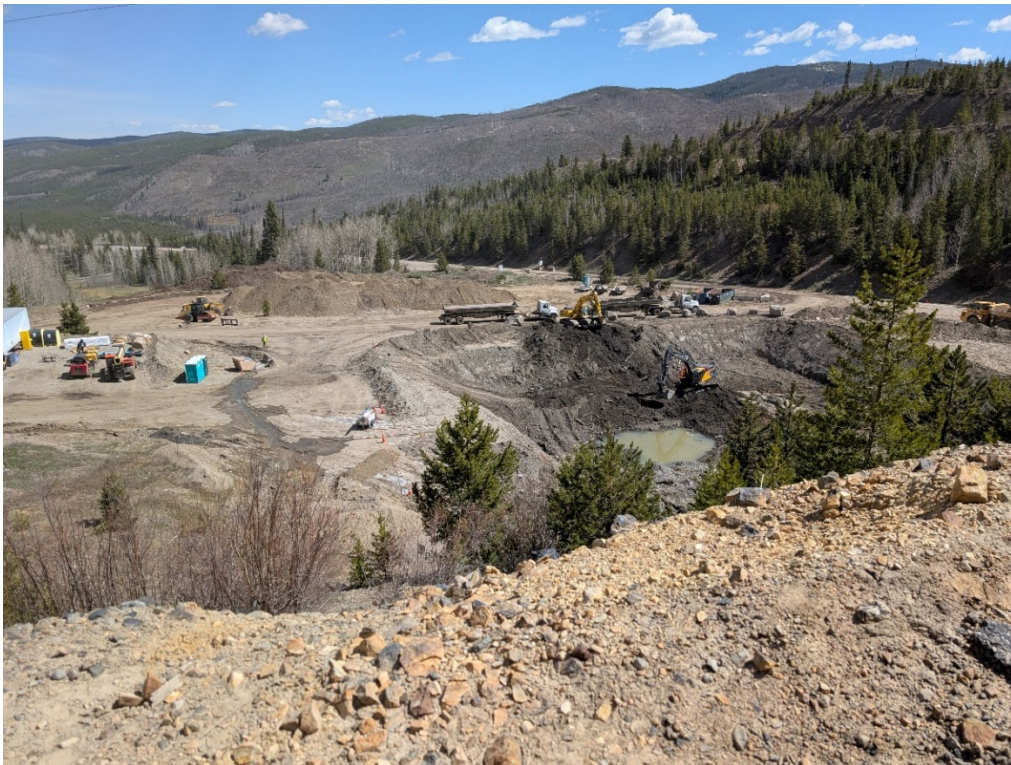
Photo 17: Standing on a ledge along the north side of the Mill looking down at the excavation work for the foundation of the future Water Treatment Plant.
