## Inspection report for C1981-028

<b>Permit Number:</b> C-1981-028 <b>Mine Name:</b> Keenesburg Strip Mine <b>Operator:</b> Coors Energy Company <b>Operator Address:</b> Mr. Ben Moline P.O. Box 4030 Golden, CO 80402	<b>County:</b> Weld <b>Operation Type:</b> Surface <b>Permit Status:</b> Permanent Cessation <b>Ownership:</b> Private
	<b>Operator Representative Present:</b>  None
<b>Operator Representative Signature: (Field Issuance Only)</b>

<b>Inspection Start Date:</b> May 23, 2025 <b>Inspection Start Time:</b> 09:00 <b>Inspection End Date:</b> May 23, 2025 <b>Inspection End Time:</b> 10:20	<b>Inspection Type:</b> Coal Partial Inspection <b>Inspection Reason:</b> Normal I&E Program <b>Weather:</b> Clear
<b>Joint Inspection Agency:</b>  None	<b>Joint Inspection Contacts:</b>  
<b>Post Inspection Agency:</b>  None	<b>Post Inspection Contacts:</b>  
<b>Inspector(s):</b>  Robert Zuber, P.E.	<b>Inspector's Signature:</b>

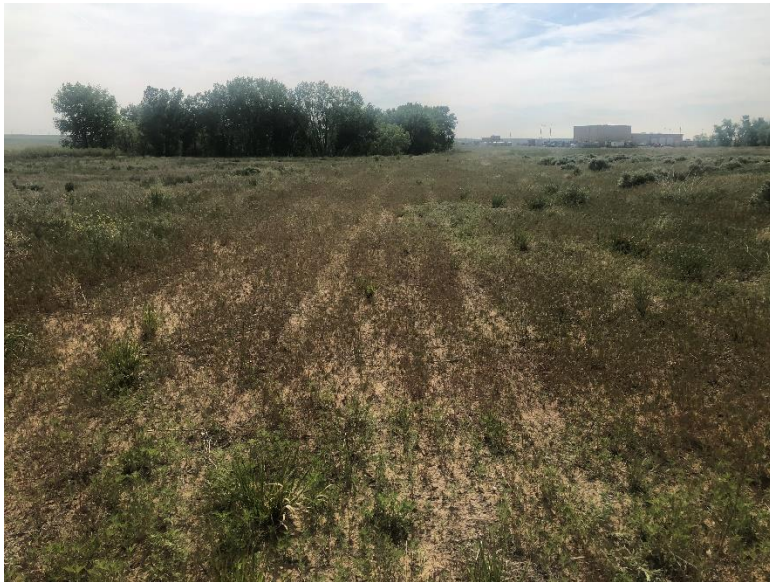
A large amount of cheat grass was seen in many areas of the site, including the undisturbed areas. Cheat grass can also be seen within the surrounding parcels near the site.

**Cheat grass within reclaimed road area, west of Sediment Pond 2**

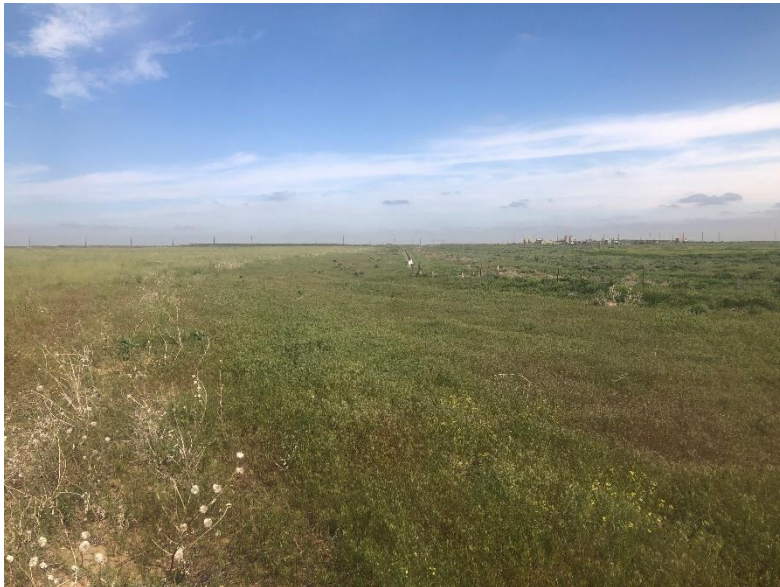
**North side of site, looking northwest at fence line**

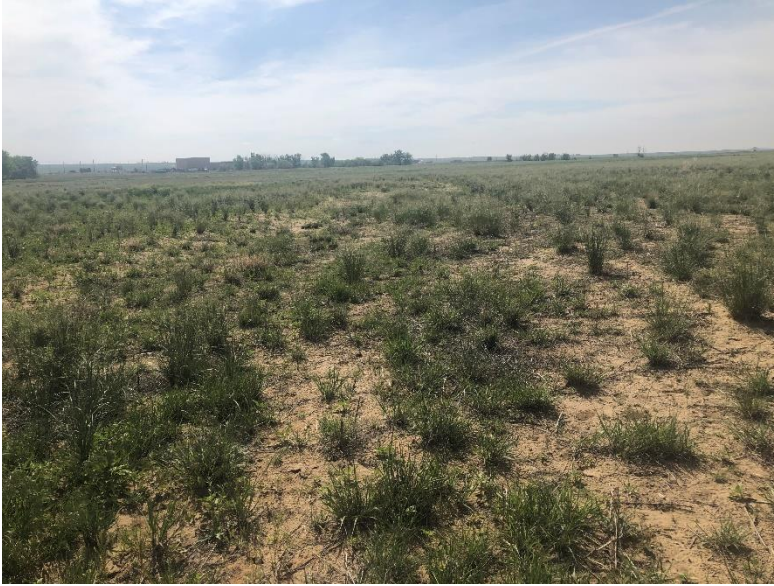
Across the site, vegetation cover was very good in some locations, but somewhat sparse in others. Two particular areas that have sparse vegetation were found in the following areas:

- The eastern portion of the reclaimed Long Term Spoil Area, on the edge of Areas 36 and 37. This area is located at 40.1955 deg N, -104.5007 deg W (using GPS technology and confirmed with Google Earth).
- The western portion of the reclaimed Long Term Spoil Area, within Area 36. This area is located at 40.1946 deg N, -104.5028 deg W (using GPS technology and confirmed with Google Earth).

**Bare area in eastern portion of reclaimed Long Term Spoil Area**

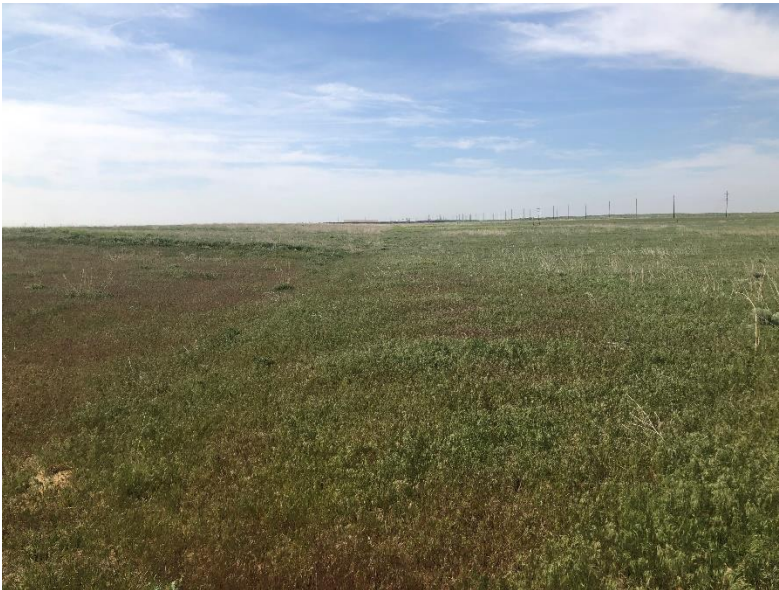
**Western side of reclaimed B Pit, looking south, with undisturbed area on the right**

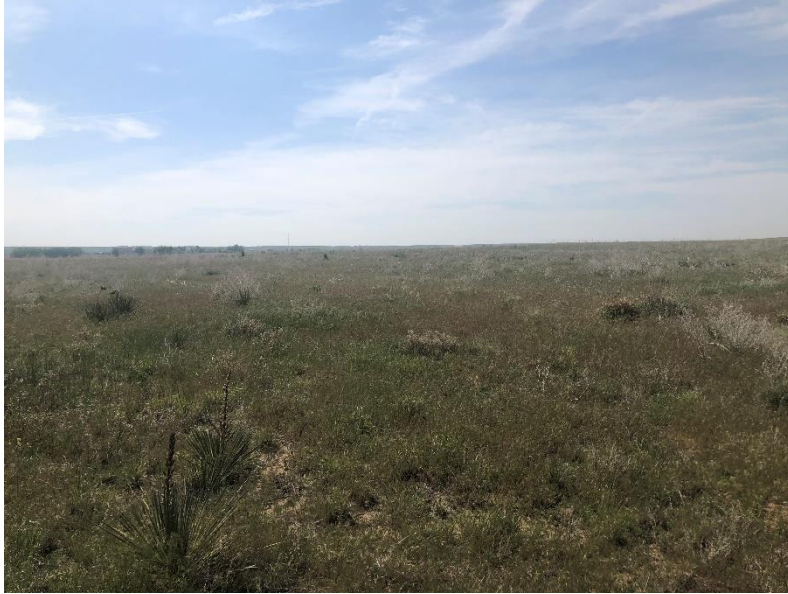
**Area 43, looking southeast (note yucca and cheat grass)**

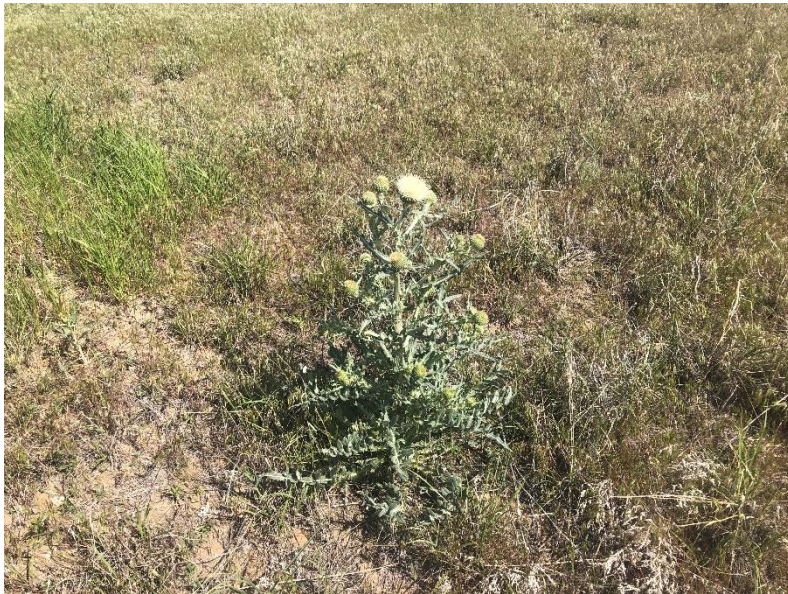
Other than cheat grass, no noxious weeds were identified. One thistle plant was seen in the eastern portion of Area 43, but it appears to be a non-noxious species, possibly prairie thistle.

**Thistle in Area 43 (appears to be native species)**
