MINERALS PROGRAM INSPECTION REPORT
PHONE: (303) 866-3567

MINE NAME: Hale Pit aka Earl's Pit	MINE/PROSPECTING ID#: M-1981-121	MINERAL: Sand and gravel	COUNTY: El Paso
INSPECTION TYPE: Surety-Related Inspection	WEATHER: Clear	INSP. DATE: May 21, 2025	INSP. TIME: 09:00
OPERATOR: Atticus Land, LLC	OPERATOR REPRESENTATIVE: Chad & Sonya Miller	TYPE OF OPERATION: 110c - Construction Limited Impact	
REASON FOR INSPECTION: Surety Related	BOND CALCULATION TYPE: Complete Bond	BOND AMOUNT: \$0.00	
DATE OF COMPLAINT: NA	POST INSP. CONTACTS: None	JOINT INSP. AGENCY: None	
INSPECTOR(S): Hunter Ridley	INSPECTOR'S SIGNATURE:

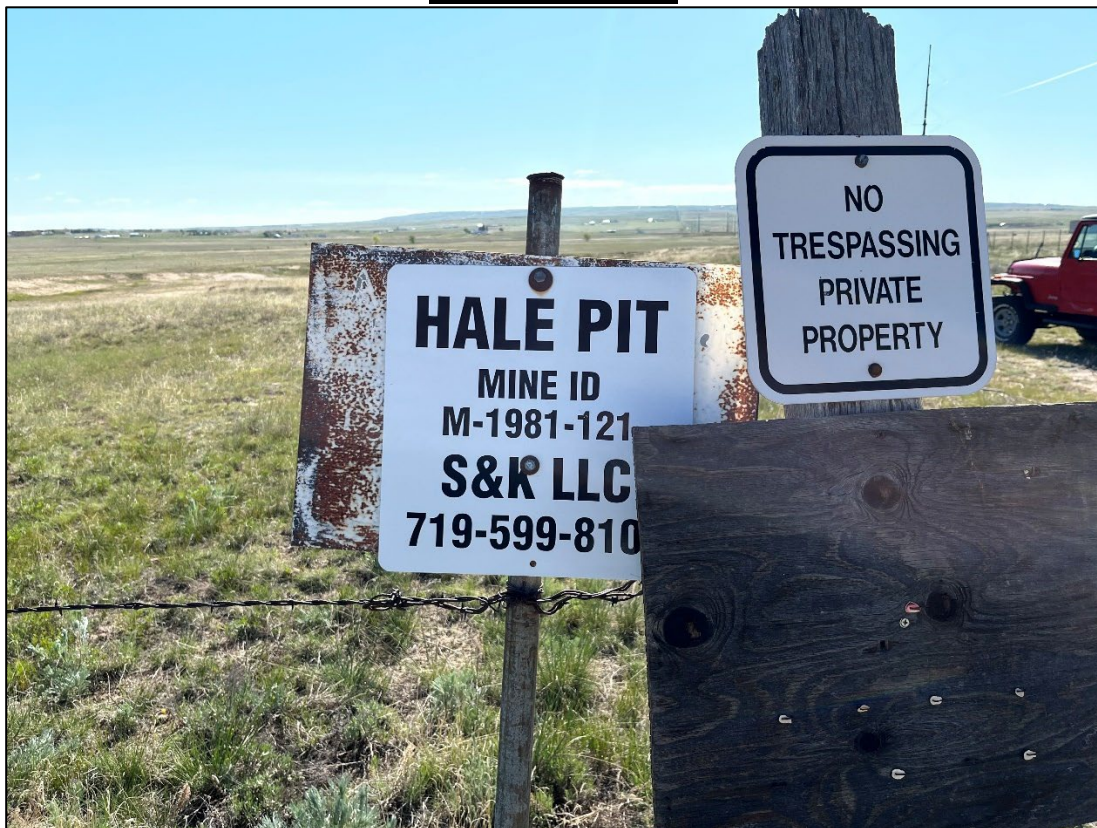
Signs and Markers: The permit sign was properly posted (Photo 1).

Photo 1: Mine sign posted at the site entrance.

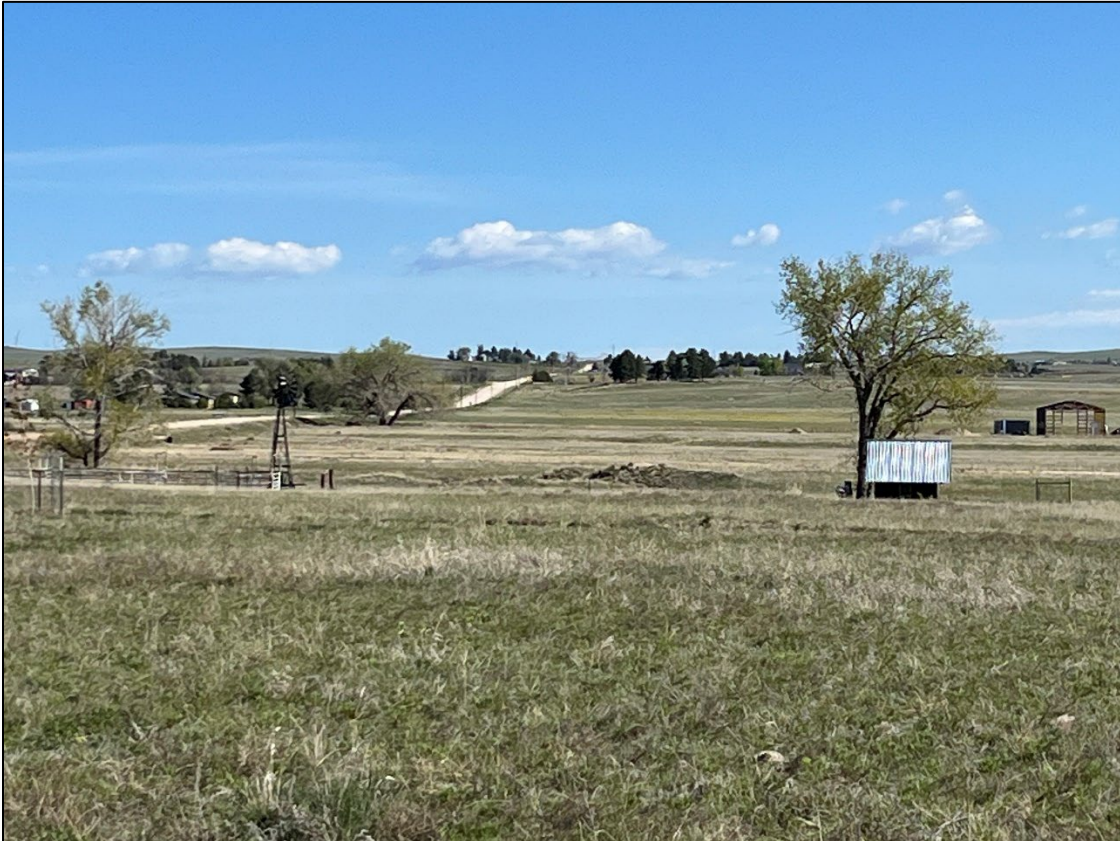
Photo 2: View north of the t-post marking the northwest permit corner.

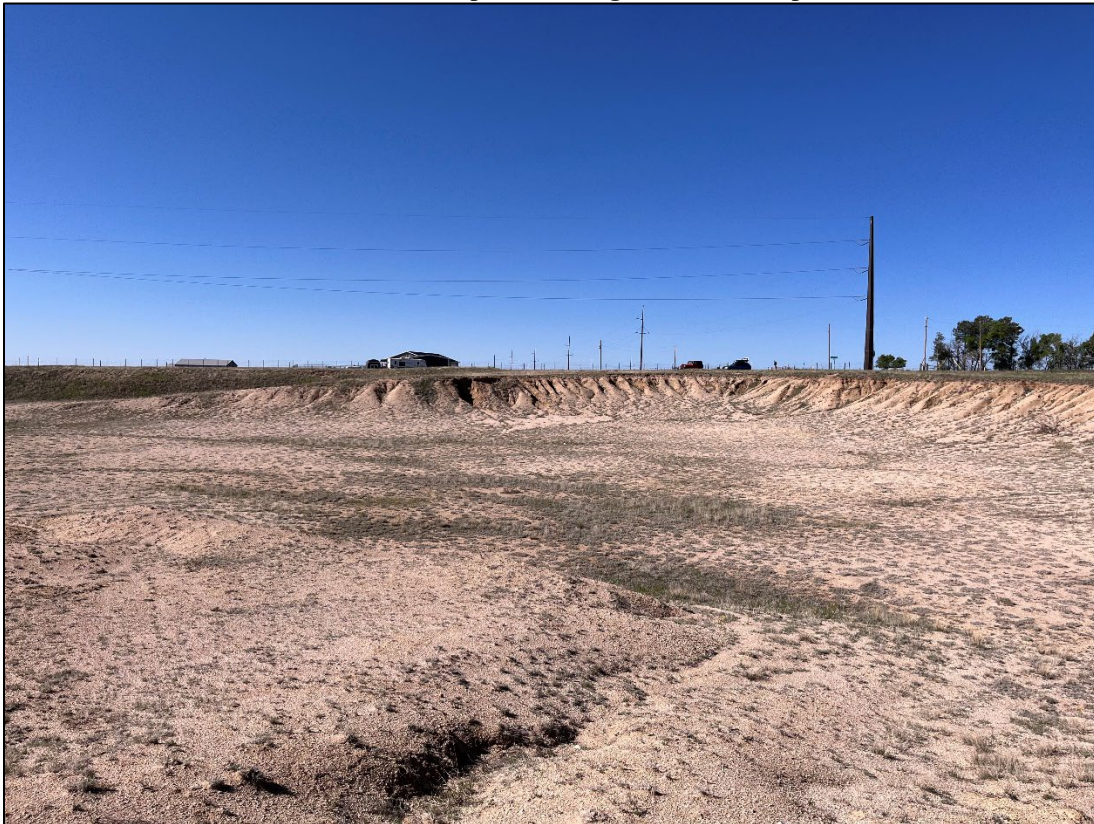
Off-site Damage: The operation appeared to be confined to the permit boundary, based on Google Earth review and site observations. The southern and western edges of the permit boundary have been determined to be pre-law disturbances (see inspection report dated January 30, 2024) and are therefore not required to be reclaimed under the current permit (Photo 3). No out of bounds disturbances associated with the permitted mining operation were observed.

Photo 3: View south of pre-law disturbance areas.

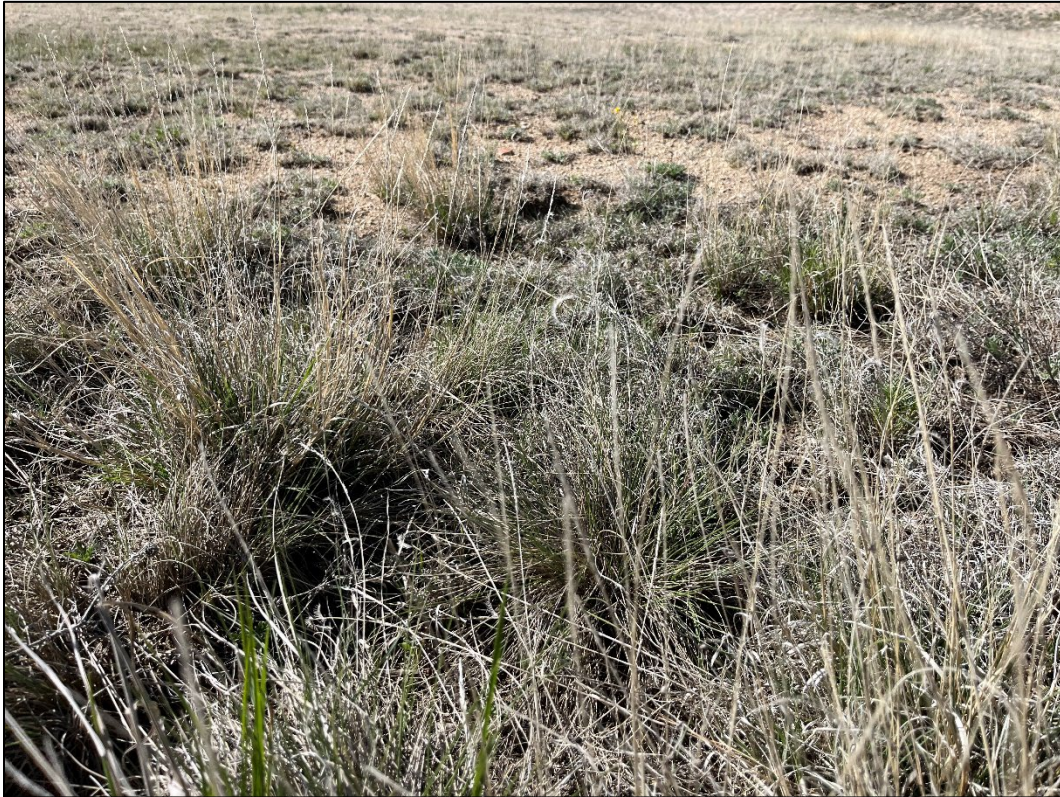
Reclamation Success & Revegetation: Graded areas had been broadcast seeded in 2022 after topsoiling was complete. The Division observed mature and emerging vegetation throughout the reclaimed areas of the site (Photos 4, 6, and 7). These include several native species of grasses and forbs (Photos 4 and 5): Desert paintbrush, Jacob's Ladder, Cicer milkvetch, Blue grama, and a few varieties of wheatgrass. Carex and Juncus genus vegetation types were also observed but could not be more specifically identified in the field. This revegetation has had 3 years of growing seasons, which is in compliance with the Division's usual preference for at least two growing seasons before determining if revegetation is adequately established for a permit release. A small patch of Cheatgrass (a.k.a. Downy Brome) was observed. This is a noxious weed List C species, so it was not cited as a problem. However, this was a small area when compared to the overall permit acreage and was surrounded by mostly native or other acceptable vegetation species.

Photo 4: Example of mature Blue grama and other bunch grasses growing on the reclamation area.

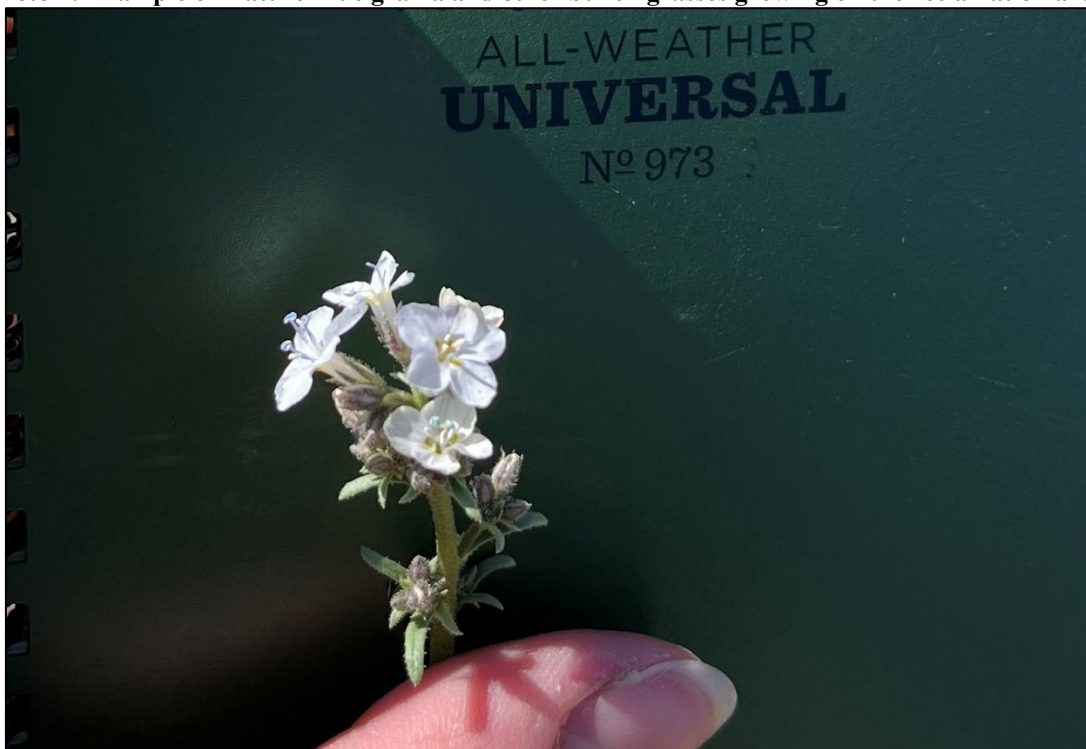
Photo 5: Jacob's Ladder forb found onsite.

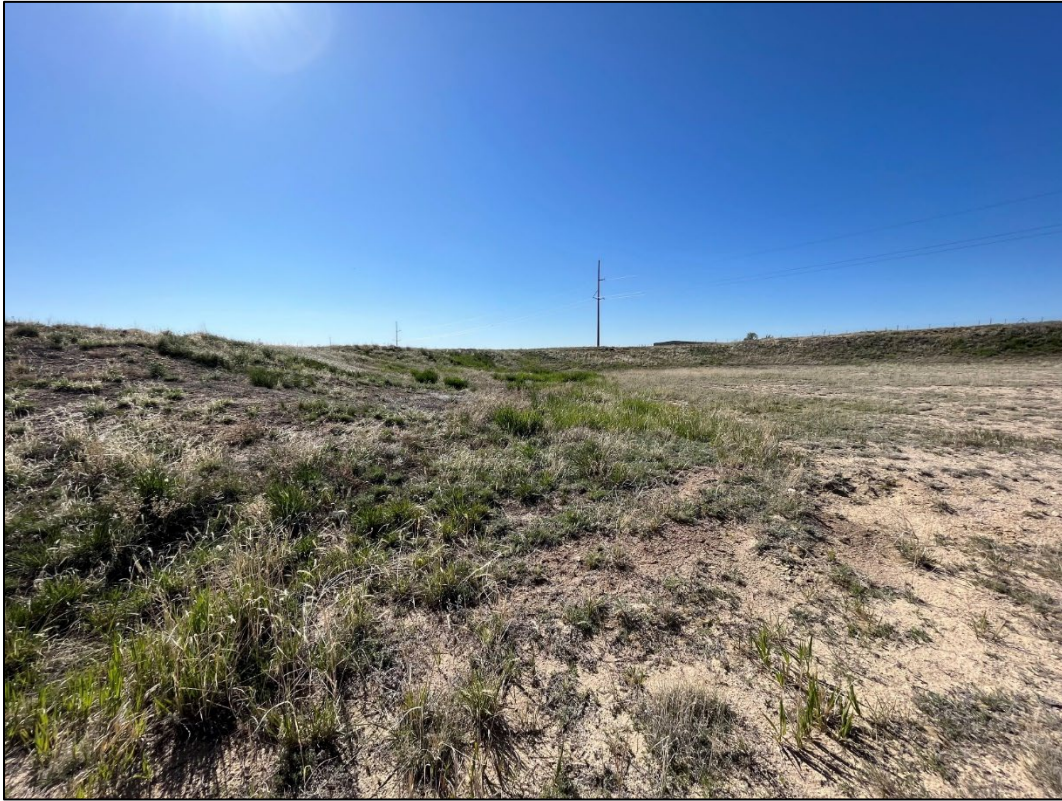
Photo 6: View east of reclaimed and revegetated areas.

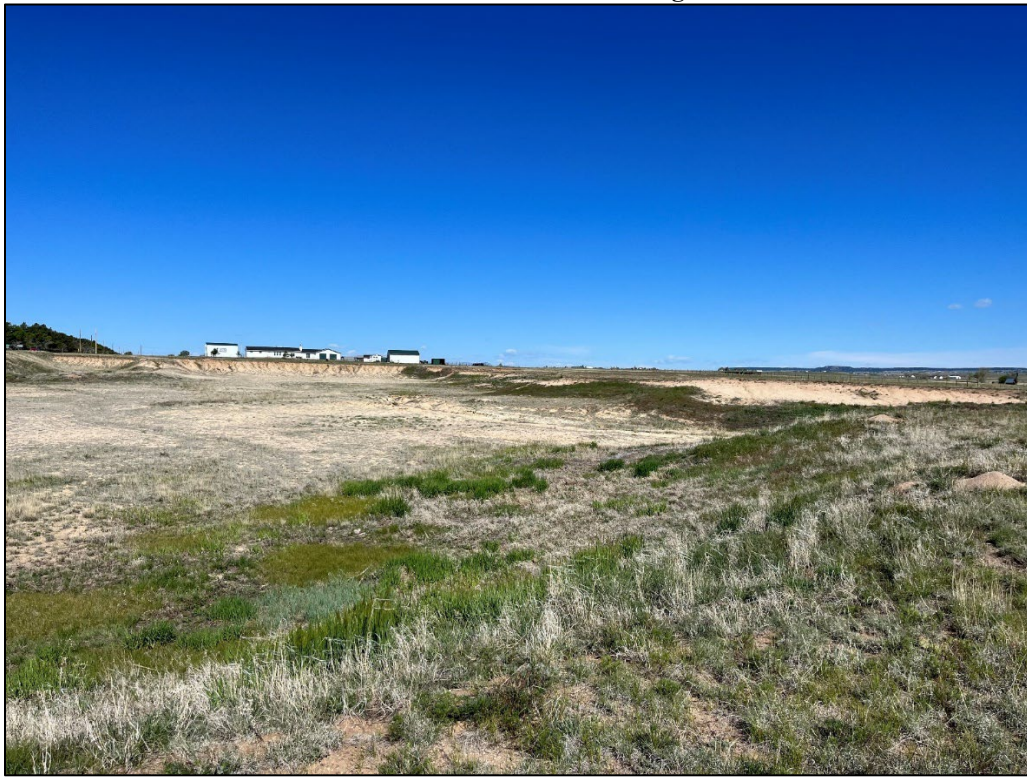
Photo 7: View northwest of vegetated and reclaimed slopes, historic mining disturbance is visible to the west and south.
