**MINERALS PROGRAM INSPECTION REPORT**  
**PHONE: (303) 866-3567**

| <b>MINE NAME:</b><br>Cross Gold Mine | <b>MINE/PROSPECTING ID#:</b><br>M-1977-410 | <b>MINERAL:</b><br>Gold, copper, silver, zinc | <b>COUNTY:</b><br>Boulder |
| <b>INSPECTION TYPE:</b><br>Monitoring | <b>WEATHER:</b> Windy | <b>INSP. DATE:</b><br>May 20, 2025 | <b>INSP. TIME:</b><br>09:30 |

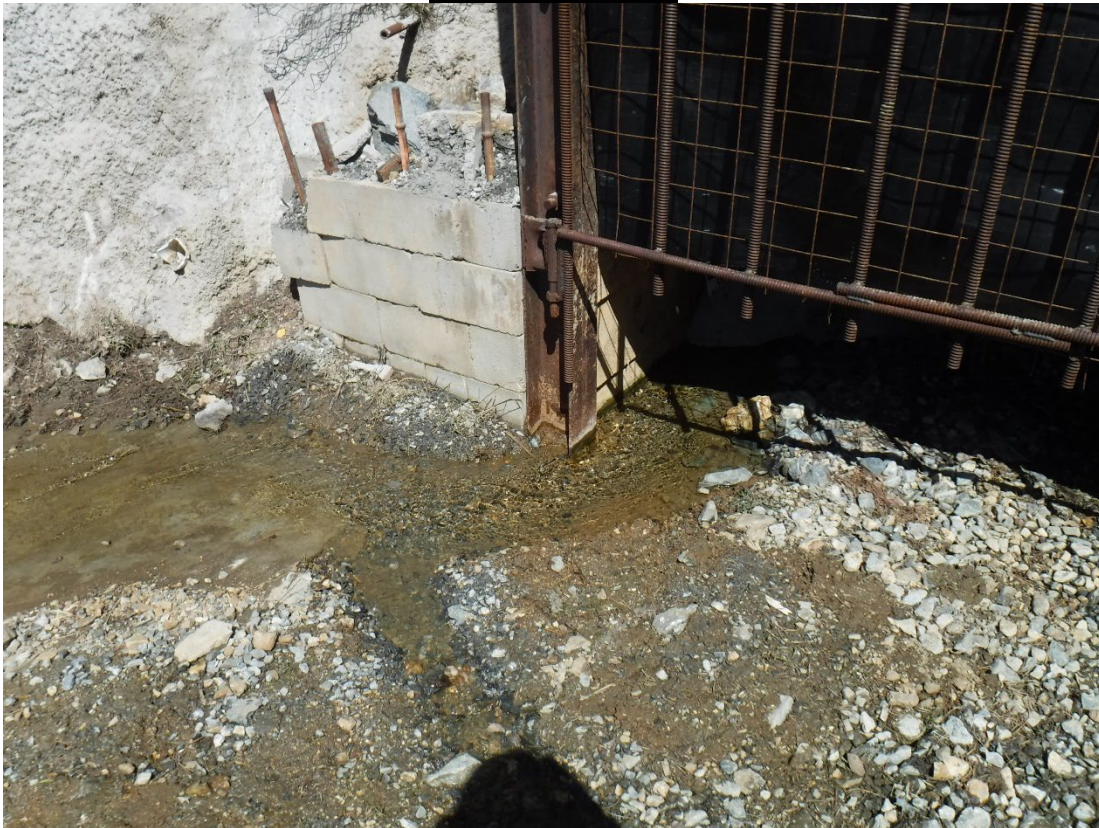
**Photo 1:** Idaho Tunnel effluent discharge

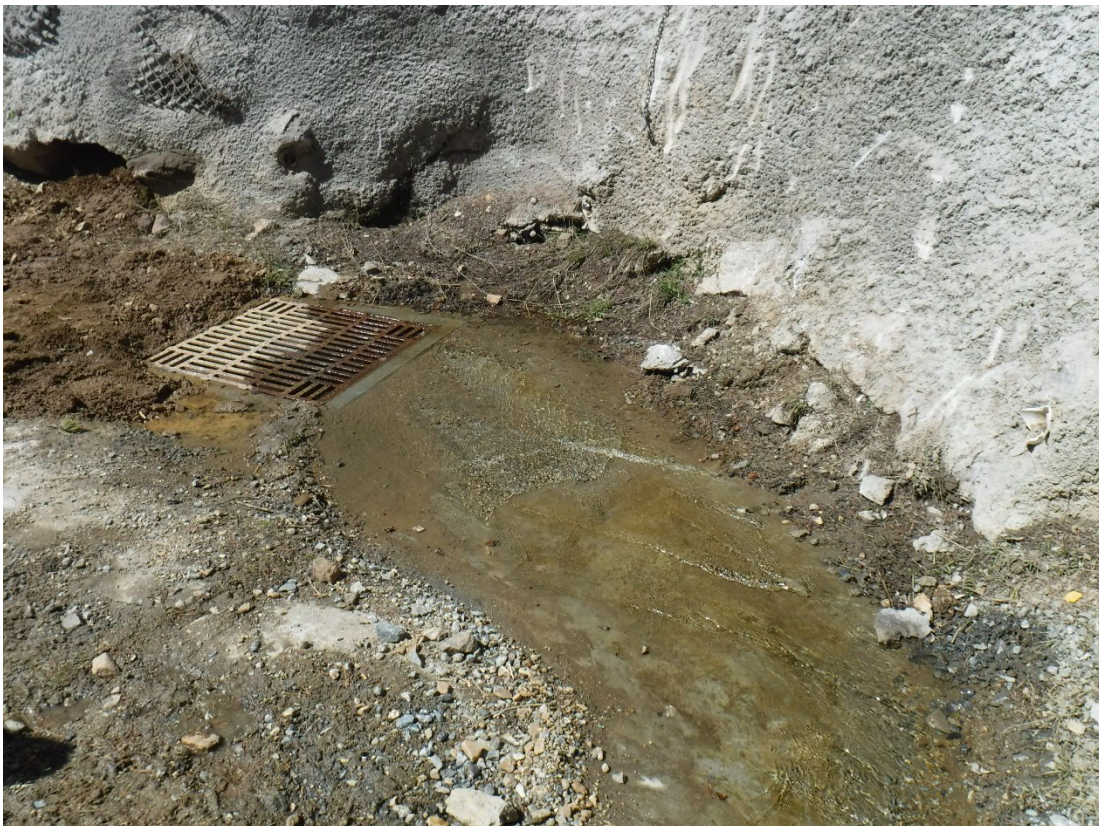
The Caribou effluent was being discharged to the Joliet Raise through a pipeline that bypasses the 3-series ponds and diverted prior to the discharge point at Pond 1. Pond 1 was receiving water from Joliet Raise and was being run through the water treatment plant and discharged at the CDPHE discharge location.

**Photo 2:** Idaho Tunnel effluent discharge directed to grated drop structure to enter pipeline

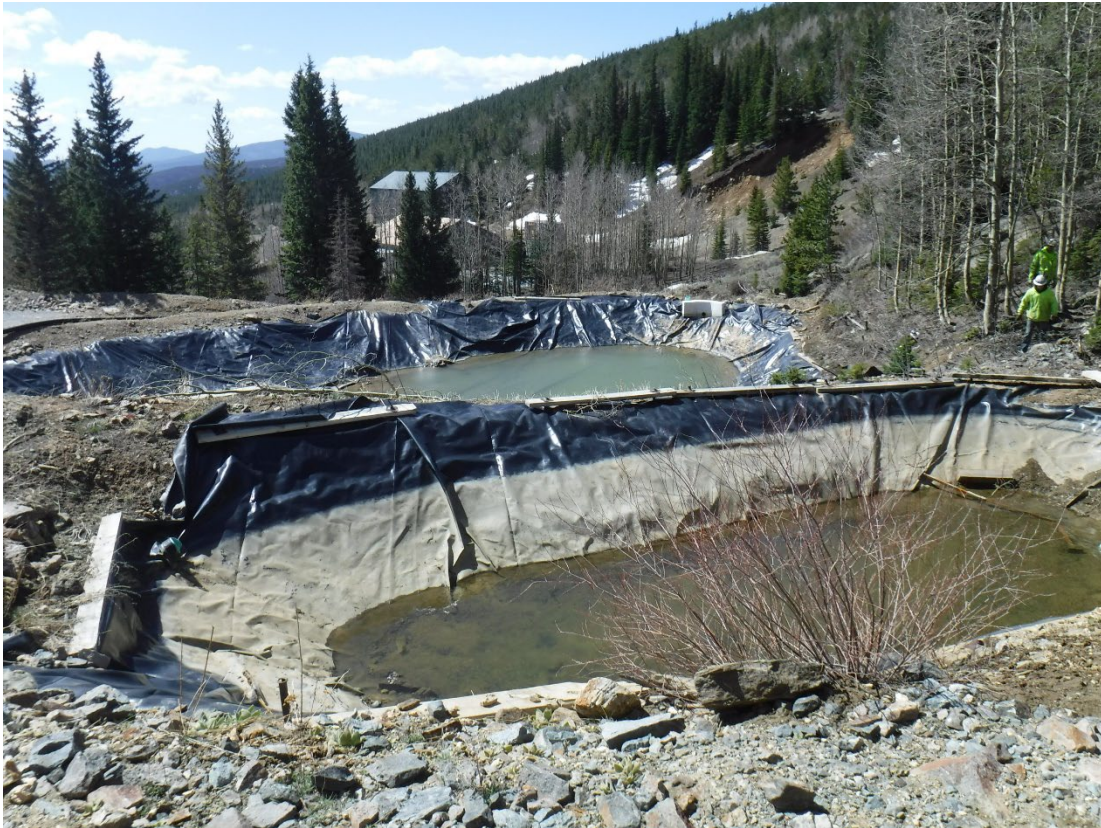
**Photo 3:** Series 3 Ponds 3A and 3B not in use

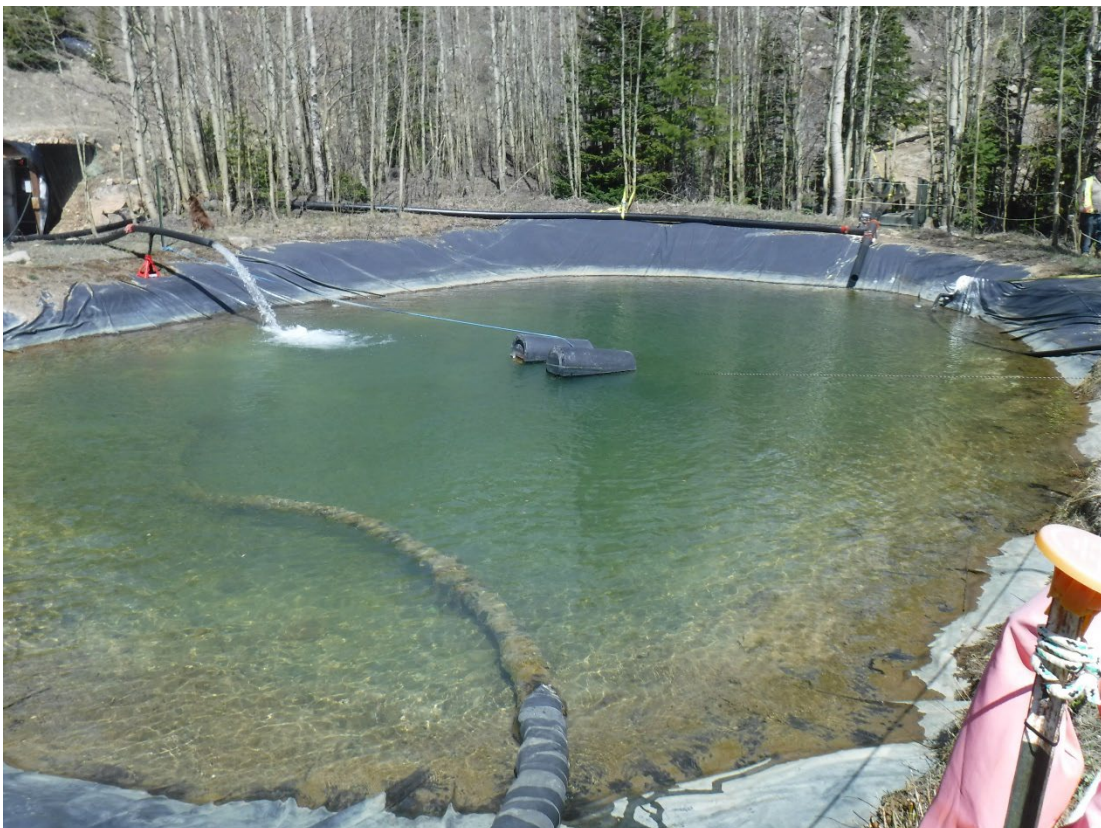
**Photo 4:** Pond 1 with the Joliet Raise inflow and Idaho Tunnel effluent being direct to the Raise

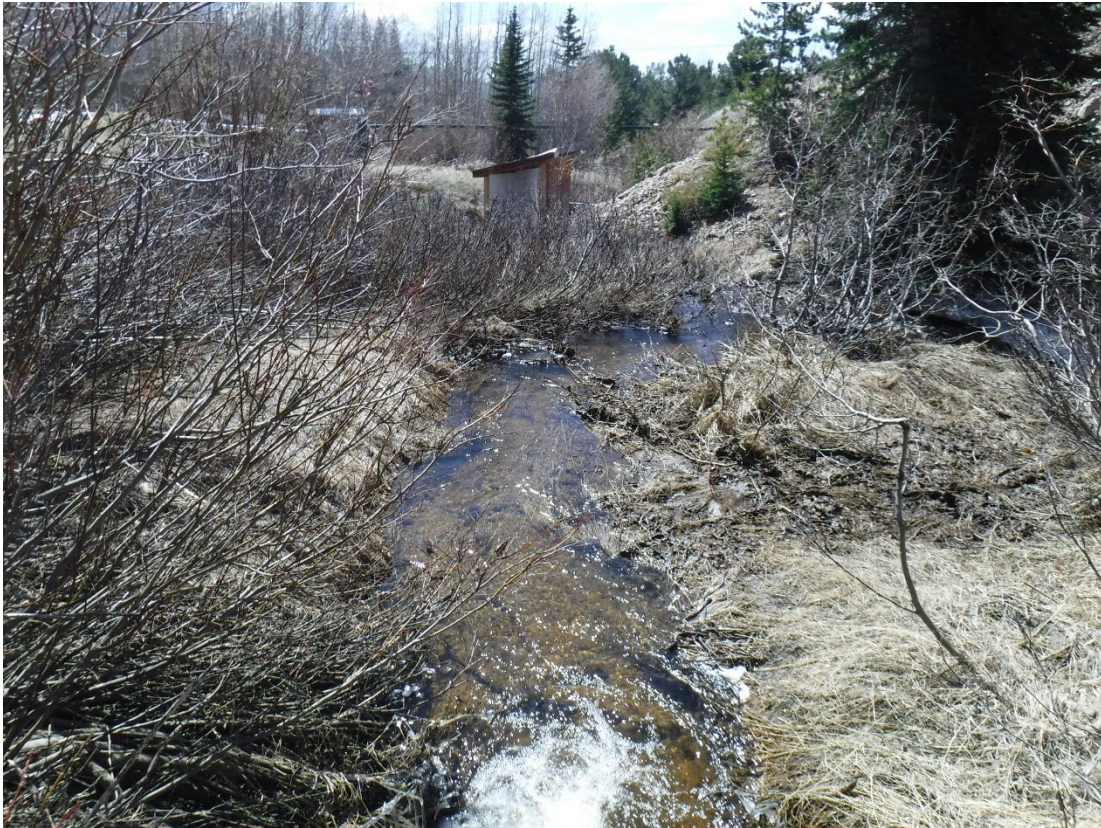
**Photo 5:** Coon Track Creek upstream of the approved discharge point

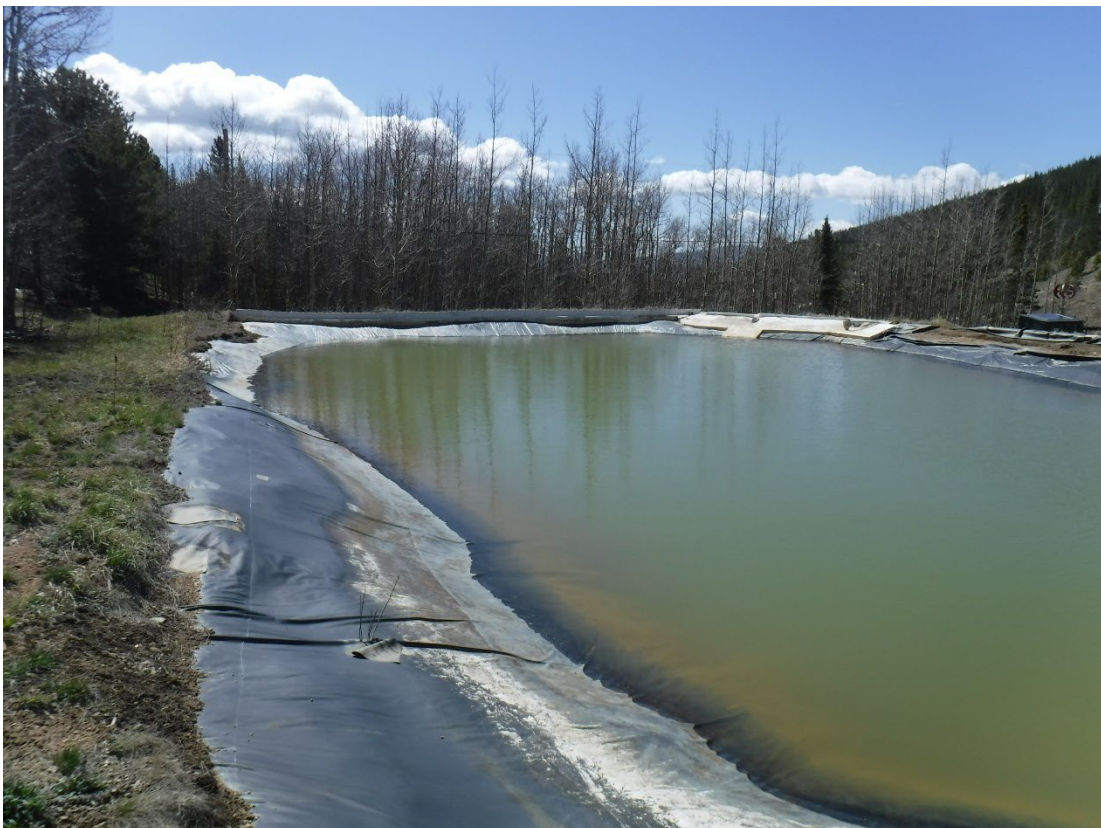
**Photo 6:** Pond 2 looking south

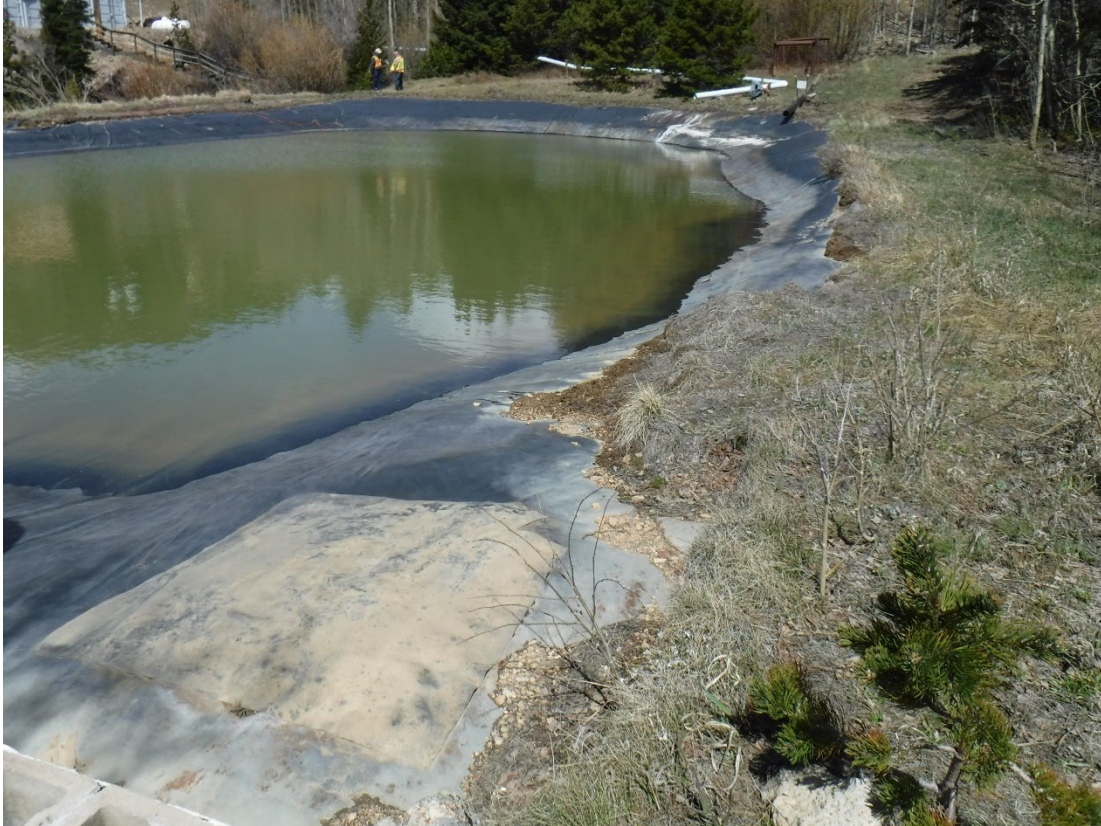
**Photo 7:** Pond 2 looking north

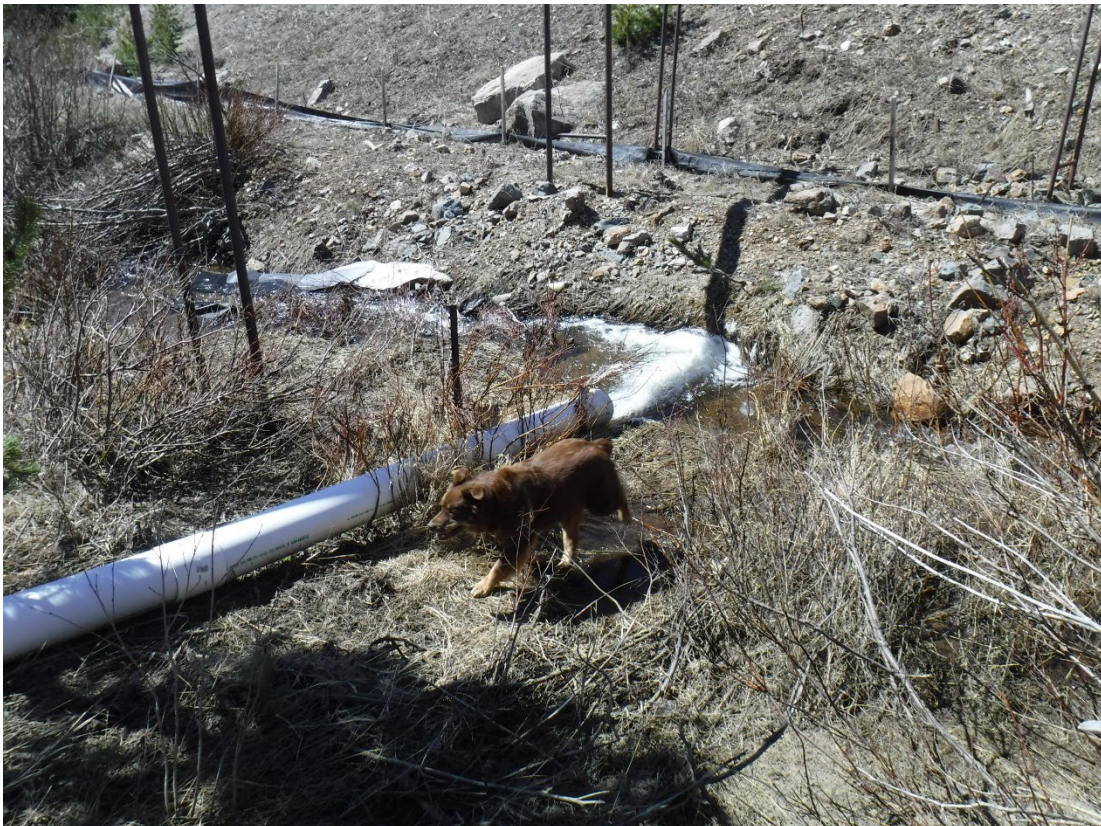
**Photo 8:** Approved discharge point at Coon Track Creek

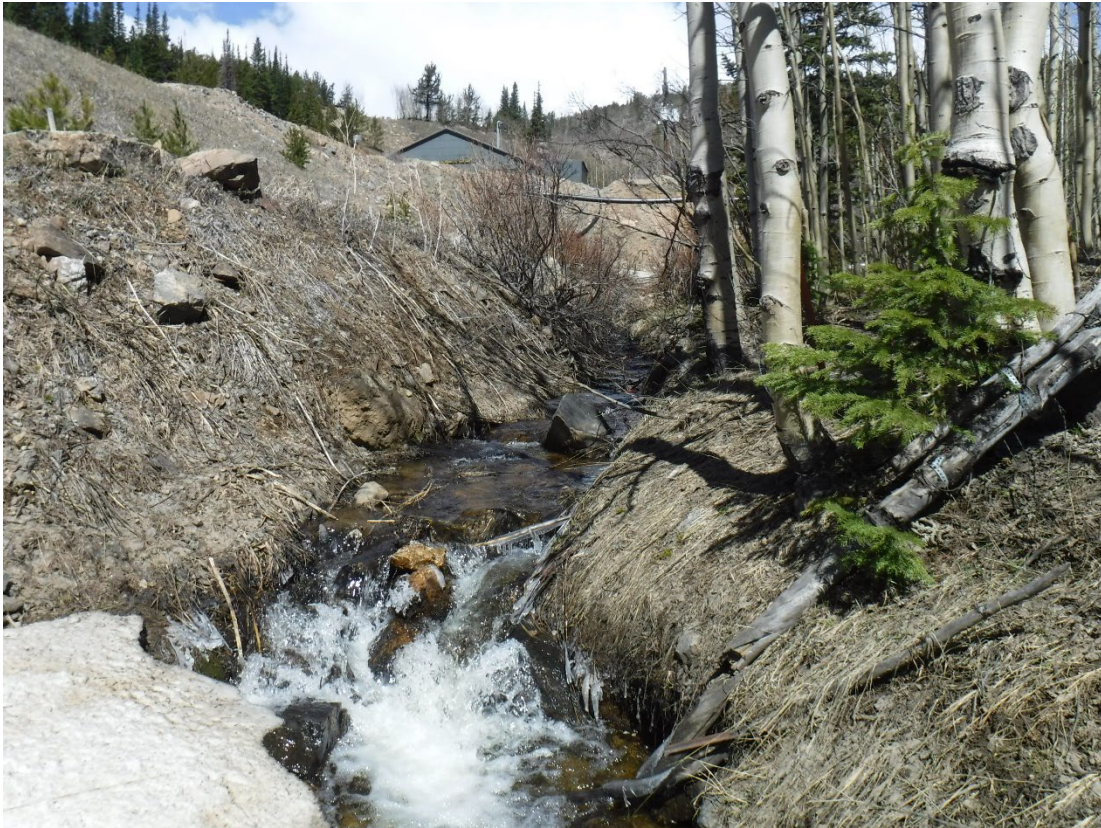
**Photo 9:** Downstream of approved discharge point on Coon Track Creek

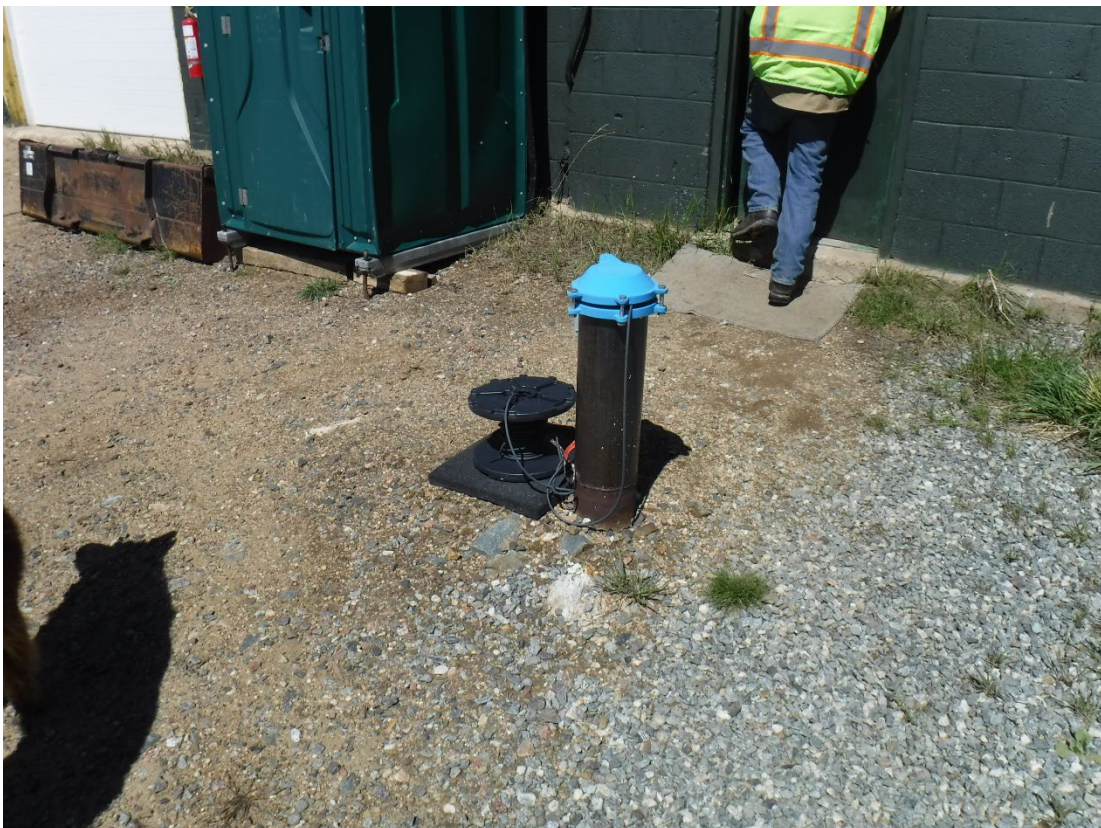
**Photo 10:** Cross Well

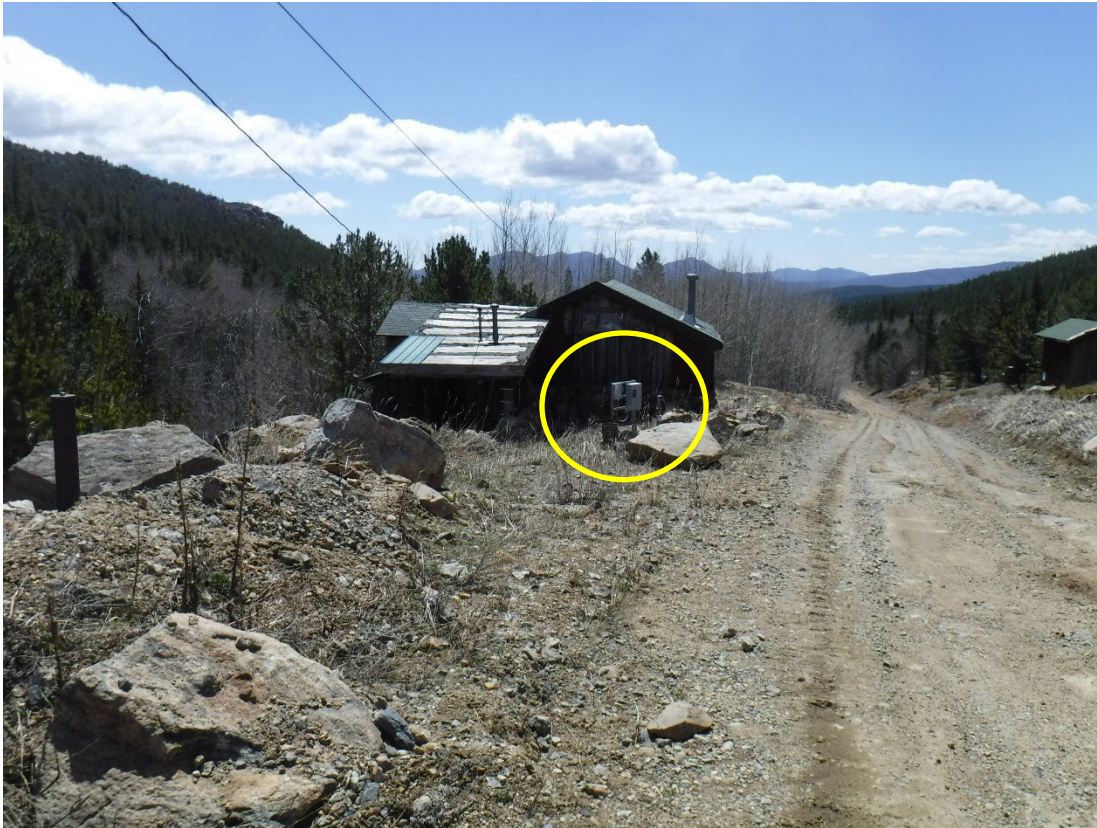
with reduced staff at the mine, corrosion of copper pipes within the mine buildings, reduced groundwater elevations during low flow months. To date, the point-of-compliance well, Cabin Well, has not had any recent detections of copper.

**Photo 11:** Cabin Well, point-of-compliance well

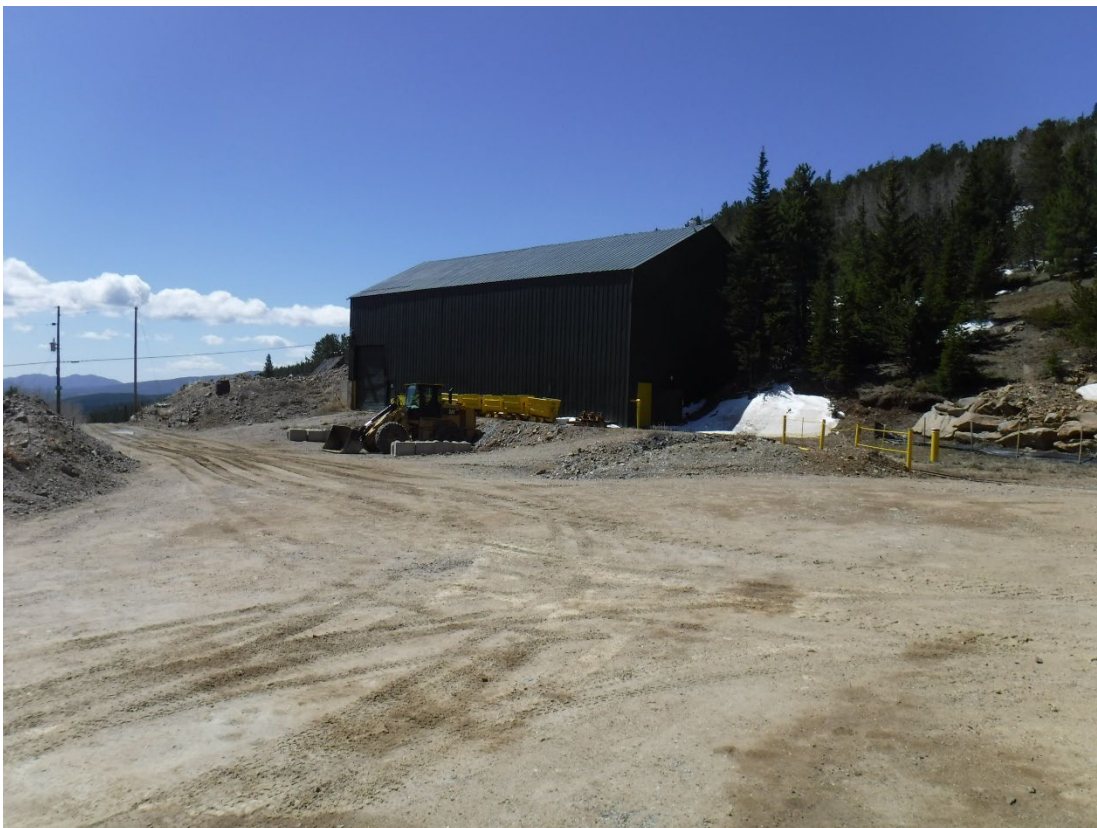
**Photo 12:** Warehouse

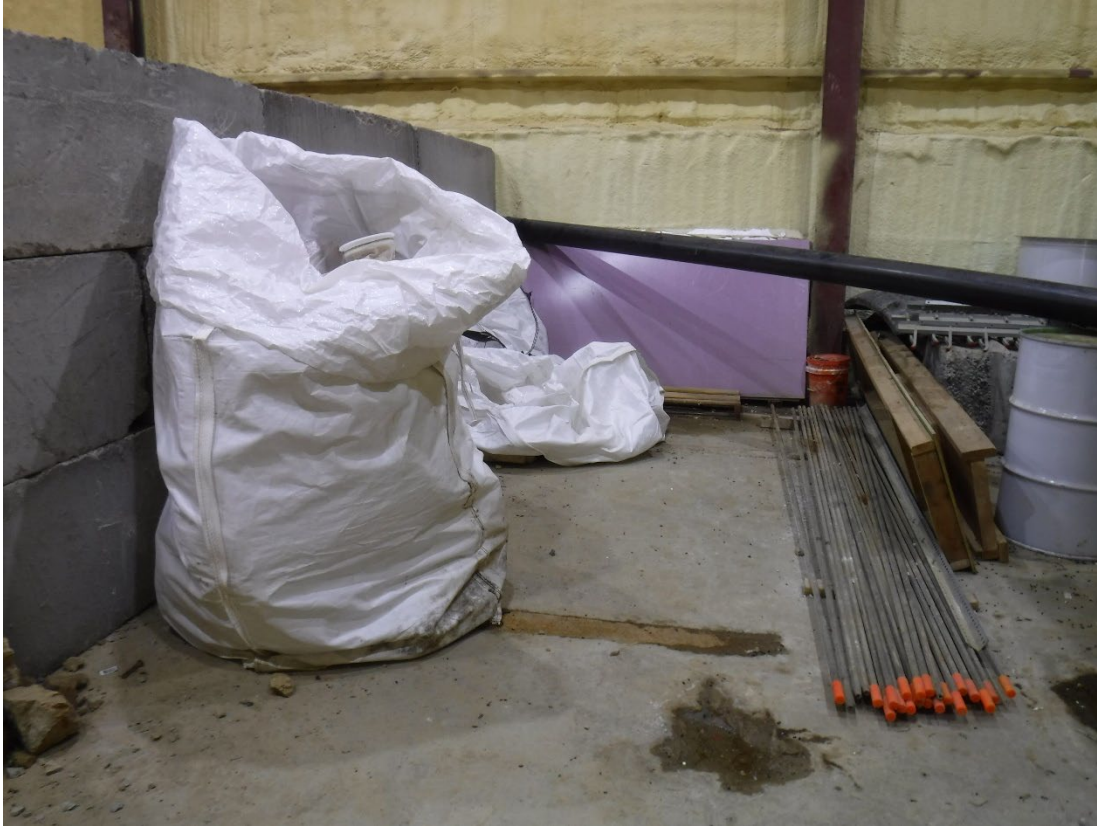
The Division observed the inside of the warehouse. In the warehouse the Division noted a SuperSac of spent filters and approximately 10 SuperSacs of sediment from the water treatment operations, including sediment from the water treatment methods used by the previous Operator. The sediment is from the cleaning out of the ponds and backflush material from the treatment system. This material is to be disposed of in an appropriate off-site facility. The Operator is to submit to the Division prior to transporting the sediment and filters off-site, for proper disposal, a memo that provides information from analytical sample results of the materials where the materials are to be disposed and any other relevant information that shows proper disposal protocols are being followed.

**Photo 13:** SuperSack of spent water treatment filters

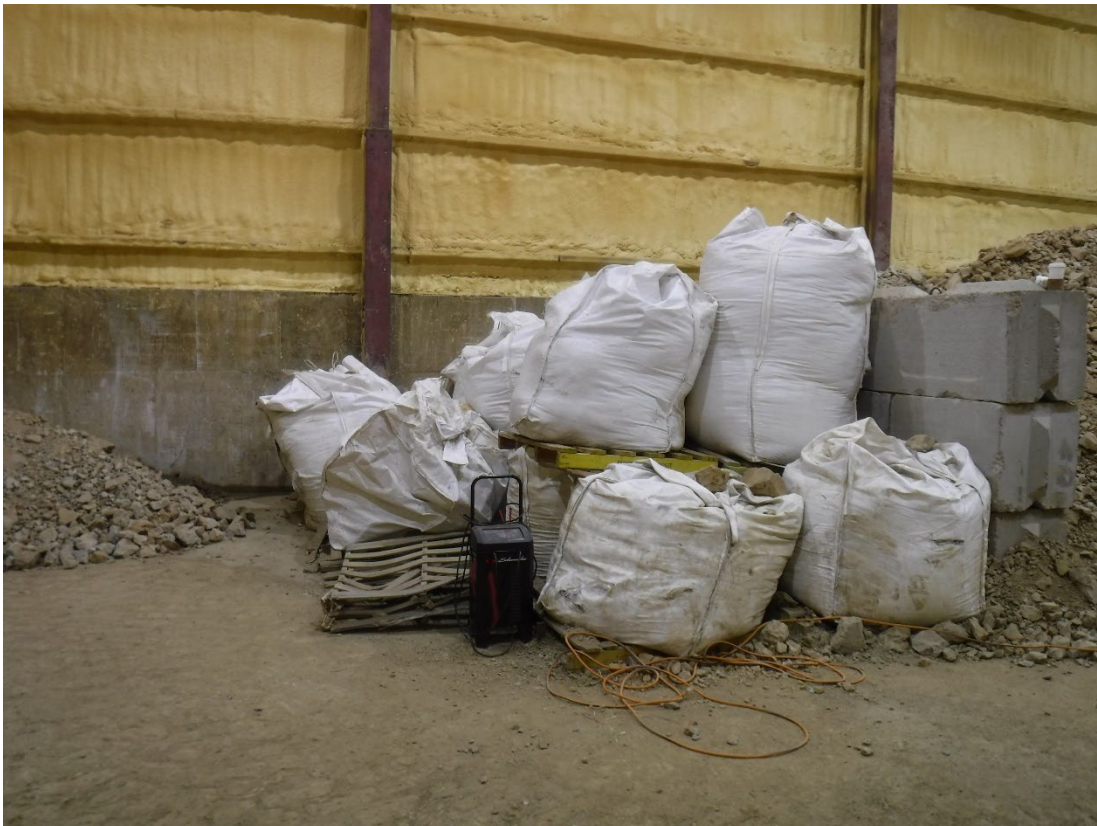
**Photo 14:** SuperSacks of sediment from water treatment operations
