MINERALS PROGRAM INSPECTION REPORT
PHONE: (303) 866-3567

MINE NAME: State Line Ranch Pit	MINE/PROSPECTING ID#: M-2000-040	MINERAL: Aggregate	COUNTY: Jackson
INSPECTION TYPE: Monitoring	WEATHER: Clear	INSP. DATE: April 23, 2025	INSP. TIME: 10:30
OPERATOR: Medicine Bow - Routt National Forest USDA Service	OPERATOR REPRESENTATIVE: Nate Davis	TYPE OF OPERATION: 110c - Construction Limited Impact	
REASON FOR INSPECTION: Normal I&E Program	BOND CALCULATION TYPE:	BOND AMOUNT: \$0.00	
DATE OF COMPLAINT: NA	POST INSP. CONTACTS: None	JOINT INSP. AGENCY: None	
INSPECTOR(S): Brock Bowles	INSPECTOR'S SIGNATURE:

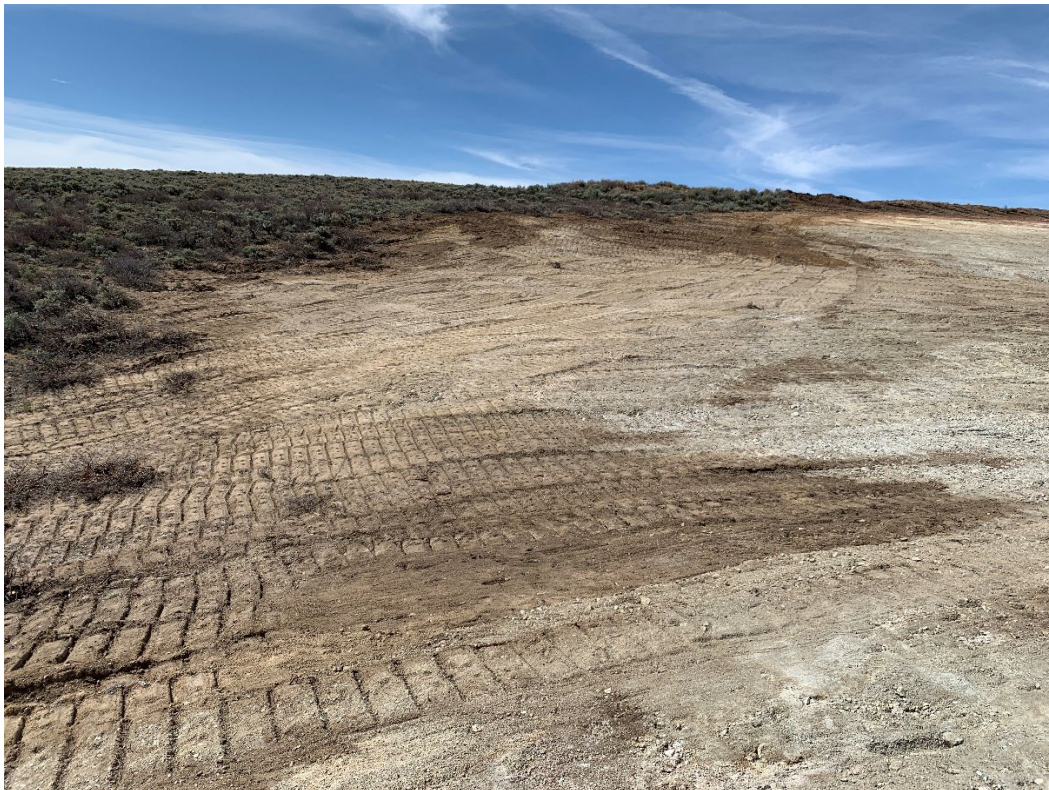
The south highwall has been backfilled and graded to integrate with the surrounding terrain (photo 1). The reconstructed pit slope is approximately 5h:1v, directing runoff north and northeast (photo 2). A shallow swale at the slope's toe carries runoff east, connecting to a natural drainage with an operator-reported 1% slope.

The backfill and grading appear excellent, blending seamlessly with the surrounding topography and landscape. The shallow slopes are favorable for erosion control.

Photo 1- East end of backfilled highwall, facing south

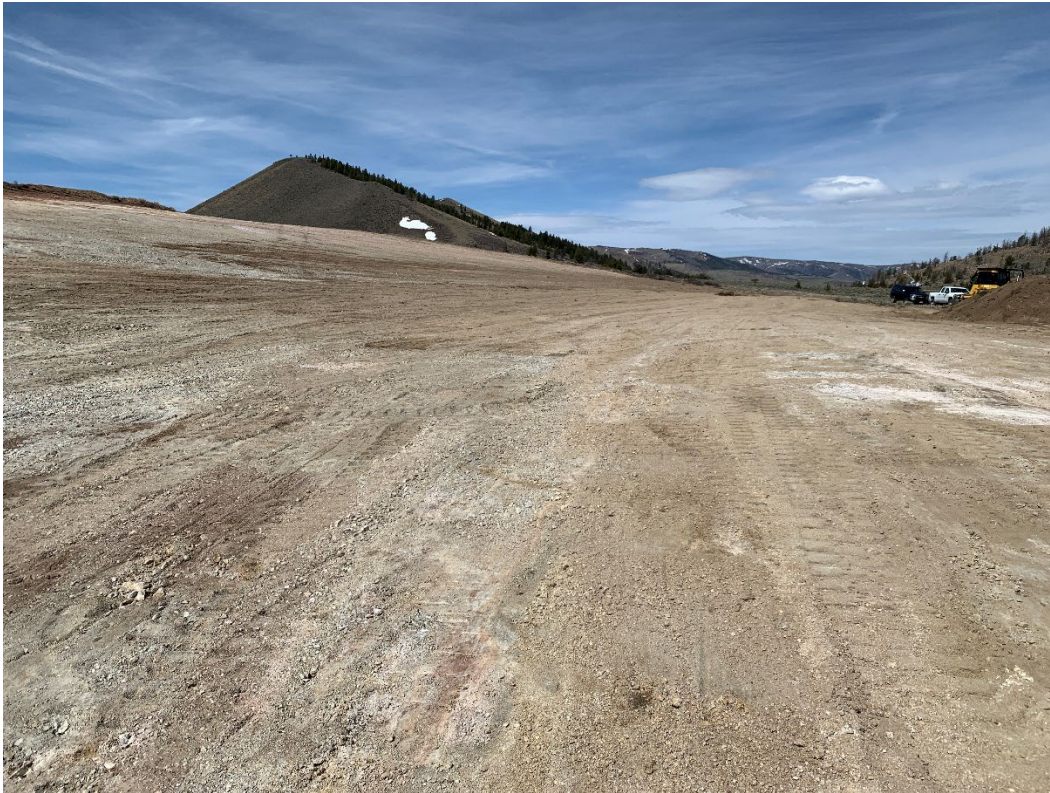
Photo 2- Pit area sloped to north with shallow swale directing runoff to lower left of photo. Photo facing the west.
