**MINERALS PROGRAM INSPECTION REPORT**  
**PHONE: (303) 866-3567**

<b>MINE NAME:</b> Lupton Meadows Gravel Mine	<b>MINE/PROSPECTING ID#:</b> M-2016-076	<b>MINERAL:</b> Sand and gravel	<b>COUNTY:</b> Weld
<b>INSPECTION TYPE:</b> Monitoring	<b>WEATHER:</b> Clear	<b>INSP. DATE:</b> March 20, 2025	<b>INSP. TIME:</b> 11:30
<b>OPERATOR:</b> BURNCO Colorado, LLC	<b>OPERATOR REPRESENTATIVE:</b> Joel Bolduc	<b>TYPE OF OPERATION:</b> 112c - Construction Regular Operation	
<b>REASON FOR INSPECTION:</b> Normal I&E Program	<b>BOND CALCULATION TYPE:</b> Complete Bond	<b>BOND AMOUNT:</b> \$1,921,500.00	
<b>DATE OF COMPLAINT:</b> NA	<b>POST INSP. CONTACTS:</b> None	<b>JOINT INSP. AGENCY:</b> None	
<b>INSPECTOR(S):</b> Nikie Gagnon	<b>INSPECTOR'S SIGNATURE:</b>

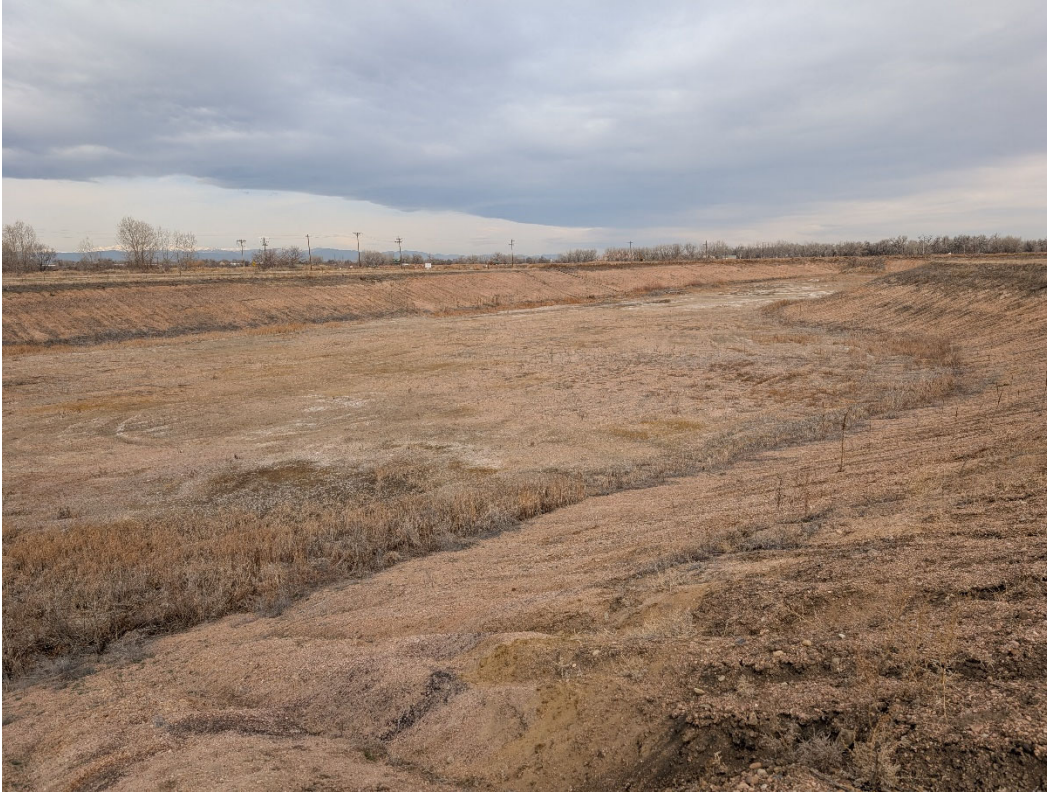
Photo 1: Looking at East Mining Area, south pit. Slopes graded to 3:1.

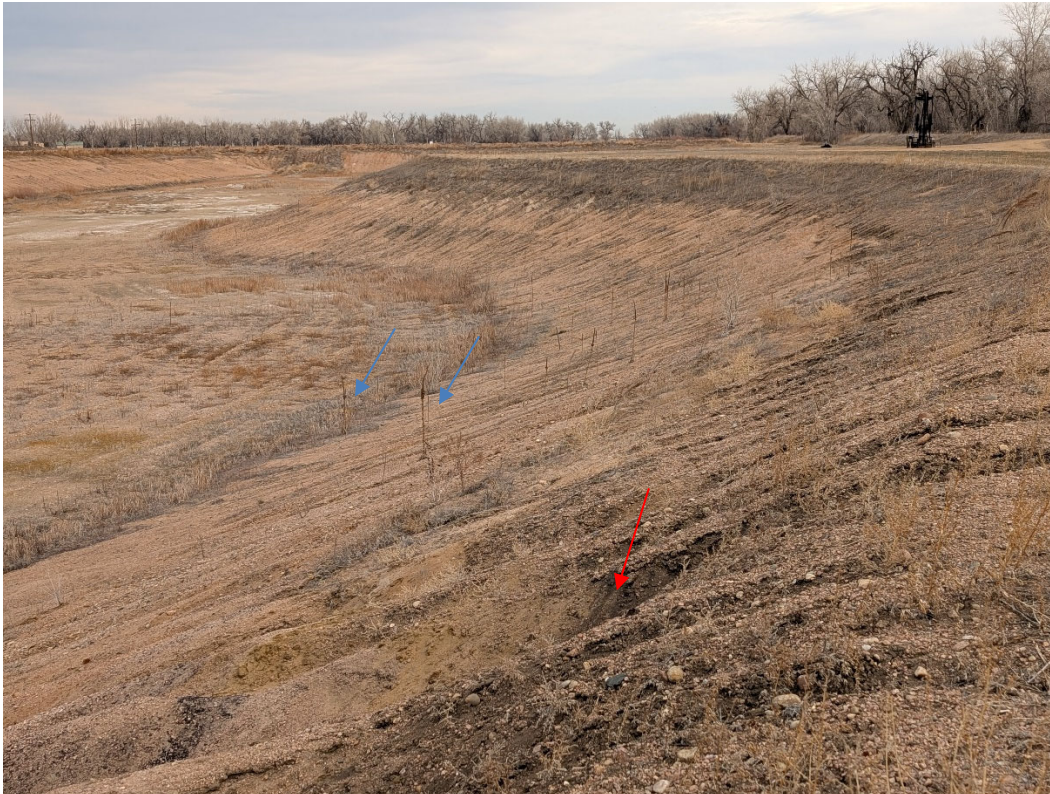
**PROBLEM:** There are state-listed noxious weeds present on site. This is a problem for failure to employ weed control methods for state listed noxious weed species within the permitted area, and to reduce the spread of weeds to nearby areas as required by Section 3.1.10 (6) of the rule.

The East Mining Area on the east side of WCR 25 contains two mined pits, a 13.7 acre pit on the south end and an 8.5-acre pit on the north end. Mining is complete in this area. The slopes of the pits were graded to 3:1, however, since reclamation activity in this area stalled, erosion rills are developing on the graded slopes. Deeper rills will need to be repaired prior to topsoiling and seeding. Based on the soil color observed along the top of the south reservoir, stockpiled topsoil was placed around the top of the reservoir; however, other than annual weeds, no desired vegetation is growing on the slope or in the upland areas. Coniferous trees have been planted on the south end.

The Division observed annual weeds across the site. Additionally, common Mullein was observed on pit slopes on both sides of WCR 25. Common mullein is a List C noxious weed. The approved weed plan states that the operator will control weeds via mechanical methods or herbicides. **As noted in the Problem listed above, the Operator shall implement the approved weed control plan and provide proof to the Division that this has been done by the corrective action date.**

Photo 2: Topsoil replaced along the top 3 feet of the south reservoir (East Mining Area). Annual weeds and Common mullein noted on the slopes (blue arrows). No desired vegetation here. Erosion rills developing along the slopes (red arrow).

**CORRECTIVE ACTIONS:** Implement approved weed control plan and provide proof to the Division that this has been done.

According to the approved 2016 Reclamation Plan, finish grading to 3:1 slope, topsoil placement (minimum of 6 inches) and drill seeding (with approved seed mix) will occur once the resource is completely removed. Each phase will be completed within one to two years from the completion of mining. Based on Division records, mining of the east side was complete in 2021 and only stockpiles of material remained in the pits at that time. During this inspection, the Division observed that the stockpiles have been removed. Therefore, in accordance with Rule 3.1.3, the operator needs to complete grading/repair of the reservoir slopes and complete reclamation of the east area according to the approved plan with all reasonable diligence.

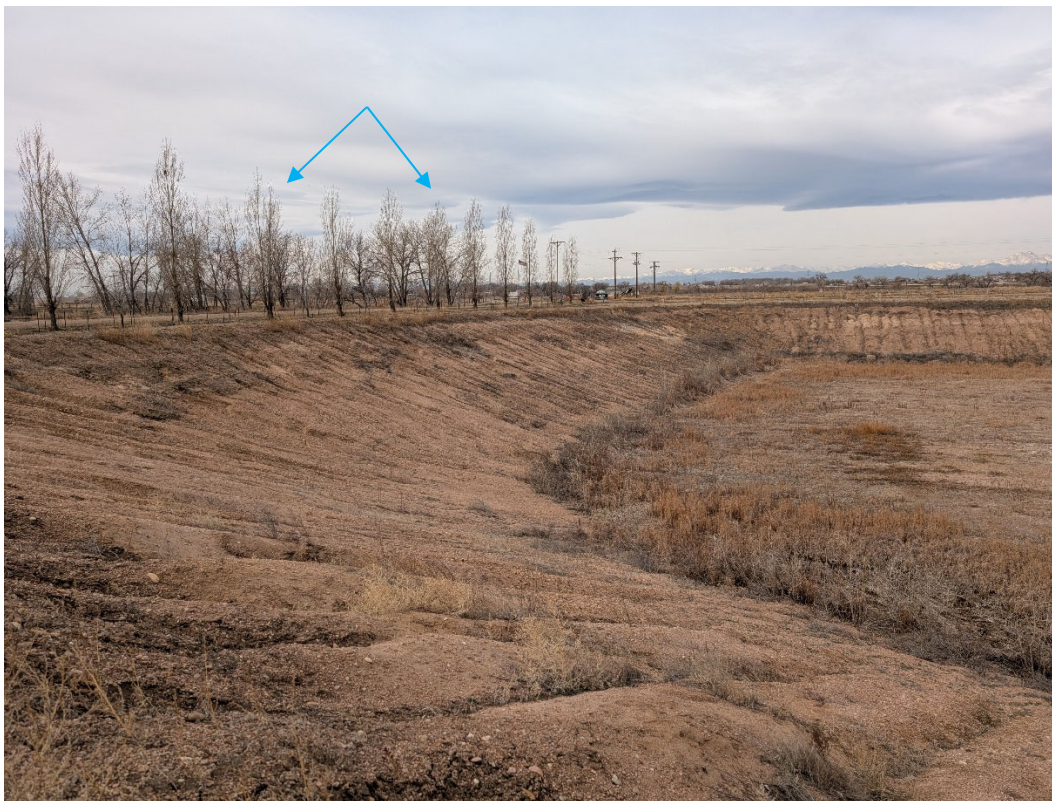
Photo 3: Looking along the southern end of the south reservoir in the East Mining Area. Cottonwood trees planted along the boundary (blue arrows).

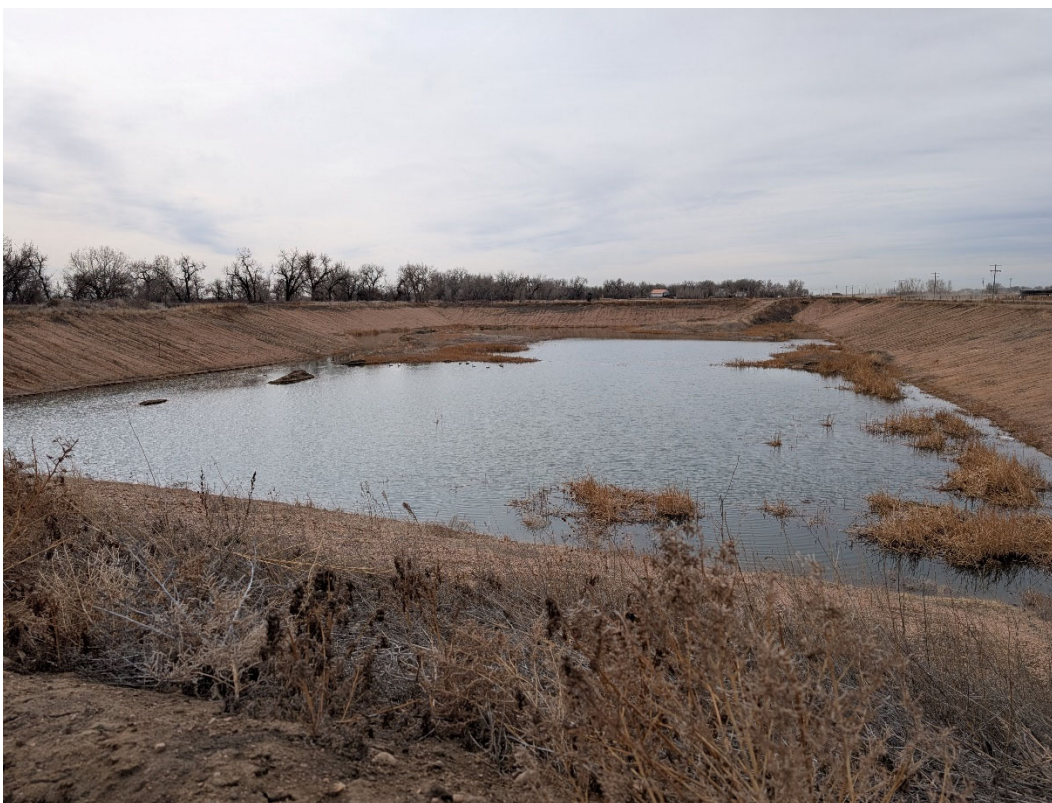
Around the north reservoir, small (2-ft) topsoil/overburden berms were observed above the slope indicating topsoil has not been placed. Water was observed in the pit. Two spillways are depicted on the approved reclamation plan map. As of the date of this inspection, the spillways have not been installed.

Photo 4: Looking south across the north reservoir in the East mining area.

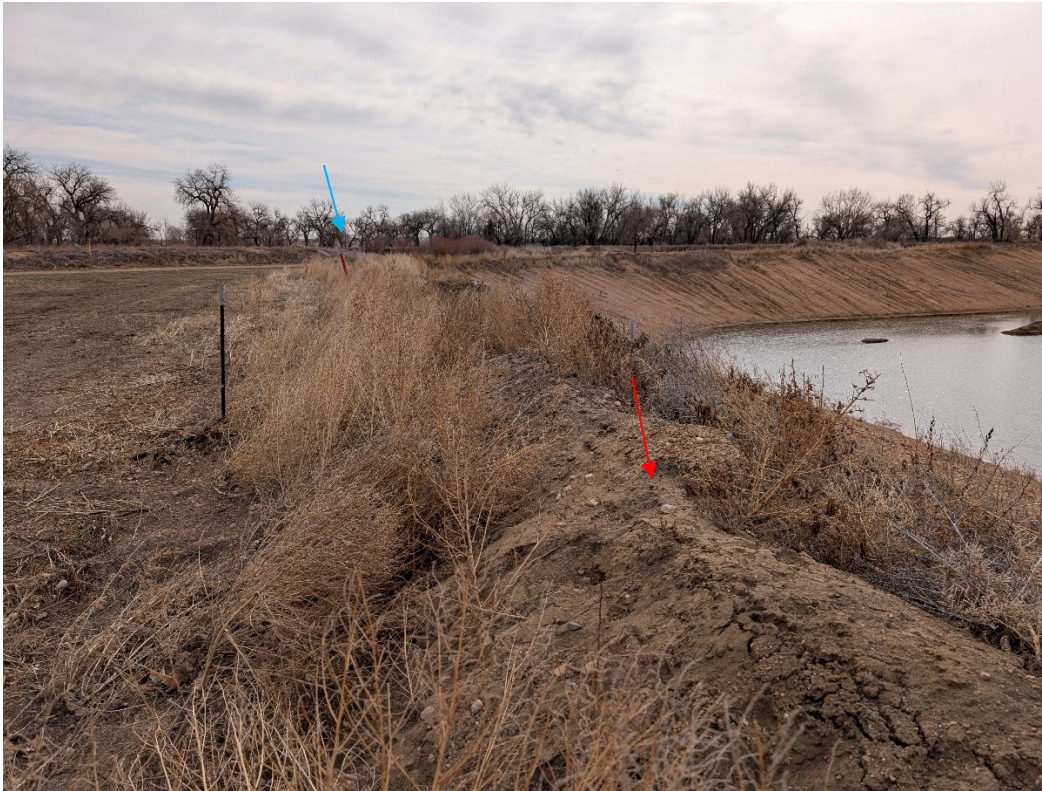
Photo 5: Looking at the topsoil berm above the north reservoir in the East Mining Area (red arrows. Red plastic stake marks the slurry wall (blue arrow)

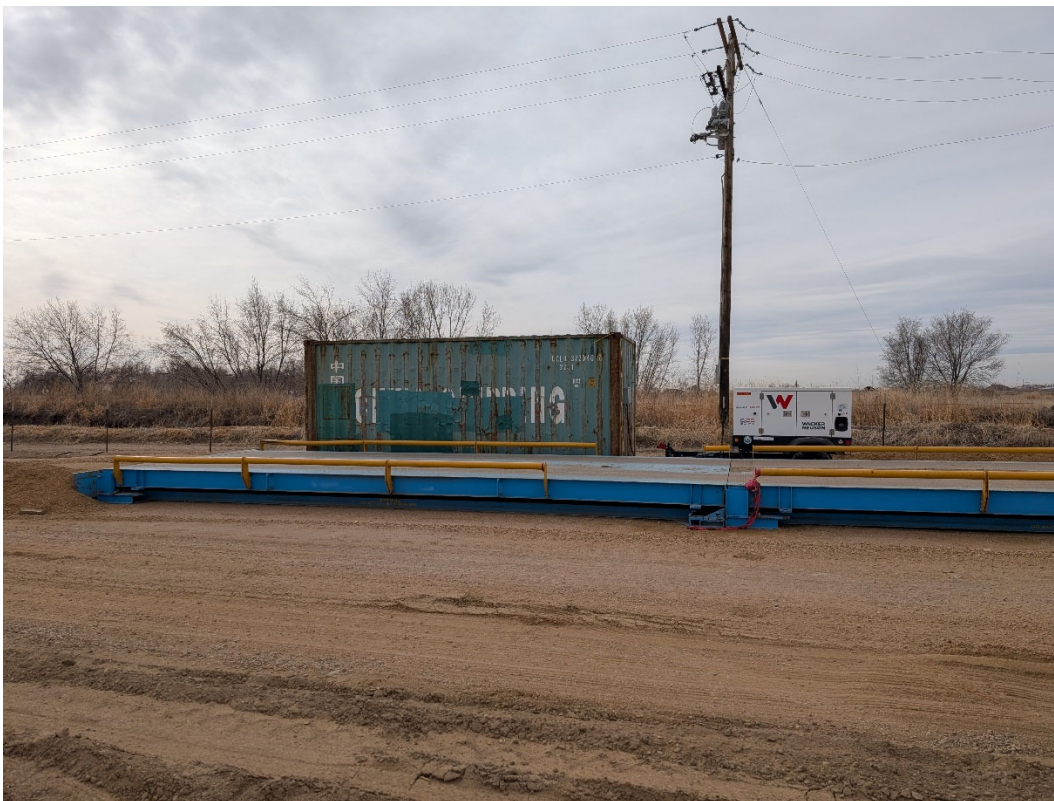
Photo 6: Looking at the portable scale house and Conex storage box in the West Mining Area, near the entrance to the site.

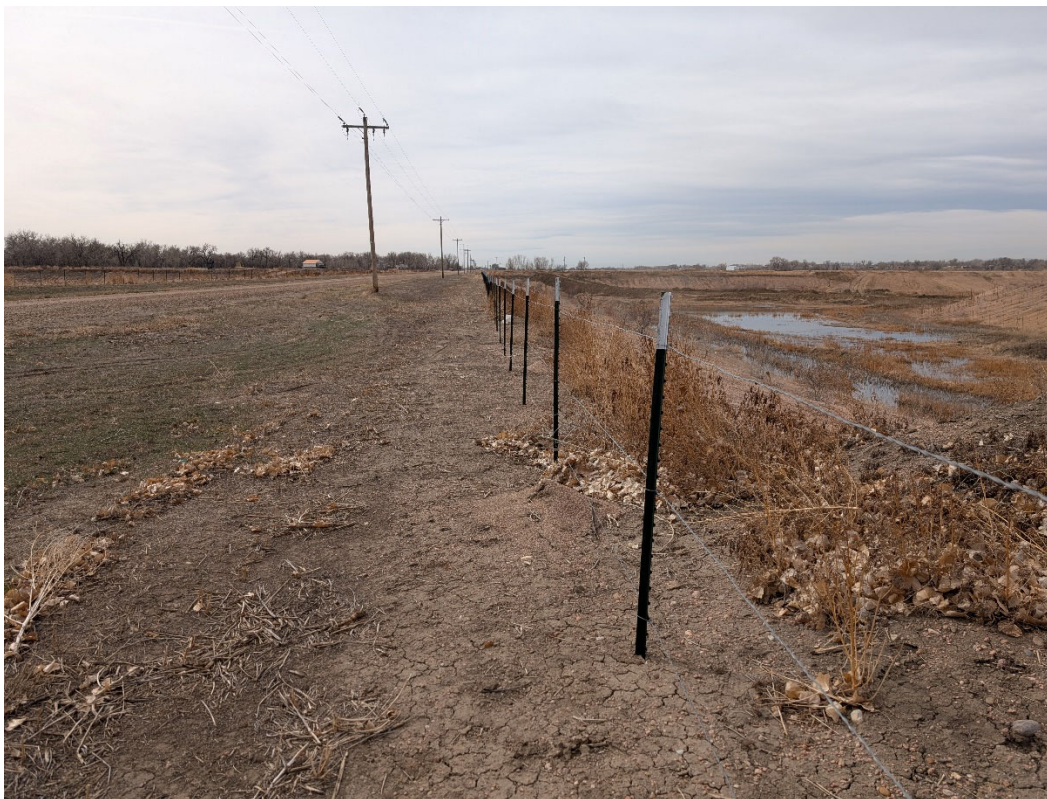
Photo 7: Looking south down the eastern boundary of the West Mining Area. Barbed wire fence surrounds the permit area.

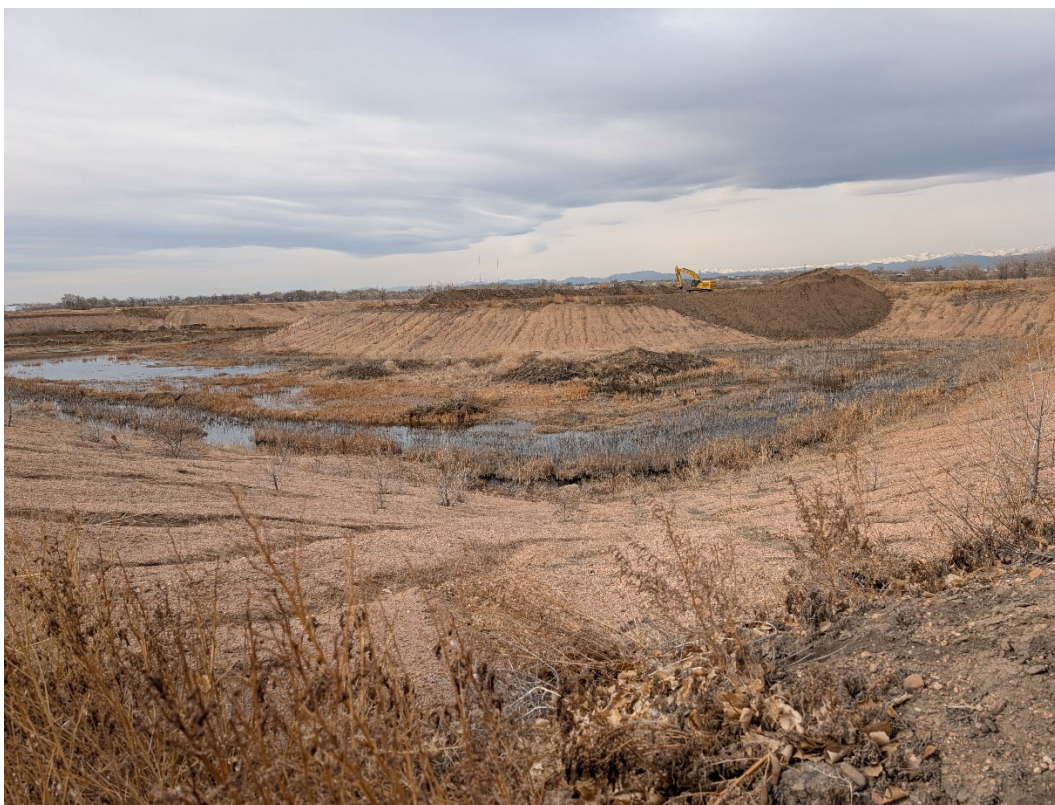
Photo 8: Looking southwest across the north pit in the West Mining Area.

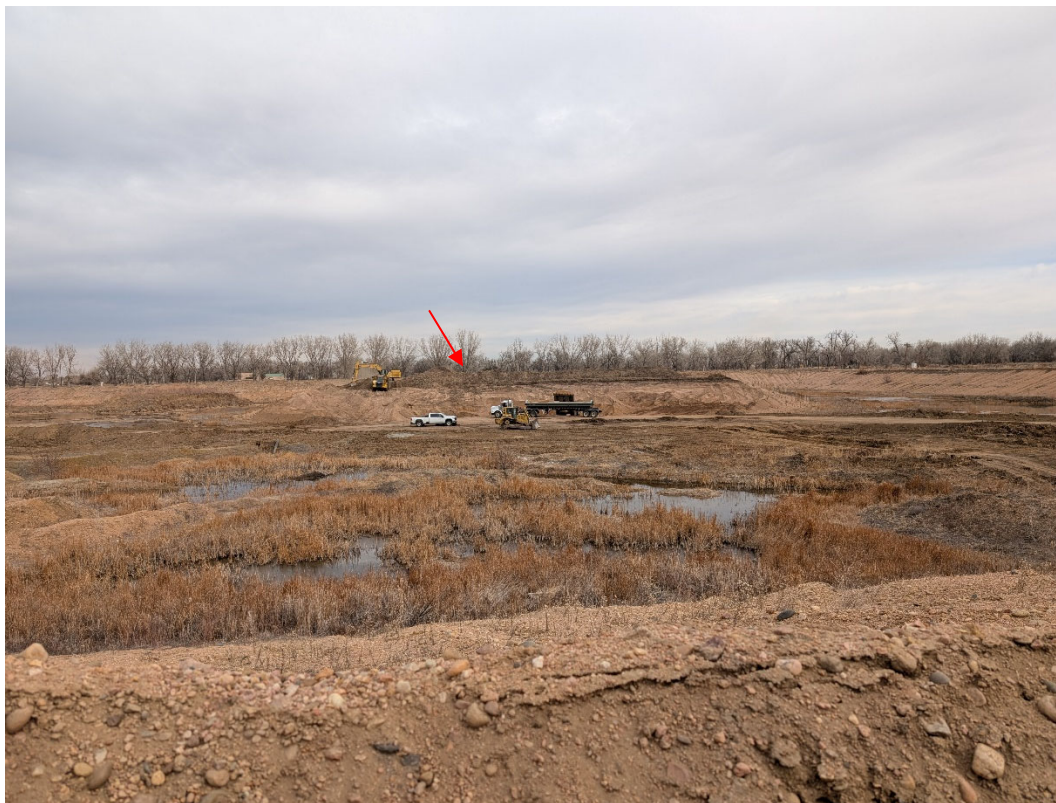
Photo 9: Looking north at the excavation work in the north pit where the former oil and gas well pad was located.

During the inspection, Mr. Bolduc informed the Division that an oil and gas well on the north side of the west area was removed and they are currently mining the pad out to enlarge the reservoir. **Prior to seeking a release of the west area, the Operator will need to submit a Technical Revision to update the reclamation plan to show the final configuration of the northwest reservoir.**

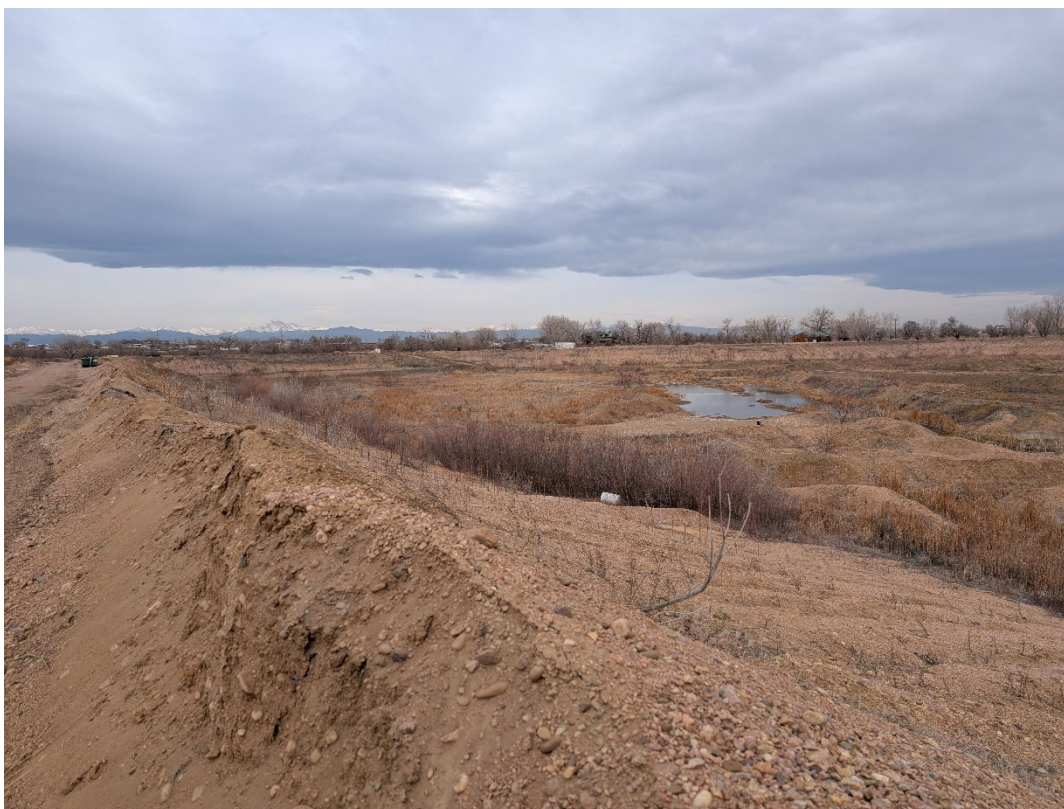
Photo 10: Looking northwest at the north pit in the West Mining Area. Overburden stored in a berm at the top of the slope.

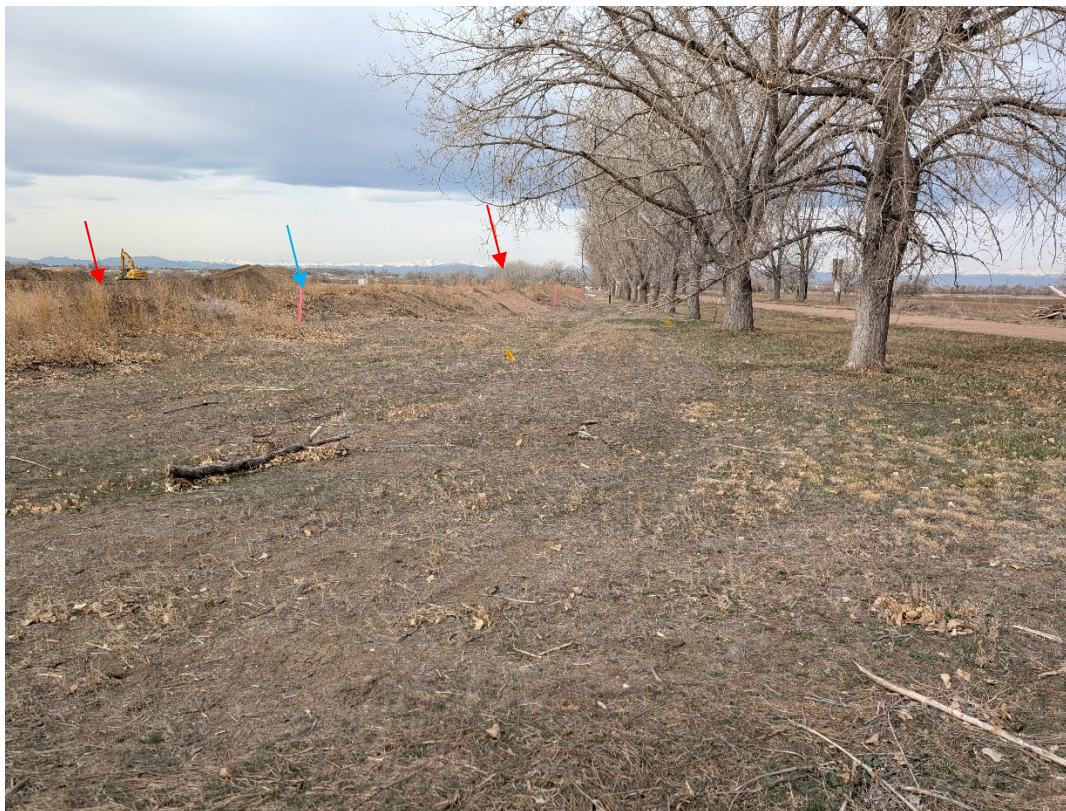
Topsoil/overburden berms were observed along the northern permit boundary in the west mining area. The berm appeared stable. During the inspection, the operator stated they plan to import topsoil to ensure that there is a minimum of 6 inches of growth medium on the disturbed areas.

Photo 11: Looking along the northern permit boundary. Topsoil stored in a berm (red arrows). Red plastic stakes mark the slurry wall (blue arrow).

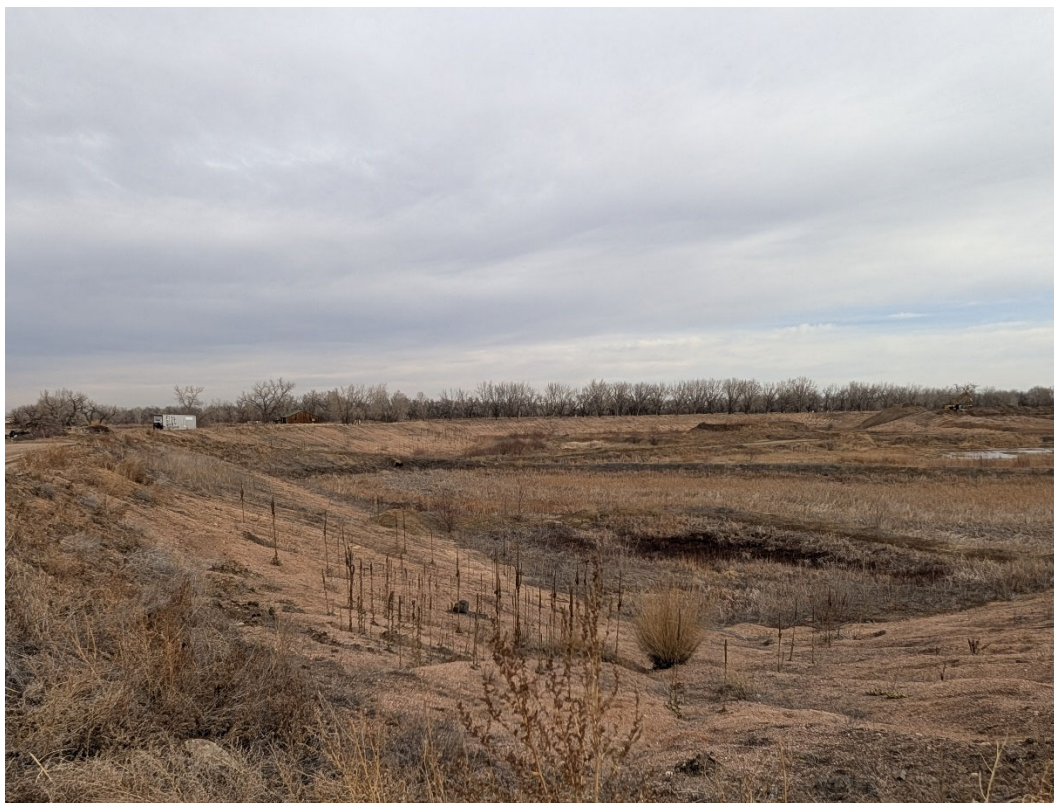
Photo 12: Looking at the north pit from the southwest corner. Annual weeds and Common mullein observed across the pit.

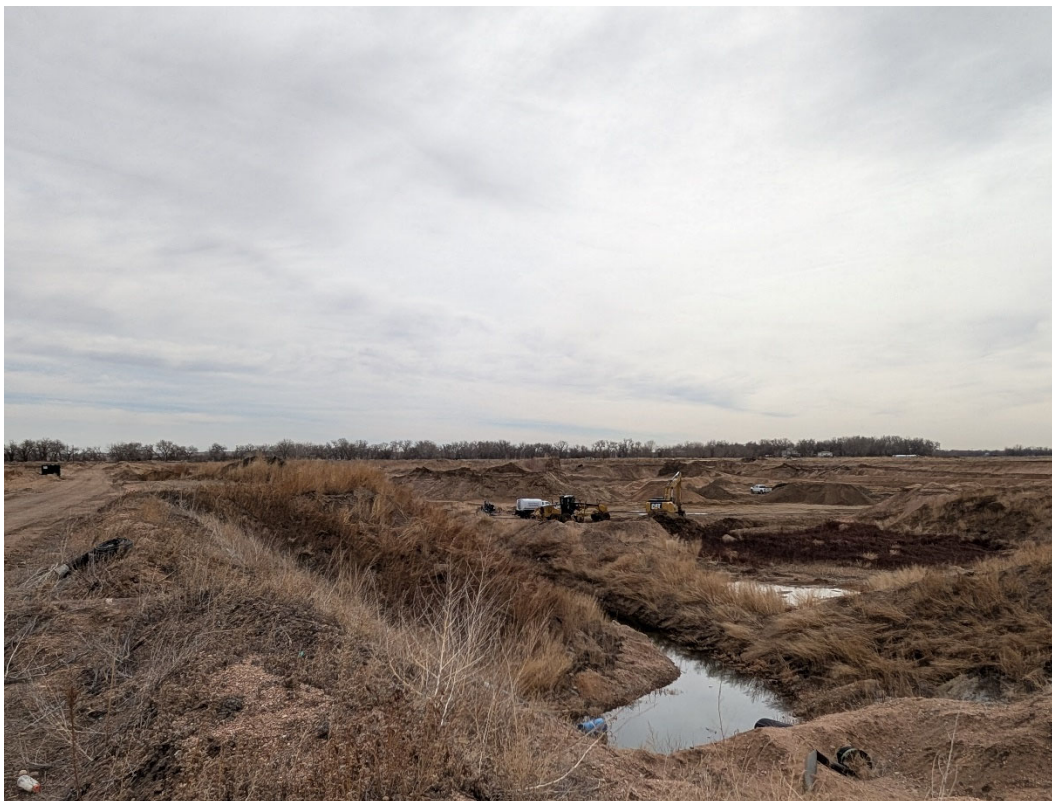
Photo 13: Looking at active mining in the south pit in the West Mining Area from the northwest corner. Dewatering sump located in this area.

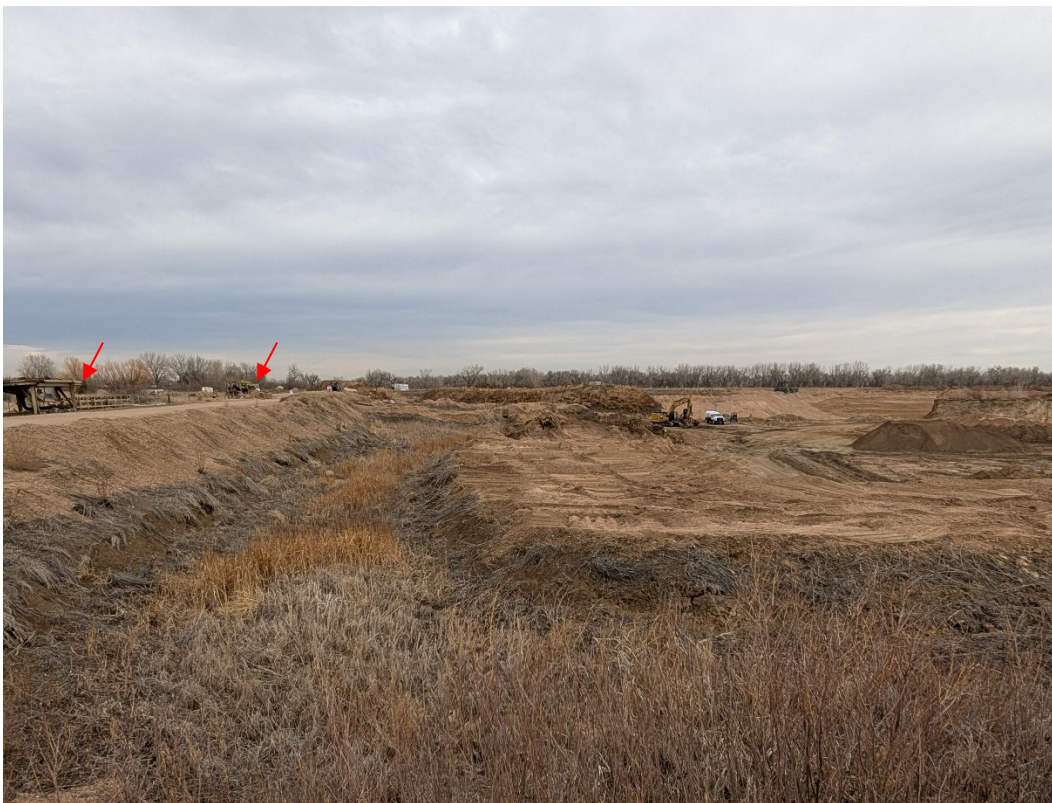
Photo 14: Looking north along the western boundary of the south pit in the West Mining Area. Processing equipment stored within the permit area on the west end (red arrows).

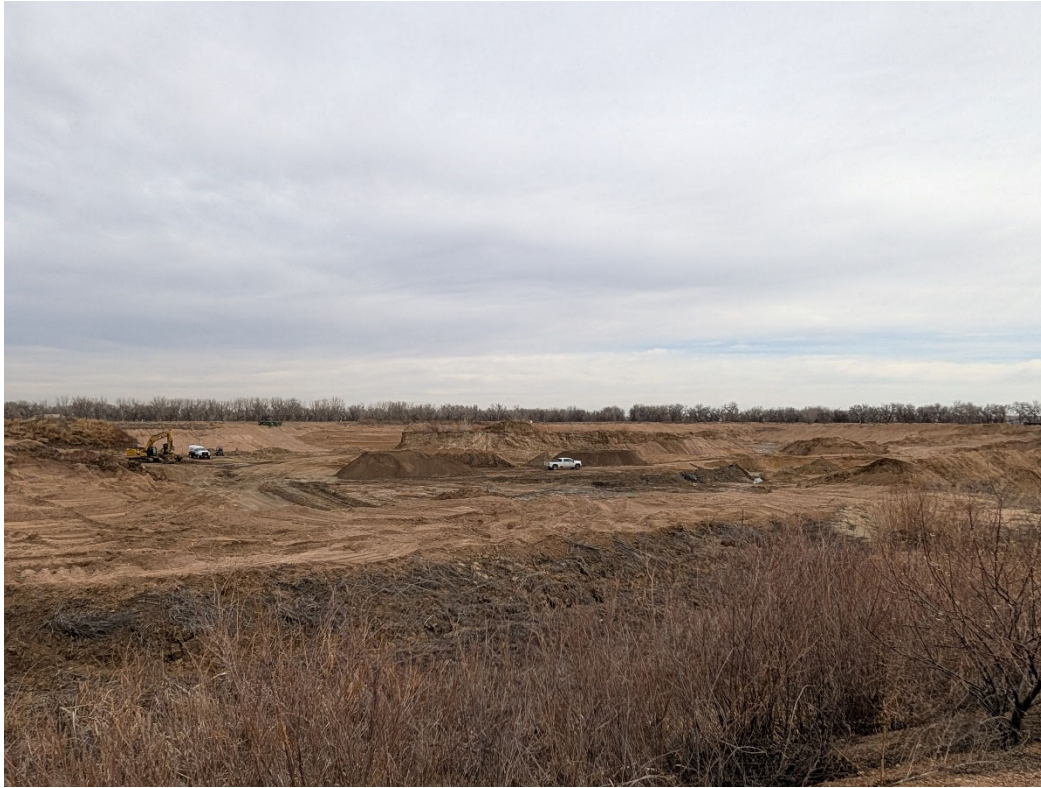
Photo 15: Looking northeast across the south pit in the West Mining Area. Active mining here.

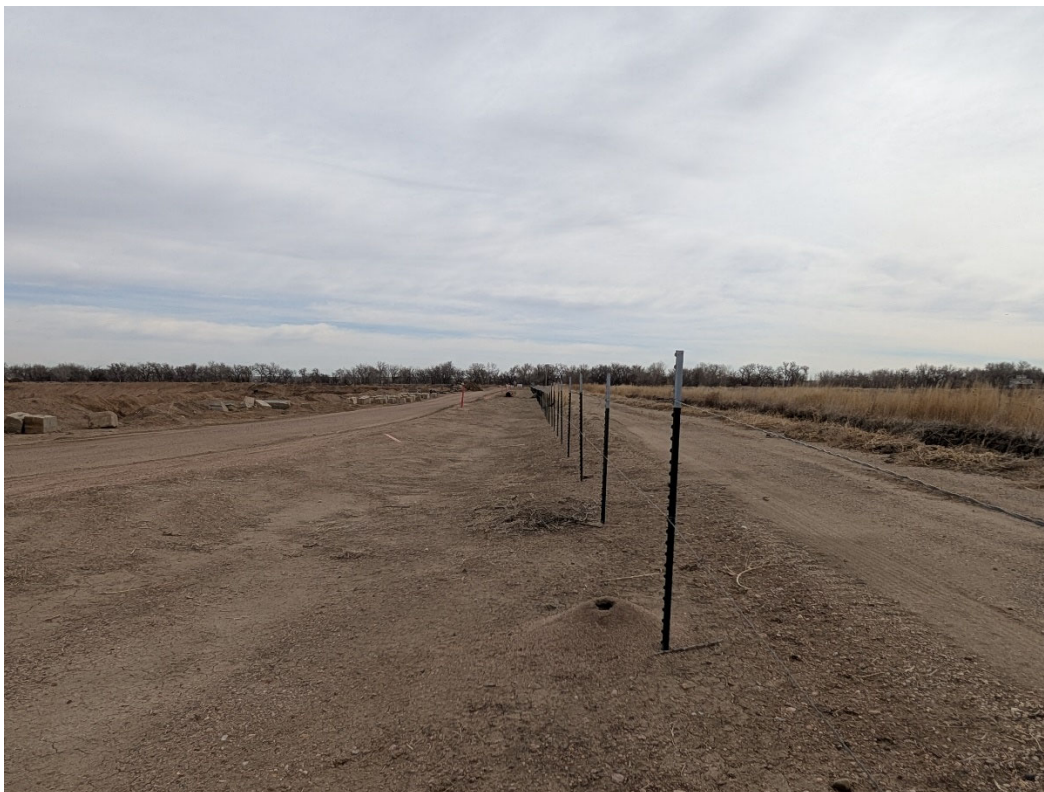
Photo 16: Looking east along the south boundary of the permit area on the west side.

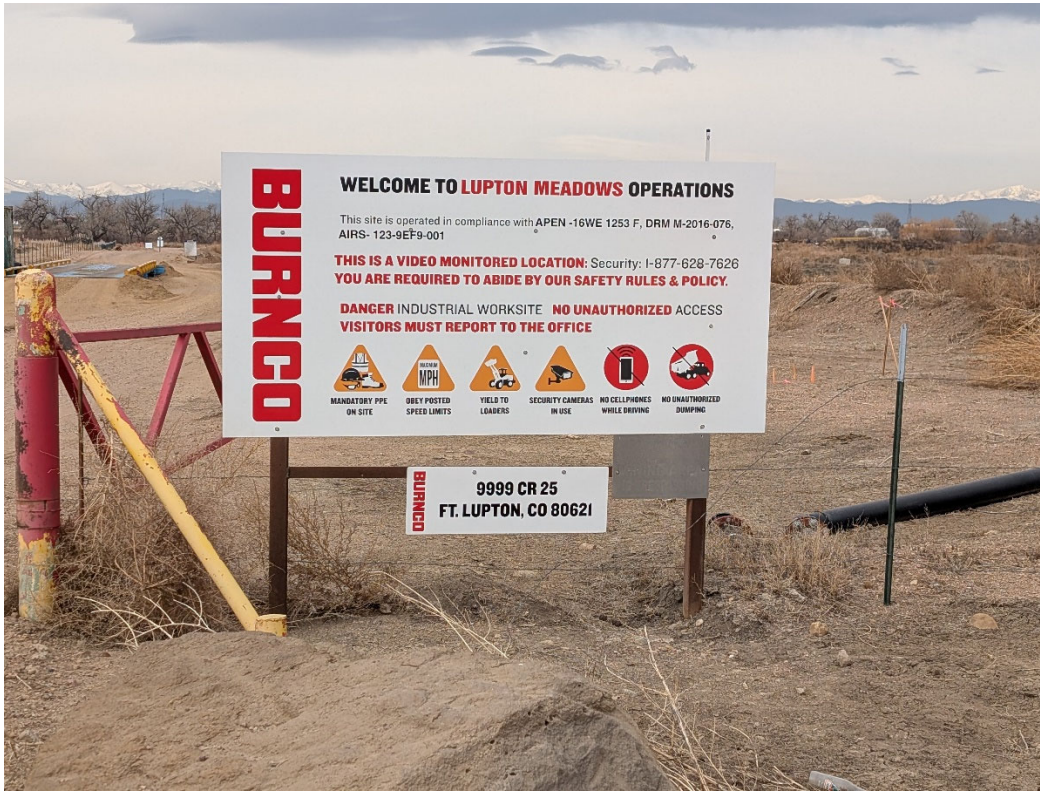
A mine sign was posted at the entrance in the northwest corner, as required by Rule 3.1.12(1). A barbed wire fence was installed around site. Red plastic markers were observed marking the edge of the slurry walls.

Photo 17: Mine sign located at the entrance to the West Mining Area.
