C1980007, West Elk Mine, May Inspection Report

PERMIT INFORMATION

Permit Number: C-1980-007 Mine Name: West Elk Mine Operator: Mountain Coal Company, LLC Operator Address: Robert Munz 5174 Highway 133 Somerset, CO 81434	County: Delta, Gunnison Operation Type: Underground Permit Status: Active Ownership: Private
	Operator Representative Present: Josh Thompson, Natalie Stafford
Operator Representative Signature: (Field Issuance Only)

Inspection Start Date: May 20, 2025 Inspection Start Time: 08:30 Inspection End Date: May 20, 2025 Inspection End Time: 12:30		Inspection Type: Coal Partial Inspection Inspection Reason: Normal I&E Program Weather: Clear	
Joint Inspection Agency: OSMRE		Joint Inspection Contacts: Dan Mackinnon, Kyler Yingling	
Post Inspection Agency: None		Post Inspection Contacts: 	
Inspector(s): Leigh Simmons	Inspector's Signature:

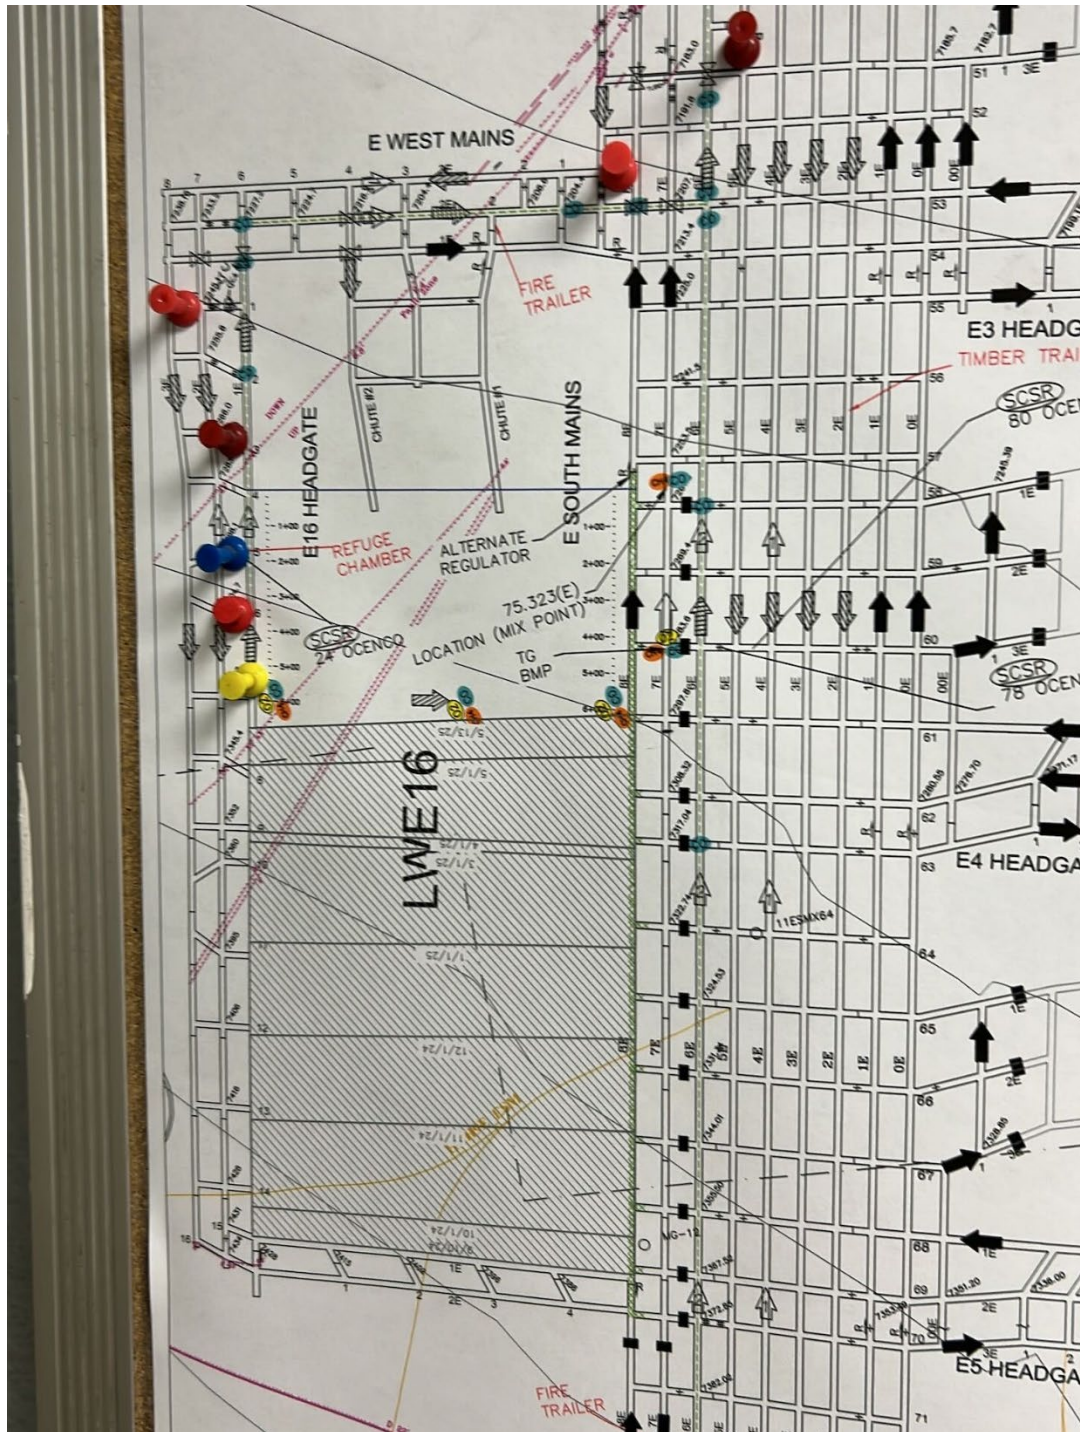
Longwall mining of the LWE16 panel was in progress, at around cross cut 8 on the head gate. A longwall move to the B26 panel was anticipated in mid-June.

Figure 1: Mine map showing longwall progress in LWE16 panel

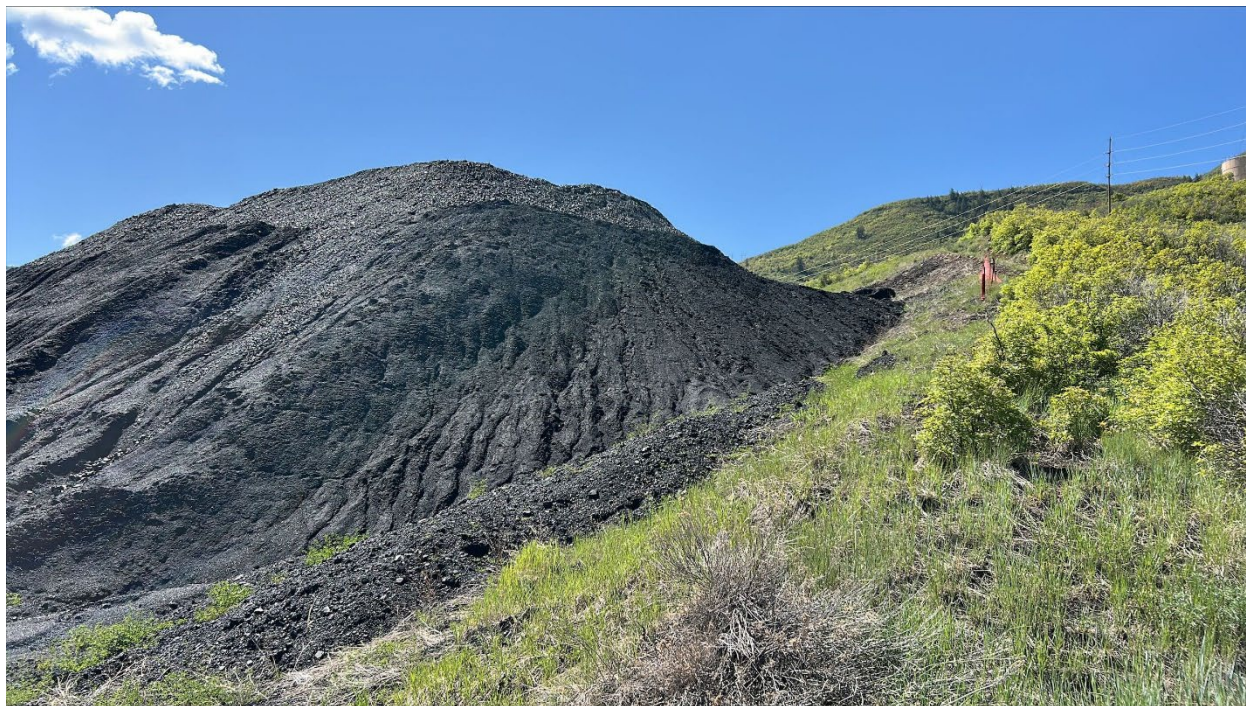
Figure 4: Western end of Run-of-Mine coal stockpile pad; material retained within pad footprint.

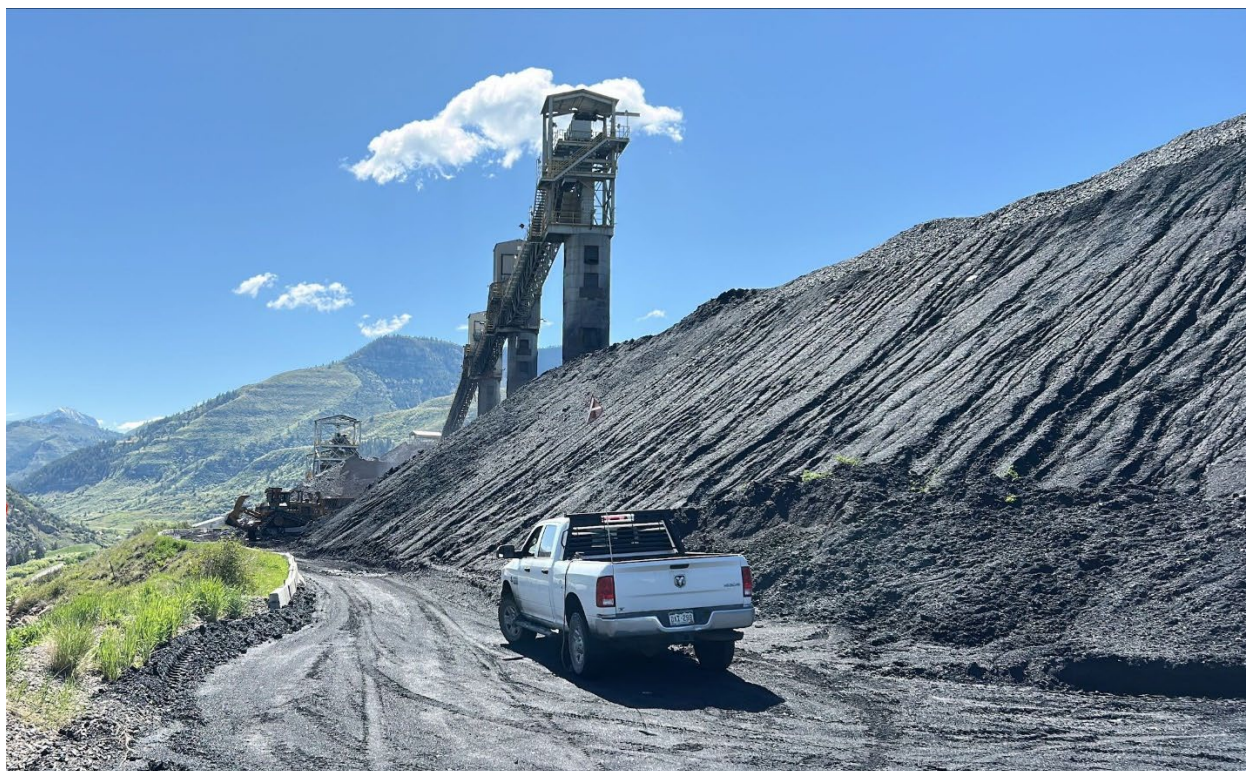
Fines were being generated and stockpiled at ST-1 on the Run-of-Mine pad, ready to be blended back in to coal shipments as customer specifications allow. Processing waste was being transported directly to the RPEE.

Figure 5: Run-of-Mine coal stockpile, with Stack Tube 3 in foreground and stack tubes 2 and 1 behind

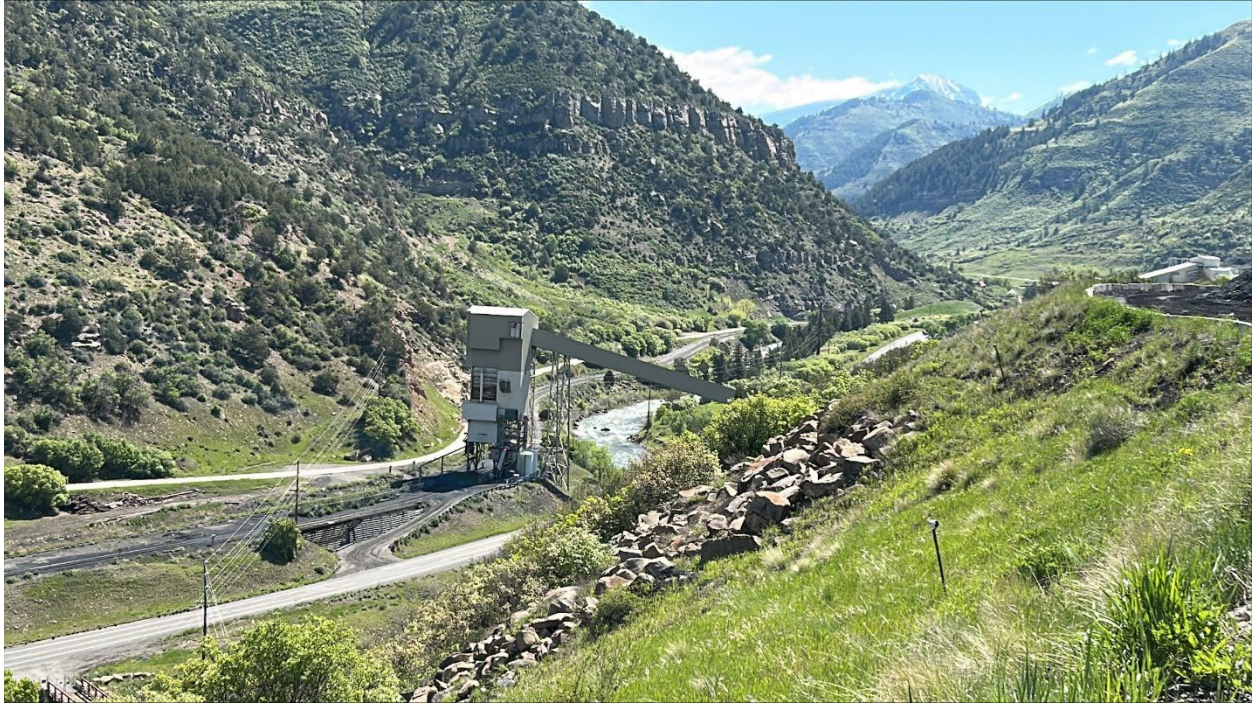
Work had not yet begun on the surface water project at the train loadout.

Figure 6: Train Loadout

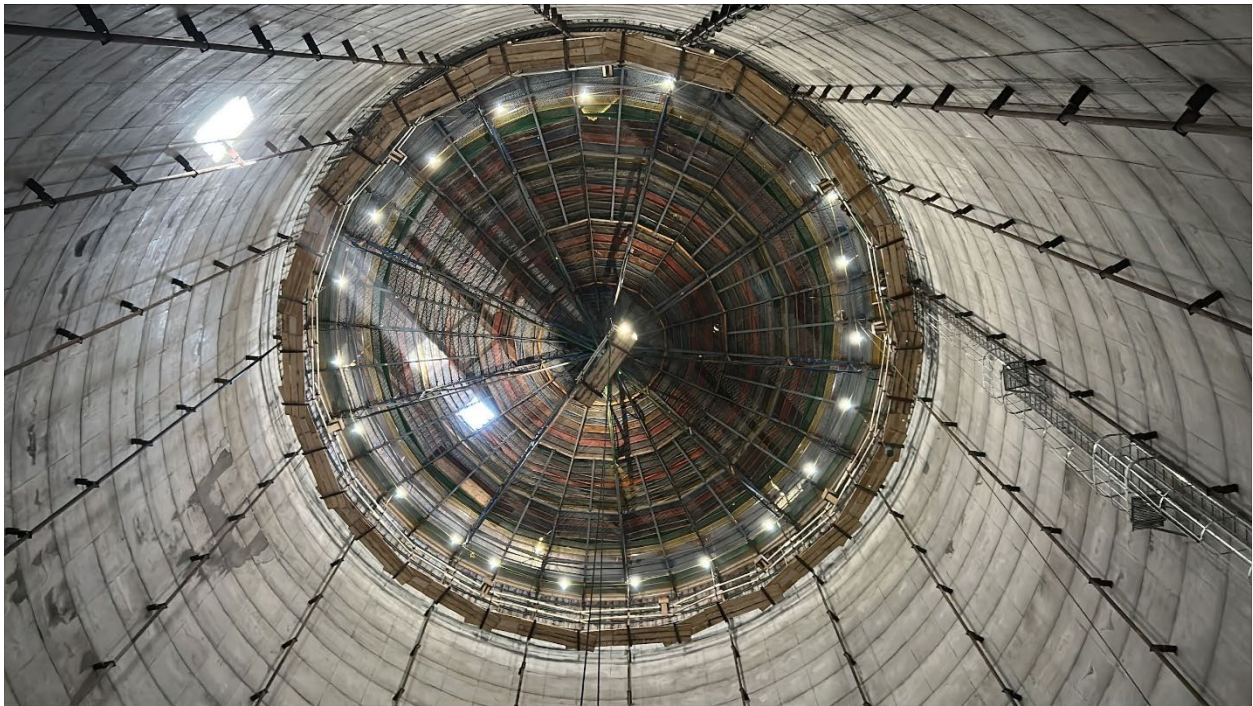
Contractors working on lining the silo had made good progress and had almost reached the top.

Figure 7: Inside re-lined silo

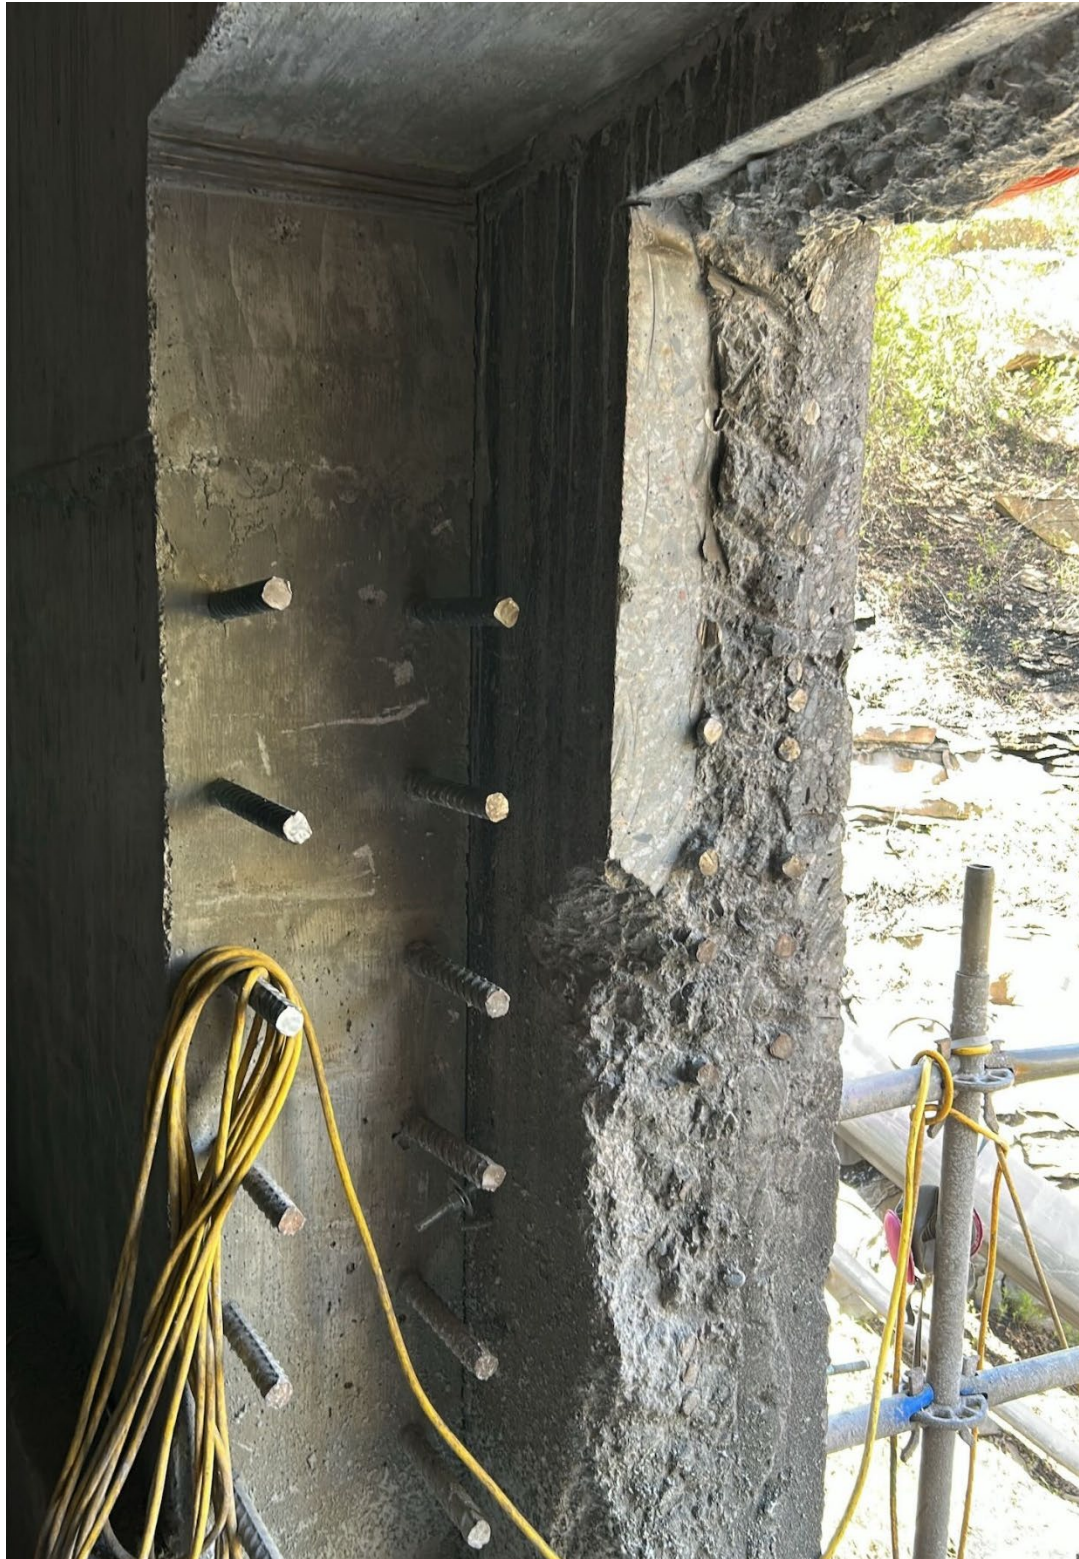
Figure 8: Wall of silo, showing original concrete(R) and new lining(L)

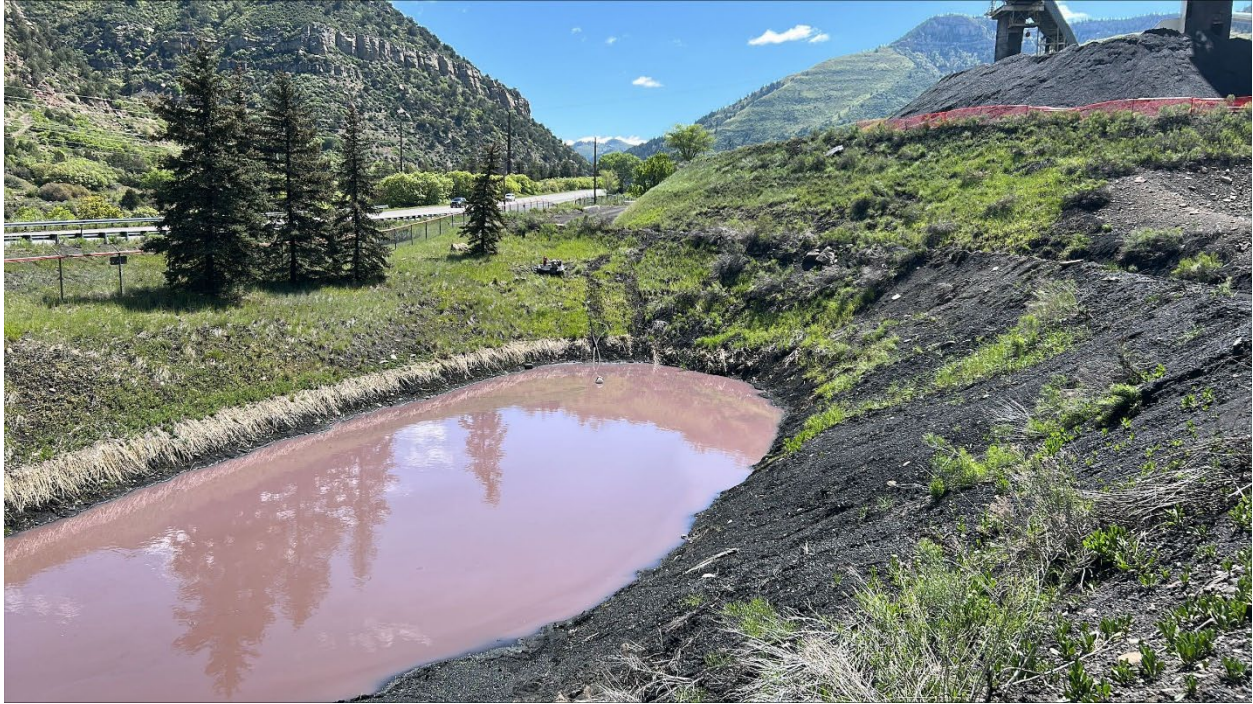
The MB5E, MB3, RPE and SG1 ponds were all inspected and were holding water. None of the ponds were discharging.

Figure 9: MB3 pond (east)

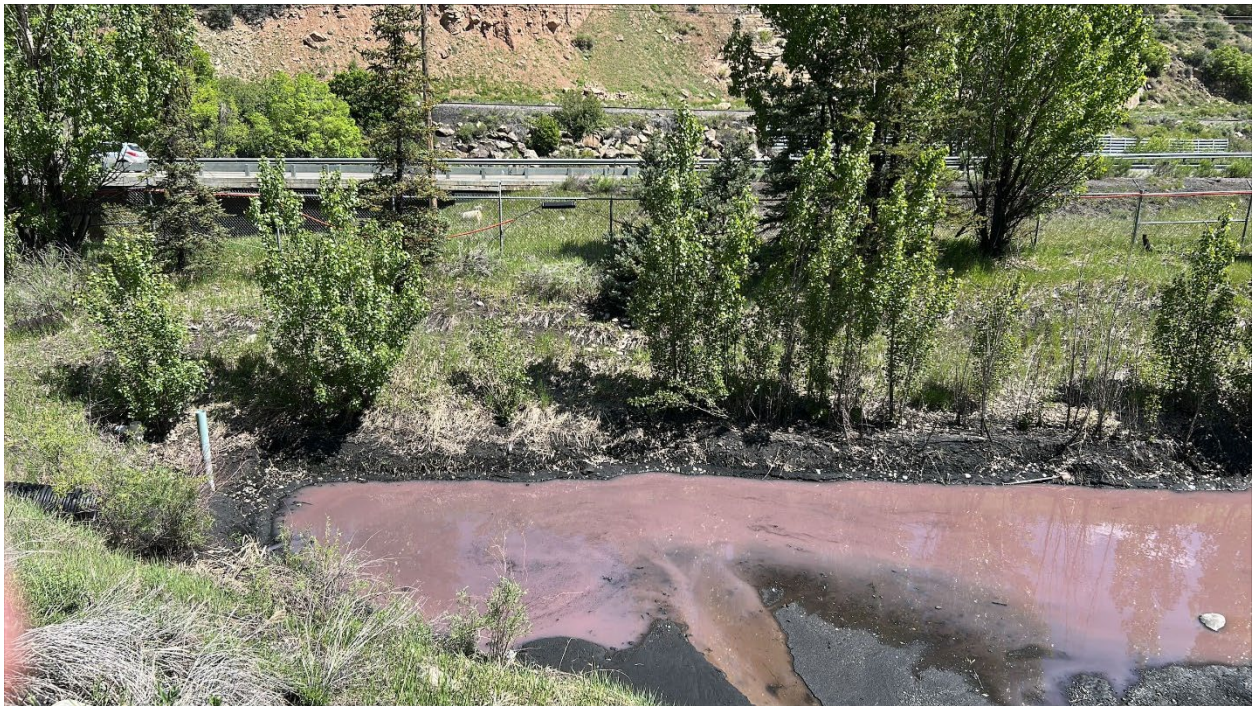
Figure 10: MB3 pond (west)

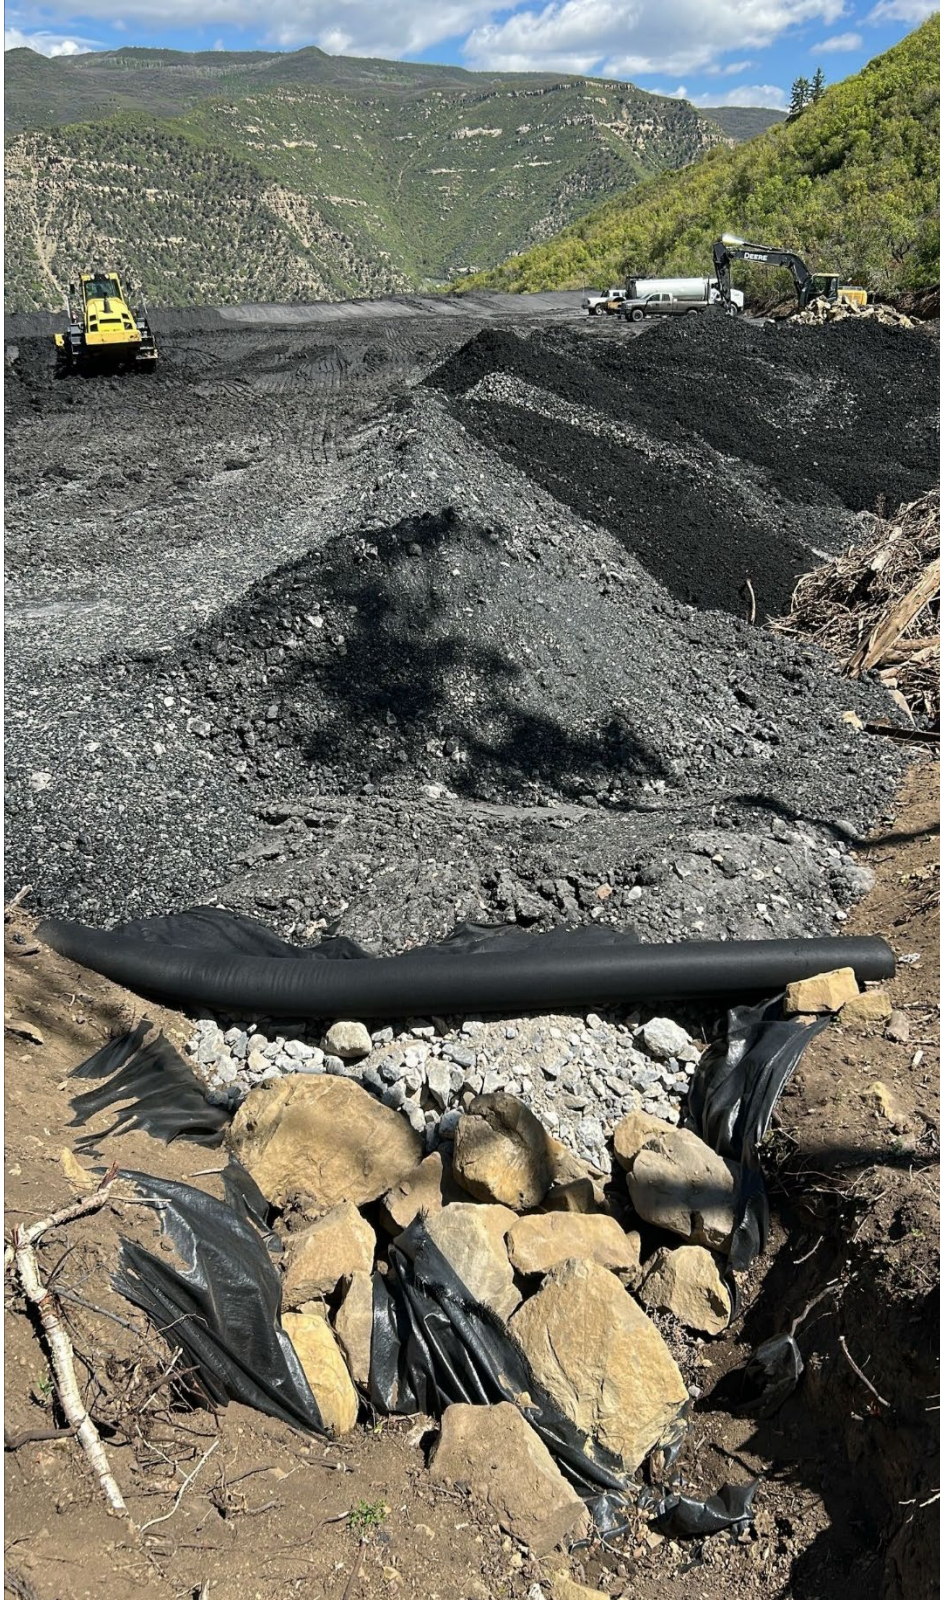
The underdrain was exposed at the southern extent of the RPEE and will need to be extended for the pile to grow any taller. Just east of the underdrain a considerable amount of grubbed vegetation as well as some scrap metal will need to be removed before material can be placed and compacted. The surface of the RPEE was sloped to the northwest, and work was ongoing to add and compact material, raising the grade at the front of the pile.

Figure 11: Underdrain on RPEE

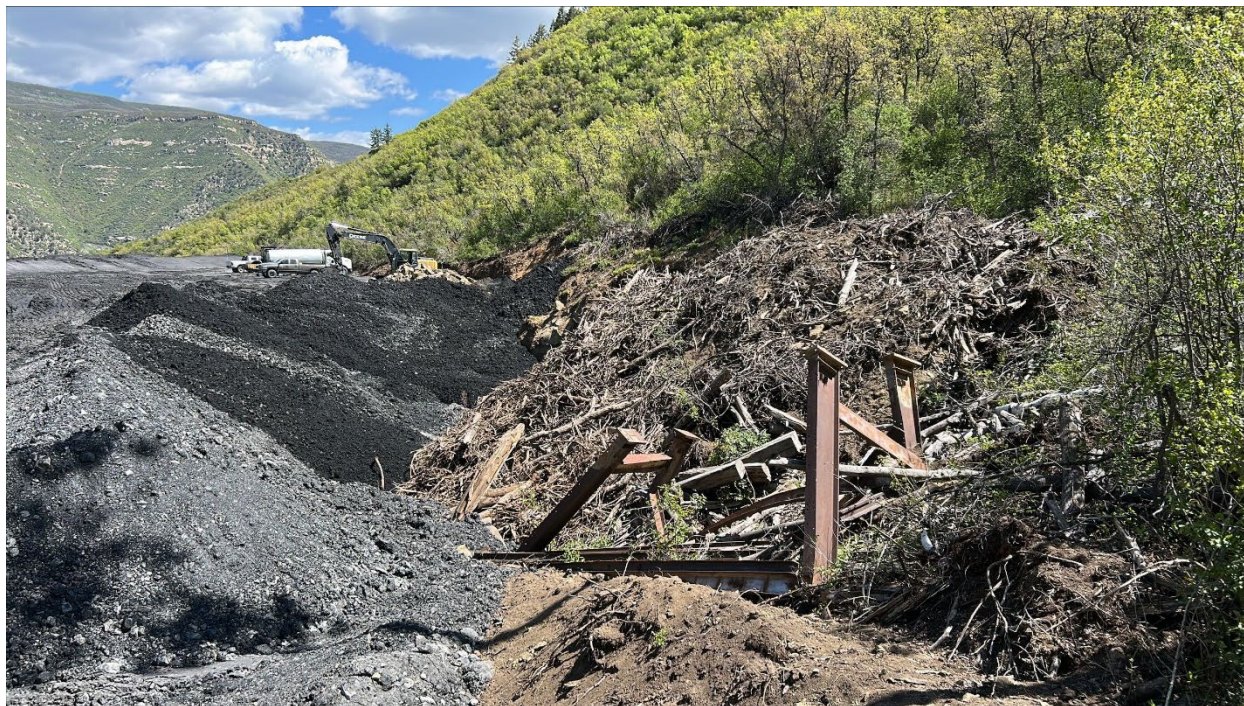
Figure 12: Grubbed vegetation and scrap metal at southeast edge of RPEE must be removed before refuse can be placed

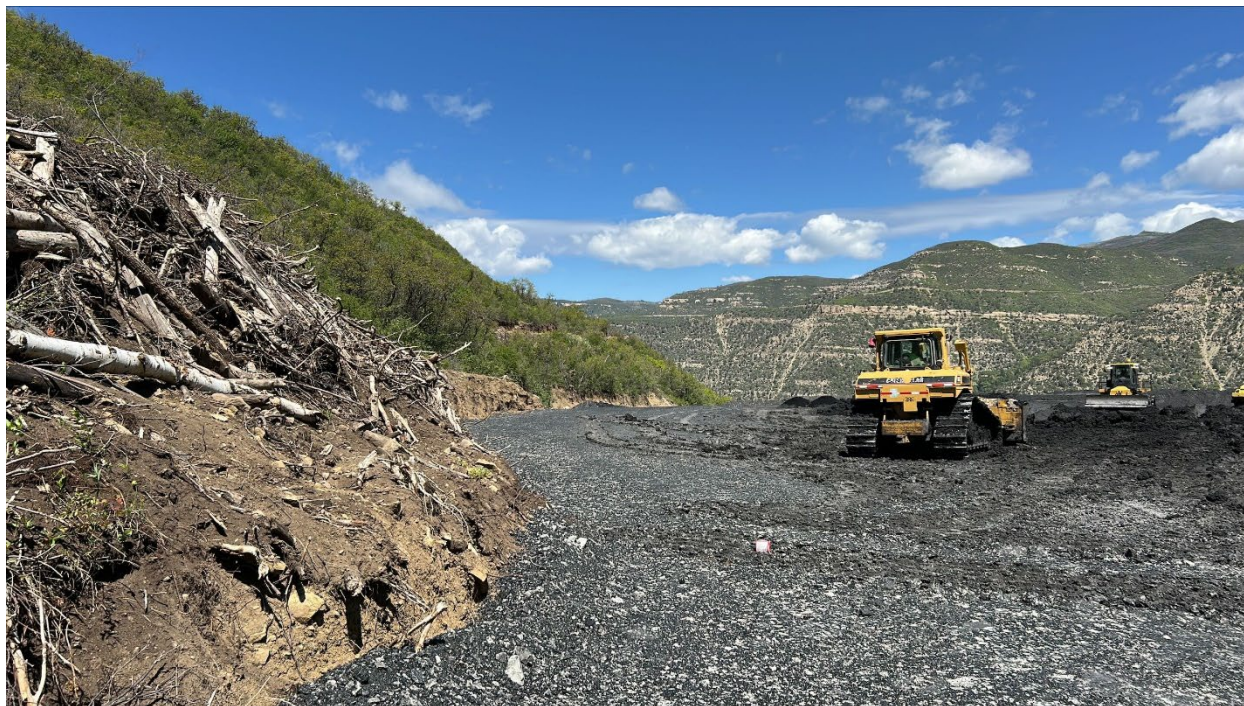
Figure 13: Compaction of processing waste in progress

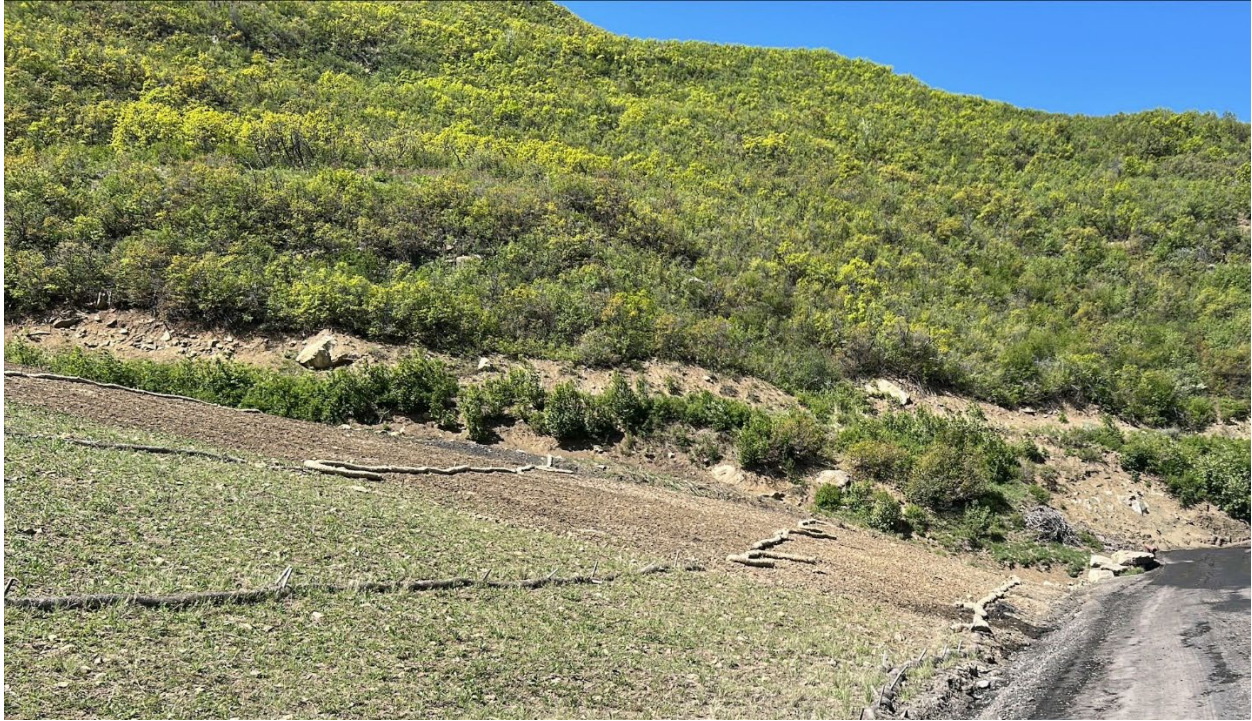
Straw wattles had been placed on the recently reclaimed outcrops of the RPEE, but had moved in places. The wattles should be re-staked.

Figure 14: Straw wattles need to be re-staked

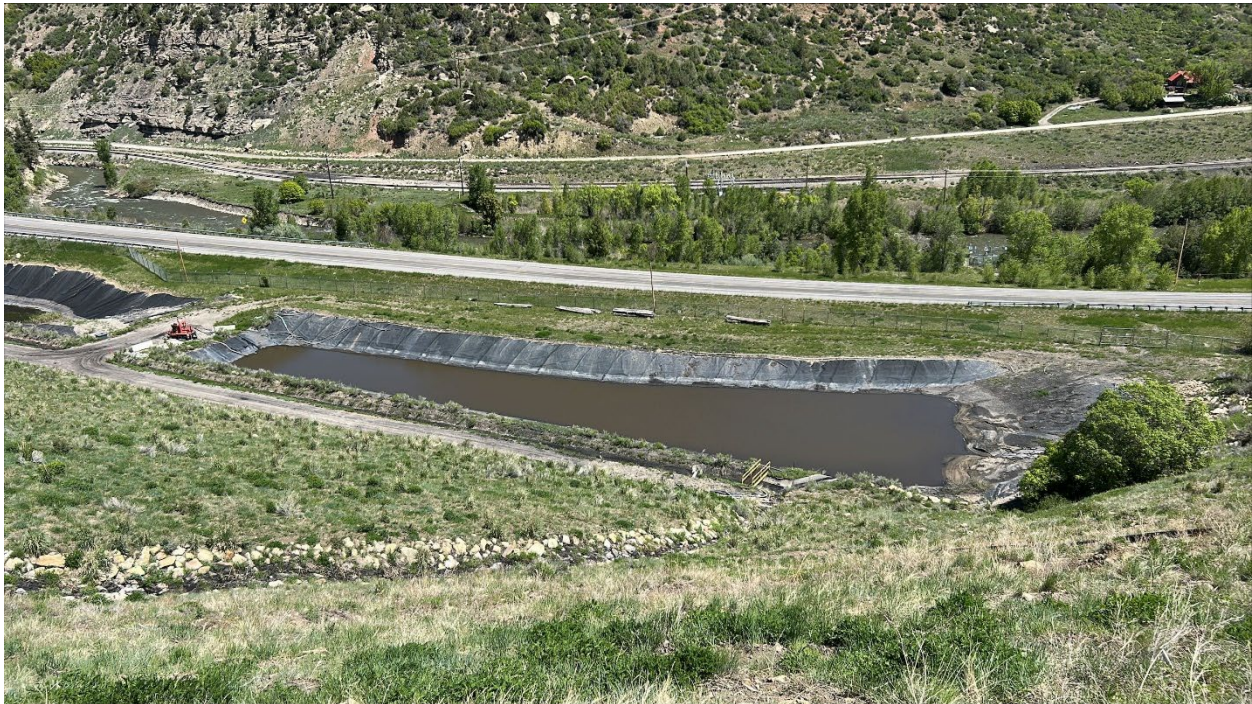
Figure 15: RPE pond (east)

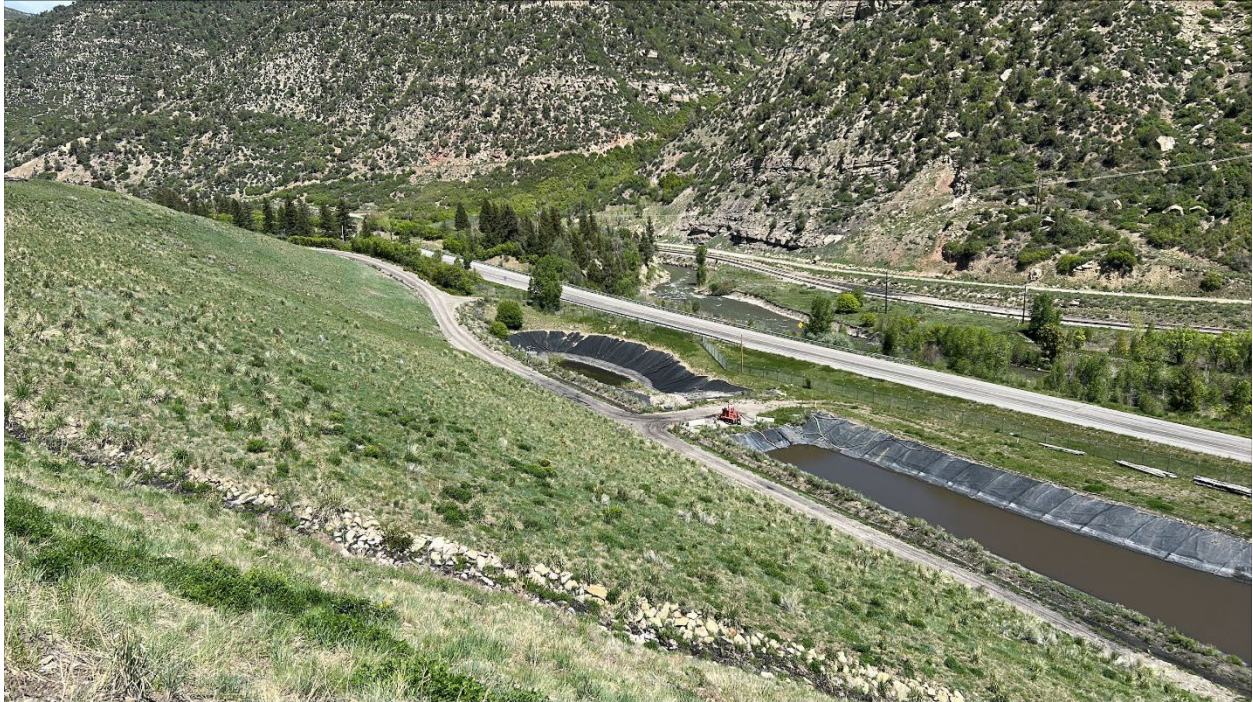
Figure 16: RPE pond (west)

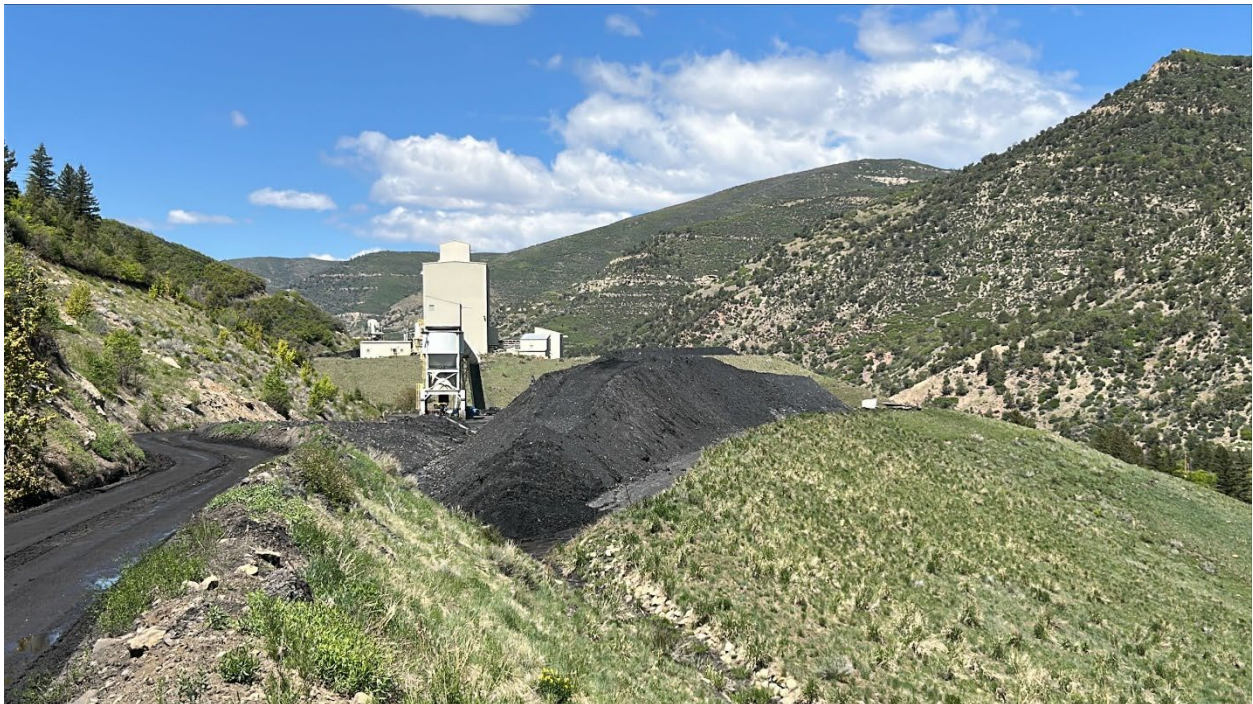
Waste from the temporary stockpile on the RPE was also being transported to the RPEE.

Figure 17: Temporary waste pile on RPE
