## Inspections Complete 2025 May Yoast and Seneca IIW

Division of Reclamation,  
Mining and Safety

<b>Permit Number:</b> C-1982-057 <b>Mine Name:</b> Seneca IIW Mine <b>Operator:</b> Seneca Property LLC <b>Operator Address:</b> Ms. Miranda Kawcak 29515 Routt County Road 27 Oak Creek, CO 80467	<b>County:</b> Routt <b>Operation Type:</b> Surface <b>Permit Status:</b> Permanent Cessation <b>Ownership:</b> Private
	<b>Operator Representative Present:</b>  Mirand Kawcak
<b>Operator Representative Signature: (Field Issuance Only)</b> This report was issued electronically from the Divisions' Denver Office.

<b>Inspection Start Date:</b> 19 May 2025 <b>Inspection Start Time:</b> 3:00 p.m. <b>Inspection End Date:</b> 20 May 2025 <b>Inspection End Time:</b> 11:45 a.m.		<b>Inspection Type:</b> Coal Complete Inspection <b>Inspection Reason:</b> Normal I&E Program <b>Weather:</b> Cloudy	
<b>Joint Inspection Agency:</b>  None		<b>Joint Inspection Contacts:</b>	
<b>Post Inspection Agency:</b>  None		<b>Post Inspection Contacts:</b>	
<b>Inspector(s):</b>  Robin Reilley, M.S. GISP	<b>Inspector's Signature:</b>

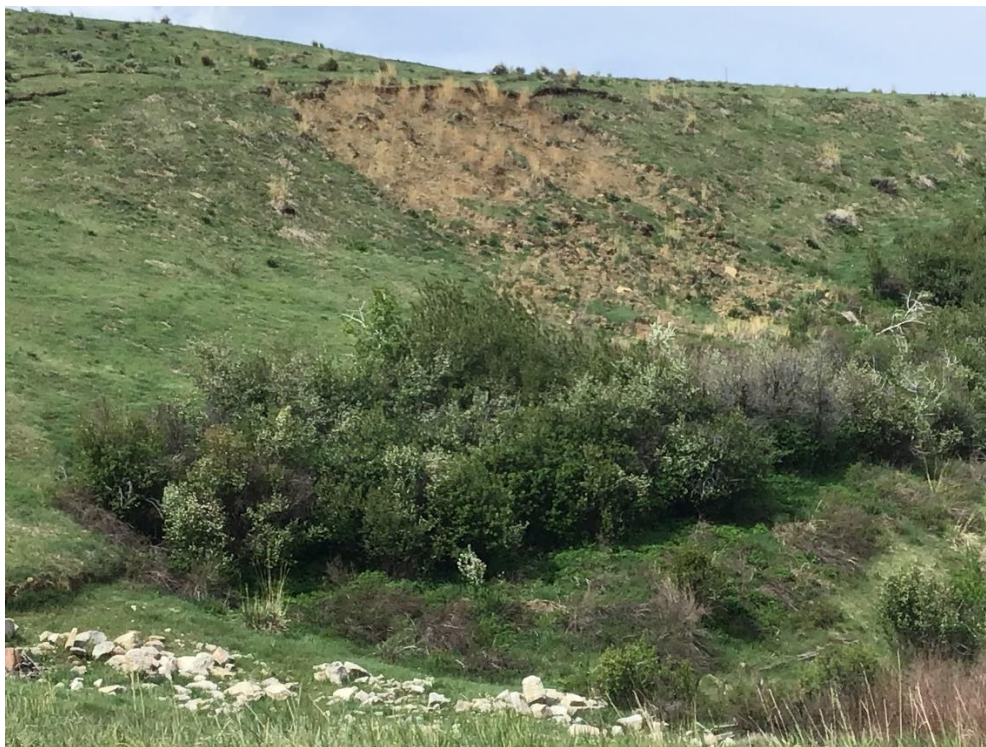
- The two slumps and associated crack between them at Pond 6 were documented.
- No new movement was noted at the time of inspection.

*Photo 1: Pond 6 slump of 2023 at the right in the photo and slope fissures.*

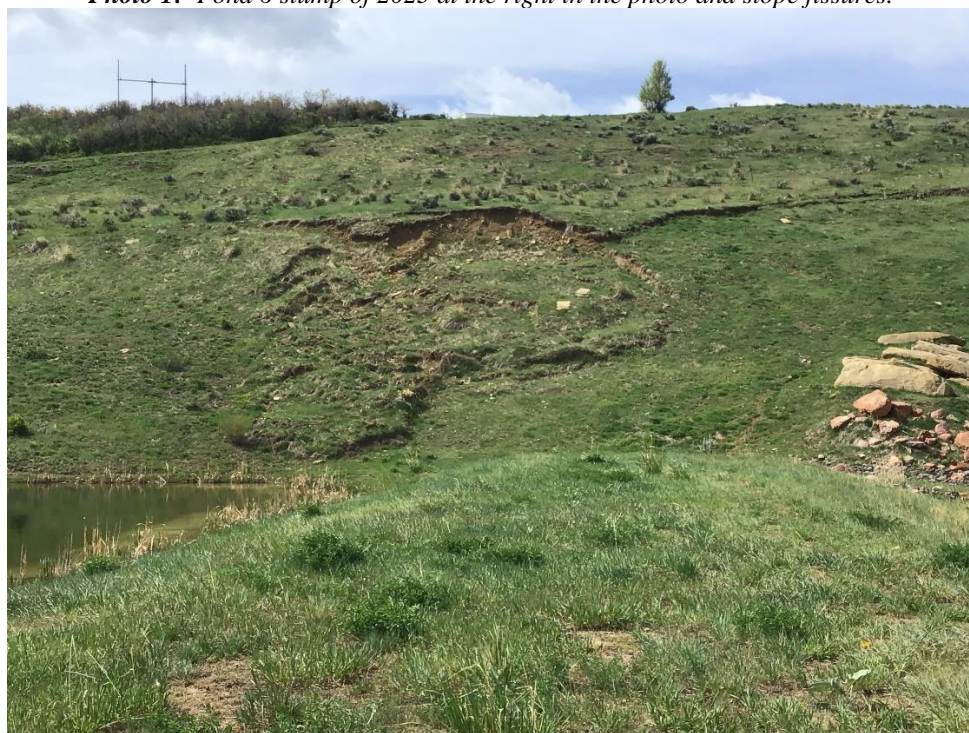
*Photo 2: Longstanding slump at Pond 6, no new slump activity.*

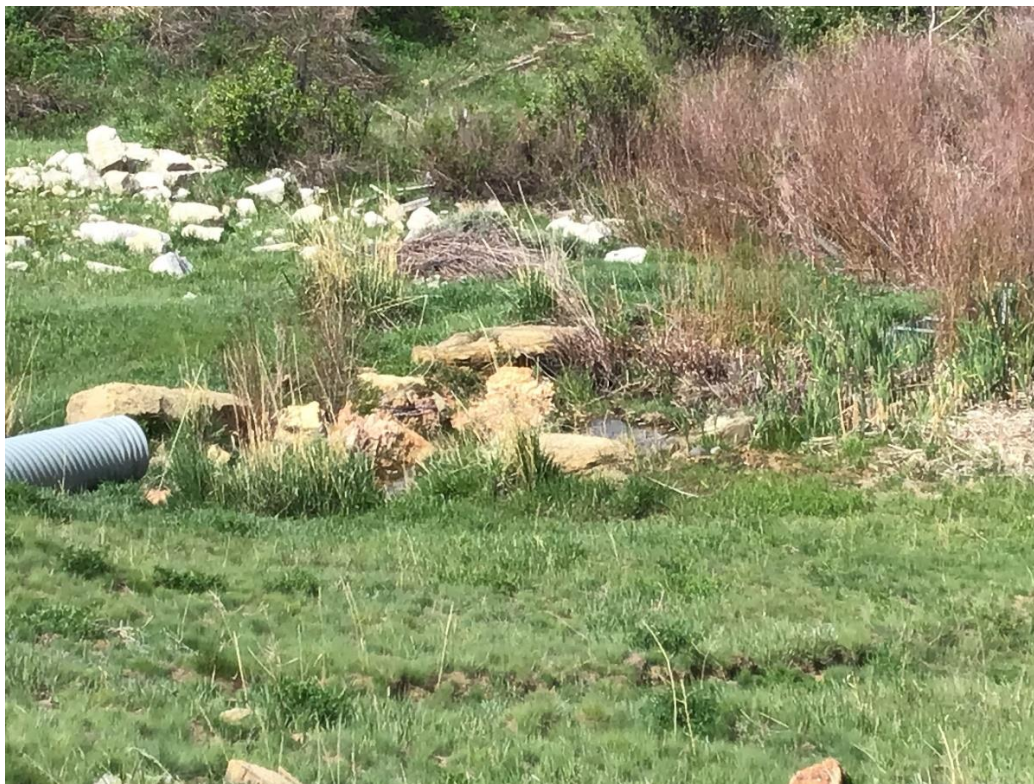
*Photo 3: Pond 6 discharge structure discharging clear water.*

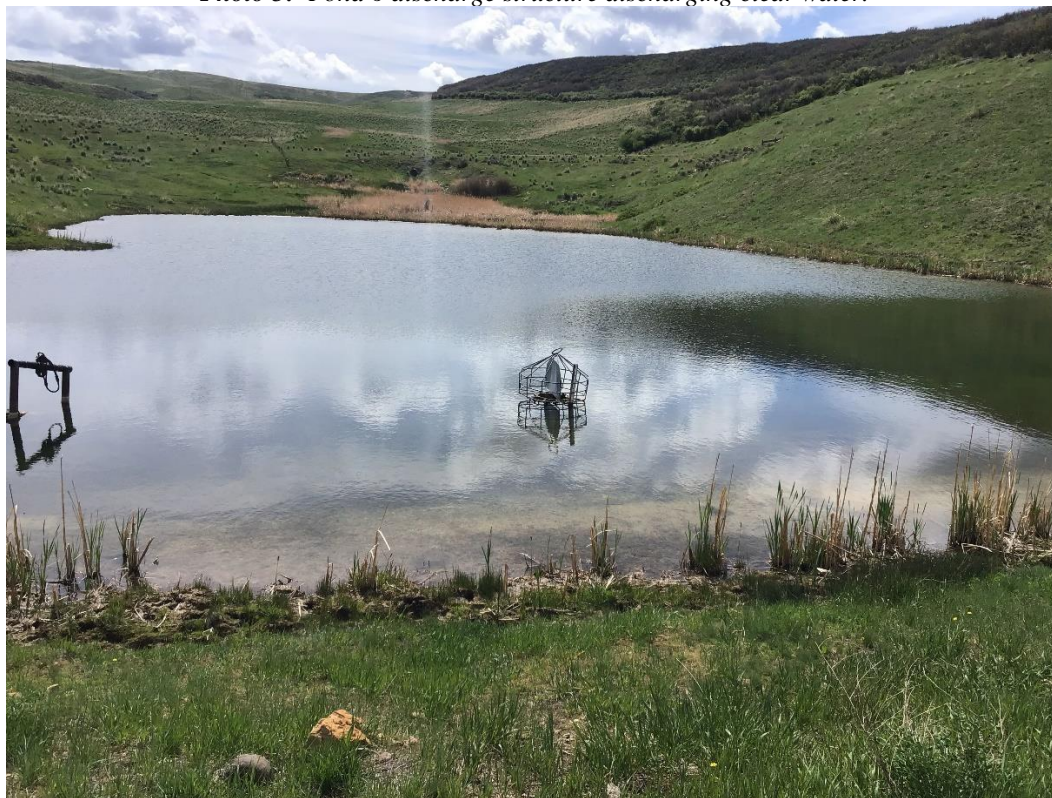
*Photo 4: Pond 6 discharging clear water*

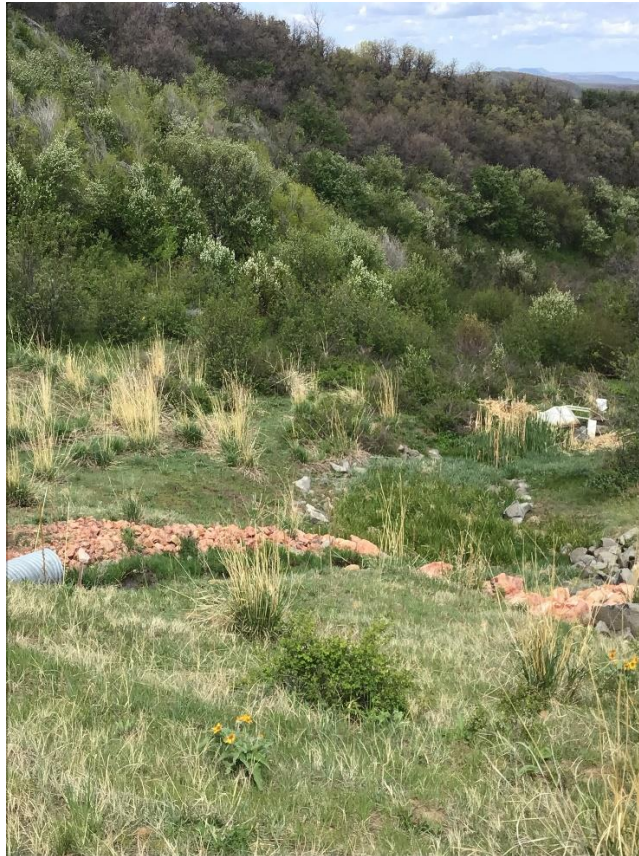
*Photo 5: Pond 16 discharge structure.*

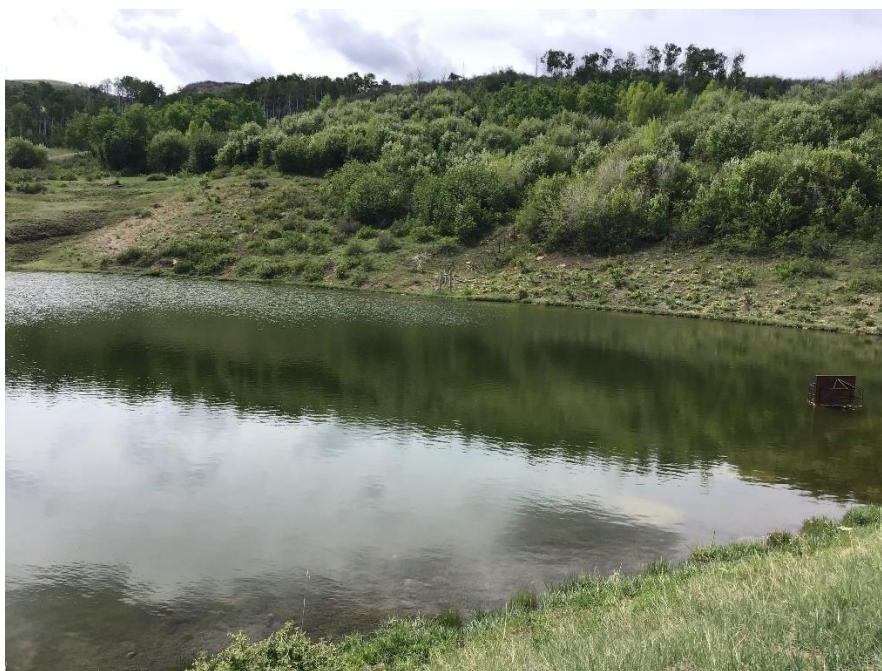
*Photo 6: Pond 16 discharging clear water.*

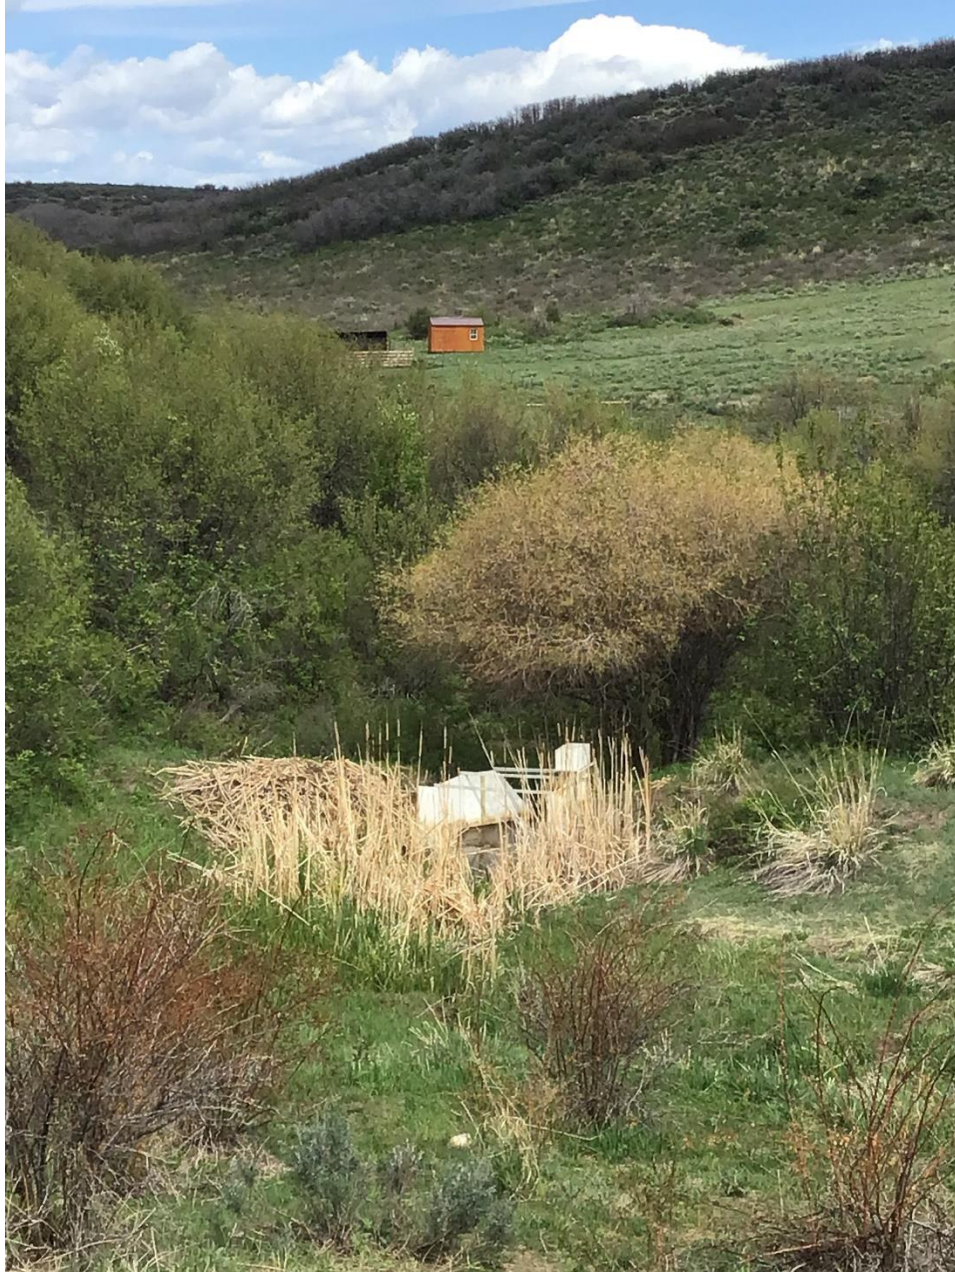
*Photo 7: Pond 17 discharge structure.*
