Inspections Complete 2025 May Yoast and Seneca IIW

COLORADO
Division of Reclamation,
Mining and Safety
Department of Natural Resources

Permit Number: C-1994-082 Mine Name: Yeast Mine Operator Address: Seneca Property LLC Ms. Miranda Kawcak 29515 Routt County Road No. 27 Oak Creek, CO 80467	County: Routt Operation Type: Surface Permit Status: Permanent Cessation Ownership: Private Operator Representative Present: Miranda Kawcak
Operator Representative Signature: (Field Issuance Only) This report was issued electronically from the Divisions' Denver Office.

Inspection Start Date: 19 May 2025 Inspection Start Time: 3:30 p.m. Inspection End Date: 21 May 2025 Inspection End Time: 10:00 a.m.	Inspection Type: Coal Complete Inspection Inspection Reason: Normal I&E Program Weather: Clear
Joint Inspection Agency: None	Joint Inspection Contacts:
Post Inspection Agency: None	Post Inspection Contacts:
Inspector(s): Robin Reilley, M.S. GISP	Inspector's Signature:

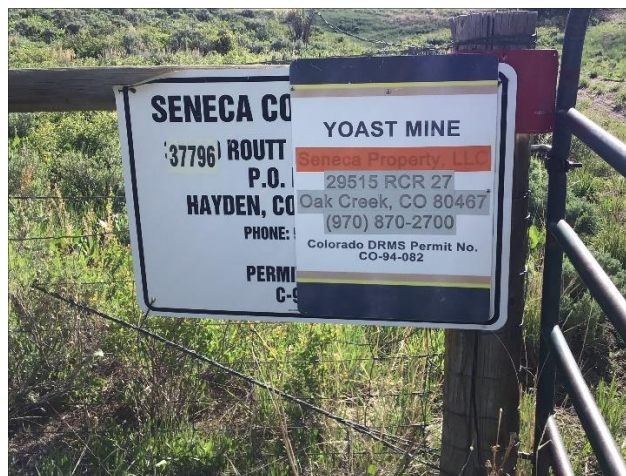
- Topsoil stockpiles observed were clearly marked with identifying signs.
- Mine Identification showed all required information: permit number, operator address and phone number.

Photo 1: Mine identification sign at county road below Pond 13.

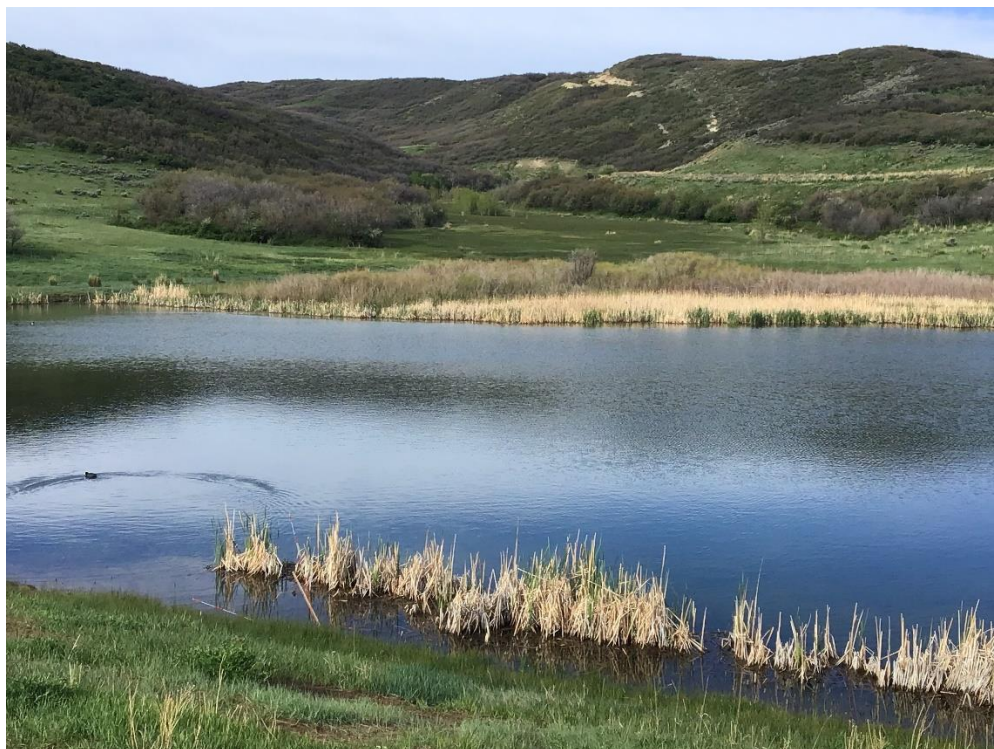
***Photo 2:** Pond 6, discharging, looking east.*

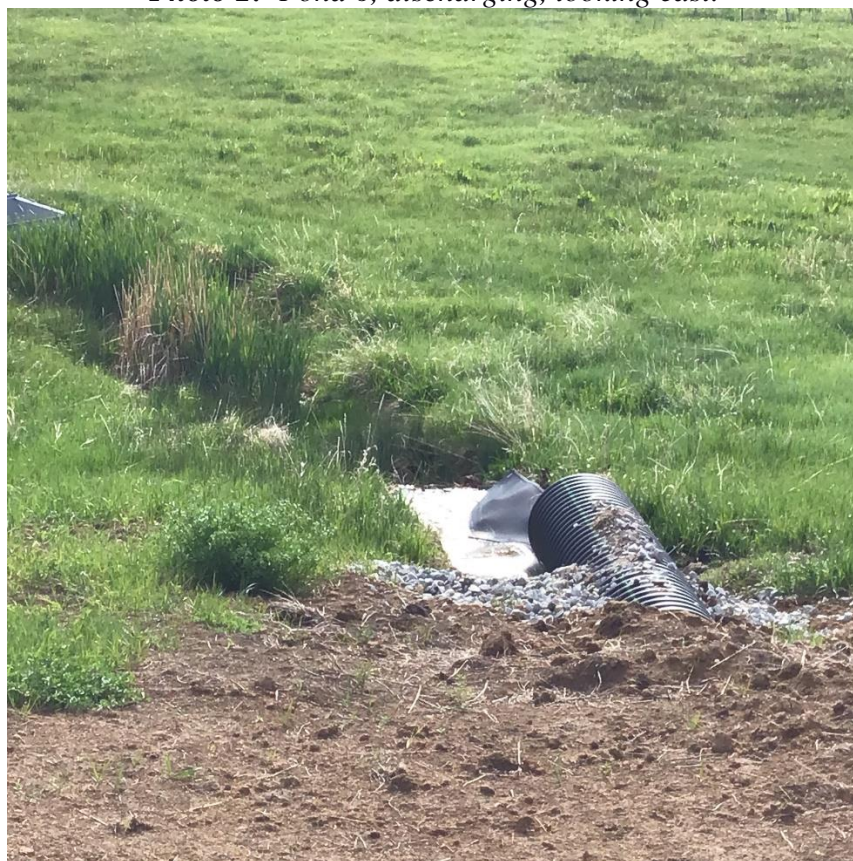
***Photo 3:** Pond 6, discharge culvert.*

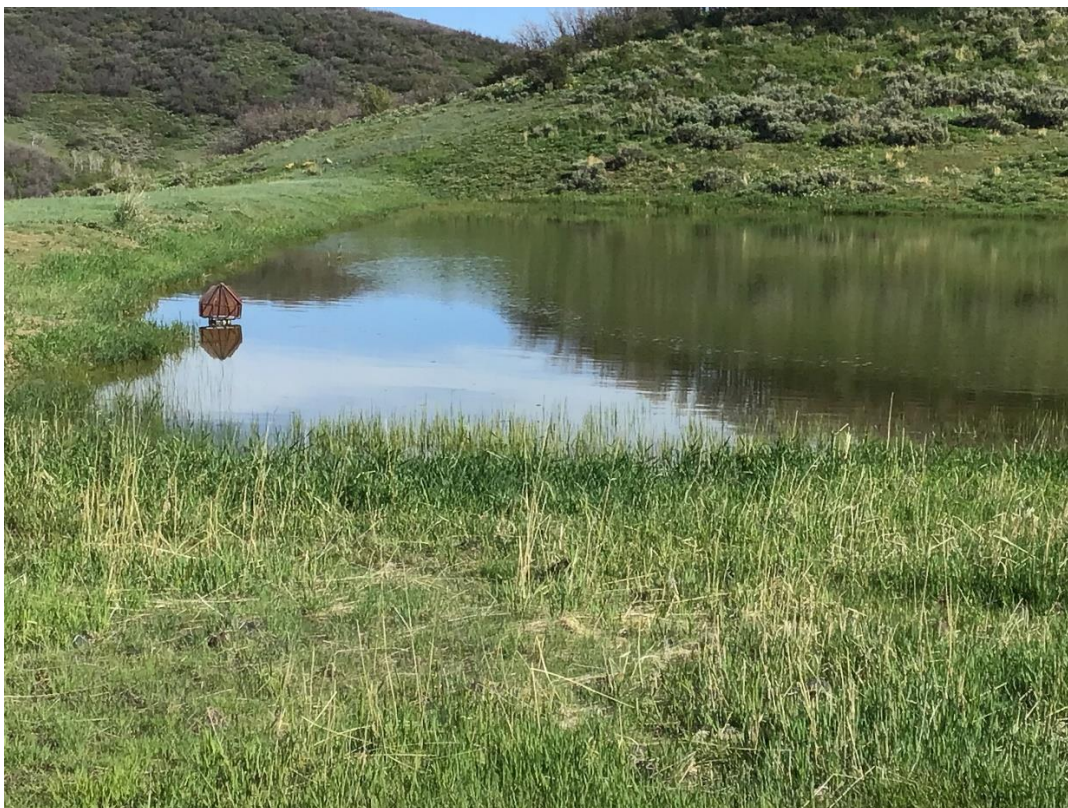
Photo 4: Yoast Pond 13, not discharging.

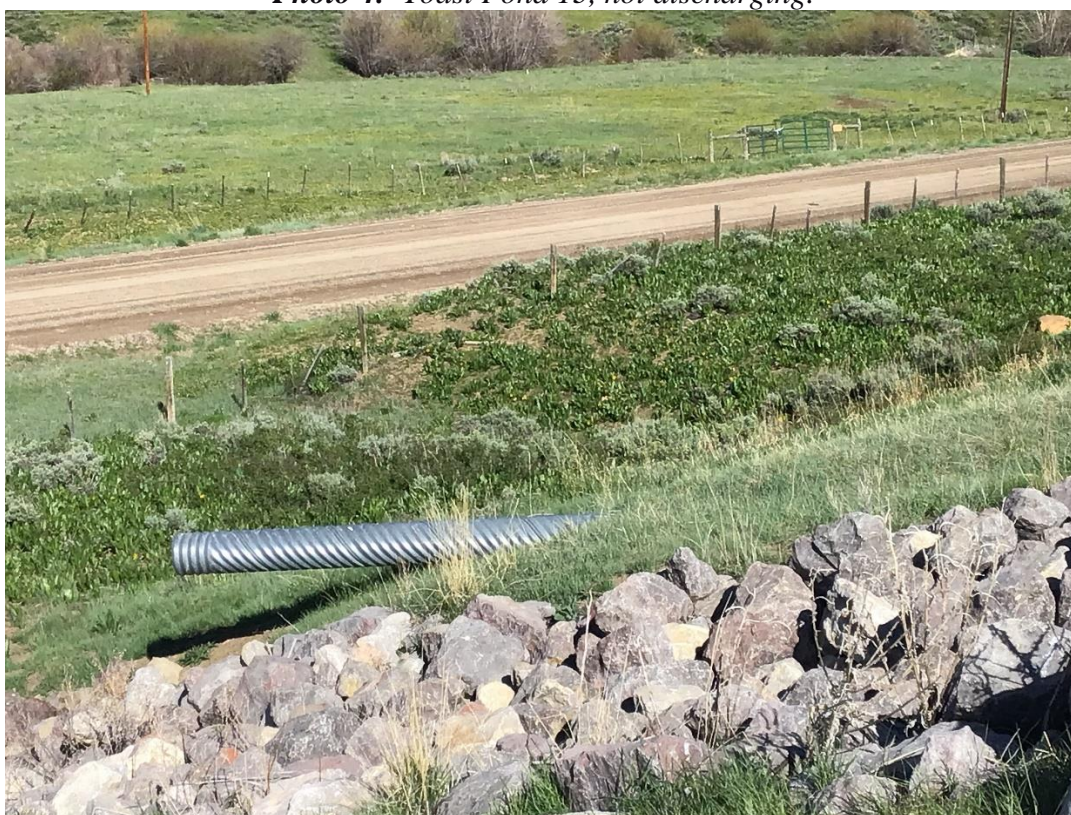
Photo 5: Pond 13 discharge culvert.

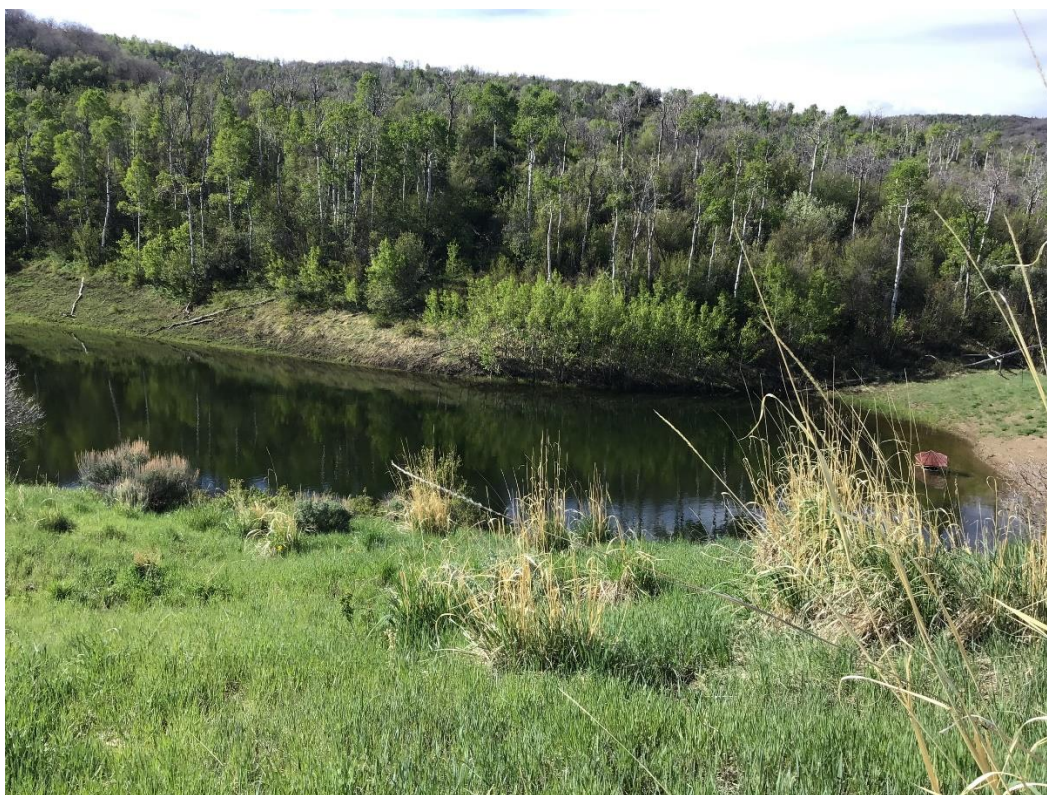
Photo 6: Pond 14, discharging

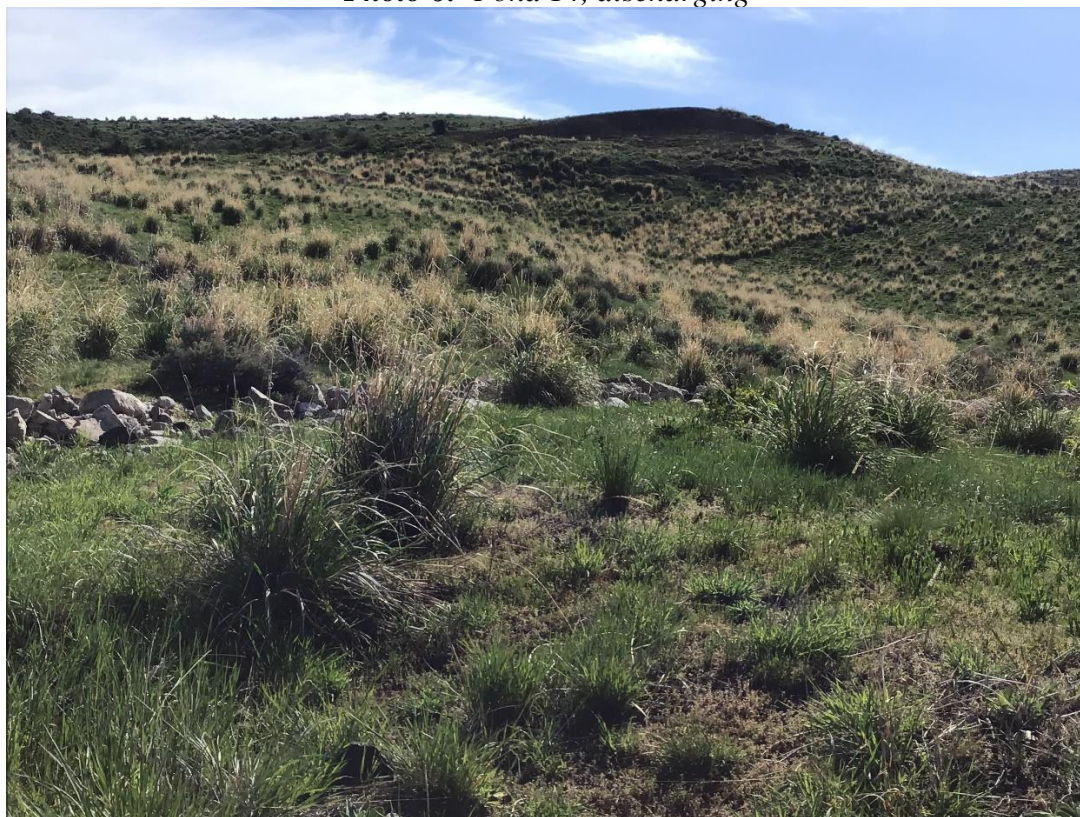
- Slide area above pond 13 appeared stable at the time of inspection.
- No new movement was noted at the time of inspection.

Photo 7: Slide area above Pond 13. No new slide activity.

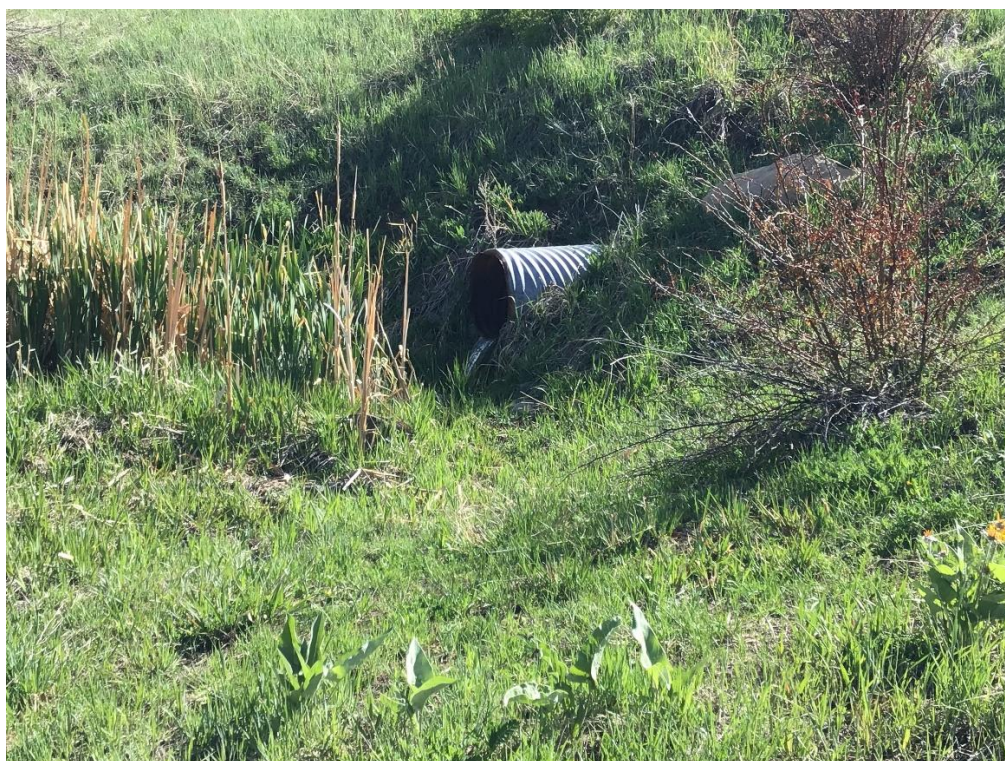
Photo 8: Pond 12, discharge culvert.

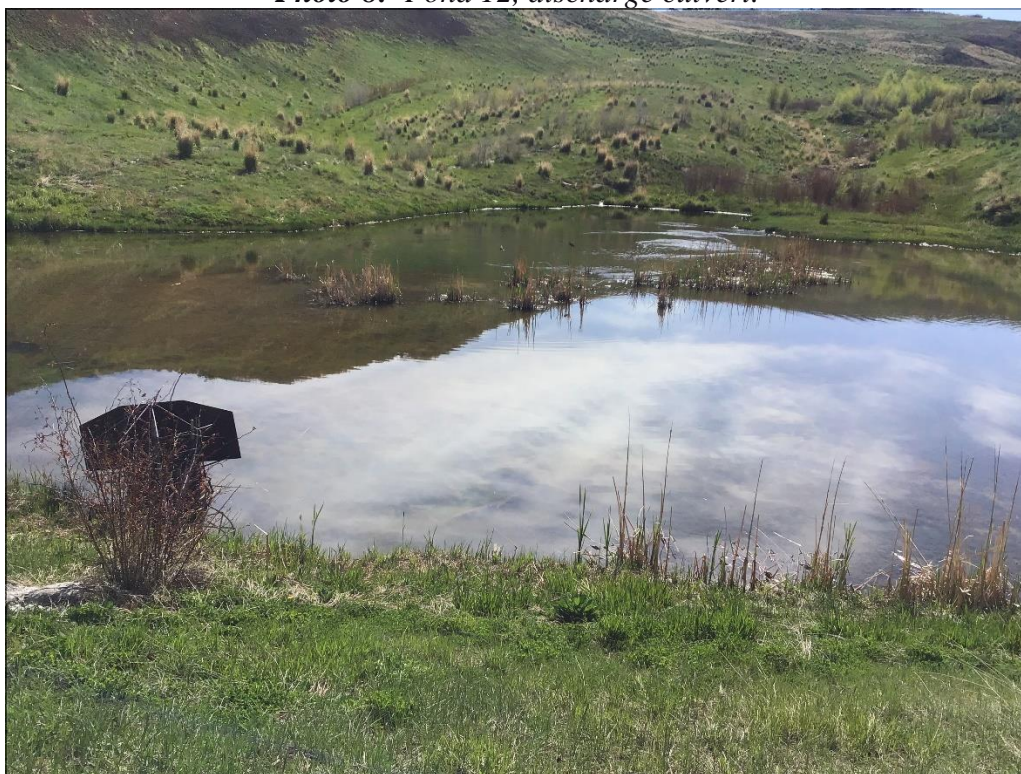
Photo 9: Pond 12, discharging.

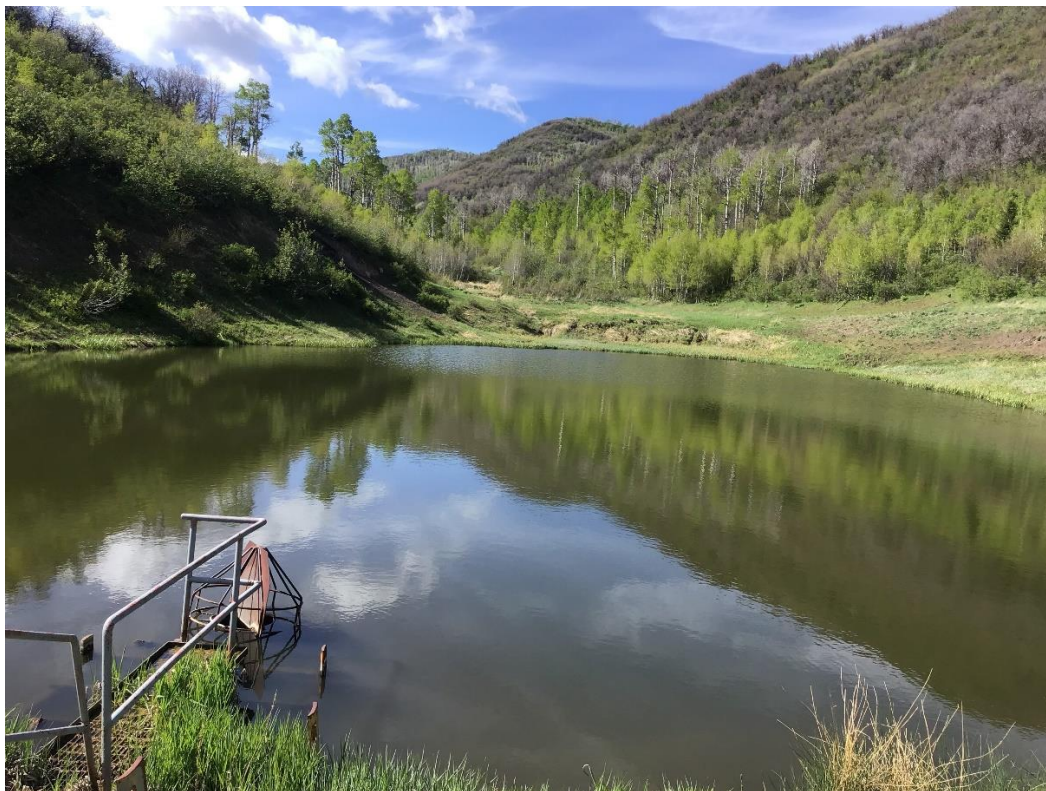
Photo 10: Pond 15, discharging.
