## Inspection complete 2025 May

**COLORADO**  
 Division of Reclamation,  
 Mining and Safety  
 Department of Natural Resources

**20 May 2025**

Permit Number: C1981010 Mine Name: Trapper Mine Operator: Trapper Mining, Inc. Operator Address:  Mr. Graham Roberts P.O. Box 187 Craig, CO 81626	County: Moffat Operation Type: Surface Permit Status: Active Ownership: Federal  Operator Representative Present: Graham Roberts
This report was issued electronically from the Divisions' Denver Office.

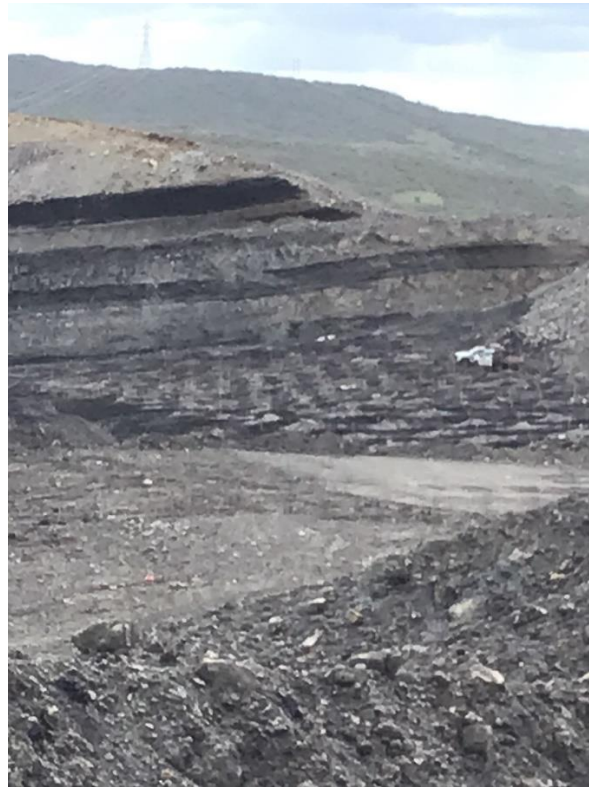
- Blasts were being prepared in L Pit
- Blasting records for quarter 1 were checked. All required information was adequately documented in the blasting logs and no irregularities were noted.

*Photo 1: Blast configured in L Pit.*

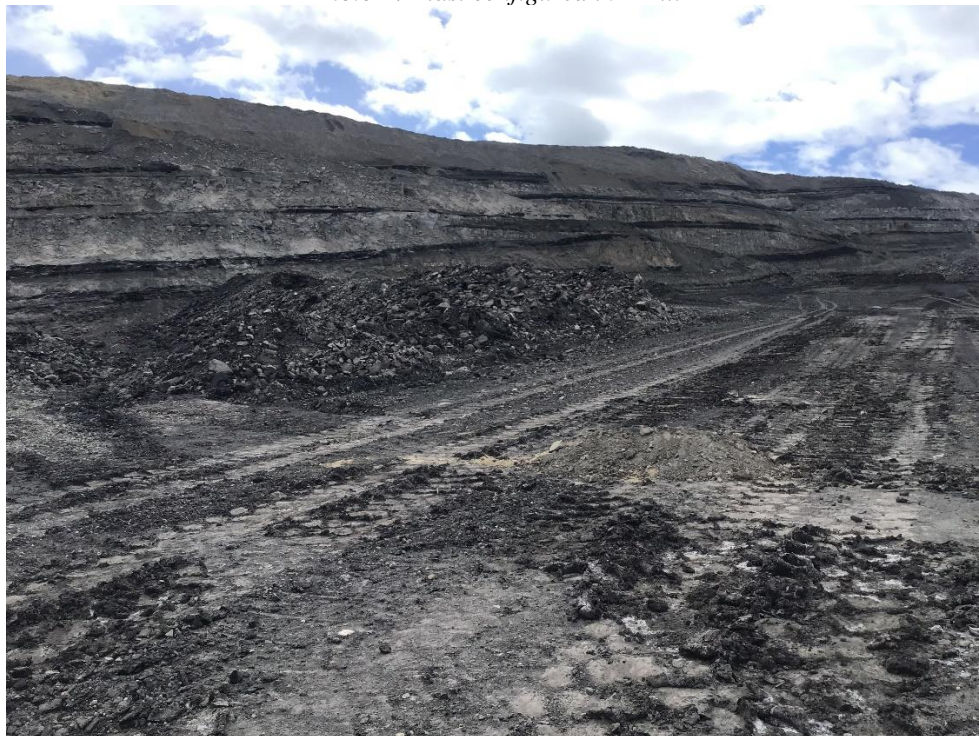
**Photo 2:** Coal bedding on east highwall in L Pit, looking south.

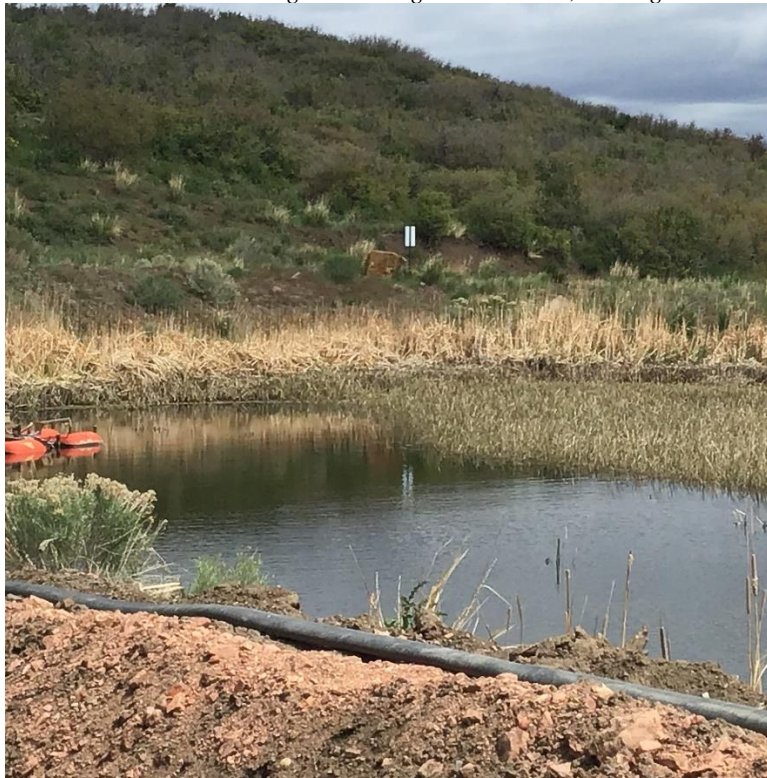
3. No Name #5 was discharging through the flume.
4. Middle Flume #3 was being drawn down for road watering purposes and for dredging. The pond exhibits a significant delta at the inlet.

**Photo 3:** Pumping equipment in place in Middle Flume #3 Pond.

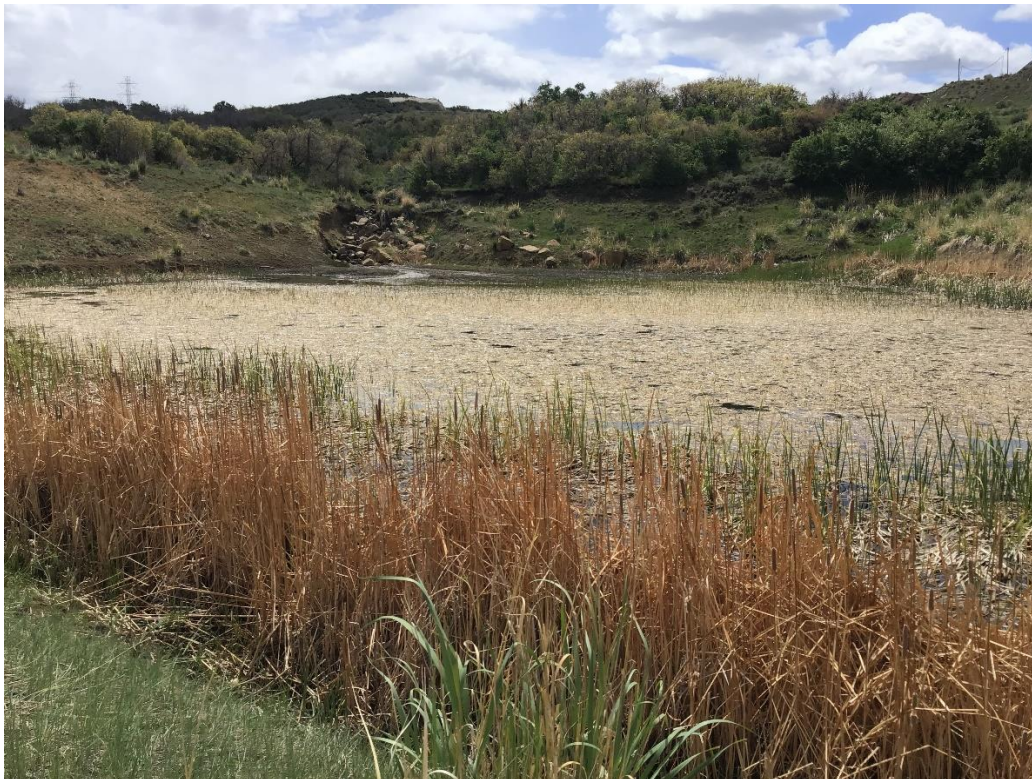
5. East Flume appeared dry at the time of inspection.
6. Middle Flume #1 needs its water pumped for dredging scheduled later this summer.
7. East Middle Flume #1 was holding water and requires pumping for dredging this field season. The pond is covered emergent cattails. Rocked inflow channel requires stabilization.

**Photo 4:** Cattail crop covering East Middle Flume #1 Pond. Inflow channel requires stabilization.

1. *Certain ponds are scheduled for dredging this field season.*
2. *East Middle Flume #1 Pond. Inflow channel requires stabilization.*
3. *Constructed drainages in D and K Pits will be tidied up as some channel deepening occurred and various check dams require stabilizing.*

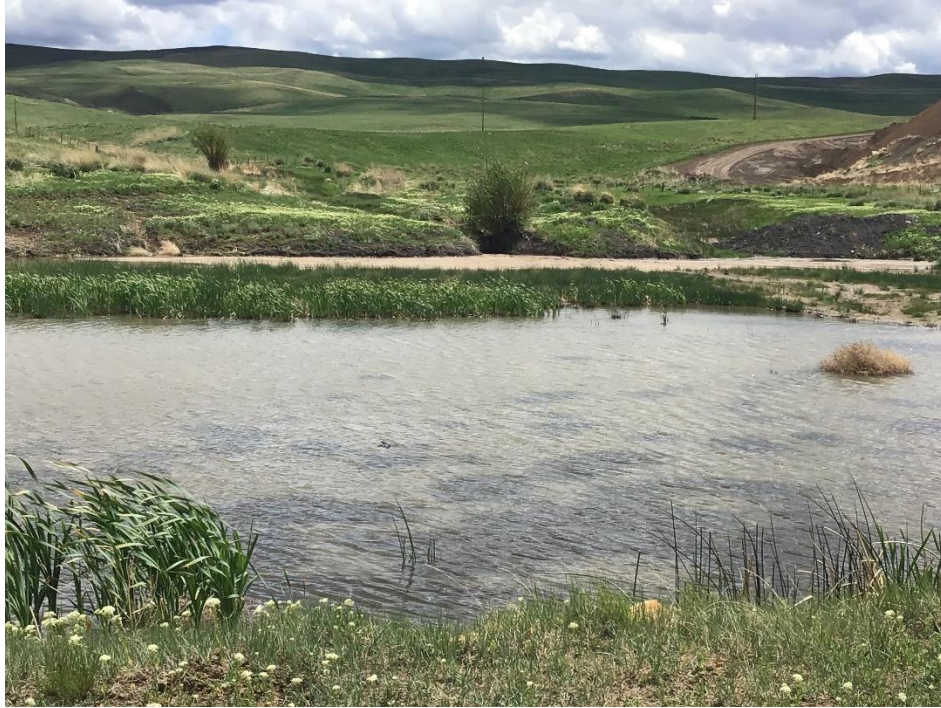
1. No Name #2 exhibits a large sediment fan. Spoil is piled above the pond. The pond is scheduled for dredging.
2. No Name #4 was full and discharging a trickle of clearwater through the decant culvert.

*Photo 5: No Name #2 Pond looking south with sediment fan beyond the cattail growth.*

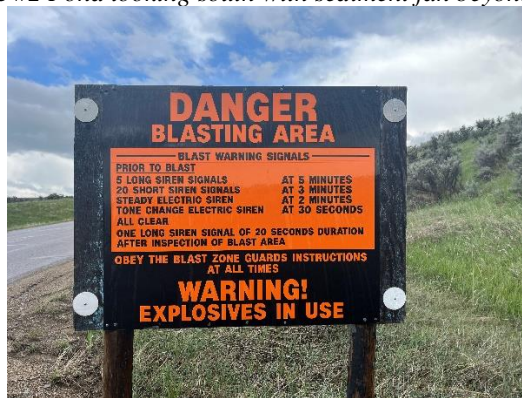
*Photo 6: Blast notification sign at site entrance from Highway 31.*

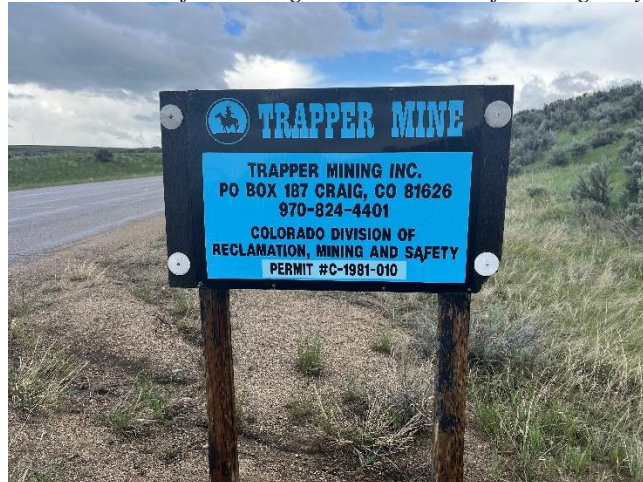
- Pond identification signs were prominently displayed in the vicinity of the ponds and were in adequate repair at the time of inspection.
- Topsoil stockpiles observed were clearly marked with identifying signs.
- Mine Identification showed all required information: DRMS permit number, operator address and phone number.
- Blasting signage at the entrance to the site indicated the required warning system.
- Permit markers were observed along the north boundary at the Pyeatt Systems.

*Photo 7: Mine identification sign at entrance.*
