## New Horizon Mine, C-1981-008, May Complete Inspection Report

**PERMIT INFORMATION**

**INSPECTION INFORMATION**

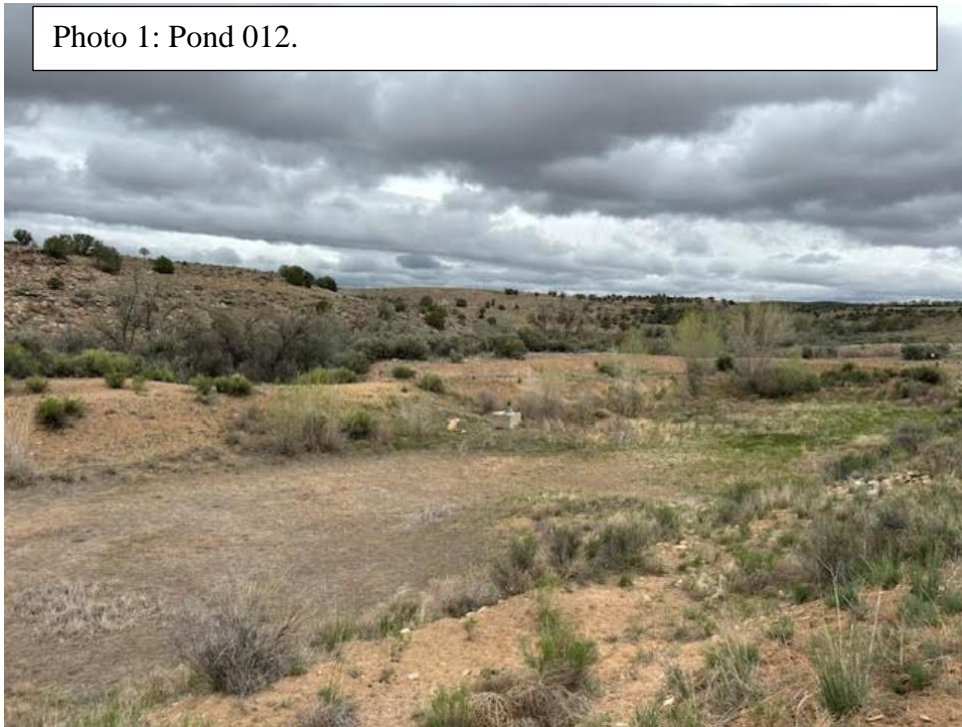
Photo 1: Pond 012.

Pond 12 is located within the northern portion of the reclamation located northwest of 2700 Rd. and BB Road. Pond 012 was dry at the time of the inspection (Photo 1). The embankment was covered with vegetation and stable. No erosional features or burrows were identified. The outlets for the pond were clear of debris.

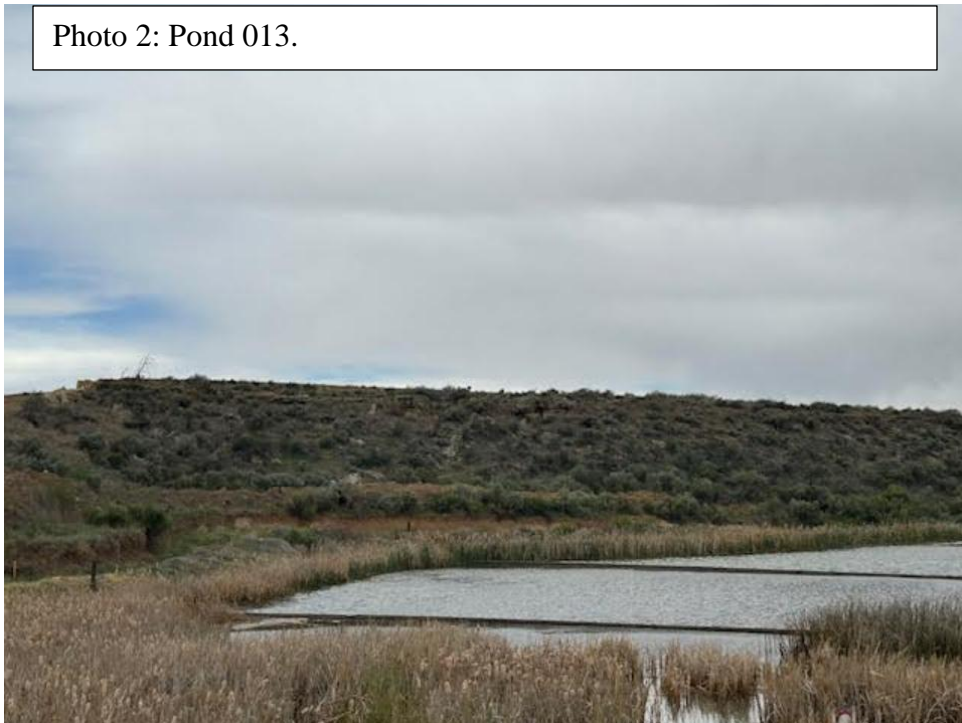
Photo 2: Pond 013.

Pond 013 is located in the northwestern portion of the reclamation located in the northwestern corner of the intersection of 2700 Rd. and BB road. Pond 013 was impounding water from both irrigation runoff and the seep during the inspection (Photo 2). The level of water in the pond was at the primary discharge outlet and discharge

from the pond was occurring. The discharge outlet was clear of obstructions and functioning as designed. The embankment was vegetated and stable. No burrows or erosional features were observed.

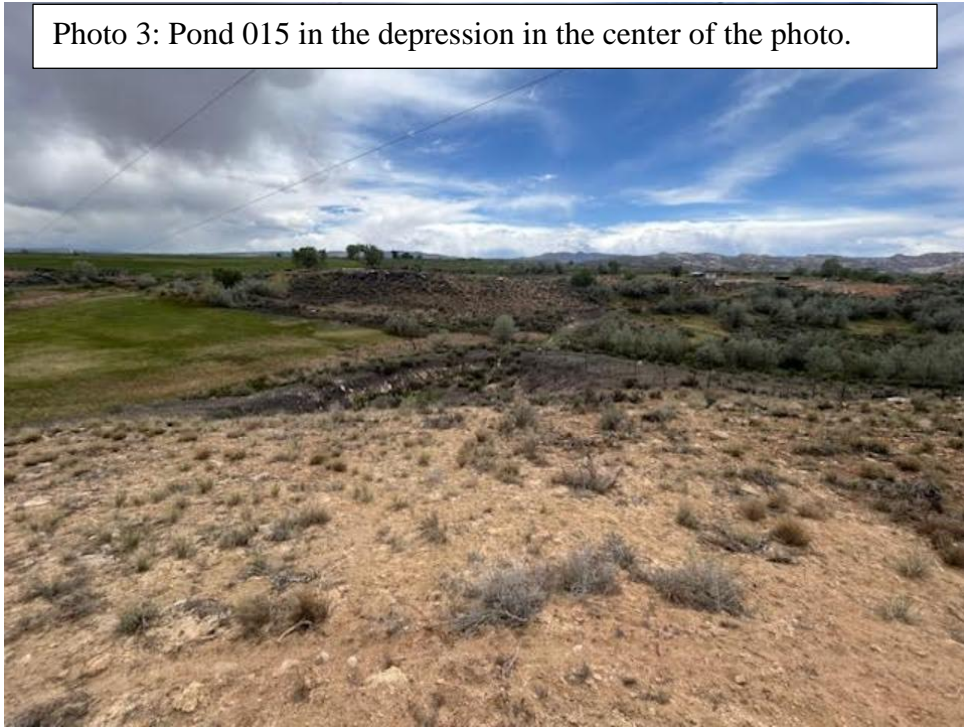
Pond 015 is located within the western portion of the reclamation within the northwest corner of 2700 Rd. and BB road. Pond 015 was dry at the time of the inspection. The pond's embankment was stable with vegetative cover (Photo 3). The outlet for the pond was clear of debris. No erosional features other than the minor rills previously observed on the inside of the pond's embankment were identified. The rills have been noted in previous Division inspection reports. The rills do not affect the pond's stability or functionality.

Photo 3: Pond 015 in the depression in the center of the photo.

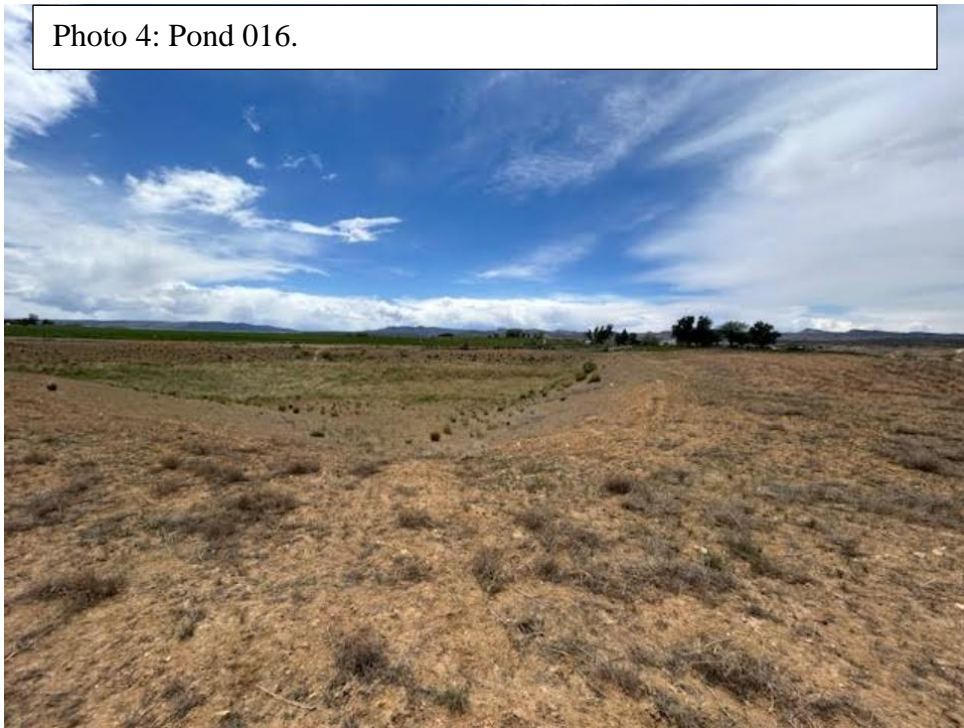
Photo 4: Pond 016.

Pond 016 is located within the southwestern portion of the reclamation located within the northwestern corner of the 2700 Rd. and BB Road intersection. Pond 016 was also dry during the inspection. The pond's embankment was covered with vegetation and stable. There were no erosional features or burrows observed (Photo 4).

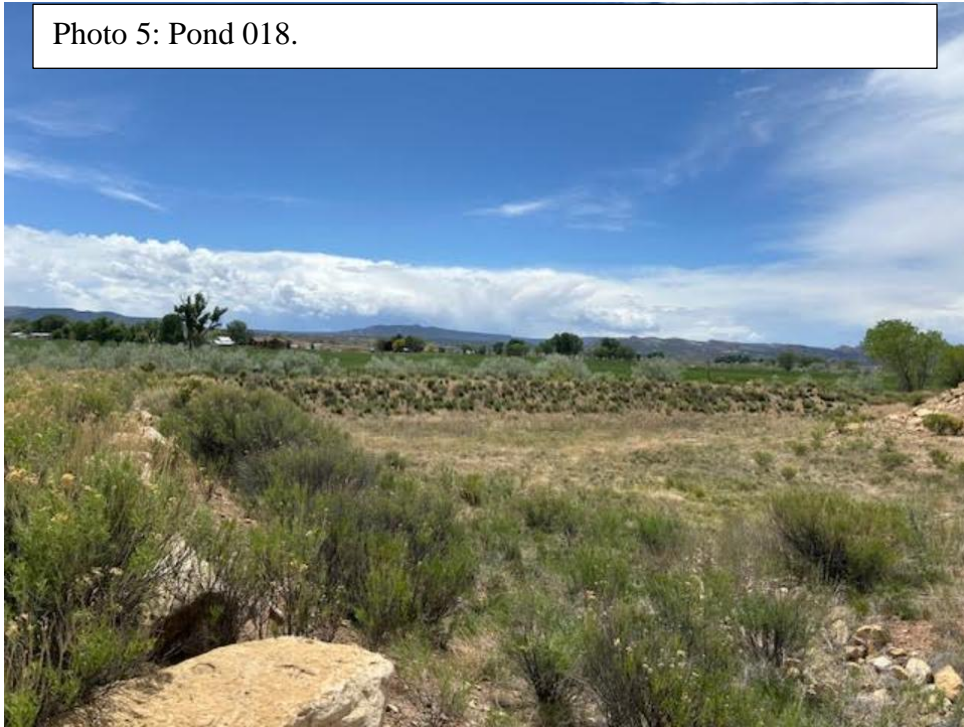
Photo 5: Pond 018.

Pond 018 is located to the south of the mine office. Pond 018 was dry during the inspection (Photo 5). The embankment was vegetated and stable. No erosional features or animal burrows spotted. The outlet for the pond was clear of debris.

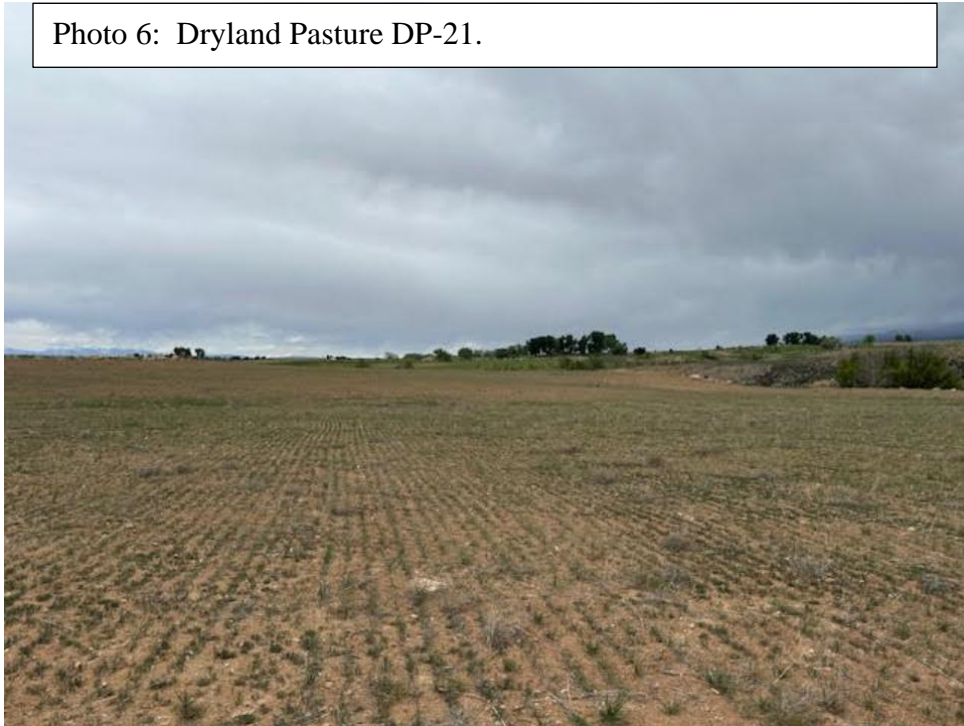
Photo 6: Dryland Pasture DP-21.

Dryland pasture DP-21 was also seeded in 2023. The reclamation parcel was stable with no erosional features. Vegetation on the site was continuing to grow in (Photo 6). There were no indications of differential settling.

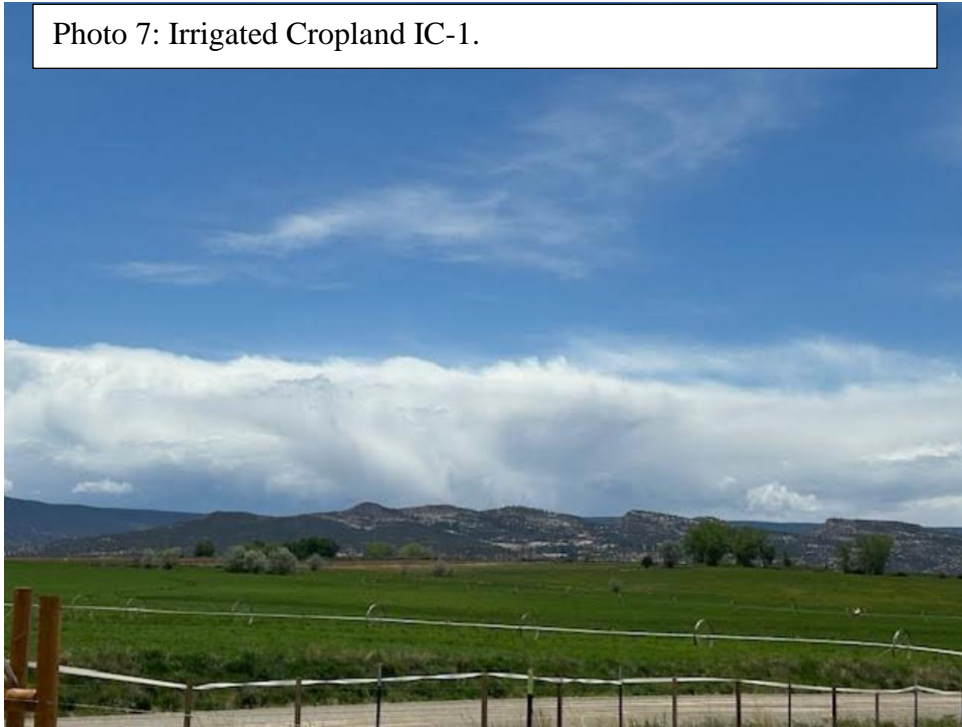
Photo 7: Irrigated Cropland IC-1.

Irrigated cropland IC-1 is south of BB Road across from Pond 016 (Photo 7). IC-1 was covered with vegetation and being irrigated. There were no indications of instability, erosional or differential settling observed

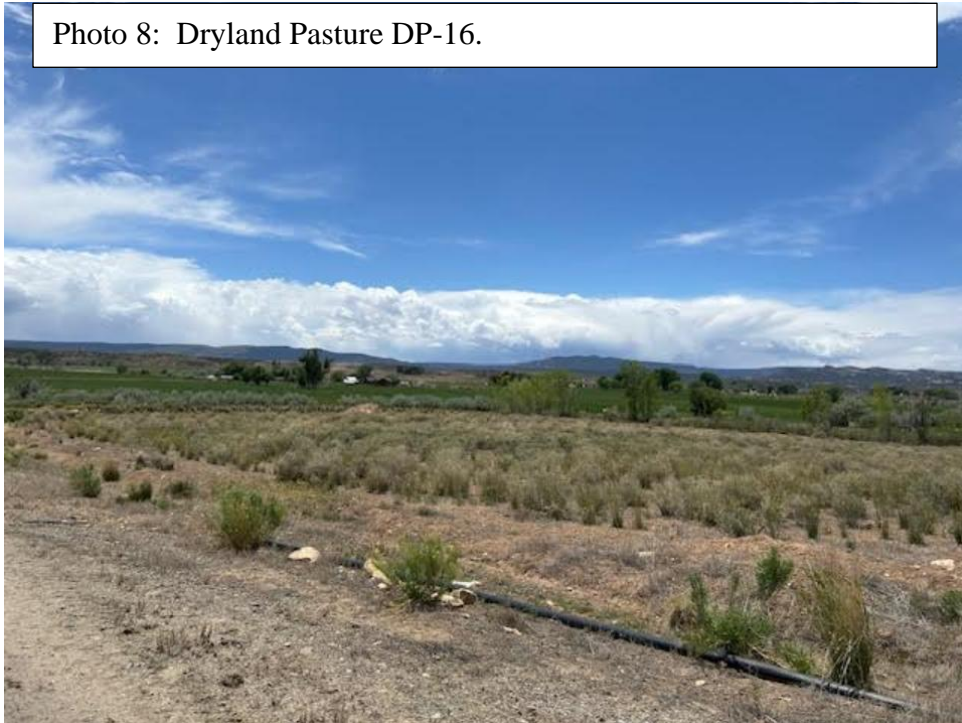
Photo 8: Dryland Pasture DP-16.

Dryland Pasture Parcels DP-16 (Photo 8), DP-17 and DP-19 are located around Pond 018. The reclaimed parcels were stable with vegetative cover. There were no signs of differential settling observed.

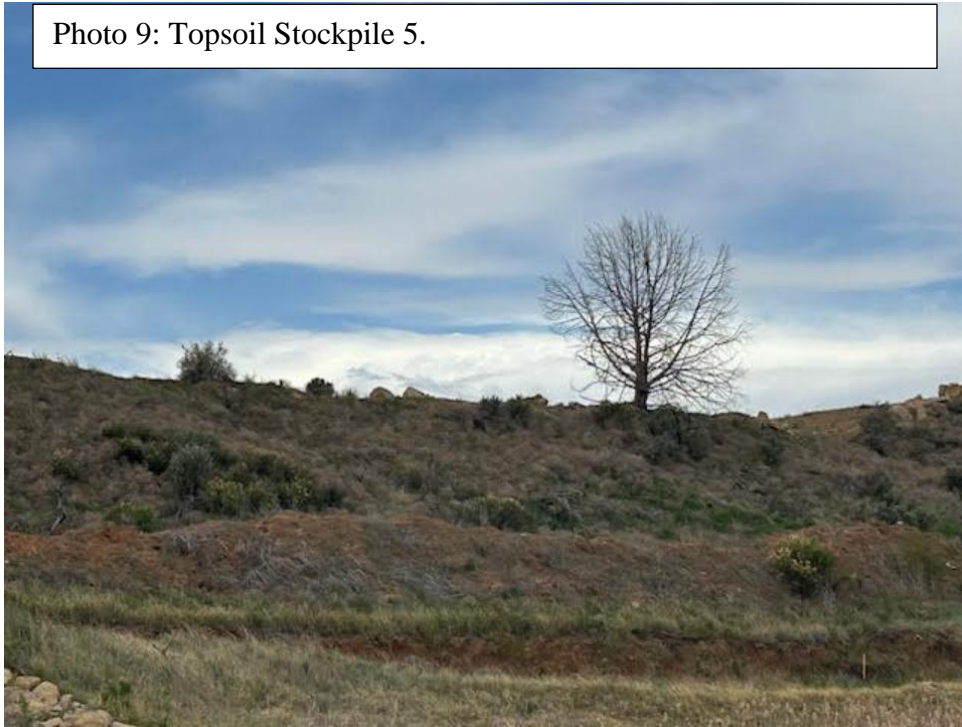
Photo 9: Topsoil Stockpile 5.

Topsoil piles 5 (Photo 9), 14, 15, and 16 (Photo 10) are associated with various sediment ponds at the mine site. These topsoil piles were stable with vegetative cover. There were no indications of erosional features or loss of topsoil resource observed. Topsoil pile markers were spotted for each of the piles.

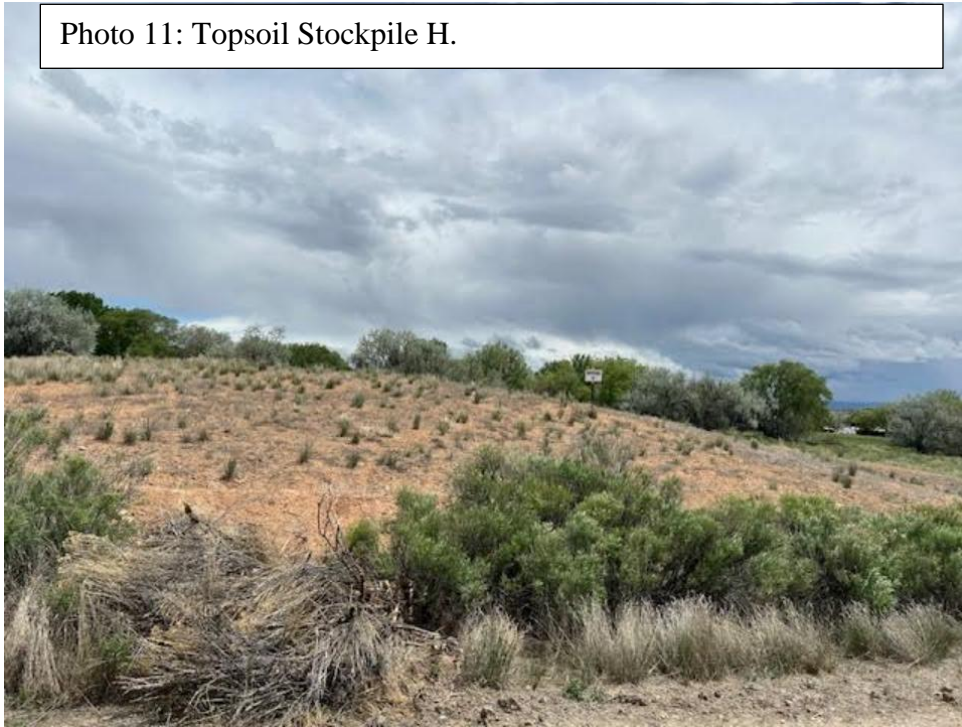
Photo 11: Topsoil Stockpile H.

Topsoil stockpiles C, D and H (Photo 11) are located to the south of the facilities area. The stockpiles were observed to be stable with vegetative cover. There were no erosional features or loss of topsoil identified. Each of the topsoil piles had an identifying marker.
