**MINERALS PROGRAM INSPECTION REPORT**  
**PHONE: (303) 866-3567**

| <b>MINE NAME:</b><br>Becker Pit | <b>MINE/PROSPECTING ID#:</b><br>M-2020-022 | <b>MINERAL:</b><br>Sand, gravel and borrow material for construction | <b>COUNTY:</b><br>Huerfano |
| <b>INSPECTION TYPE:</b><br>Monitoring | <b>WEATHER:</b><br>Cloudy | <b>INSP. DATE:</b><br>April 25, 2025 | <b>INSP. TIME:</b><br>12:00 |

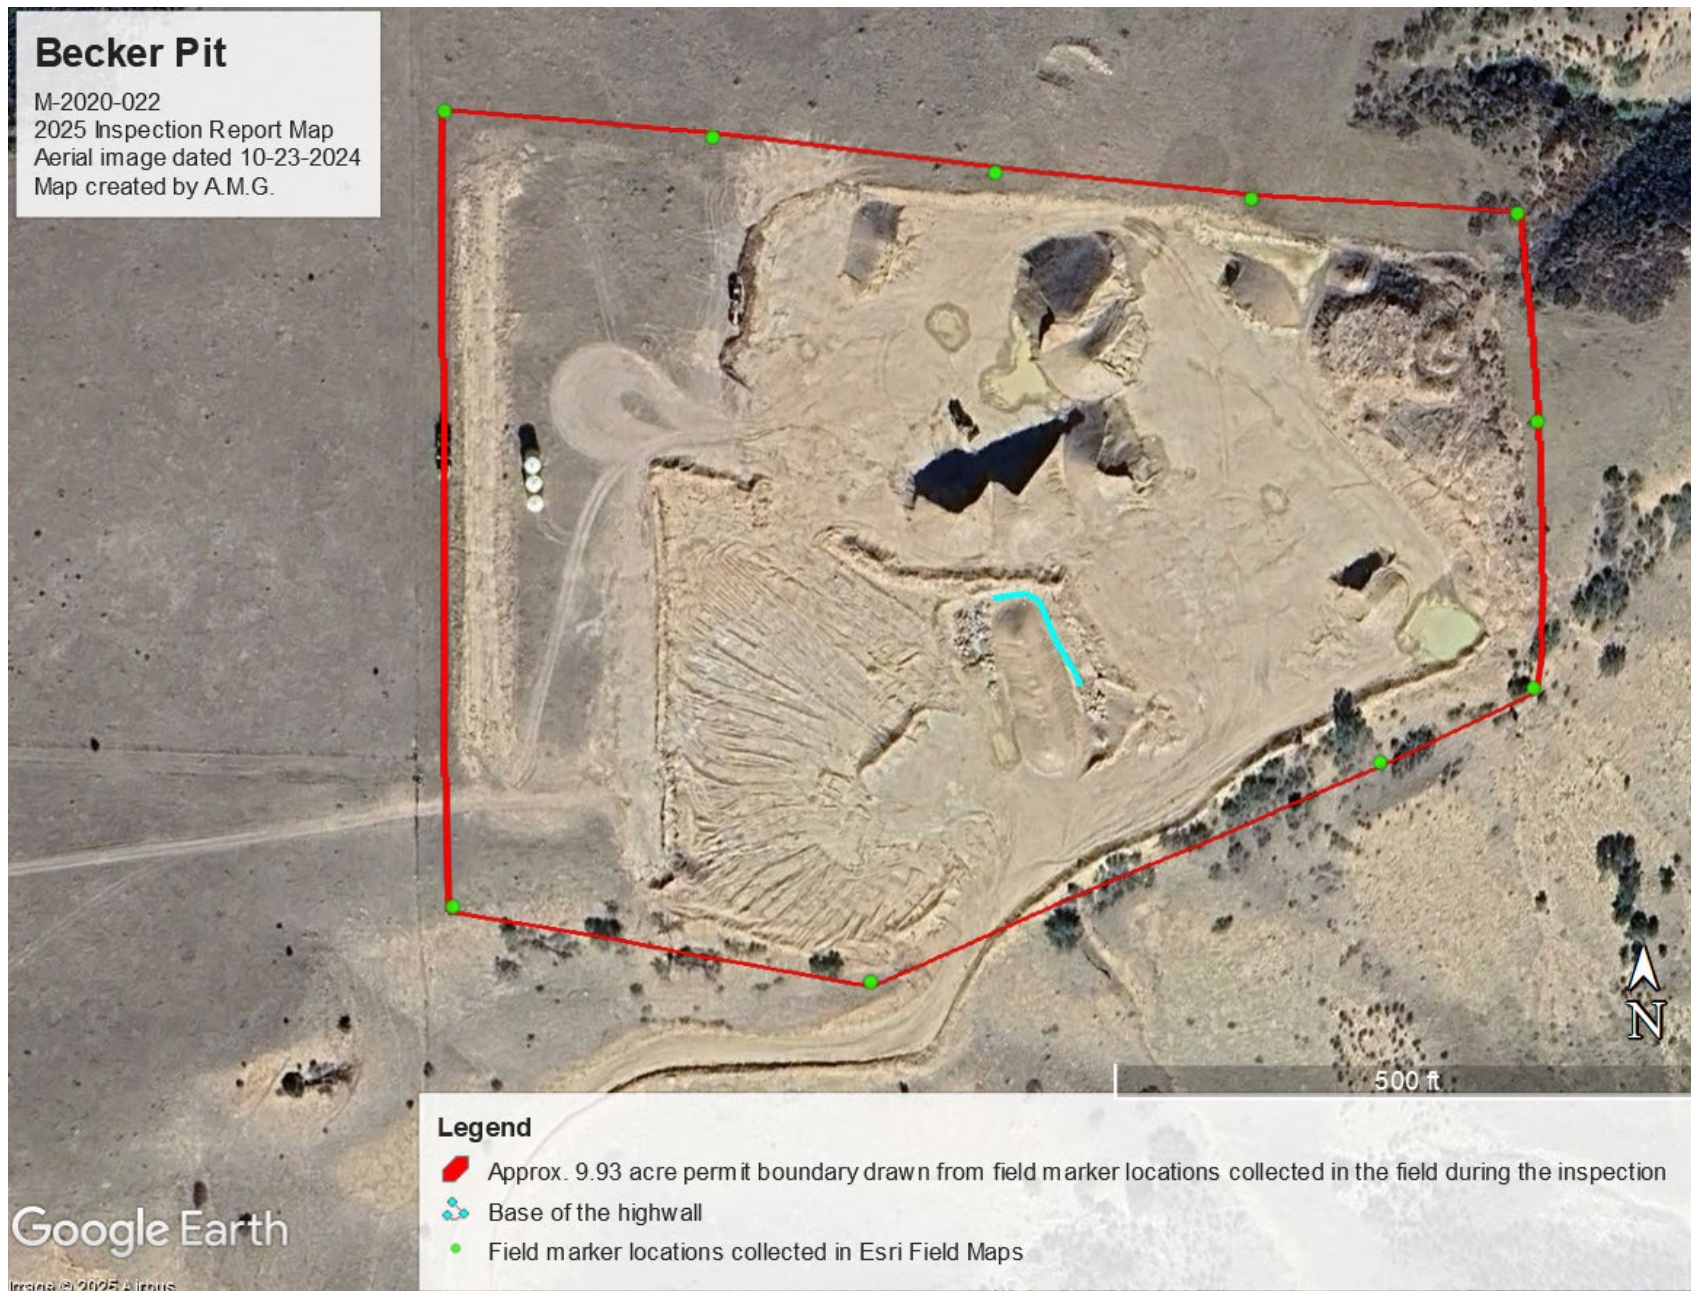
**Map 1:** 2025 Inspection map generated in Google Earth Pro.

There were a few pieces of equipment onsite at the time of the inspection. No equipment was observed outside of the permit boundaries. However, in the aerial image dated October 23, 2024 on Map 1, it appears that a piece of equipment was located along the west boundary at one point. The Division cautions the Operator to ensure that all equipment and equipment disturbance is confined within the permit boundaries to prevent enforcement actions for offsite impacts.

A sign is posted at the entrance to the site in compliance with Rule 3.1.12(1). Permit boundary markers consist of t-posts posted around the site in compliance with Rule 3.1.12(2). The field marker coordinates were collected during the inspection using the Esri FieldMaps application (see green dot icons on Map 1). The permit boundary markers appear to be placed in the correct positions. There are also additional markers placed at the site to aid with line-of-site along the northern permit boundary.

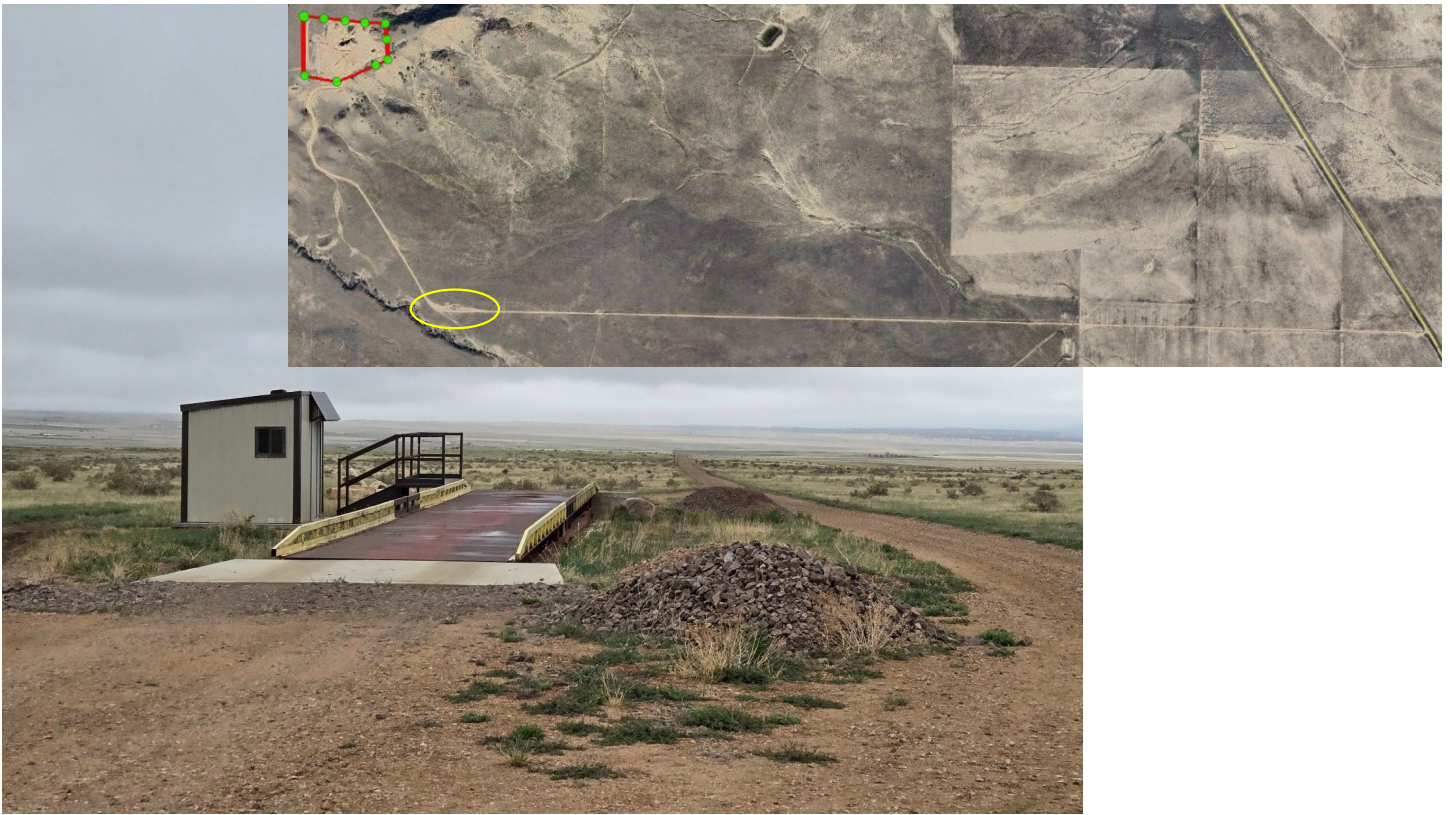
**Photo 1:** Truck scale located along the private road within the Clennin Ranch property.

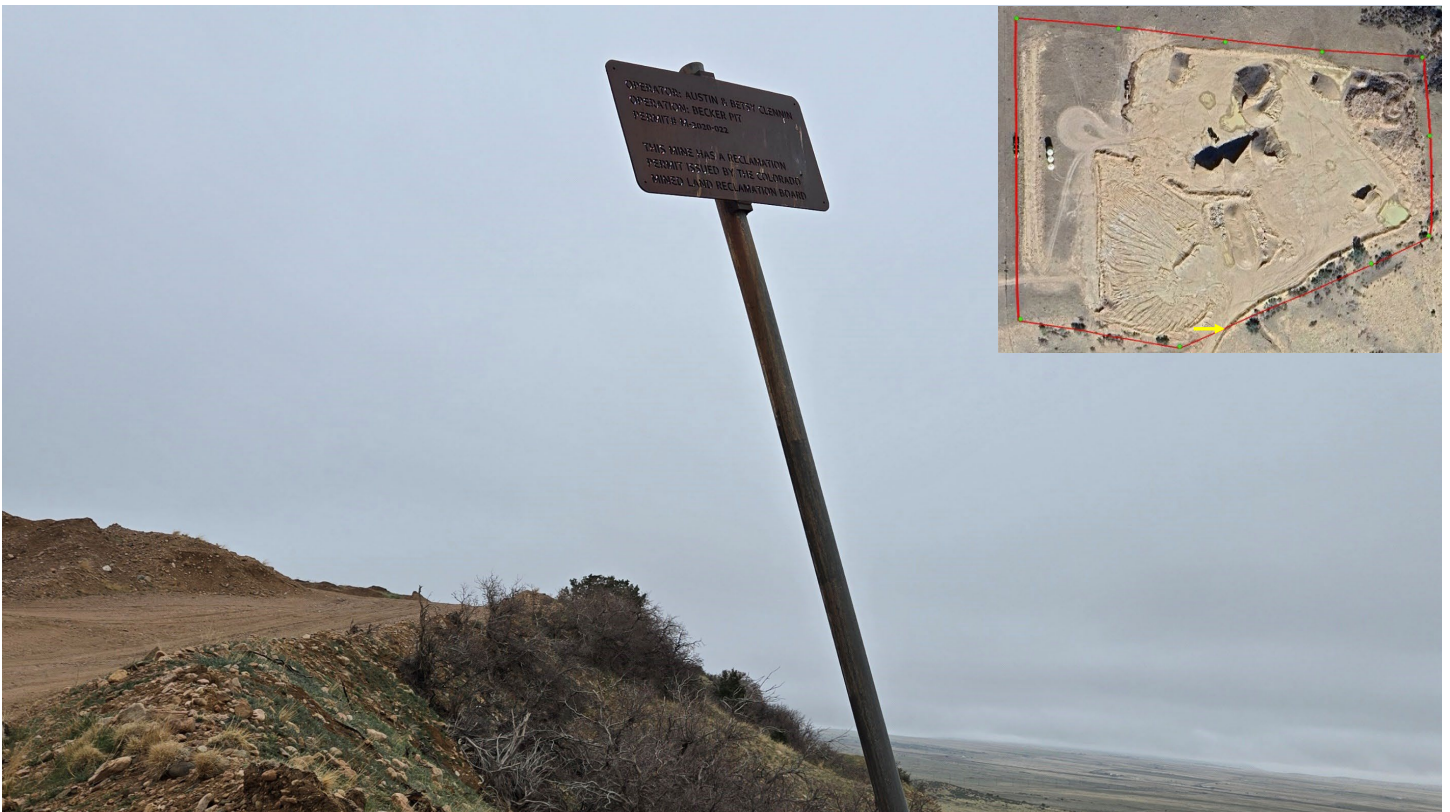
**Photo 2:** Mine sign located at the entrance to the site.

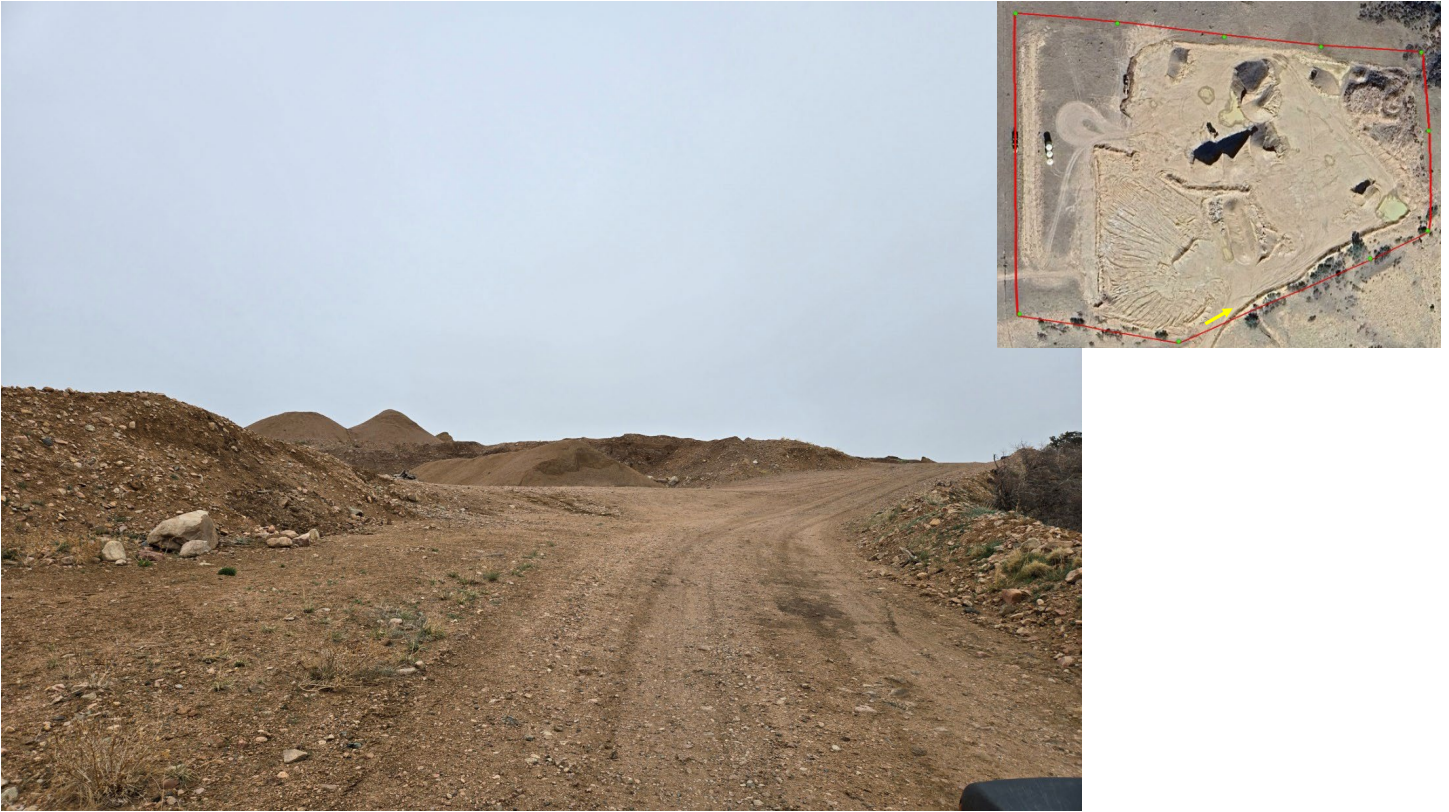
**Photo 3:** Looking into the site from the entrance. Safety berms are located along the south side of the road.

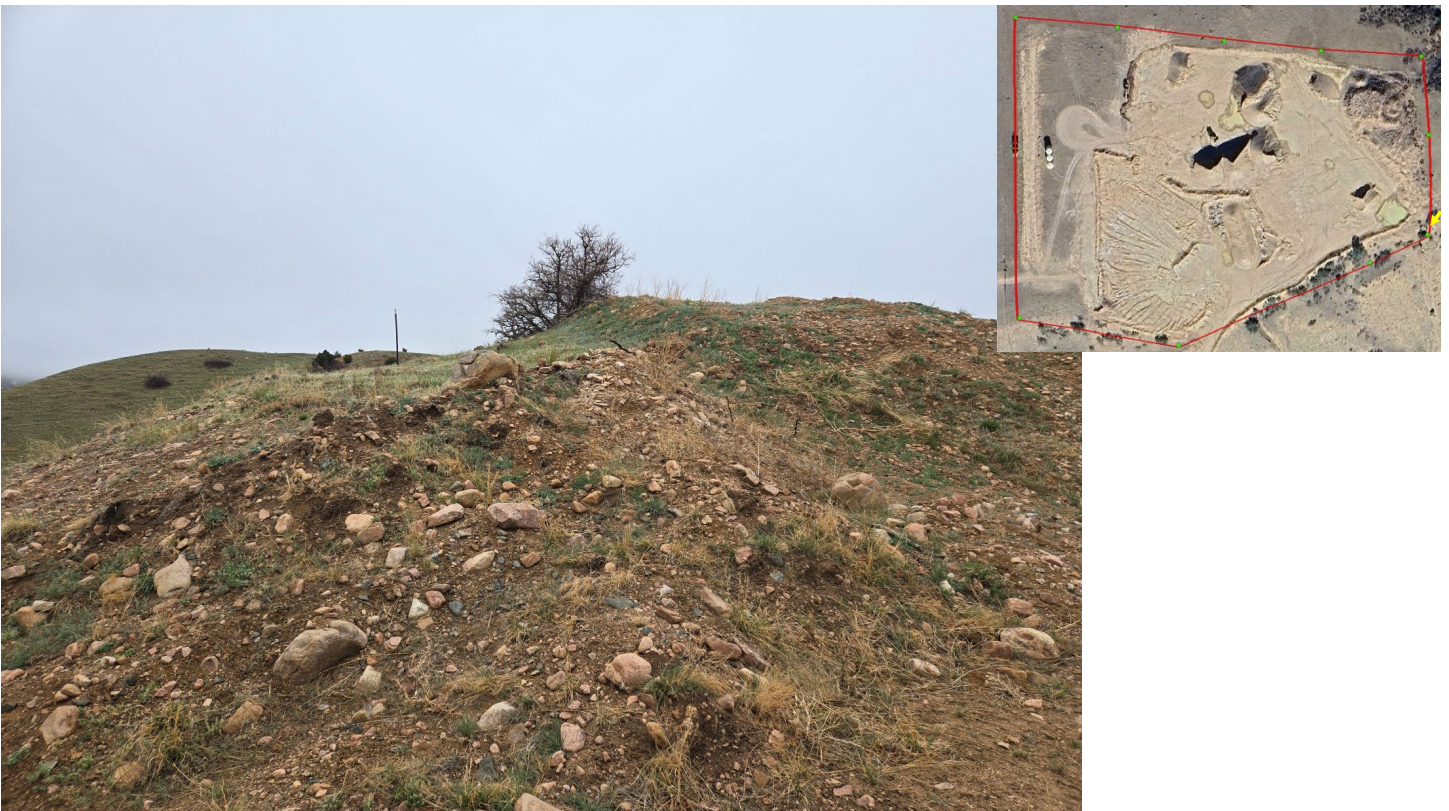
**Photo 4:** Looking along the south side of the permit area at the edge of the mesa.

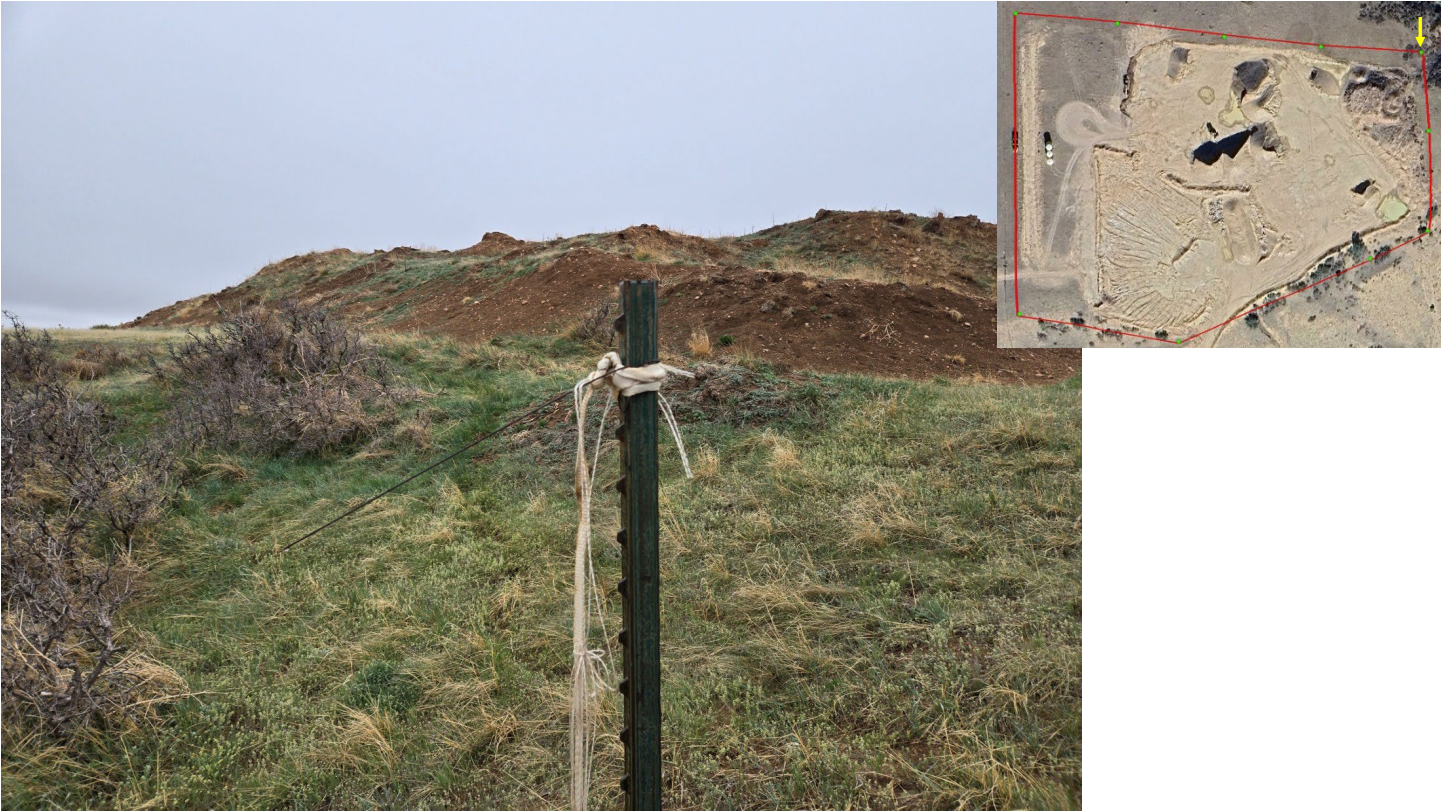
The Division believes that the material on the east side of the permit area may also consist of topsoil, as shown on the 2024 map, as much of it has what appears to be original grass cover. Per Rule 3.1.9(1), topsoil shall be removed and segregated from other spoil. If the east side does have topsoil, the **Operator shall** separate topsoil from overburden material and ensure that it is stabilized and protected from erosion. The darker pile on the west side of the pit shall also be stabilized. Also, as stated in the mining plan, if the topsoil stockpiles remain undisturbed for more than one growing season they **shall be seeded using the approved seed mix at a rate of 40lbs-pls per acre.**

**Photo 5:** Looking south from the northeastern permit boundary corner marker. The soil stockpiled in this area appears to at least partially consist of topsoil. If so, it needs to be segregated from overburden material, stabilized, and vegetated if not used for reclamation within one growing season.

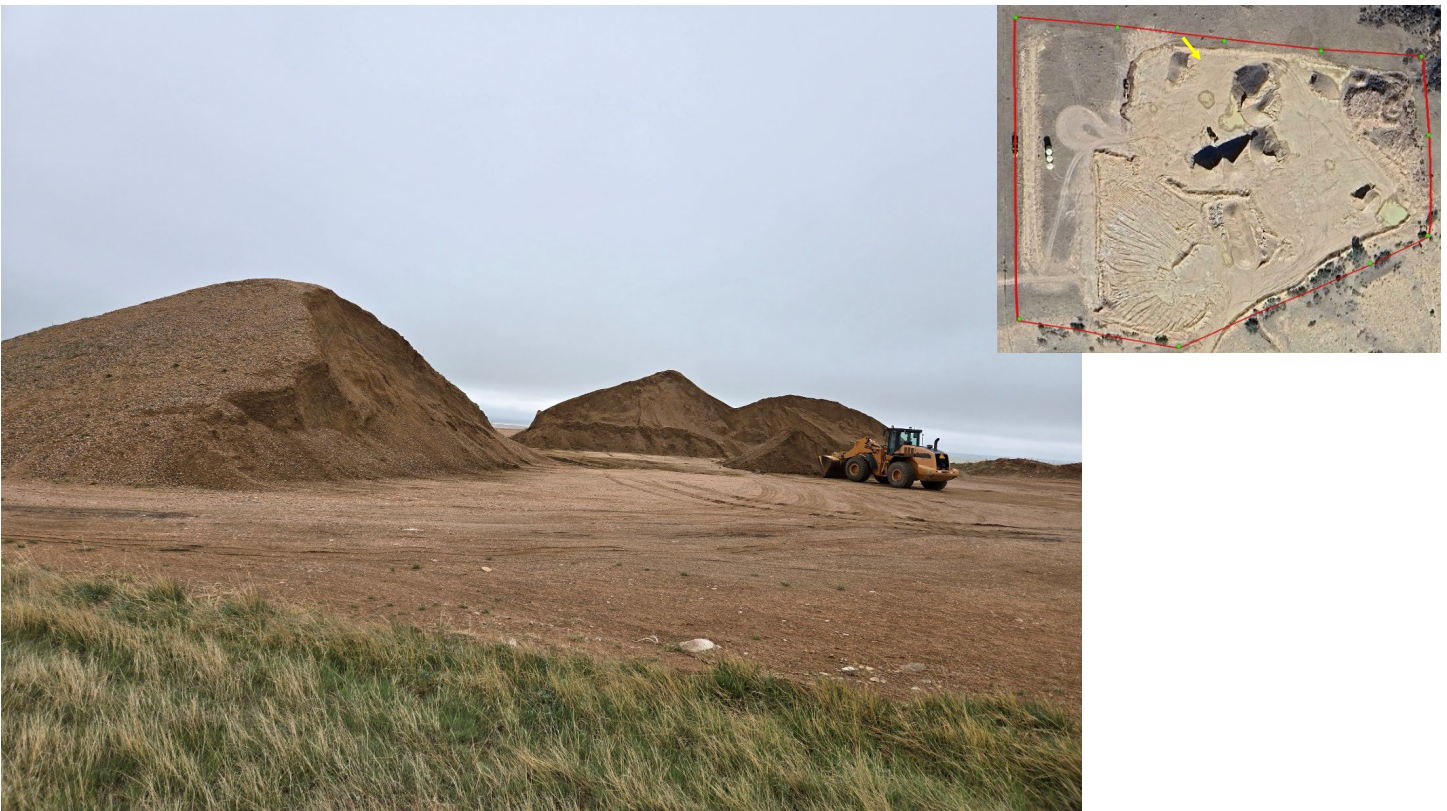
**Photo 6:** Looking southeast at some product stockpiles and equipment within the site.

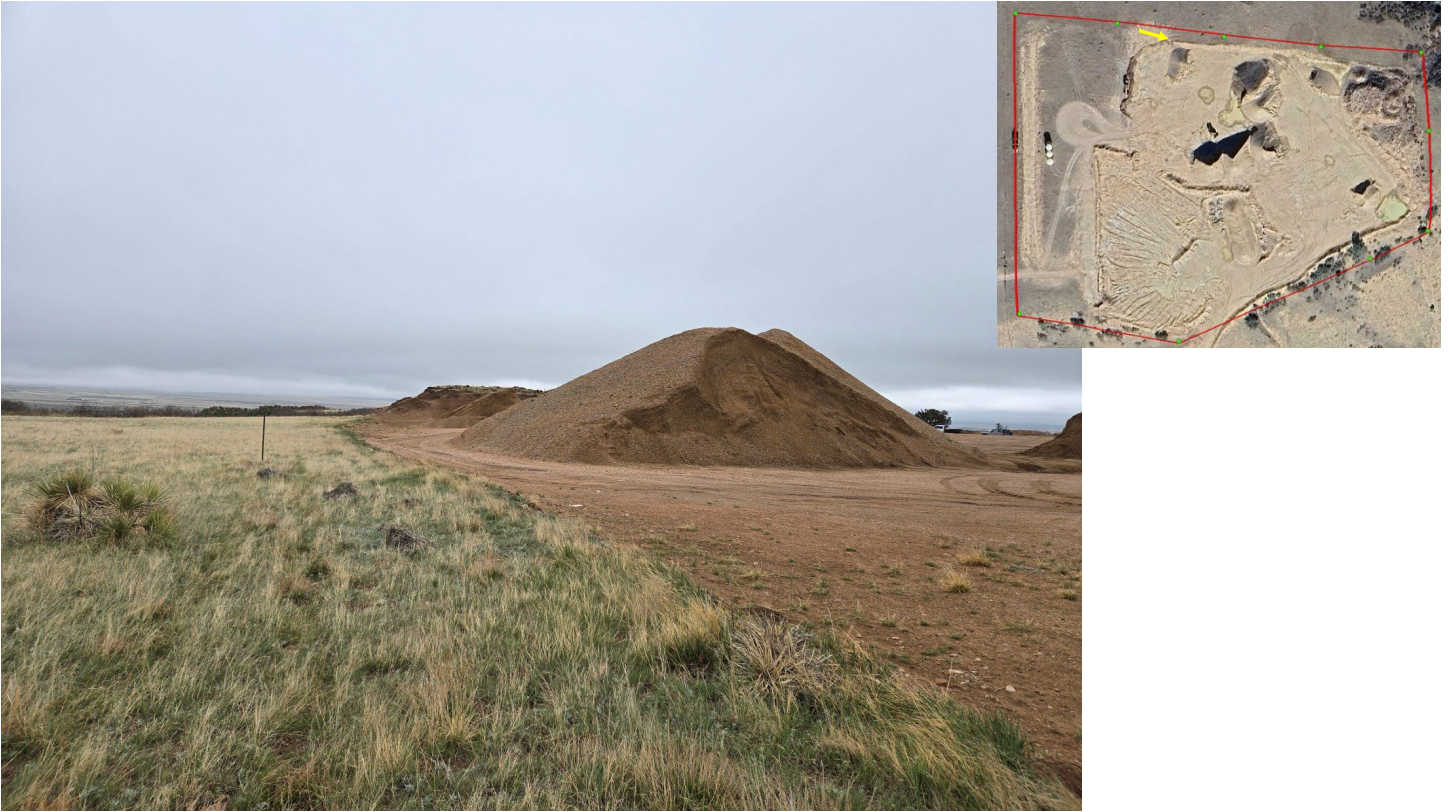
**Photo 7:** Looking east along the northern permit boundary at the 10' setback that is being maintained within this area.

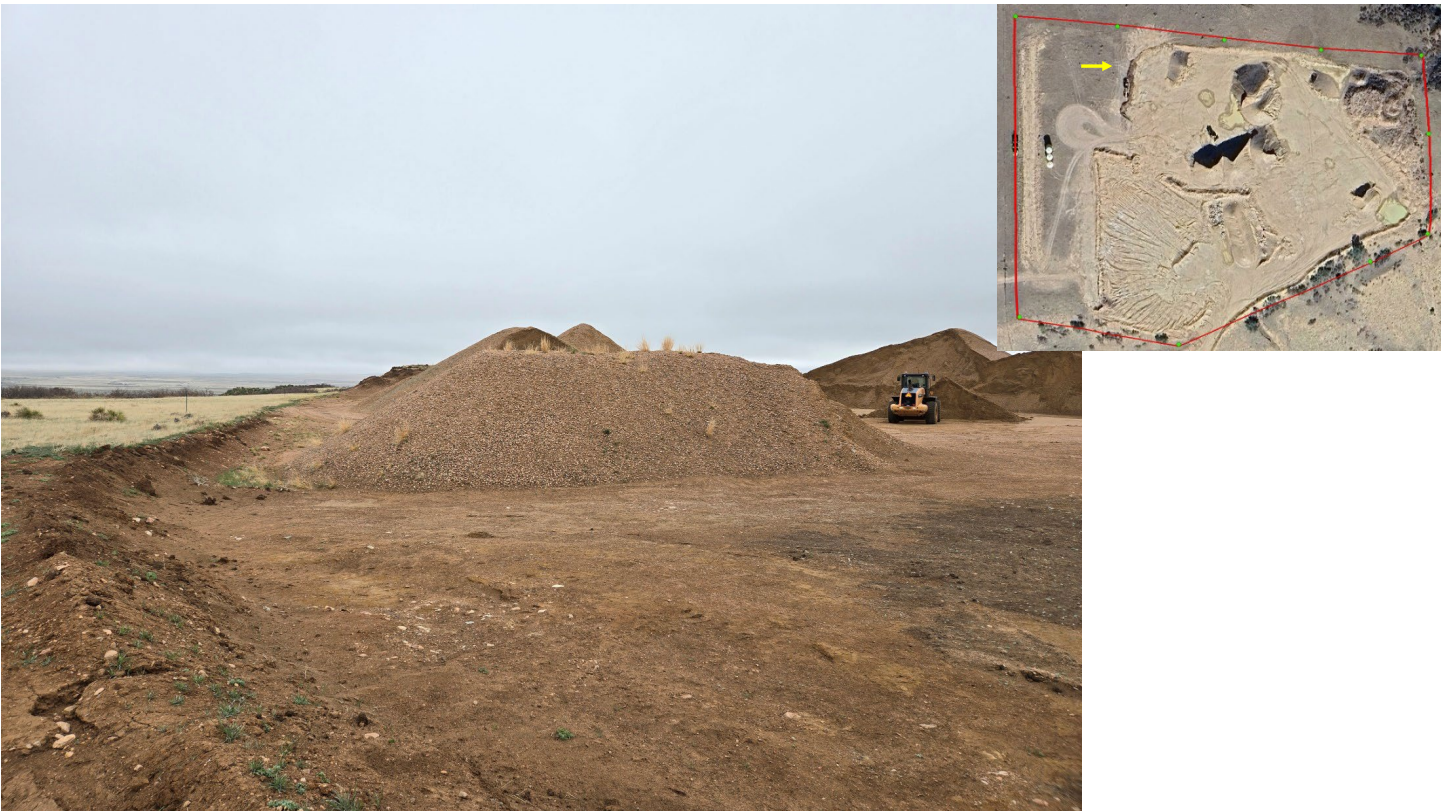
**Photo 8:** Looking east at some stockpiled product.

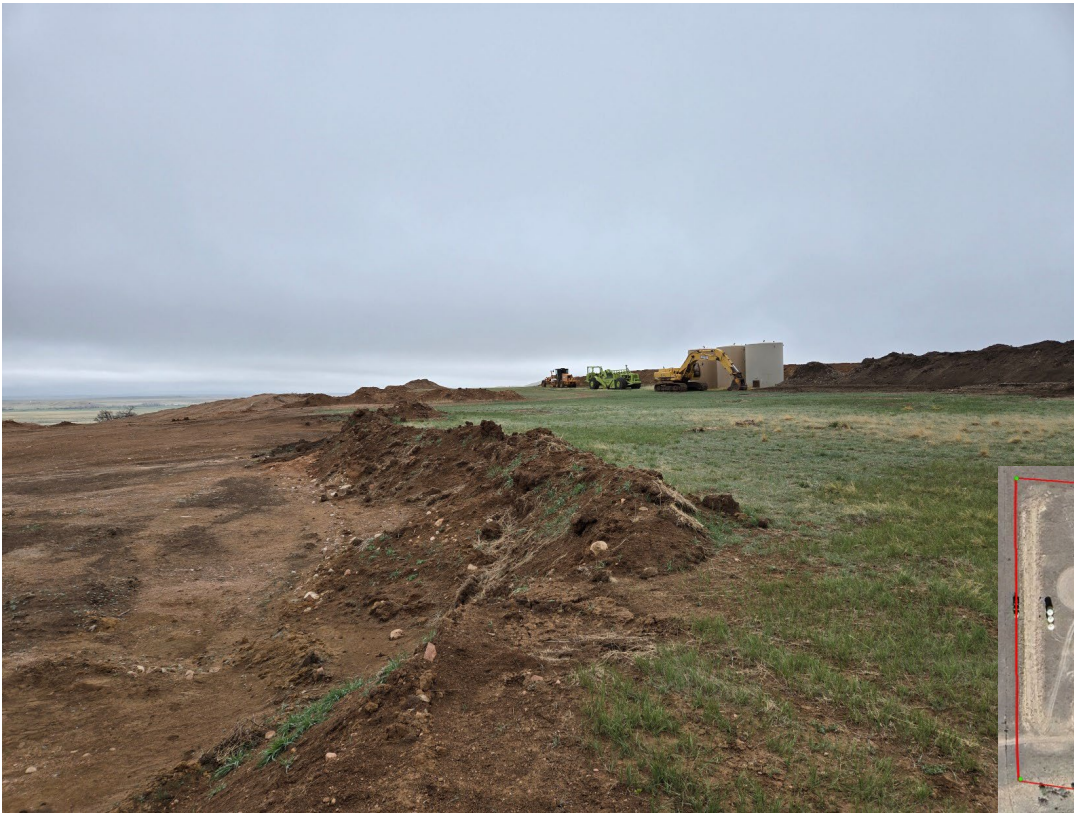
**Photo 9:** Looking southwest at the western extent of the stripped area and at some equipment onsite.

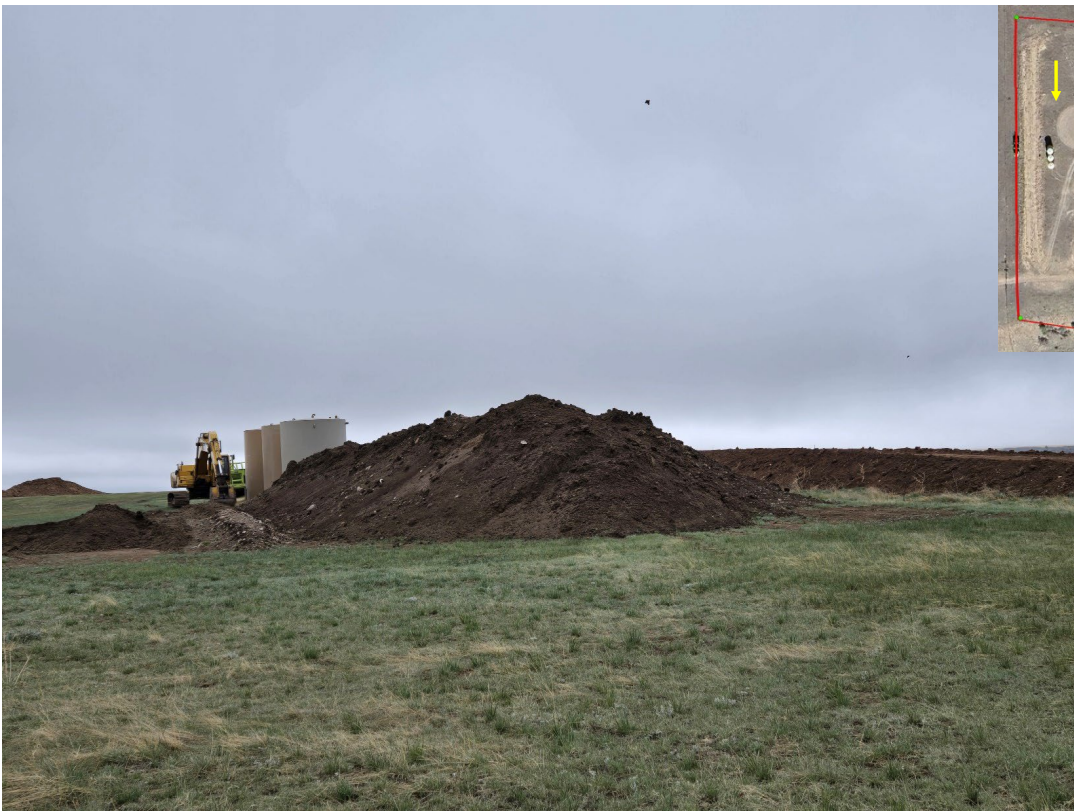
The mining plans states that "prior to mining a section of the surface it will be stripped of topsoil and placed around the mine setback or on the mine floor for used in reclamation. As mining progresses the stripped material may be placed directly on the seedbed, if it will not be re-disturbed." The 2024 annual report map indicates that topsoil is located within the mining setback along the west side of the pit, and at the edge of the disturbed area on the east side of the pit (see Figure 1). During the inspection, the Operator was asked if the material on the east side was topsoil to which they stated no, and that the topsoil was located on the west side in the stabilized configuration (Photo 11), and an additional newer pile is located east of that (Photo 10).

**Photo 10:** New topsoil pile east of the stabilized pile. The Operator shall ensure this pile is stabilized and seeded if not used for reclamation within one growing season.

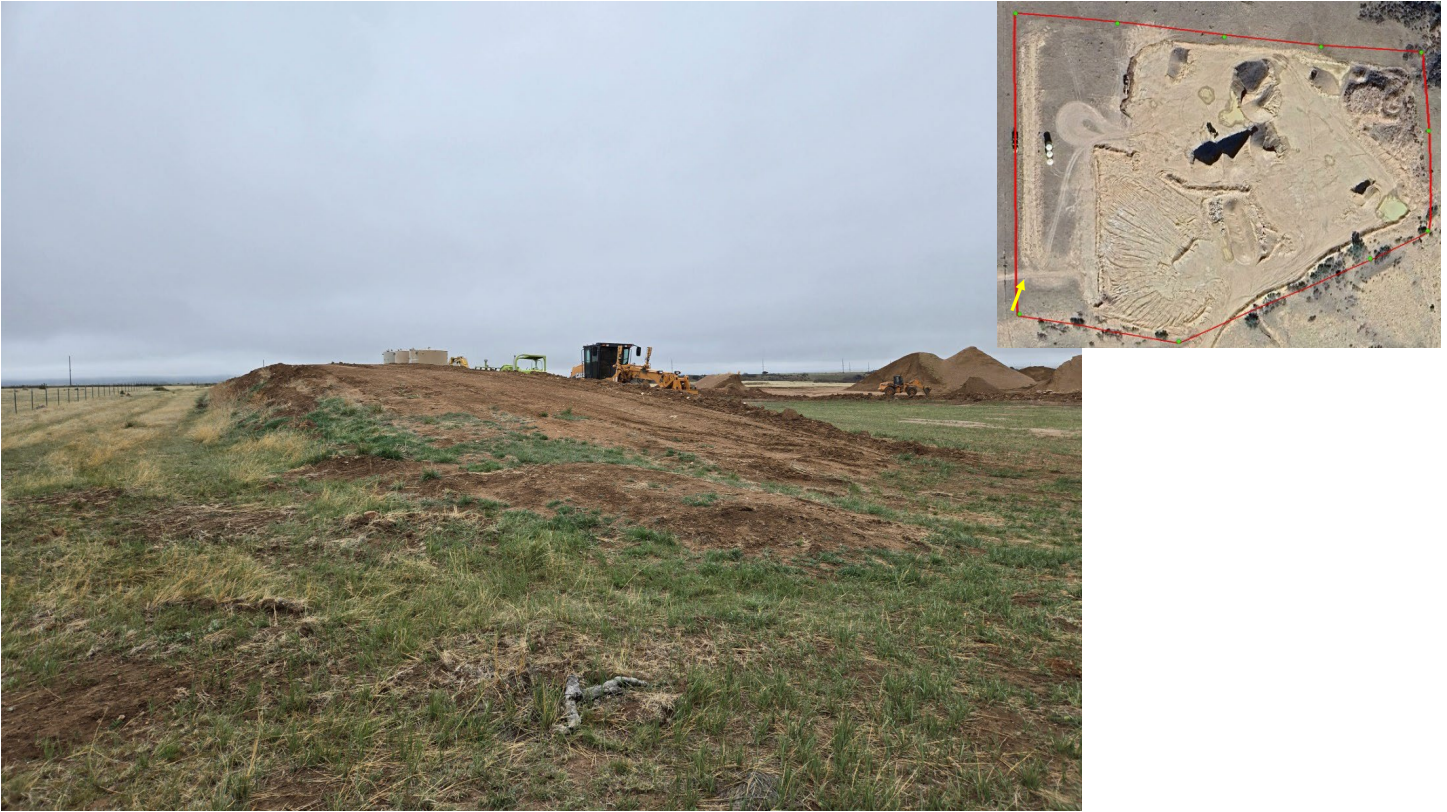
**Photo 11:** Looking north at the stabilized topsoil stockpile located within the mining setback on the west side of the permit area.

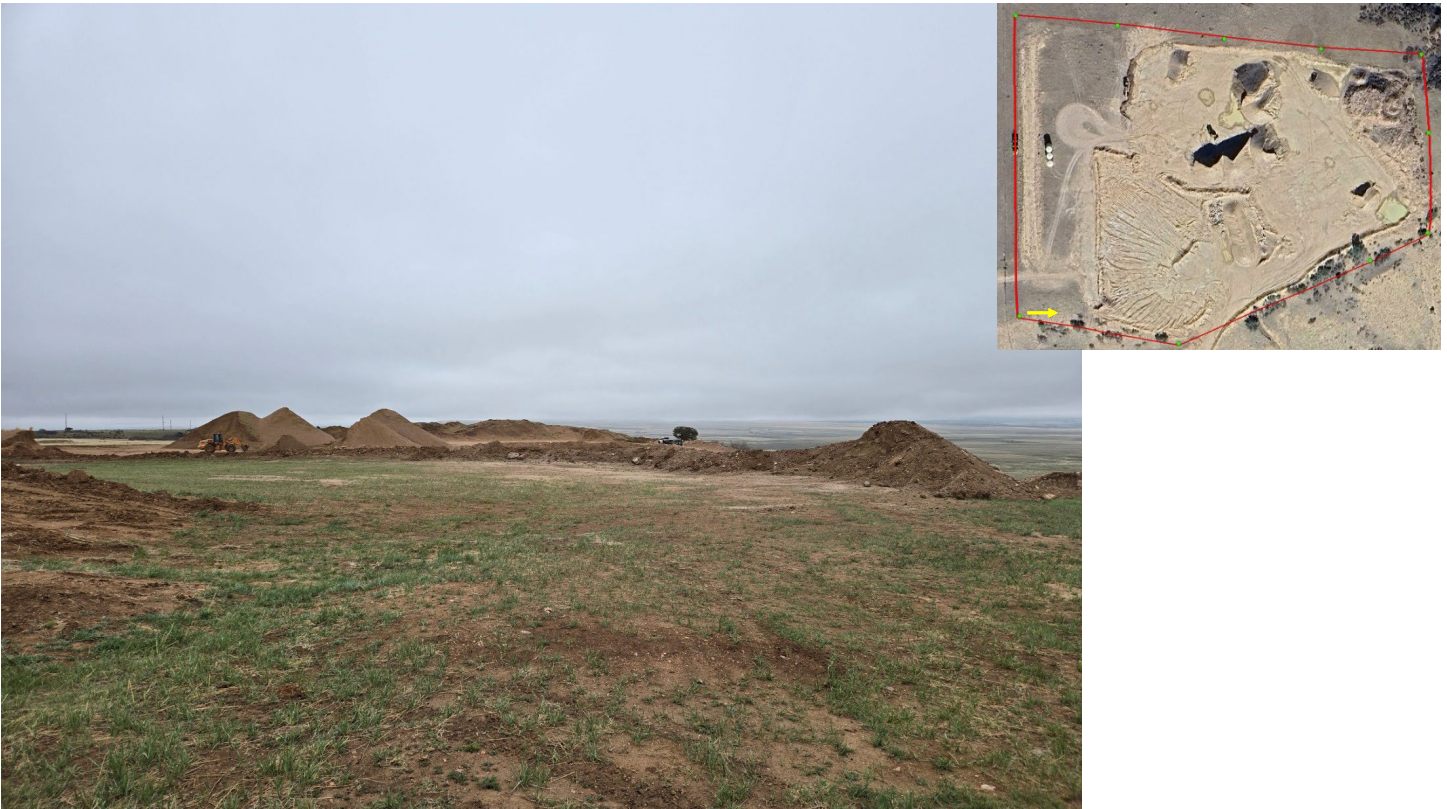
**Photo 12:** Looking east along the south side of the site from the southwest corner.

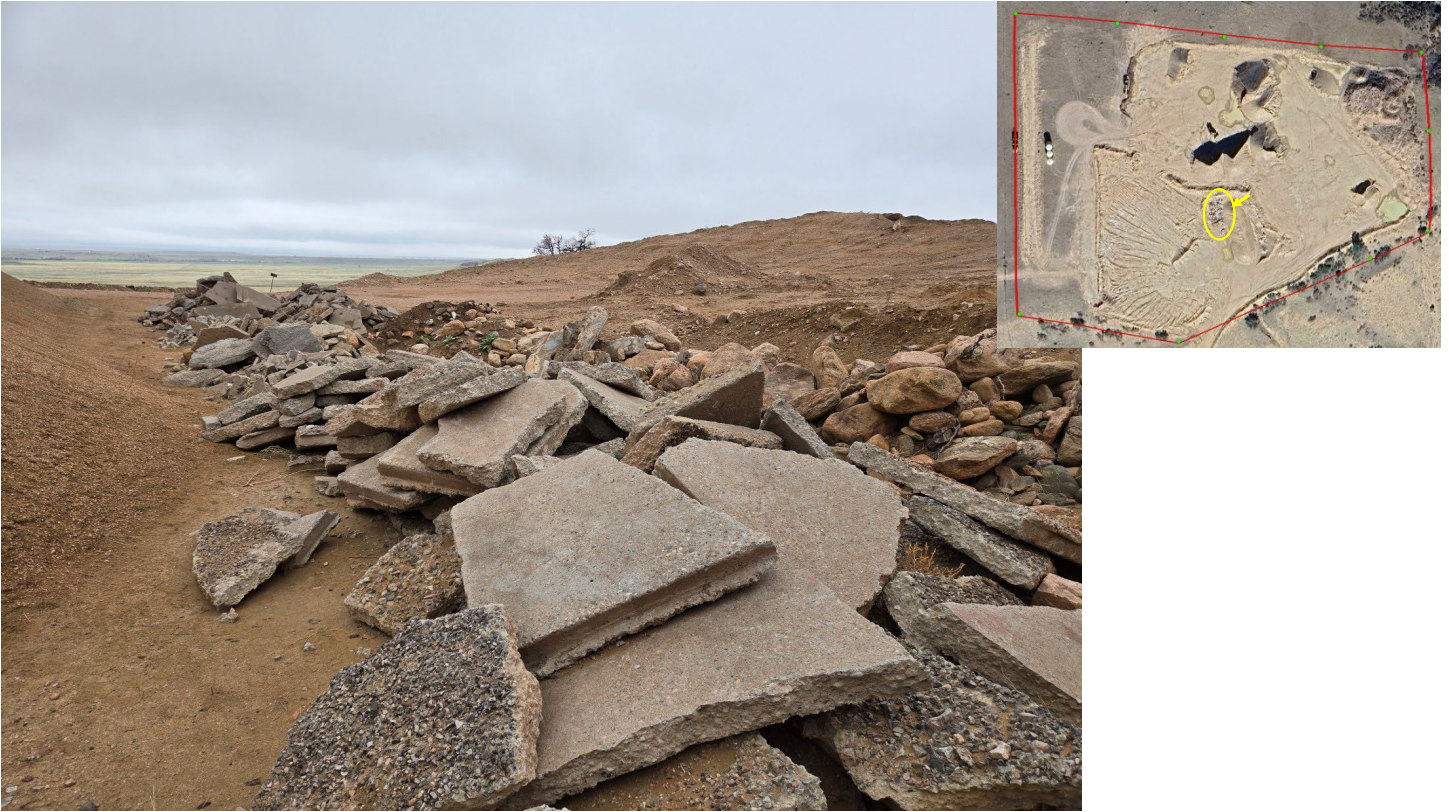
**Photo 13:** Stockpiled concrete stored onsite to be recycled into product.

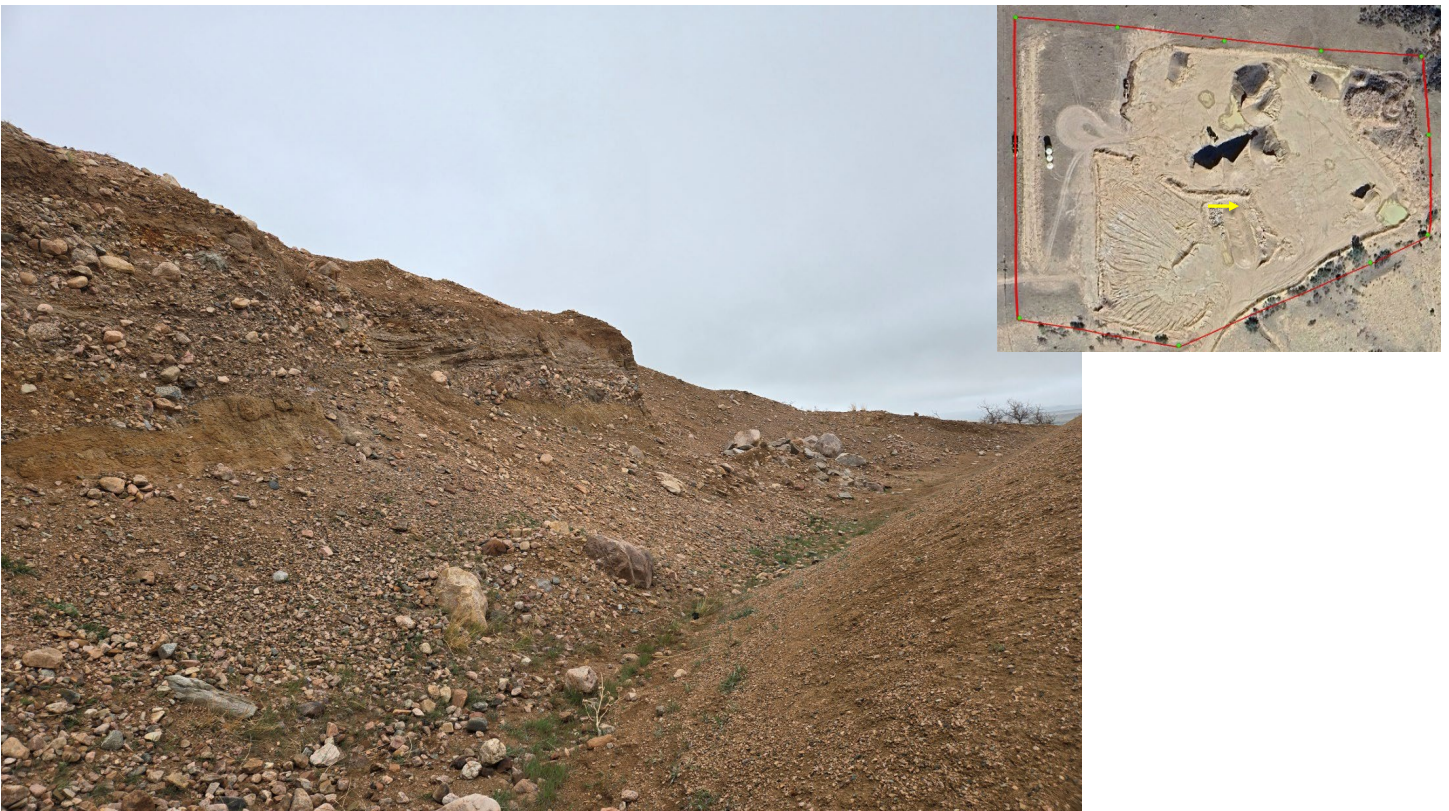
**Photo 14:** Looking south along the section of highwall within the pit area.

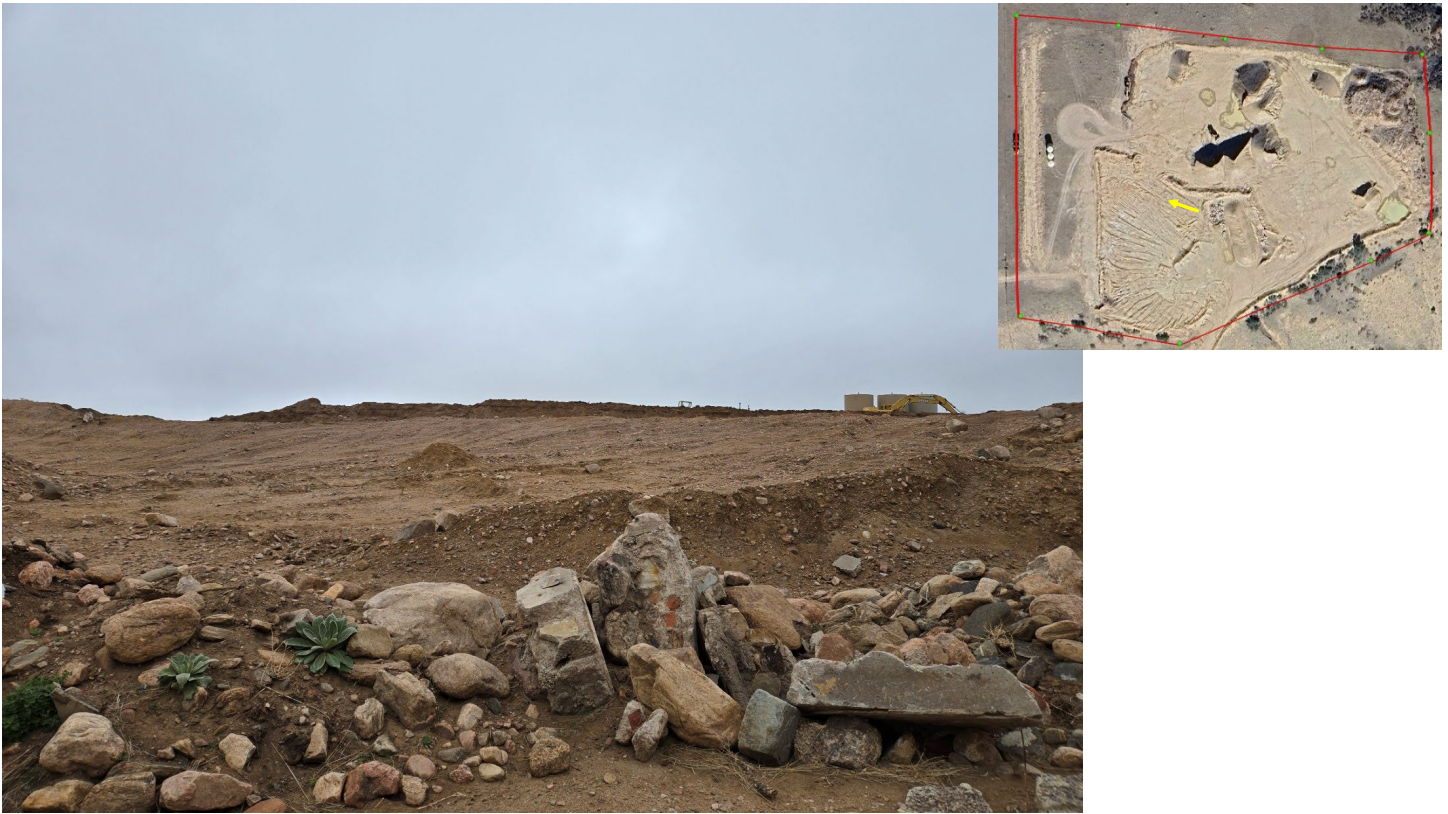
**Photo 15:** Looking northwest at the gently sloped area on the west side of the striped area.

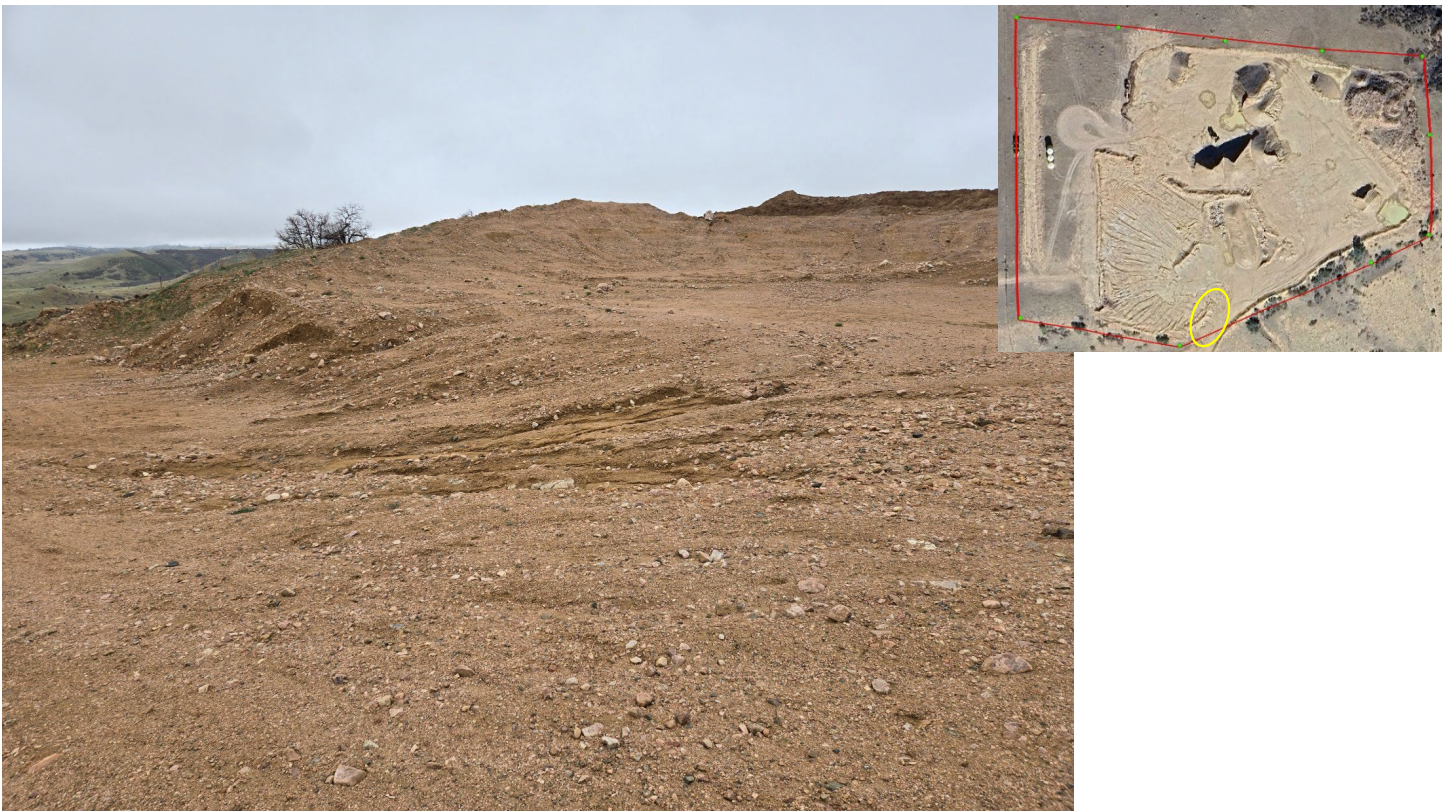
No standing water was observed at the time of the inspection. The disturbance onsite is lined by berms and/or sloped towards the center of the pit. No excess sediment was observed outside of the permit boundary during the inspection. There is a small area along the entrance to the road that has begun to erode **that will need to be stabilized** (Photo 16). During the inspection, the Operator stated that they will grade the area to help stabilize it.

**Photo 16:** Looking west at the small area near the entrance to the stie where some erosion has begun to form that the Operator shall stabilize.
