**MINERALS PROGRAM INSPECTION REPORT**  
**PHONE: (303) 866-3567**

| <b>MINE NAME:</b><br>Becker Pit | <b>MINE/PROSPECTING ID#:</b><br>M-2020-022 | <b>MINERAL:</b><br>Sand, gravel and borrow material for construction | <b>COUNTY:</b><br>Huerfano |
| <b>INSPECTION TYPE:</b><br>Monitoring | <b>WEATHER:</b><br>Cloudy | <b>INSP. DATE:</b><br>April 25, 2025 | <b>INSP. TIME:</b><br>12:00 |

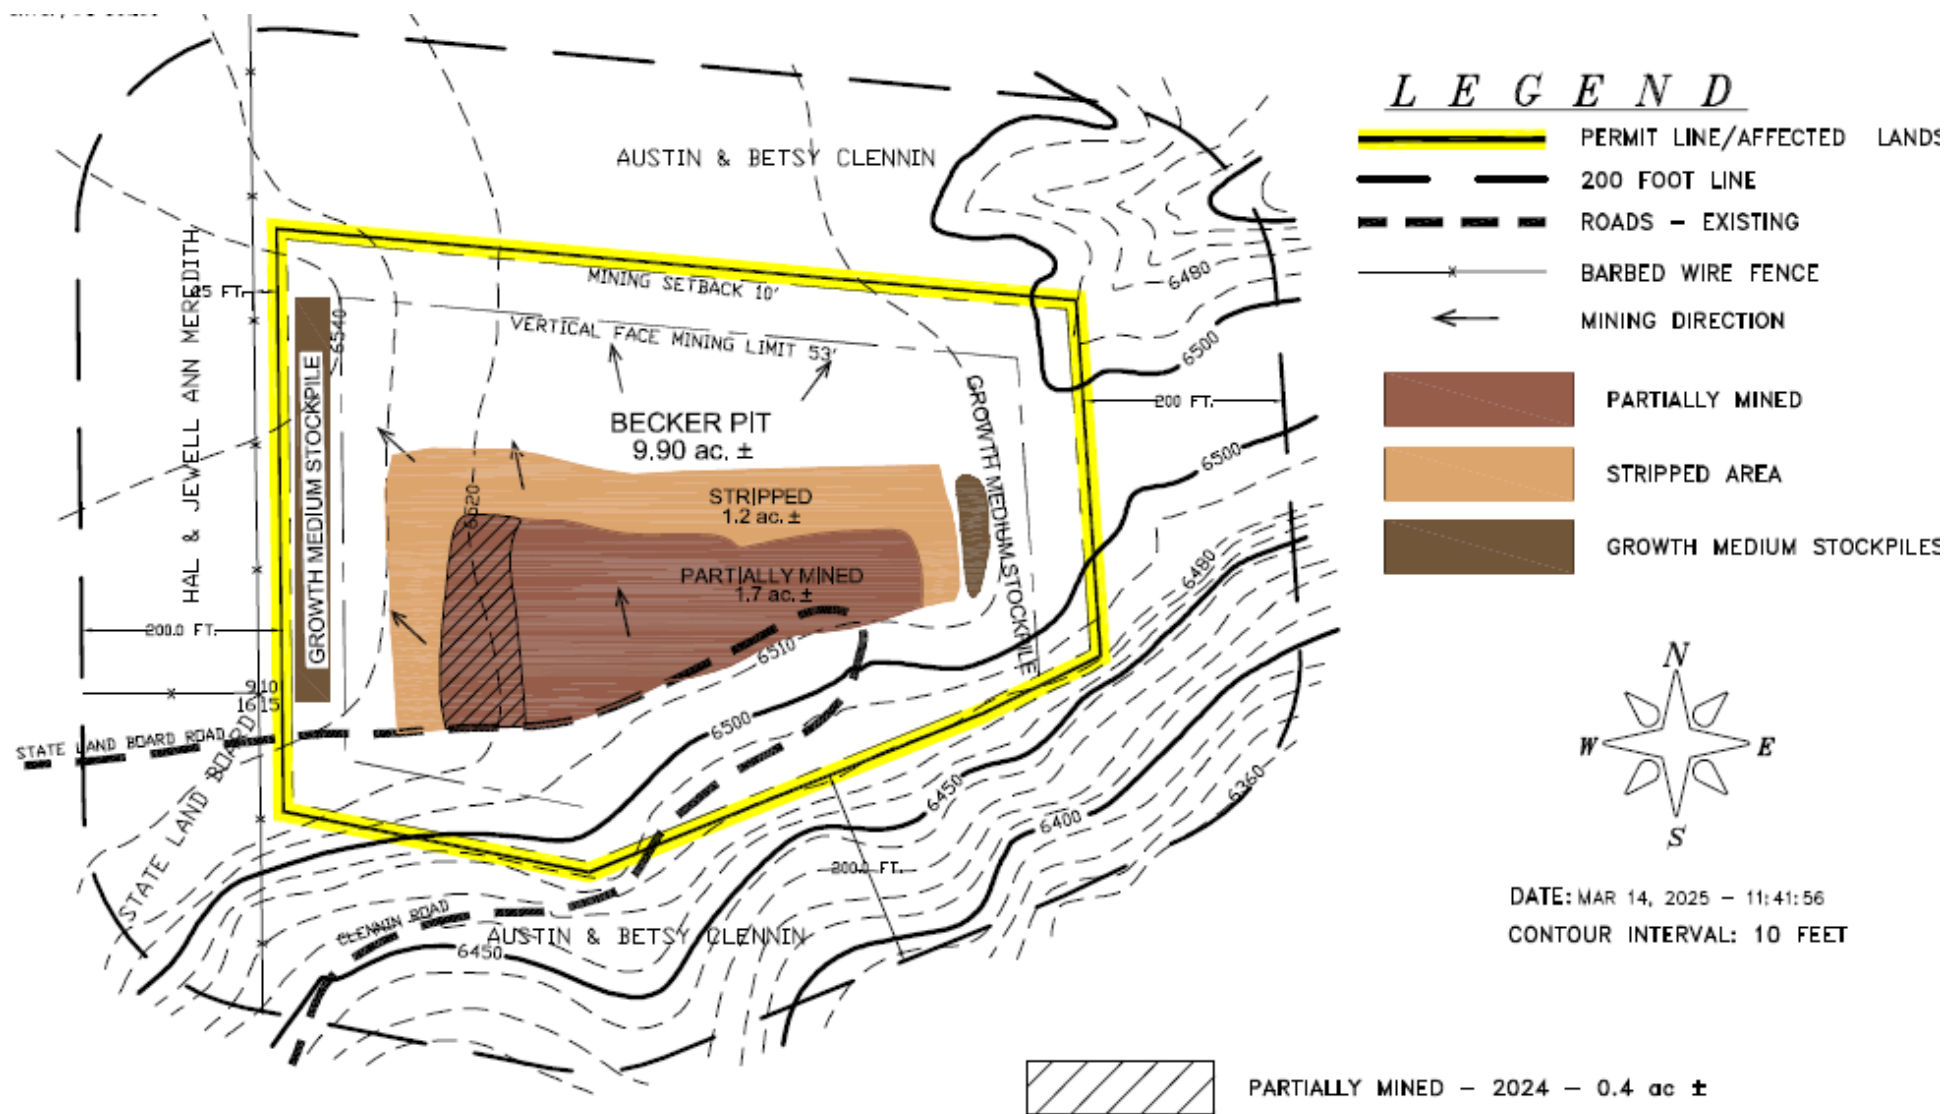
Figure 1: Screenshot from the Operator's 2024 annual report submission.

The Operator provides detailed annual report and annual report maps. Since the Operator's 2024 annual report map submission (see Figure 1 at the end of this report) additional land in the north has been stripped. As seen in the aerial imagery on Map 1, much of the disturbed area has been stripped and topsoil is stockpiled on the
