**MINERALS PROGRAM INSPECTION REPORT**  
**PHONE: (303) 866-3567**

<b>MINE NAME:</b> Dawson Creek	<b>MINE/PROSPECTING ID#:</b> P-2023-002	<b>MINERAL:</b> Sand and gravel	<b>COUNTY:</b> Routt
<b>INSPECTION TYPE:</b> Monitoring	<b>WEATHER:</b> Clear	<b>INSP. DATE:</b> April 22, 2025	<b>INSP. TIME:</b> 13:00
<b>OPERATOR:</b> Routt County	<b>OPERATOR REPRESENTATIVE:</b> Zach Schaffner	<b>TYPE OF OPERATION:</b> MP - Mineral Prospecting	
<b>REASON FOR INSPECTION:</b> Normal I&E Program	<b>BOND CALCULATION TYPE:</b> None	<b>BOND AMOUNT:</b> \$0.00	
<b>DATE OF COMPLAINT:</b> NA	<b>POST INSP. CONTACTS:</b> None	<b>JOINT INSP. AGENCY:</b> None	
<b>INSPECTOR(S):</b> Brock Bowles	<b>INSPECTOR'S SIGNATURE:</b>

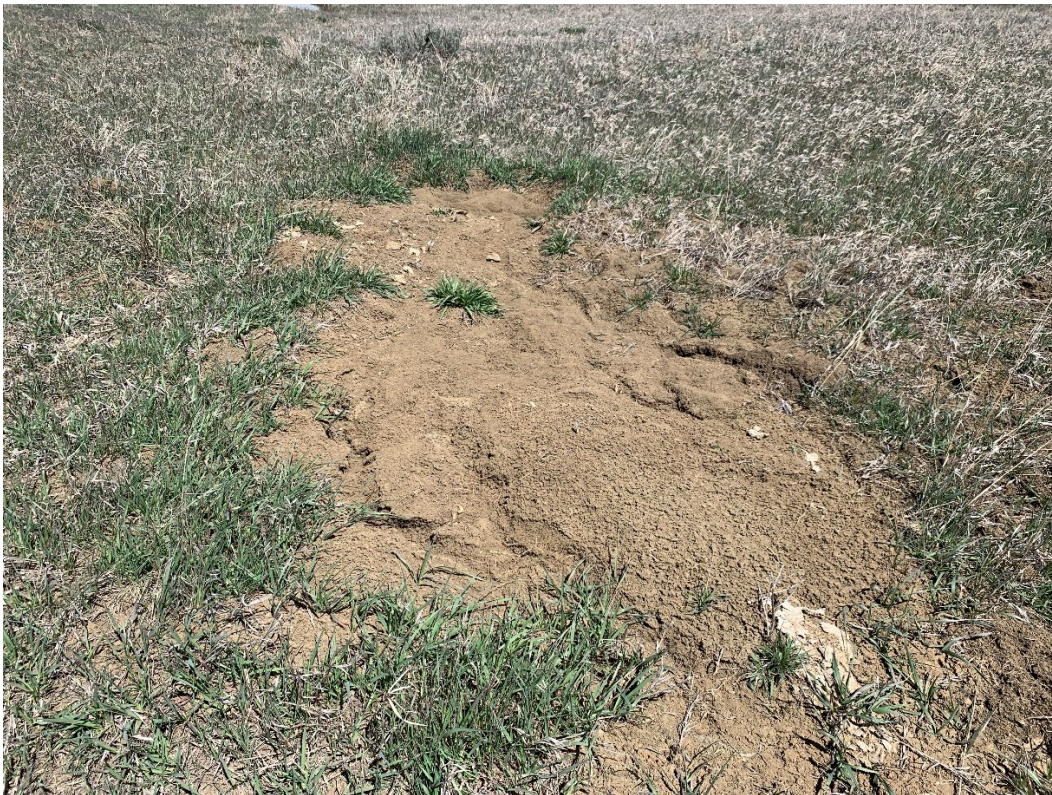
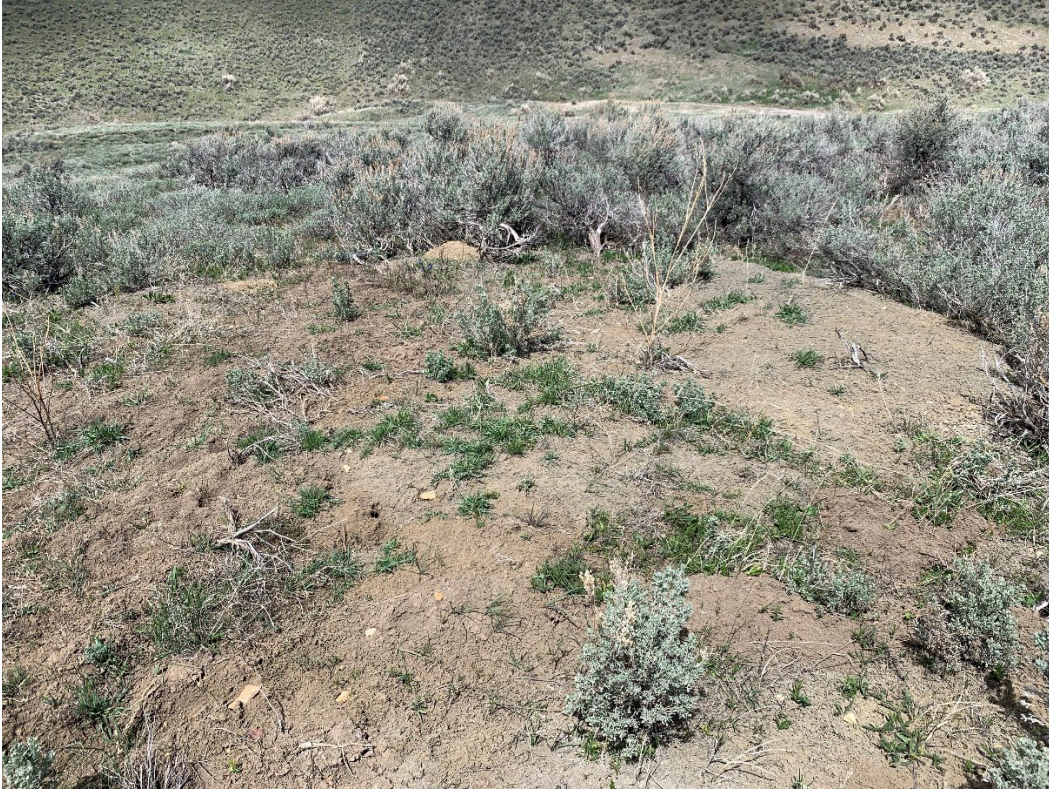
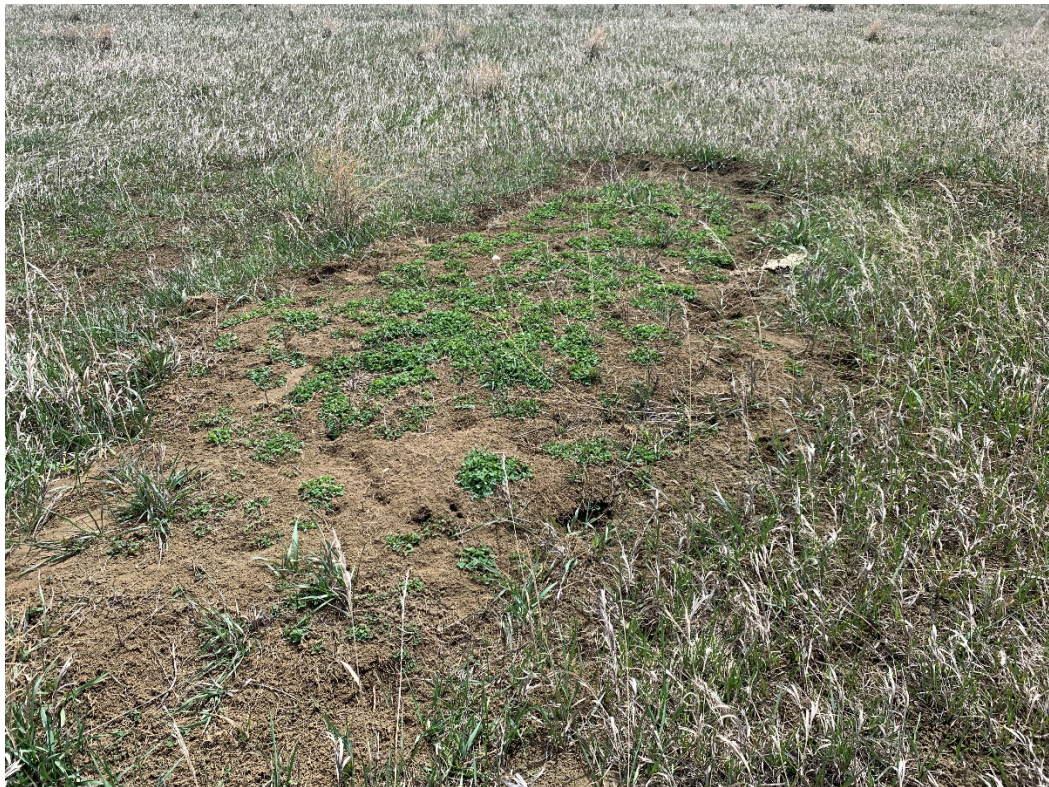
Approximately 12 holes have been dug to date and of those, 6 were inspected. The holes were seeded 2 seasons ago. The vegetation establishment on each hole was varied. Some were sparse and some were doing well (see photos). Overall, at least another year is needed for establishment. Some of the sites may need to be reseeded and this was discussed with the operator.
