## King Mine, C-1981-035, May Complete Inspection Report

## COLORADO

Division of Reclamation,  
Mining and Safety

### PERMIT INFORMATION

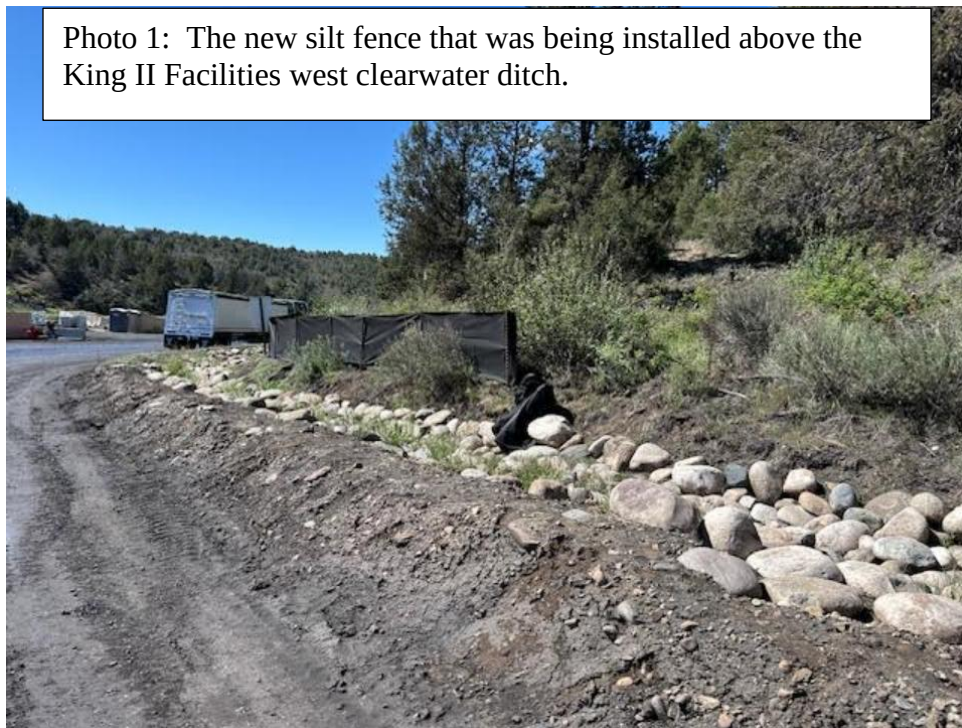
1. During the inspection on March 26, 2025 the Division observed coal dust on the southern hillside adjacent to Coal Stack #1. The west clearwater ditch for the King II area is located at the base of this hillside. GCC needs to ensure the clearwater ditches at the King II area will not be impacted by coal dust. During the May 15<sup>th</sup> inspection, the operator was installing a silt fence on the upgradient hillside above the West clearwater ditch (Photo 1).

Photo 1: The new silt fence that was being installed above the King II Facilities west clearwater ditch.

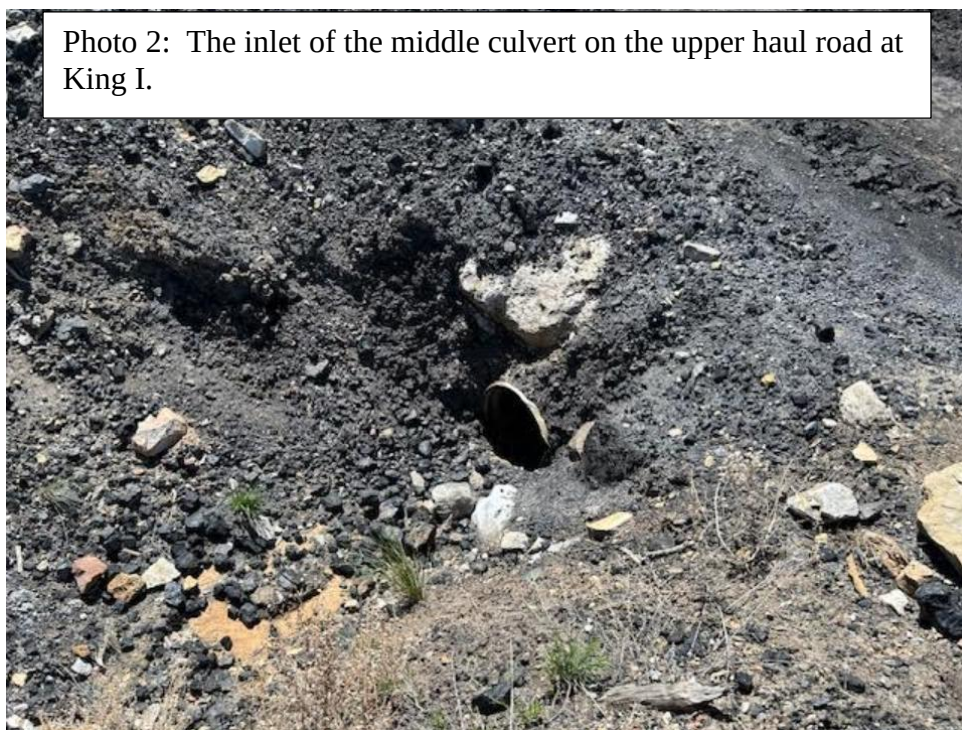
Three culverts are located beneath the haul road extending from the URDA down to the LRDA. The upper most culvert was in good repair. The inlet and outlet of the pipe was clear of obstructions and sediment levels were minimal. The middle culvert is placed beneath the switchback above the LRDA. The inlet (Photo 2) and outlet to the culvert was free of debris. There were no excessive amounts of sediment observed. The lowest culvert is underneath the haul road just above the LRDA and connects to Reach 10 on the LRDA. The inlet and outlet to the culvert were in good condition.

Photo 2: The inlet of the middle culvert on the upper haul road at King I.

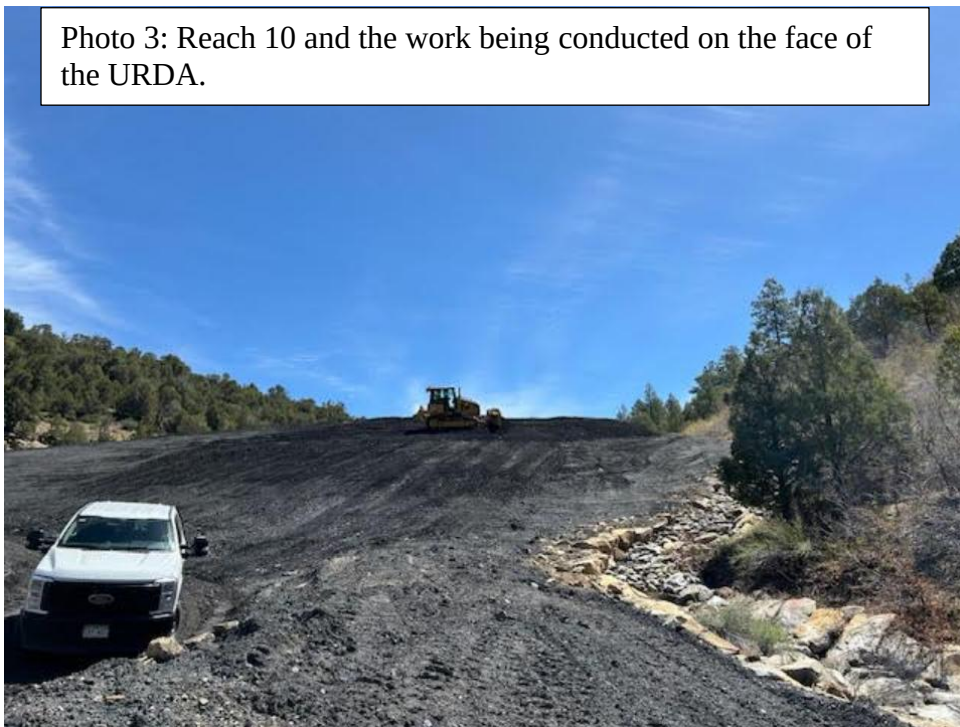
Reach 10 was observed to be clear of debris (Photo 3). The ditch was stable and there were no erosional concerns identified. There was no flow through Reach 10 during the inspection.

Two coal waste piles are located at the King I facilities. The URDA was stable with minor rills observed on the top of the pile. These rills have been noted in previous Division inspections and do not impact the stability of the pile. During the inspection a dozer was re-surfacing the face of the URDA (Photo 3). The slope was stable with no erosional concerns. A stockpile of refuse was placed on the southern end of the pile. The refuse material will be spread and compacted when conditions allow. The LRDA was also stable during the inspection. The face of the pile had no erosional features and had been recently re-surfaced (Photo 4). There was coal refuse stockpiled on the URDA. The material will be spread and compacted as conditions allow.

Photo 3: Reach 10 and the work being conducted on the face of the URDA.

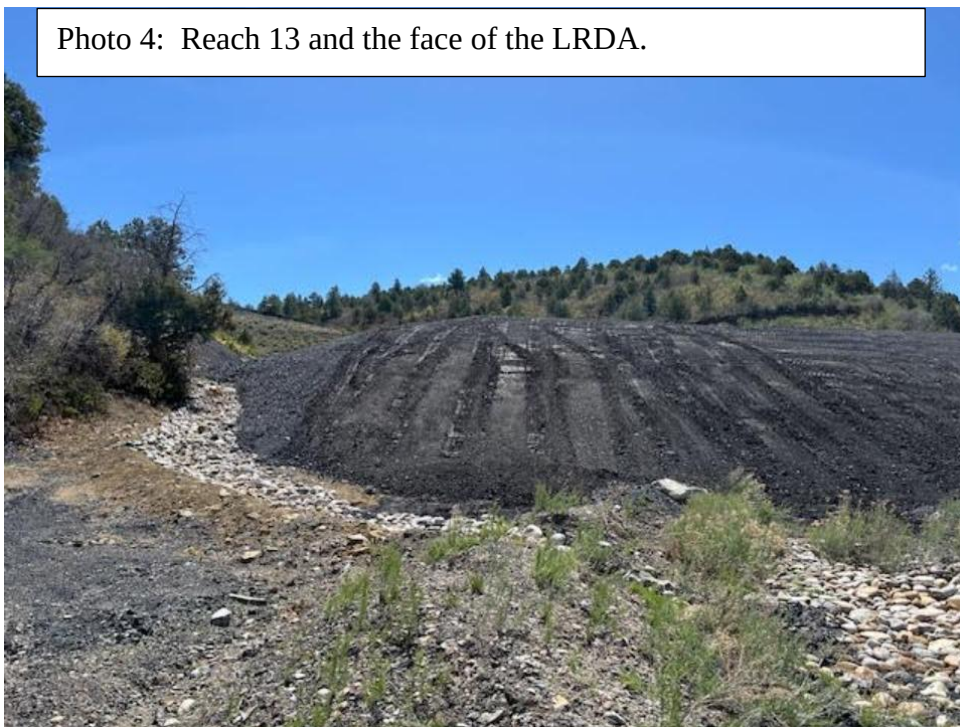
Reach 13 was clear of blockages (Photo 4). There were no observed erosional features or indications instability. Reach 13 was also dry at the time of the inspection. The armored portion of reach 13 on the east side of the LRDA was in good repair. There were minimal amounts of sediment within the ditch. The end of Reach 13 enters a culvert with a metal grate over it. The grate was clear of blockages.

Photo 4: Reach 13 and the face of the LRDA.

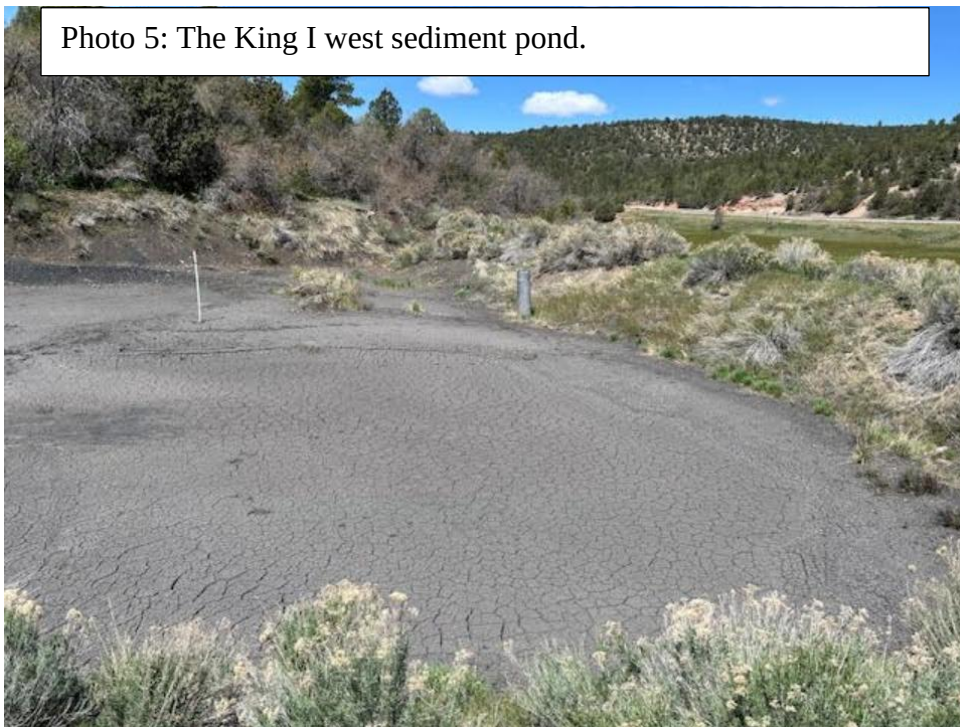
The west pond was dry during the inspection (Photo 5). The inlet and outlet for the pond were observed to be unobstructed. The embankment for the pond was stable with vegetative cover. There were no erosional features were observed.

Photo 5: The King I west sediment pond.

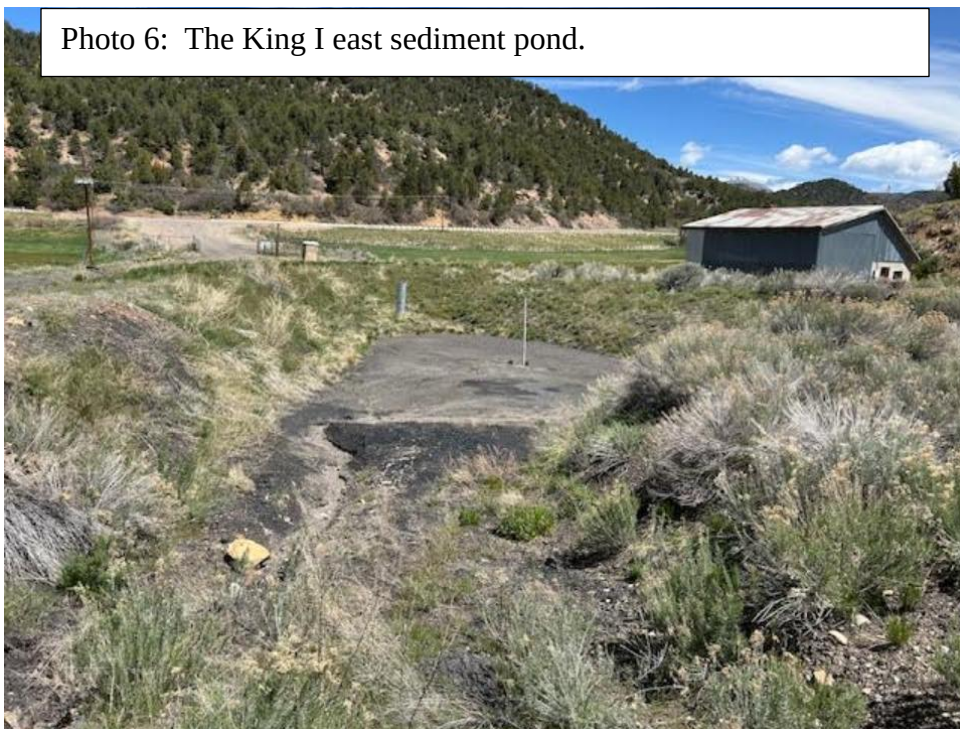
The east pond was dry (Photo 6). The inlet and outlet to the pond were clear of blockages. The embankment for the pond was stable with vegetative cover. No erosional concerns noted.

Photo 6: The King I east sediment pond.

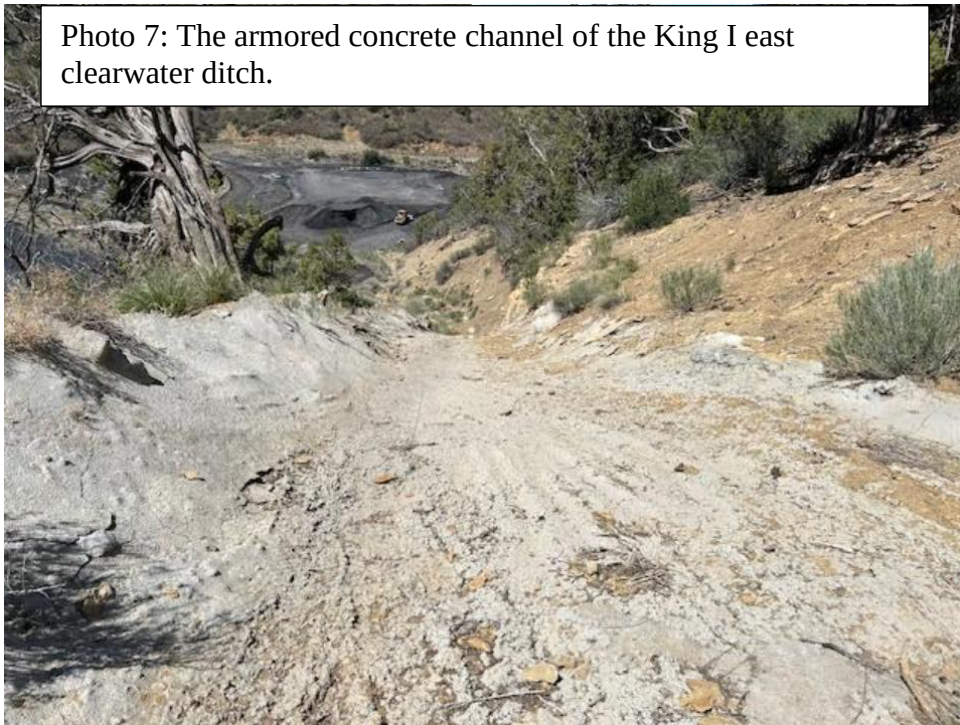
The two clearwater diversion ditches at the King I facilities, the east and west clearwater ditches, were dry. There were no blockages or erosional features observed. Sediment levels within the ditches were minimal. The concrete armored portion of the east ditch extends down the hill adjacent to the upper refuse disposal area to the adjacent hillside of the lower refuse disposal area. This portion was stable and there was no undercutting observed (Photo 7). The west clearwater ditch was observed to have minimal sediment levels within the ditch.

Photo 7: The armored concrete channel of the King I east clearwater ditch.

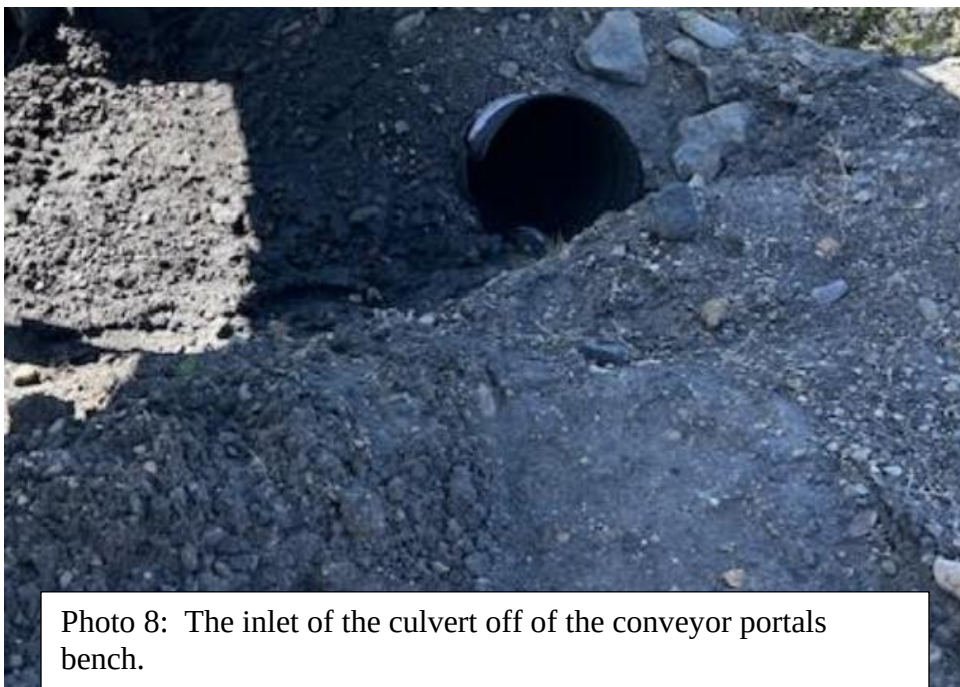
Drainage ditches and the associated culverts within the King II area report to the sediment pond. Drainage ditches were observed to be conveying water during the inspection. The open ditches were clear of debris and functioning as designed. There were no erosional features. Culvert inlets and outlets throughout the facilities area were unobstructed (Photo 8).

Photo 8: The inlet of the culvert off of the conveyor portals bench.

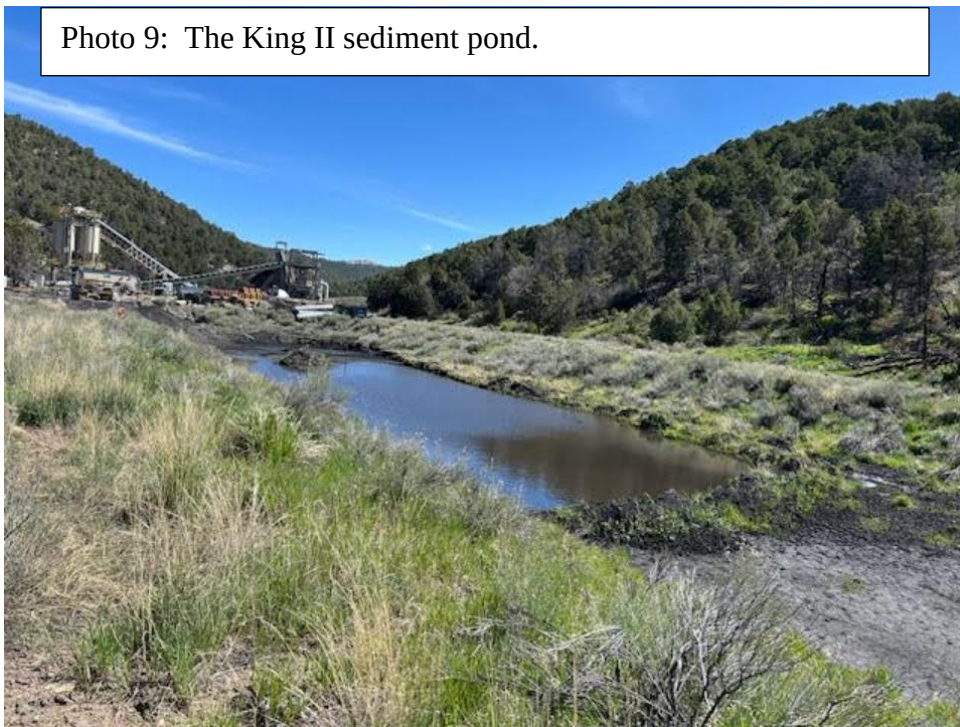
The sediment pond is located on the south end of the King II facilities. The sediment pond was holding water at the time of the inspection (Photo 9). No discharge was occurring. The discharge outlet was clear of debris. The embankments for the pond were stable with vegetative cover. There were not any erosional features observed.

Photo 9: The King II sediment pond.

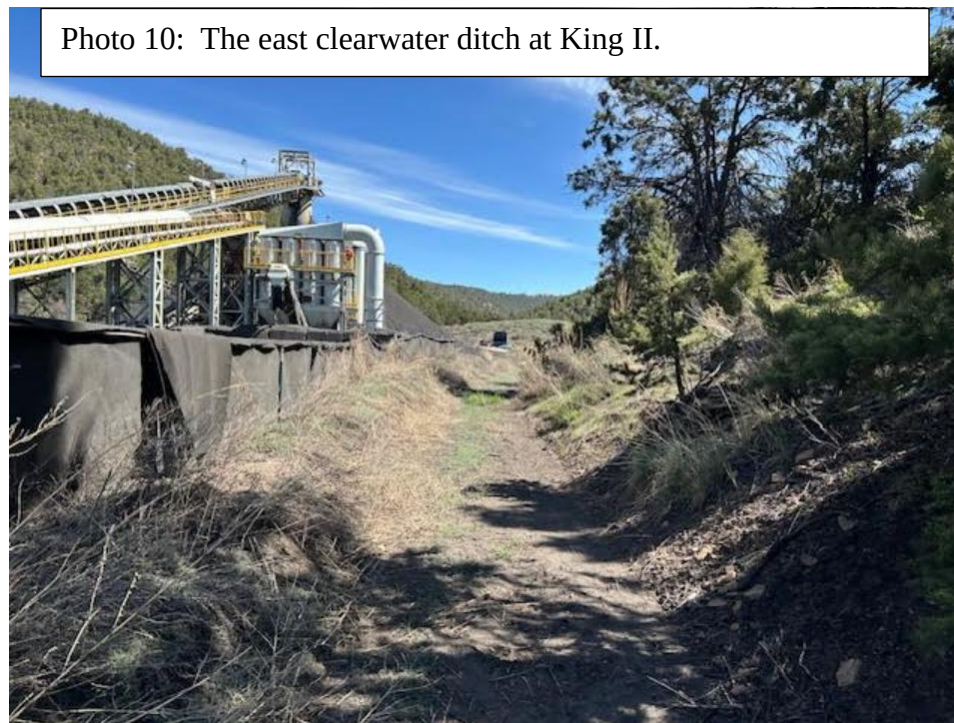
There are two clearwater diversion ditches, the east (Photo 10) and west clearwater ditches (Photo 11), located at the King II Facilities. The east clearwater ditch was dry during the inspection. No erosional features were identified. The diversion ditch was stable. Minimal amounts of sediment had deposited in the channel. The west clearwater diversion starts above the northwest corner of the King II area, turns south along the haul road and ends near the entrance to the mine site. The ditch was dry. There were no indications of erosional features. Some fallen dead trees were observed in the upper part of the clearwater ditch. The operator stated that the debris would be removed as soon as possible. The debris was not significant enough to plug or reduce the diversion ditches flow capacity.

Photo 10: The east clearwater ditch at King II.

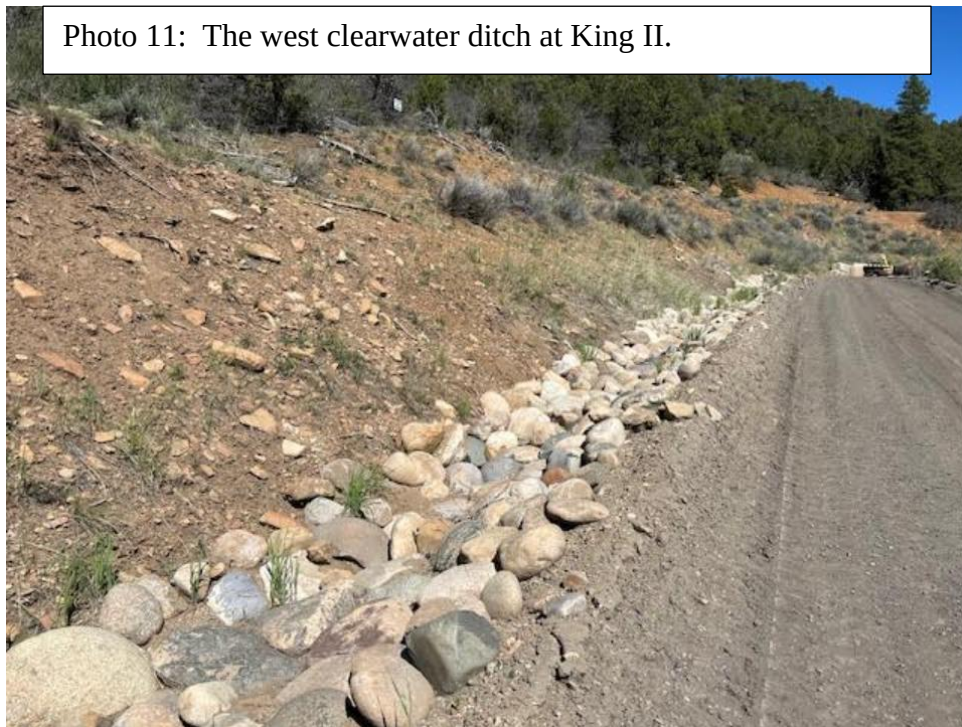
Photo 11: The west clearwater ditch at King II.

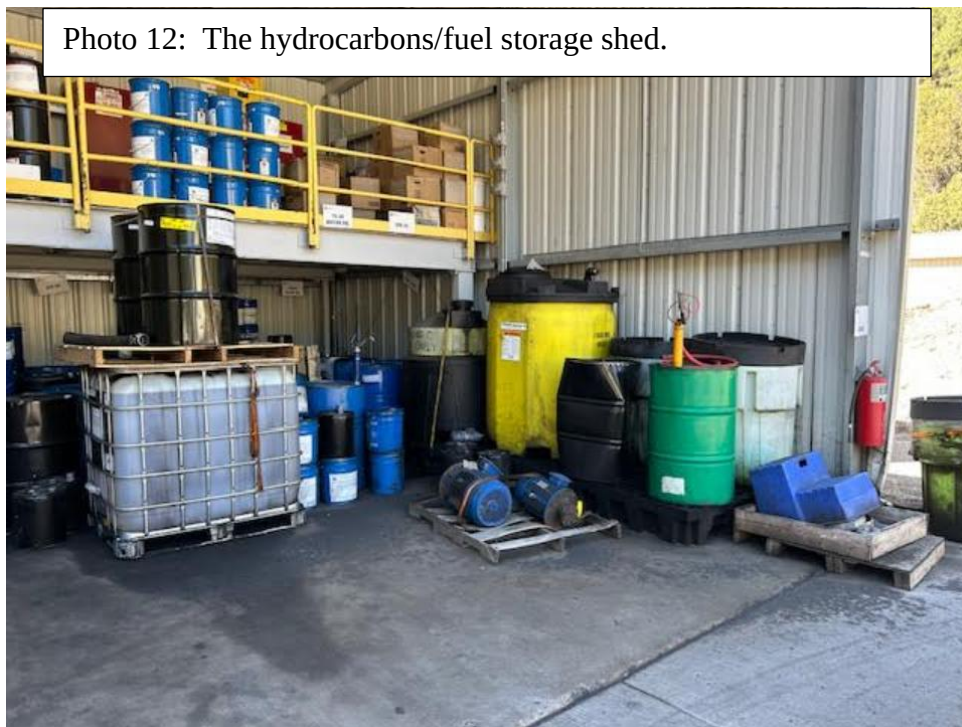
The King II facilities area was also in good condition. Materials were organized and stored in their respective laydown areas. Trash was placed in the proper receptacles. The hydrocarbon storage shed had all materials placed in secondary containment (Photo 12). The operator has agreed to monitor the area surrounding the Coal Stack #1 for any coal dust that may be escaping as observed during the Division's March 26, 2025 inspection. The operator will propose a plan to remedy this issue once the cause has been determined.

Photo 12: The hydrocarbons/fuel storage shed.

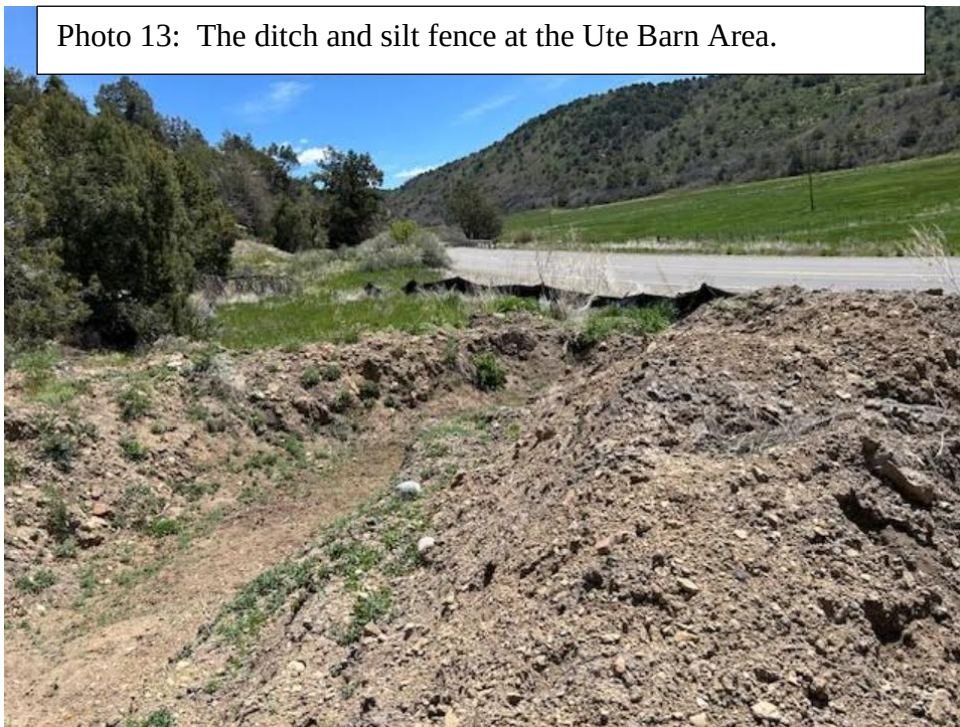
The Ute barn area was stable with no erosional concerns. The drainage ditch was clear of debris. The silt fence at the end of the sump was observed to be in good condition (Photo 13). There were no off-site impacts were observed.

Photo 13: The ditch and silt fence at the Ute Barn Area.

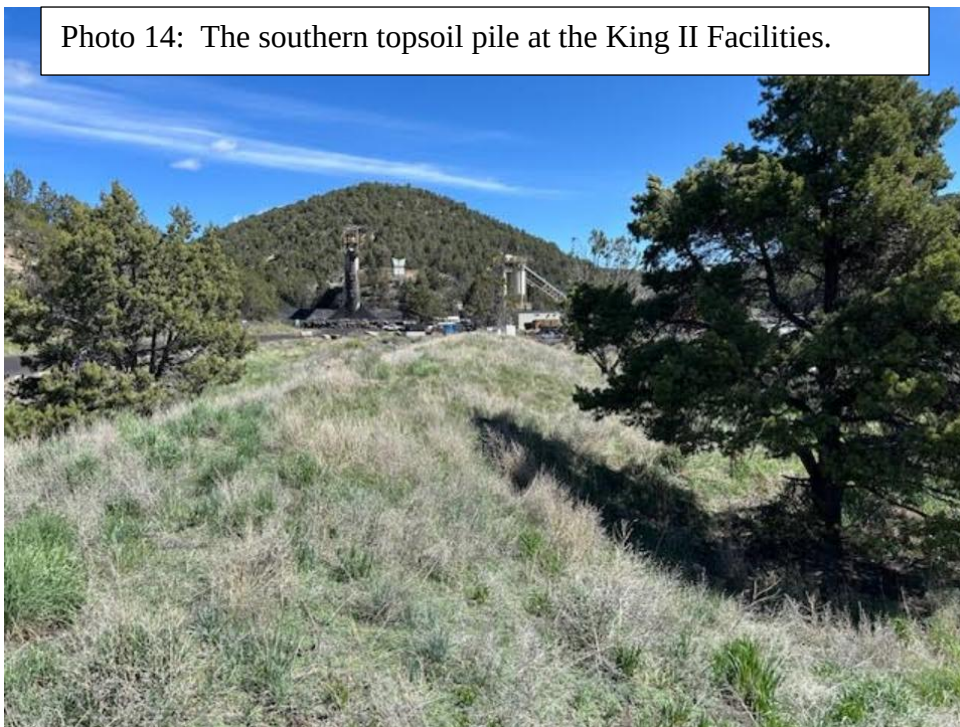
Topsoil stockpiles at the King II Facilities were stable and covered with vegetation (Photo 14). No erosional features were identified. There was no loss of topsoil resource.

Photo 14: The southern topsoil pile at the King II Facilities.
