**MINERALS PROGRAM INSPECTION REPORT**  
**PHONE: (303) 866-3567**

<b>MINE NAME:</b> Kurtz Resource Recovery & Land Development	<b>MINE/PROSPECTING ID#:</b> M-1999-006	<b>MINERAL:</b> Sand and gravel	<b>COUNTY:</b> Weld
<b>INSPECTION TYPE:</b> Monitoring	<b>WEATHER:</b> Clear	<b>INSP. DATE:</b> May 9, 2025	<b>INSP. TIME:</b> 09:00
<b>OPERATOR:</b> Raptor Materials LLC	<b>OPERATOR REPRESENTATIVE:</b> Quentin Borum	<b>TYPE OF OPERATION:</b> 112c - Construction Regular Operation	
<b>REASON FOR INSPECTION:</b> Normal I&E Program	<b>BOND CALCULATION TYPE:</b> Complete Bond	<b>BOND AMOUNT:</b> \$431,000.00	
<b>DATE OF COMPLAINT:</b> NA	<b>POST INSP. CONTACTS:</b> None	<b>JOINT INSP. AGENCY:</b> None	
<b>INSPECTOR(S):</b> Patrick Lennberg	<b>INSPECTOR'S SIGNATURE:</b>

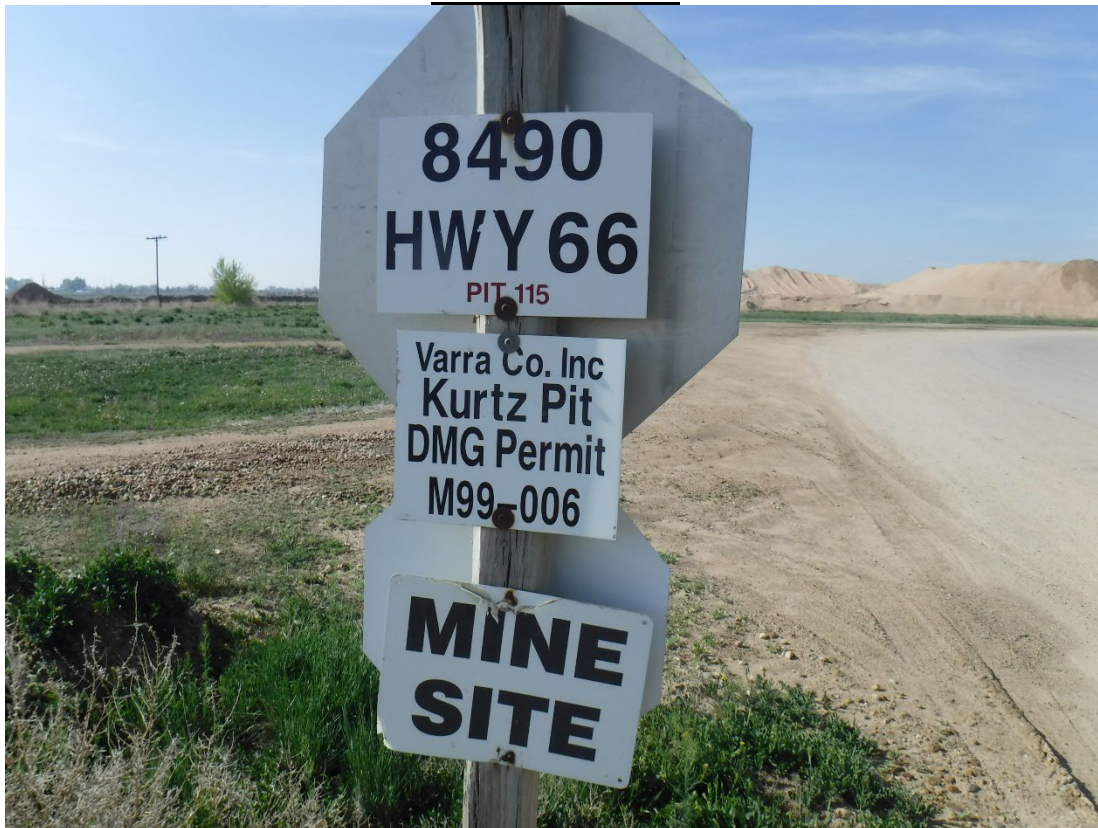
**PROBLEM:** The mine identification sign was posted at the entrance of the mine site but did not have up-to-date information. This is a problem for failure to post an accurate mine identification sign as required by Section 3.1.12(1) of the rule. The Operator shall, at the entrance of the mine site post a sign, which shall be clearly visible from the access road, with a minimum size equaling one hundred and eighty-seven (187) square inches, such as eleven (11) inches in height and seventeen (17) inches in width, with appropriate font size, with the following: the name of the Operator, a statement that a reclamation permit for the operation has been issued by the Colorado Mined Land Reclamation Board; and the permit number.

The site is 112c Construction Materials permit for 295.4 acres. The permit area is in Weld County, approximately 3.8 miles southwest of Platteville, CO. The site is accessed from the north off Hwy 66. The post-mining land use for this site is general agriculture with open water ponds. The affected lands are owned by the Operator. A mine sign was posted along the primary mine entrance as required by Rule 3.1.12, however the information on the sign lists the previous Operator Varra Companies Inc. The Division is citing a problem, pursuant to Rule 3.1.12, the mine sign needs to be updated with current Operator's name by the corrective action due date listed above.

**Photo 1:** Mine sign at primary mine entrance, note wrong operator (Varra Co., Inc.) listed

**CORRECTIVE ACTIONS:** The Operator shall, at the entrance of the mine site, post a sign which shall be clearly visible from the access road with the following: the name of the Operator, a statement that a reclamation permit for the operation has been issued by the Colorado Mined Land Reclamation Board; and the permit number. The operator shall submit photo documentation that a proper sign has been posted by the corrective action date.

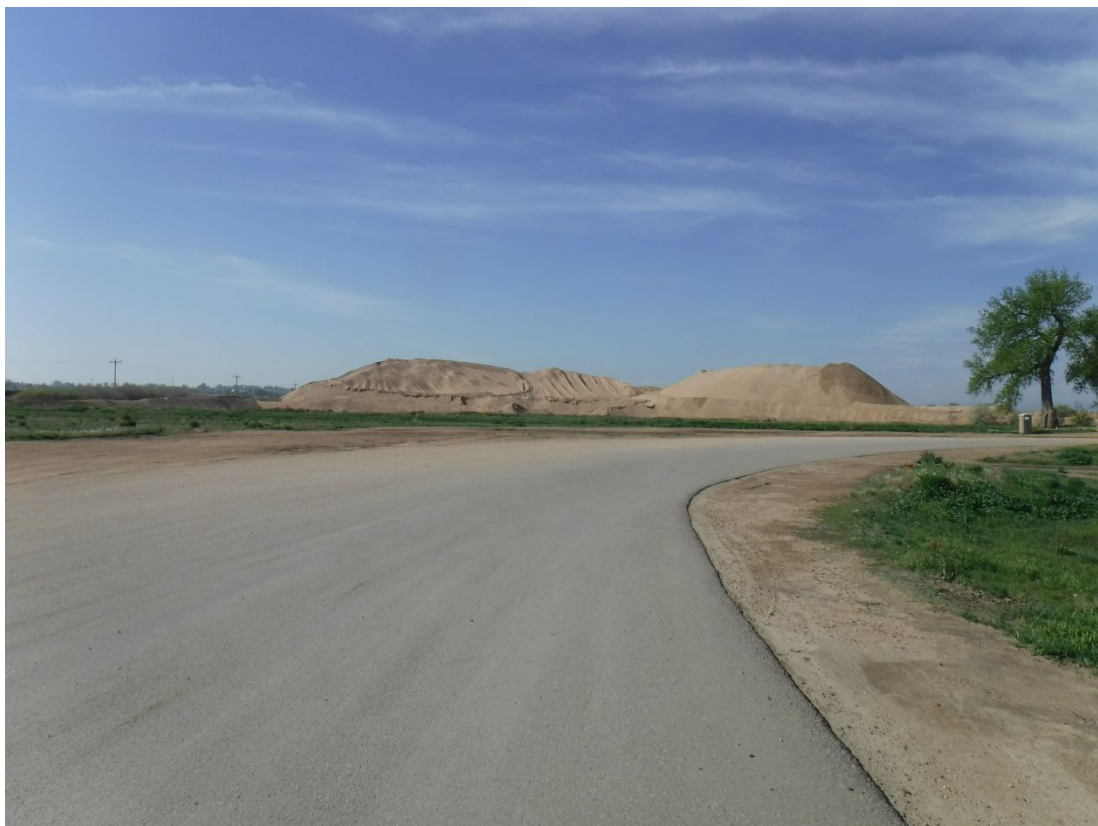
Tract B located north of Tract A is the location of the wet processing plant, mining cells and a very large stockpile of waste concrete sand material. This is the same location as material described in the 2014 inspection report that had an estimated volume of 500,000 cubic yards. The Division believes that volume is similar to what is currently at this location. As mentioned above, TR-2 changed the number of ponds from two to one but during the inspection the Operator stated that they have to mine in different cells and the area will be location of multiple ponds. It is unclear if these ponds will be clay lined or open water ponds like what was

approved as part of the original permit application. The large stockpile of sand was sold by the previous Operator, but the current Operator has not been able to sell the same quantity of material, and the pile is getting larger. Currently there is no clear plan for the sand material.

The currently calculated financial warranty for the site is \$431,100.00. The warranty amount is not sufficient for the State to reclaim the site and has been cited as a problem within this report. Given the level of disturbance and the volume of stockpiled material at the site the Operator will be required to submit a new reclamation cost estimate. Pursuant to Rule 6.4.12, the Operator shall submit an updated Exhibit L which details all information necessary to calculate the costs of reclamation, broken down into the various major phases of reclamation by the corrective action due date.

**Photo 2:** Stockpile of concrete sand located in Tract B, ~500,000 cy

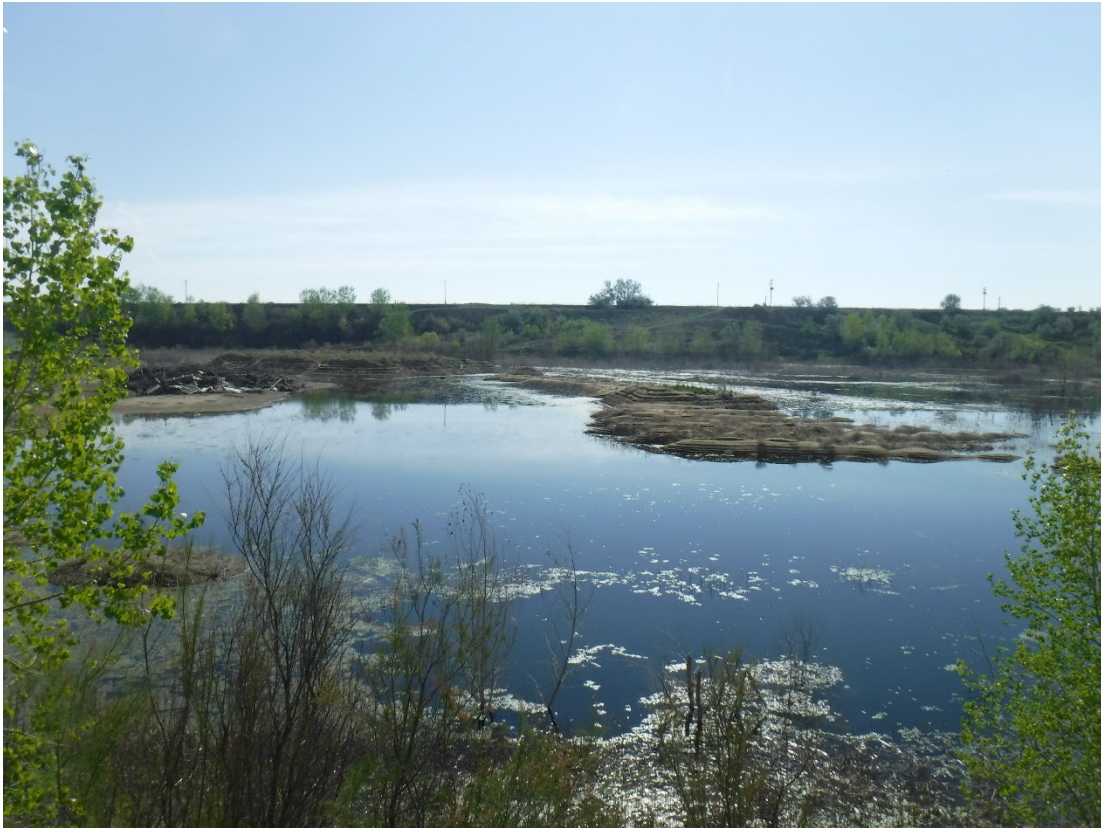
Tract A is in the southern portion of the permit area and is approximately 140 acres in size. In the southwestern portion of the tract a conveyor line enters the site. The conveyor belt brings mined material from permits located south of the site to be processed by a wet processing plant located in Tract B. Also located in this area is a series of sedimentation ponds used by the processing plant. In the northeastern area of tract, north of the sedimentation ponds, is an area that is receiving material that is being stockpiled to be recycled in the future. The Operator will bring in another contractor to process, crush and screen, the recycled material. The remaining portion of the tract consists of a mined-out cell. In 2009 the Operator submitted and got approval for TR-2. The revision decreased the number of open water ponds at the site from five (5) to two (2). Tract A was to have three ponds and that was reduced to one and Tract B was to have two and that was reduced to one. Included in TR-2 Tract A was to have three oil and gas peninsulas into the open water pond. It appears that two of the three have been plugged and abandoned and will no longer be part of the reclamation of Tract A. The sedimentation ponds are to be backfilled, according to the 2018 inspection report, and the western portion of the tract, that was to be pond area, has been backfilled. Finally, the pond walls that have been established have been lined with clay material making the pond area into a developed water resources pond. About 70% of the pond's perimeter has been lined to date.

**Photo 3:** Looking east across Tract A, mined out area and partially lined side slopes

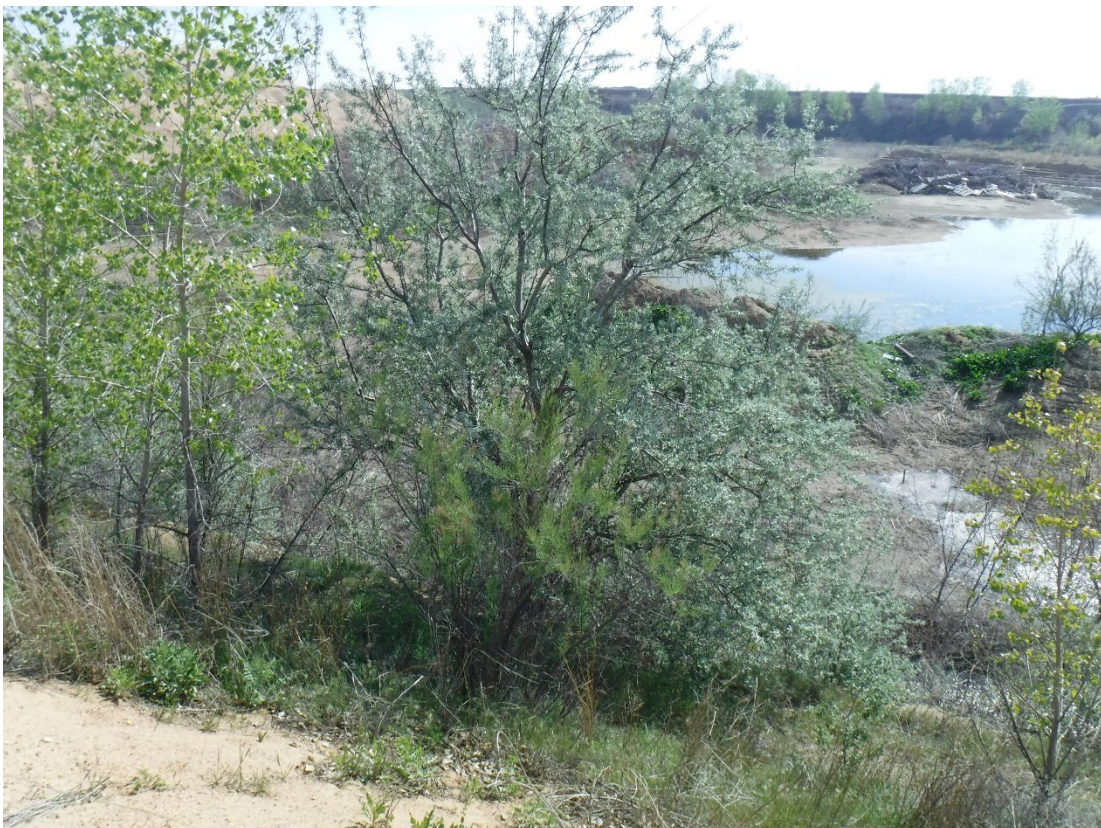
**PROBLEM:** There are state-listed noxious weeds present on site. This is a problem for failure to employ weed control methods for state listed noxious weed species within the permitted area, and to reduce the spread of weeds to nearby areas as required by Section 3.1.10 (6) of the rule.

During the inspection the Division noted many Russian Olive trees and Tamarisk (salt cedar) trees throughout the permit area. These are Colorado List B noxious weed species. In 2005 the Division approved TR-1 to address management of these species. The Division is citing this as a problem for failure to implement the currently approved Weed Control and Management Plan.

**Photo 4:** Typical example of established Russian-Olive Tree and Salt Cedar

**CORRECTIVE ACTIONS:** Implement the approved weed control plan and provide proof to the Division that this has been done by the corrective action date.

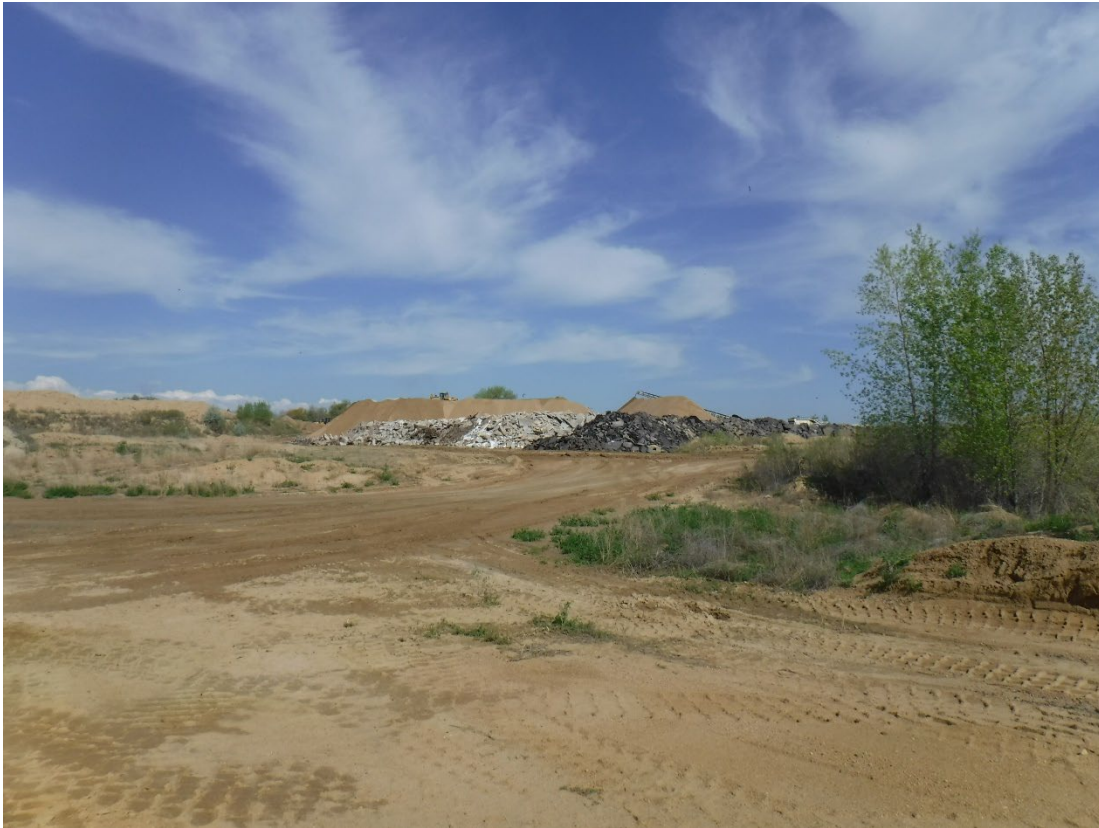
**Photo 5:** Material being stockpiled in Tract A to be recycled

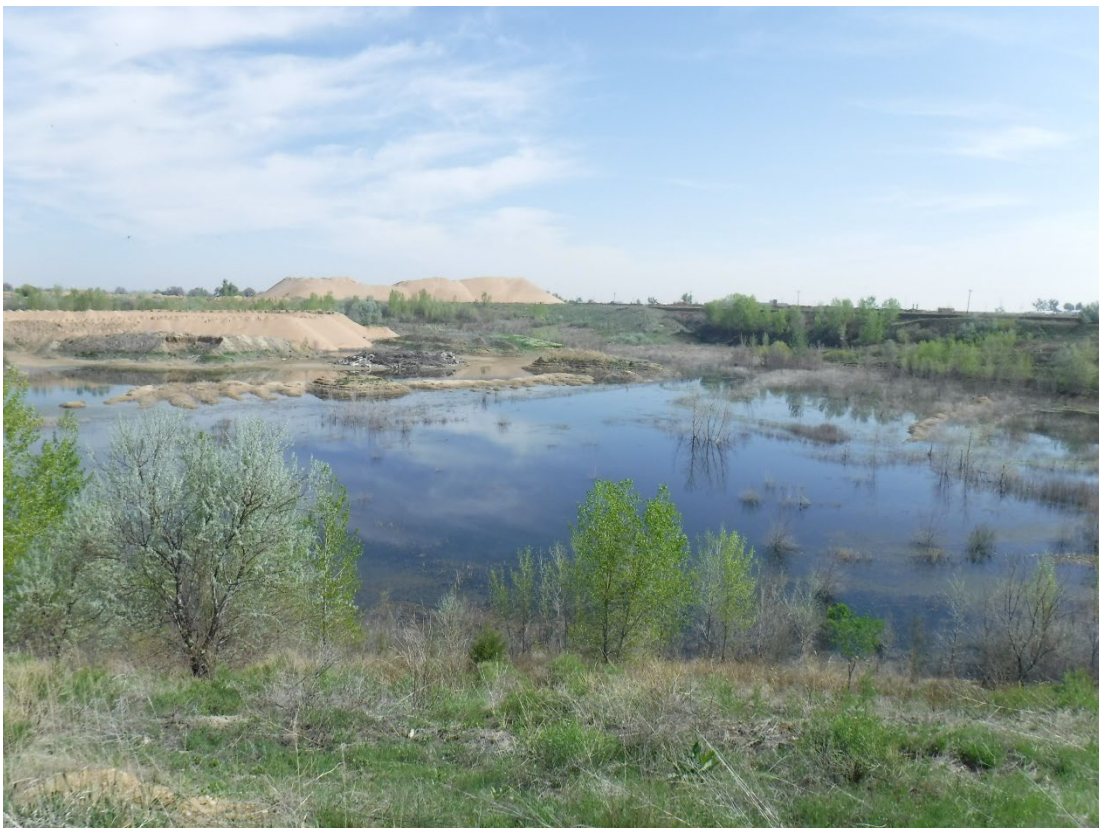
**Photo 6:** Looking north across Tract A mined out area, sand stockpile in background

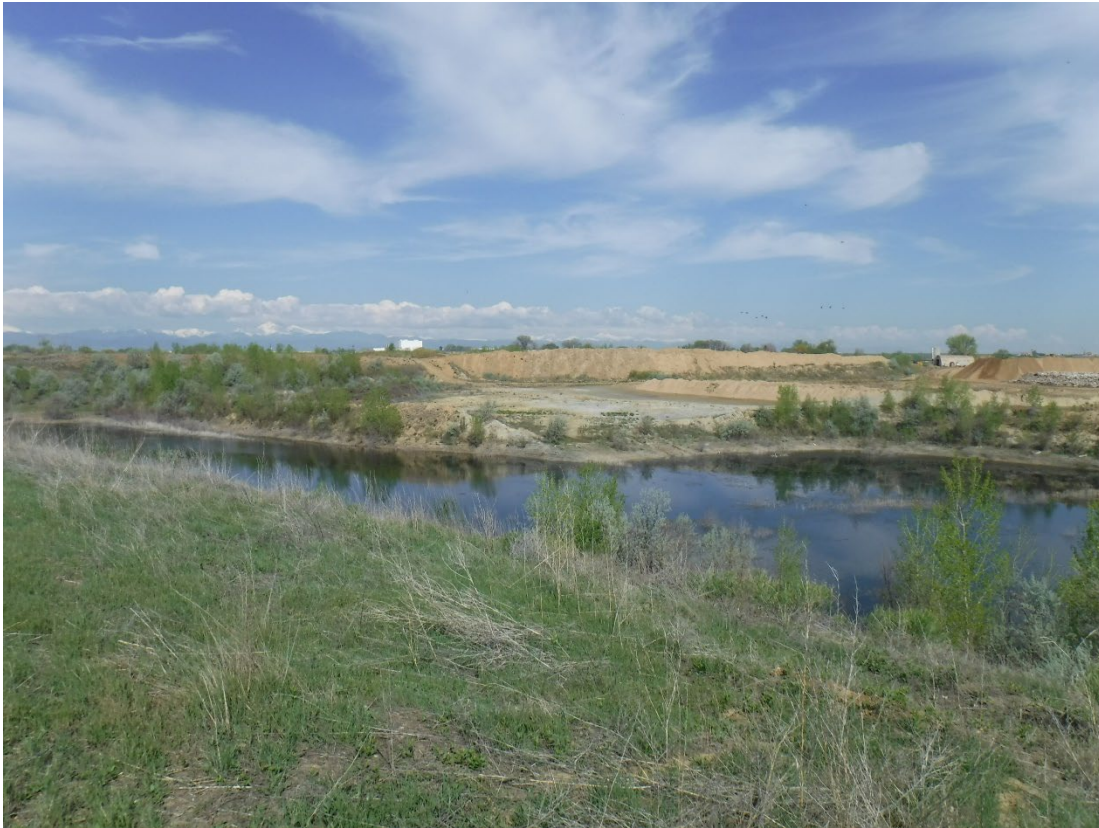
**Photo 7:** Looking west across Tract A, area in center of picture has been backfilled or not planned for mining

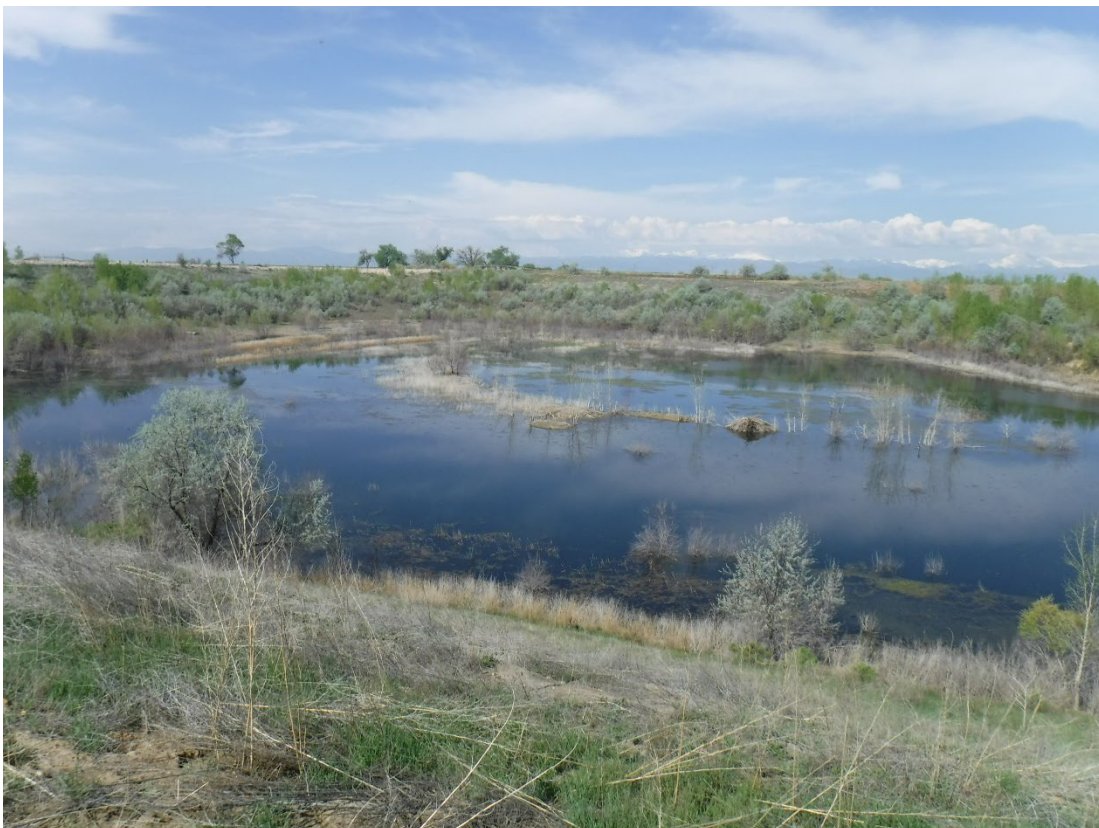
**Photo 8:** Numerous Russian-Olive trees established within Tract A

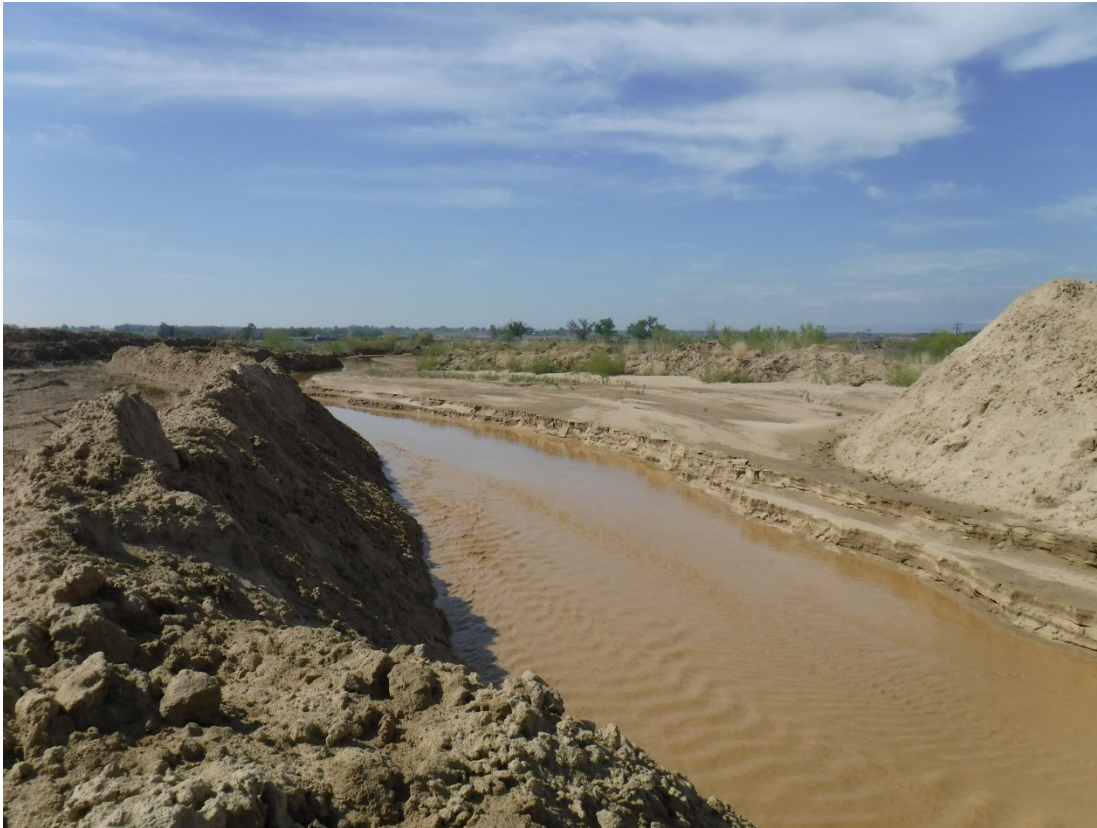
**Photo 9:** North end of the sedimentation ponds looking south

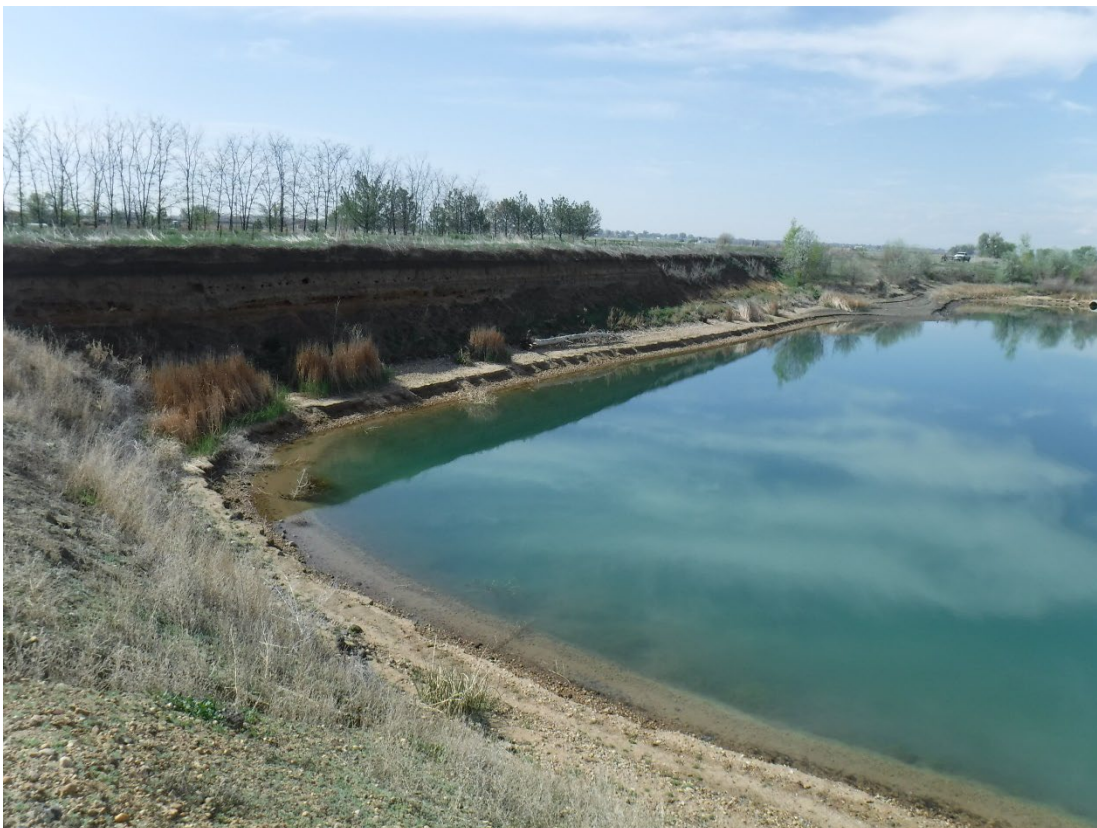
**Photo 10:** Eastside of Tract C near vertical highwall

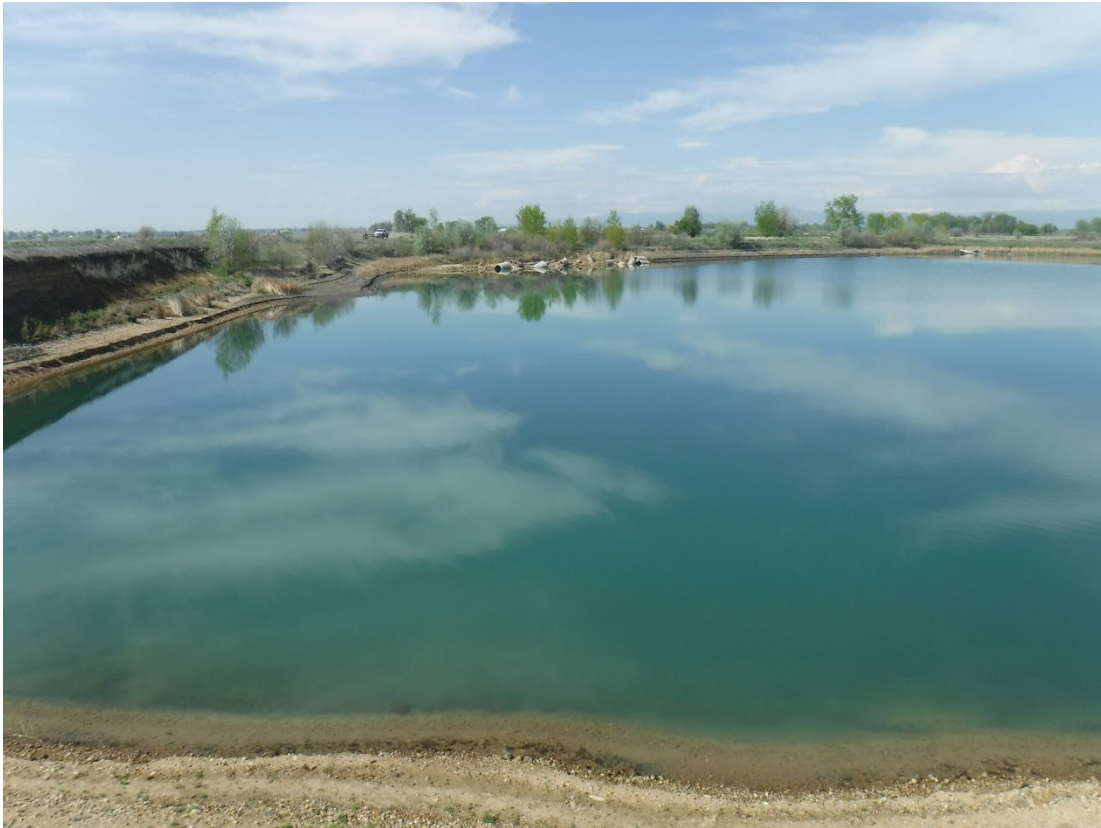
Tract C is located west of Tract A and southwest of Tract B. Mining is complete at this location and the mined-out area has been filled with groundwater. The approval of TR-3 in 2011 approved the mining and reclamation of this tract as an open water pond. As indicated in the 2018 inspection, the pond was partially lined with clay material, and it is unclear if lining of the pond was completed. However, since the pond has been filled with groundwater it probably was never completely lined. The eastern portion of the tract, adjacent to the roadway, has a highwall that remains and is near vertical. The approved plan requires all side slopes to be reclaimed at a minimum 3H:1V slope. Along the southern portion of the tract concrete culverts have been dumped into the pond. While the Division did not inspect the culverts closely it is assumed that they are reinforced with rebar. Rebar is not allowed to be backfilled in areas where it may be inundated by groundwater. During the inspection the Operator stated that Tract C was now going to be backfilled.

**Photo 11:** Looking south across Tract C at concrete pipes dumped into pond

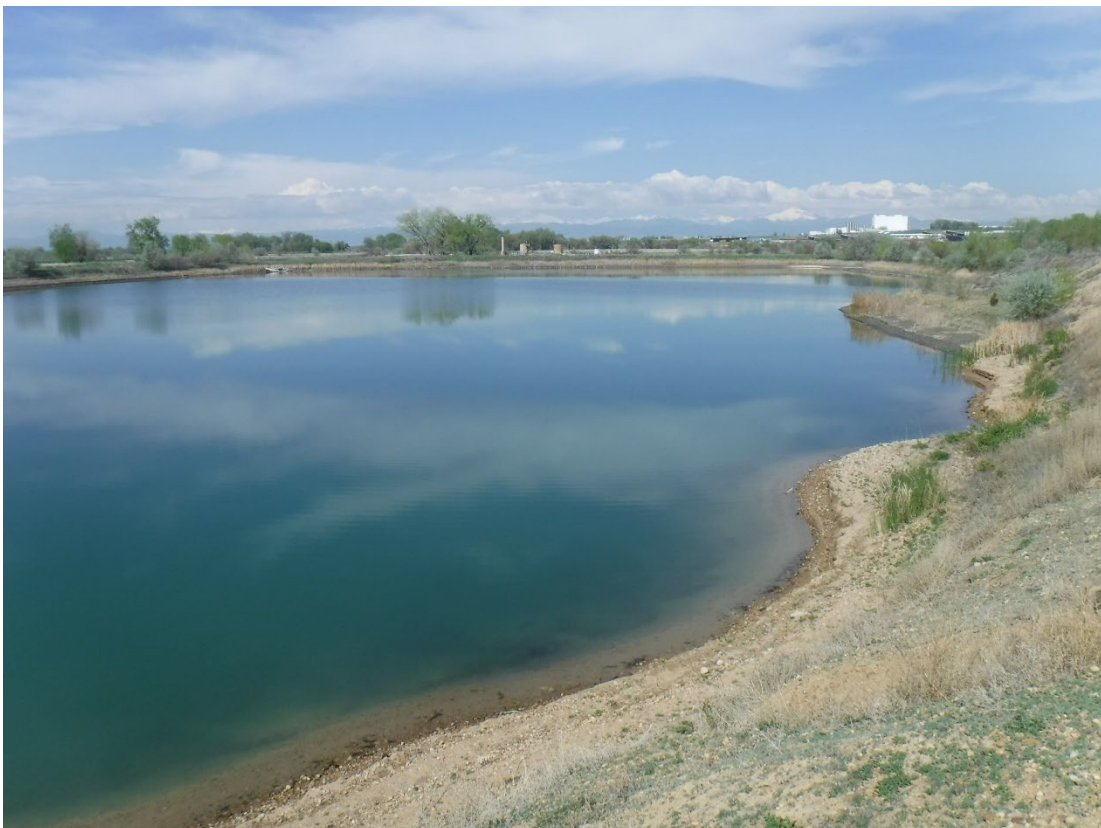
**Photo 12:** Looking west across Tract C

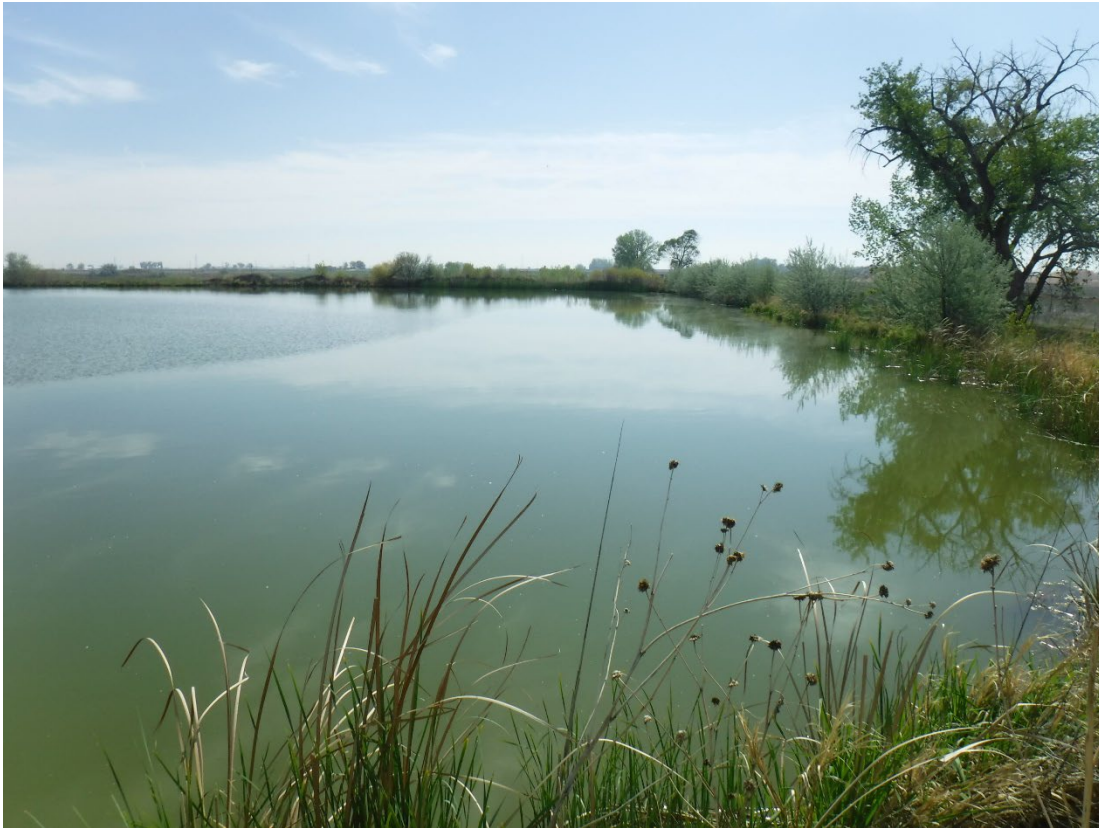
**Photo 13:** Looking east across the southern most sedimentation pond, note Russian-Olive Trees

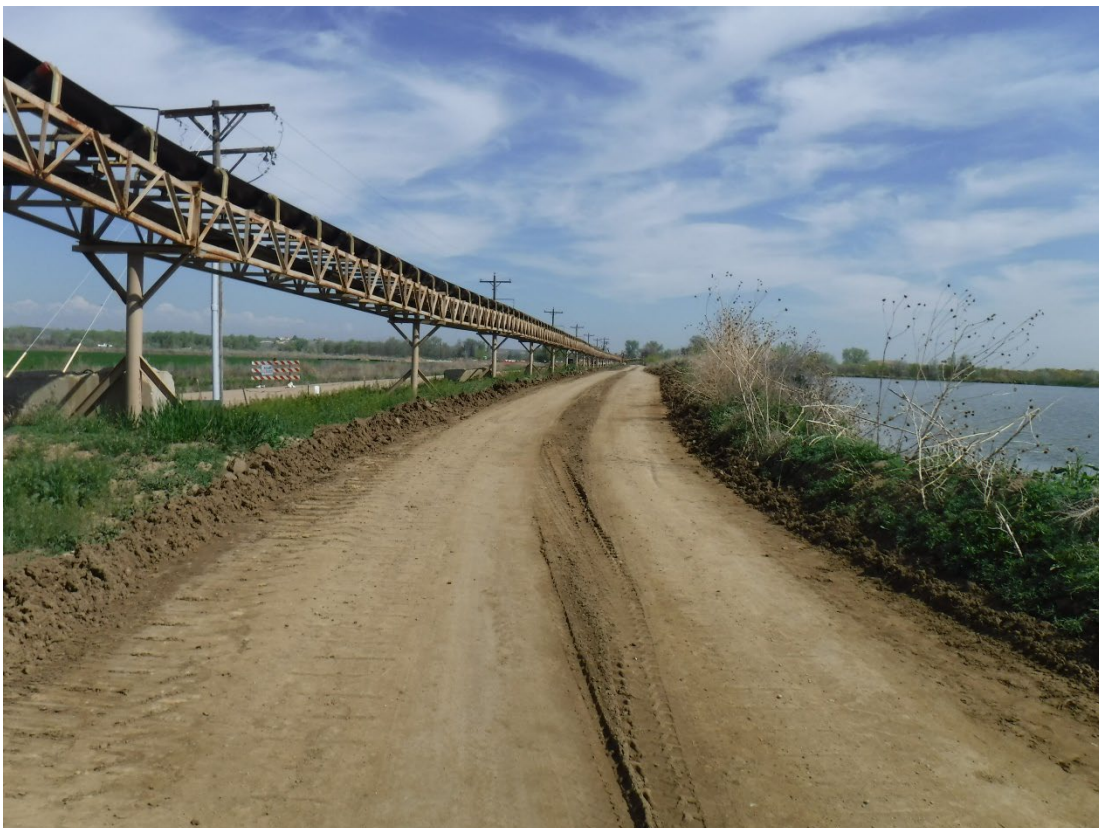
**Photo 14:** Looking north along conveyor corridor entering permit in the southwestern corner

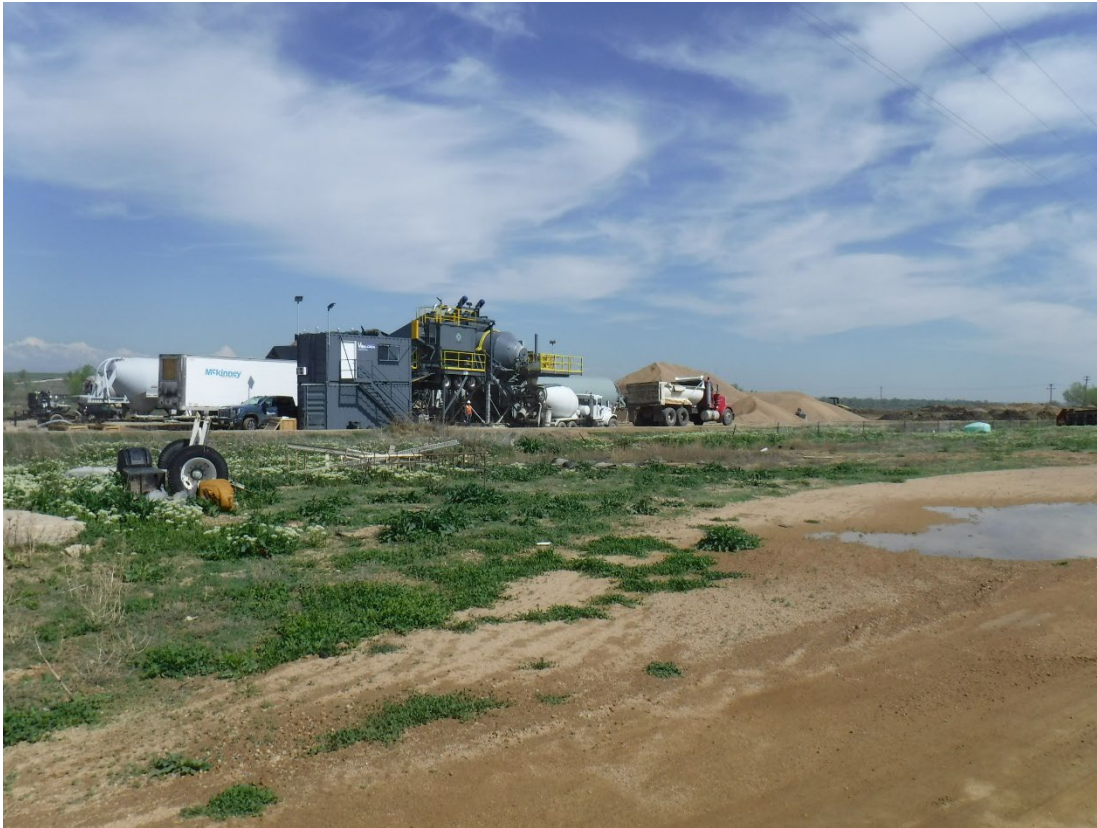
Tract D is in a triangular area in the north of the permit area west of Tract B. Mining in this area is complete and is slowly being backfilled. The area is being used by a concrete production contractor supplying concrete to a nearby project.

**Photo 15:** Concrete batch plant set-up in Tract D

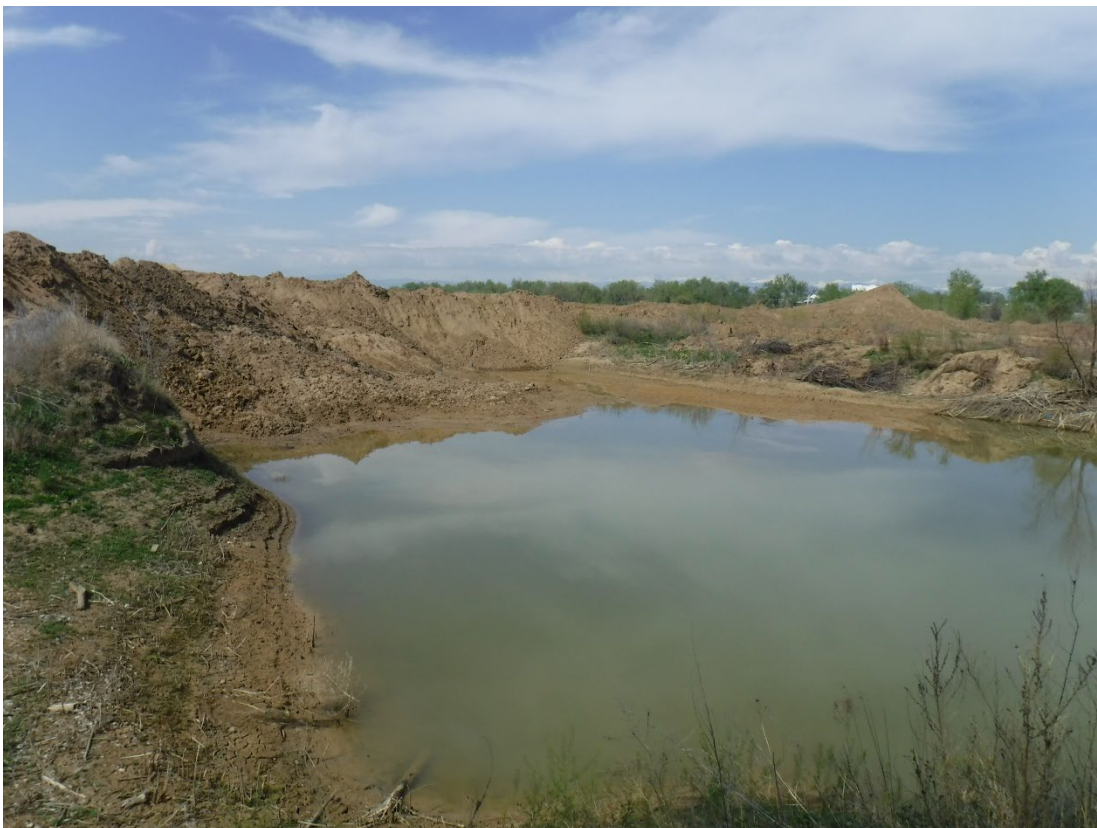
**Photo 16:** Backfilling in Tract D

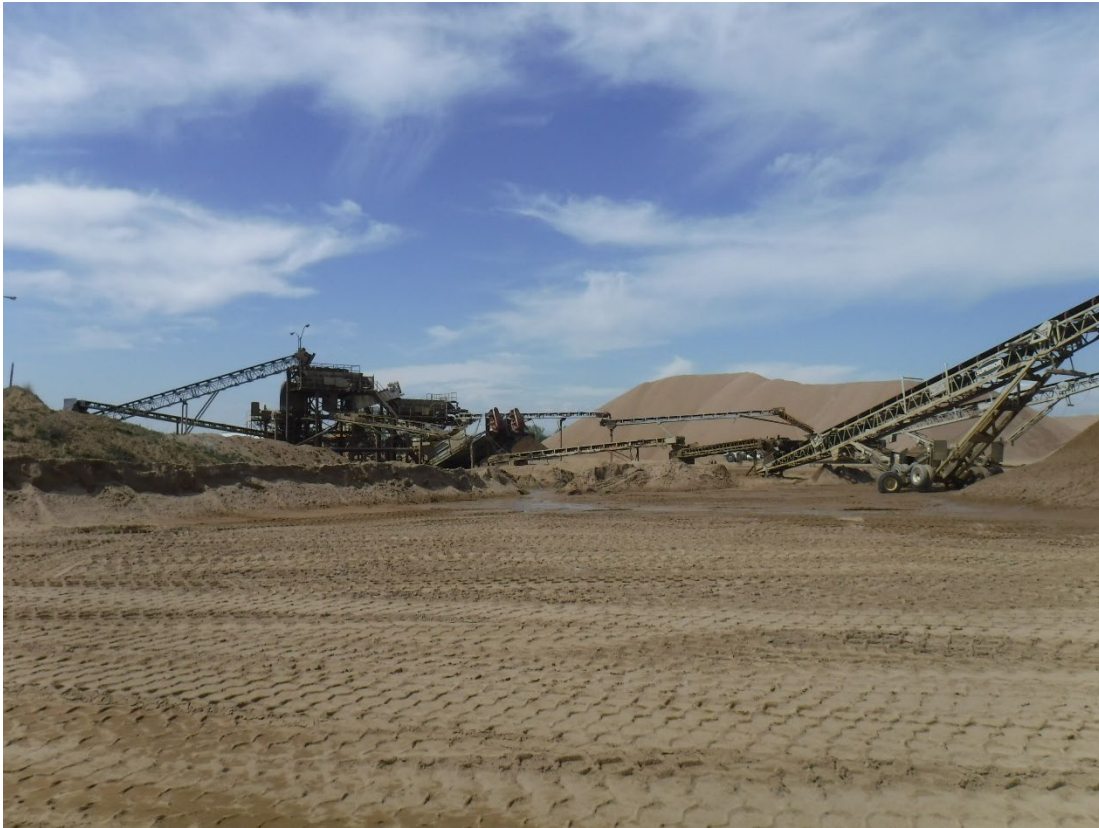
**Photo 17:** Wet processing plant in Tract B

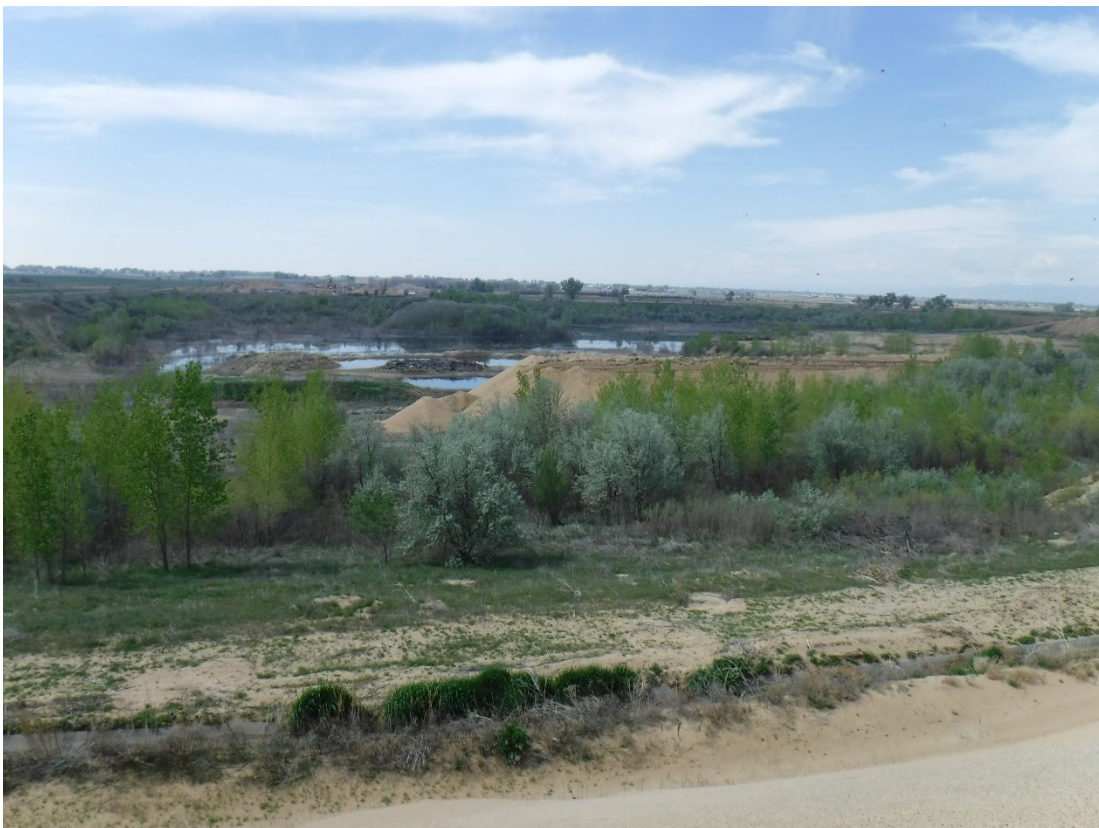
**Photo 18:** Looking south across Tract A from sand pile

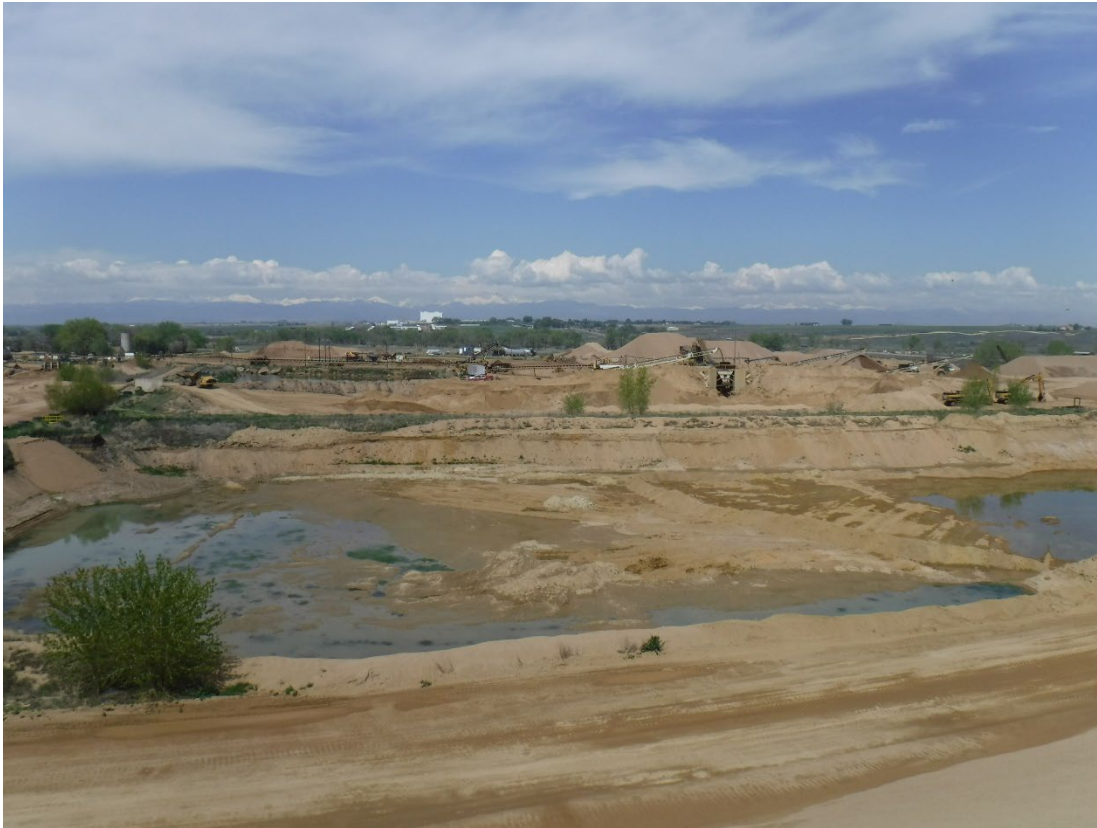
**Photo 19:** Looking west across Tract B, a mined cell in foreground and conveyor and processing plant background

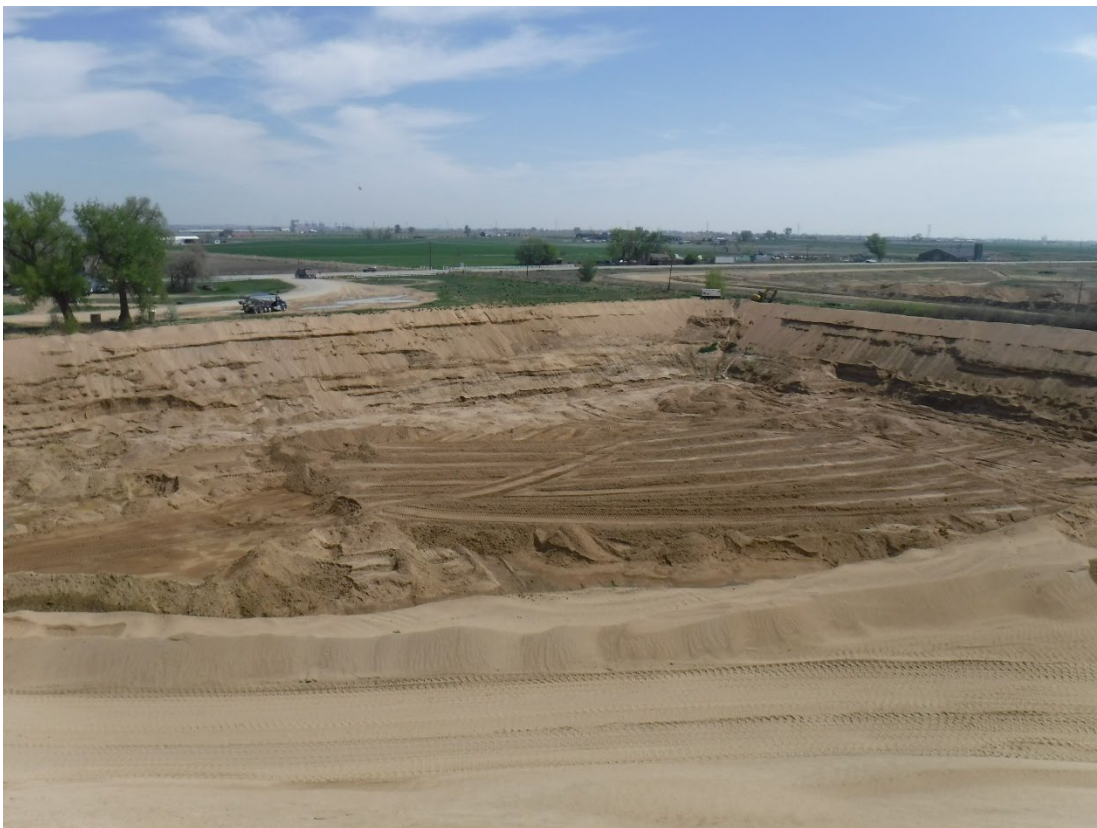
**Photo 20:** Looking north across Tract B, cell being mined in foreground and primary mine entrance background
