C1983059, Terror Creek Loadout, May Inspection Report

PERMIT INFORMATION

INSPECTION INFORMATION

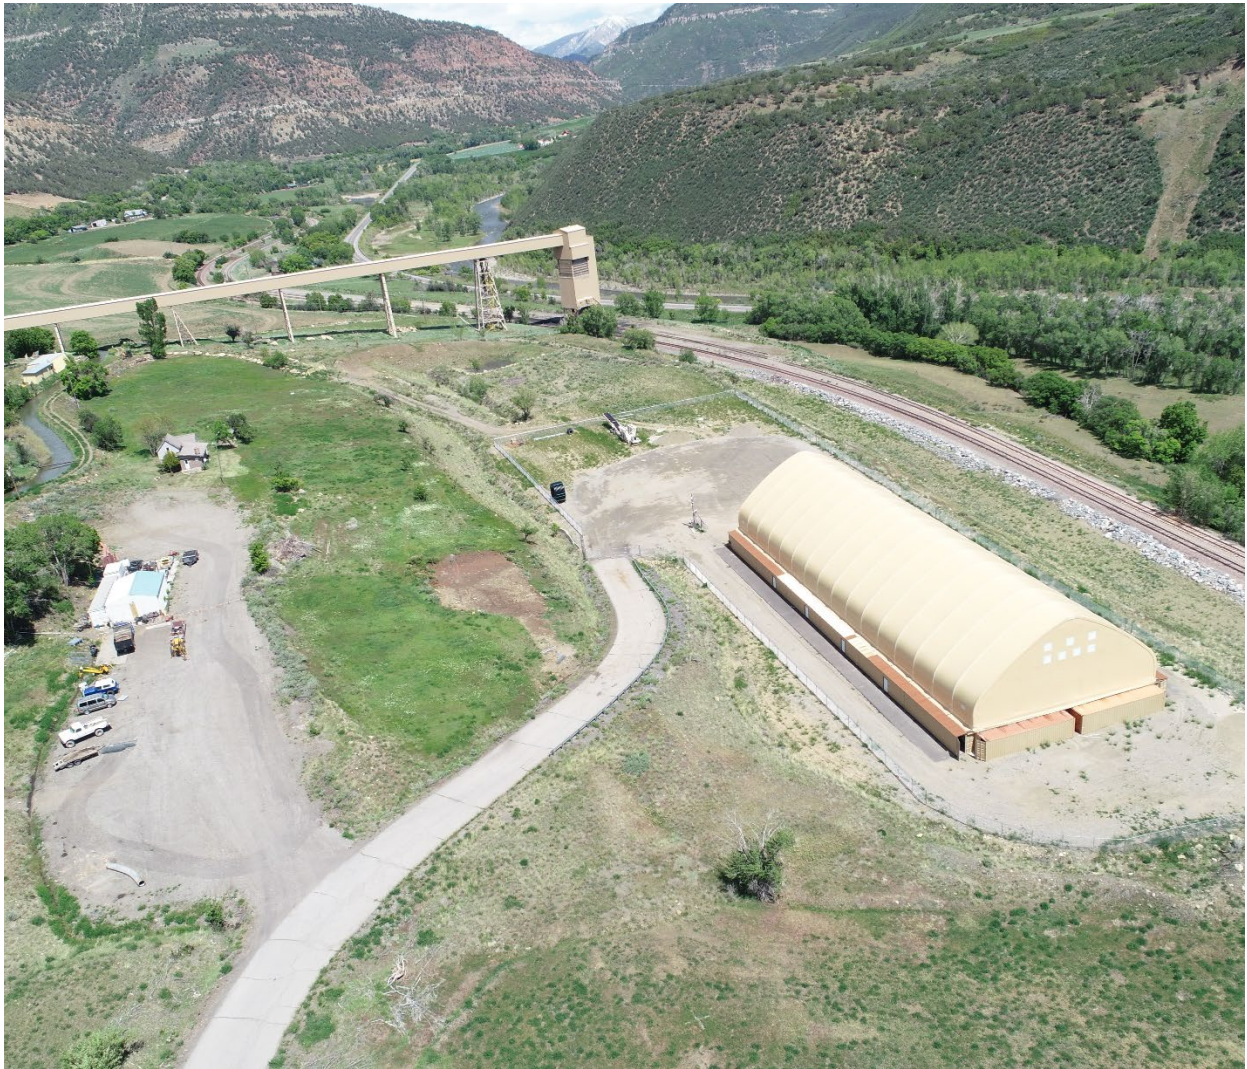
Figure 1: Overview of site

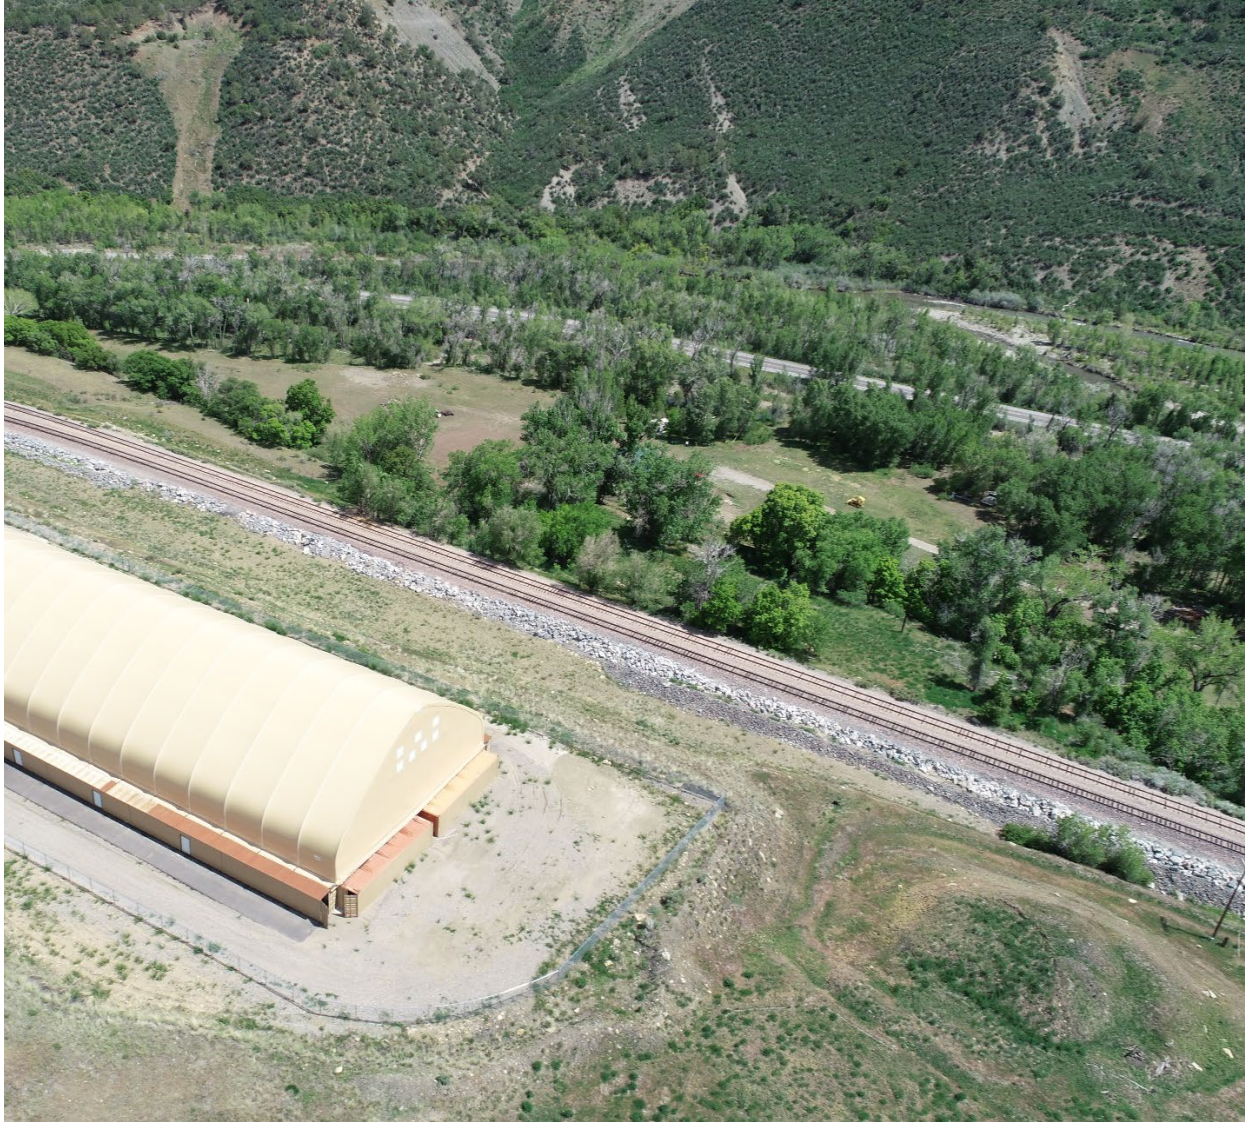
Figure 2: West end of lower pad, and topsoil stockpile

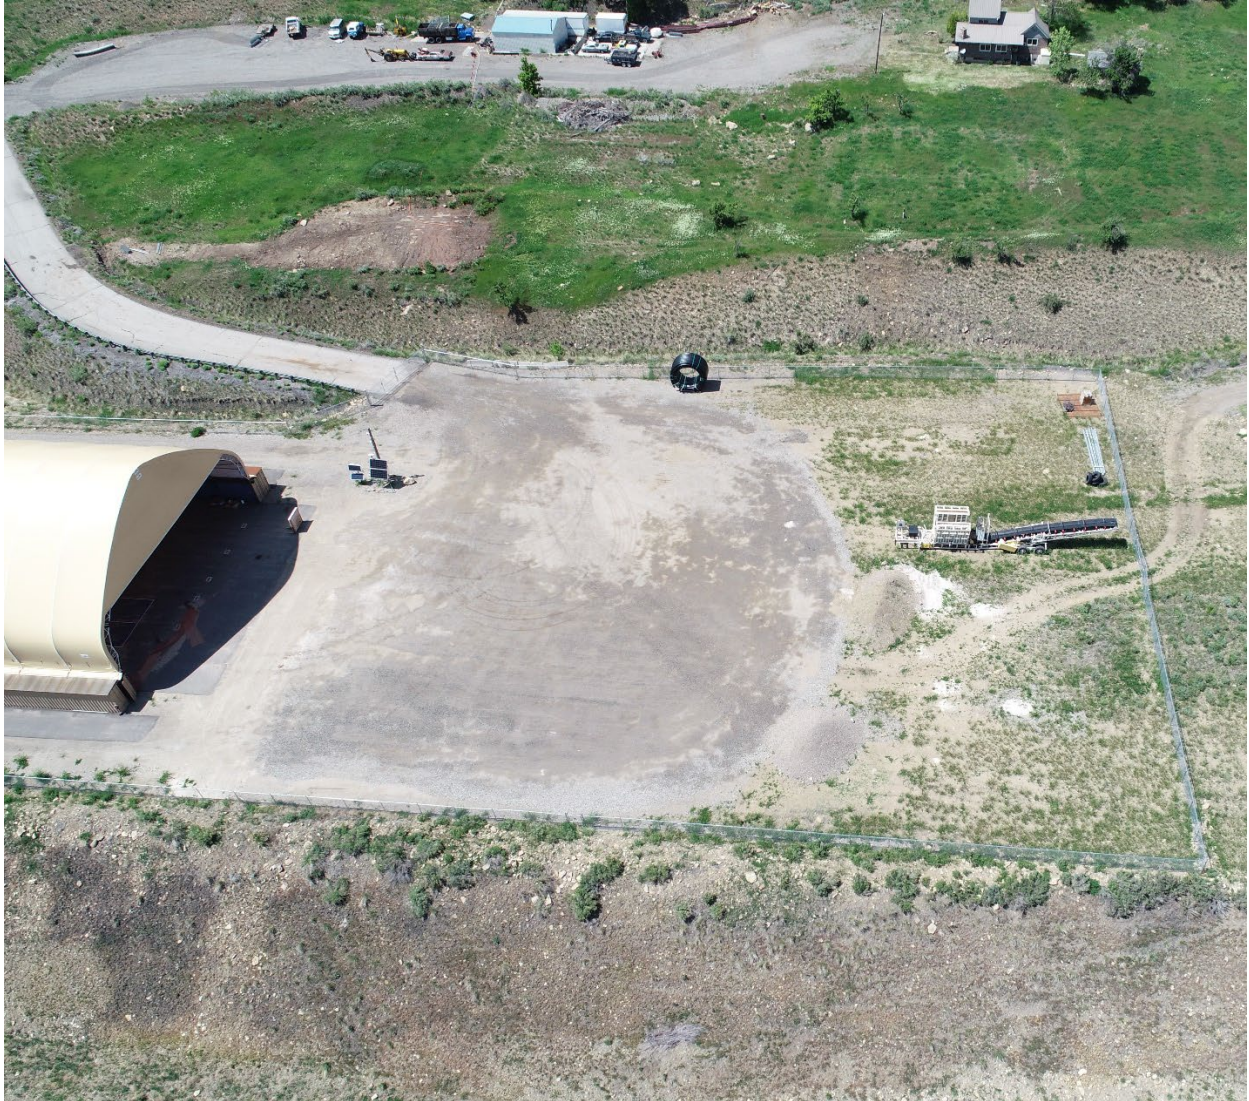
Figure 3: Railway embankment, east end of temporary building, security fence and gate

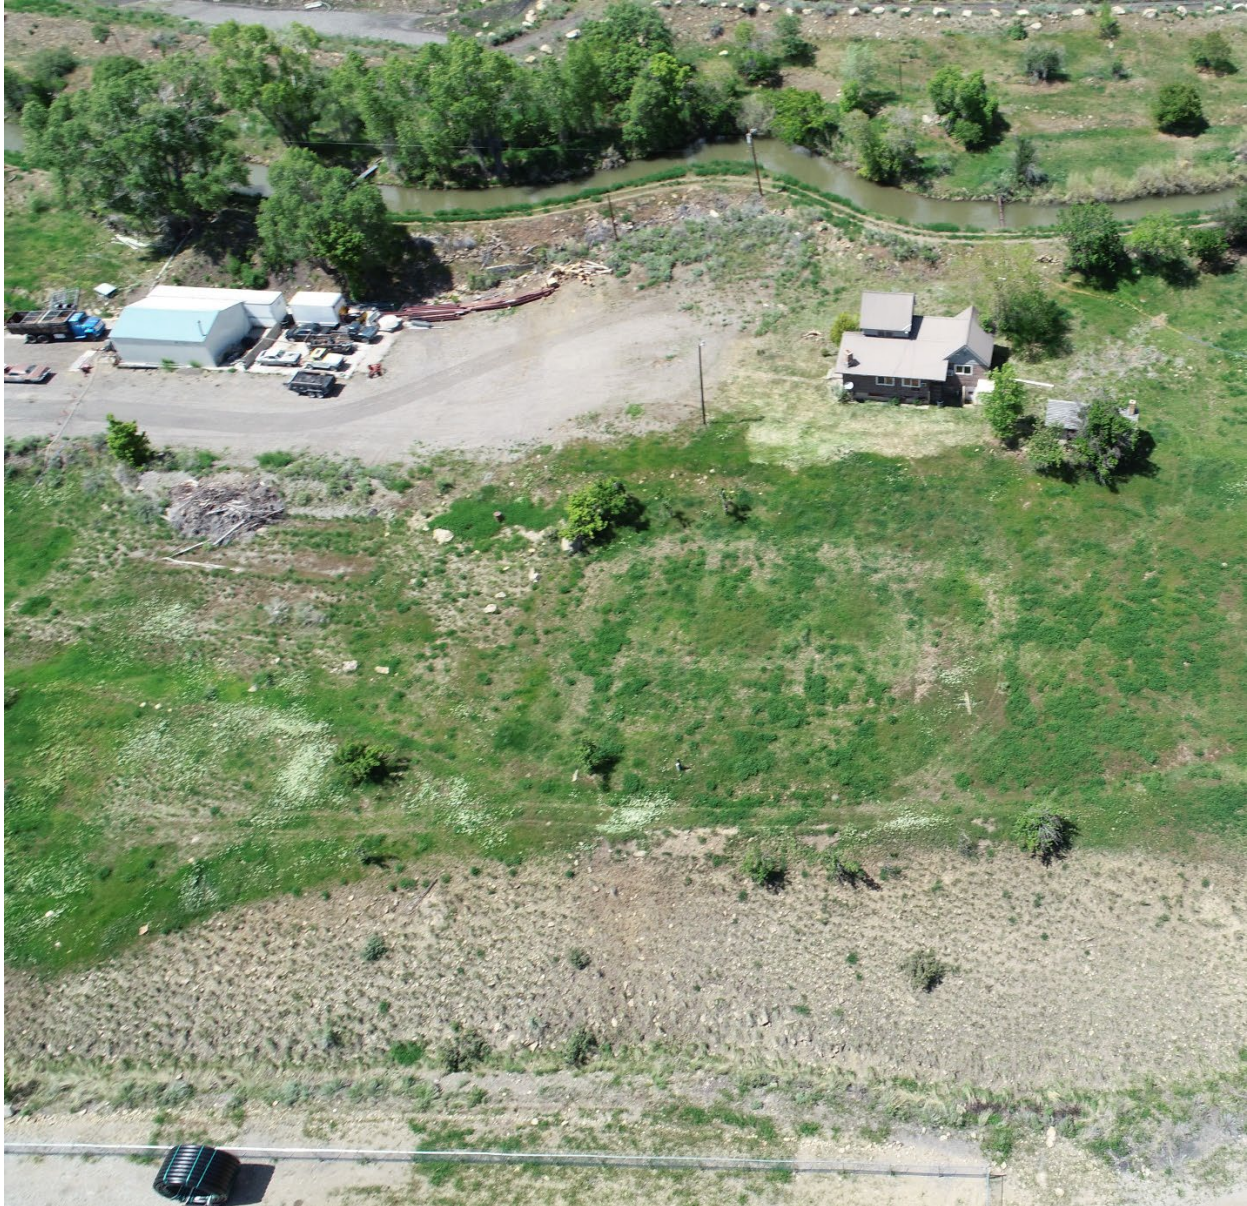
Figure 4: Office and east end of upper pad

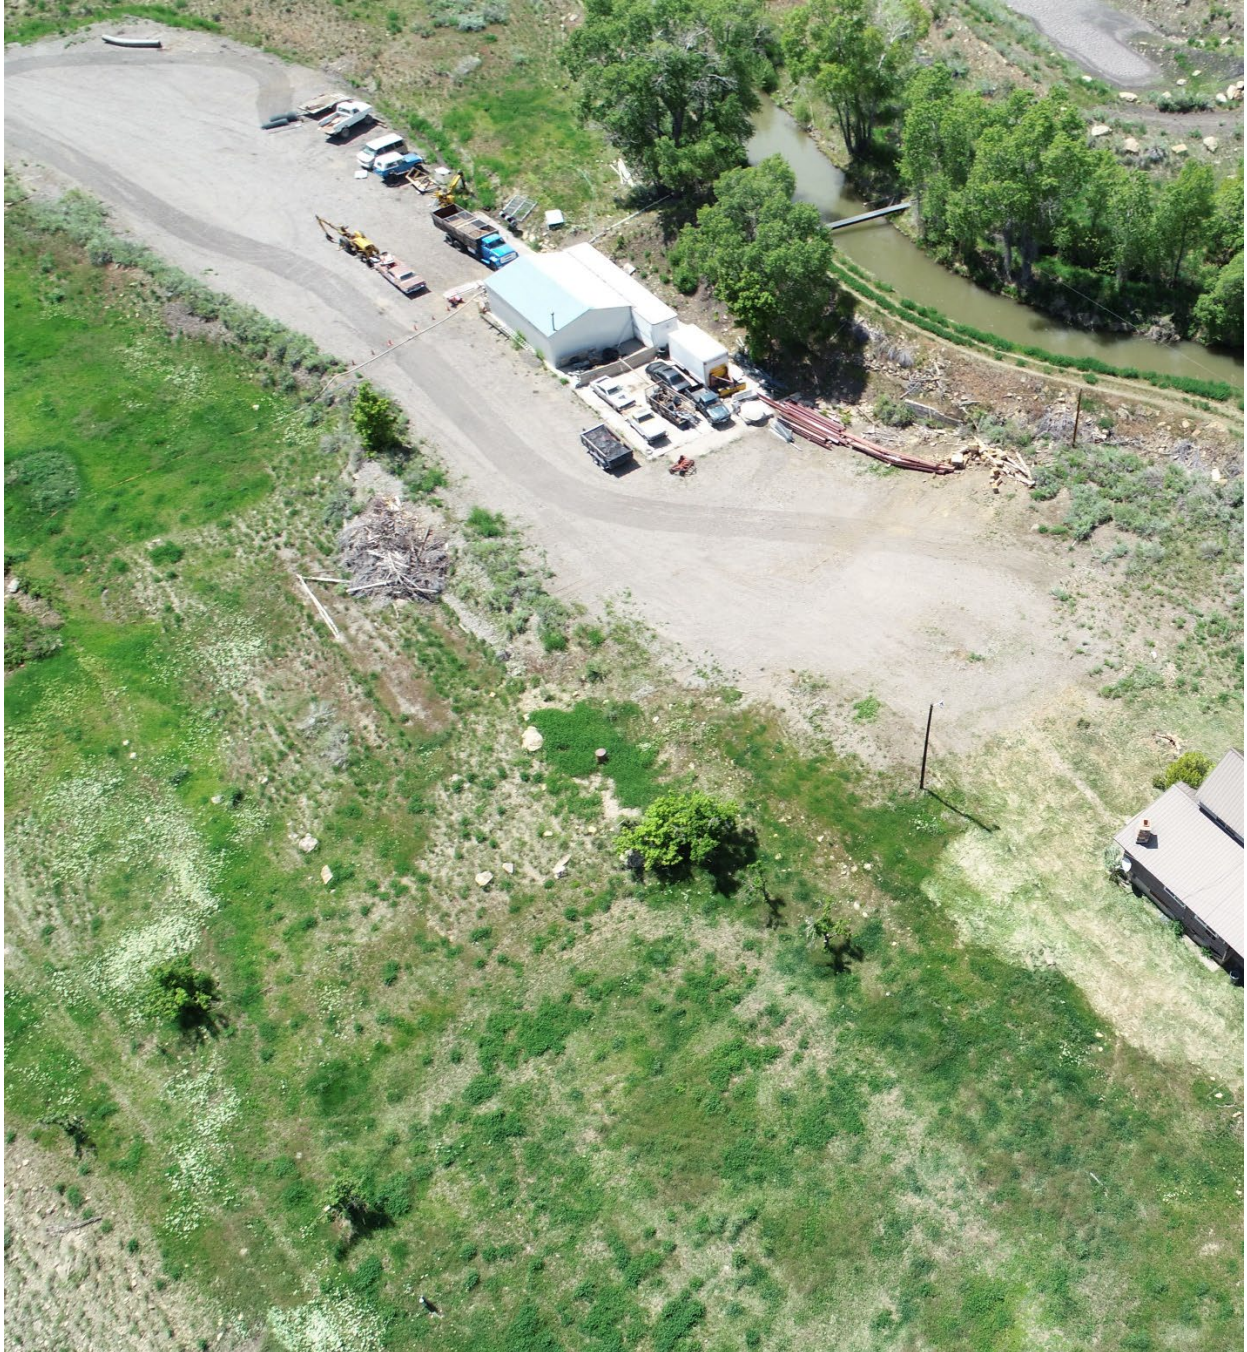
There was no activity on the site at the time of the inspection. The lower pad and temporary building were secure behind a locked gate. Vehicles and other equipment were stored on the upper pad. A sprinkler had been set up to irrigate the recently reclaimed substation pad.

Figure 5: Upper pad

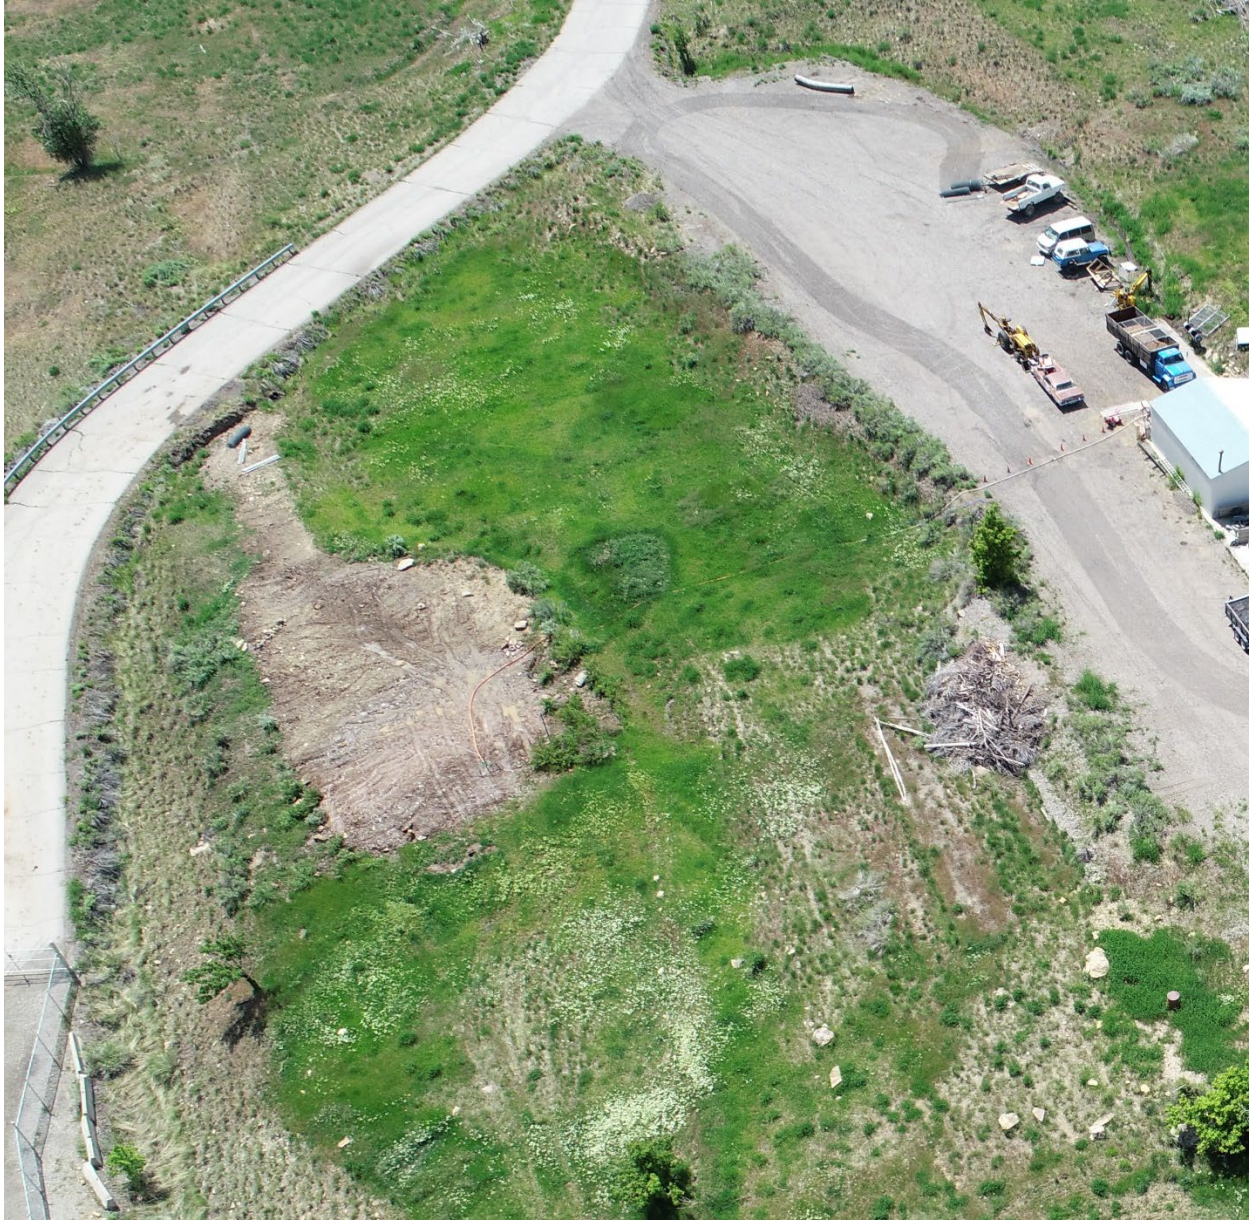
Figure 6: Reclaimed substation
