MINERALS PROGRAM INSPECTION REPORT
PHONE: (303) 866-3567

MINE NAME: Silt Pit	MINE/PROSPECTING ID#: M-1981-202-SG	MINERAL: Sand and gravel	COUNTY: Garfield
INSPECTION TYPE: Monitoring	WEATHER: Clear	INSP. DATE: May 20, 2025	INSP. TIME: 09:00
OPERATOR: Flag Resources Inc	OPERATOR REPRESENTATIVE: Eric Frei	TYPE OF OPERATION: 112c - Construction Regular Operation	
REASON FOR INSPECTION: Normal I&E Program	BOND CALCULATION TYPE:	BOND AMOUNT: \$337,611.00	
DATE OF COMPLAINT: NA	POST INSP. CONTACTS: None	JOINT INSP. AGENCY: None	
INSPECTOR(S): Todd Jesse	INSPECTOR'S SIGNATURE:

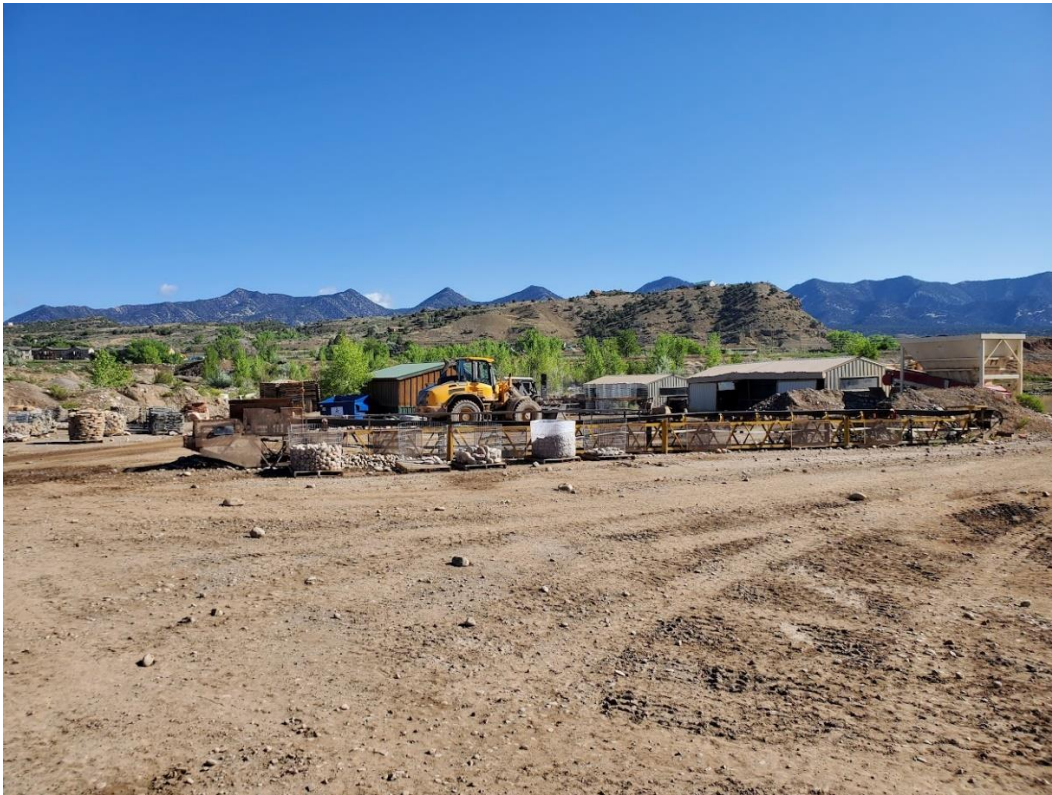
Photo 1 – View to the north of finished product stockpiles

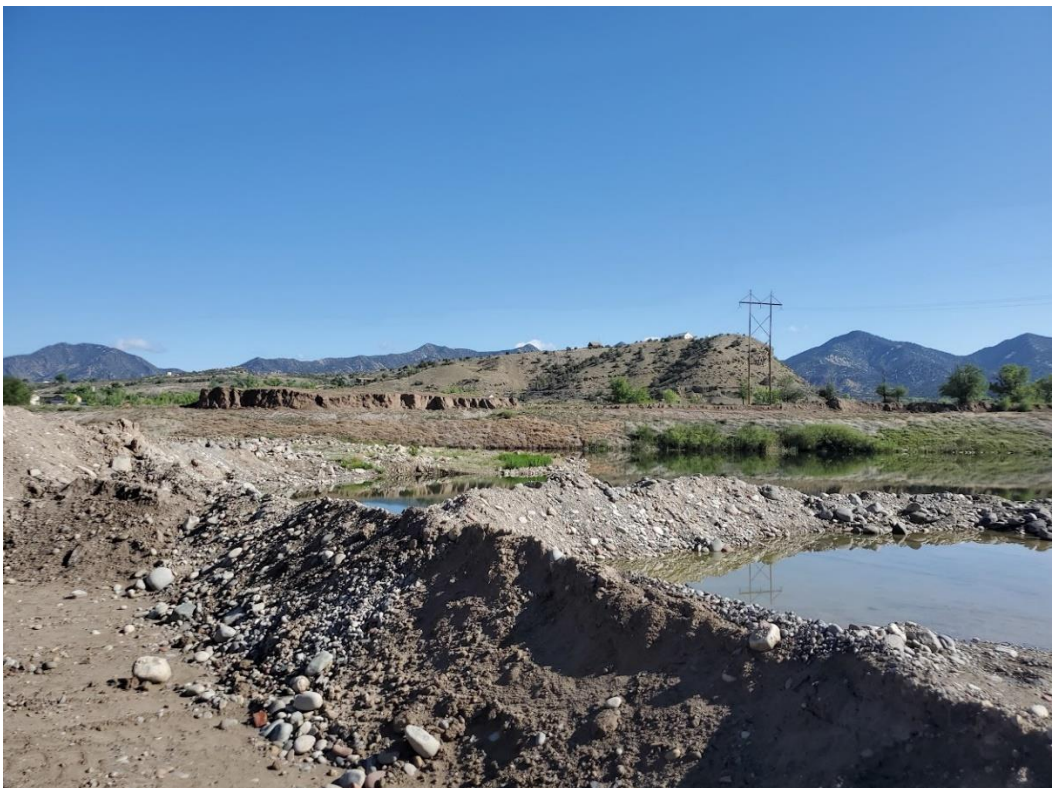
Photo 2 – View to the north of mining area with topsoil stockpile in background.

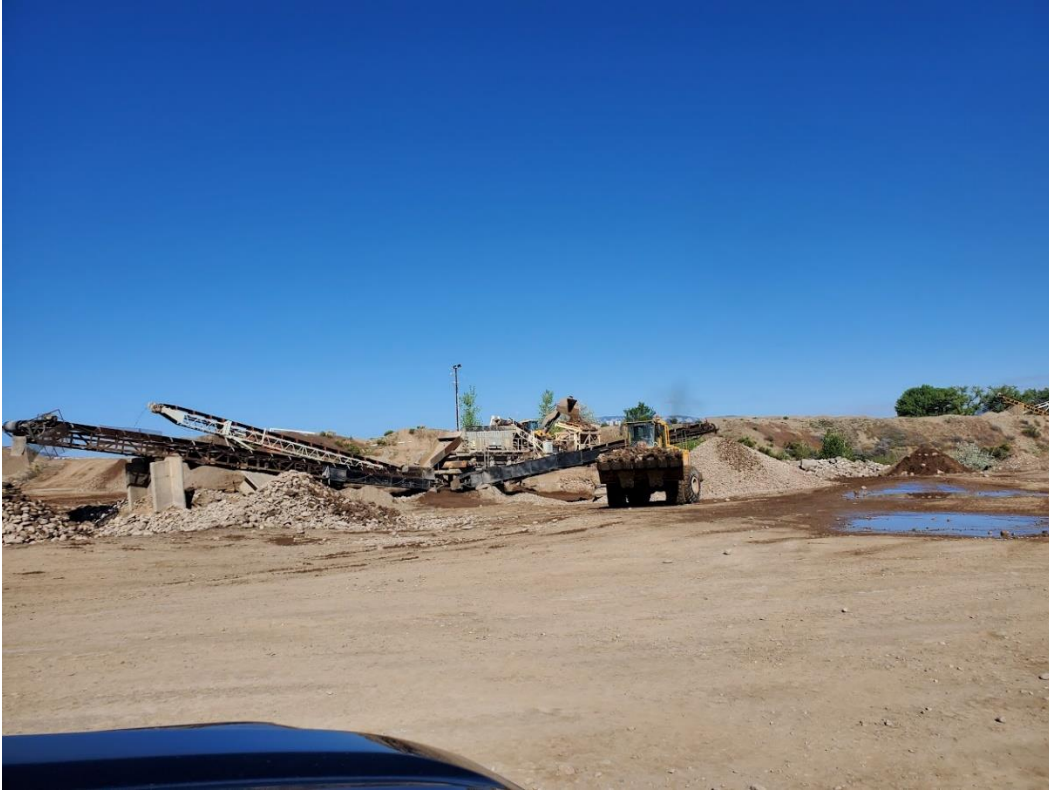
Photo 3 – View to the south of crushing and screening area.

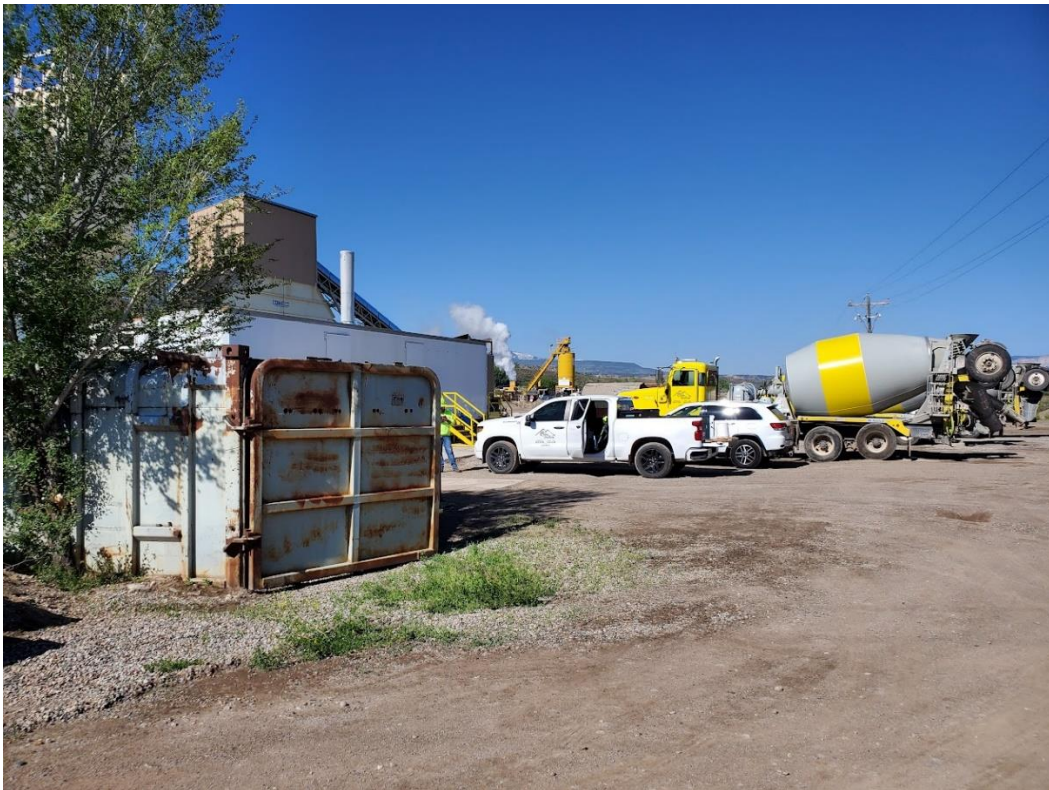
Photo 4 – View to the west of ready-mix plant in the foreground and hot plant in the distance.

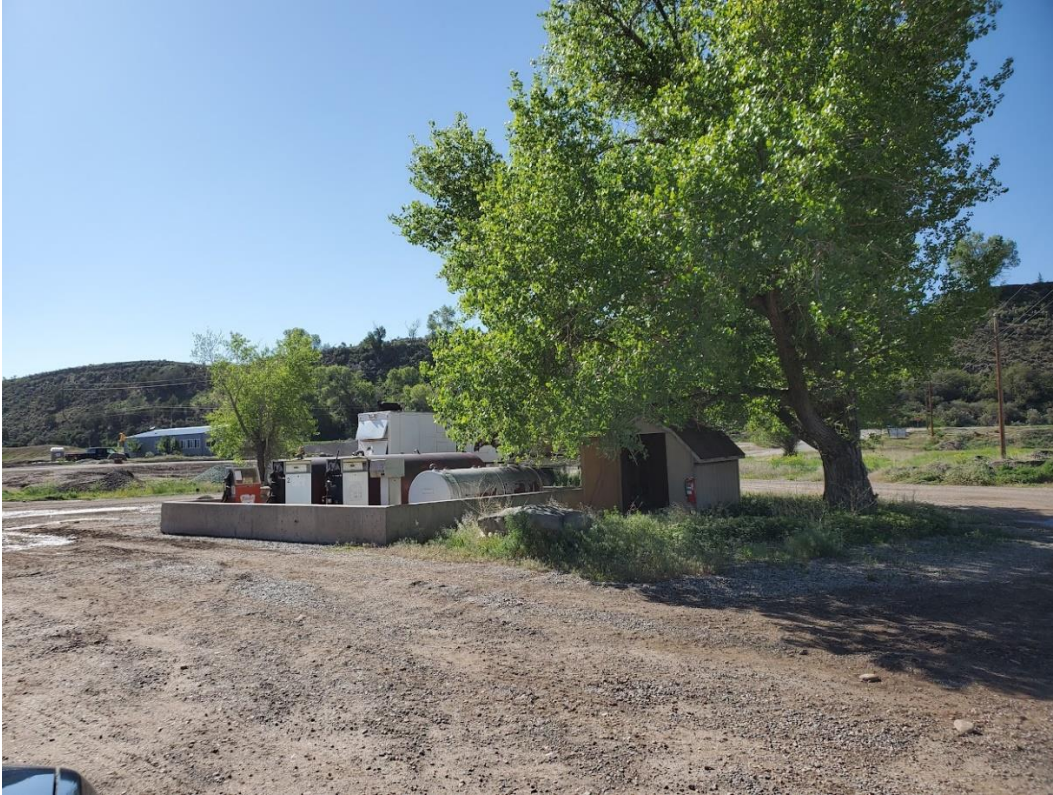
Hydrocarbons are stored in concrete berm secondary containment. Fuel storage is located between the ready-mix plant and office. Used oil is also stored in the shop area to be burned for heat in the winter.

Photo 5 – View to the southwest of fuel storage in secondary containment.

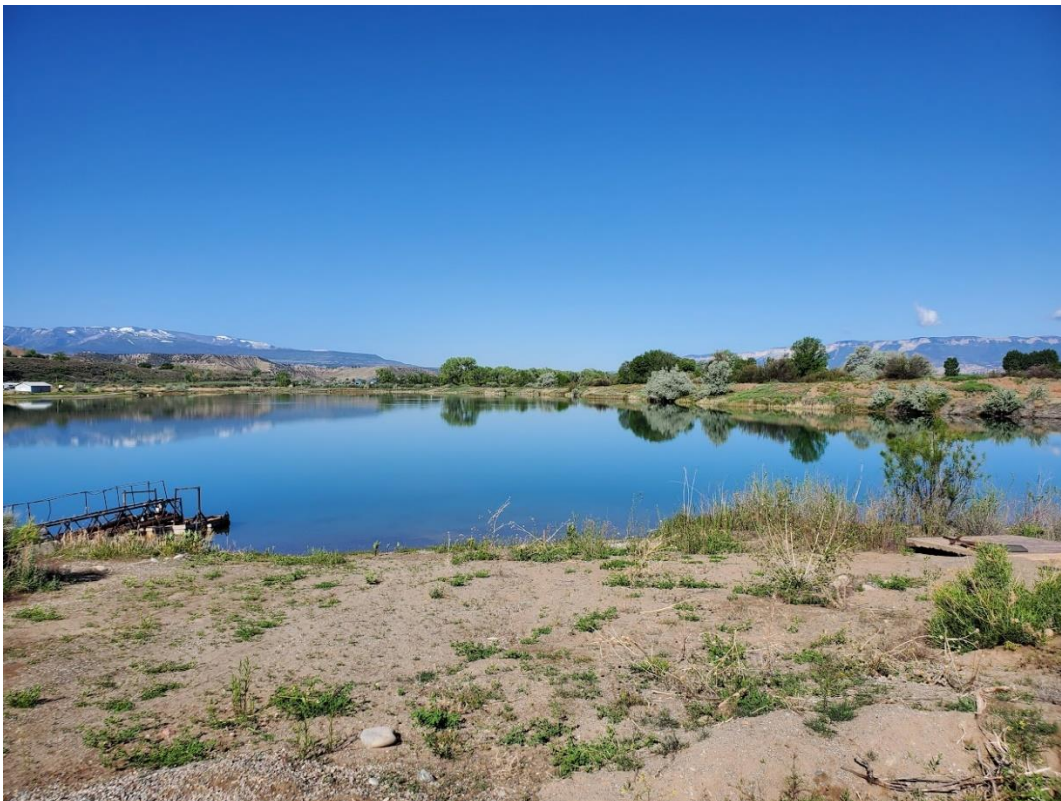
The banks of the main western pond areas are well vegetated with the exception of the northeast corner. Smaller ponds along the western boundary contain wetland species. Pasture areas are diverse effective cover that is capable of self-regeneration without continued dependence on irrigation, soil amendments or fertilizer. Minor amounts of cheatgrass were observed near the Xcel right of way in the reclaimed area. There were also several Russian olive and tamarisk seen along the banks of the western pond. Please work with your county on the implementation of a weed management plan.

Photo 6 – View to the west of the main western pond. A minor infestation of Russian olive can be seen on the far bank.

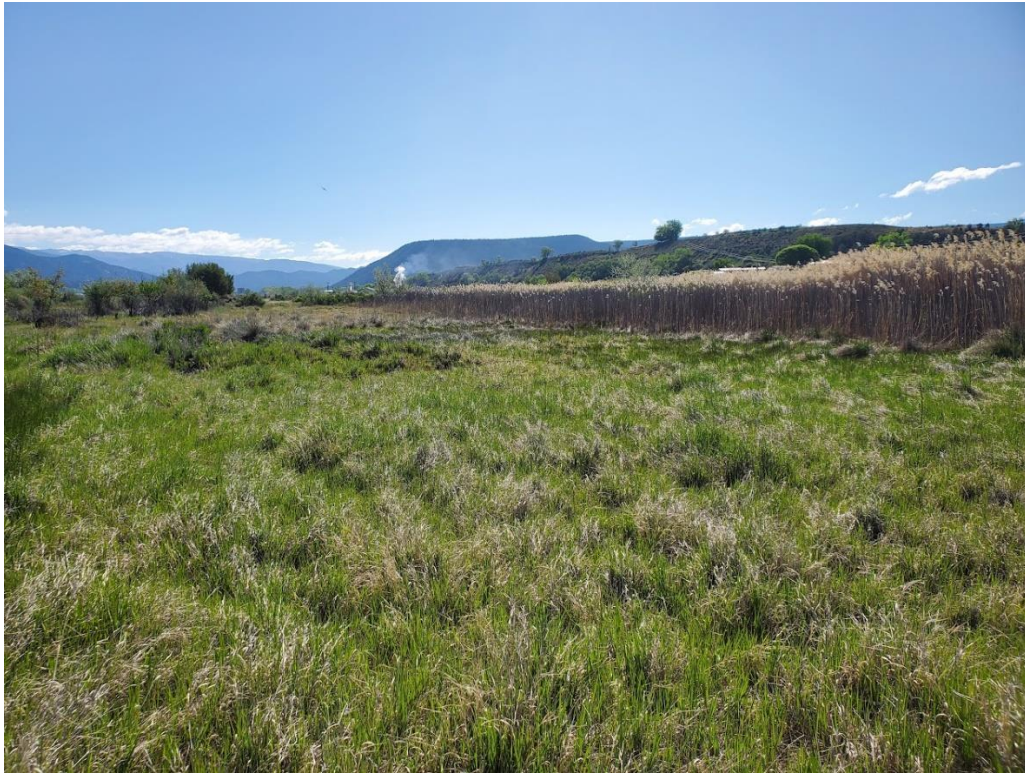
Photo 7 – View to the east of reclaimed pastureland adjacent to smaller ponds.
