Division of Reclamation,
Mining and Safety

PERMIT INFORMATION

Permit Number: C-1996-084 Mine Name: Lorencito Canyon Mine Operator: New Elk Coal Company, LLC Operator Address: 12250 Highway 12 Weston, CO 81091	County: Las Animas Operation Type: Surface Permit Status: Suspended Ownership: Private
	Operator Representative Present: None
Operator Representative Signature: (Field Issuance Only)

Inspection Start Date: May 20, 2025 Inspection Start Time: 15:20 Inspection End Date: May 20, 2025 Inspection End Time: 16:38	Inspection Type: Coal Partial Inspection Inspection Reason: Normal I&E Program Weather: Clear
Joint Inspection Agency: None	Joint Inspection Contacts:
Post Inspection Agency: None	Post Inspection Contacts:
Inspector(s): Amber M. Gibson	Inspector's Signature:

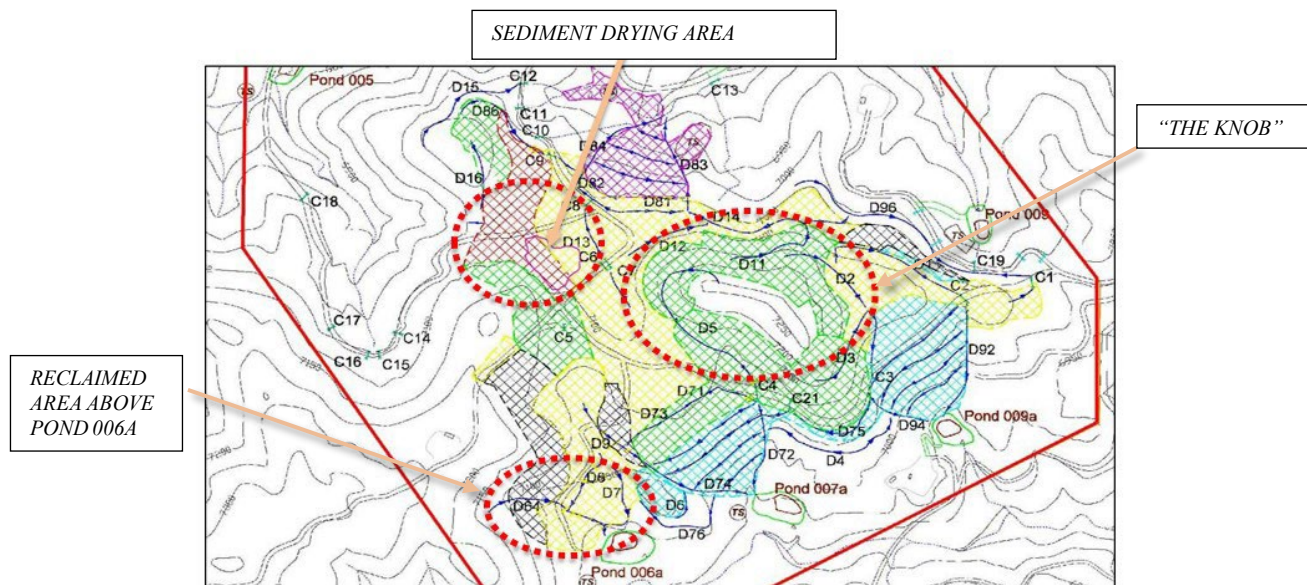
4. The following items pertain to ongoing erosional issues in the areas shown in Figure 1, that pursuant to Rule 4.14.6 need to be addressed. A Technical Revision will be required to expand on the current Rill and Gully plan in the PAP. **The Operator shall submit the technical revision, obtain approval, repair the erosion, and stabilize the slopes pursuant to the approved plan.**

FIGURE 1. AREAS WHERE RILLS, GULLIES AND SPARSE VEGETATION HAS BEEN FOUND TO BE A PERSISTENT PROBLEM AT THE SITE ARE WITHIN THE DOTTED CIRCLE AREAS. BACKGROUND IMAGE IS THE 2020 ANNUAL REPORT MAP.

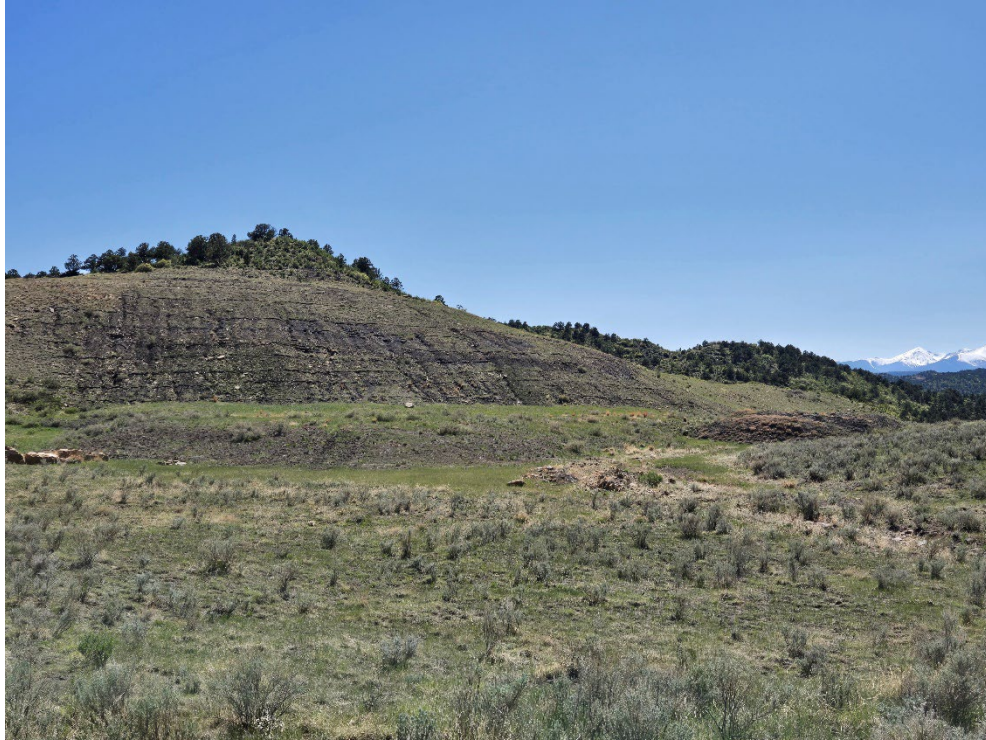
Photo 1: Erosion on the north-facing slope of the reclaimed area above the sediment drying area.

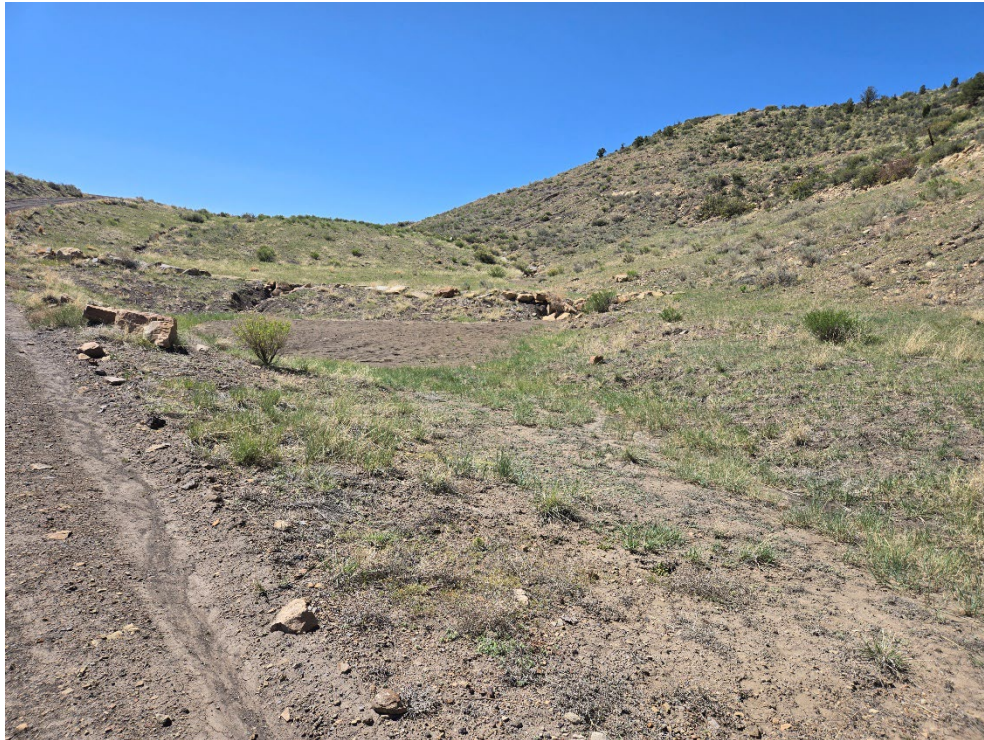
- a. Ditch D5 is located on the southside of a previously disturbed area referred to as “The Knob”. The Knob is north of Fill 7 and north of the road. Check dams are located throughout D5, and a small sediment catchment area is located at the base of the ditch that leads to culvert C4. The check dams are full and need to be cleaned, and a few need to be repaired. The catchment basin also has an increased sediment load, however C4 appears to still be clear at this time. Still, the Operator **shall clean the sediment out of the check dams and the catchment basin located within D5, north of C4.**

Photo 2: Looking northwest at the sediment catchment basin on the north side of the road, on the south side of “The Knob”.

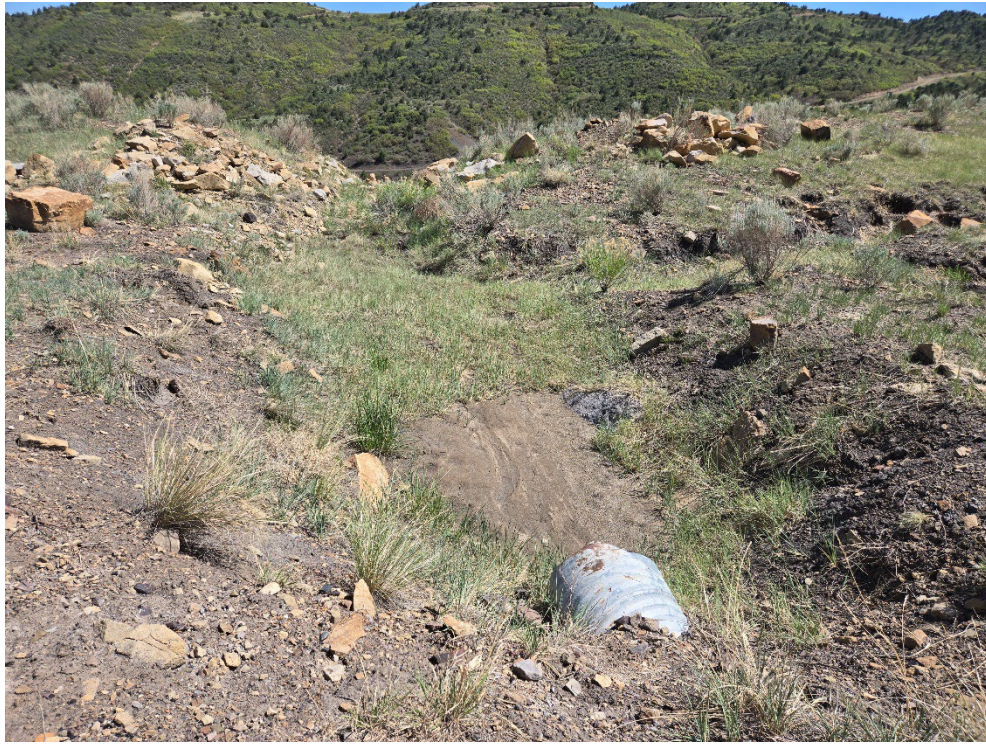
- c. The outlet for C4 is located on the south side of the culvert and leads into Ditch D72 along the east side of Fill 7. Sediment has been deposited at the outlet of C4 and has covered small portion of vegetation at the top of Ditch D72. **The Operator shall monitor this area and ensure that sediment deposition in this area is controlled. To help retain the vegetation established in the area, removing the excess sediment may be warranted in the near future.**

Photo 3: Looking at the outlet for culvert C4 on the southside of the road.

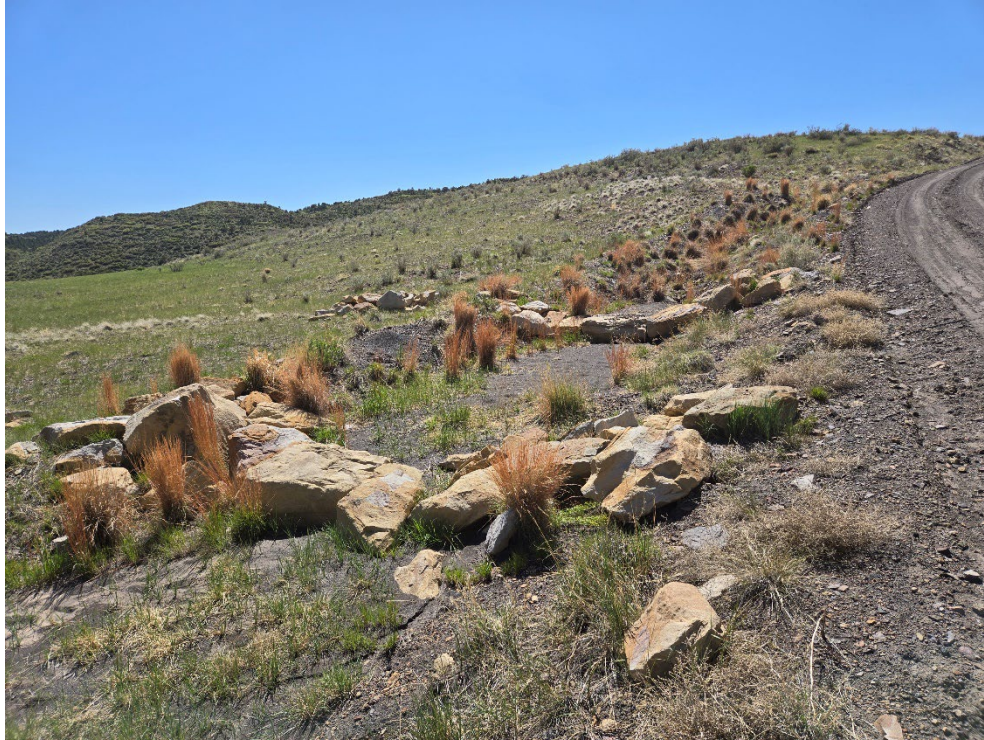
- d. D71, located along the southside of the road and north side of Fill 7, empties at the west side of the outlet for C4. The check dams within D71 are nearly full of sediment. **The Operator shall clean the sediment from the check dams within D71 and ensure the dams are functioning appropriately.**

Photo 4: Sediment built up in the check dams within ditch D71.

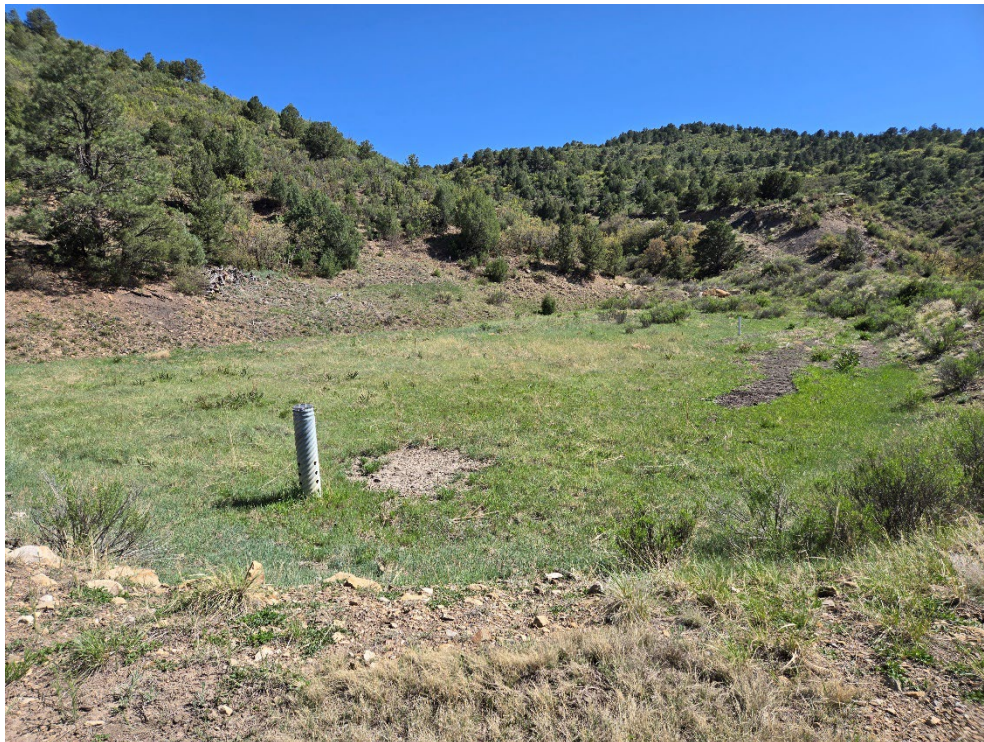
Photo 5: Pond 005

- Pond 005:
 - Pond 006a was dry at the time of the inspection (Photo 5).
 - The flume contained water, but was not discharging (Photo 6).
 - The primary and emergency spillways appeared to be clear and functional.
 - The ongoing maintenance issues listed in Item #6a at the beginning of this report are still a concern.

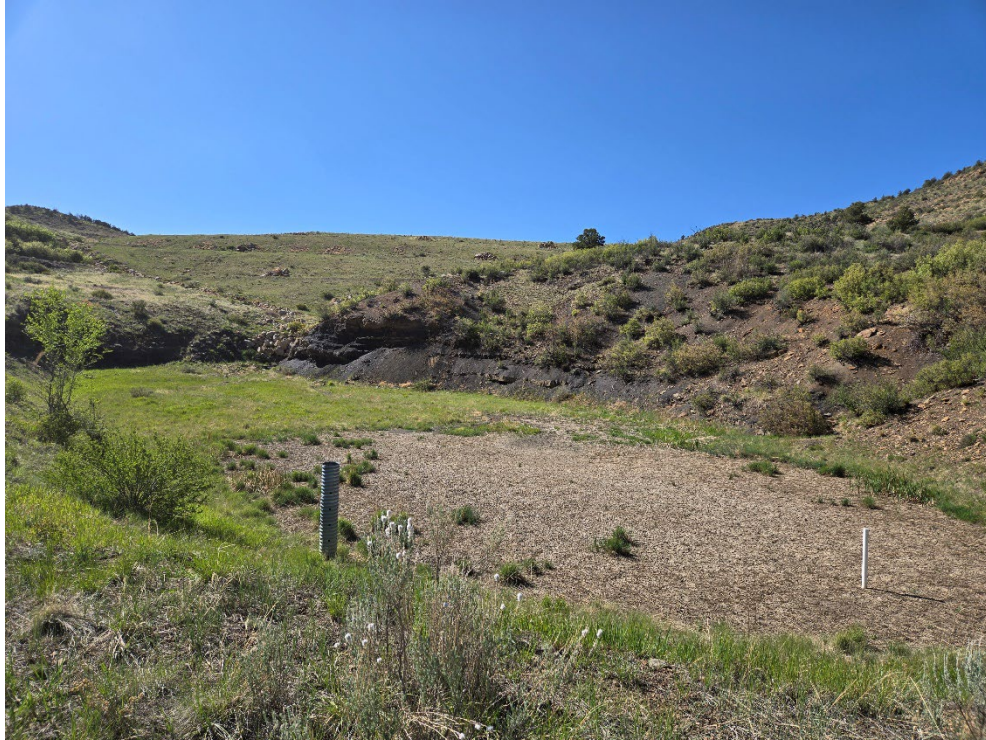
Photo 7: Pond 007a

- Pond 007a:
 - The pond was dry at the time of the inspection. (Photo 7).
 - The pond embankment appeared to be stable and vegetated.
 - The primary and emergency spillways appeared clear and functional.
 - The flume was dry (Photo 8).

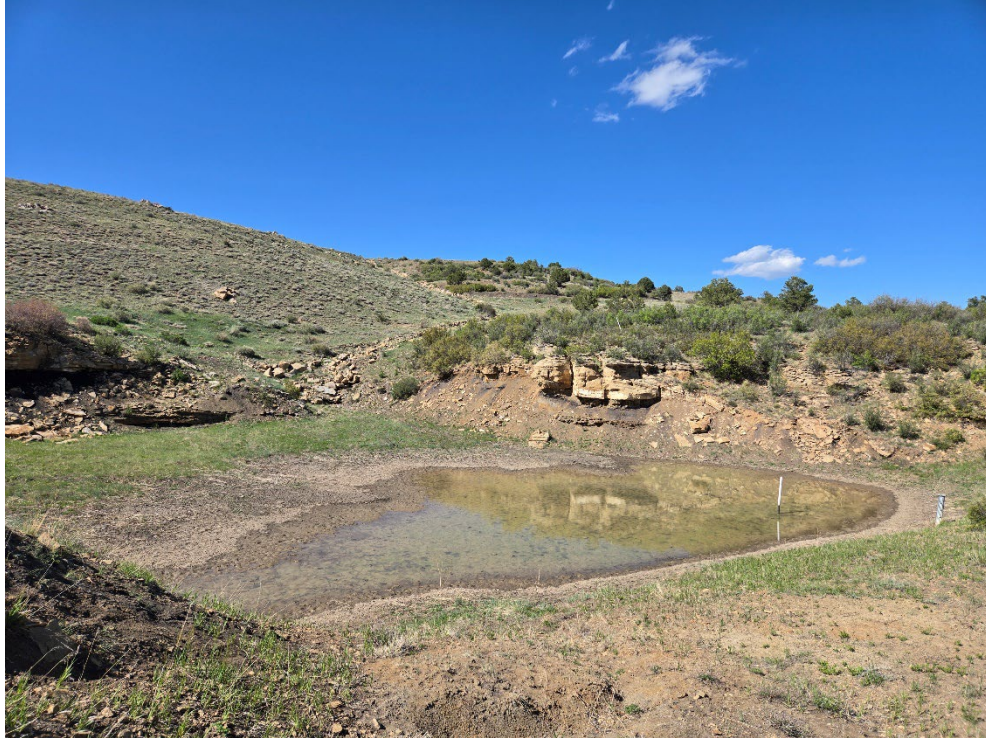
Photo 9: Pond 009a

- Pond 009a:
 - The pond contained some water at the time of the inspection. (Photo 9).
 - The pond embankment appeared to be stable and vegetated.
 - The primary and emergency spillways appeared clear and functional.
 - The flume was dry (Photo 10).

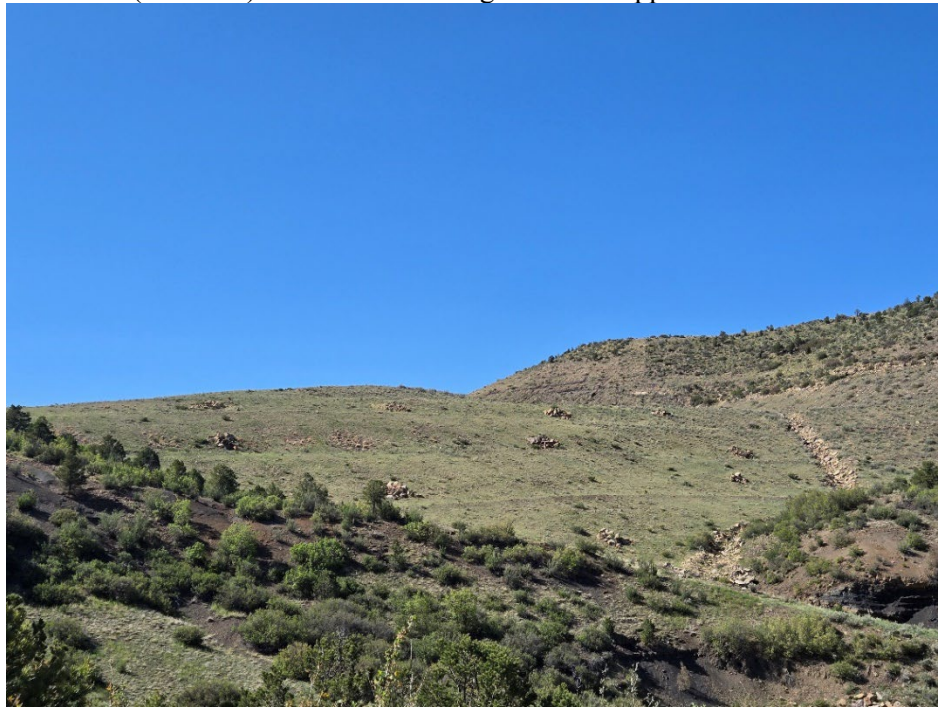
Photo 11: Looking northeast upslope at Fill 7

- Fill 7 was observed (Photo 11). Fill 7 was well vegetated and appeared stable.

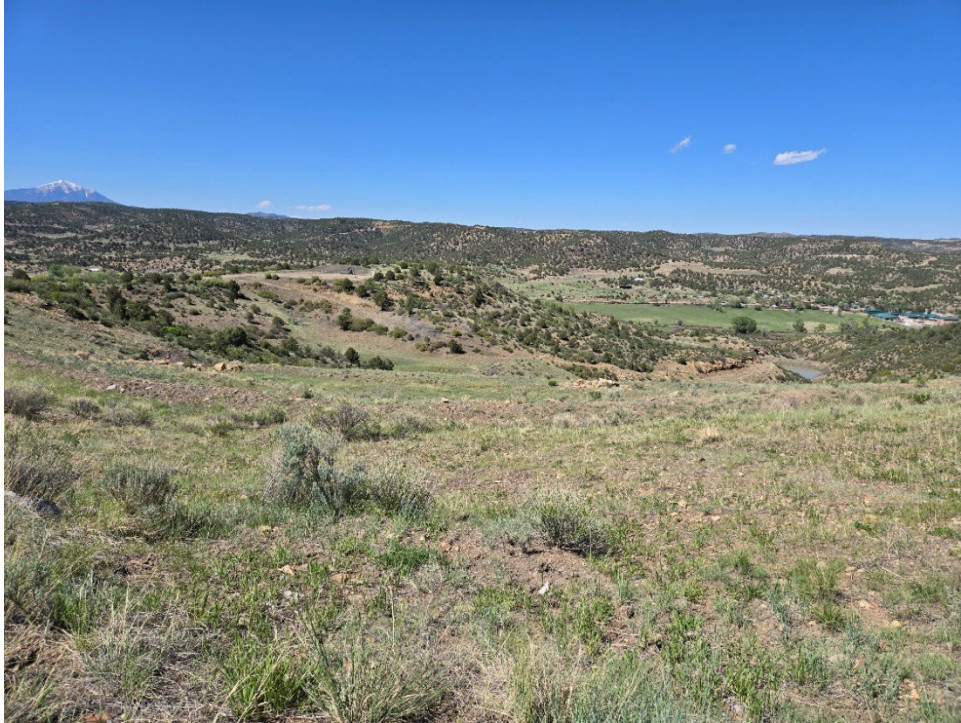
Photo 12: Looking north, downslope at Fill 8.

- Fill 8 was observed (Photo 12). Fill 8 was well vegetated and appeared stable.

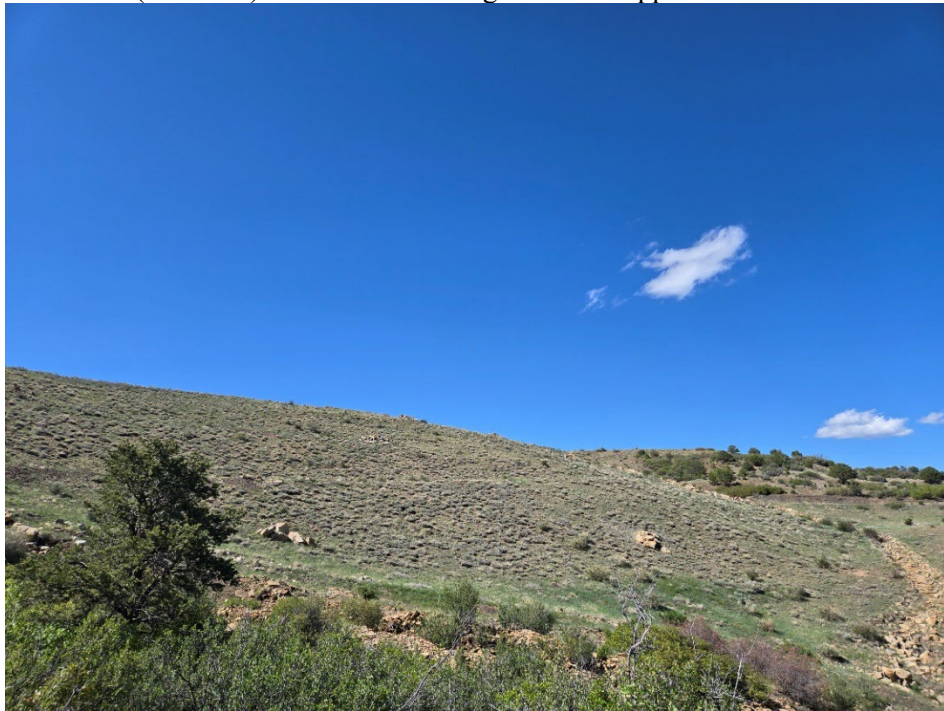
Photo 13: Looking northeast, upslope at Fill 9.

- Fill 9 was observed (Photo 13). Fill 9 was well vegetated and appeared stable.

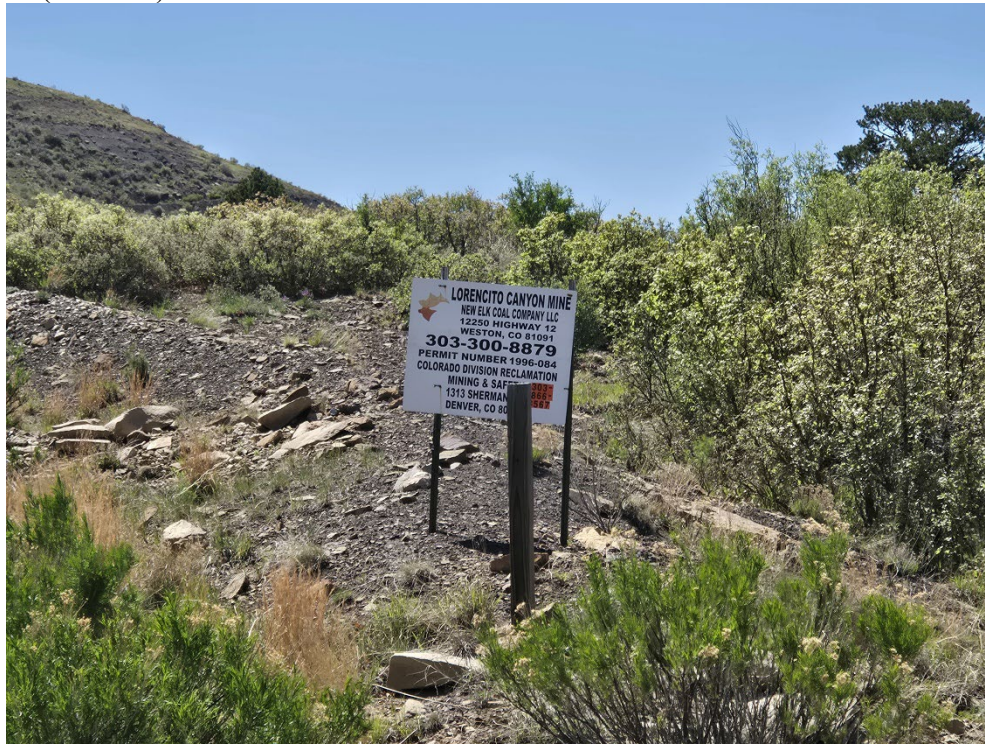
Photo 14: Mine sign

- Mine signs were posted at road entrances and at the entrance to the permit boundary in compliance with Rule 4.02 (Photo 14).
