## Roadside Portals Mine, C-1981-041, May Partial Inspection Report

<b>Permit Number:</b> C-1981-041 <b>Mine Name:</b> Roadside Portals <b>Operator:</b> Snowcap Coal Company, Inc <b>Operator Address:</b> Ms Tonya Hammond P. O. Box 443 Grand Junction, CO 81502	<b>County:</b> Mesa <b>Operation Type:</b> Underground <b>Permit Status:</b> Active <b>Ownership:</b> Private
	<b>Operator Representative Present:</b>  Tonya Hammond
<b>Operator Representative Signature:</b> (Field Issuance Only)

<b>Inspection Start Date:</b> May 22, 2025 <b>Inspection Start Time:</b> 13:30 <b>Inspection End Date:</b> May 22, 2025 <b>Inspection End Time:</b> 14:00		<b>Inspection Type:</b> Coal Partial Inspection <b>Inspection Reason:</b> Normal I&E Program <b>Weather:</b> Clear	
<b>Joint Inspection Agency:</b>  None		<b>Joint Inspection Contacts:</b>  None	
<b>Post Inspection Agency:</b>  None		<b>Post Inspection Contacts:</b>  None	
<b>Inspector(s):</b>  Clayton Wein	<b>Inspector's Signature:</b>  <i>Clayton Wein</i>		
			<b>Signature Date:</b> 6/4/2025

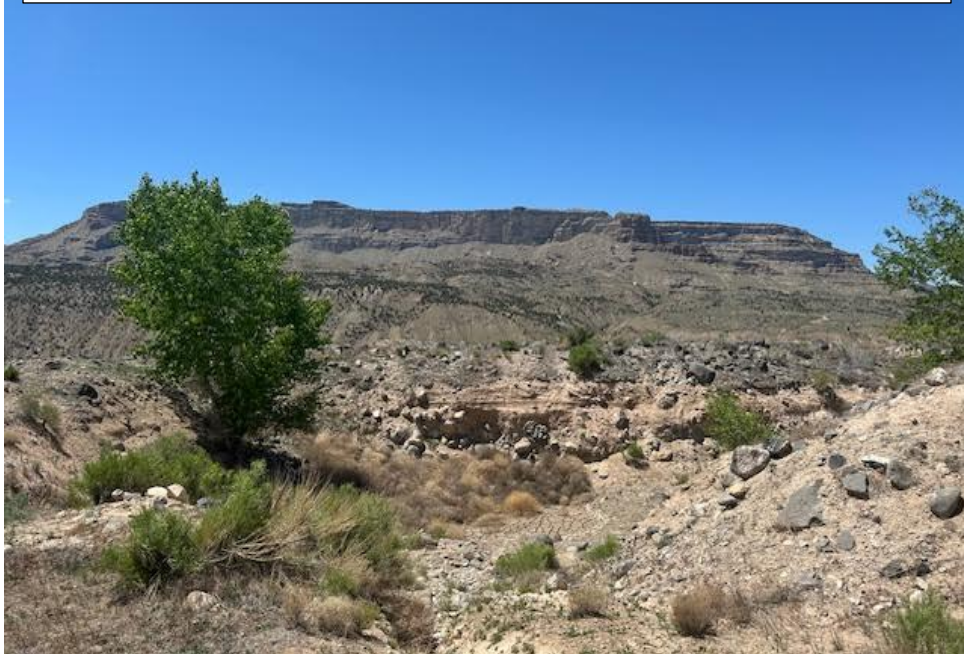
During the inspection, the Landowner's middle field was being irrigated. There was no runoff from the field observed affecting the remaining reclamation at the mine site. The landowner's trenches located on the north and eastern portions of Tract 71, adjacent to the TR-69 Repair Area, were dry. There was no indication of recent water application in the trenches. No impacts to the TR-69 Repair Area were identified. A pit located to the southwest of the TR-69 Repair Area and adjacent to the permit boundary is referred to as the Carey Pit. The pit was observed from the permit boundary to be dry (Photo 1). A trench connects the landowner's buried pipeline to the mouth of the pit. The trench appeared to have been recently cleaned (Photo 2) and some evidence of flow in the dirt of the trench was seen.

Photo 1: The Carey Pit.

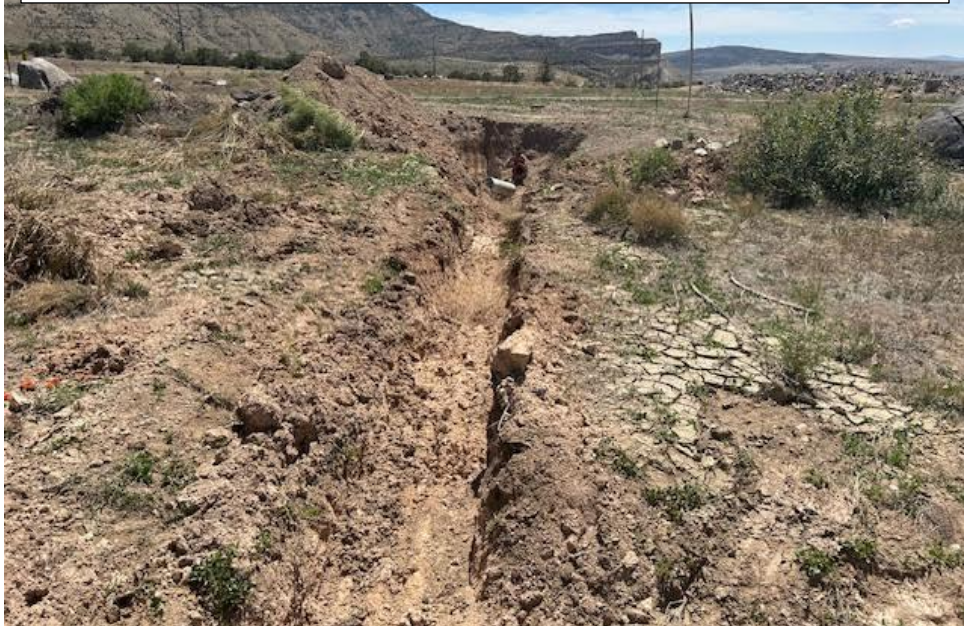
Photo 2: The trench connecting the Carey Pit to the landowner's buried pipeline.

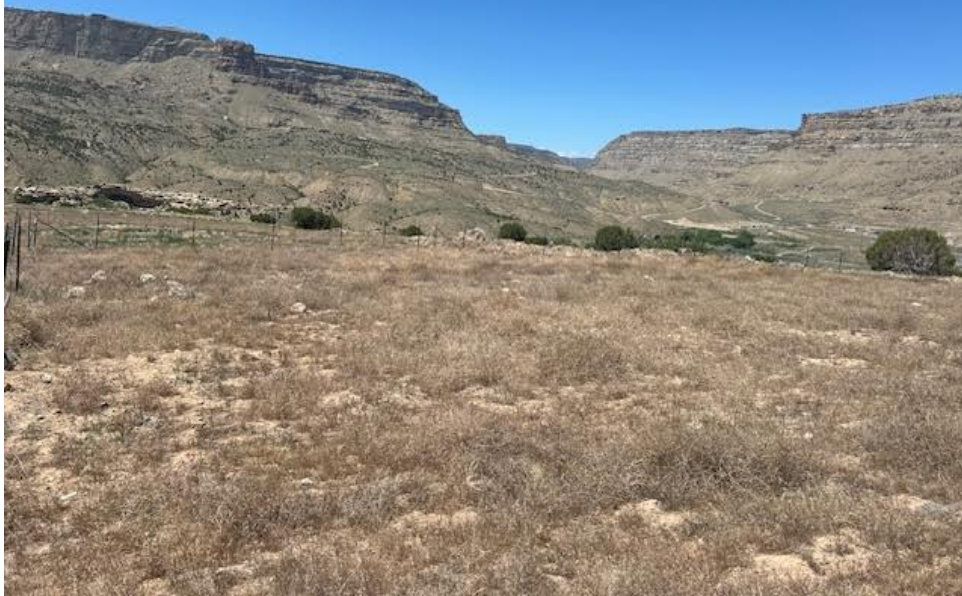
The remaining reclamation permitted at the mine site is located within the northern portion of Tract 71 and is referred to as the TR-69 Repair Area. The reclamation for the 0.4 acres was initially completed in 2019 and the site was re-seeded in the fall of 2023 following activities by the landowner that disturbed the reclamation. The TR-69 Repair area was stable with vegetative cover. Vegetation was green but beginning to dry out due to the recent warming temperatures (Photos 3 through 5). There were no indications of differential settling. The straw waddles located on the down-gradient boundary of the reclamation were in good repair (Photo 6). There were no

Photo 3: The western portion of the TR-69 Repair Area.

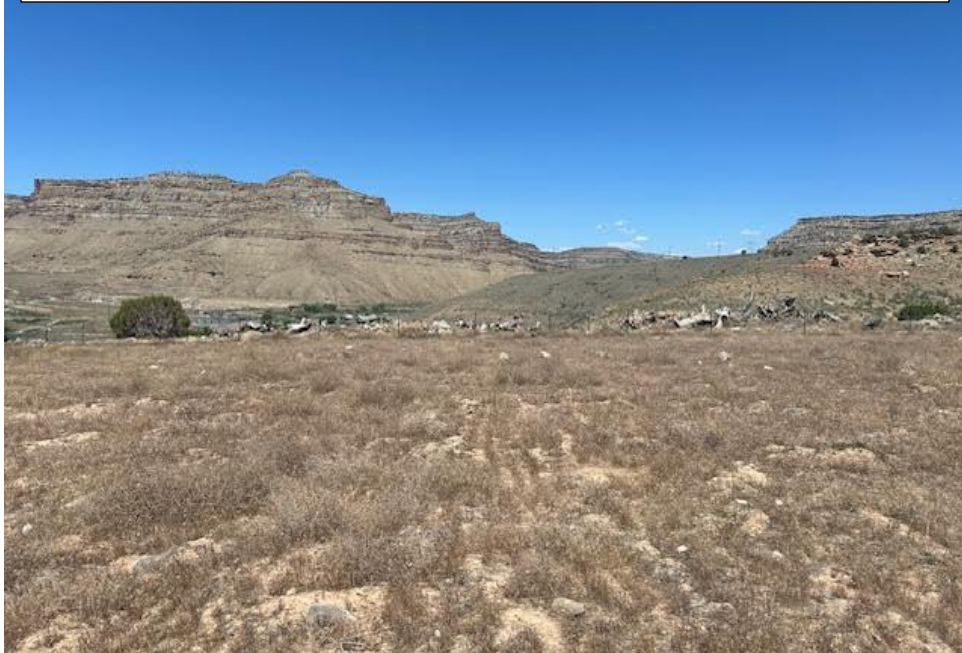
Photo 4: The central portion of the TR-69 Repair Area.

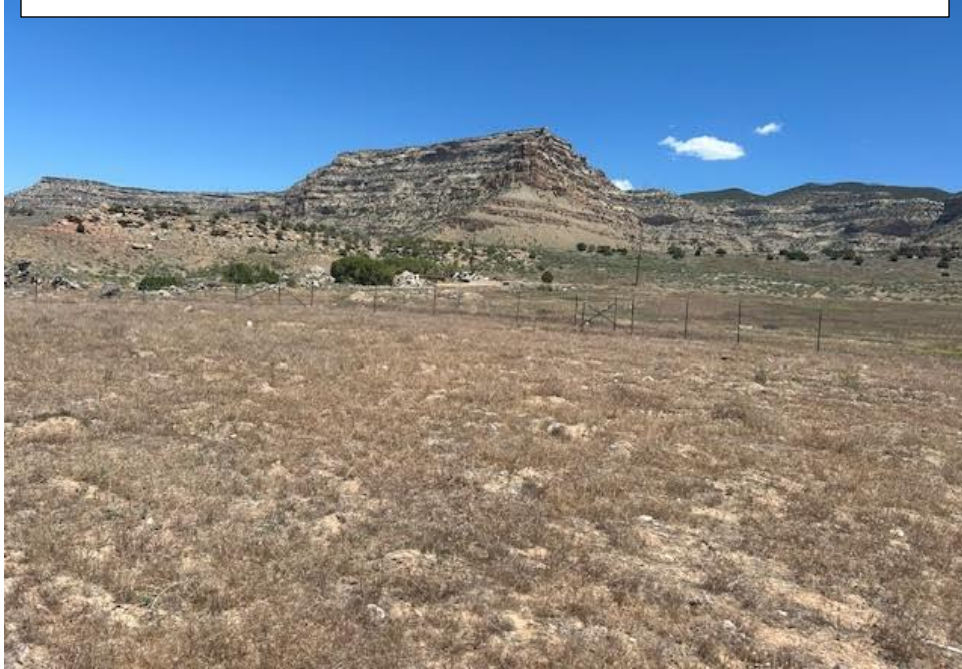
Photo 5: The eastern portion of the TR-69 Repair Area.

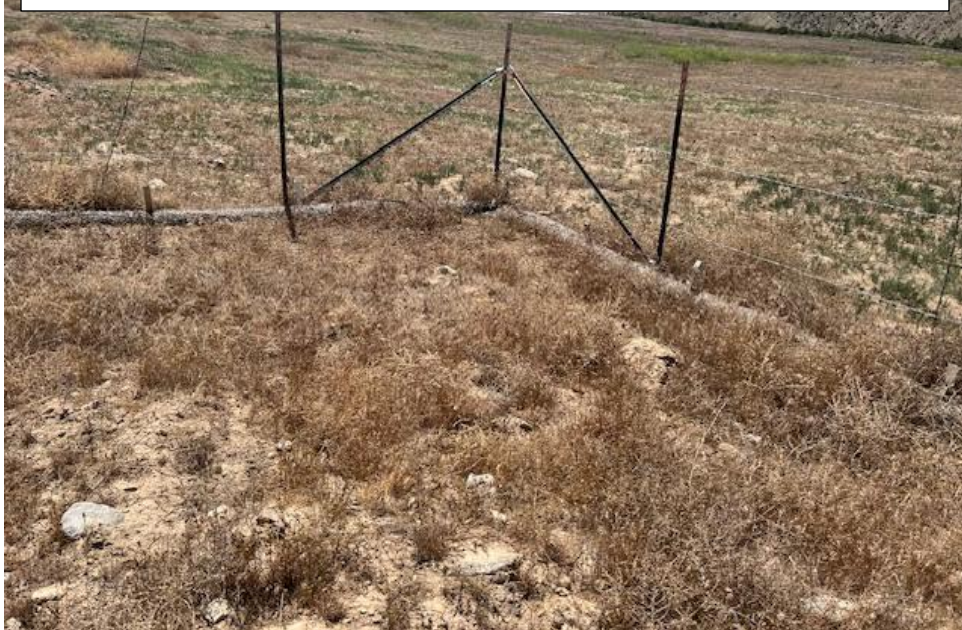
Photo 6. The connection of the southern and western straw waddles at the TR-69 Repair Area disturbed area boundary.
