MINERALS PROGRAM INSPECTION REPORT
PHONE: (303) 866-3567

MINE NAME: Goldman Gravel Pit	MINE/PROSPECTING ID#: M-1978-279	MINERAL: Gravel	COUNTY: Garfield
INSPECTION TYPE: Monitoring	WEATHER: Clear	INSP. DATE: May 20, 2025	INSP. TIME: 10:00
OPERATOR: Flag Resources Inc	OPERATOR REPRESENTATIVE: Eric Frei	TYPE OF OPERATION: 110c - Construction Limited Impact	
REASON FOR INSPECTION: Normal I&E Program	BOND CALCULATION TYPE: None	BOND AMOUNT: \$22,017.00	
DATE OF COMPLAINT: NA	POST INSP. CONTACTS: None	JOINT INSP. AGENCY: None	
INSPECTOR(S): Todd Jesse	INSPECTOR'S SIGNATURE:

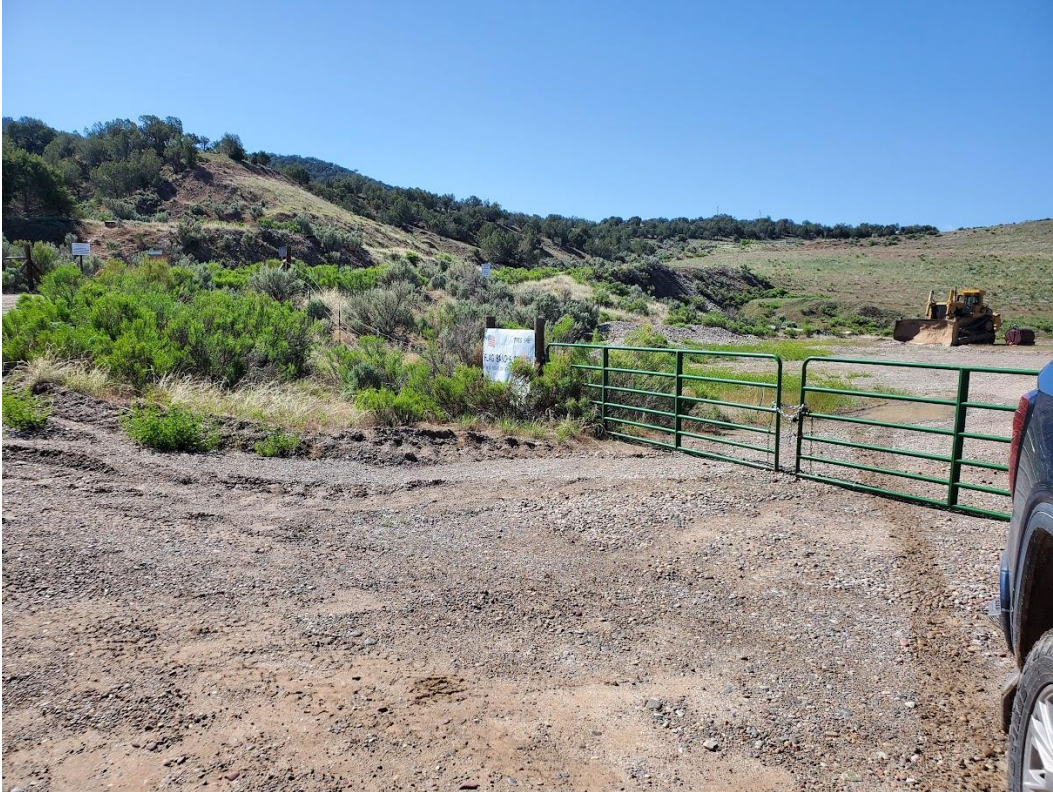
The mine identification sign and boundary markers are in place and in compliance with Rule 3.1.12. The sign is posted by the entrance off CR 335. The sign had fallen down in a wind event, but the operator replaced it during the inspection. The permit boundary is marked with fence line and posts that are easily identifiable as well as earthen berms.

Photo 1 – View to the south of site entrance with proper mine ID sign.

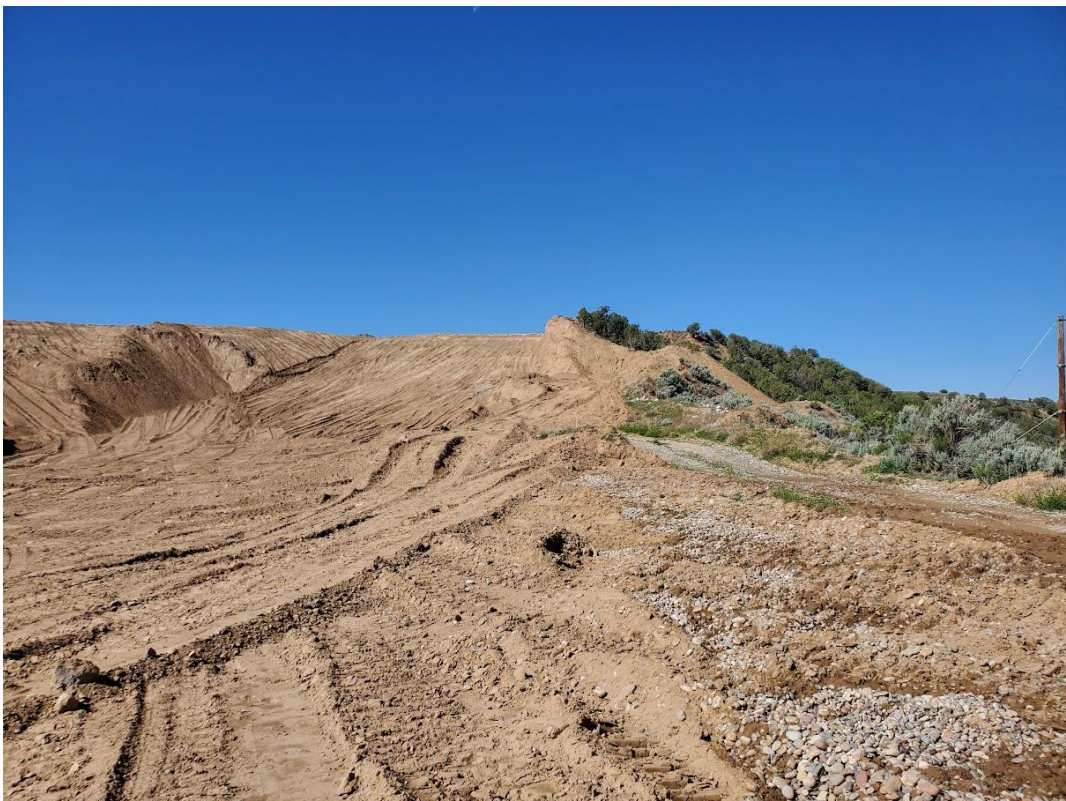
The majority of the pit has been graded to at least a 3:1 grade, but some work remains before the entire permit area is a reclamation grade. Small highwalls remain on the edges of the grading area.

Photo 2 – View to the west of grading and highwall along the northern boundary.

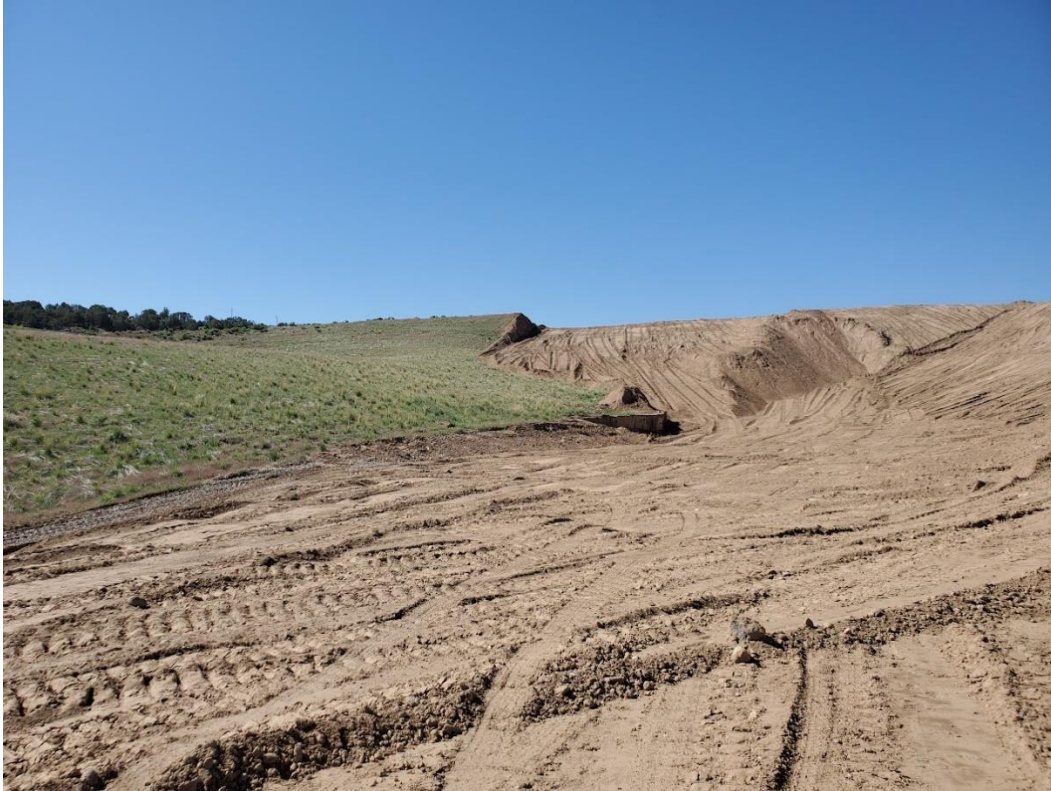
The mine is in final reclamation and no additional mining is anticipated to occur at site. The southeastern portion of the permit has been graded and reseeded. There are approximately 3 acres in the center of the pit that are being graded and seeded. A well pad is located along the southeast boundary.

Photo 3 – View to the southwest of reclaimed area below well pad and highwalls near the area being graded.

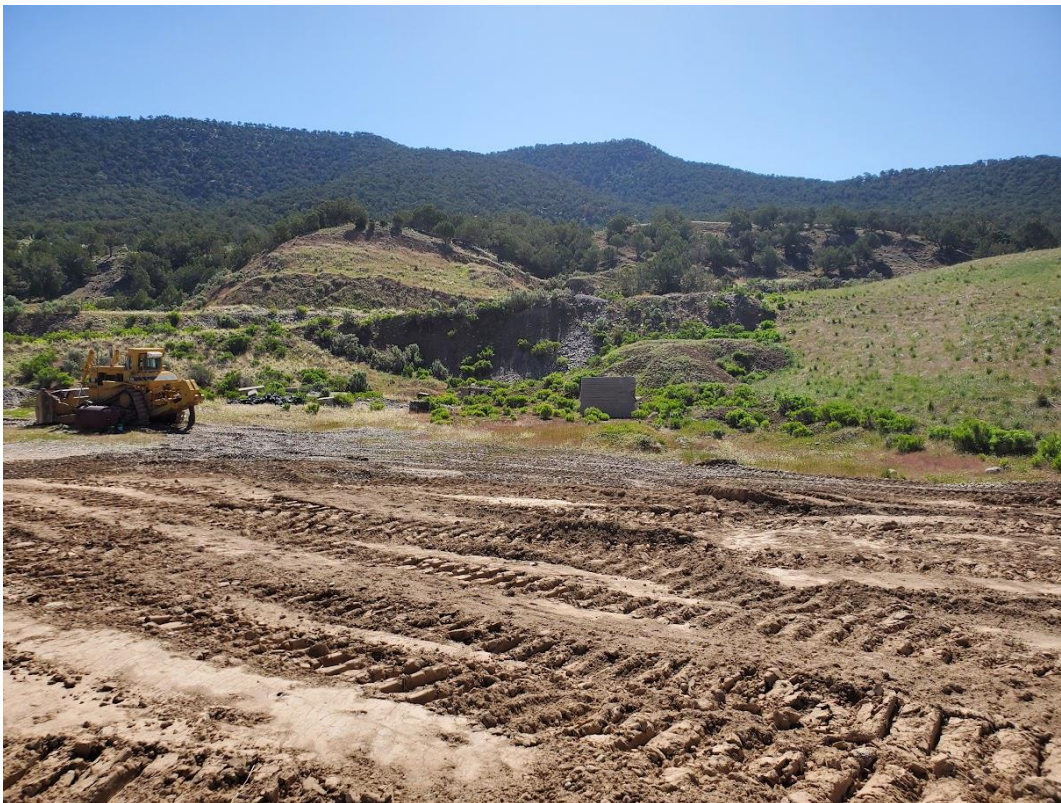
Photo 4 – View to the east reclamation equipment.
