Division of Reclamation,  
Mining and Safety

<b>Permit Number:</b> C-1981-012 <b>Mine Name:</b> New Elk Mine <b>Operator:</b> New Elk Coal Company, LLC <b>Operator Address:</b> 12250 Highway 12 Weston, CO 81091	<b>County:</b> Las Animas <b>Operation Type:</b> Underground <b>Permit Status:</b> <b>Suspended</b> <b>Ownership:</b> Private
	<b>Operator Representative Present:</b>  None
<b>Operator Representative Signature: (Field Issuance Only)</b>

<b>Inspection Start Date:</b> May 21, 2025 <b>Inspection Start Time:</b> 09:24 <b>Inspection End Date:</b> May 21, 2025 <b>Inspection End Time:</b> 11:32	<b>Inspection Type:</b> Coal Complete Inspection <b>Inspection Reason:</b> Normal I&E Program <b>Weather:</b> Clear
<b>Joint Inspection Agency:</b>  None	<b>Joint Inspection Contacts:</b>  
<b>Post Inspection Agency:</b>  None	<b>Post Inspection Contacts:</b>  
<b>Inspector(s):</b>  Amber M. Gibson	<b>Inspector's Signature:</b>

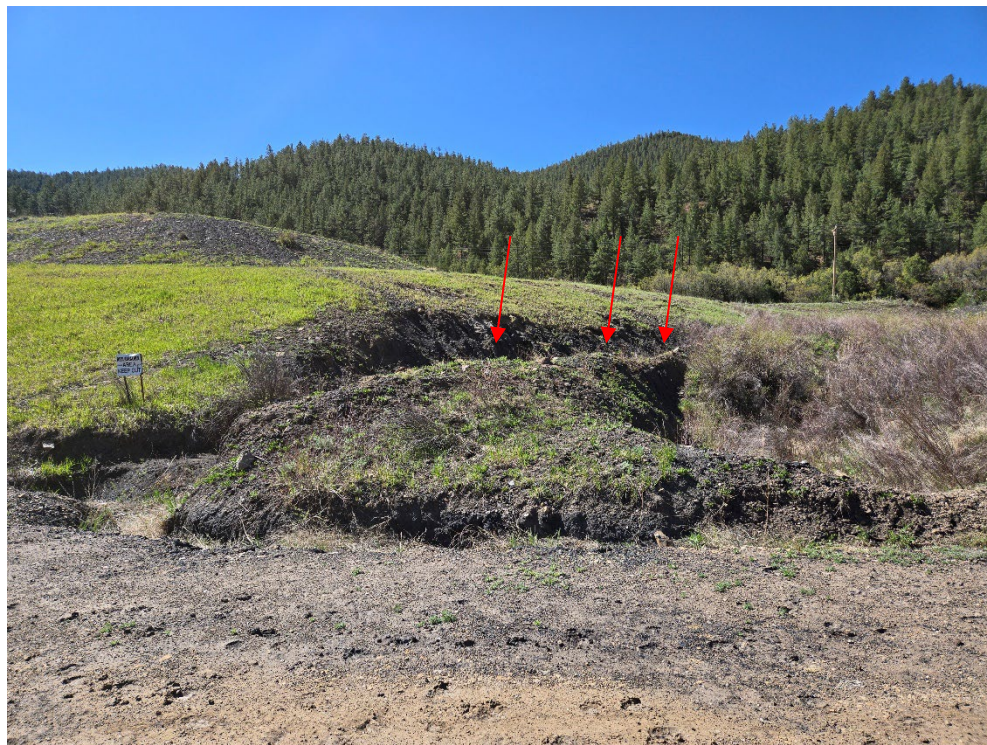
During the September 2023 inspection, it was noted that the embankment slope on the northwest side of the Soil Storage Area was eroding and sluffing into the ditch that discharges to ditch D6. NECC was instructed to repair and stabilize the area. The ditch embankment separating the affected land drainage from the adjacent clear water ditch (D7) is very thin in areas. Failure of this embankment may overwhelm the ditch and cause sediment to discharge into the clean water ditch D7 that discharges to the river. During the October 2023 inspection, the Operator stated that they had hydro-mulched the northwest side of the Soil Storage Area in an attempt to stabilize the slope. They also stated that they are unable to safely get equipment in the area to mechanically stabilize the slope and berm separating the treated water run-off from the clean water ditch. NECC had been monitoring this area. As of this December 2024 inspection, it appears that the hydro-mulching and seeding of the bench has failed, as no vegetation appears to have been established. **The Operator shall determine how to re-stabilize this bench and do so as soon as possible.**

*Photo 1: The arrow points to the eroding embankment separating the affected land drainage from the adjacent clear water ditch (D7).*

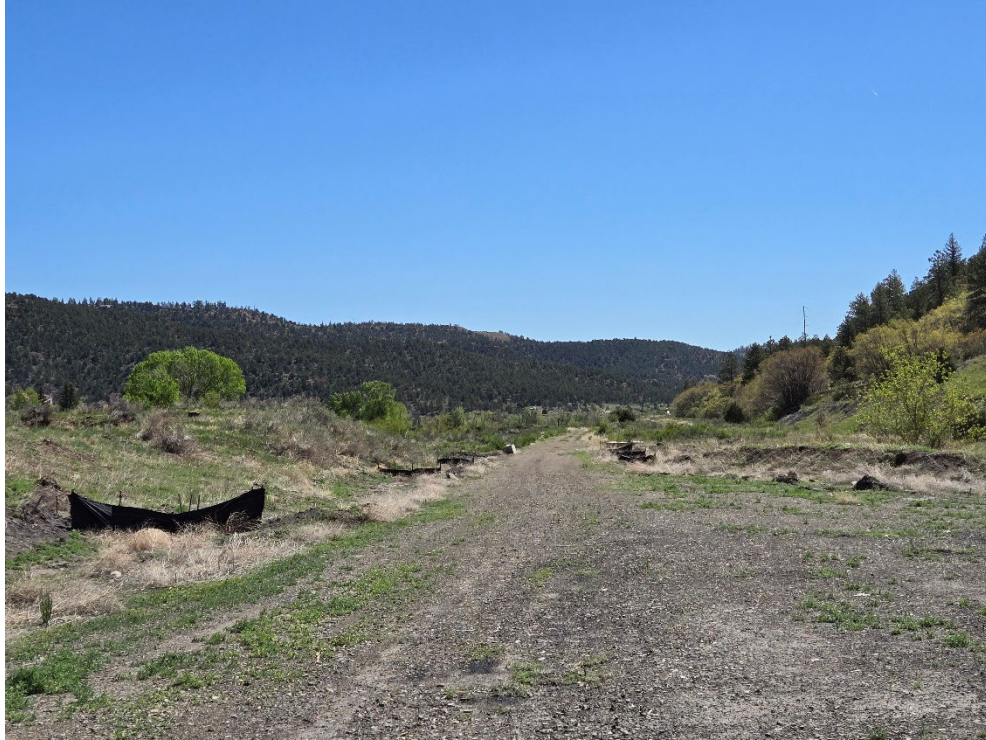
2. (January 2024 report) **The silt fences along the road in the SAE south of Pond 007 are damaged and need to be repaired.**

*Photo 2: Silt fences within S.A.E, south of Pond 007a.*

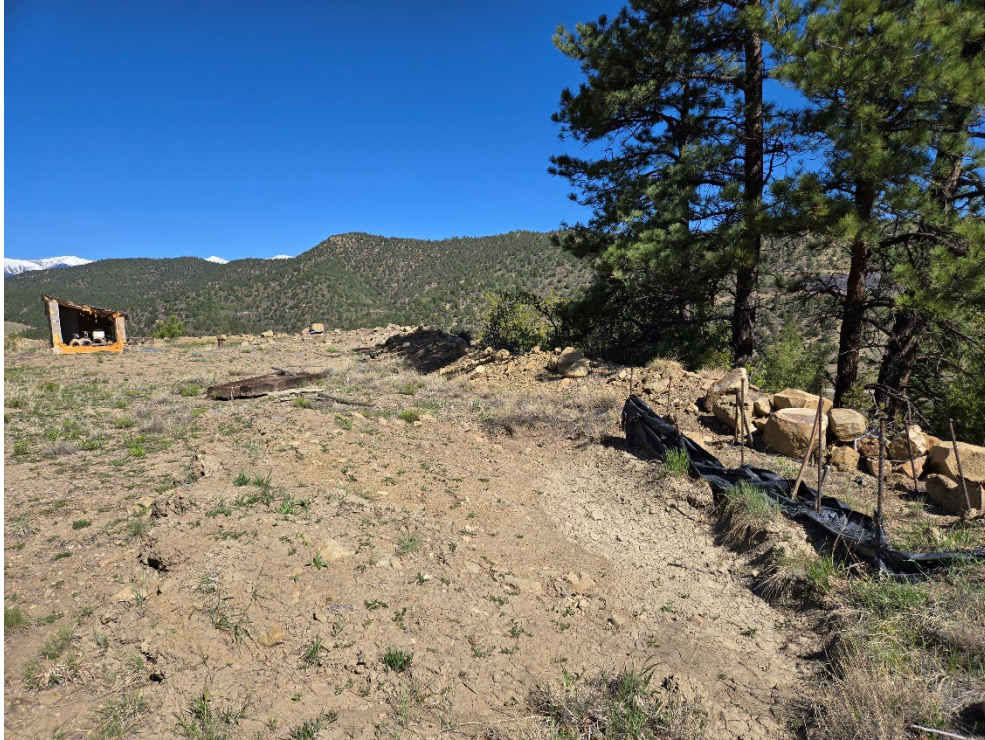
3. (February 2024) In the Stockpile Storage Area, there is a new pile of soil.
  - a. The Operator stated that the soil was salvaged during the debris clean-up work conducted during the past year in the Train Yard Area. The Operator believes that the pile contains topsoil quality soil. **If the Operator intends to salvage this material as topsoil, the topsoil pile must be stabilized with a vegetative cover (Rule 4.06.3(2)(a)(i)).**
  - b. **The Operator shall submit a Minor Revision (MR) to update *Map 11-Sheet 3: East Portal Facilities* and pages 37-41 of section 2.05 of the PAP to account for the location, source, and volume of the new topsoil pile pictured in Photo 10.**
4. (March 2024 report) **The silt fence on the western border of the S.A.E. on the top of the hill needs to be repaired.**

*Photo 3: Silt fence within S.A.E on the south side of the permit and the damaged water valve structure in Maintenance item #10 below.*

10. (December 2024 report) The water pump/valve cover structure near the water tanks on the south side of the permit has been damaged. **The Operator shall repair, replace, or remove this structure.**

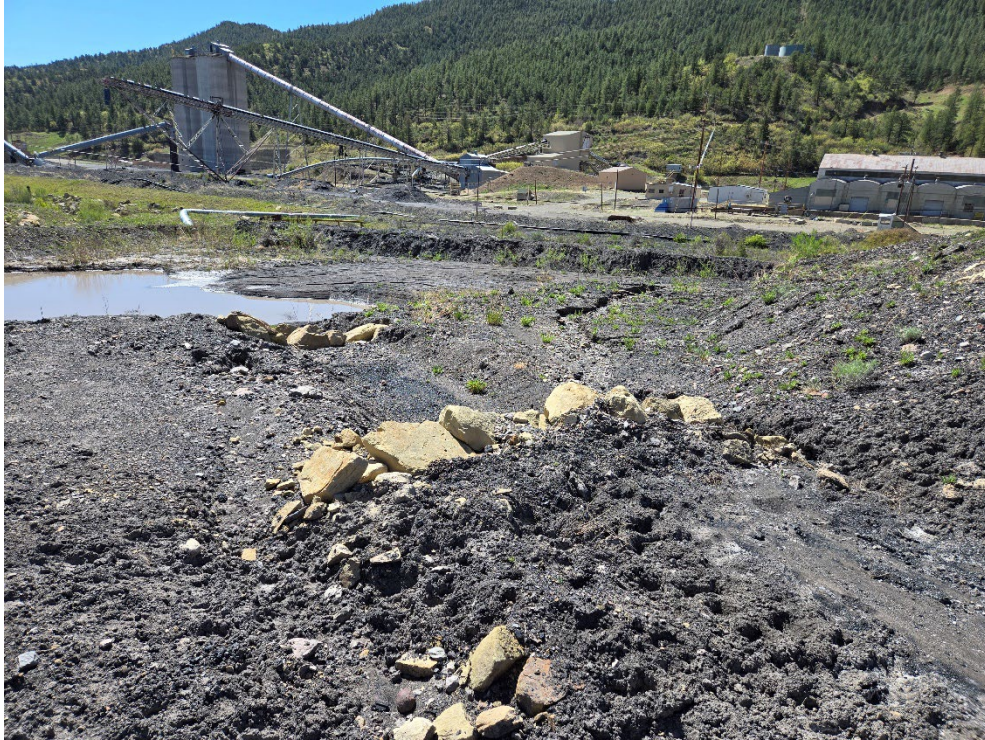
*Photo 4: Check dams on the north side of DWDA #2 leading to the sediment basin.*

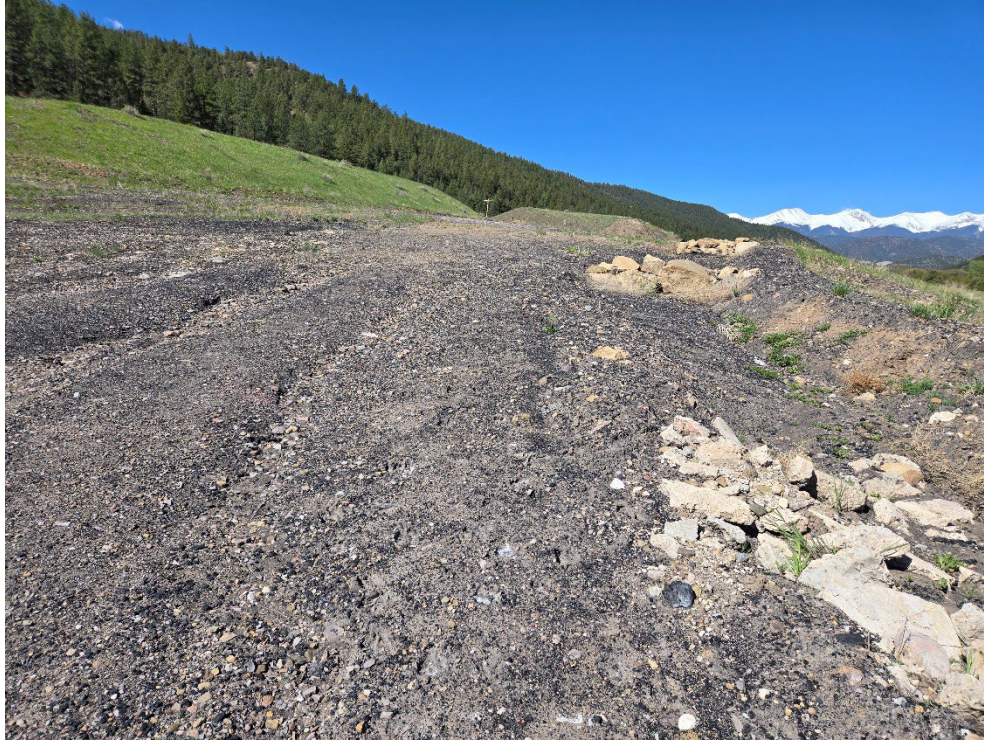
7. (October 2024 report) The check dams located along the north side of the Soil Storage Area have filled with sediment in some areas, and the sides of the check dams have begun to erode. **The Operator shall clean the check dams and stabilize the erosion.**

*Photo 5: Check dams along the north side of the soil storage area.*

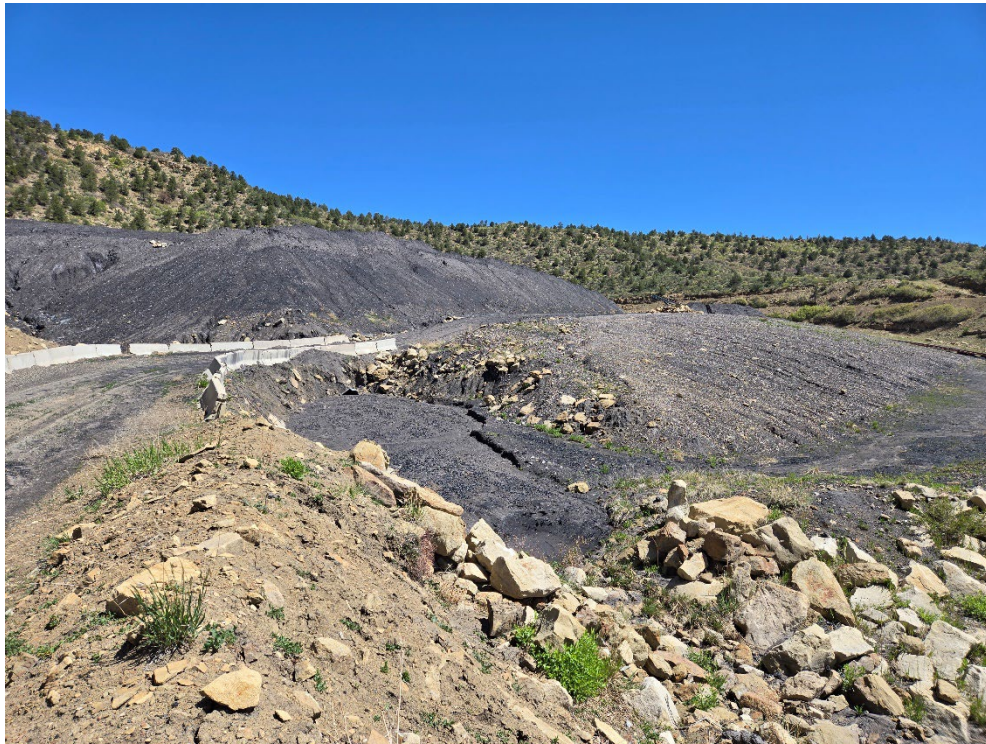
- d. The outlet side of C81 (located on the south side) has been partially filled with sediment. **The Operator shall clean sediment out of C81 and from the area around the culvert.**

*Photo 6: Sediment accumulating at the outlet of C81 from the un-reclaimed portion of the RDA and the ditches on the sides of the haul road.*

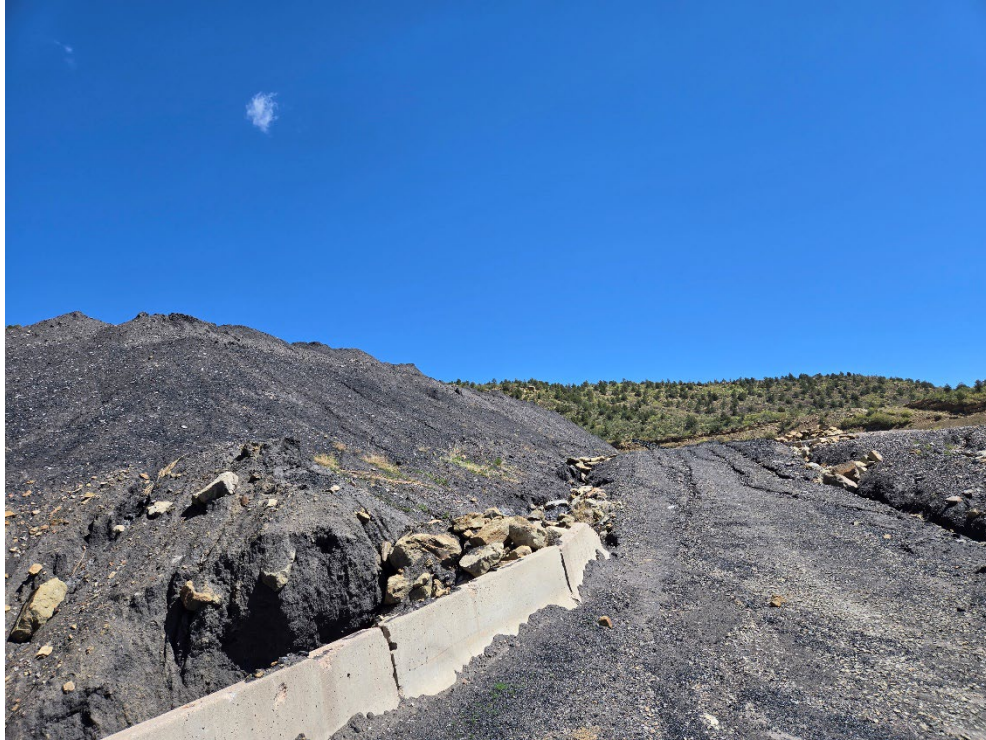
- a. Check dams line the north and south side of the road leading to the top of the RDA. These ditches along the road have filled with sediment, and many of the check dams in the ditch need to be repaired. **The Operator will need to clean the sediment from these ditches and repair the check dams.**

*Photo 8: Erosion from the un-reclaimed slope has filled the check dams along the road.*

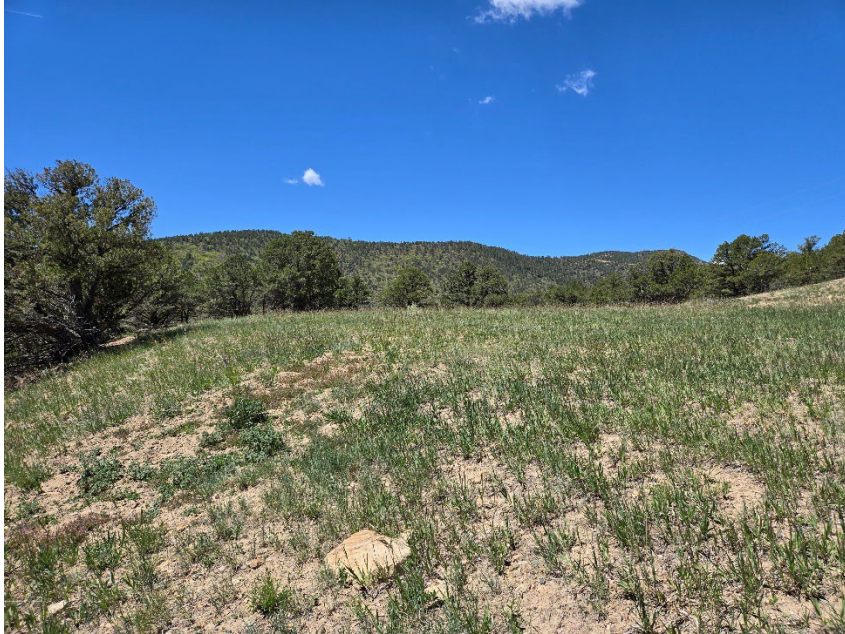
13. (December 2024 report) During the Division's June 2024 inspection, it was noted that a lot more vegetation had established since the Division observed the area in November 2023, however there were still a few bare spots. During the September 2024 inspection, the vegetation cover seemed to be recovering. As of this December 2024 inspection, the vegetation seems to have stabilized, but the Operator may want to assess the area to determine species diversity. **The Operator is advised to monitor this area and consider re-seeding if necessary.**

*Photo 9: Vegetation growth on the Golden Eagle ventilation shaft area.*

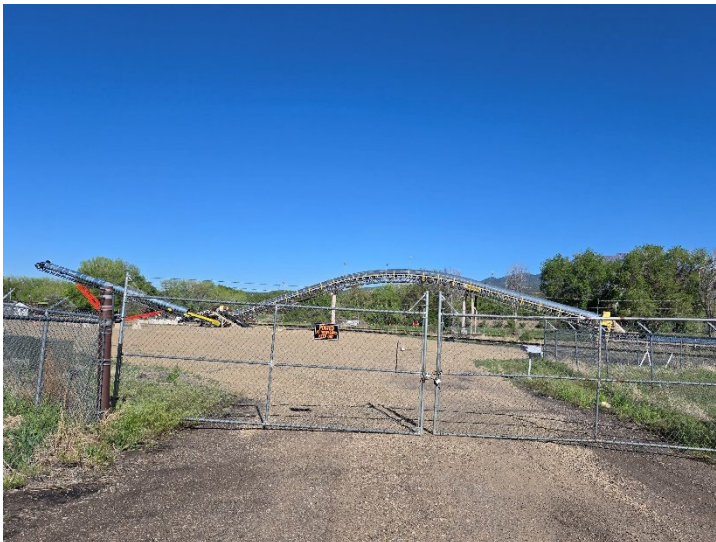
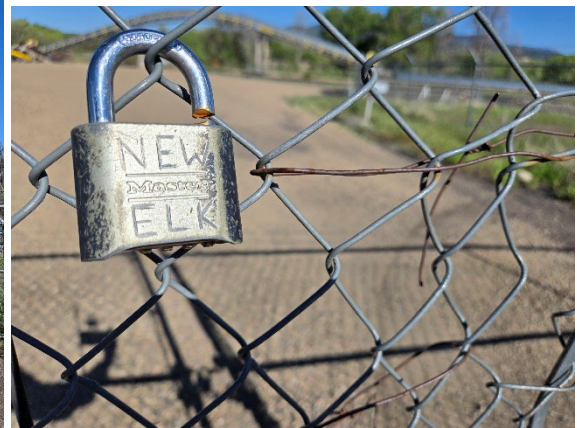
14. (December 2024 report) The Portable Explosives and Chemical Storage area was overall stable. However, the Division observed an empty tank in the ditch to the east of the storage area. **The Operator shall remove the tank from the ditch.**
15. (December 2024 report) Jansen Loadout:
  - a. The mine sign is no longer posted at the Jansen Loadout. Therefore, **the Operators shall post a new sign at the Jansen Loadout to comply with the requirements of Rule 4.02.**

*Photo 10: Entrance gate to the Jansen Loadout. The New Elk permit signs have been removed, and the New Elk lock has been cut.*

- b. Once an Operator for the New Elk permits is restored, they will need to clarify to the Division through a revision, the operational status of the Jansen Loadout in regard to the mining operation.**

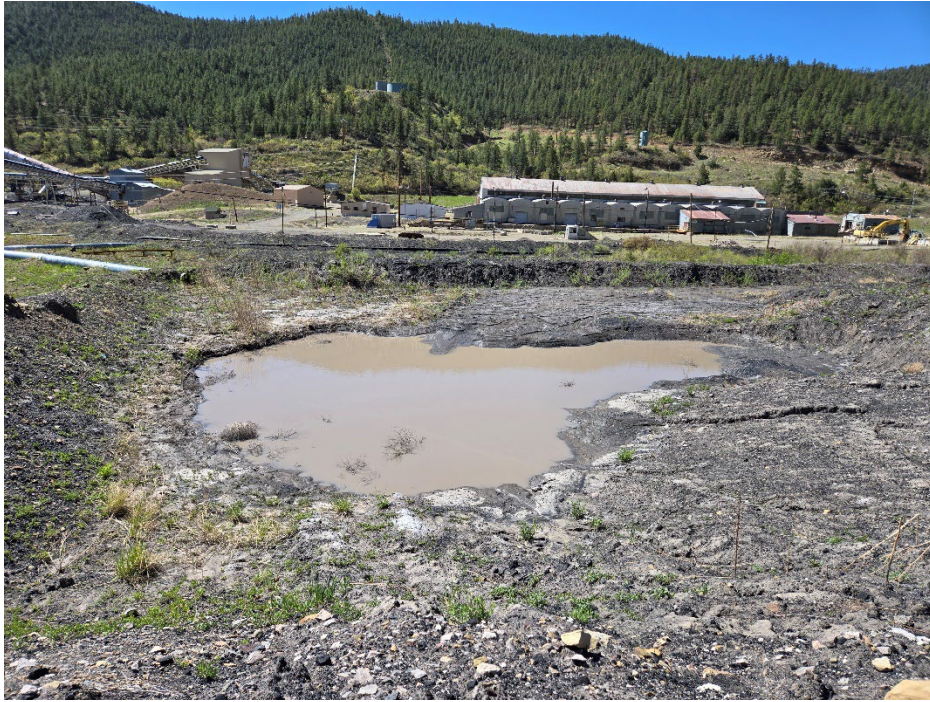
- The sediment basin at the east end of DWDA #2 held water at the time of the inspection.
- No signs of erosion were observed along the slopes of DWDA #1. The slopes appear to be well vegetated and stable.
- The Division walked along ditches D3 and D4 on the west and south sides of DWDA #1. The berms on the outside of these ditches appeared to be intact with no observed erosional areas.

*Photo 11: Water in the sediment basin on the east side of DWDA #2.*

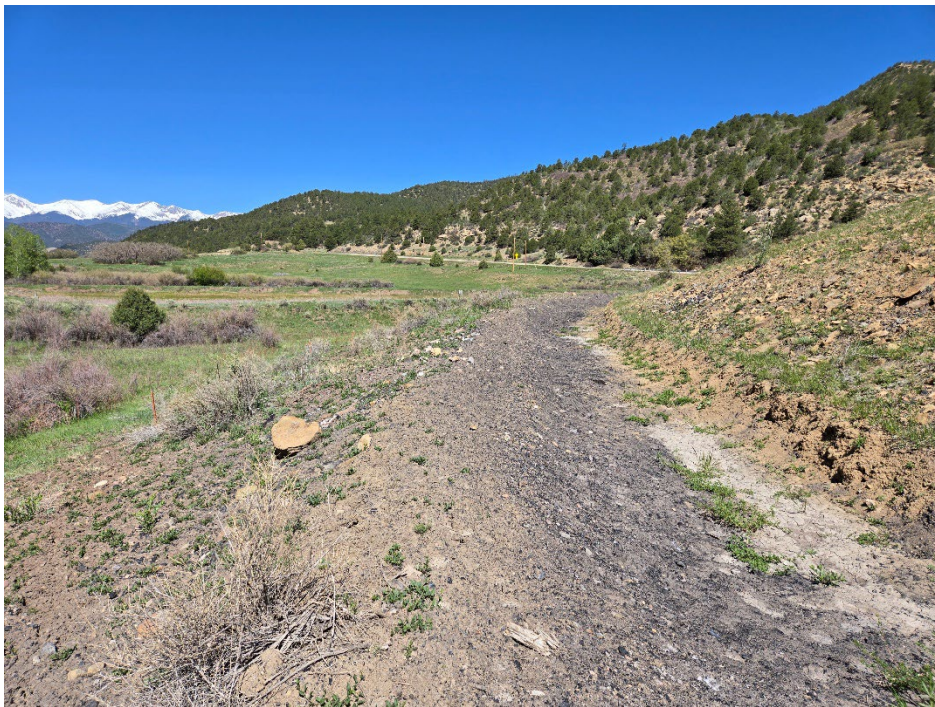
*Photo 12: Looking along ditch D3.*

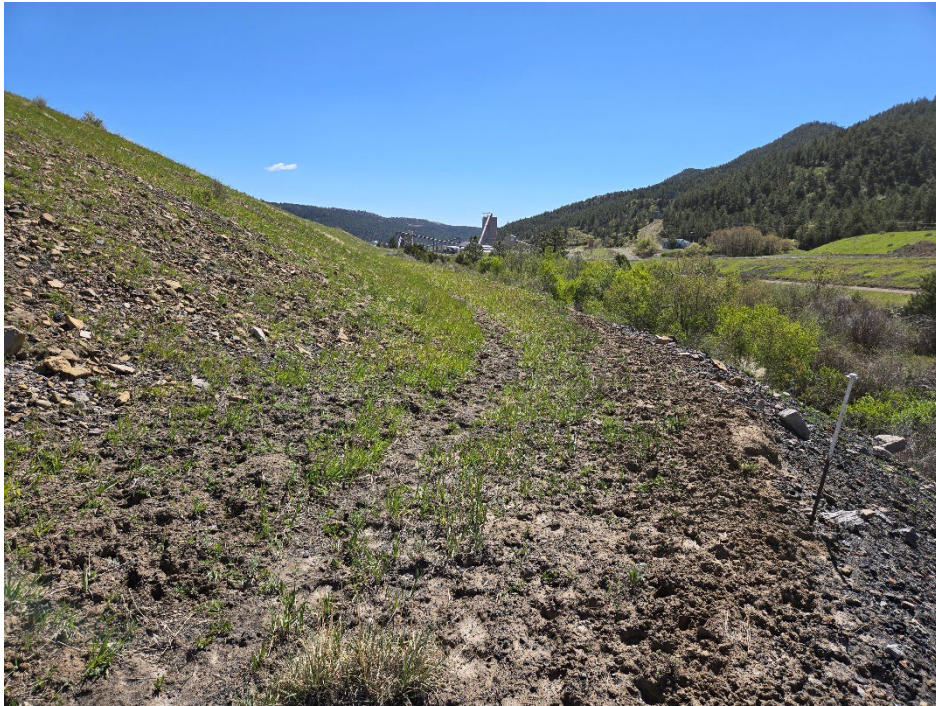
*Photo 13: Looking along ditch D4.*

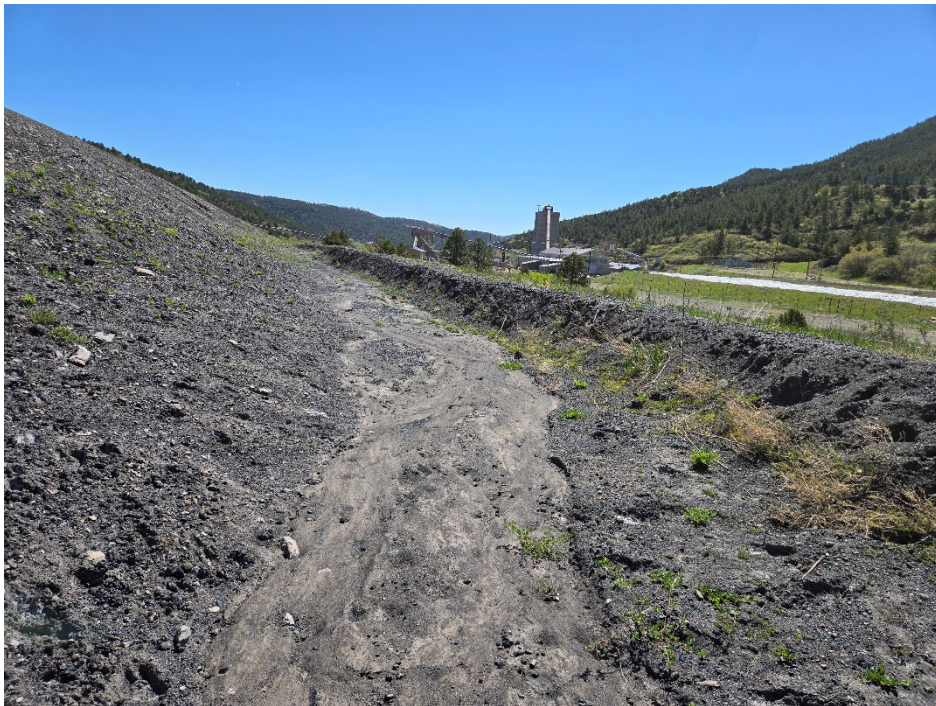
- The Division walked along ditch D14 on the west and south sides of DWDA #2. The berms on the outside of these ditches appeared to be intact with no observed erosional areas.

*Photo 14: Looking along ditch D14.*

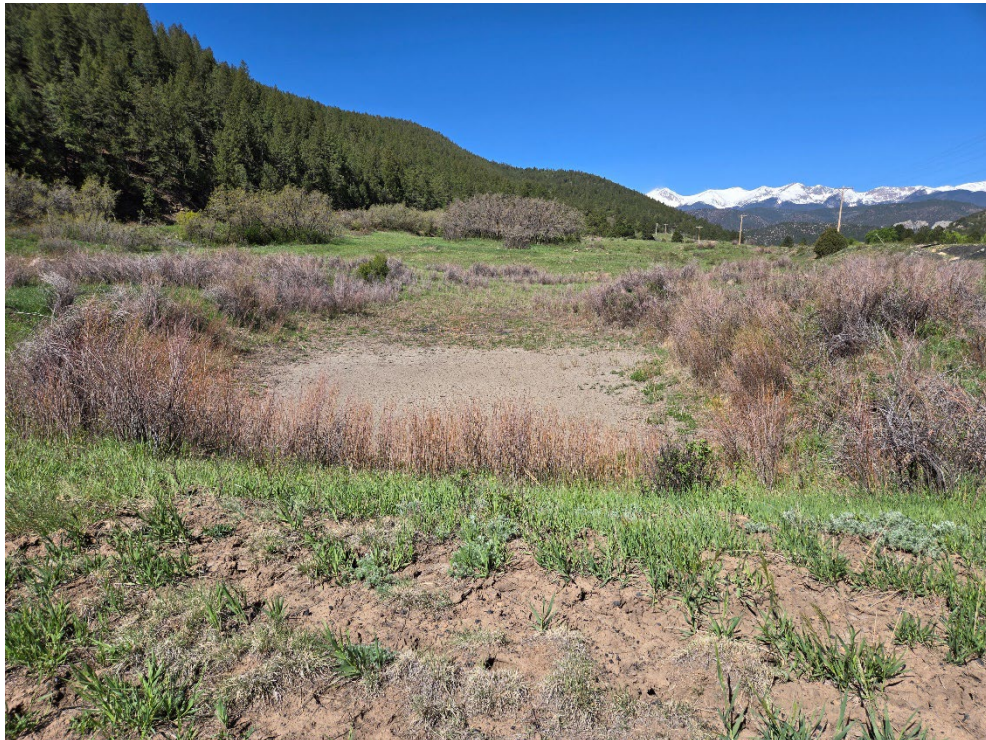
*Photo 15: Containment area #1.*

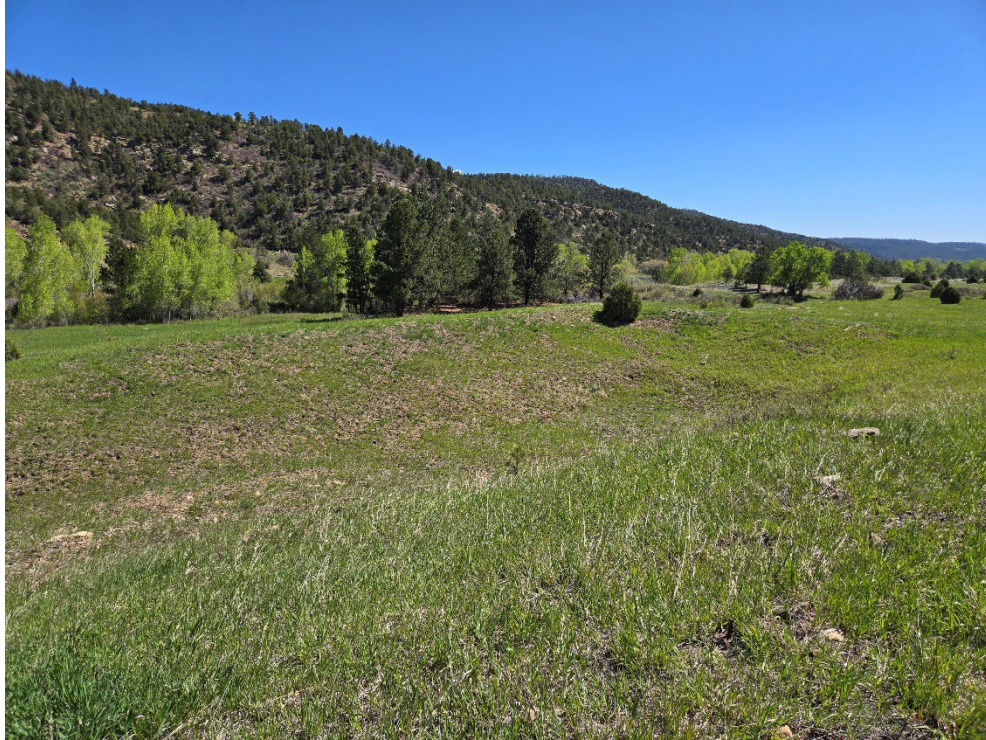
*Photo 16: Containment area #2.*

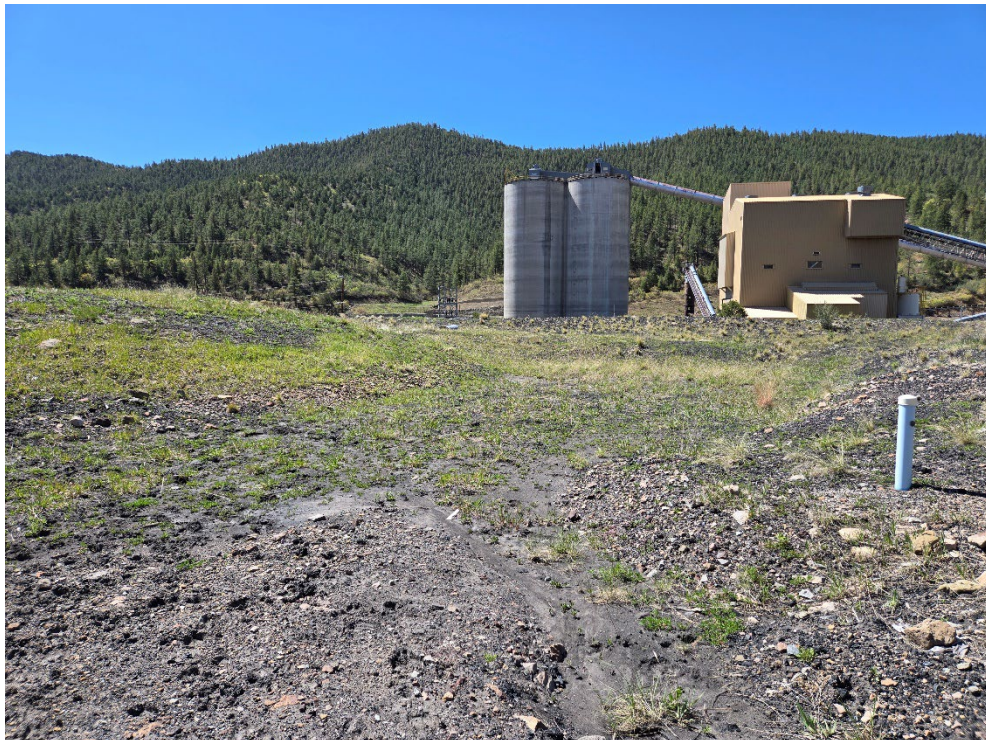
*Photo 17: Containment area #3.*

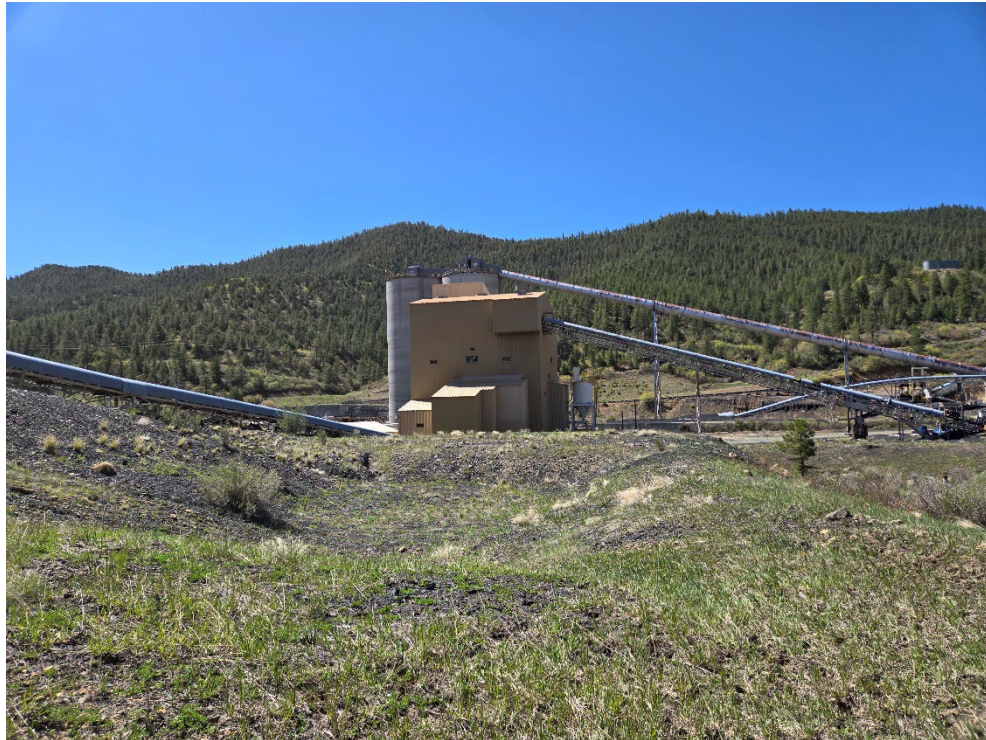
*Photo 18: Containment area #4.*

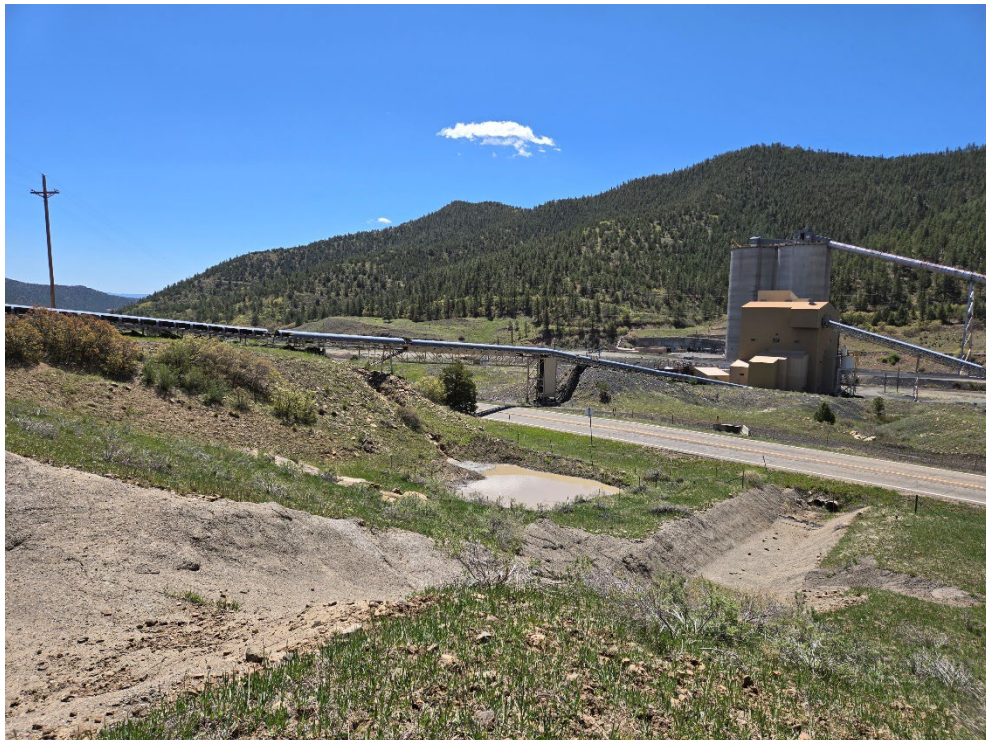
- Containment area #1 was dry.
- Containment area #2 was dry.
- Containment area #3 was dry.
- Containment area #4 was dry.
- Containment area #5 contained water and was still below capacity.

*Photo 19: Containment area #5.*

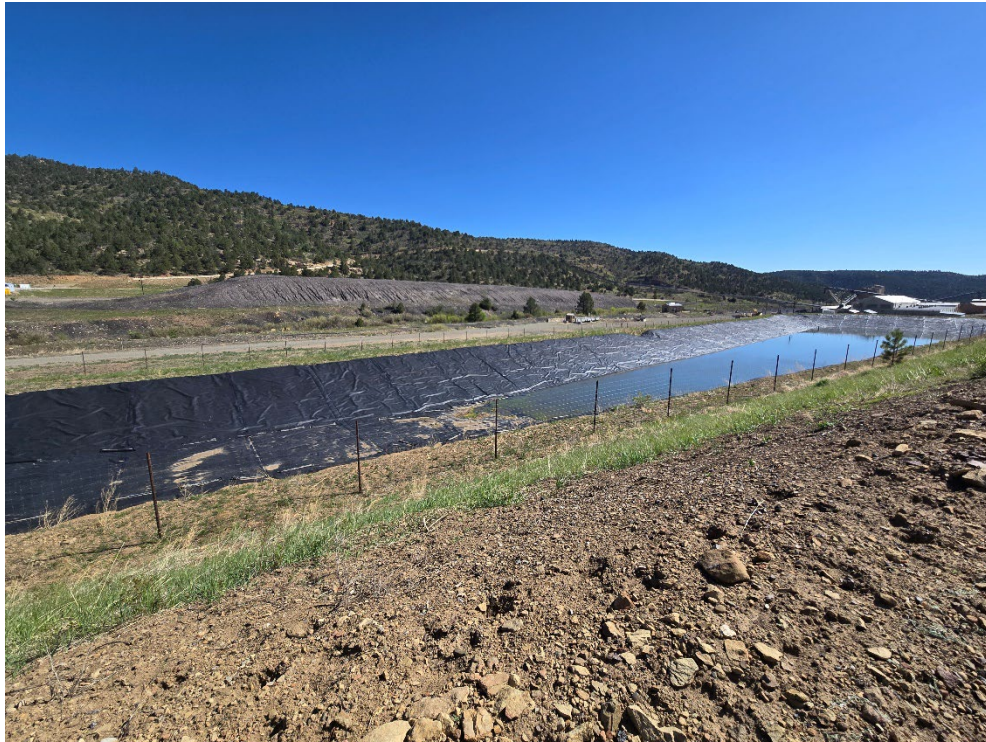
*Photo 20: Pond 001A.*

- Pond 001A held some water at the time of the inspection. No tears were observed in the pond lining.
- Pond 004A contained a small amount of water located within the southeast corner.
- Pond 006A contained some water at the time of the inspection. The banks of the pond appeared to be stable.
- The water was high in Pond 007A at the time of the inspection but had plenty of capacity before reaching the blue marker on the white PVC pipe. The water was above some of the holes in the principal spillway, but the pond was not discharging. The banks appeared stable and the emergency spillway was clear.
- Pond 08 contained some water at the time of the inspection and was below its capacity. The spillways appeared clear, and the banks were stable. Pond 08 was not discharging.

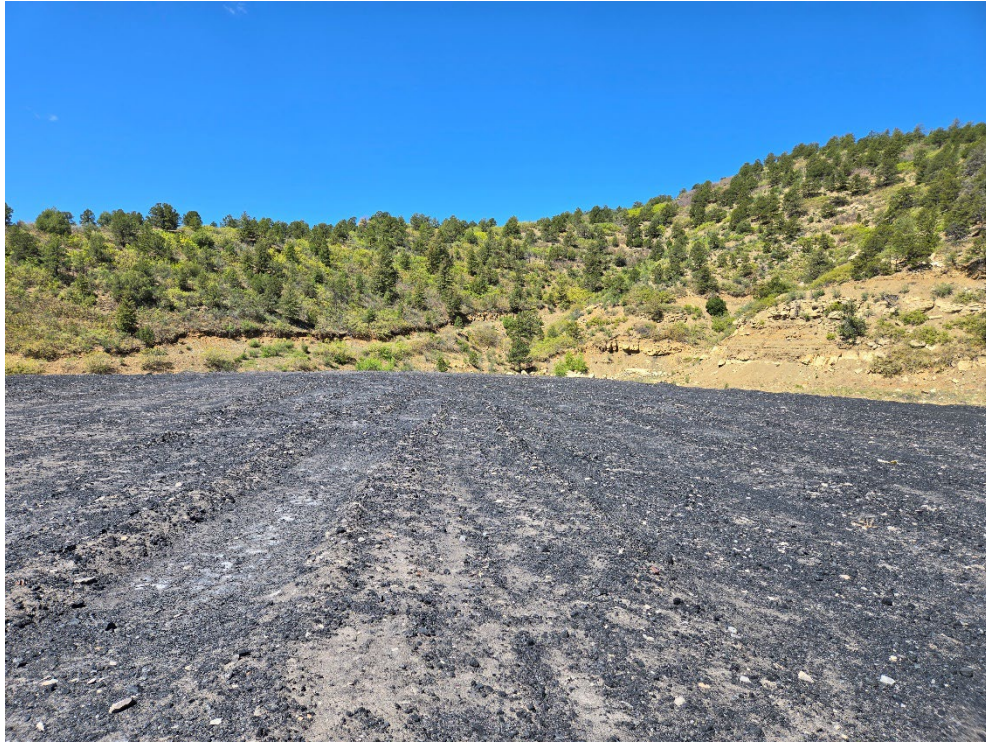
- The mine was idle at the time of the inspection. Therefore, the wash plant was not processing coal at the time of the inspection. The RDA appears to exhibit positive drainage at this time.
- The reclaimed slopes on the RDA appear to be well vegetated and stable. No signs of erosion on the reclaimed slopes were observed during the inspection.
- **See Ongoing Maintenance Items 11 and 12**

*Photo 25: Positive drainage on the RDA slope within the un-reclaimed area on the north side of the RDA.*

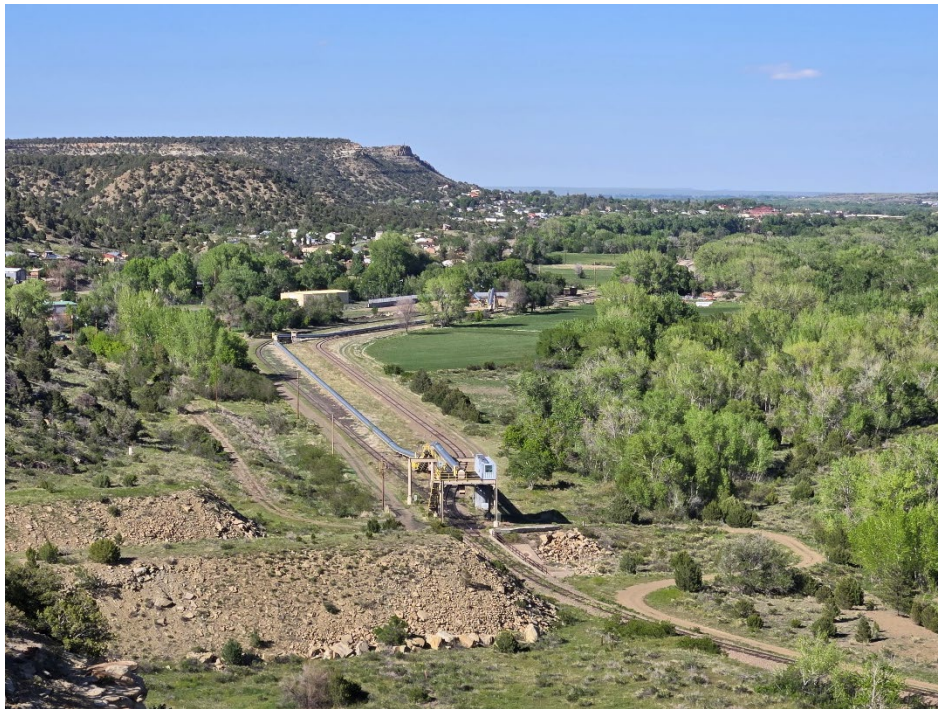
- The facilities at the Jansen Loadout were **unable to be observed**. The current Lessee of the loadout facility area was contacted after the inspection to verify the combination for the current lock on the gate. The Division does have the correct combination, but the lock sometimes sticks. The Division was unable to access the site during this inspection, but was told to contact the current Lessee if there are issues accessing the area in the future.
- **See Ongoing Maintenance Item # 15.**

*Photo 26: Overview of the Jansen Loadout from the Trinidad Lake dam.*
