MINERALS PROGRAM INSPECTION REPORT
PHONE: (303) 866-3567

MINE NAME: Nahcolite Project	MINE/PROSPECTING ID#: M-1983-194	MINERAL: Carbonates	COUNTY: Rio Blanco
INSPECTION TYPE: Monitoring	WEATHER: Clear	INSP. DATE: June 3, 2025	INSP. TIME: 09:00
OPERATOR: Natural Soda LLC	OPERATOR REPRESENTATIVE: Jamie Reck	TYPE OF OPERATION: 112d-3 - Designated Mining Operation	
REASON FOR INSPECTION: Normal I&E Program	BOND CALCULATION TYPE: None	BOND AMOUNT: \$4,466,425.00	
DATE OF COMPLAINT: NA	POST INSP. CONTACTS: DRMS	JOINT INSP. AGENCY: U.S.BLM	
INSPECTOR(S): Amy Yeldell	INSPECTOR'S SIGNATURE:

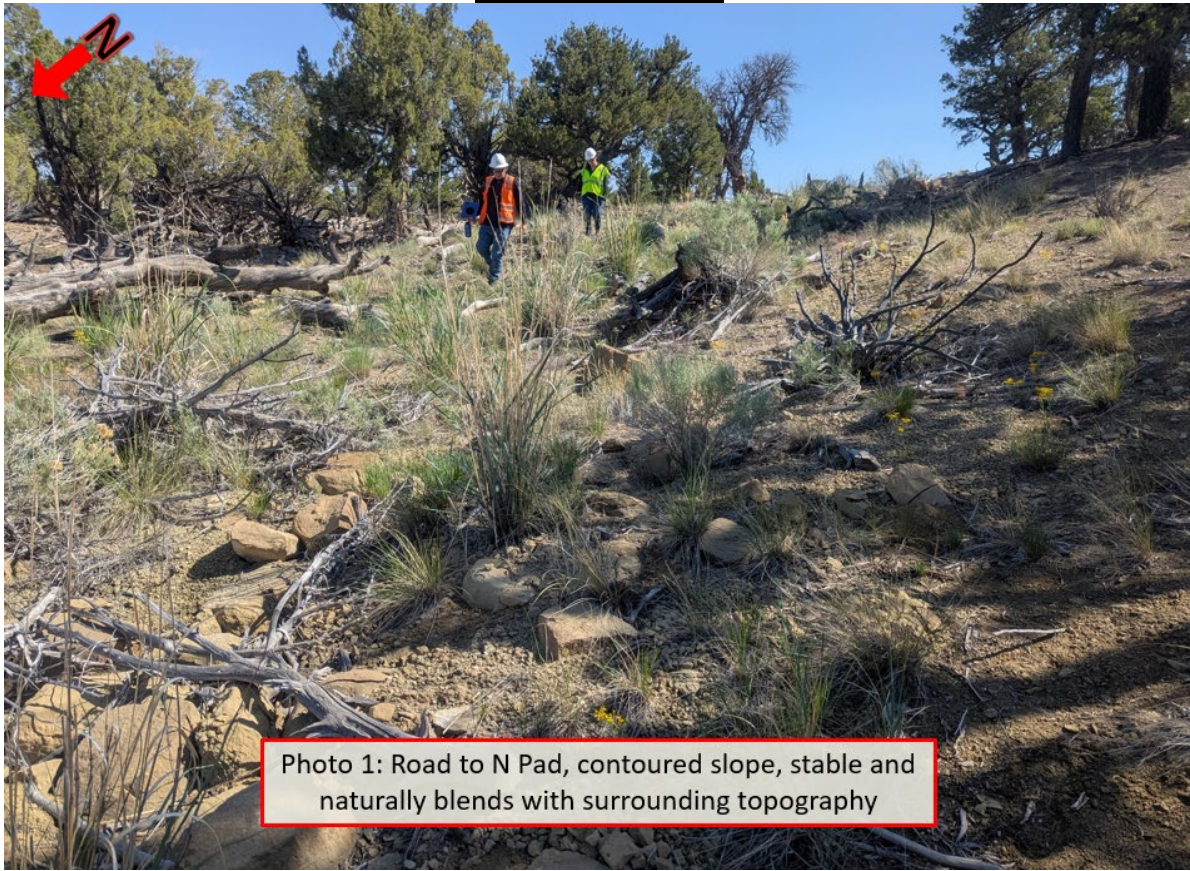
All backfilling and grading have been completed. Topography naturally blends with the surrounding reclaimed areas. Slopes generally have been graded to a 3H: 1V or less where possible and are easily traversable by livestock and wildlife. Exceptions to this are where slopes go through dry creek beds that once had culverts for crossing or following existing contour requires a steeper grade, Photo One. These steeper slopes are stable

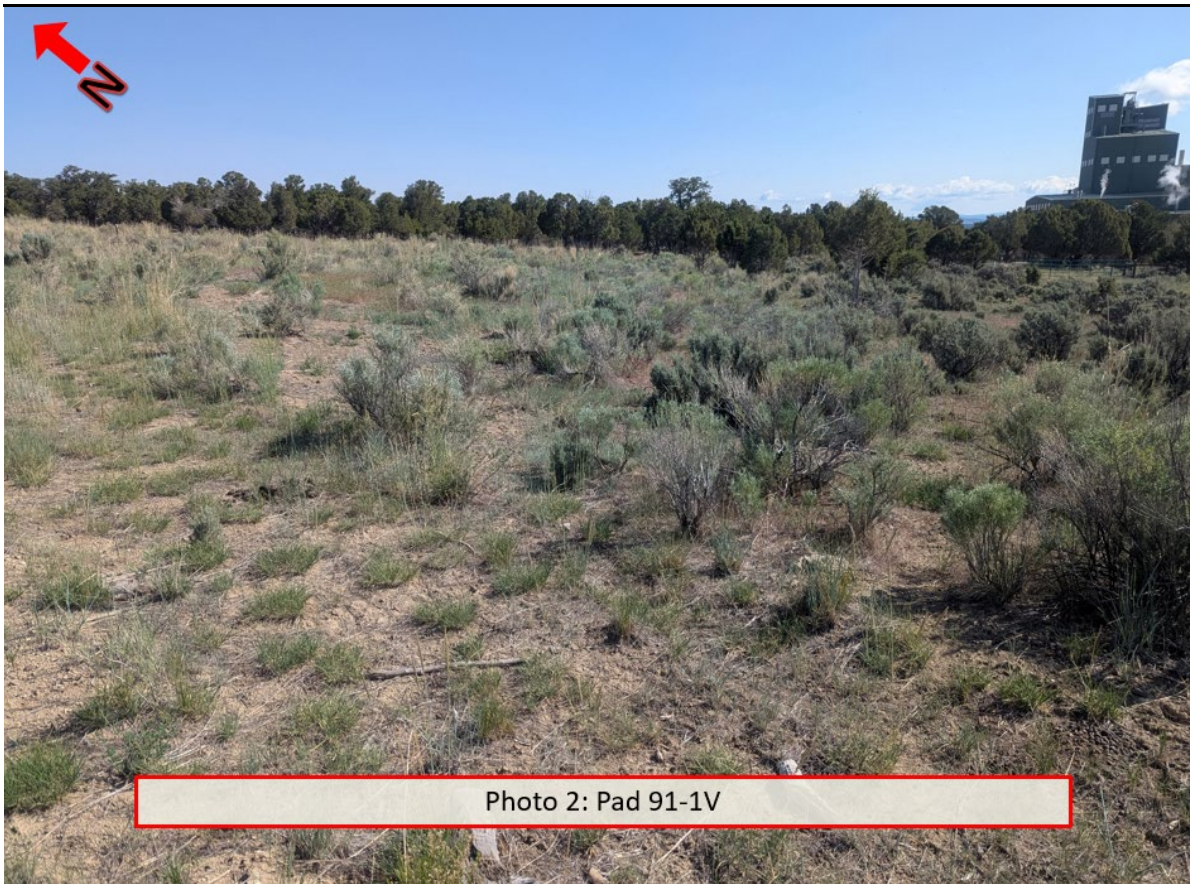
Abandoned wells 91-1V, 93-3V and 4-2V (in order from SE to NW) are all located on one long connected pad. The lower SE portion of the pad consists of more perennial grasses and some smaller shrubs, Photo Two. Overall cover is estimated to be 70%. Large shrubs are sparse and only a few forbs were observed. Cheat grass was observed but it would be considered sparse and spotty with less than 5% over composition. No other noxious weeds were observed. As you work your way uphill to the NW vegetation composition shifts to a more mid seral stage. Vegetation becomes predominantly shrubs that are much larger with limited desirable understory. Desirable cover is significantly less as compared to the lower areas. Most areas between shrubs are cheat grass (weeds), Photo Three. On the south side is the reclaimed access road to the core holes, Photo Four. Vegetation along this corridor is slightly less as it has been reclaimed for a shorter time, but it follows the same trend described above.

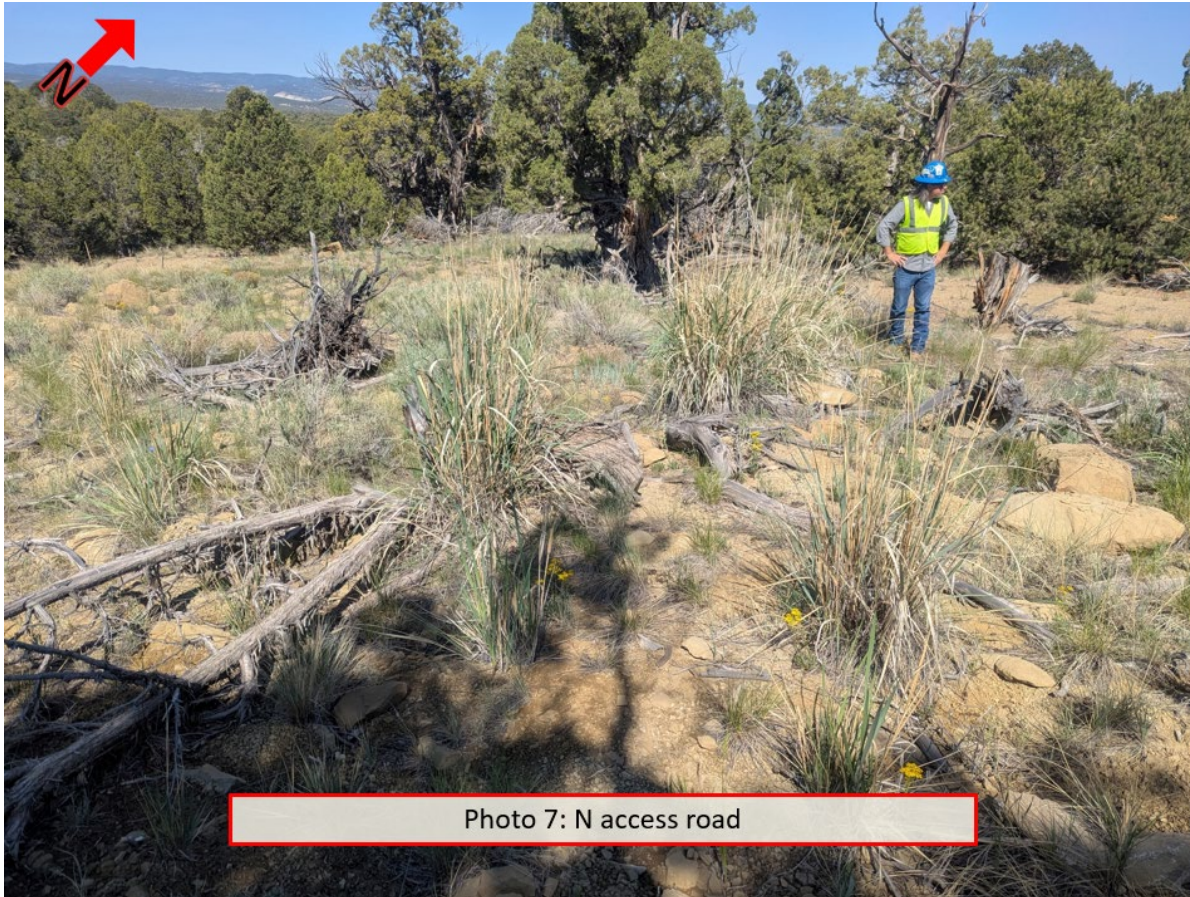
Photo 7: N access road

Moving along the Road to Pad N vegetation began to decline. In addition to cheatgrass other undesirable weeds were observed. Vegetation was either nearly all desirable and on its way to successful reclamation or almost entirely noxious weeds with a few shrubs, Photos Seven and Eight. In general, the areas in the trees fared better compared to the open areas appearing to be more heavily impacted by cheatgrass. Reclamation success on the N Pad varied. Areas with more developed shrubs had a monoculture of cheatgrass and the understory. If shrubs were low or non-existent more perennial grasses were found with significantly lower amounts of noxious weeds.

Moving forward ongoing management of Cheatgrass and other undesirable species is necessary. The Operator (and their sprayer) should employ multiple surveys/treatments throughout the year. Specifically, cheatgrass is a cool season bi-annual meaning it germinates very early spring and sometimes again in the late fall if there is adequate moisture. Most other grasses are late spring and early summer. Waiting to treat the cheatgrass the same time as other noxious weeds will result in missing the effective window. Additionally, cheatgrass is a considered prolific seed producer which is how it outcompetes. Seed is commonly viable for 2-3 years if not longer, so treatment over several years is necessary to make progress. The Division acknowledges that NSI sites may be the "sink" not the "source" however undesirable species are inhibiting successful reclamation and thus need to be managed.

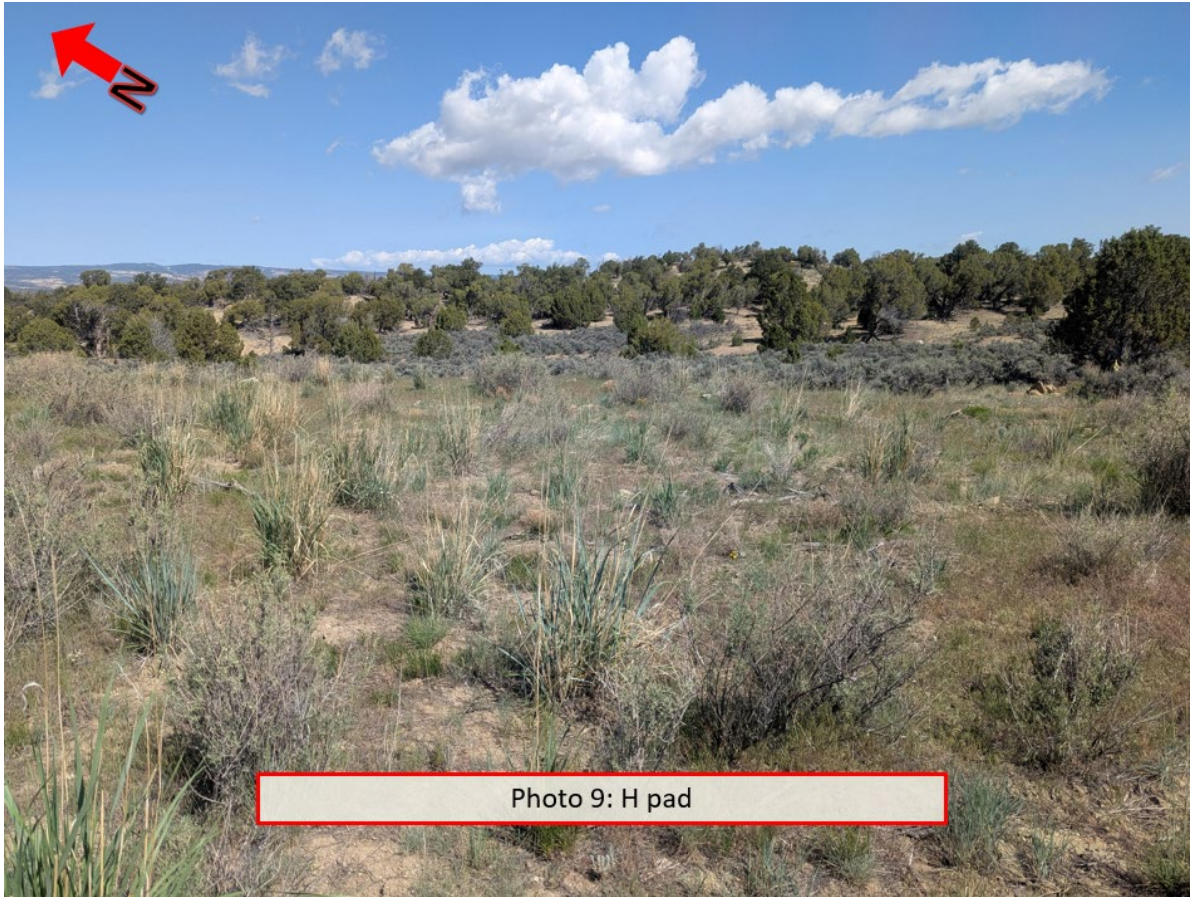
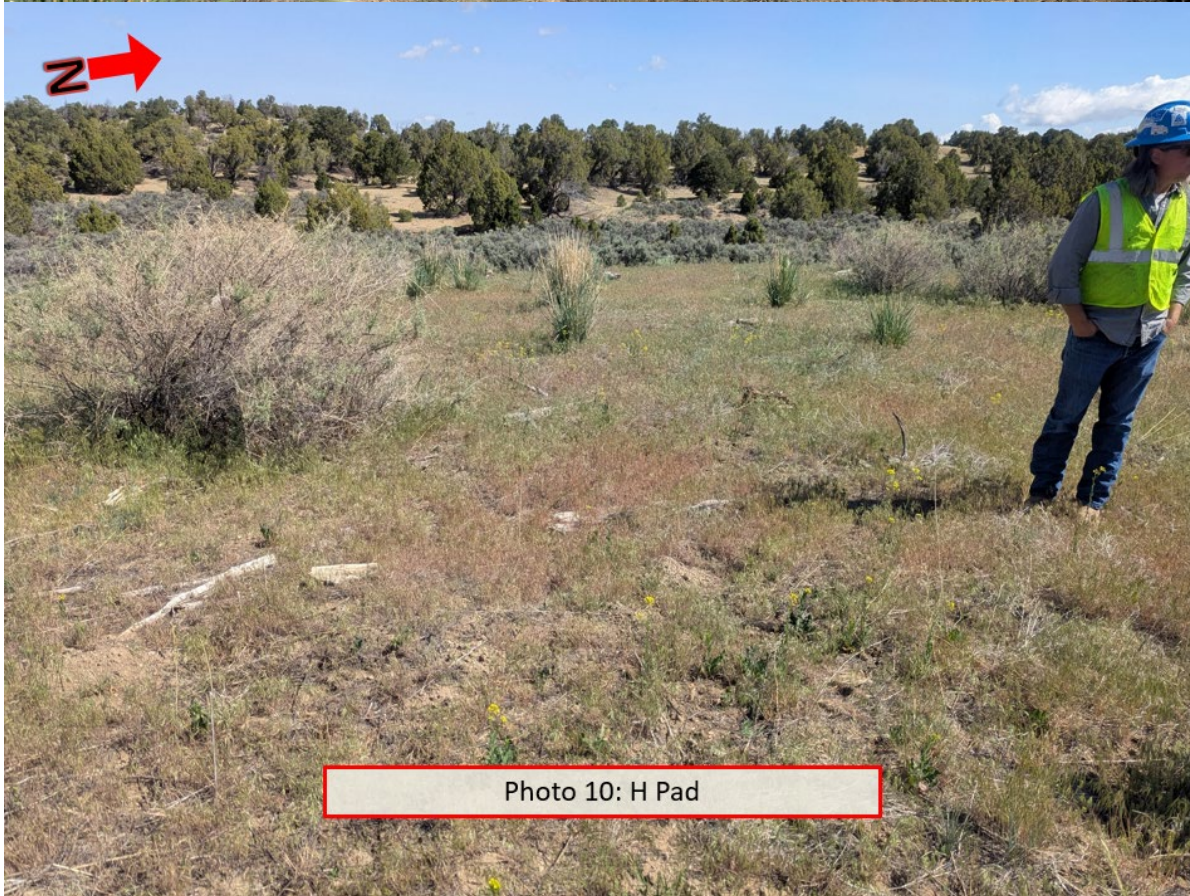
Next the Road to H pad was similar to the N Pad Road. In general, the areas seemed to be more arid with a lower overall density. Areas with developed shrubs had a higher density of noxious weeds. Northern exposure or areas in the trees tended to have more grasses and less shrubs with more desirable cover. The H Pad itself had the highest density of cheatgrass of all the pads and roads observed. There was a mix of large perennial grasses and shrubs with wide spacing. The understory was either bare ground or cheatgrass, Photos Nine and Ten.

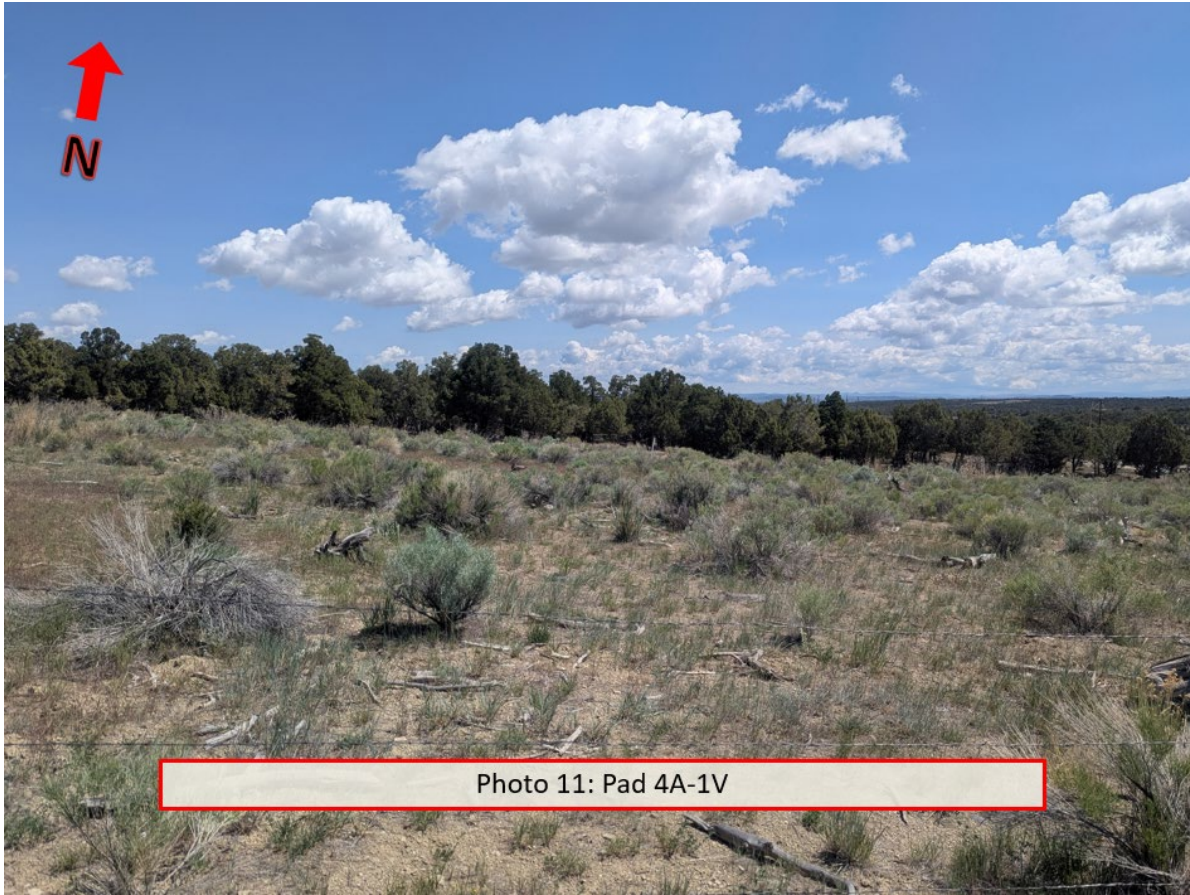
Lastly the large pad which contains 91-2H, 93-4H, 4A-1V and 4A-4V were briefly observed. In general vegetation appeared to be comparable to 93-3V. Some cheatgrass was observed but vegetation has not progressed to mid seral and perennial grasses are still more abundant than shrubs, Photo Eleven.
