MINERALS PROGRAM INSPECTION REPORT
PHONE: (303) 866-3567

MINE NAME: Section 25 Sand Mine	MINE/PROSPECTING ID#: M-2025-015	MINERAL: Sand	COUNTY: Weld
INSPECTION TYPE: Preoperation Inspection	WEATHER: Clear	INSP. DATE: June 5, 2025	INSP. TIME: 10:00
OPERATOR: 70 Ranch, L.L.C.	OPERATOR REPRESENTATIVE: Kyle Regan	TYPE OF OPERATION: 112c - Construction Regular Operation	
REASON FOR INSPECTION: Preoperation Inspection	BOND CALCULATION TYPE: Partial Bond	BOND AMOUNT: \$0.00	
DATE OF COMPLAINT: NA	POST INSP. CONTACTS: None	JOINT INSP. AGENCY: None	
INSPECTOR(S): Patrick Lennberg	INSPECTOR'S SIGNATURE:

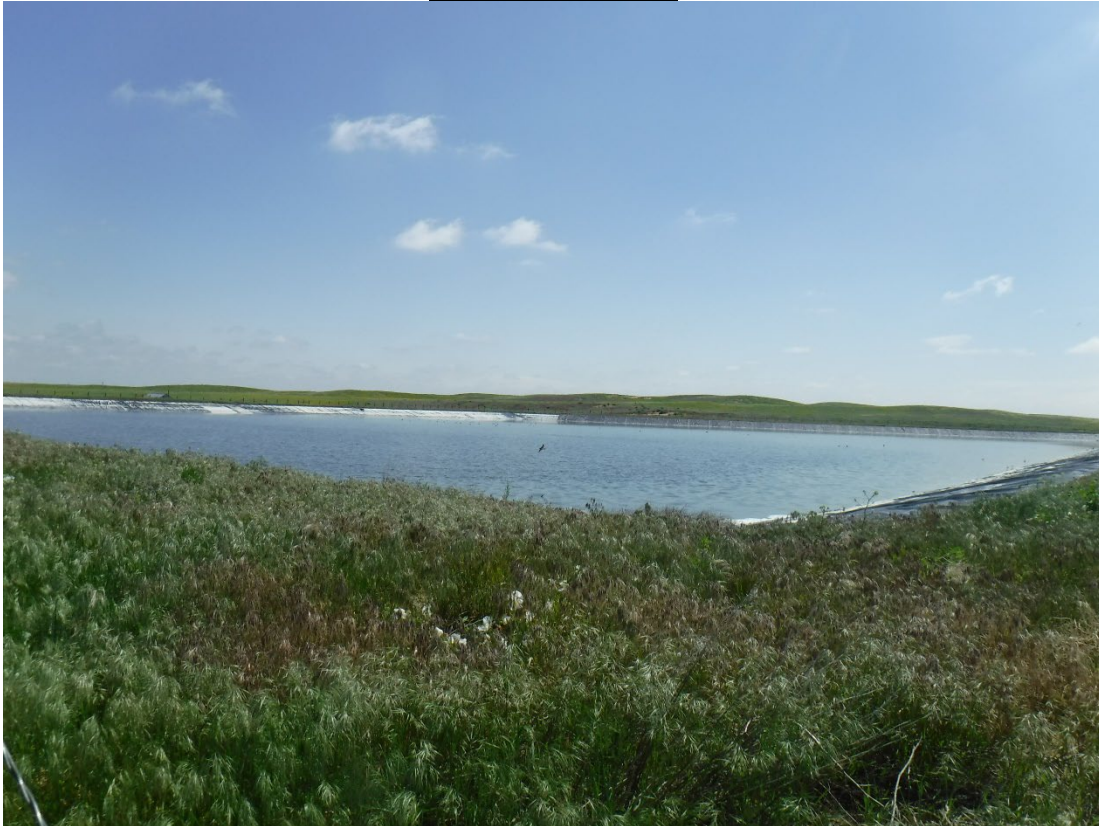
Photo 1: Lined water pond within permit boundary that will be used as a source of water for the site.

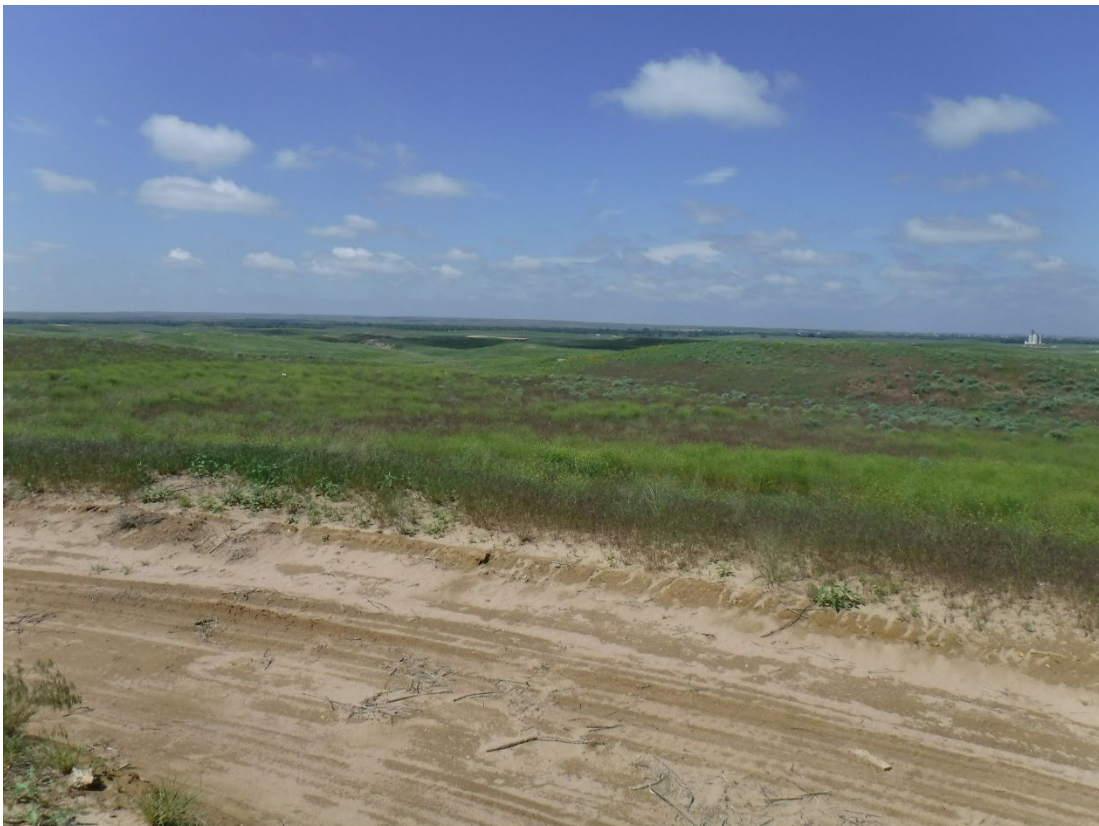
Photo 2: Looking southwest across the site from the from SW corner of pond.

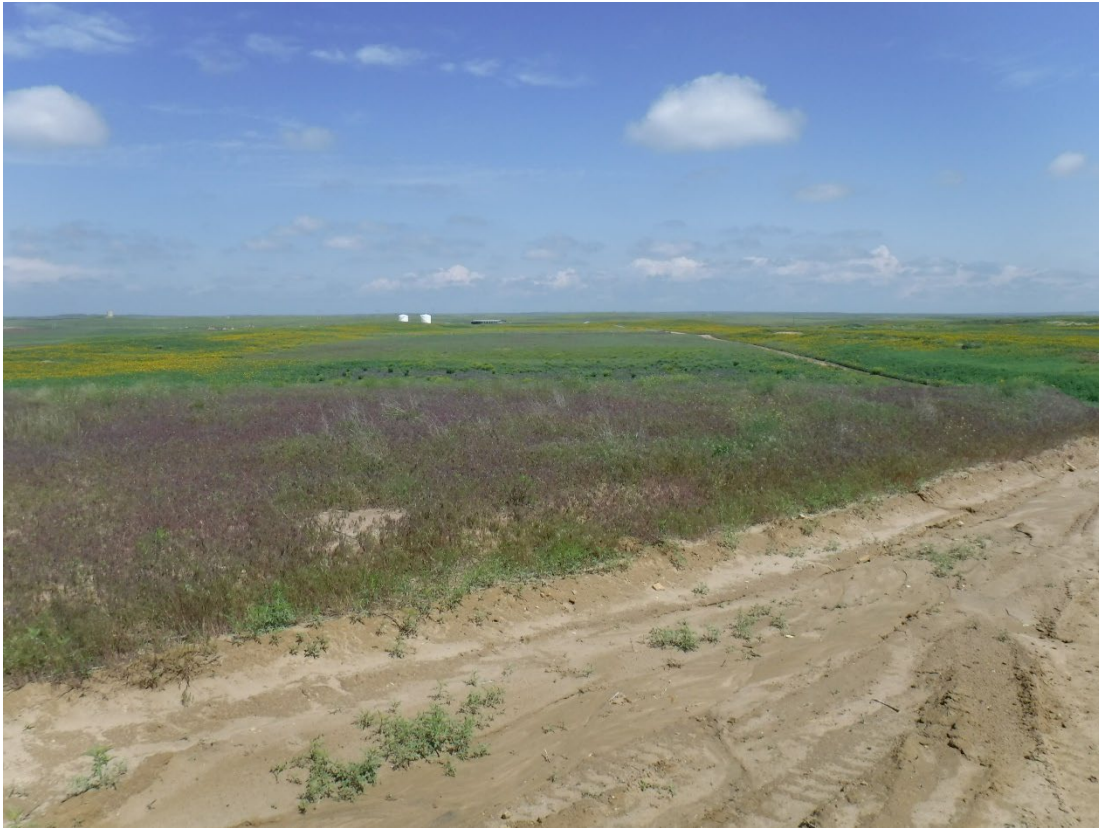
Photo 3: Looking north across the site from the from NW corner of pond, the primary access road to site center right of photo.

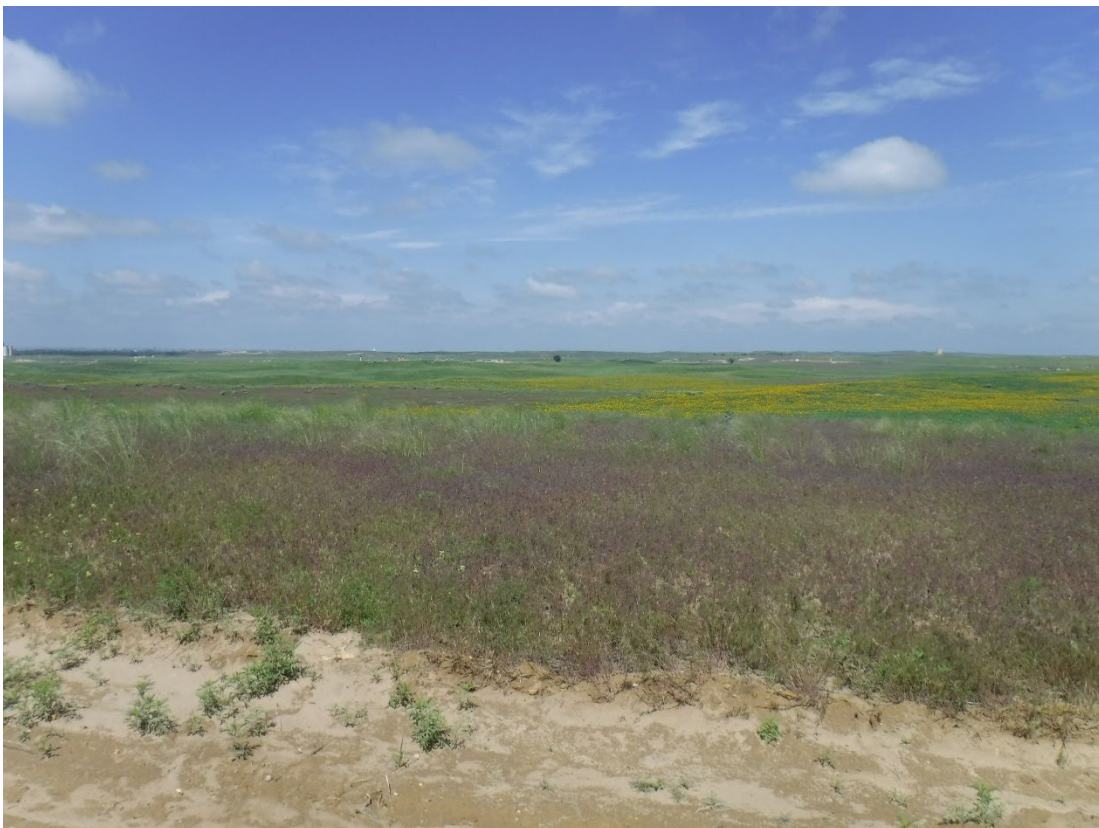
Photo 4: Looking west across the site from the from NW corner of pond.

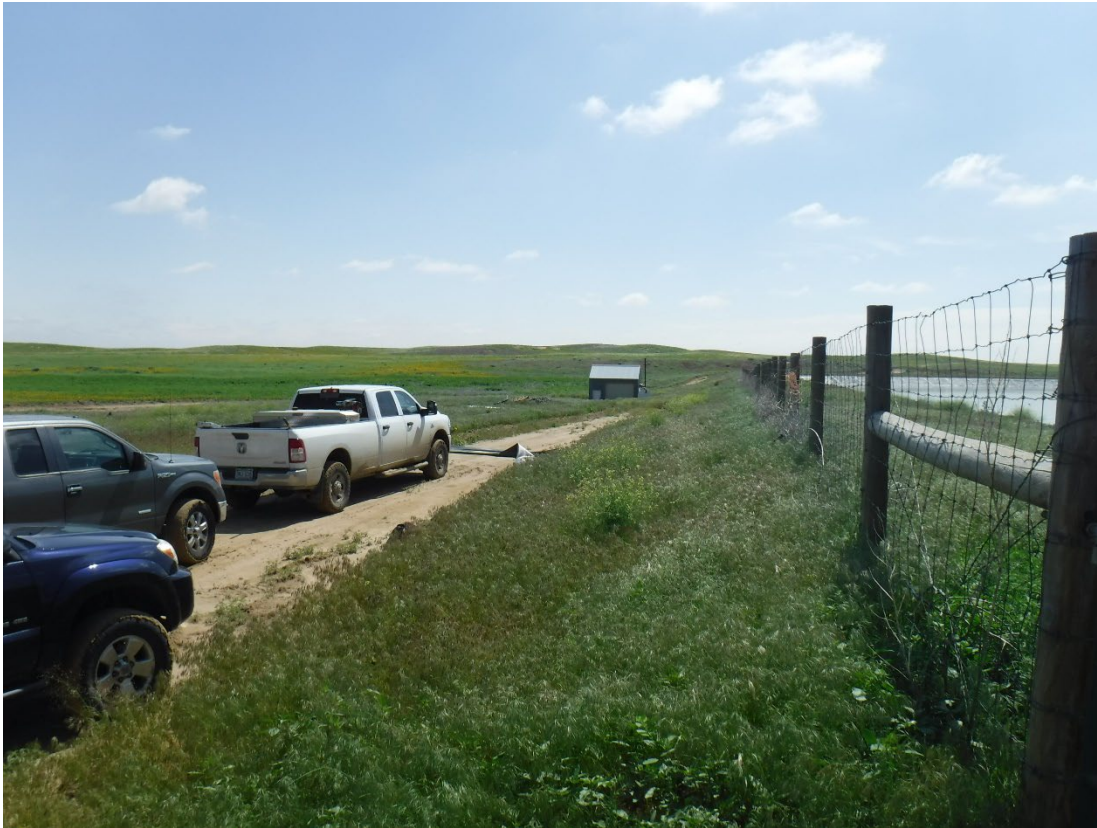
Photo 5: Looking east from NW corner of pond.

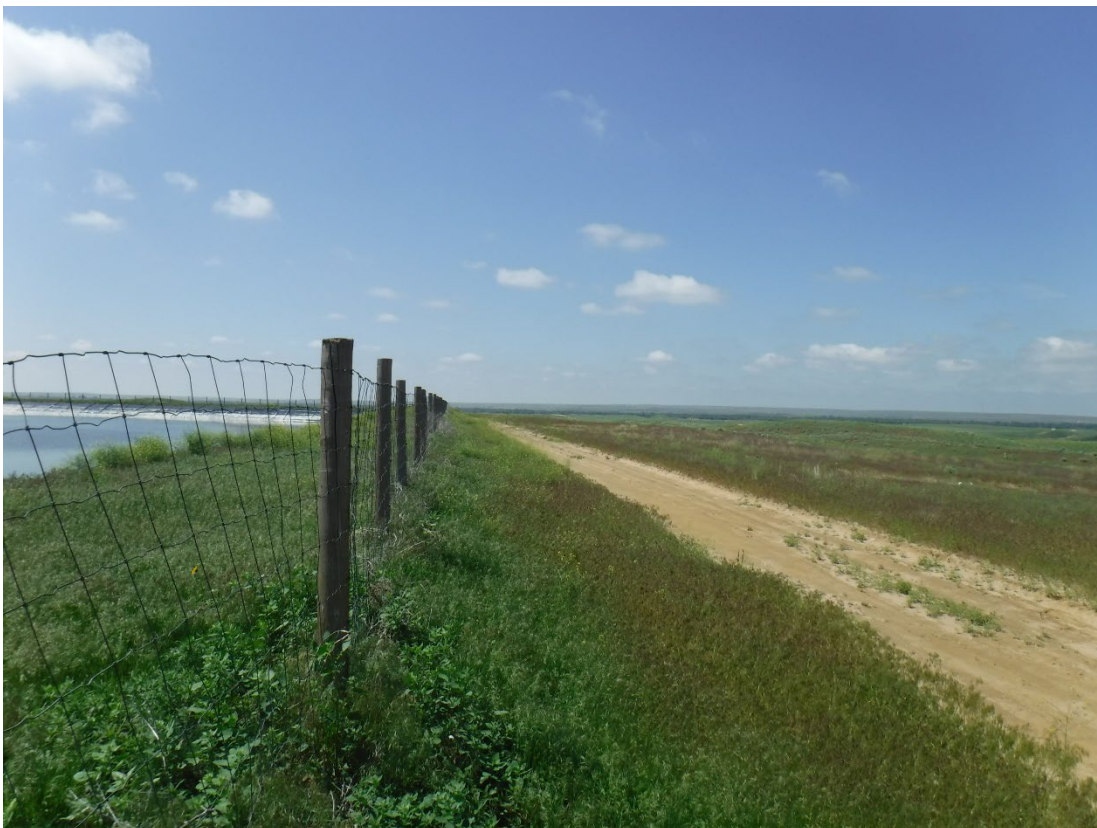
Photo 6: Looking south from NW corner of pond.
