MINERALS PROGRAM INSPECTION REPORT
PHONE: (303) 866-3567

MINE NAME: Nahcolite Project	MINE/PROSPECTING ID#: M-1983-194	MINERAL: Carbonates	COUNTY: Rio Blanco
INSPECTION TYPE: Monitoring	WEATHER: Clear	INSP. DATE: June 3, 2025	INSP. TIME: 09:00
OPERATOR: Natural Soda LLC	OPERATOR REPRESENTATIVE: Jamie Reck	TYPE OF OPERATION: 112d-3 - Designated Mining Operation	
REASON FOR INSPECTION: Normal I&E Program	BOND CALCULATION TYPE: None	BOND AMOUNT: \$4,466,425.00	
DATE OF COMPLAINT: NA	POST INSP. CONTACTS: DRMS	JOINT INSP. AGENCY: U.S.BLM	
INSPECTOR(S): Amy Yeldell	INSPECTOR'S SIGNATURE:

SIGNATURE DATE: June 9, 2025 REVISED-Updated Pad labeling

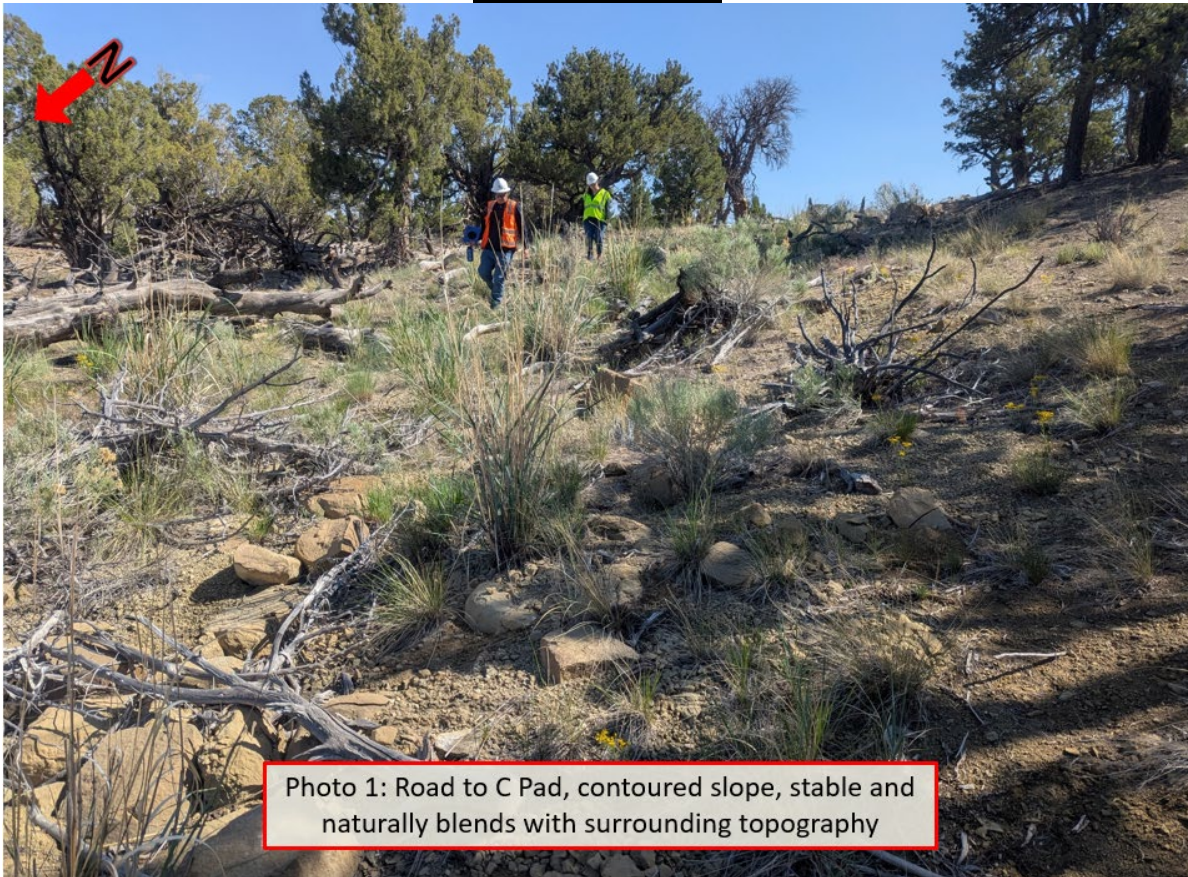
All backfilling and grading have been completed. Topography naturally blends with the surrounding reclaimed areas. Slopes generally have been graded to a 3H: 1V or less where possible and are easily traversable by livestock and wildlife. Exceptions to this are where slopes go through dry creek beds that once had culverts for crossing or following existing contour requires a steeper grade, Photo One. These steeper slopes are stable

Photo 1: Road to C Pad, contoured slope, stable and naturally blends with surrounding topography

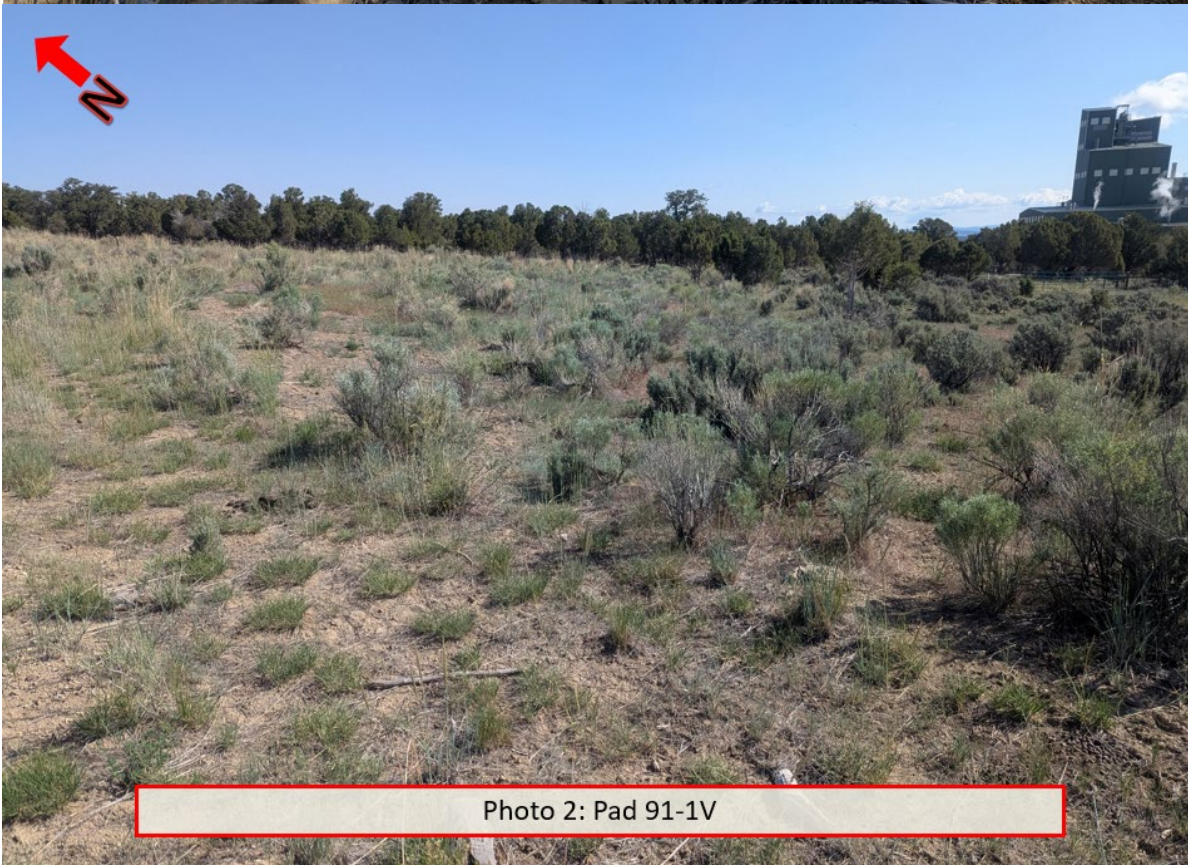
Photo 2: Pad 91-1V

Abandoned wells 91-1V, 93-3V and 4-2V (in order from SE to NW) are all located on one long connected pad. The lower SE portion of the pad consists of more perennial grasses and some smaller shrubs, Photo Two. Overall cover is estimated to be 70%. Large shrubs are sparse and only a few forbs were observed. Cheat grass was observed but it would be considered sparse and spotty with less than 5% over composition. No other noxious weeds were observed. As you work your way uphill to the NW vegetation composition shifts to a more mid seral stage. Vegetation becomes predominantly shrubs that are much larger with limited desirable understory. Desirable cover is significantly less as compared to the lower areas. Most areas between shrubs are cheat grass (weeds), Photo Three. On the south side is the reclaimed access road to the core holes, Photo Four. Vegetation along this corridor is slightly less as it has been reclaimed for a shorter time, but it follows the same trend described above.

Moving forward ongoing management of Cheatgrass and other undesirable species is necessary. The Operator (and their sprayer) should employ multiple surveys/treatments throughout the year. Specifically, cheatgrass is a cool season bi-annual meaning it germinates very early spring and sometimes again in the late fall if there is adequate moisture. Most other grasses are late spring and early summer. Waiting to treat the cheatgrass the same time as other noxious weeds will result in missing the effective window. Additionally, cheatgrass is a considered prolific seed producer which is how it outcompetes. Seed is commonly viable for 2-3 years if not longer, so treatment over several years is necessary to make progress. The Division acknowledges that NSI sites may be the "sink" not the "source" however undesirable species are inhibiting successful reclamation and thus need to be managed.

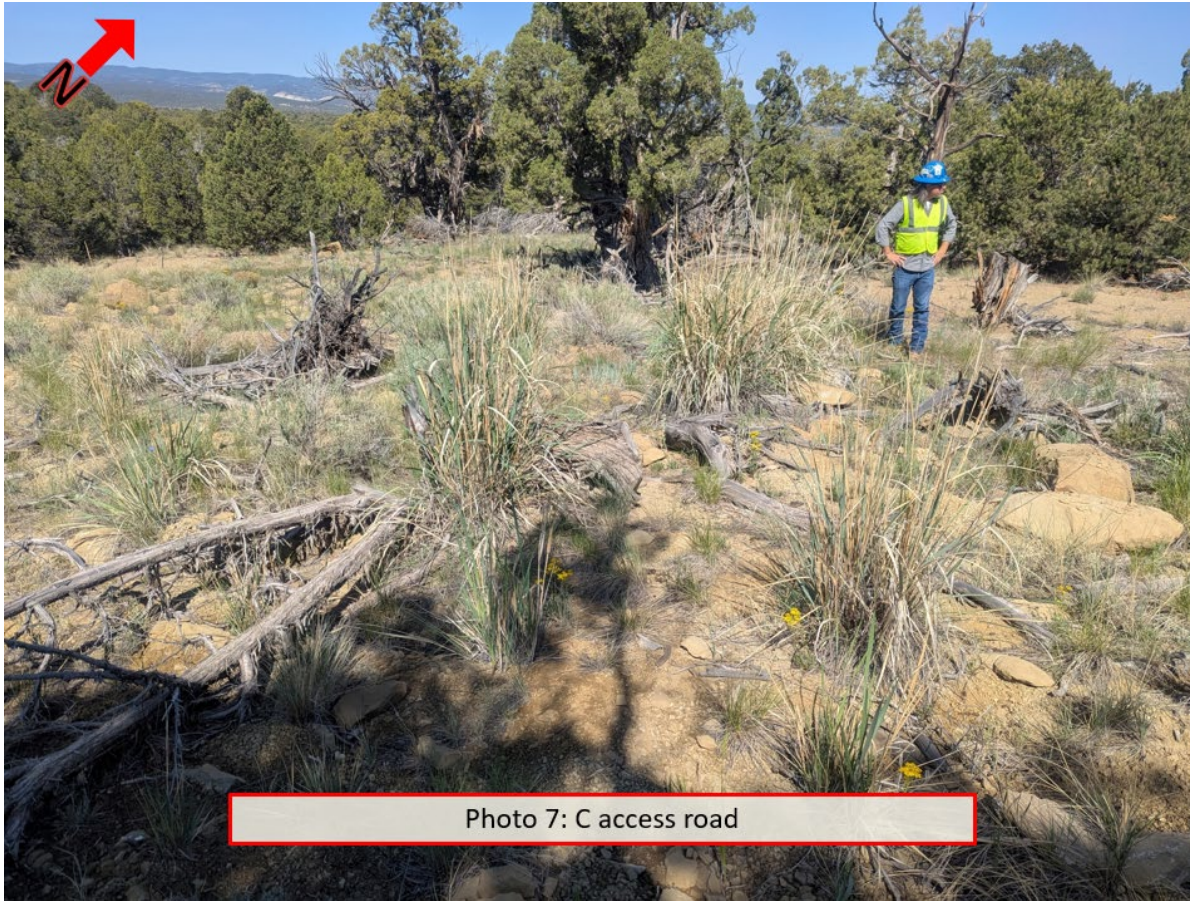
Photo 7: C access road

Moving along the Road to Pad C vegetation began to decline. In addition to cheatgrass other undesirable weeds were observed. Vegetation was either nearly all desirable and on its way to successful reclamation or almost entirely noxious weeds with a few shrubs, Photos Seven and Eight. In general, the areas in the trees fared better compared to the open areas appearing to be more heavily impacted by cheatgrass. Reclamation success on the C Pad varied. Areas with more developed shrubs had a monoculture of cheatgrass and the understory. If shrubs were low or non-existent more perennial grasses were found with significantly lower amounts of noxious weeds.

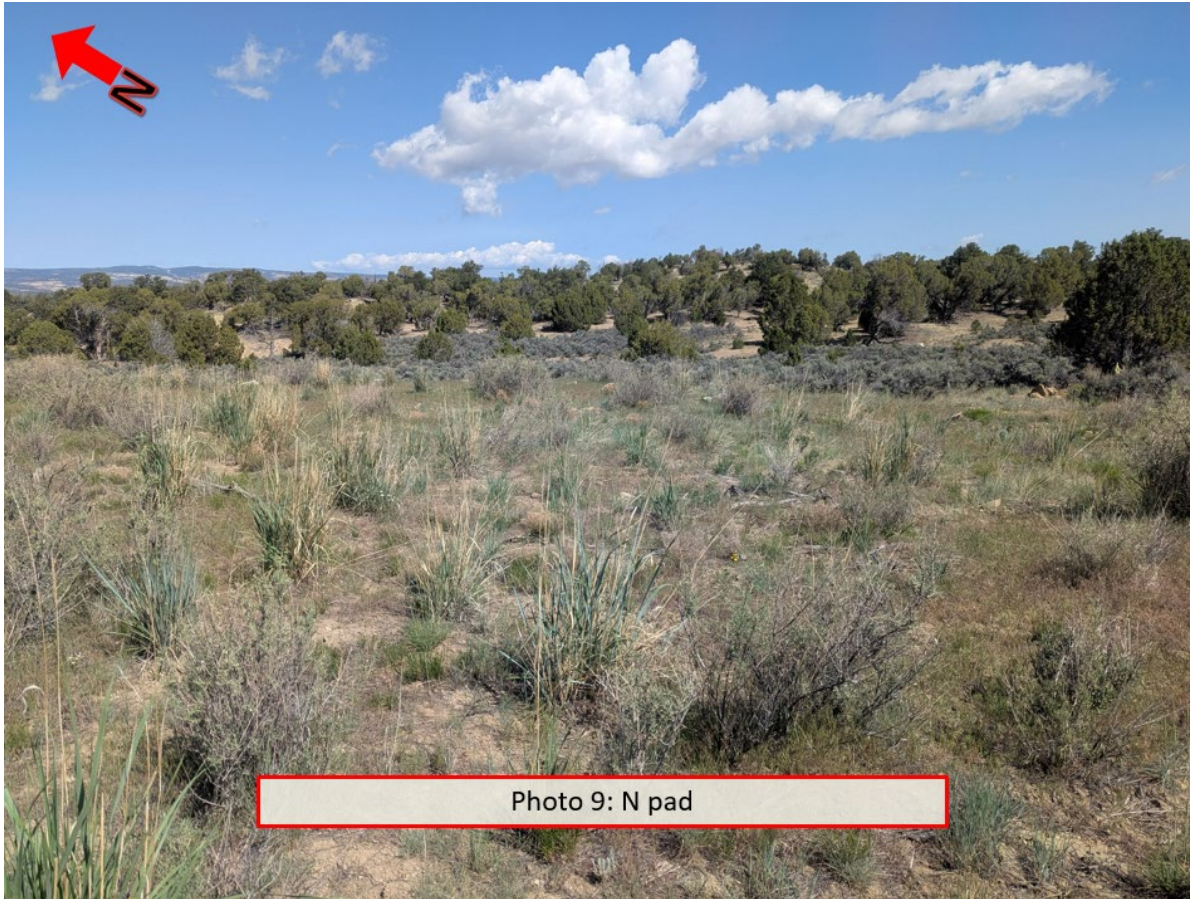
Photo 9: N pad

Next the Road to N pad was similar to the C Pad Road. In general, the areas seemed to be more arid with a lower overall density. Areas with developed shrubs had a higher density of noxious weeds. Northern exposure or areas in the trees tended to have more grasses and less shrubs with more desirable cover. The N Pad itself had the highest density of cheatgrass of all the pads and roads observed. There was a mix of large perennial grasses and shrubs with wide spacing. The understory was either bare ground or cheatgrass, Photos Nine and Ten.

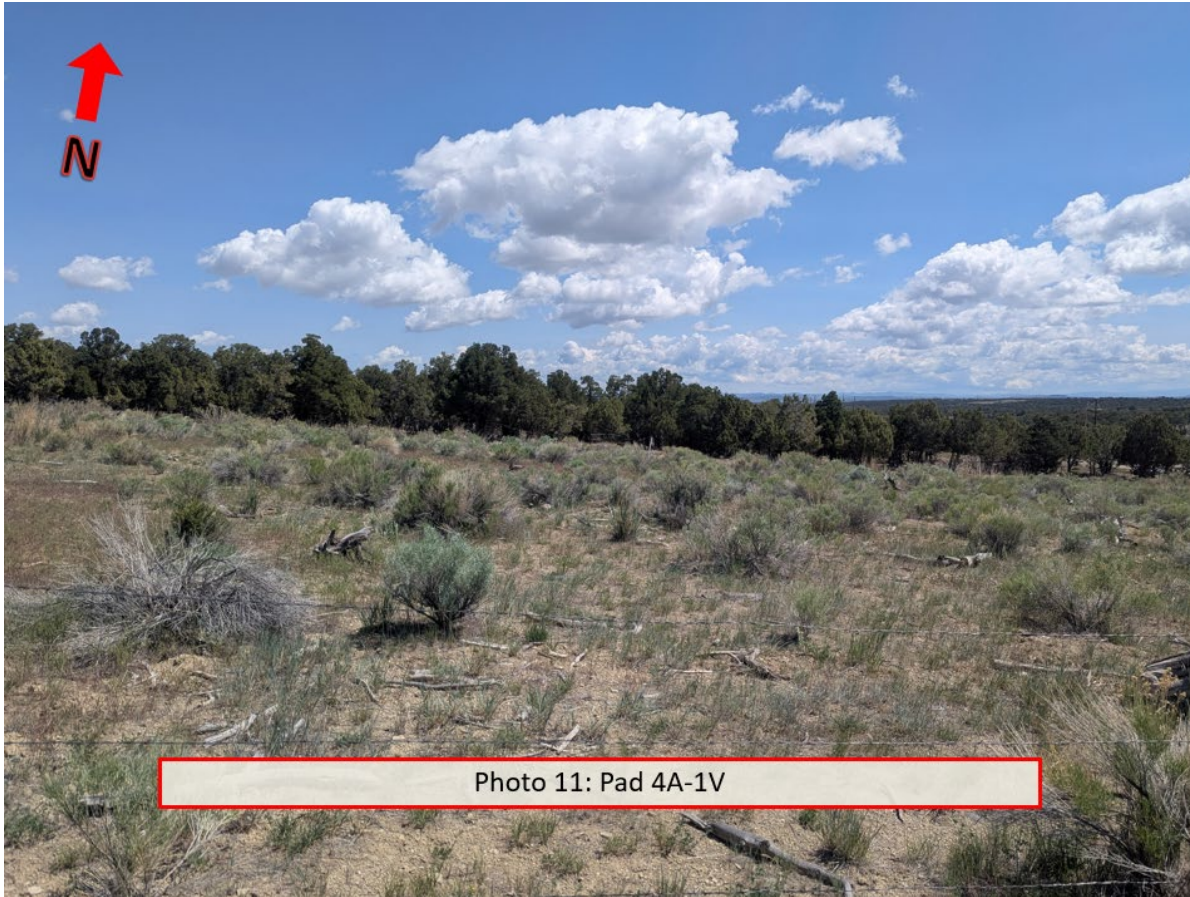
Lastly the large pad which contains 91-2H, 93-4H, 4A-1V and 4A-4V were briefly observed. In general vegetation appeared to be comparable to 93-3V. Some cheatgrass was observed but vegetation has not progressed to mid seral and perennial grasses are still more abundant than shrubs, Photo Eleven.
