DRMS Inspection 2025 June Williams Fork Mine

4 June 2025

Permit Number: C-1981-044
Mine Name: Williams Fork Mines
Operator: Moffat County Mining, LLC
Operator Address:
Ms. Miranda Kawcak
29515 Routt County Road #27
Oak Creek, CO 80467

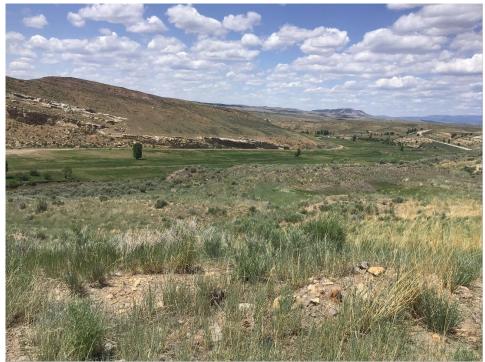
- Revegetated areas of reclamation appeared stable with a diversity of grasses, shrubs and perennials
- o Revegetated areas appeared a verdant green.
- Revegetation in the cropland area of the Williams Fork bottom lands appeared vigorous with good cover.

Photo 1: Overview of the cropland area at the Williams Fork mine site, looking northwest.

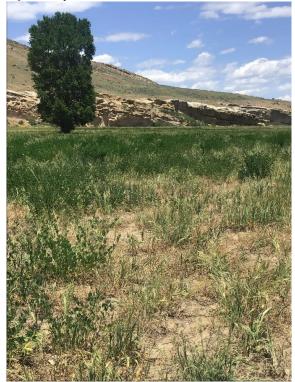
- o The south cropland showed strong growth with numerous shrubs in the hayfield, some areas with previous longstanding facilities show less cover and less production.

Photo 2: Grasses and forbs in the south section of cropland.

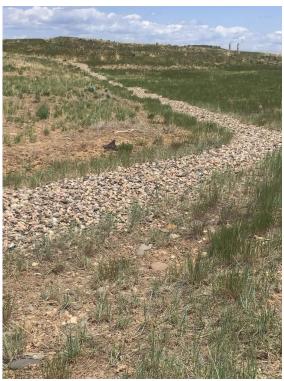
Photo 3: Rocked drain around the south and east portions of the refuse pile, looking northwest.

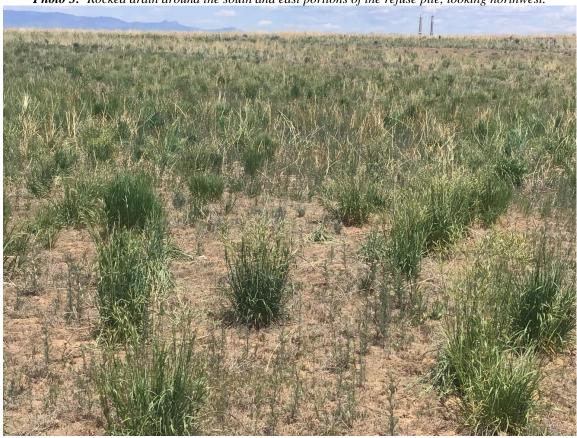
Photo 4: Grasses establishing strongly on the southeast slope of the refuse pile, looking north.

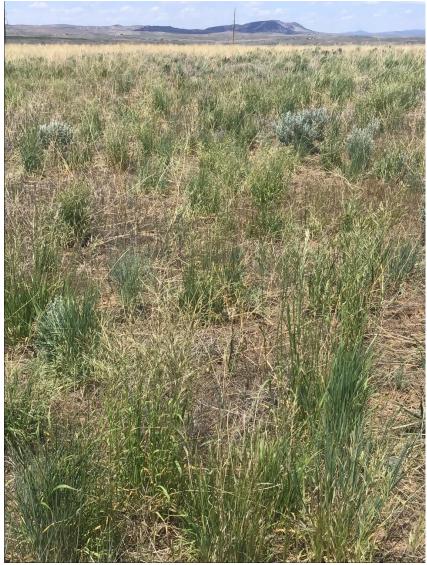
Photo 5: Grasses establishing along with a strong showing of shrubs at the north end of the refuse pile, looking northwest.

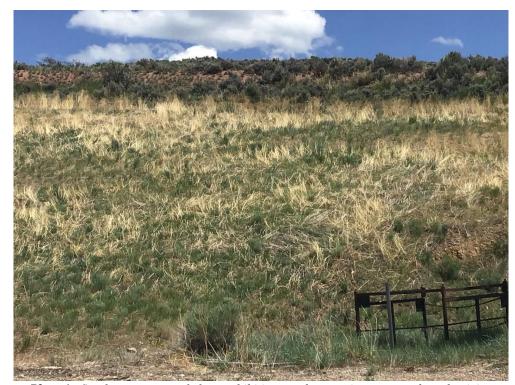
- Portal slopes exhibit a good density of shrubs and native perennials with grasses showing themselves in increased numbers. The experimental plots at the portal are exhibiting the success of the various treatments with the most southern slope nearest the shop building presenting the best results. This slope was treated with a biodynamic soil amendment. The aspect of the slopes further north is more southerly and therefore drier and more punished by the sun.

Photo6: Southernmost portal slope exhibiting good vegetative cover and productivity.

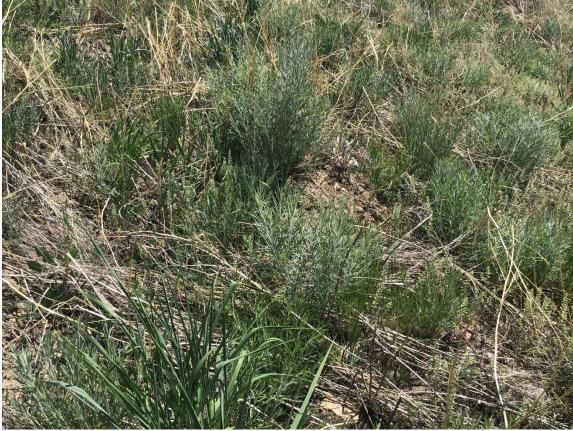
Photo7: Close up of shrub establishment on southernmost portal slope.

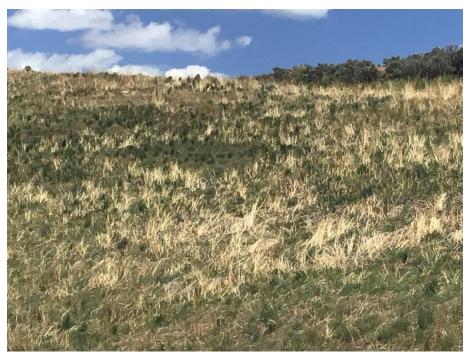
Photo 8: Middle section of the portal slope, vegetation establishing and the dry remnants of last growing seasons yellow sweet clover..

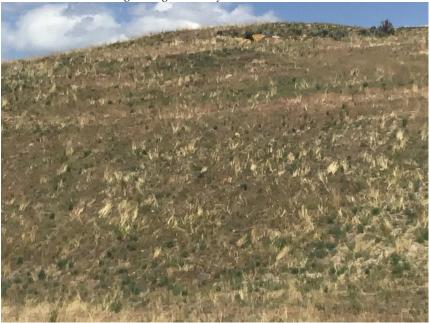
Photo 9: Northernmost portal slope exhibiting considerably less vegetation establishment than other two slopes.

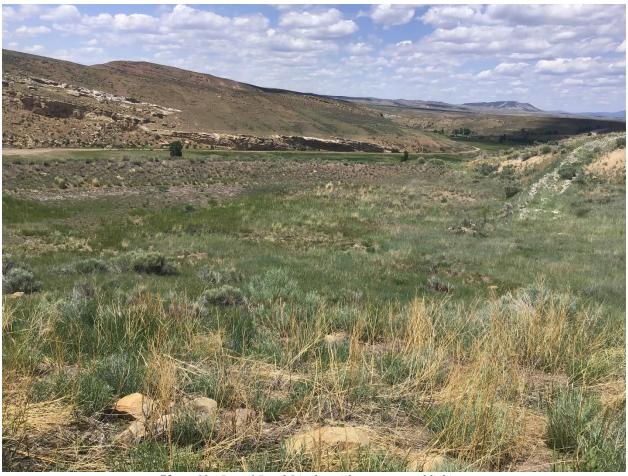
Photo 10: Portal Pond 9A, dry with grasses establishing.
