MINERALS PROGRAM INSPECTION REPORT

MINE NAME: Castillo Pit	MINE/PROSPECTING ID#: M-2000-053	MINERAL: Gravel	COUNTY: Las Animas
INSPECTION TYPE: Monitoring	WEATHER: Clear	INSP. DATE: April 24, 2025	INSP. TIME: 10:14
OPERATOR: Las Animas County	OPERATOR REPRESENTATIVE: Keith Woodring	TYPE OF OPERATION: 112c - Construction Regular Operation

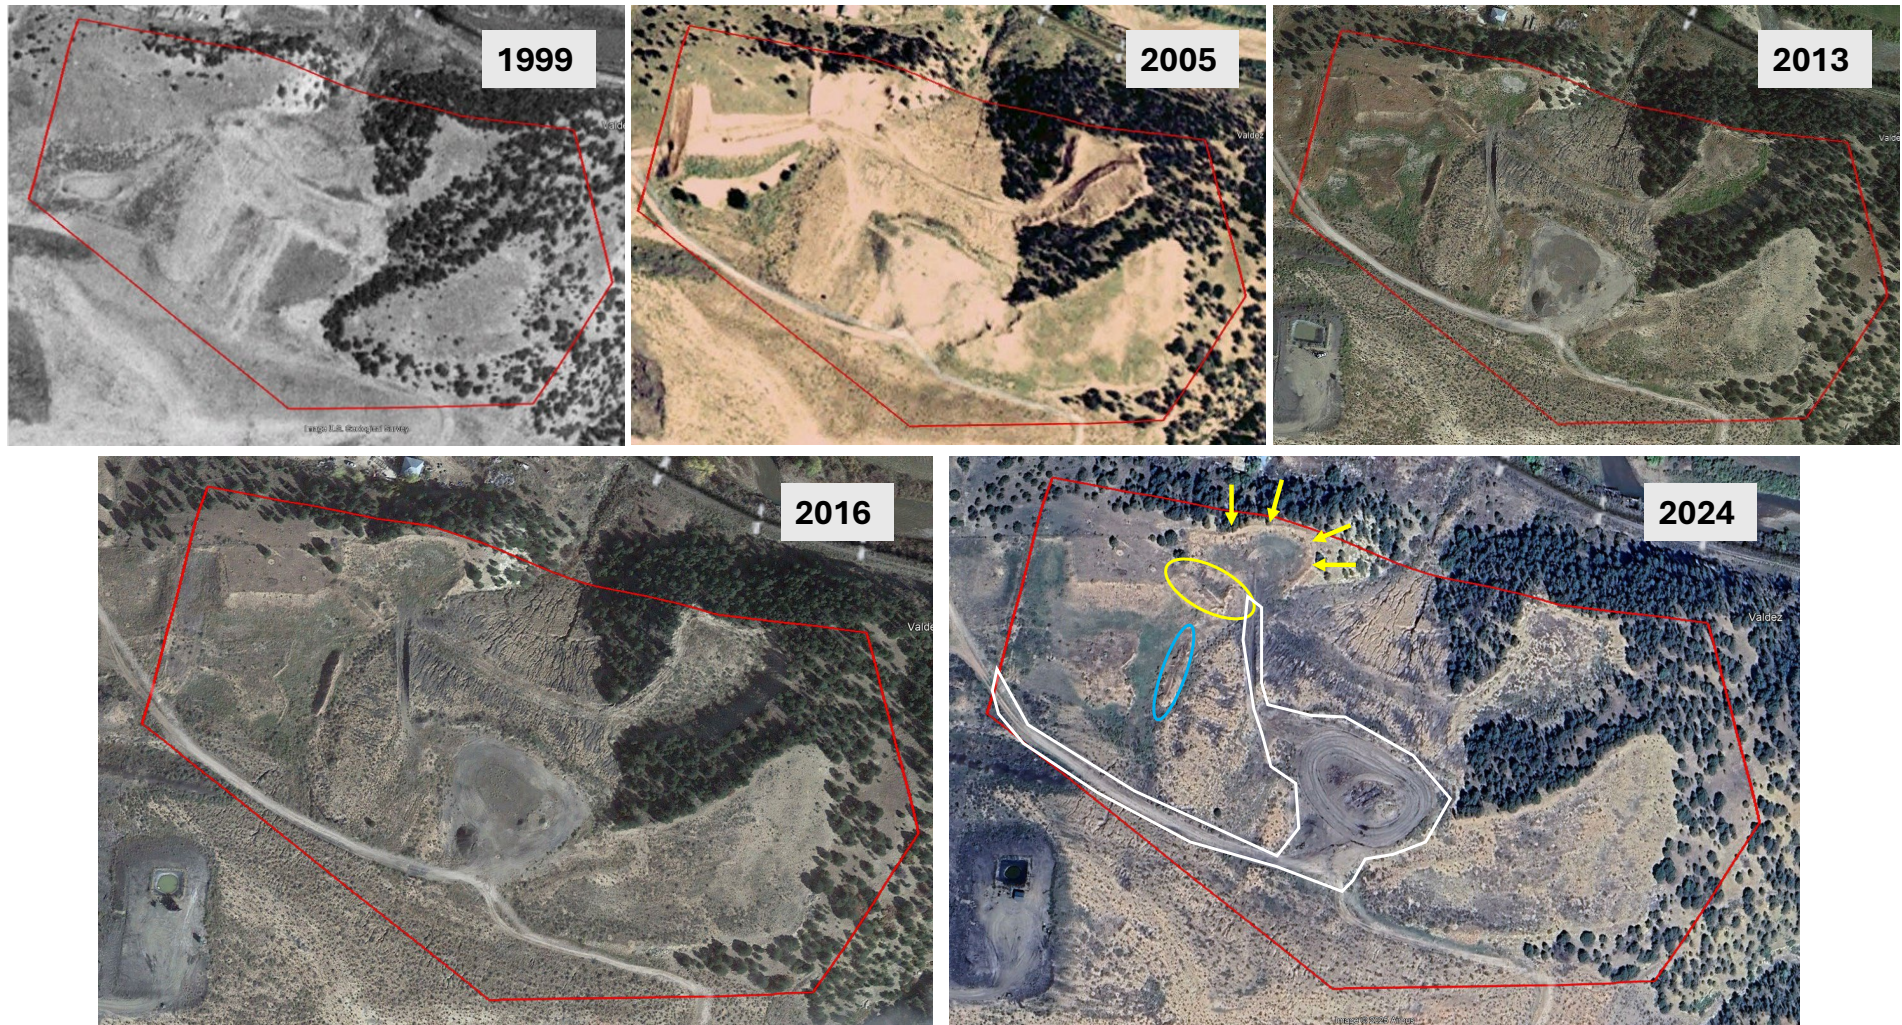
Figure 1: Progression of mining and reclamation across the site from prior to permit issuance (1999) through the most recently available aerial imagery (2024). The yellow arrows point to where slopes may need to be reseeded. The yellow circle indicates potential material to be used for reclamation. The blue circle indicates potential topsoil material to be used for reclamation. The white outline indicates the remaining areas that need to be topsoiled and seeded.

Because the current reclamation plan does not allow for any structures to remain, the road leading down to the area west of the cemetery, the flat parking area, and the west portion of the access road within the site need to be reclaimed. The imported stockpiles need to be removed from the site, and the overburden and topsoil stockpiles onsite need to be used to reclaim the remaining affected areas. During the inspection, it was discussed whether the access road could stay. Because it is not in the approved reclamation plan or on the reclamation map, it will need to be reclaimed. However, if the landowner wants it to stay, the Operator may submit a technical revision to update the reclamation plan where an affidavit from the landowner is included,

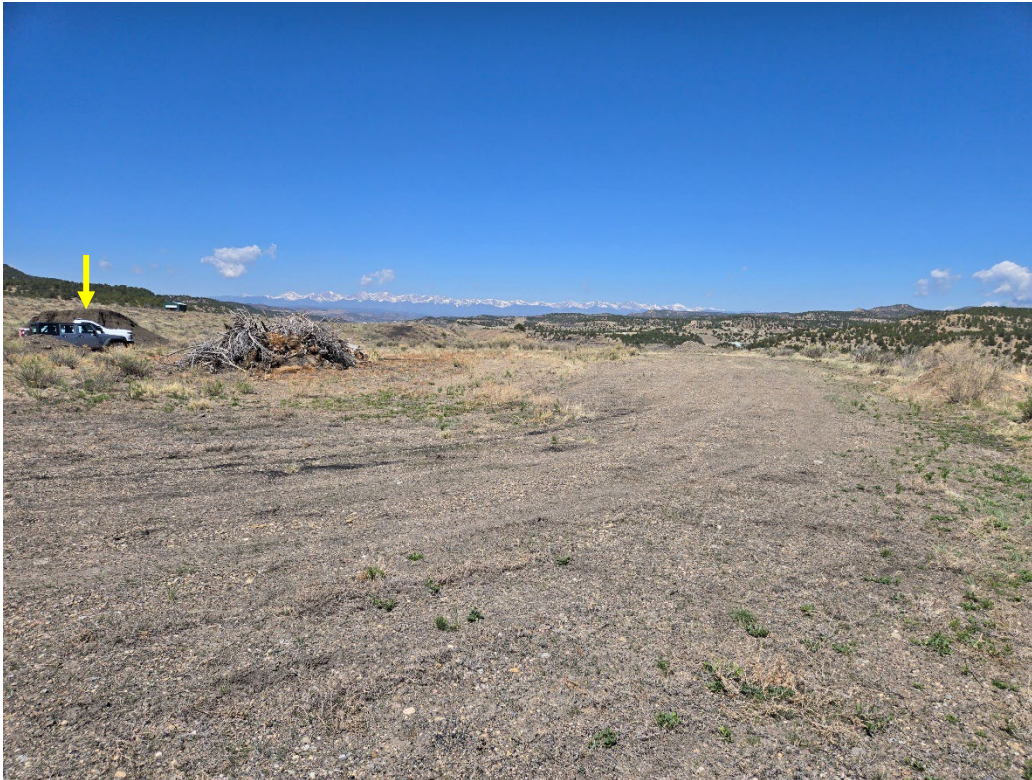
Mining has not taken place at this site for many years. The site is primarily being used for storage of recycled asphalt material, used for paved parking areas around the county, stored in the flat parking area central to the site (Photo 1). There are a couple small stockpiles of what appear to be overburden and topsoil. There is a small pile just northeast of the paved area (Photo 2). One of the piles is located within the area circled in yellow on Figure 1. The area circled in blue corresponds the topsoil location shown on the Applicant's 2024 annual report map. The Operator shall use the remaining stockpiled material to conduct reclamation across the site.

Photo 1: Looking west at the flat area. The arrow points to imported material that has been temporarily stored onsite that will need to be removed. A pile of woody debris is stockpiled within this area too from the landowner, this pile will need to be removed prior to the permit's release.

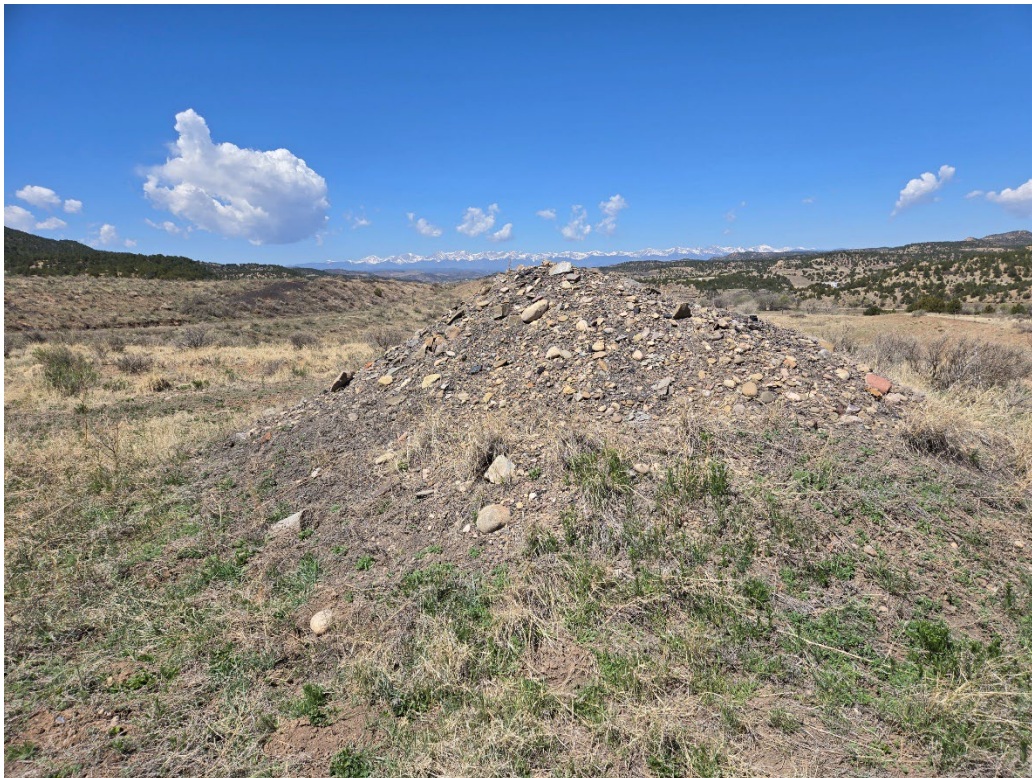
Photo 2: Available stockpiled material onsite.

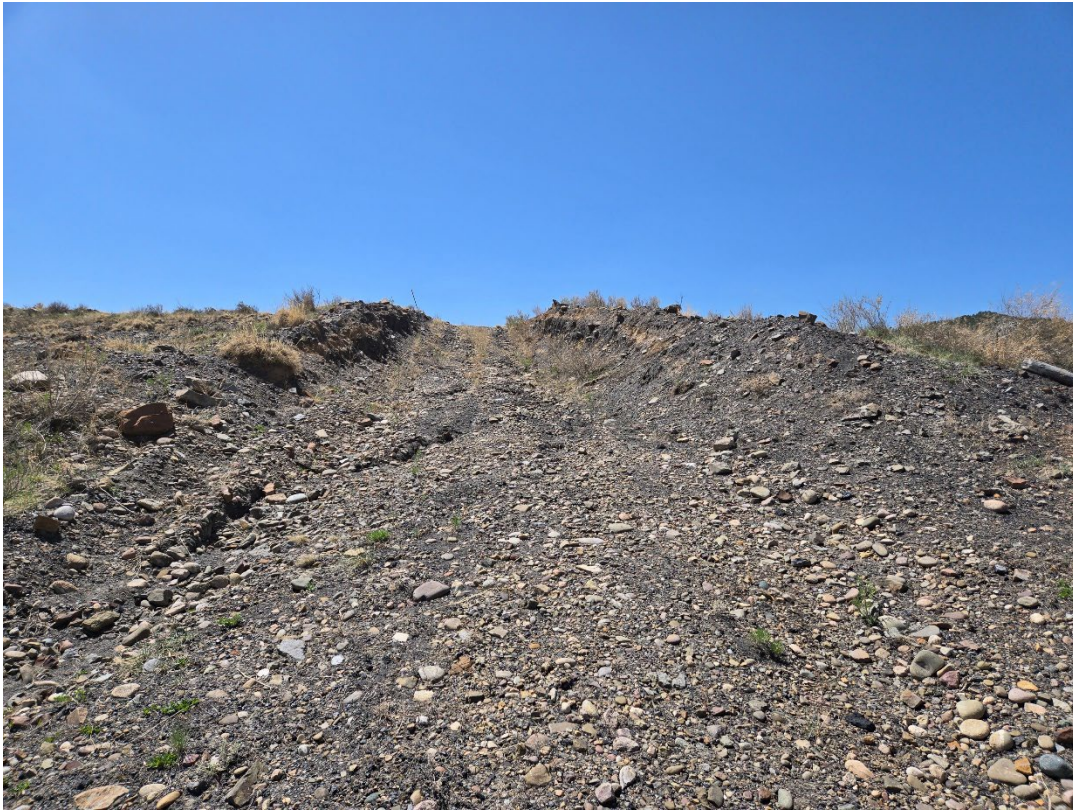
Much of the site has been reclaimed. This site had historically been coal mined and partially reclaimed. Although much of the reclaimed coal areas were not re-disturbed, there is a road leading from the central flat area down to an area just east of the cemetery that had been mined (Photos 3-6). The slopes in that area only have sparse vegetation established (Photo 5 and 7). There is also a reclaimed road leading from the mined areas on the west side, to the mined areas on the east side (Photos 8-10). The road between these two sections has been reclaimed, and the east mining area has been reclaimed as well.

Photo 3: The steep road leading down to the east mining areas.

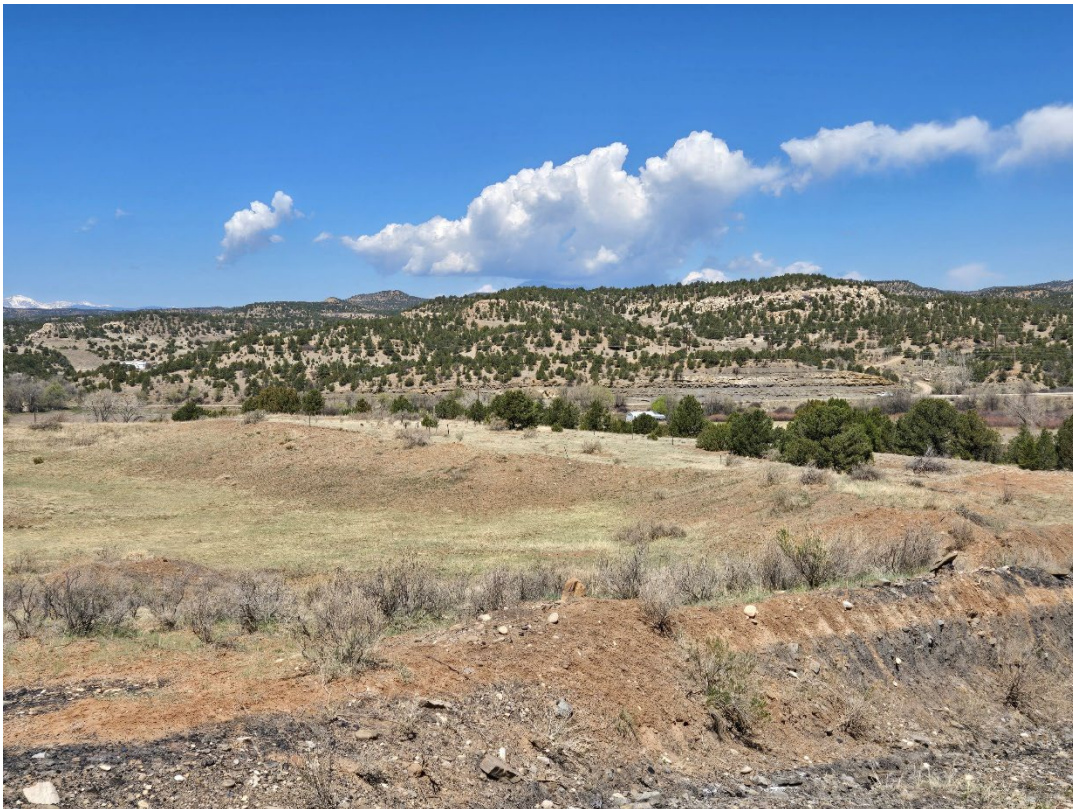
Photo 4: Looking west from the road in Photo 3 at the reclaimed slopes on the south side of the cemetery.

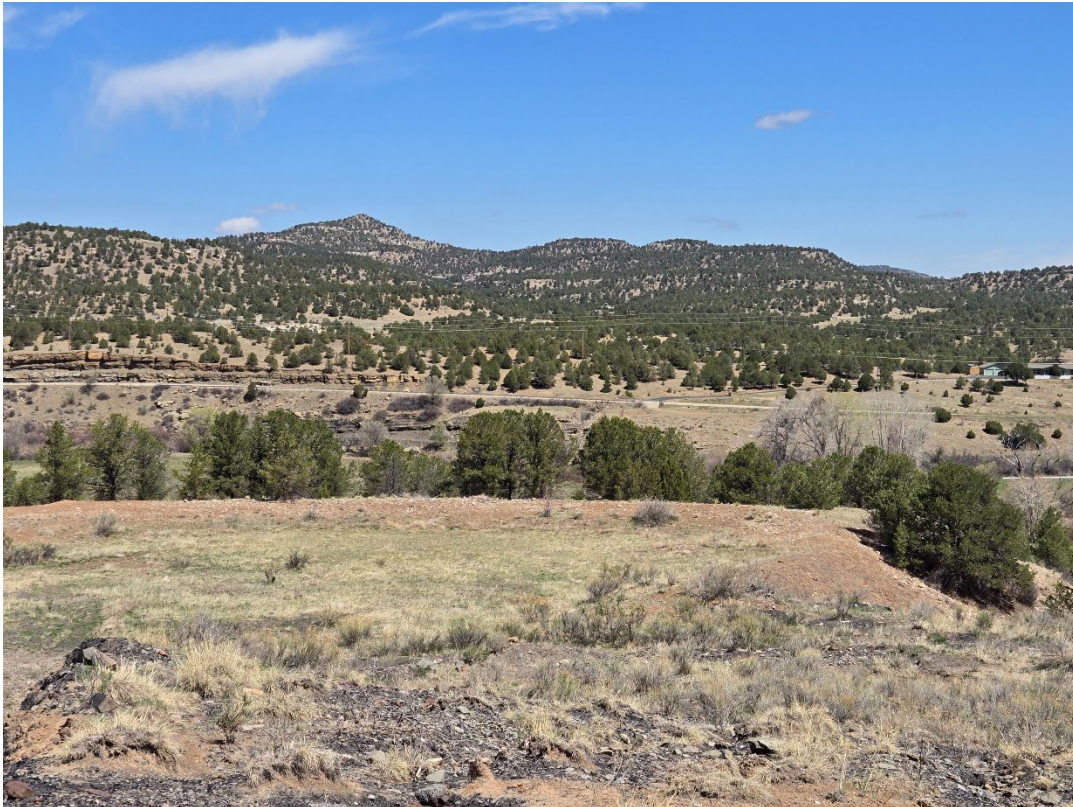
Photo 5: Looking north from the road in Photo 3 at a reclaimed mining area on the east side of the cemetery.

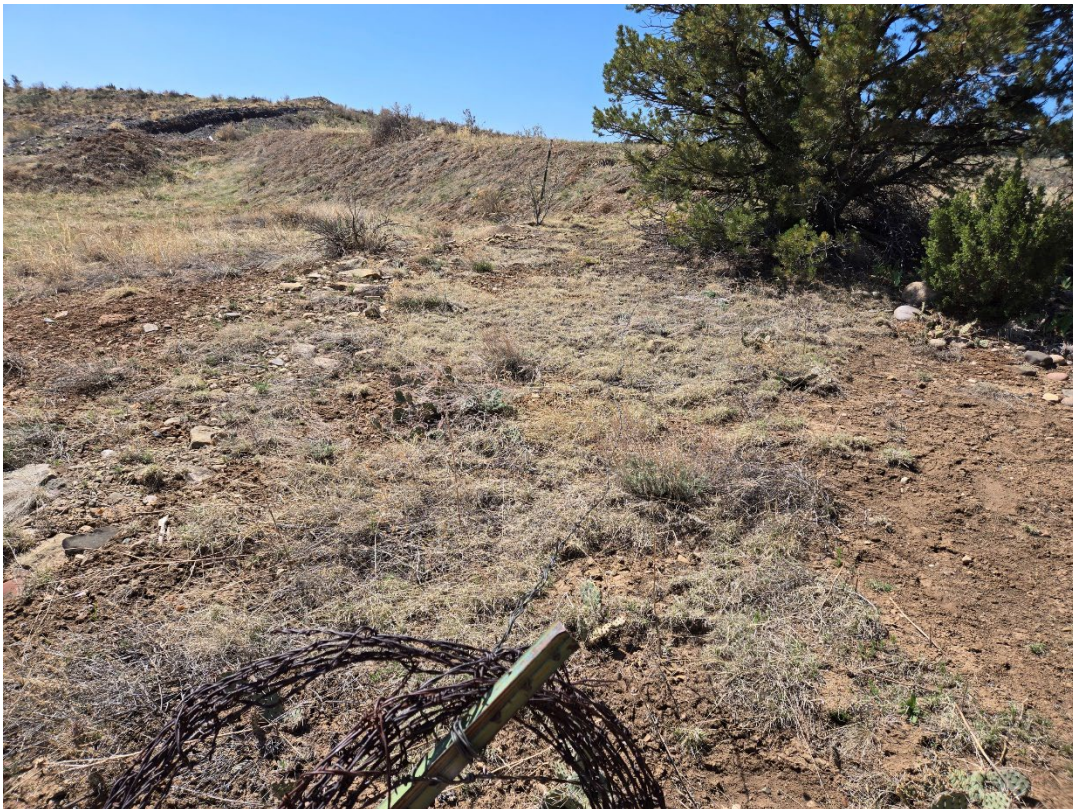
Photo 6: Looking southeast at the steep road leading down to the west mining areas. The material near the road may potentially be stockpiled material, or a steeper reclaimed slope.

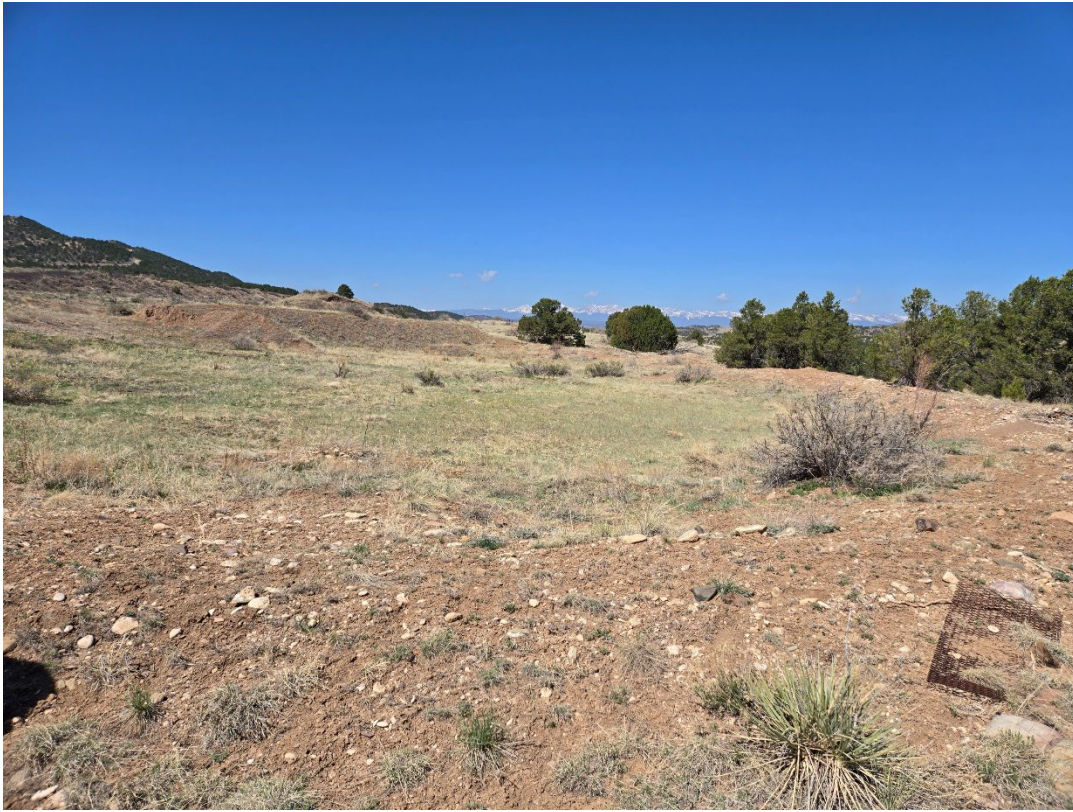
Photo 7: Looking west across the northwest mining area. The slopes within this area may need to be reseeded and the debris needs to be removed.

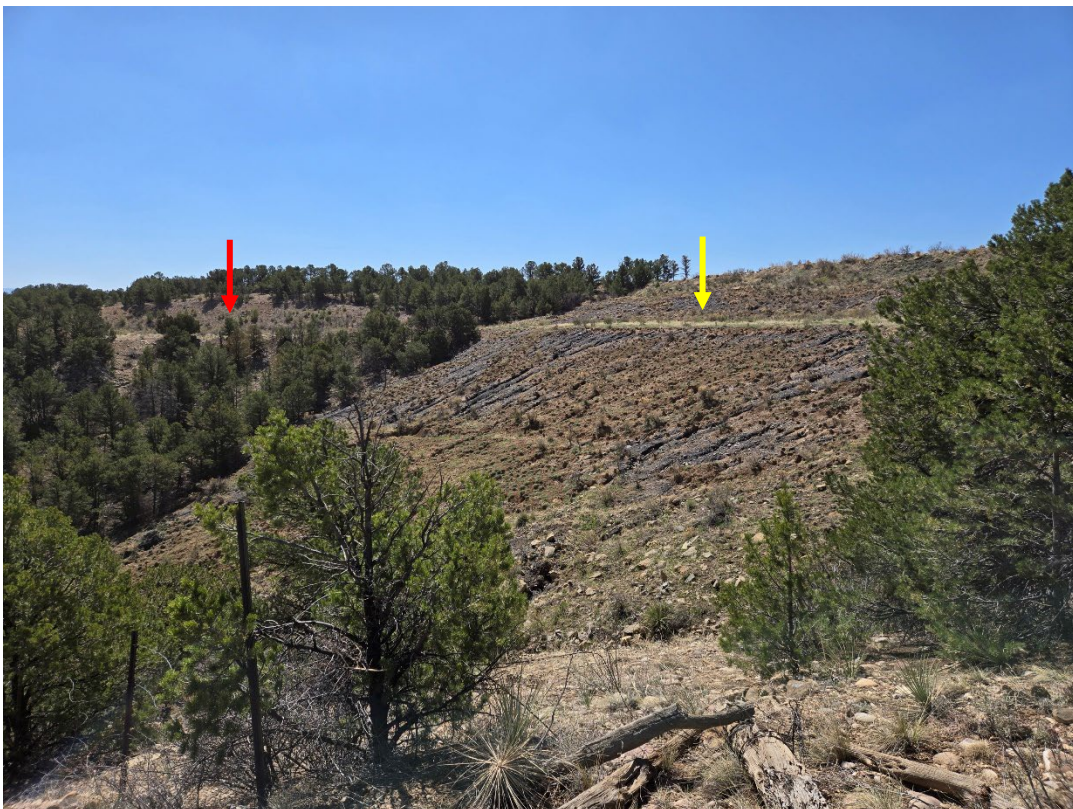
Photo 8: Looking at the reclaimed path (yellow arrow) leading from the west mining areas, across the reclaimed coal waste, the east mining area (red arrow).

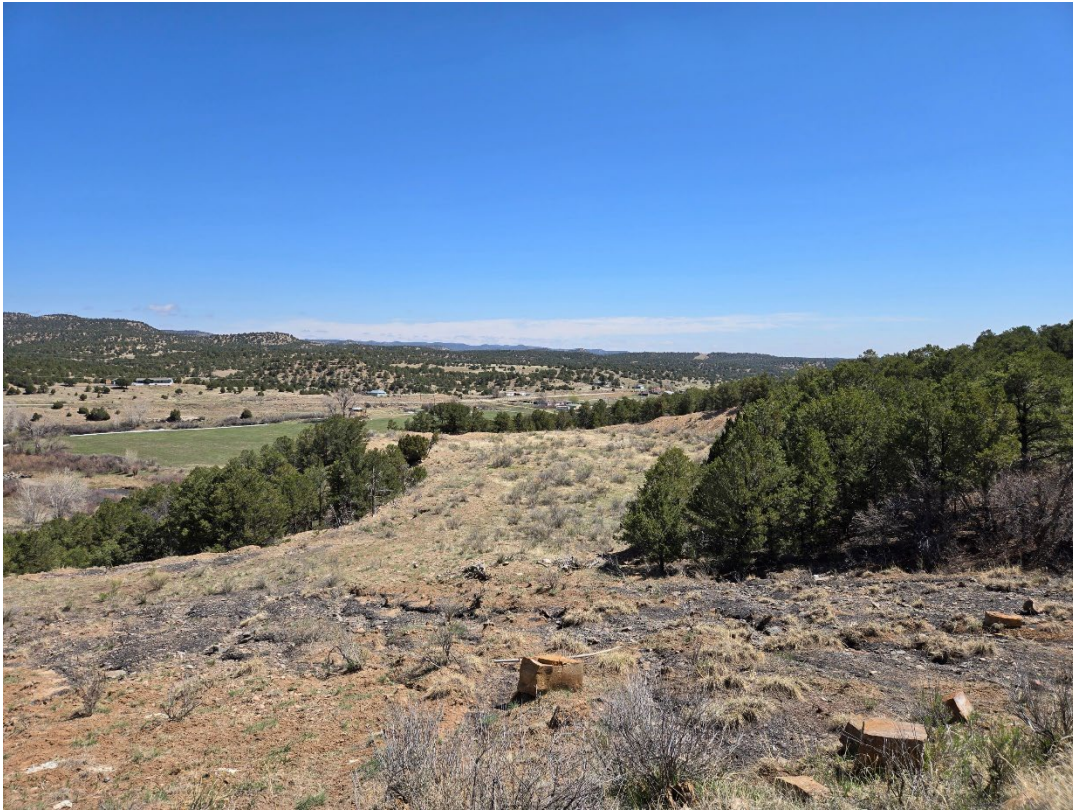
Photo 9: Looking at the reclaimed east mining area from on top of the coal waste.

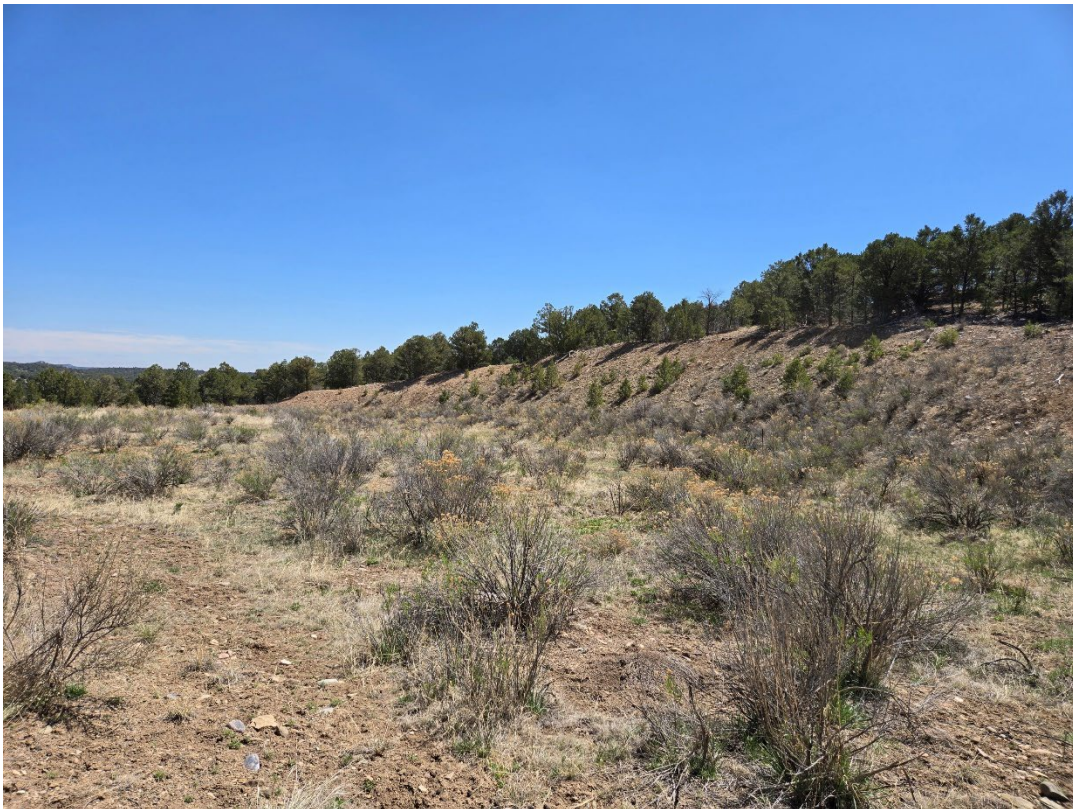
Photo 10: Looking at the reclaimed east mining area.

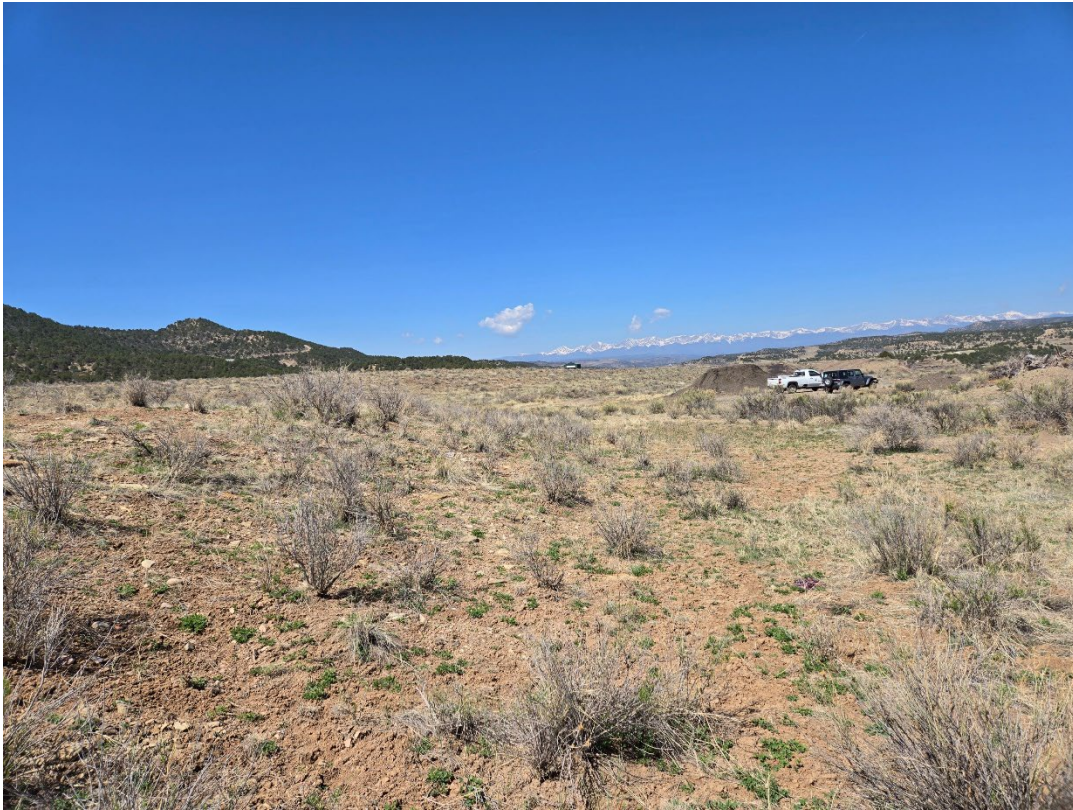
Photo 11: Looking towards the flat central area from the reclaimed southeast mining area.

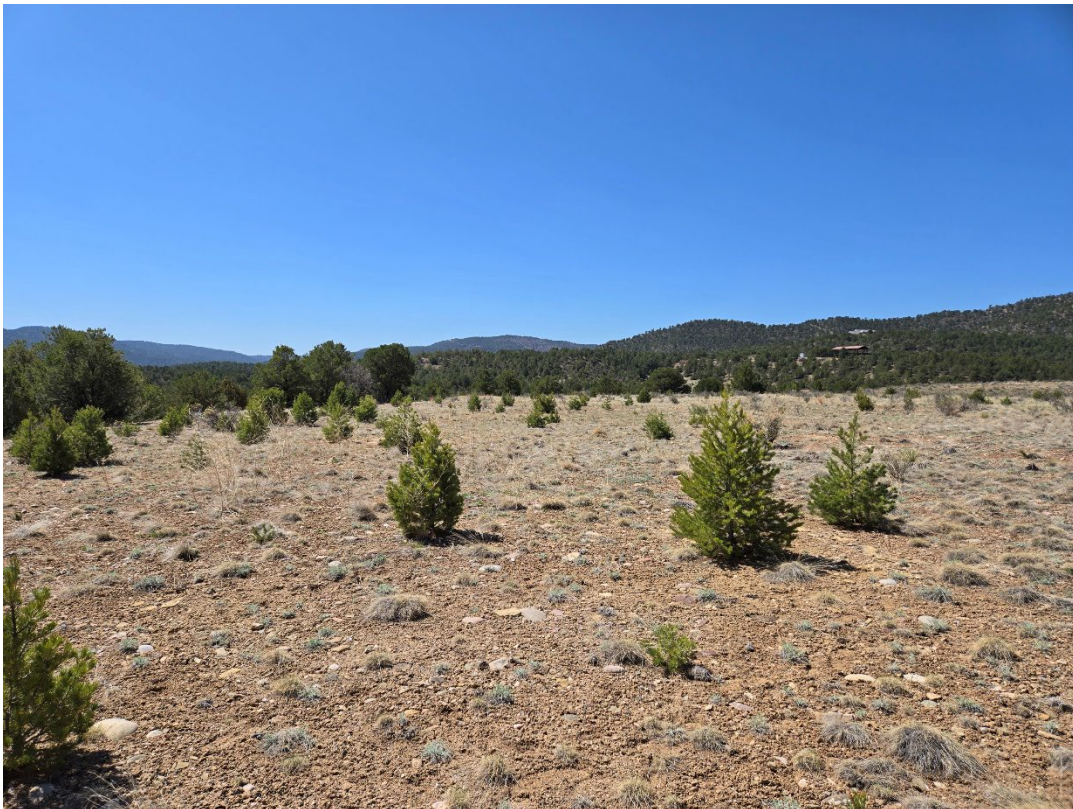
Photo 12: Looking across the reclaimed southeast mining area.

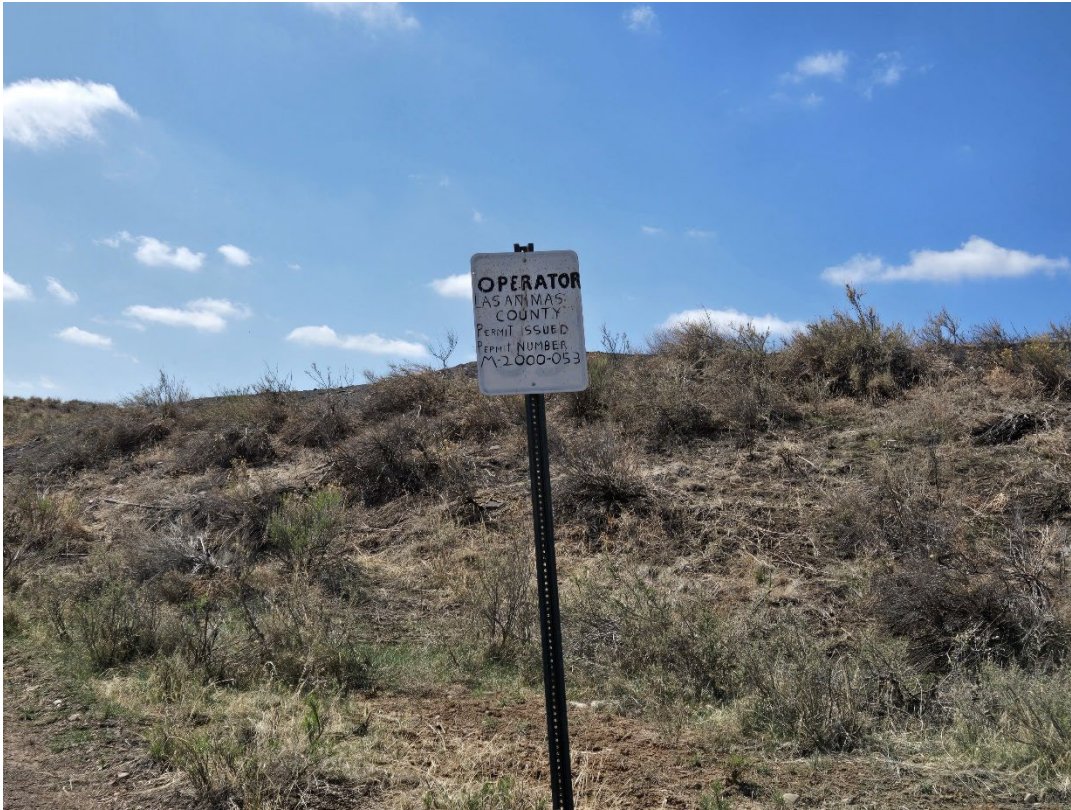
A permit sign is posted at the entrance to the site, in compliance with Rule 3.1.12(1). The permit boundary is marked by t-posts around the site in compliance with Rule 3.1.12(2). The coordinates for the permit boundary markers were collected during the inspection using the Esri FieldMaps application. The placement of the permit boundary markers appears to closely resemble the permit boundary shown on the mining plan map. The Operator and the Inspector walked around the boundary and collected markers (Map 1). There's an additional marker in the northwest side that was beyond a fence that the inspector did not collect (Photo 14).

Photo 13: Mine sign posted at the site's entrance.

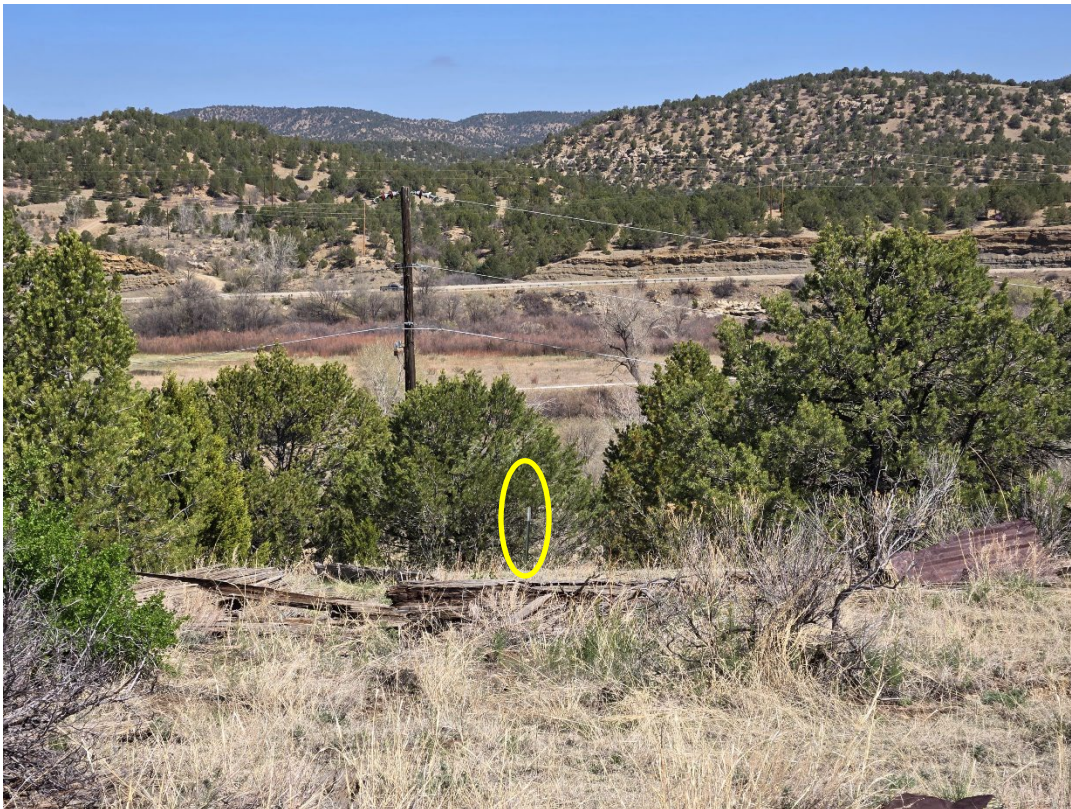
Photo 14: Circled is the permit marker that lies beyond a fence in the northwest portion of the permit.

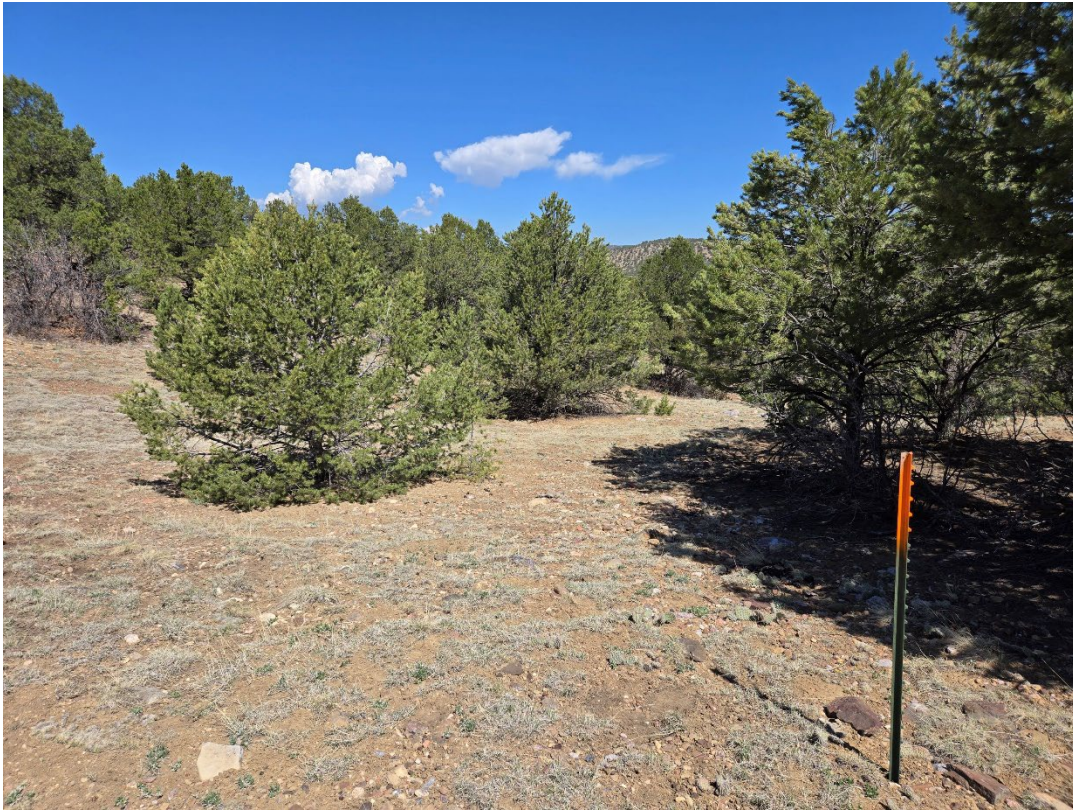
Photo 15: Near a permit marker on the east side. This area had not been mined, showing that the native vegetation/grasses is sparse at this site.

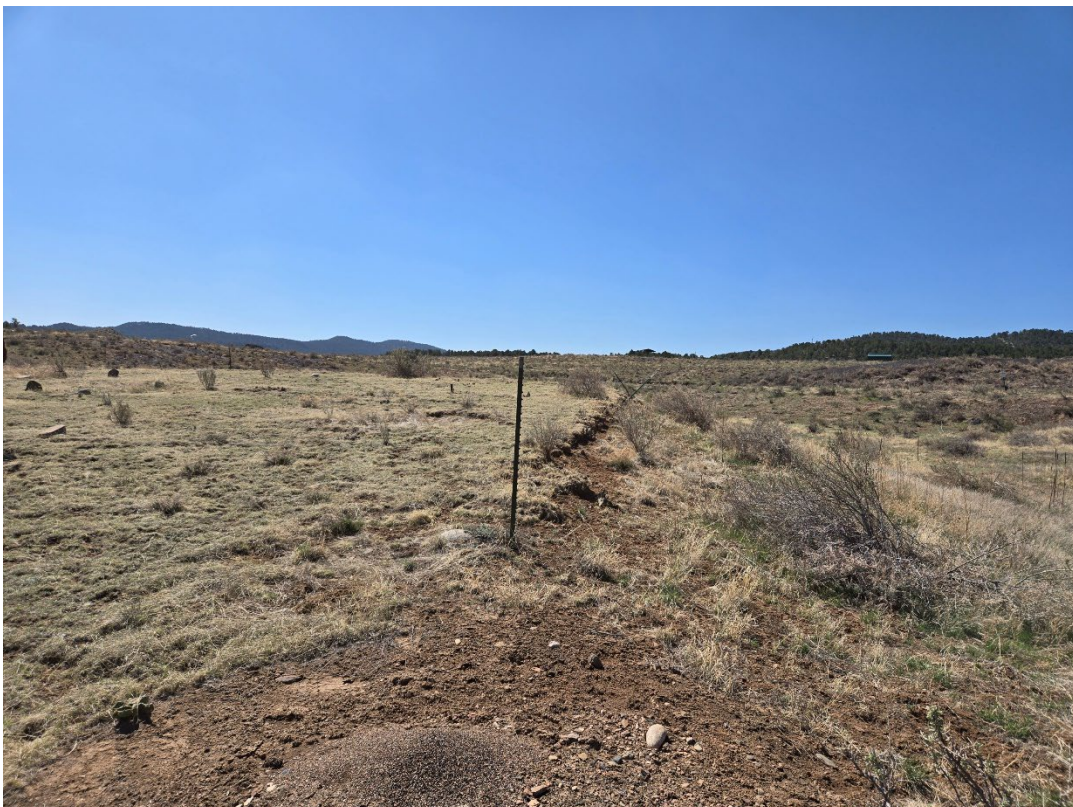
In addition to the permit boundary, the fence put around the cemetery in the northeast portion of the permit is still standing and acting as an internal boundary (Photo 16).

Photo 16: Looking south along the fence surrounding the cemetery.
