C-1981-035 King June 2025 OSMRE Oversight Partial Inspection Report

| Permit Number: C-1981-035 Mine Name: King Coal Mine Operator: GCC Energy, LLC Operator Address: Mr Jordan McCourt 6473 County Road 120 Hesperus, CO 81326 | County: La Plata Operation Type: Underground Permit Status: Active Ownership: Private |

| Inspection Start Date: June 3, 2025 Inspection Start Time: 08:26 Inspection End Date: June 3, 2025 Inspection End Time: 11:40 | Inspection Type: Coal Partial Inspection Inspection Reason: OSM Oversight Inspection Weather: Clear |

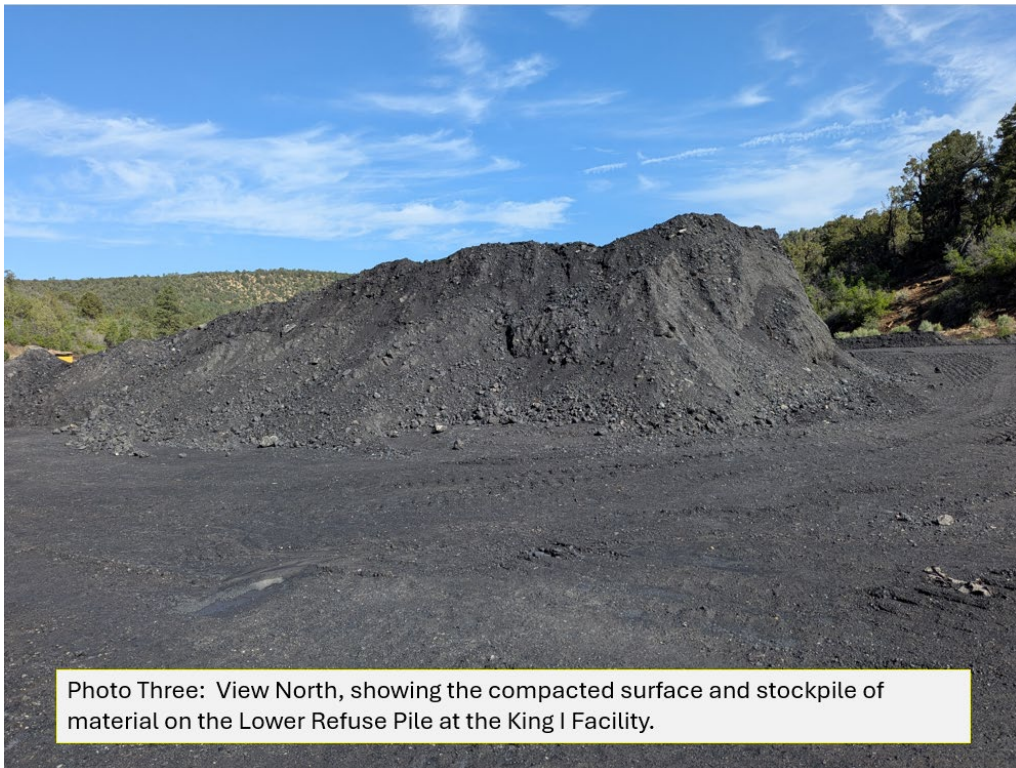
At the time of the inspection, material was actively being compacted on the Lower Refuse Pile (LRP). The material being compacted appeared to be consistent with the design specifications, and the previous layer appeared to be well compacted. The stockpile of material on the surface of the pad awaiting placement was also found to be in good condition. No evidence of significant erosion or sediment transport was noted. An example of the compacted surface as well as a partial view of the stockpile can be seen in Photo Three.

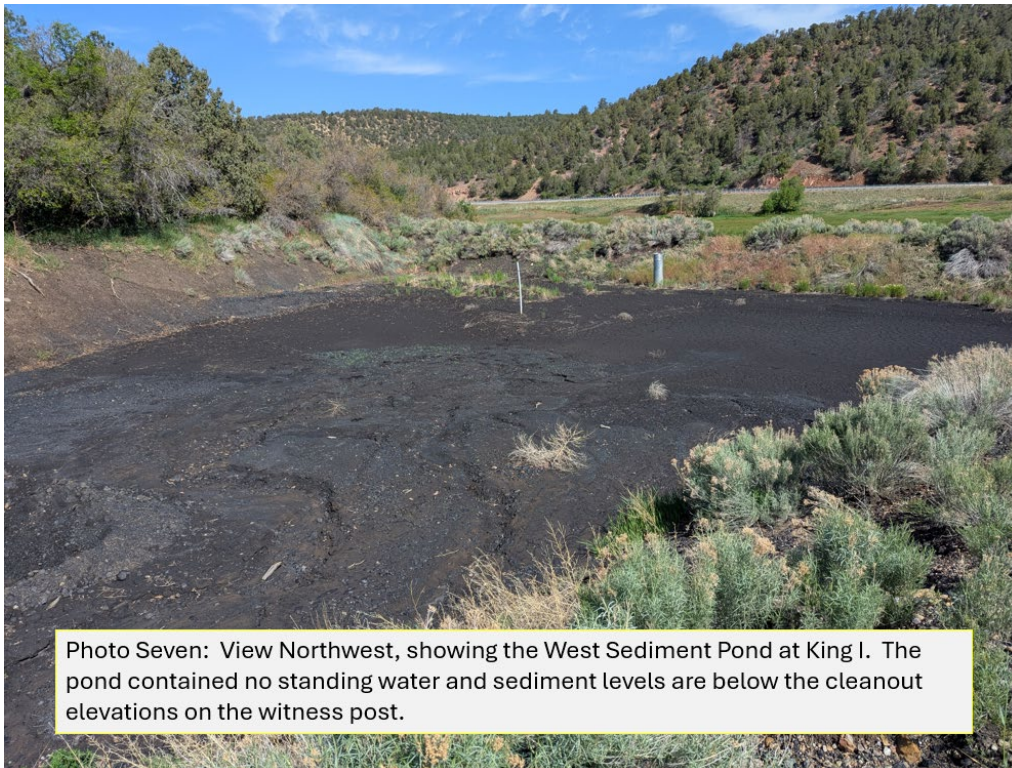
Photo Seven: View Northwest, showing the West Sediment Pond at King I. The pond contained no standing water and sediment levels are below the cleanout elevations on the witness post.

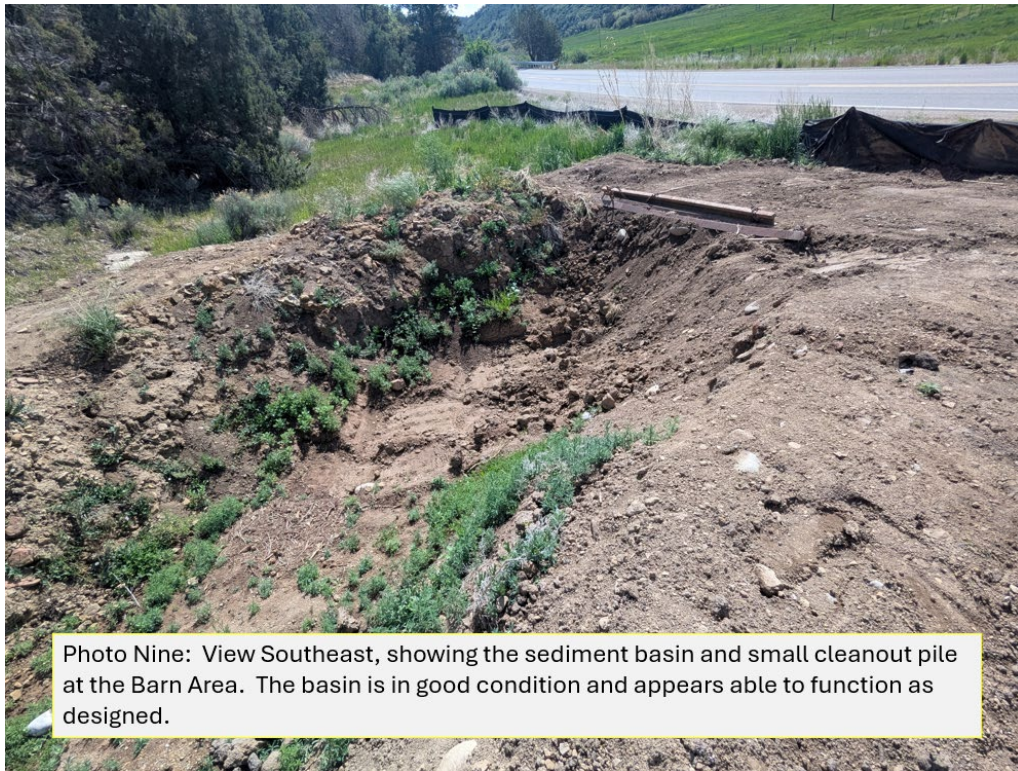
At the Barn Area, the storm water control sediment basin was observed. The basin was in good condition and appeared able to function as designed. Evidence of recent maintenance was observed via a small stockpile of cleaned out material. the small stockpile showed no evidence of erosion or sediment transport. The sediment basin and cleanout pile can be seen in Photo Nine.

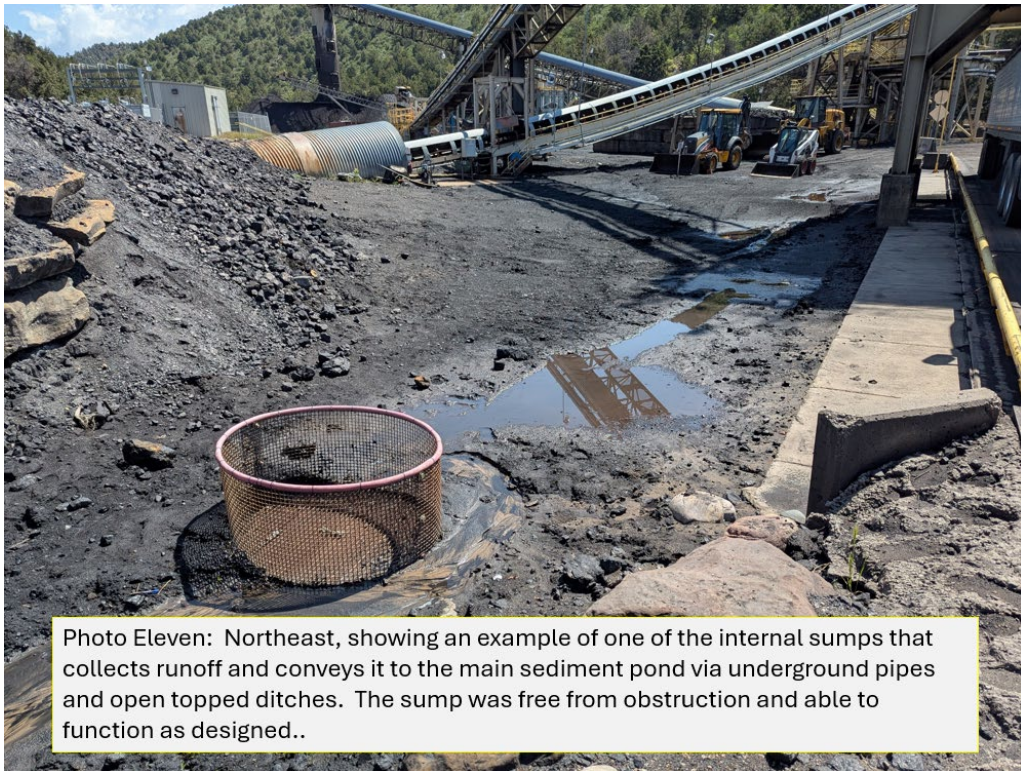
Photo Eleven: Northeast, showing an example of one of the internal sumps that collects runoff and conveys it to the main sediment pond via underground pipes and open topped ditches. The sump was free from obstruction and able to function as designed..

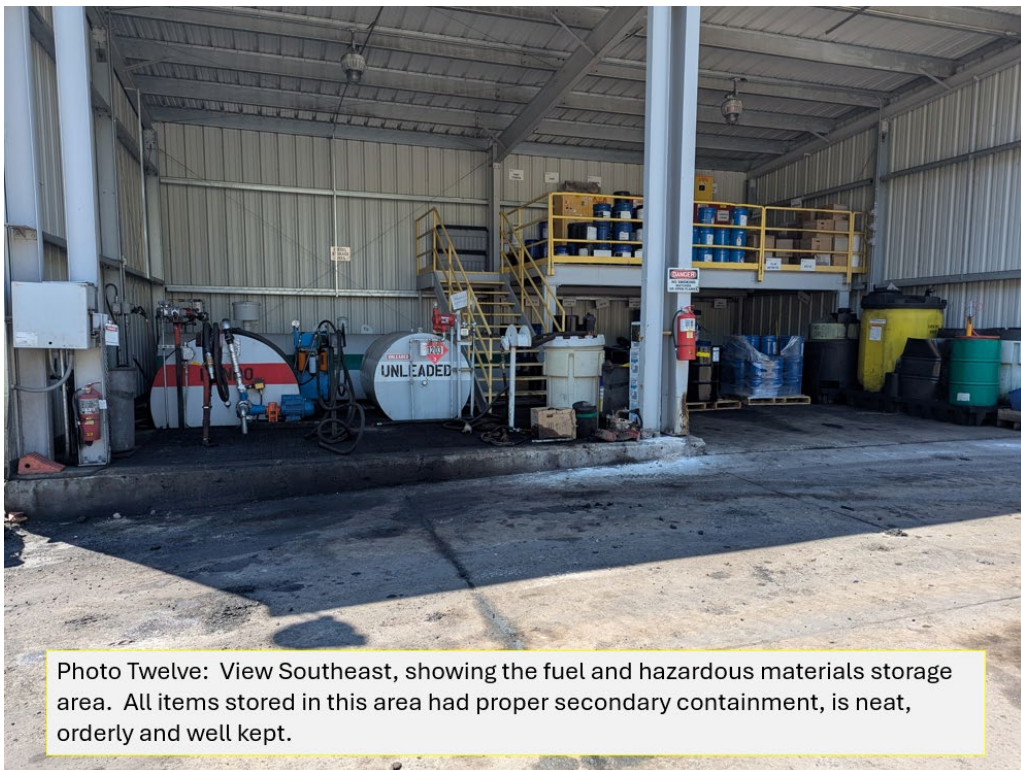
Photo Twelve: View Southeast, showing the fuel and hazardous materials storage area. All items stored in this area had proper secondary containment, is neat, orderly and well kept.
