## C-1981-008 New Horizon June 2025 Partial Inspection Report

<b>Permit Number:</b> C-1981-008 <b>Mine Name:</b> New Horizon Mine <b>Operator:</b> Elk Ridge Mining and Reclamation, LLC <b>Operator Address:</b> Mr Tony Tennyson P.O. Box 628 27646 West 5th Avenue Nucla, CO 81424	<b>County:</b> Montrose <b>Operation Type:</b> Surface <b>Permit Status:</b> Active <b>Ownership:</b> Private
	<b>Operator Representative Present:</b>  None
<b>Operator Representative Signature: (Field Issuance Only)</b>

<b>Inspection Start Date:</b> June 3, 2025 <b>Inspection Start Time:</b> 14:56 <b>Inspection End Date:</b> June 3, 2025 <b>Inspection End Time:</b> 15:40	<b>Inspection Type:</b> Coal Partial Inspection <b>Inspection Reason:</b> Normal I&E Program <b>Weather:</b> Cloudy
<b>Joint Inspection Agency:</b>  None	<b>Joint Inspection Contacts:</b>
<b>Post Inspection Agency:</b>  None	<b>Post Inspection Contacts:</b>
<b>Inspector(s):</b>  Lucas West	<b>Inspector's Signature:</b>

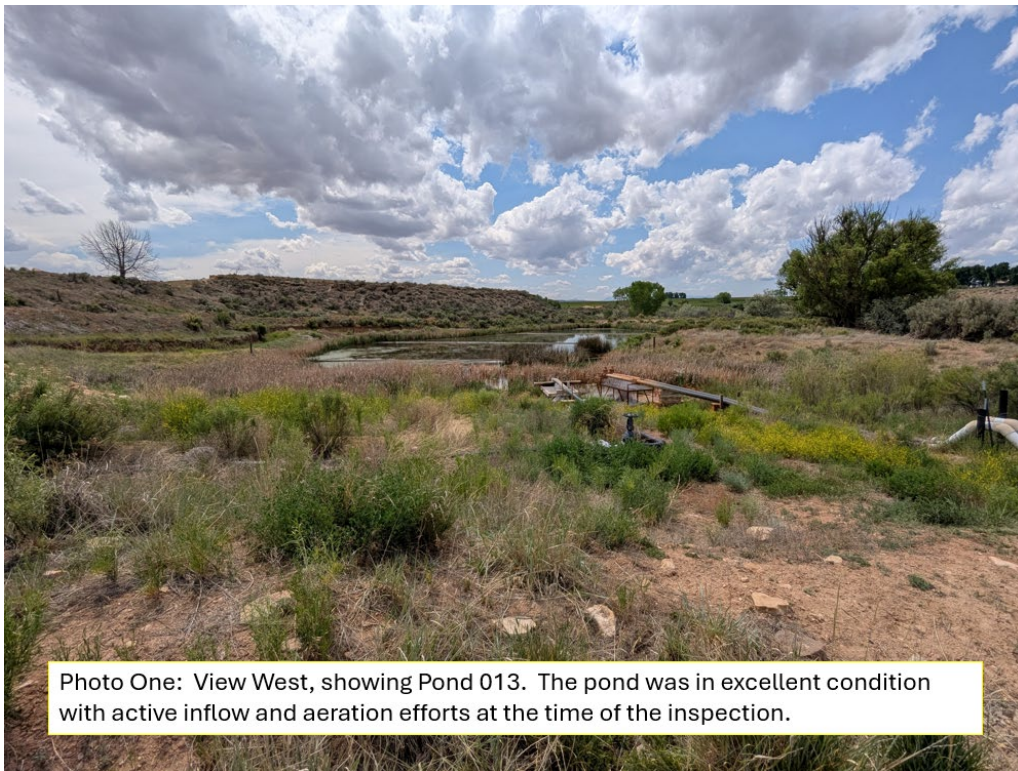
During this Inspection Pond 013 as well as the rock lined storm water conveyance was observed. Pond 013 was found to be in good condition with active inflow and aeration at the time of the inspection. The water levels in the pond appeared to be normal and the baffle curtains appeared to be functioning as designed. The aeration structure also appeared to be functioning as designed. Pond 013 can be seen in Photo One.

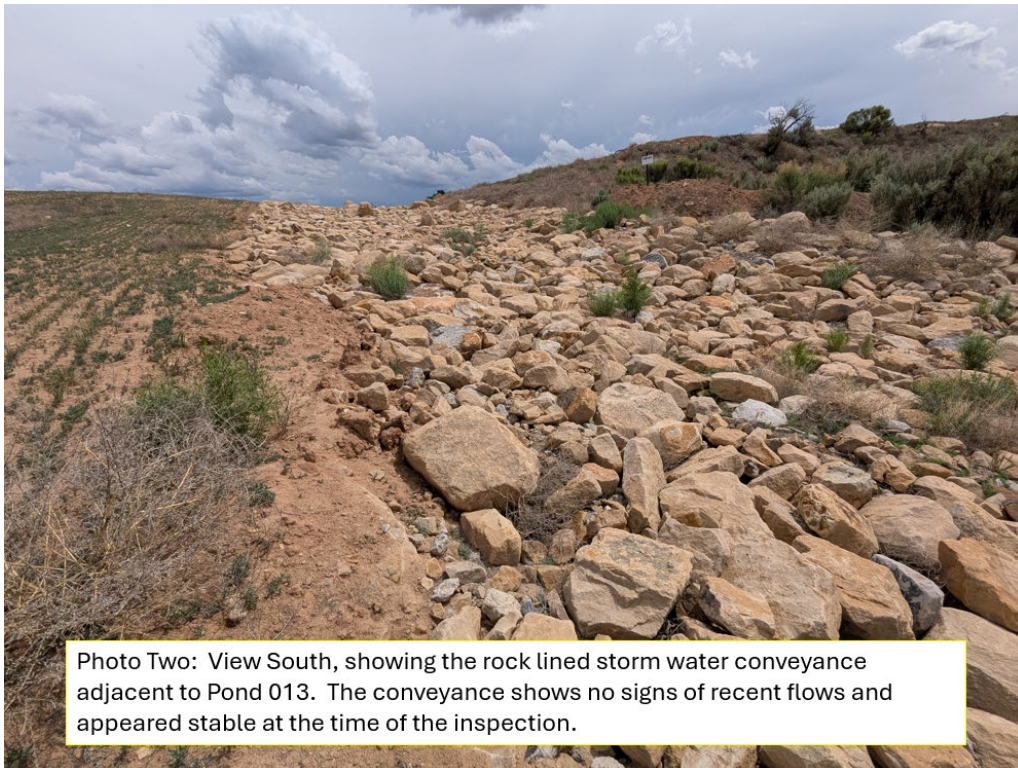
Photo Two shows the rock lined storm water conveyance that is intended to direct sheet flow from the DP-21 area toward Pond 013. The conveyance appeared stable at the time of the inspection and no evidence of recent flow was noted.

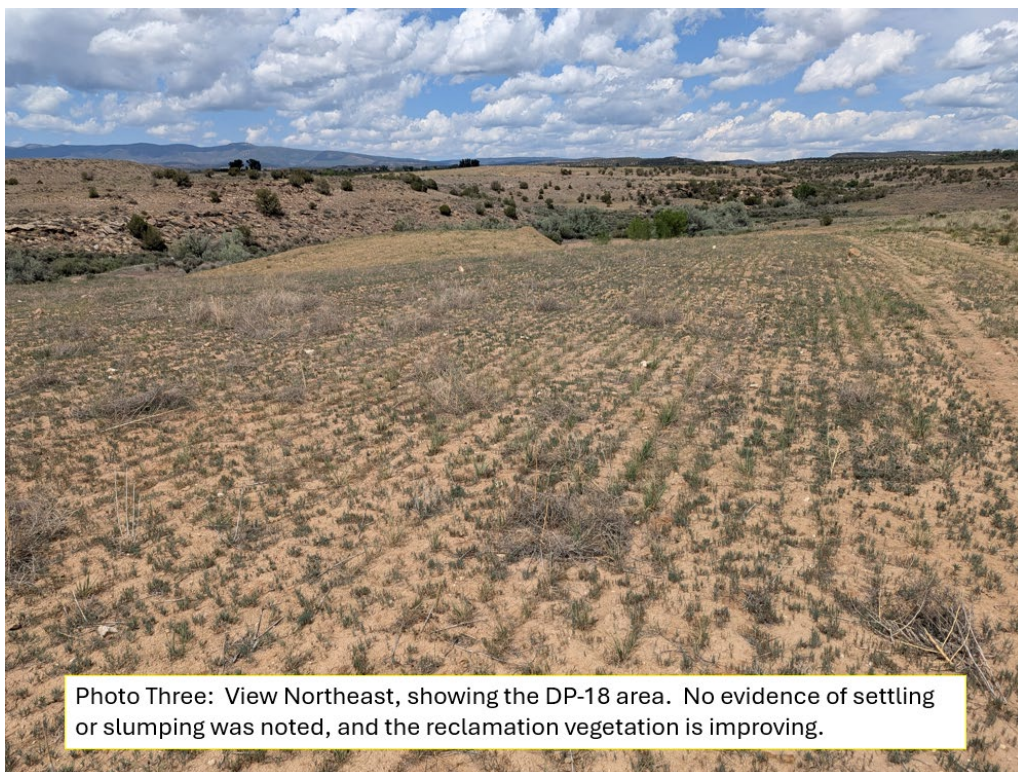
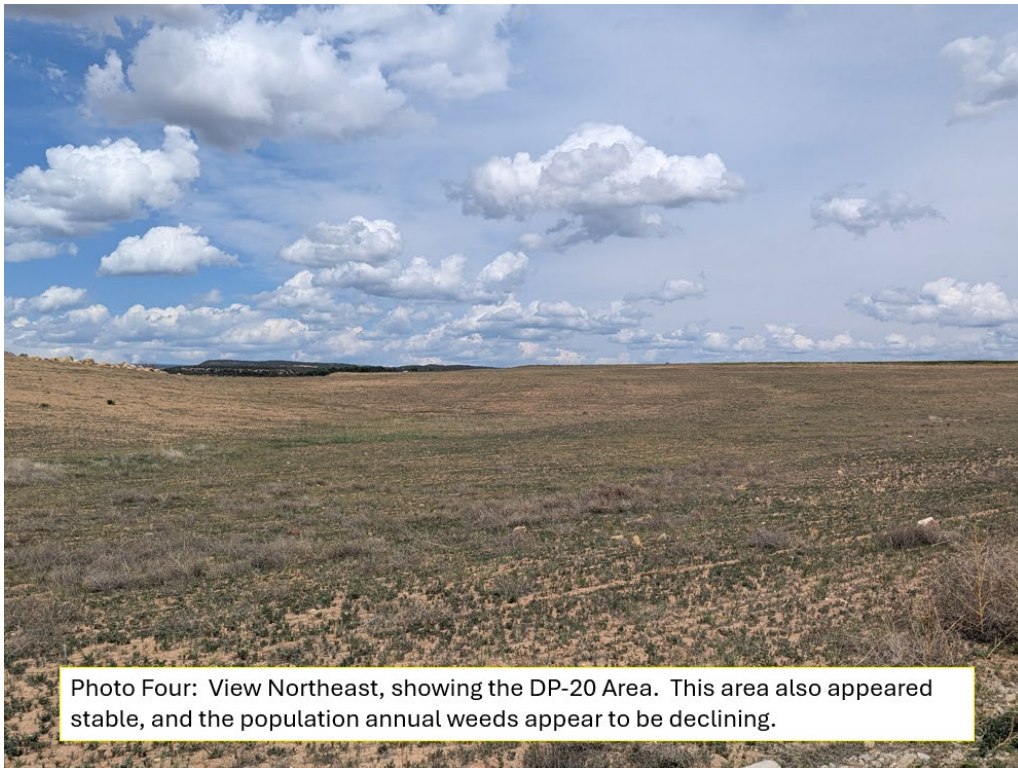
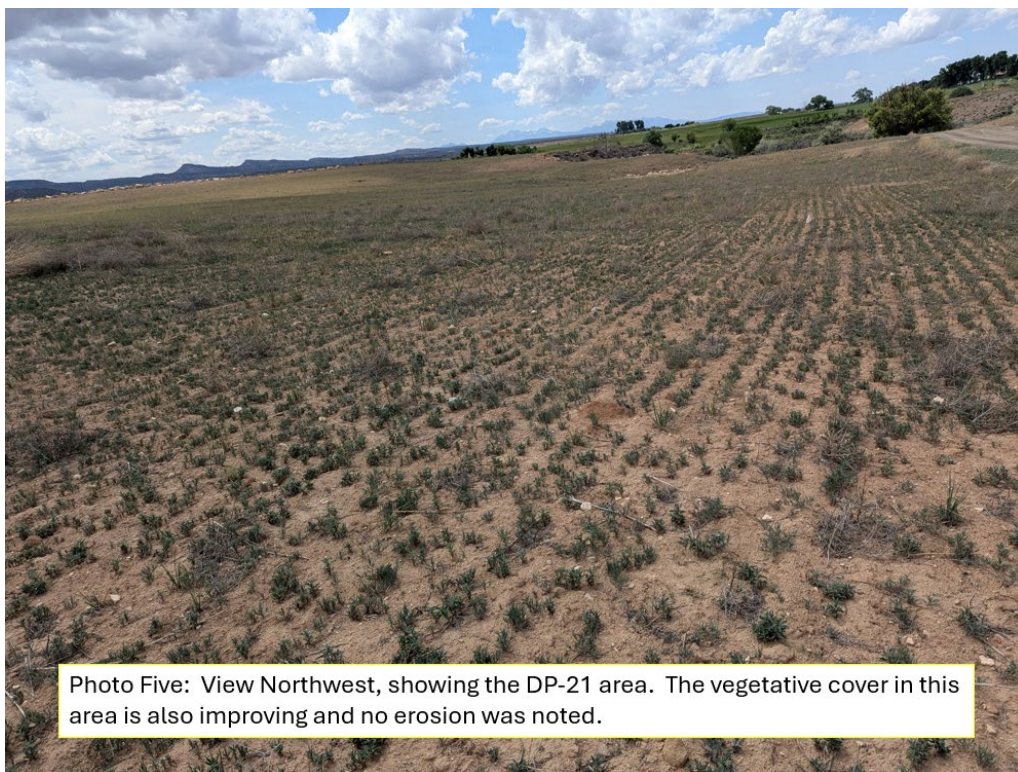
The reclamation of areas DP-18, 20 and 21 as well as IC-1 were also observed during this inspection. For the DP-18, 20 and 21 area the backfill and topsoiling appeared to be stable at the time of the inspection. No evidence of settling, slumping or erosion was noted in any of the areas. The revegetation efforts were also found to be improving with a higher proportion of reclamation species identified, and the presence of annual weeds decreasing. These areas can be seen in Photos Three through Five respectively.

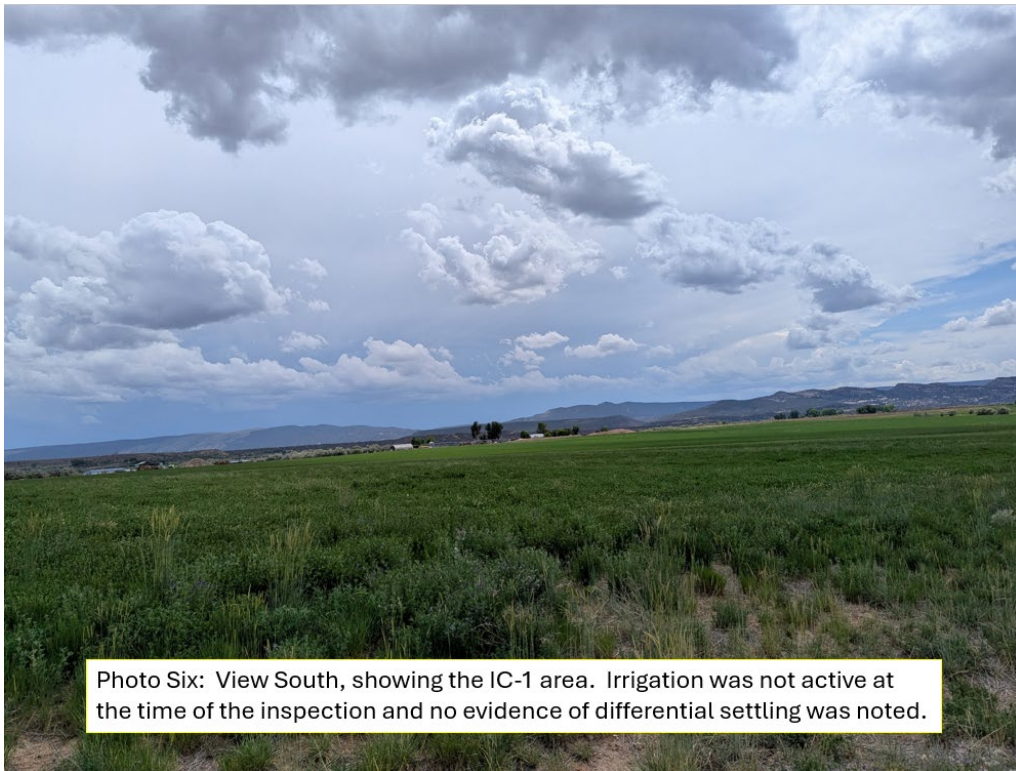
The IC-1 area, shown in Photo Six was also found to be in excellent condition. Irrigation was not active at the

time of the inspection and the first cutting of alfalfa appears to not yet have occurred. No evidence of differential settling or slumping was noted.

Photo Six: View South, showing the IC-1 area. Irrigation was not active at the time of the inspection and no evidence of differential settling was noted.
