Inspection Report Trapper Mine 2025 June

COLORADO
 Division of Reclamation,
 Mining and Safety
 Department of Natural Resources

11 June 2025

Permit Number: C1981010 Mine Name: Trapper Mine Operator: Trapper Mining, Inc. Operator Address: Mr. Graham Roberts P.O. Box 187 Craig, CO 81626	County: Moffat Operation Type: Surface Permit Status: Active Ownership: Federal Operator Representative Present: Graham Roberts
This report was issued electronically from the Divisions' Denver Office.

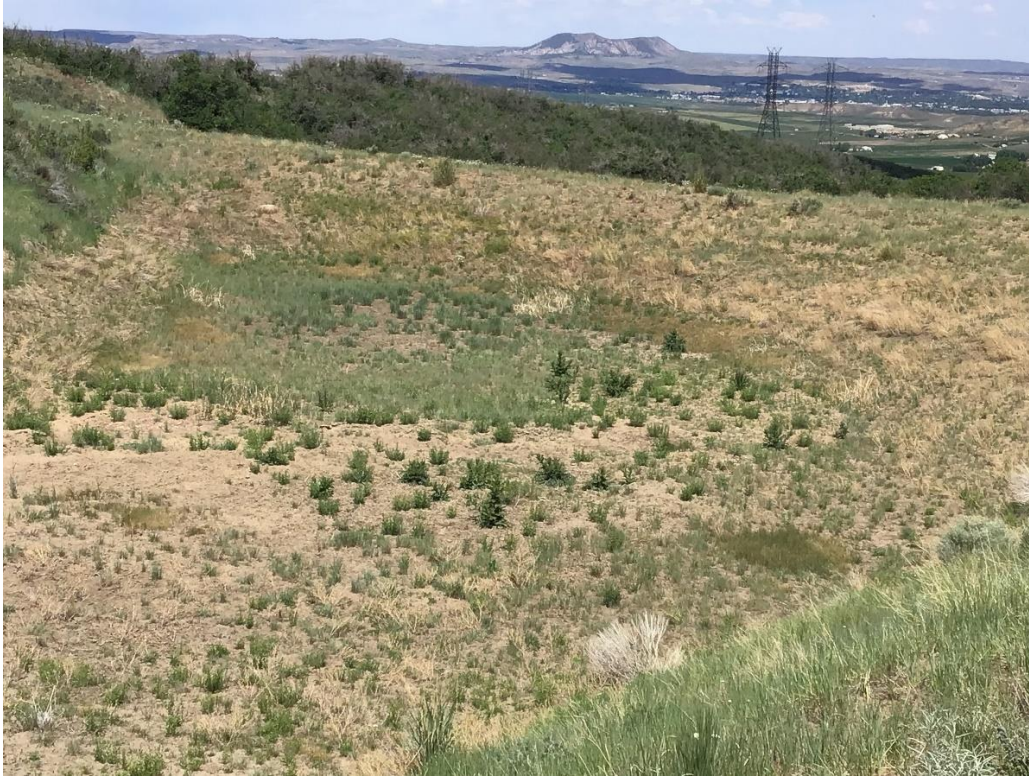
7. East Flume was dry inspection.
8. Middle Flume #1 water pumped for dredging scheduled later this summer. June
9. East Middle Flume #1 was holding water and requires pumping for dredging this field season. The pond is covered emergent cattails. Rocked inflow channel requires stabilization.

Photo 1: East Flume Pond, dry.

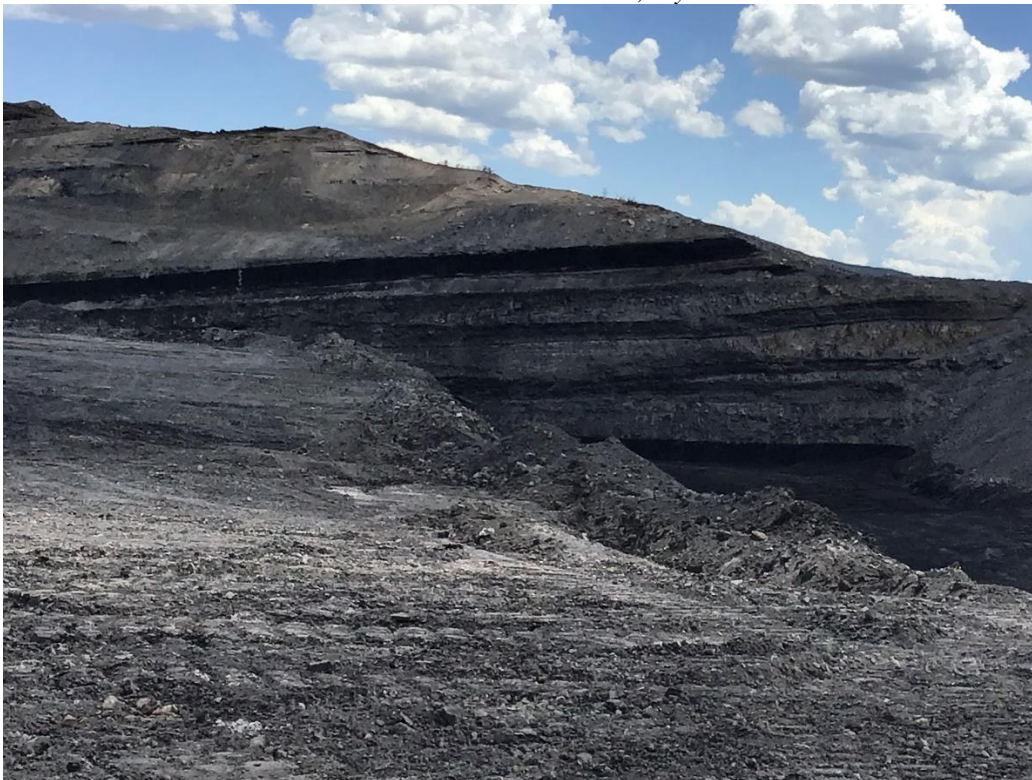
Photo 2: Coal strata in L Pit.

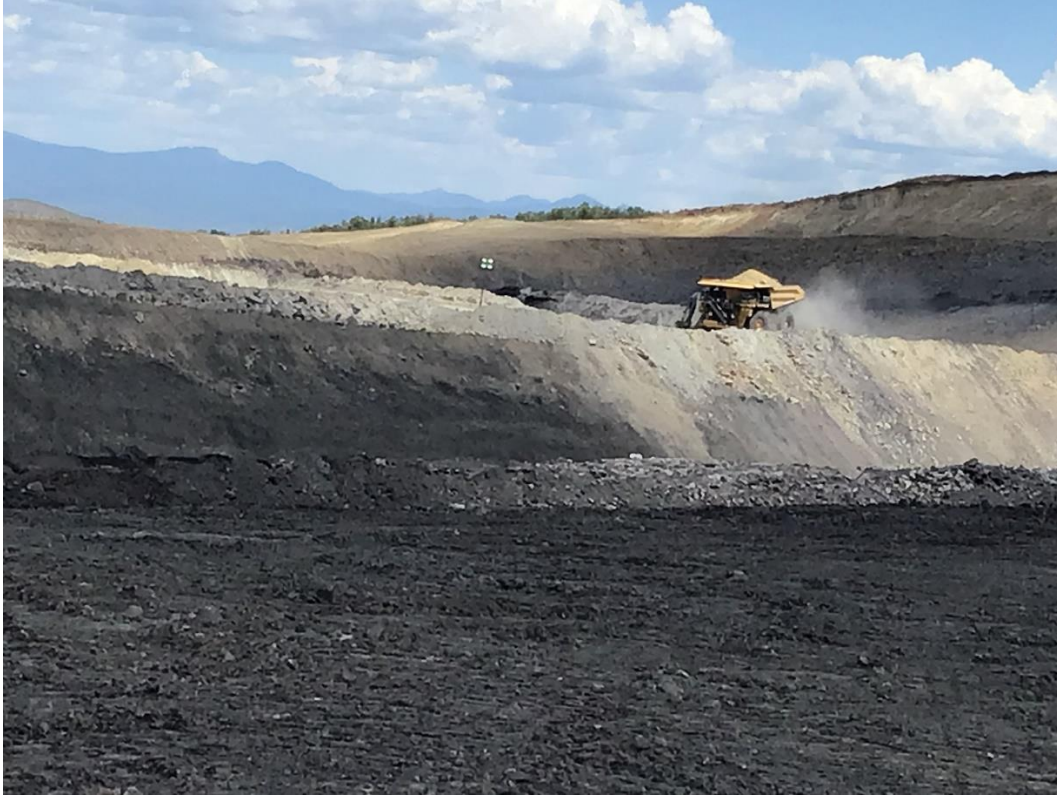
Overburden was being loaded and hauled from L and N Pits. At the time of inspection, the Molly Brown was idle at the top of the L Pit on the south end of the pit. The Baby Doe was working mid L Pit.

Photo 3: Loading and hauling overburden from north end of L Pit.

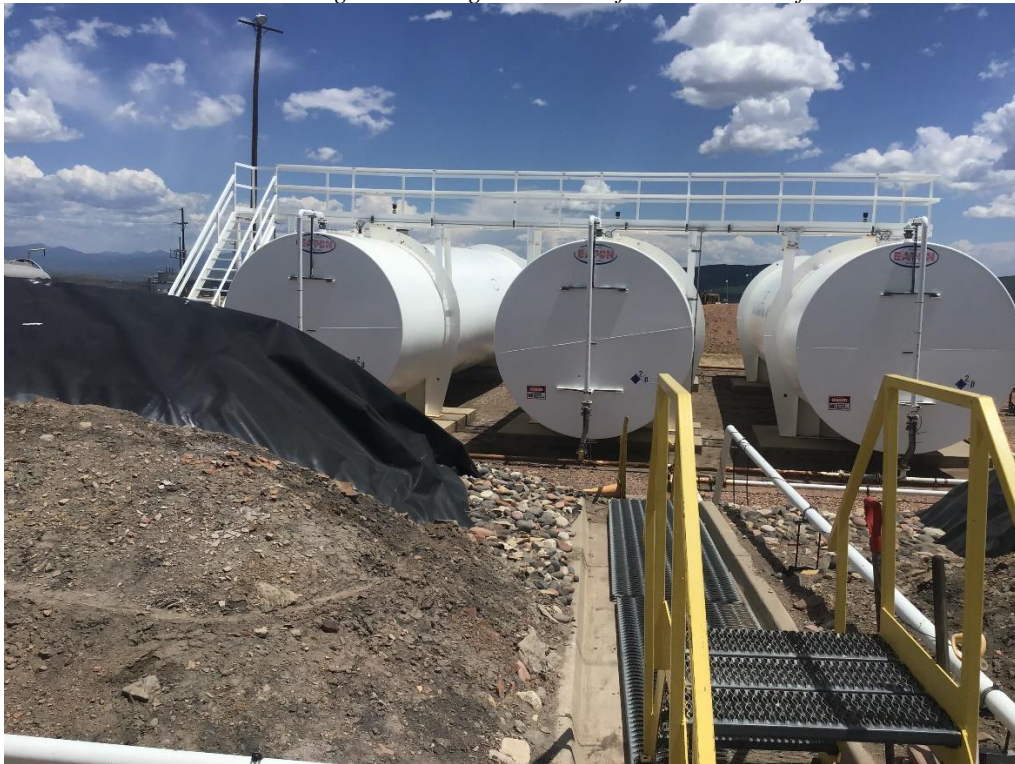
- Fuel tank storage was contained within a berm and lined.
- Ready Line area was organized and in good repair with a firm gravel pad, no standing water or ruts.

Photo 4: Fuel tank storage containment adequately maintained.

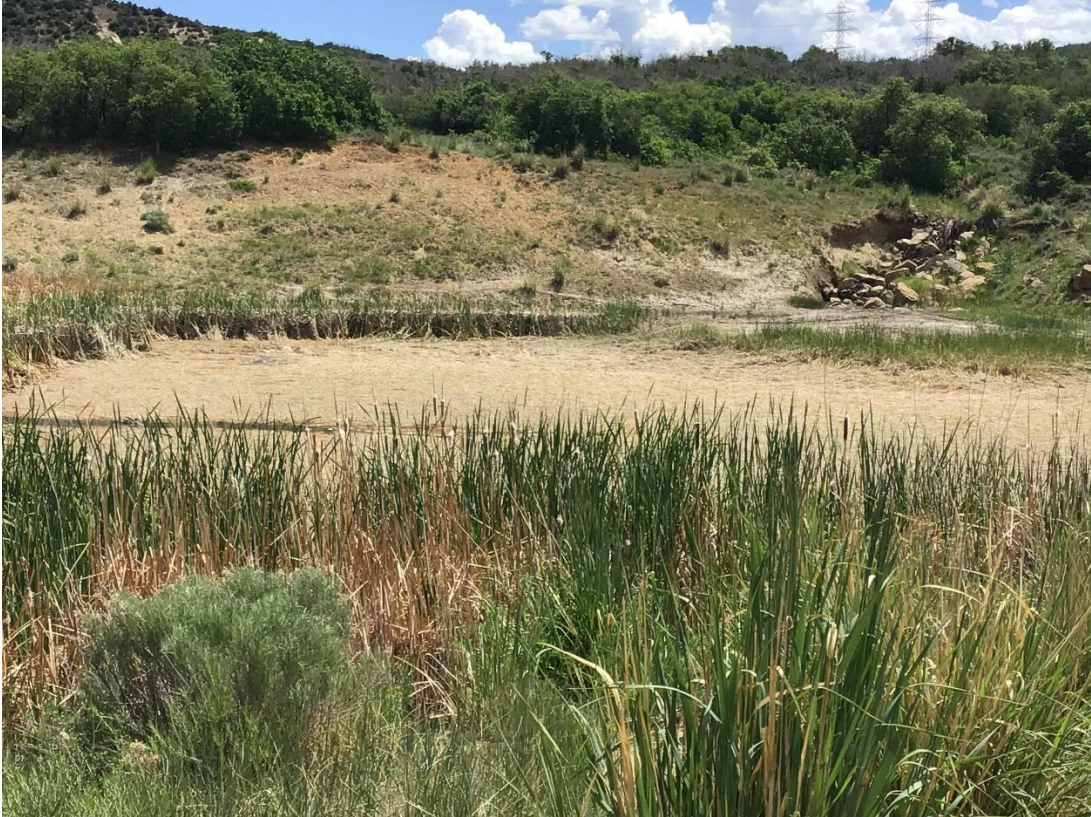
Photo 5: East Middle Flume #1, holding a small amount of water ready for dredging and stabilization of inflow channel.

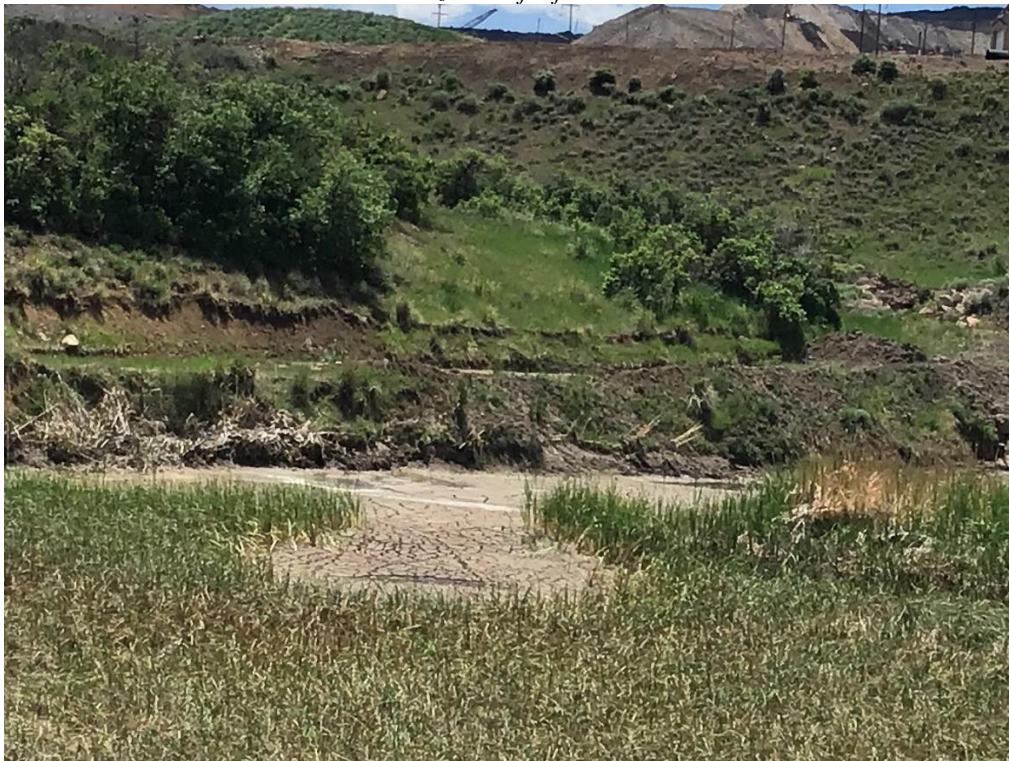
4. No Name #4 was full and discharging a trickle of clearwater through the decant culvert.
5. No Name #5 was discharging through the flume.
6. Middle Flume #3 has been drawn down for road watering purposes and for dredging. The pond exhibits a significant delta at the inlet.

Photo 6: East Middle Flume #3, holding a small amount of water having been pumped for dredging.

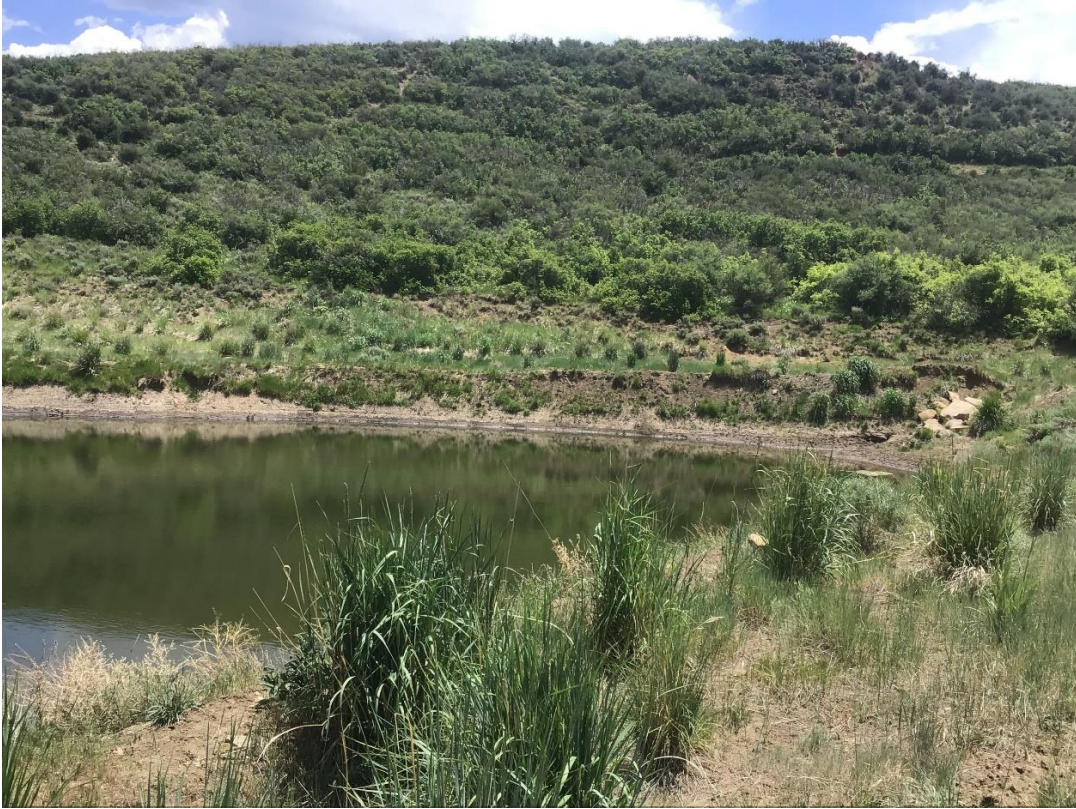
2. Oak Pond #1 held water at the time of inspection and was not discharging. The dozer basin above the pond held some water.
3. Oak Pond #2 was dry. The access road to Oak drainage was rutted.

Photo 7: Oak Pond #1 holding clear water and not discharging.

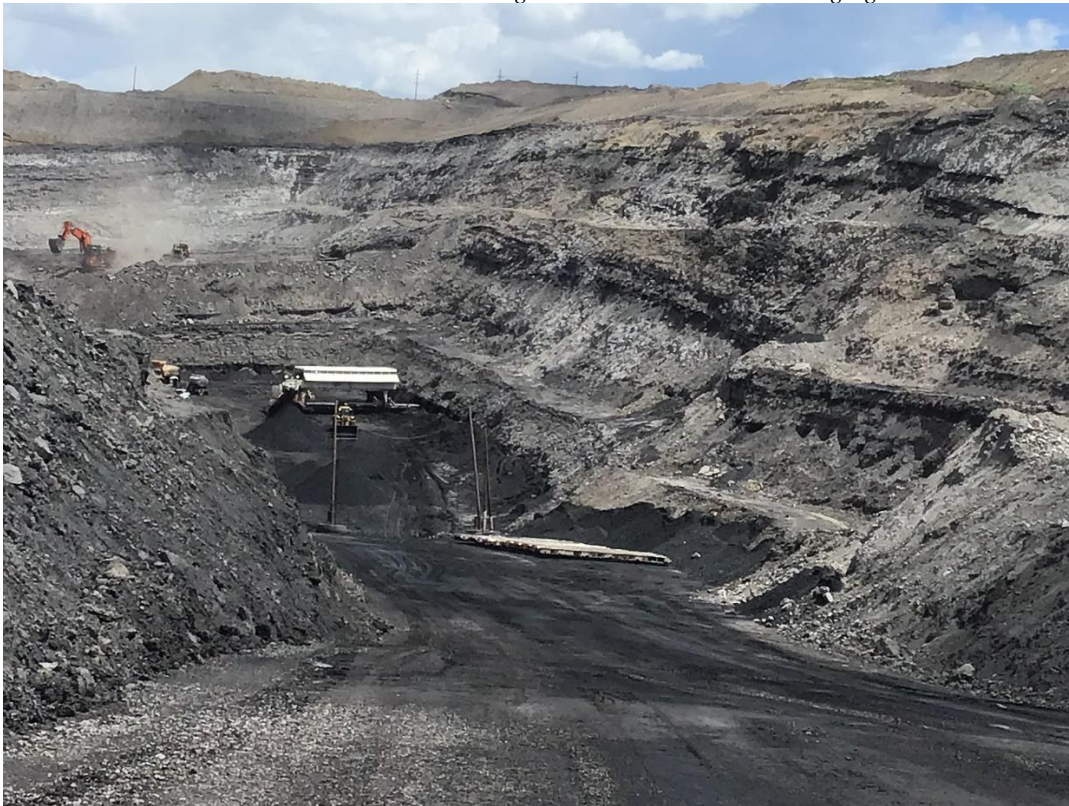
N Pit has reached its eastern extent. N pit highwall mining was finishing up on south highwall at Q seam and will be deepened to R seam the north highwall will be mined.

Photo 8: N Pit activities looking east.

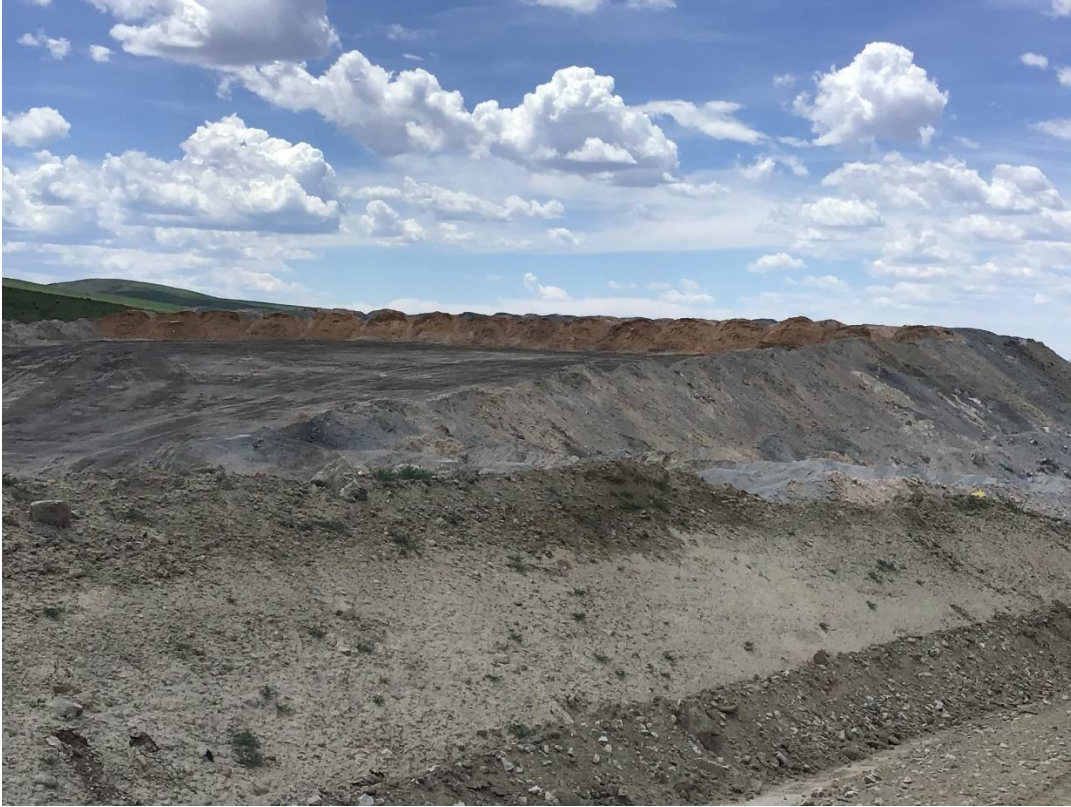
- The Ash Pit comprises loose ash piled around the perimeter of the flat surfaces. The flat surfaces of the Ash Pit were dry and firm, with no standing water or ruts and appeared to be functioning adequately at the time of inspection.
- The Ash Pit is permitted to receive waste materials such as lumber, trash and tires generated at the site.

Photo 9: Ash piles at the Ash Pit looking southwest.

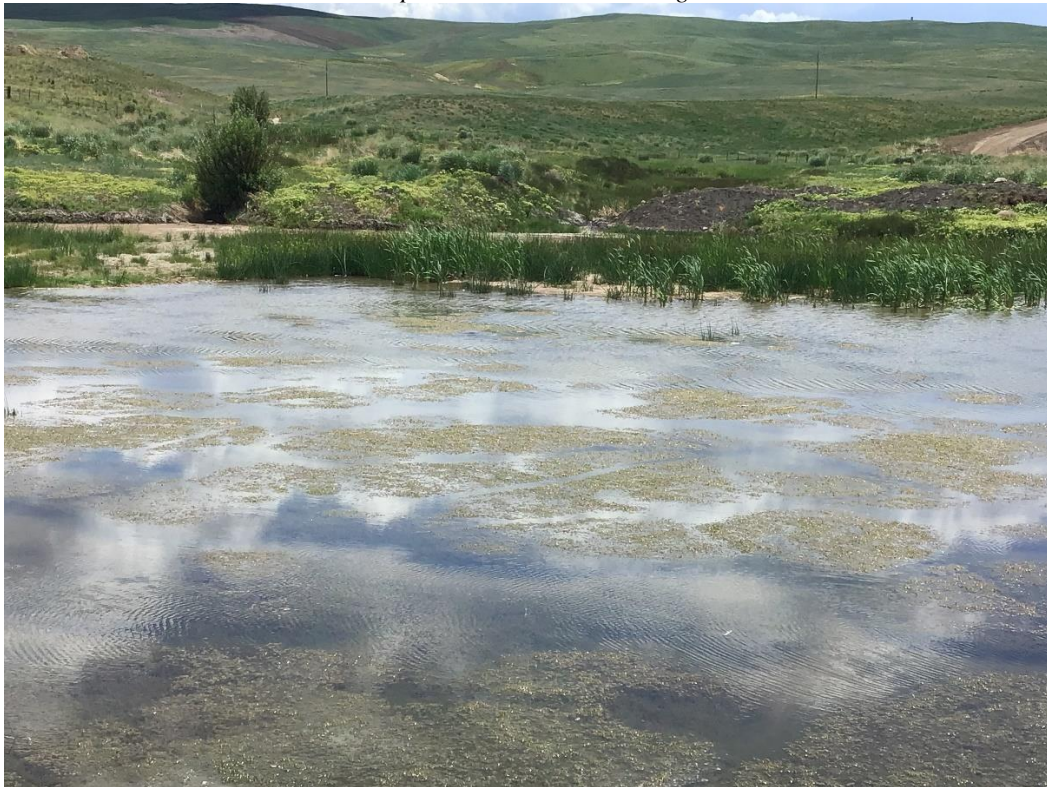
1. No Name #2 exhibits large sediment fan. Spoil is piled above the pond. The pond is scheduled for dredging. Vigorous vegetation was growing in the bottom of the pond. White top is present along the north banks of the pond. Thistles are present on the access road between the pond and the discharge drainage.

Photo 10: No Name Pond #2 exhibiting considerable vegetation on the pond bottom.
