June 9, 2025
Project No.: 19125

Holcim
1687 Cole Boulevard, Suite 300
Golden, CO 80401

Regarding: Daniels Sand Pit 2, Permit No. M-1973-007-SG
Slope Stability Monthly Monitoring Report

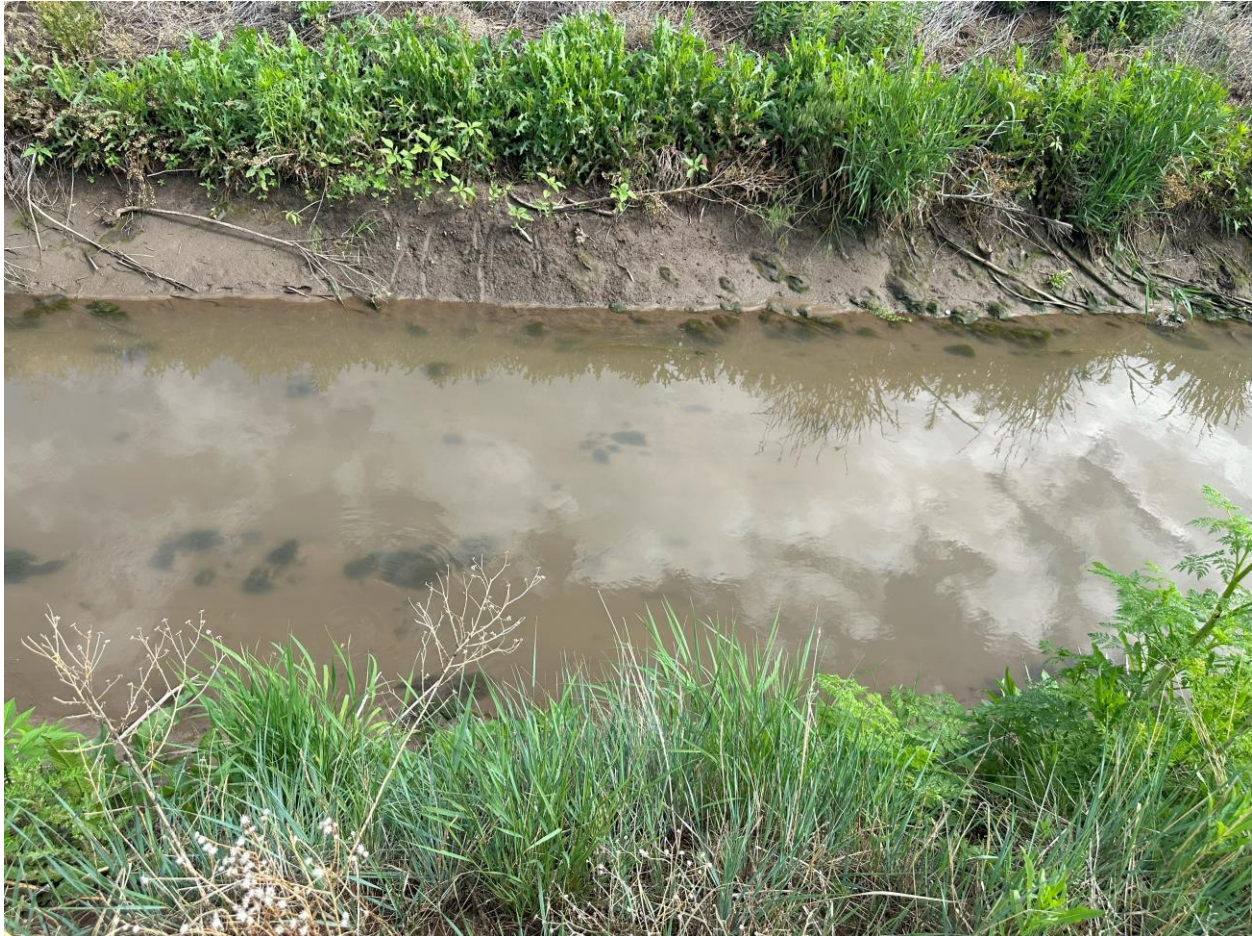
Photo 1. Water flowing in ditch

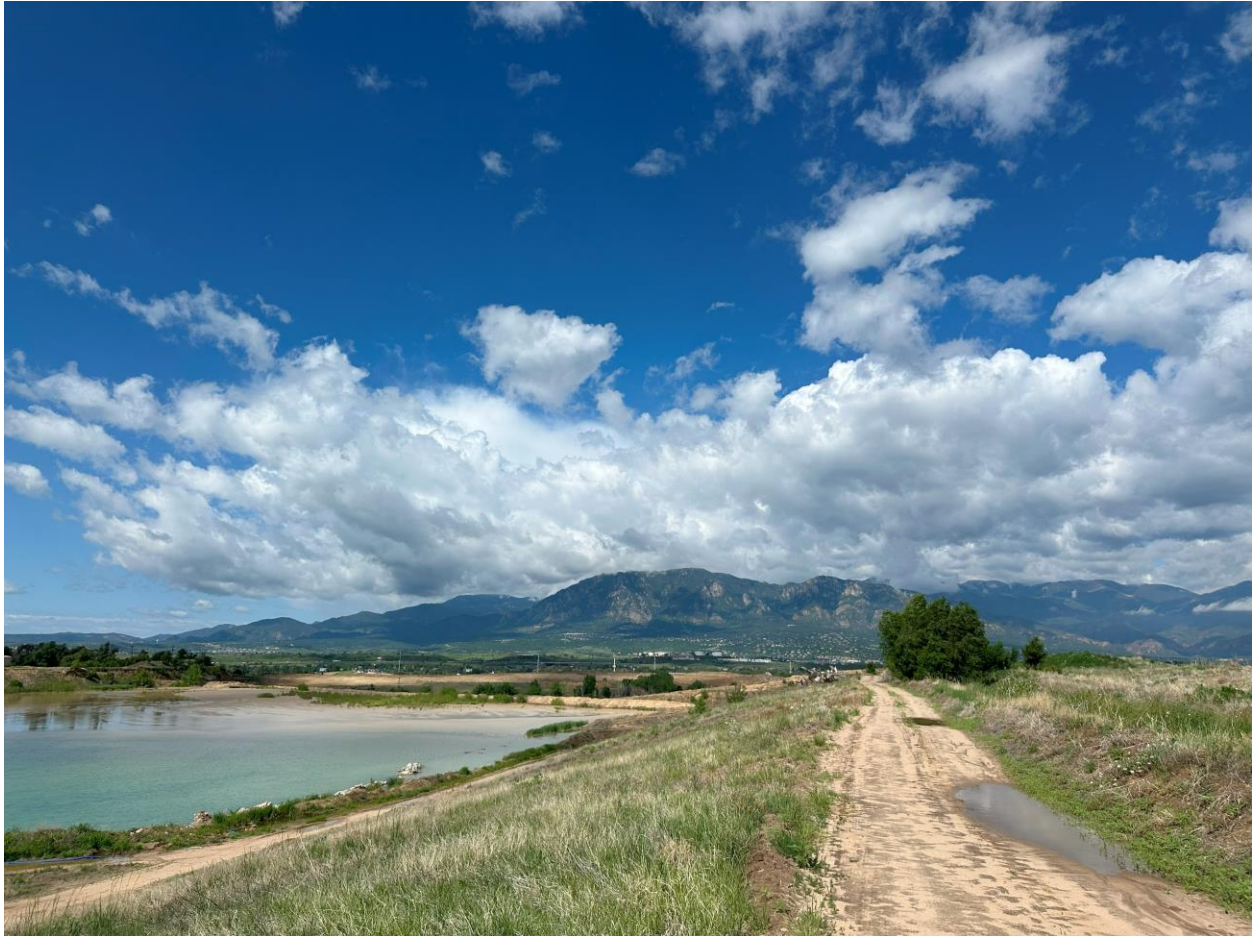
Photo 2. Buttress slope with ditch access road

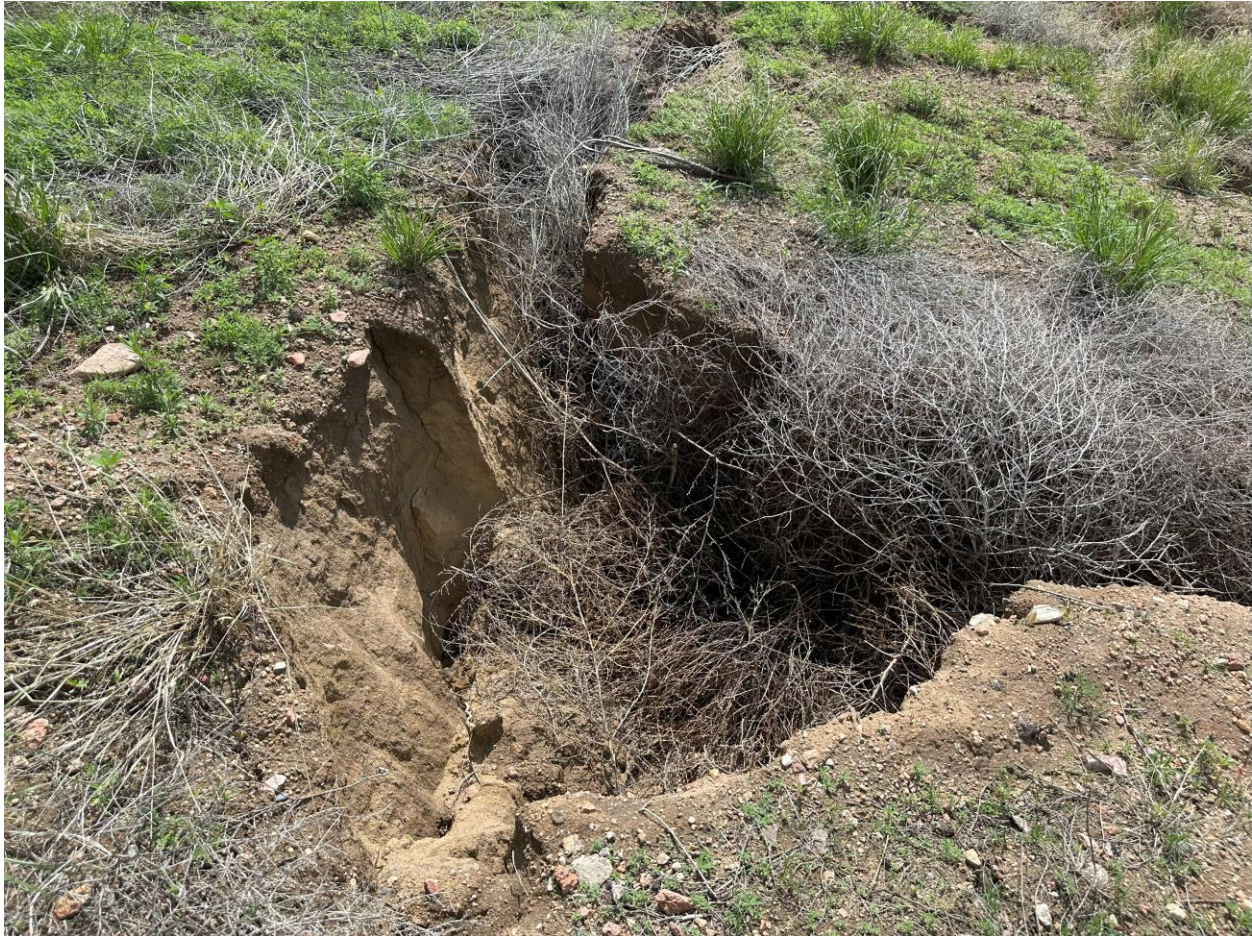
- c) Several locations show visible evidence of surface water runoff and expanding erosion gullies throughout the buttress. The erosion gullies are widespread along the buttress from east to

west, with a few located 2/3 up the slope and several feet wide and deep. Since the last site visit in December 2024, the frequency of erosion gullies has increased. The dimensions (width and depth) of individual erosion gullies have also increased.

Photo 3. Erosion gully in buttress

- 1) Several erosion gullies exist within the embankment slope. We recommend those areas be reconstructed ASAP and that the areas be seeded per the reclamation plan.

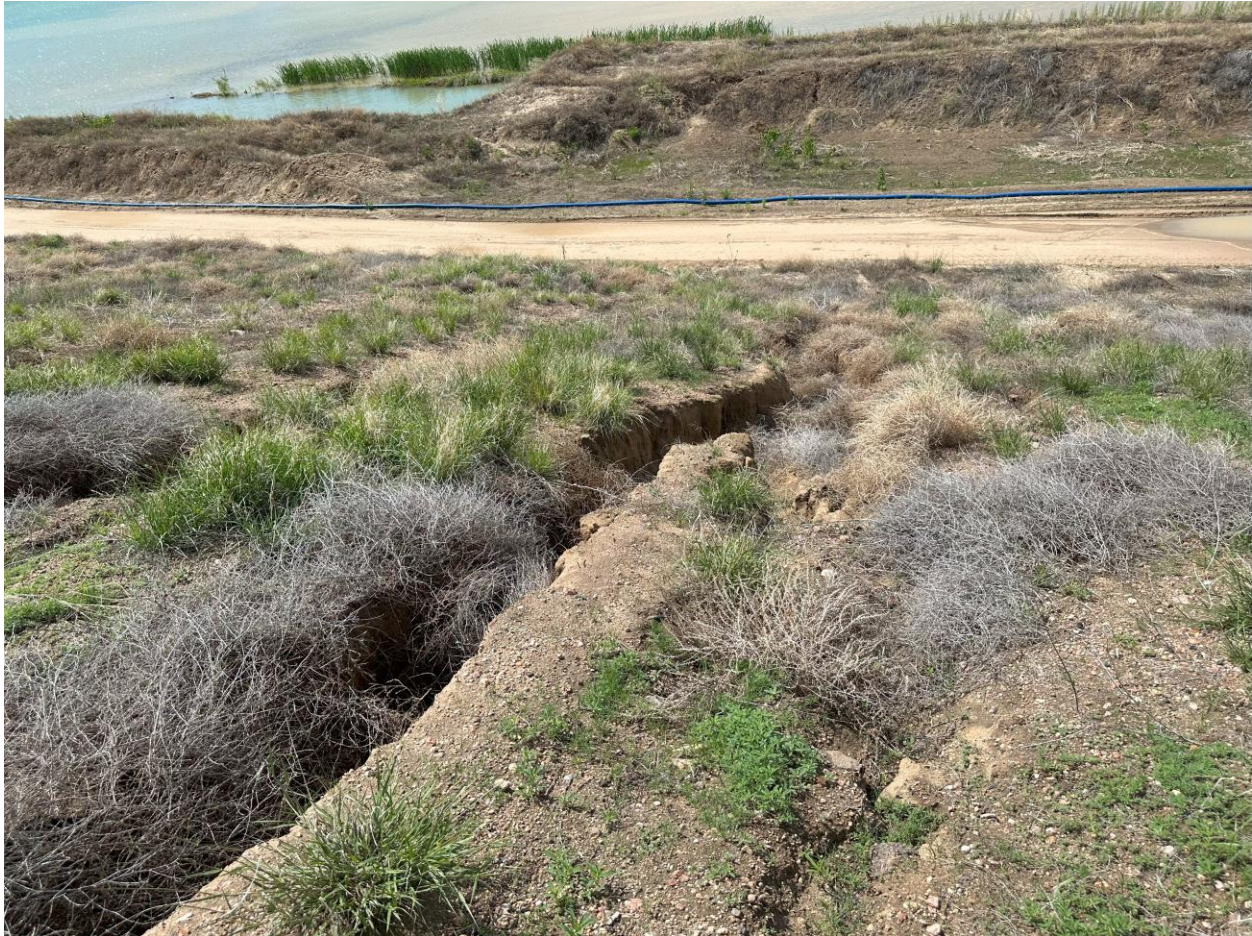
Photo 4. Erosion gullies in buttress

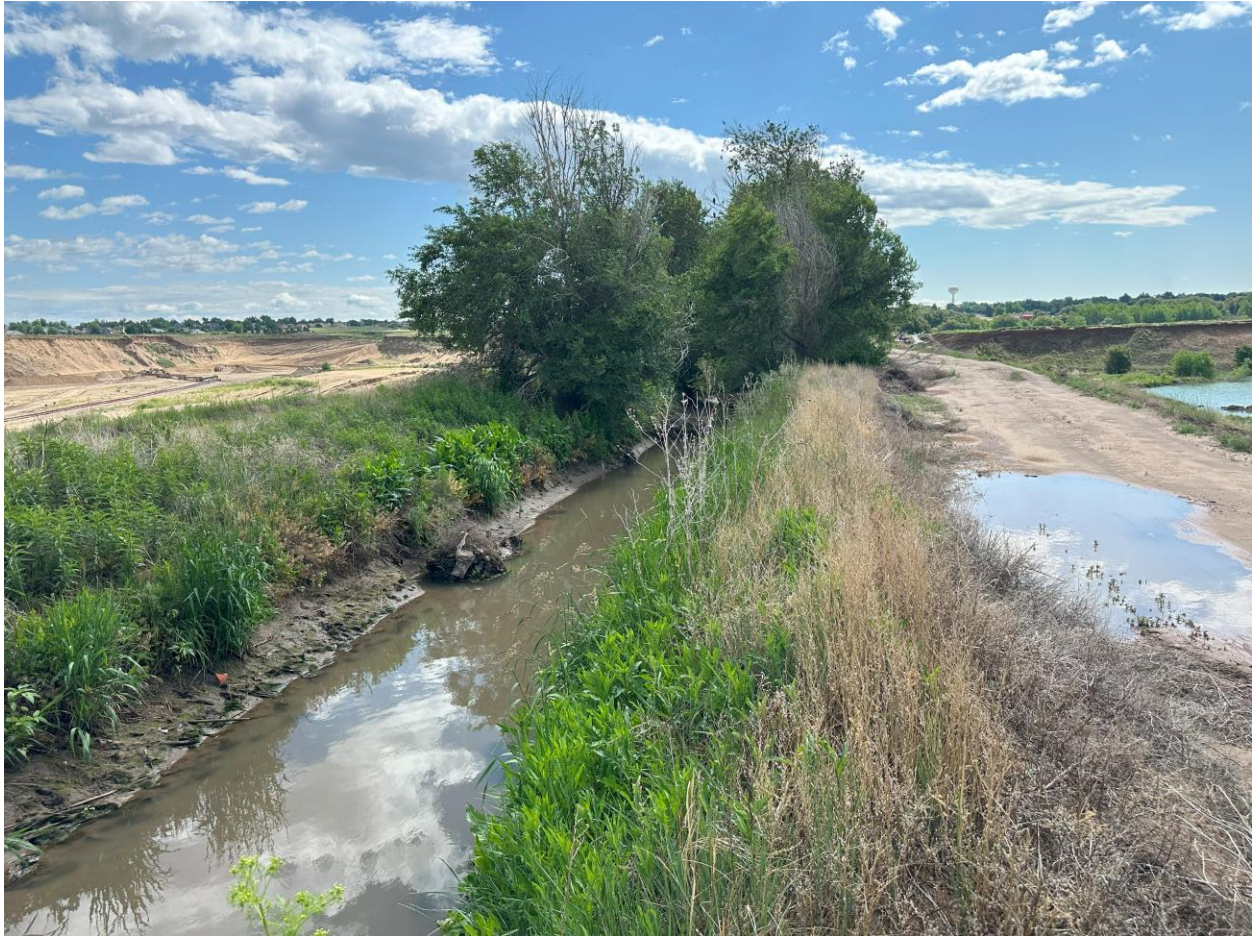
- b) Vegetation growing on banks of ditch.
 - c) Flowing water.
 - d) Ditch access road not level/flat in a few areas. Ponding water present in a few locations. Fallen tree branches also present on road.

Photo 5. Ditch and access road looking east (note ponding water on access road)

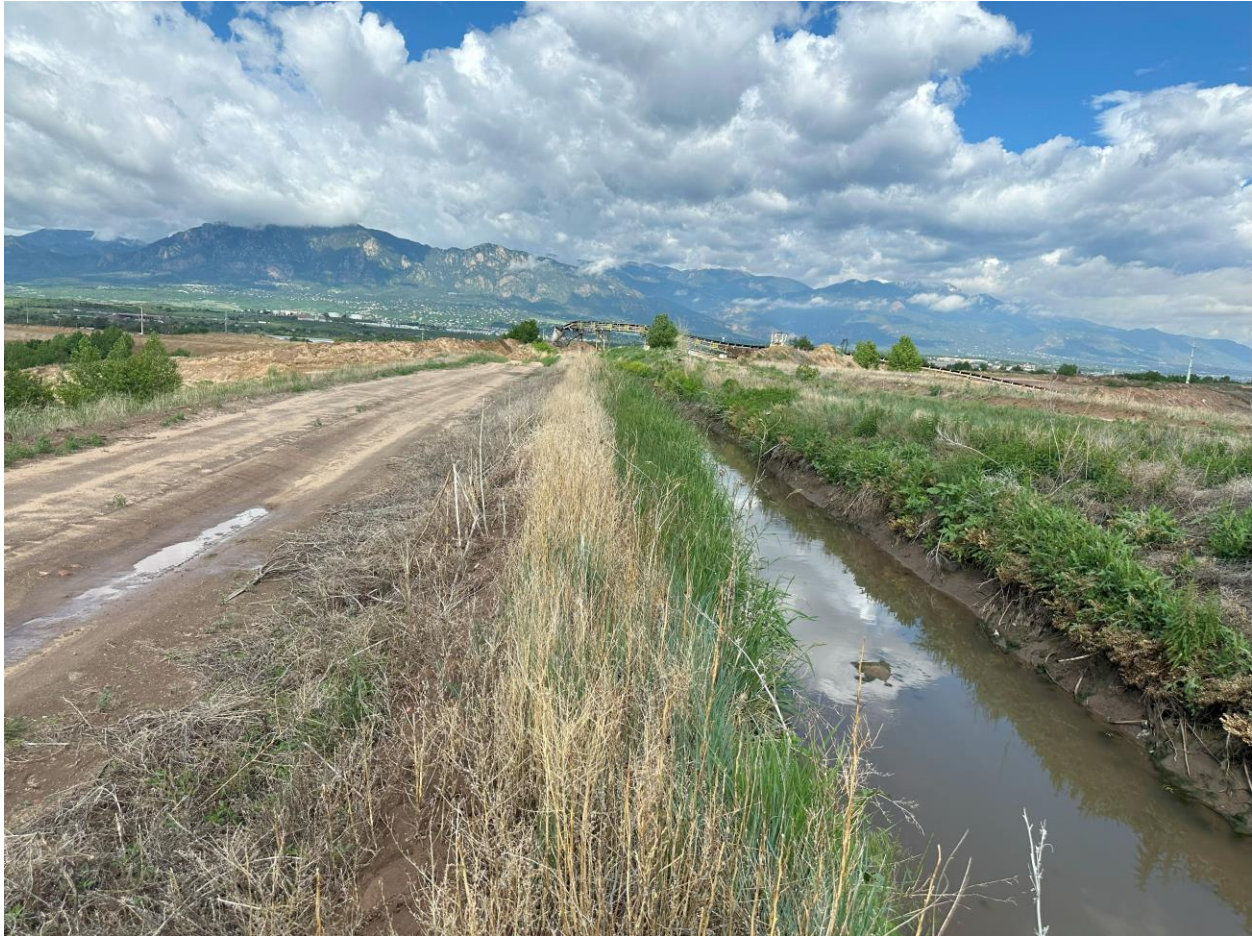
Photo 6. Ditch and access road looking west

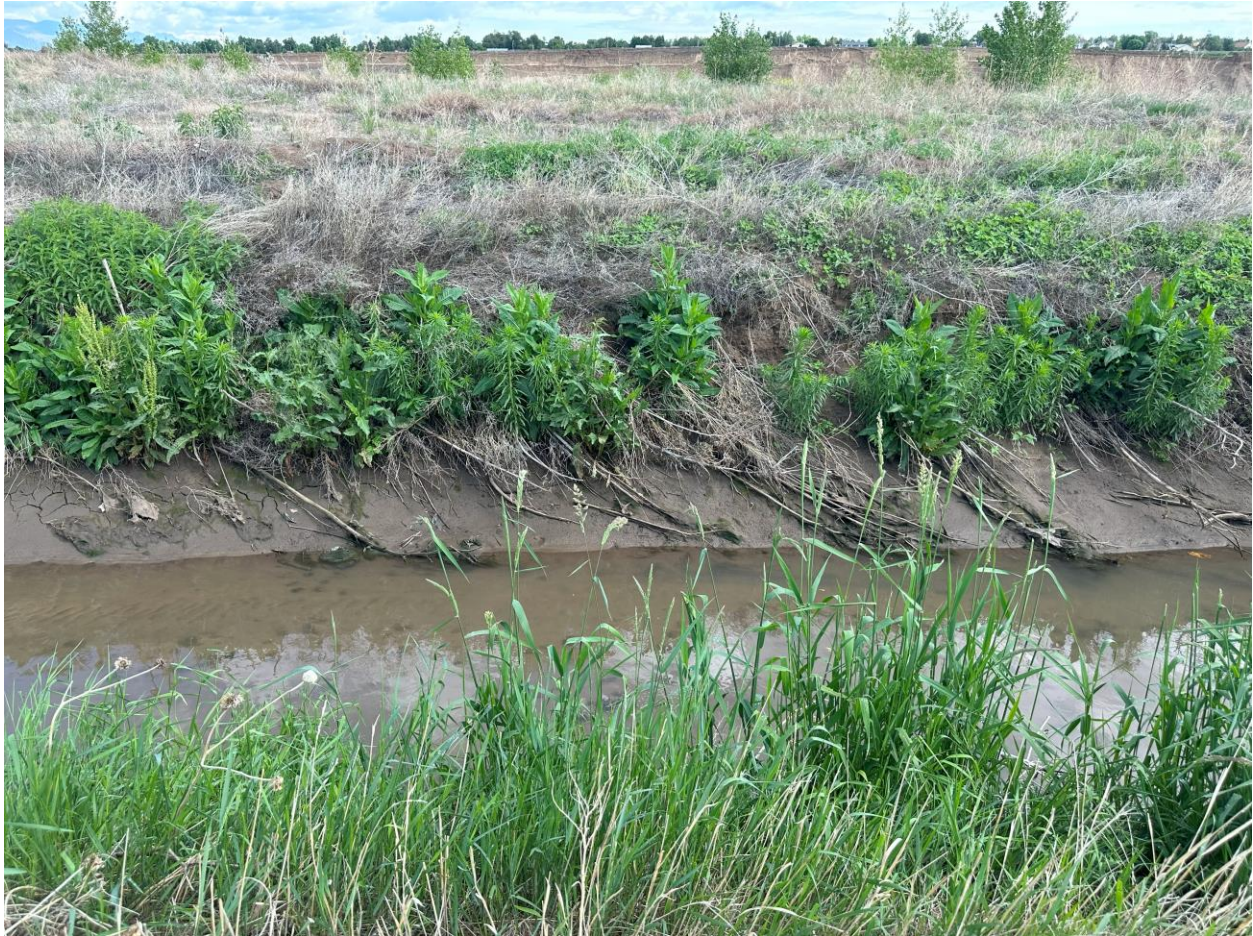
Photo 7. Ditch looking north

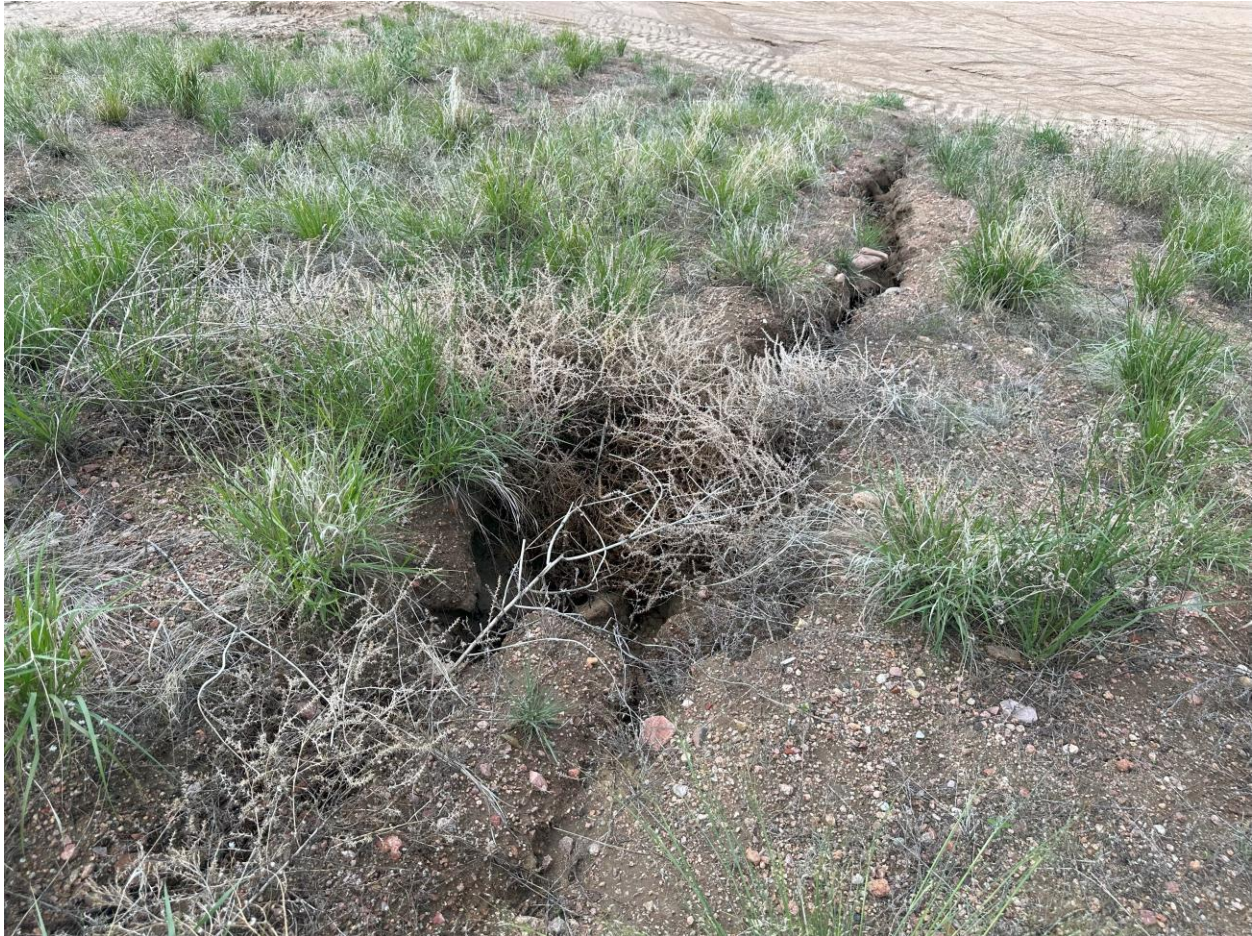
Photo 8. Erosion gully in buttress

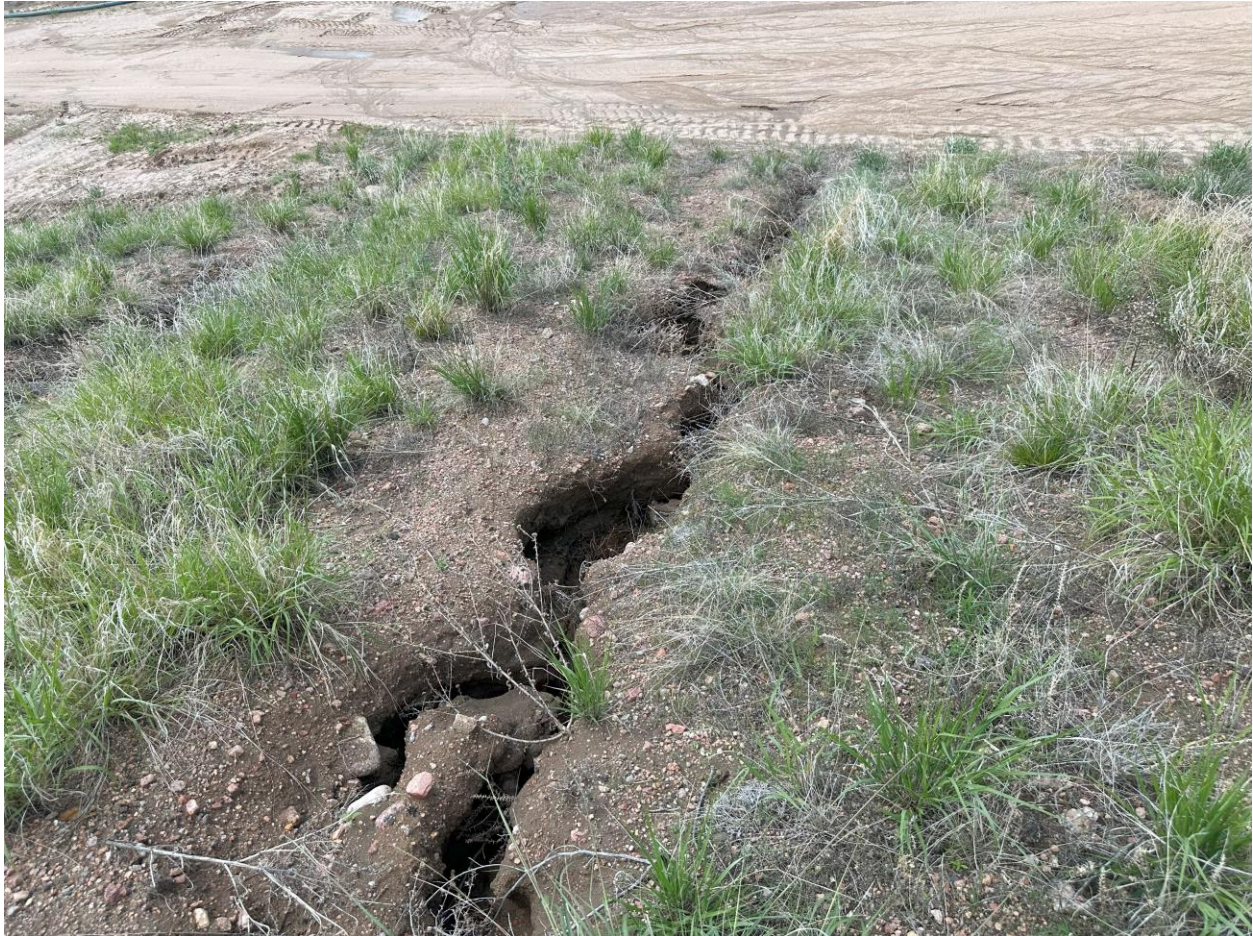
Photo 9. Erosion gully in buttress

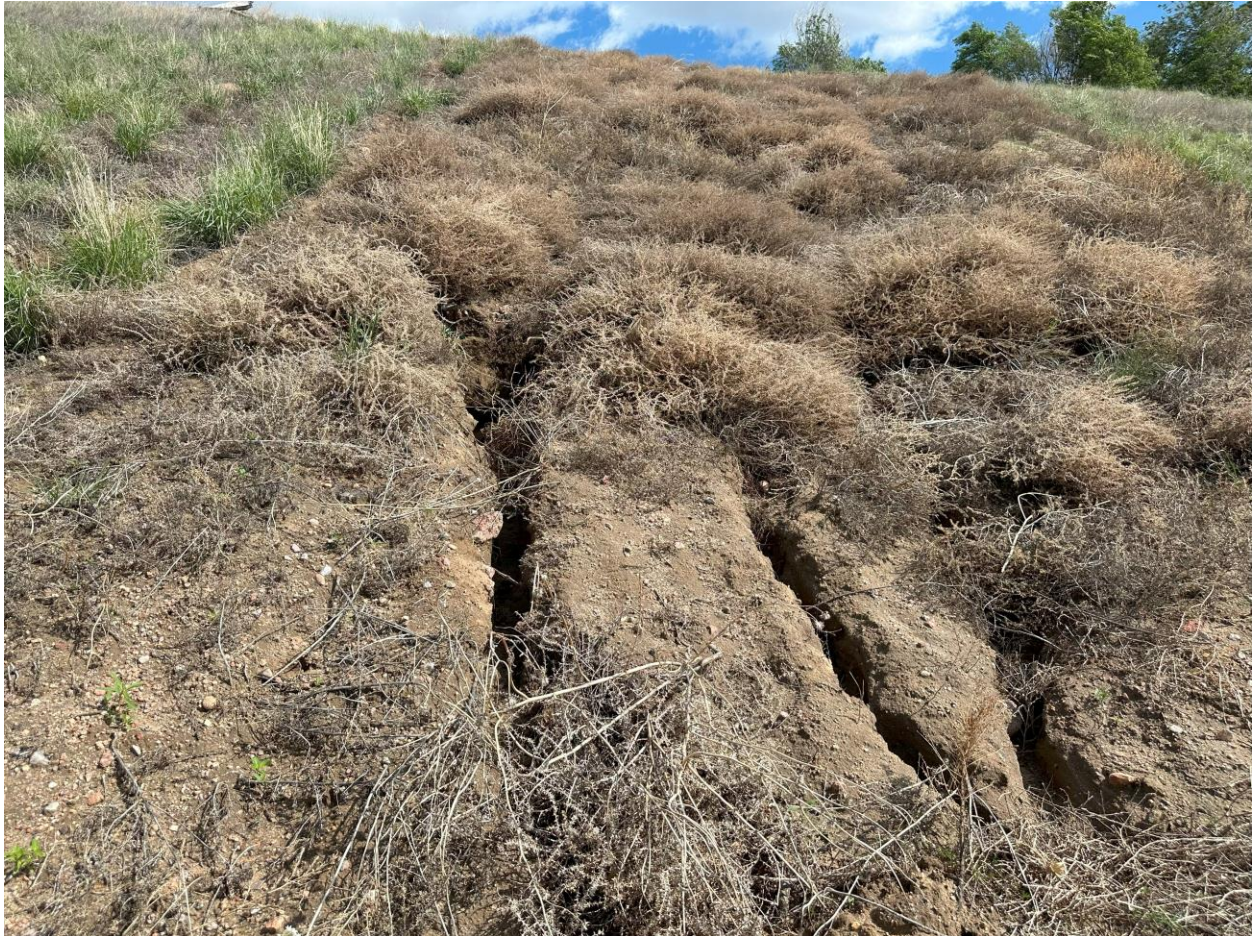
Photo 10. Erosion gully in buttress

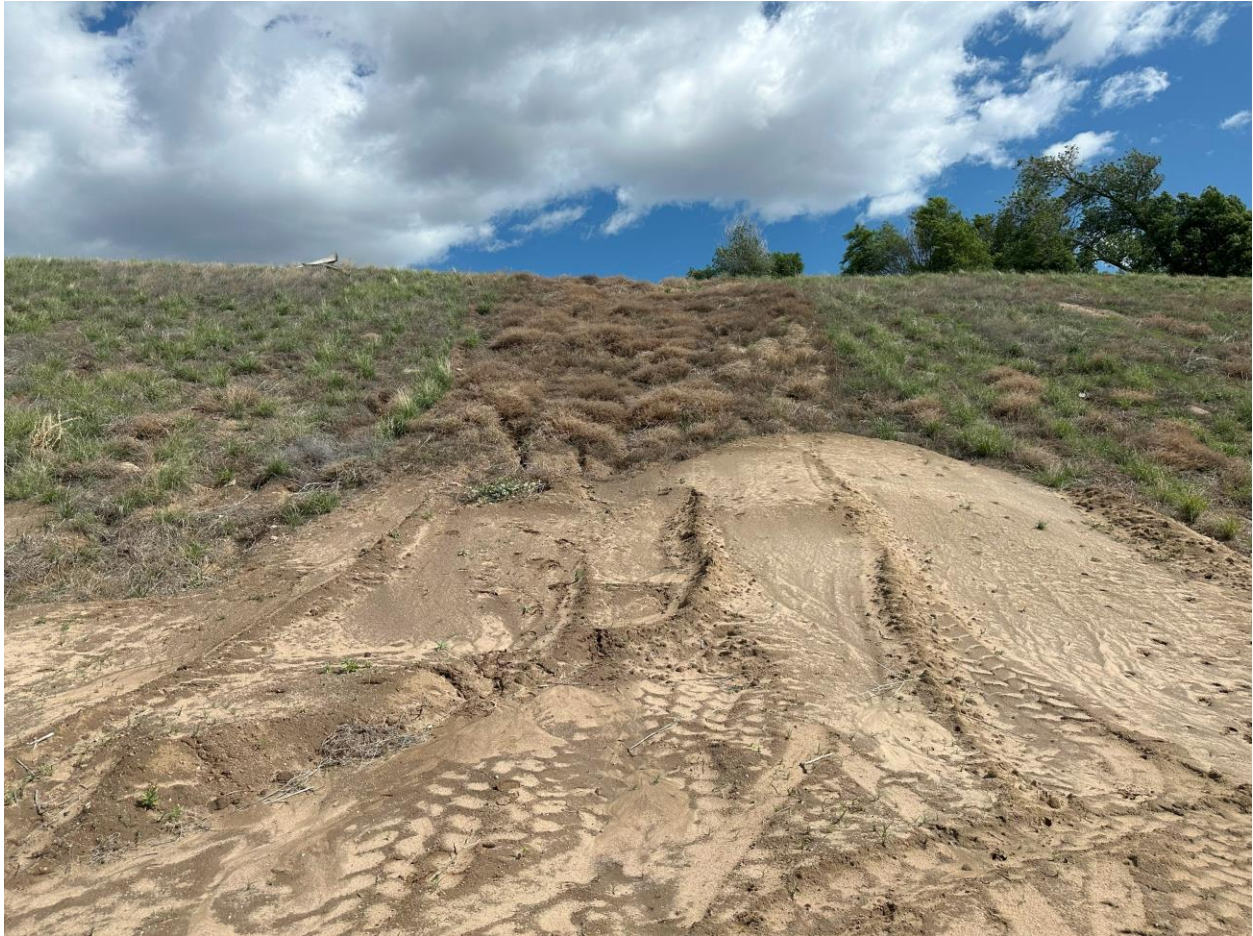
Photo 11. Buttress toe

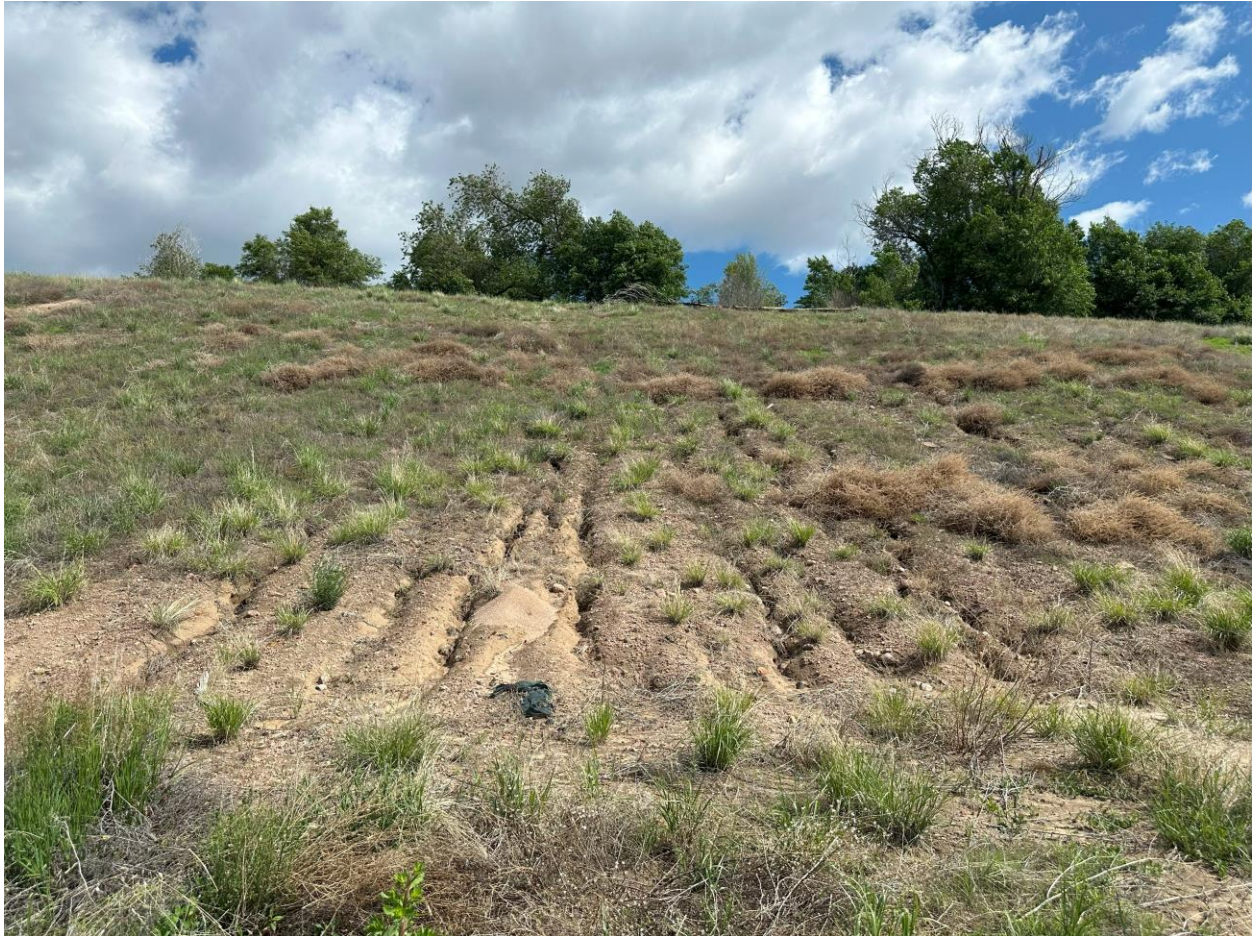
Photo 12. Erosion gullies in buttress

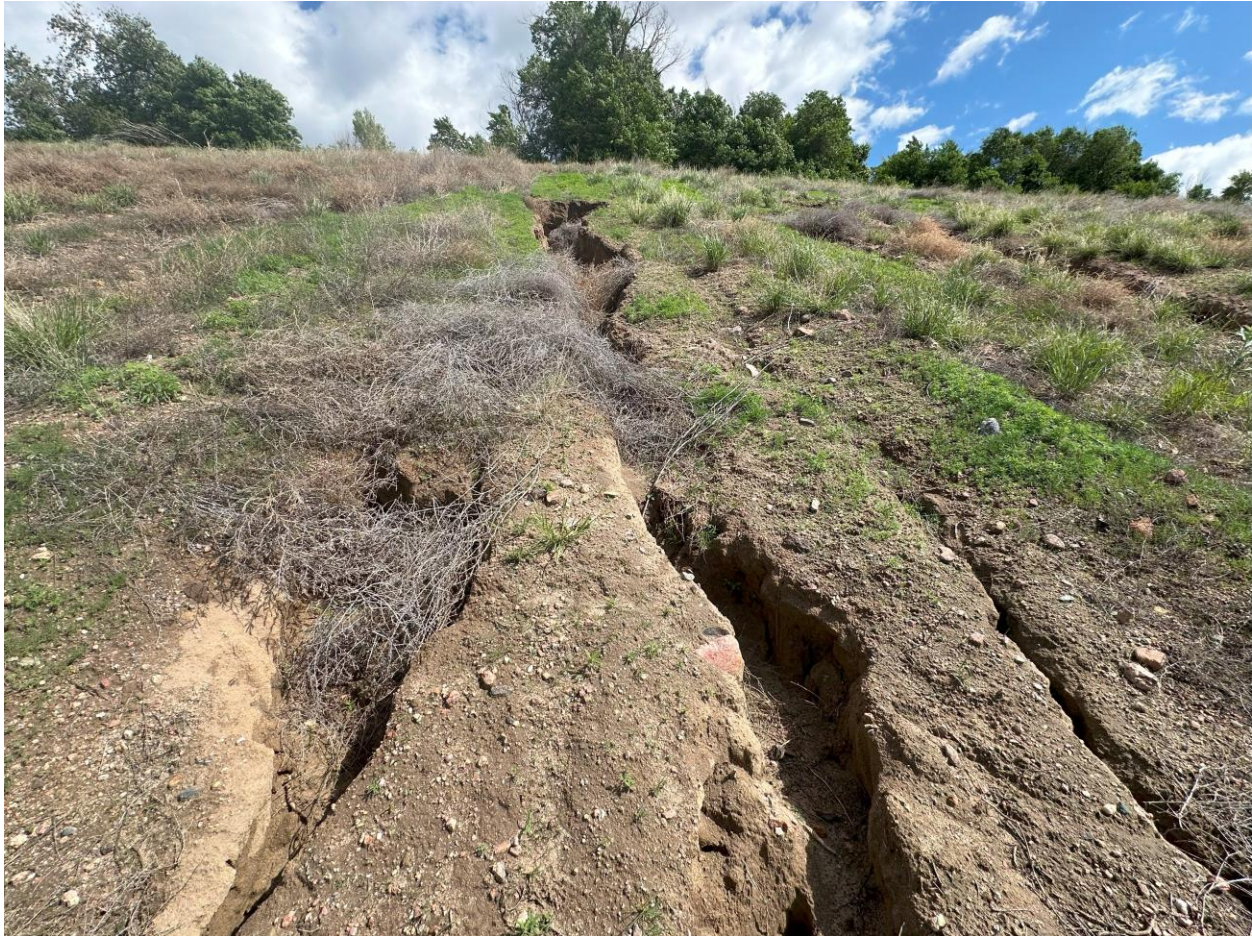
Photo 13. Erosion gully in buttress

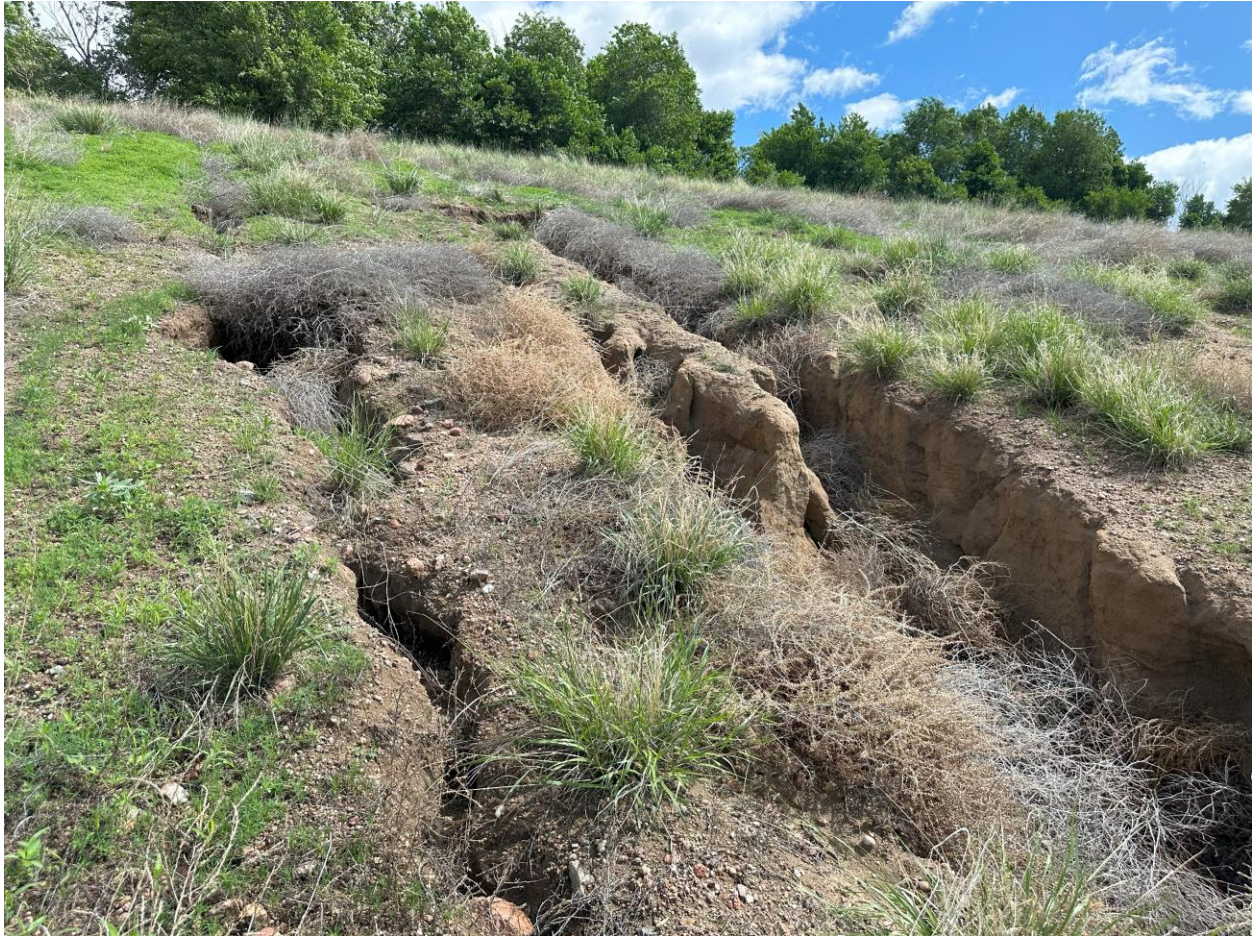
Photo 14. Erosion gully in buttress

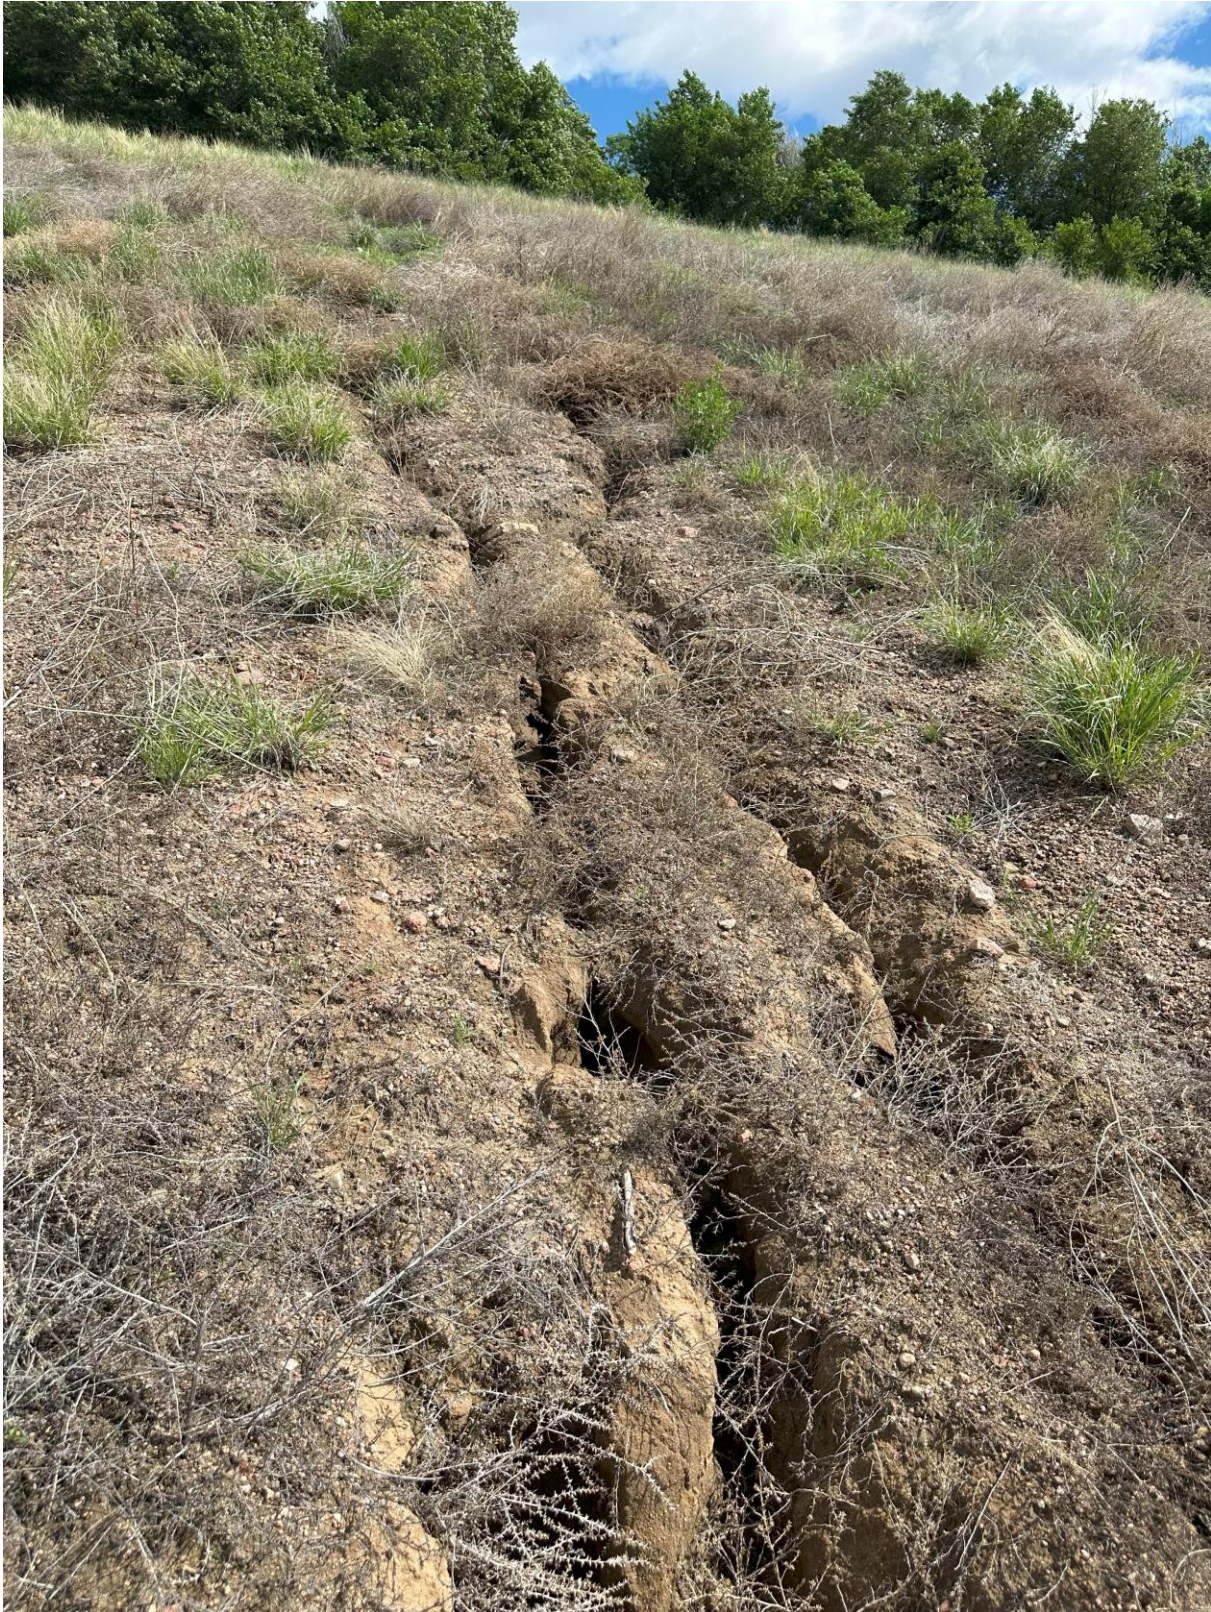
Photo 15. Erosion gullies in buttress

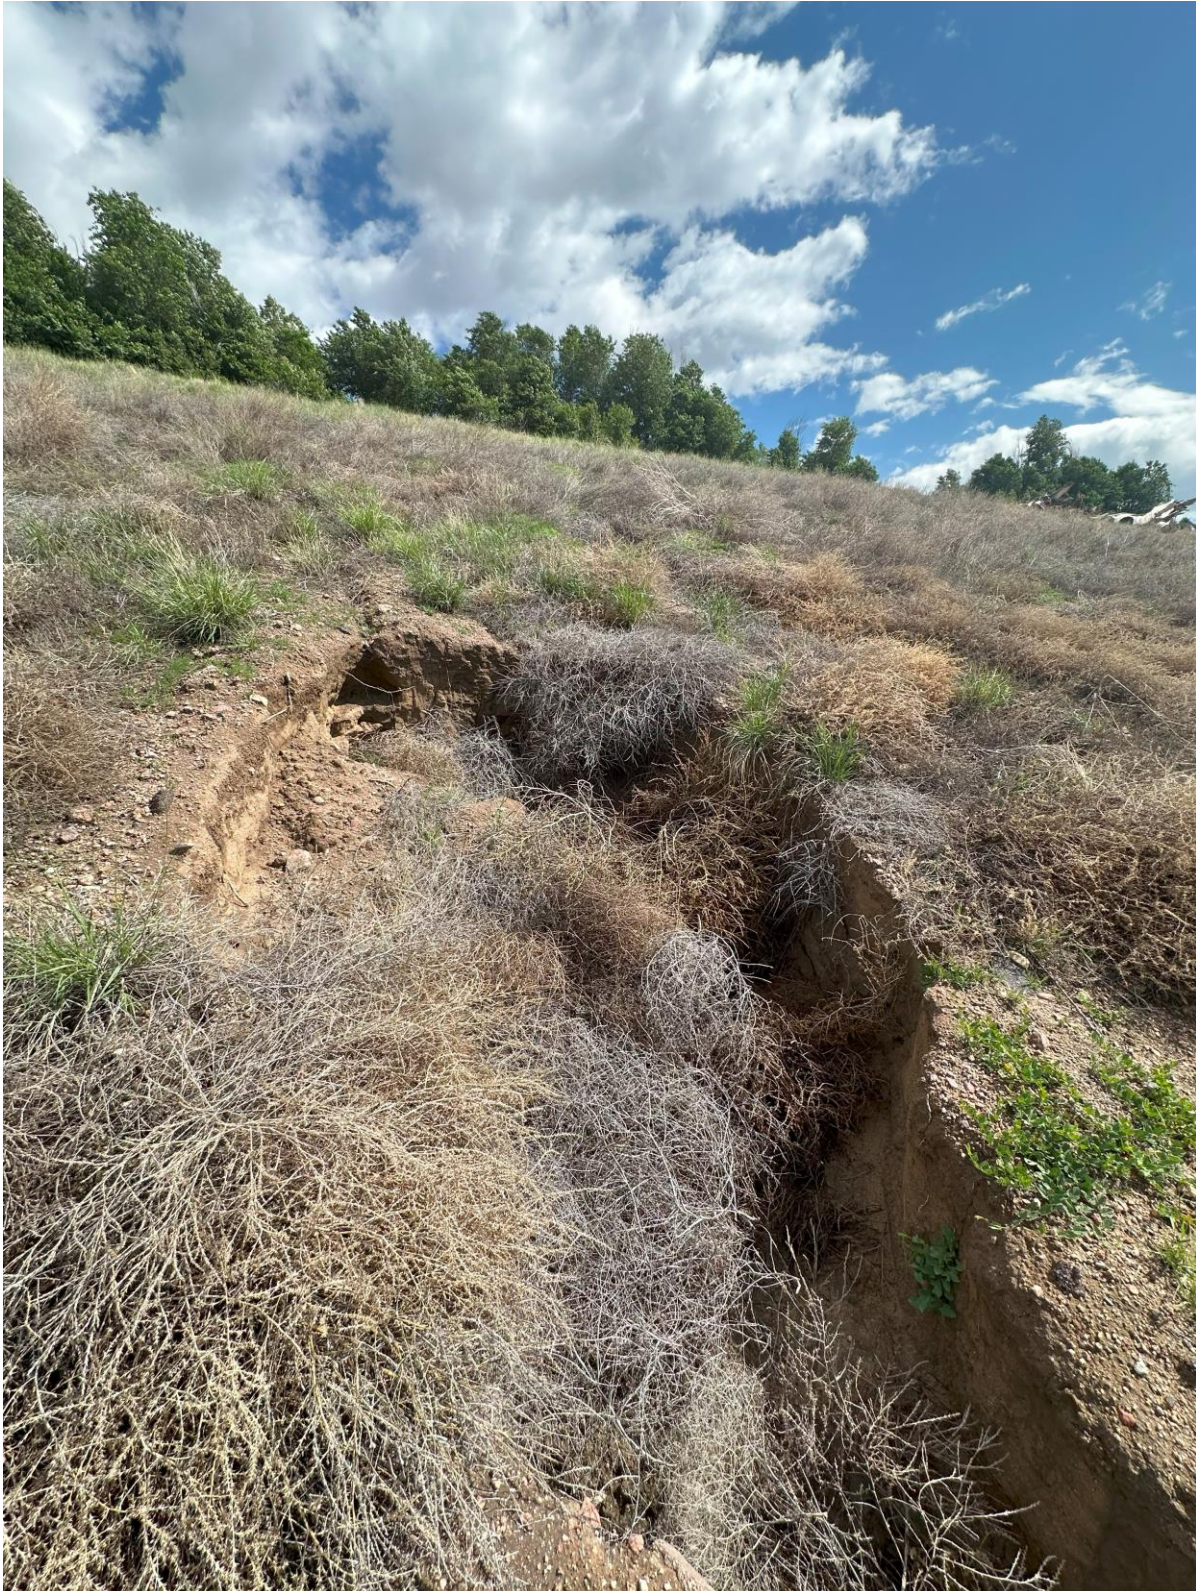
Photo 16. Erosion gully in buttress

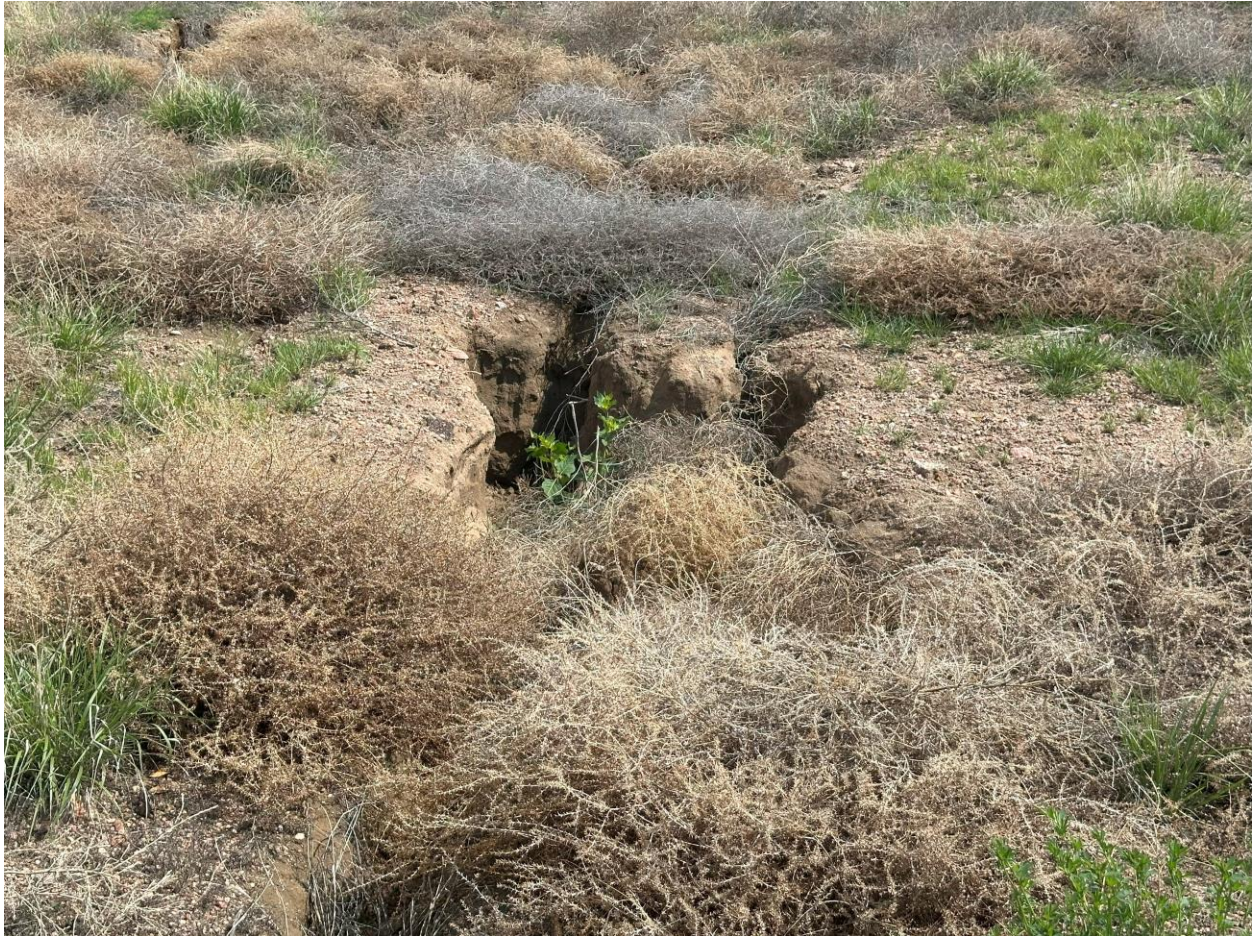
Photo 17. Erosion gully in buttress

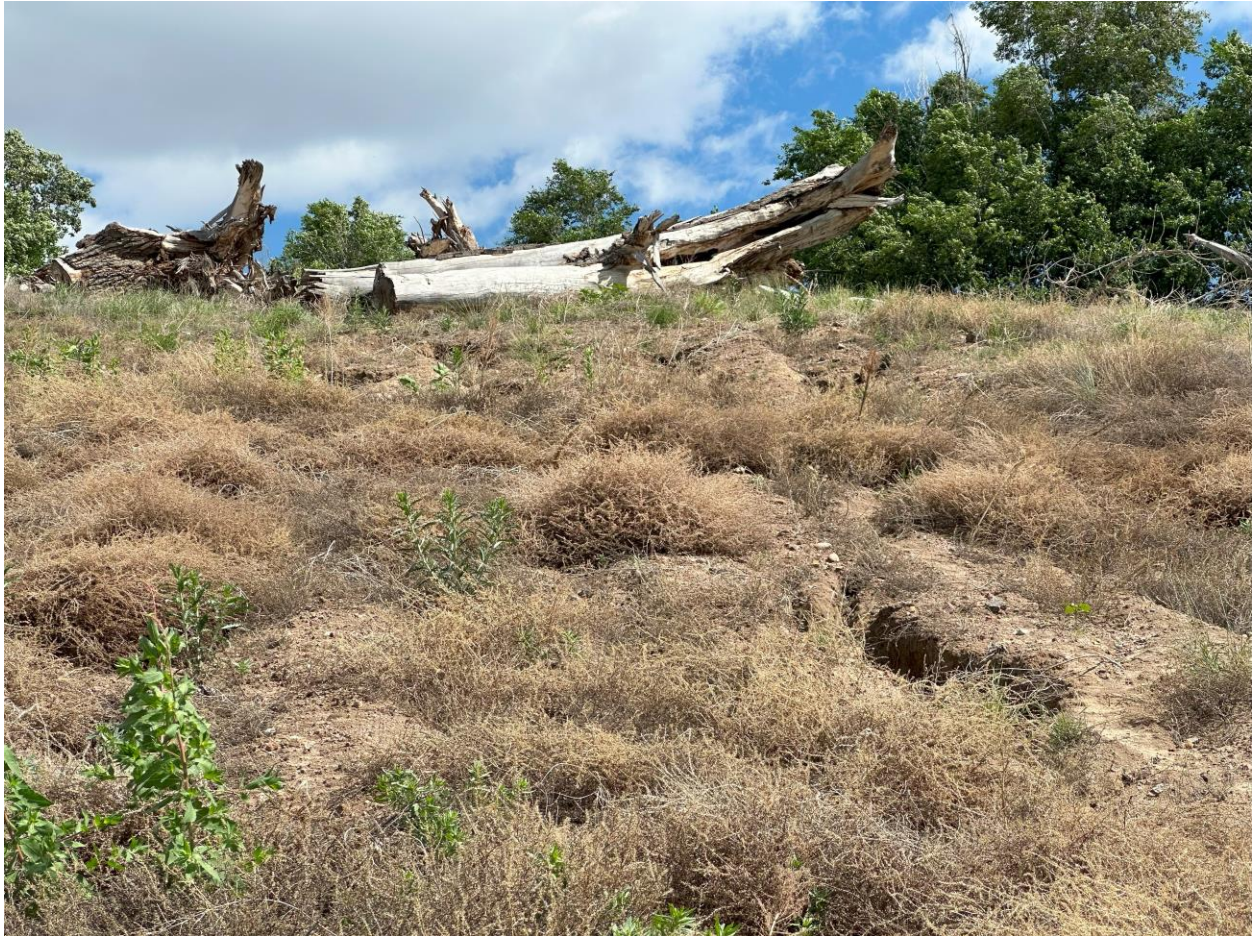
Photo 18. Erosion gully in buttress
