June 9, 2025
Project No.: 19125

Holcim
1687 Cole Boulevard, Suite 300
Golden, CO 80401

Regarding: Daniels Sand Pit 2, Permit No. M-1973-007-SG
Slope Stability Monthly Monitoring Report

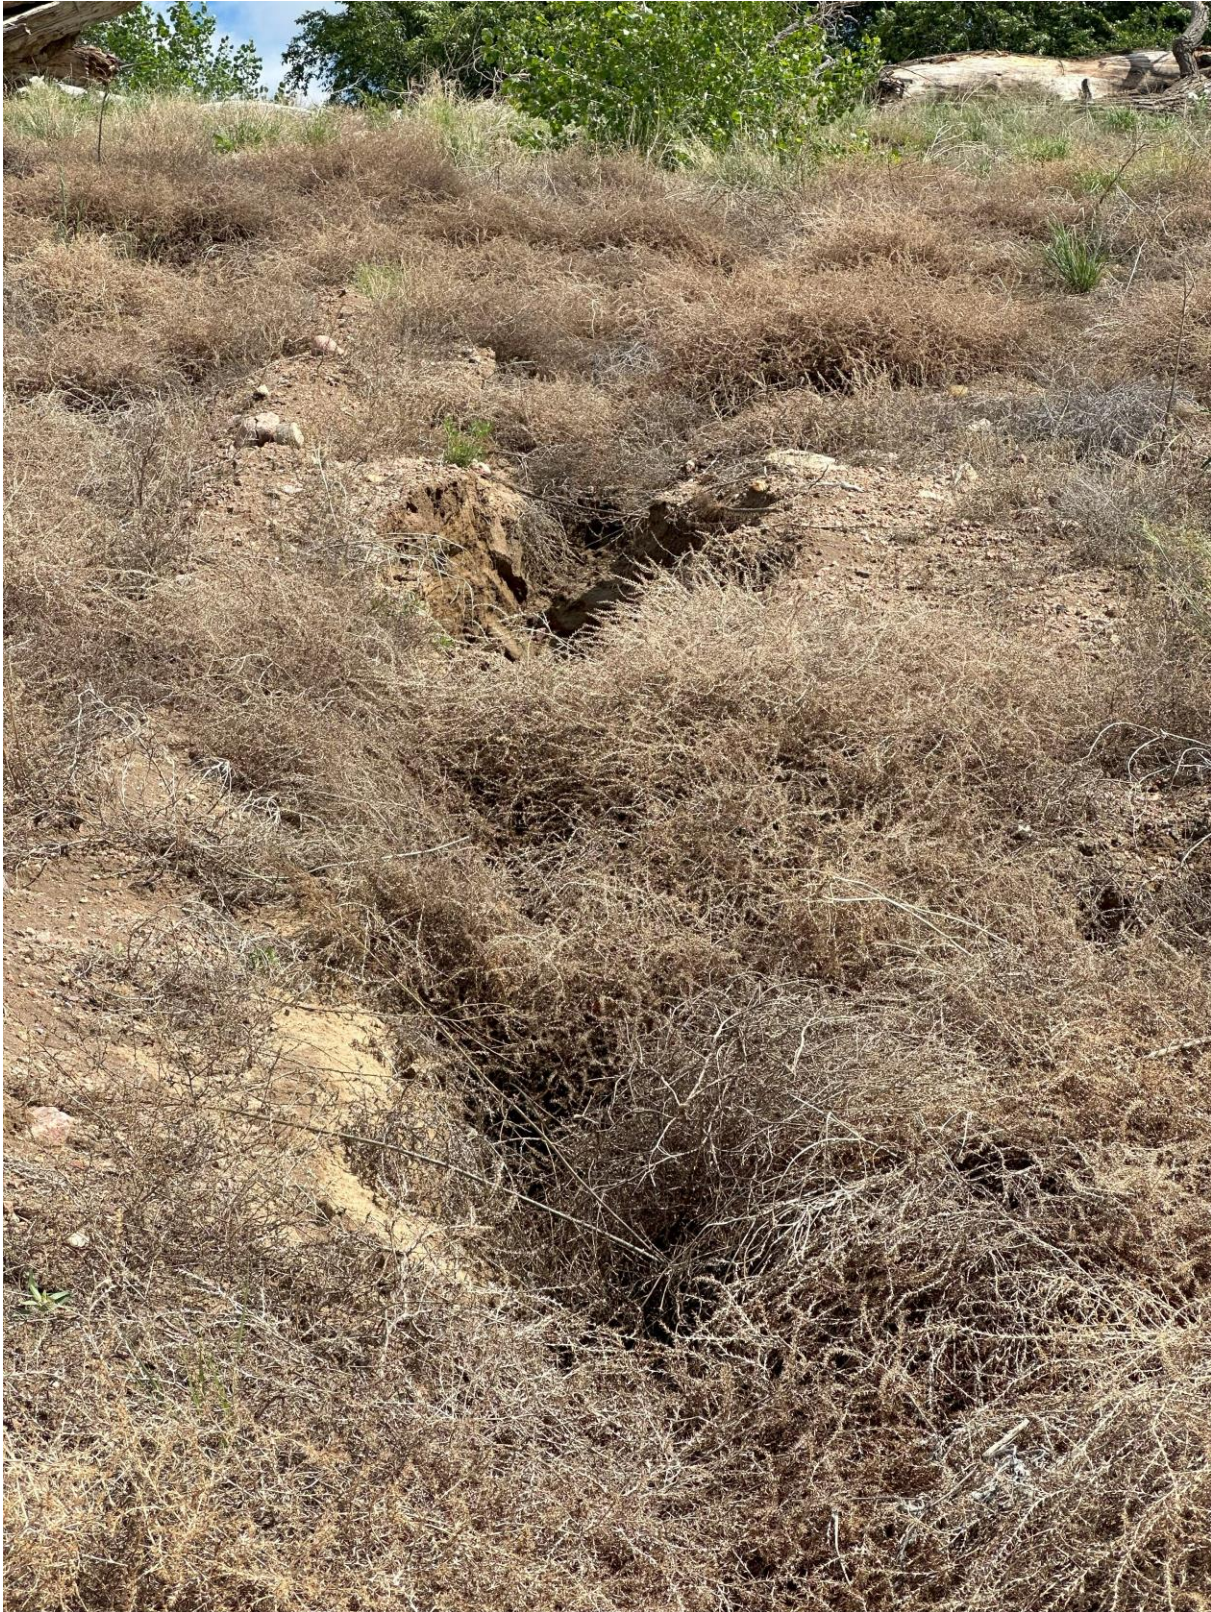
Photo 19. Erosion gully in buttress

- 1) Several erosion gullies exist within the embankment slope. We recommend those areas be reconstructed ASAP and that the areas be seeded per the reclamation plan.

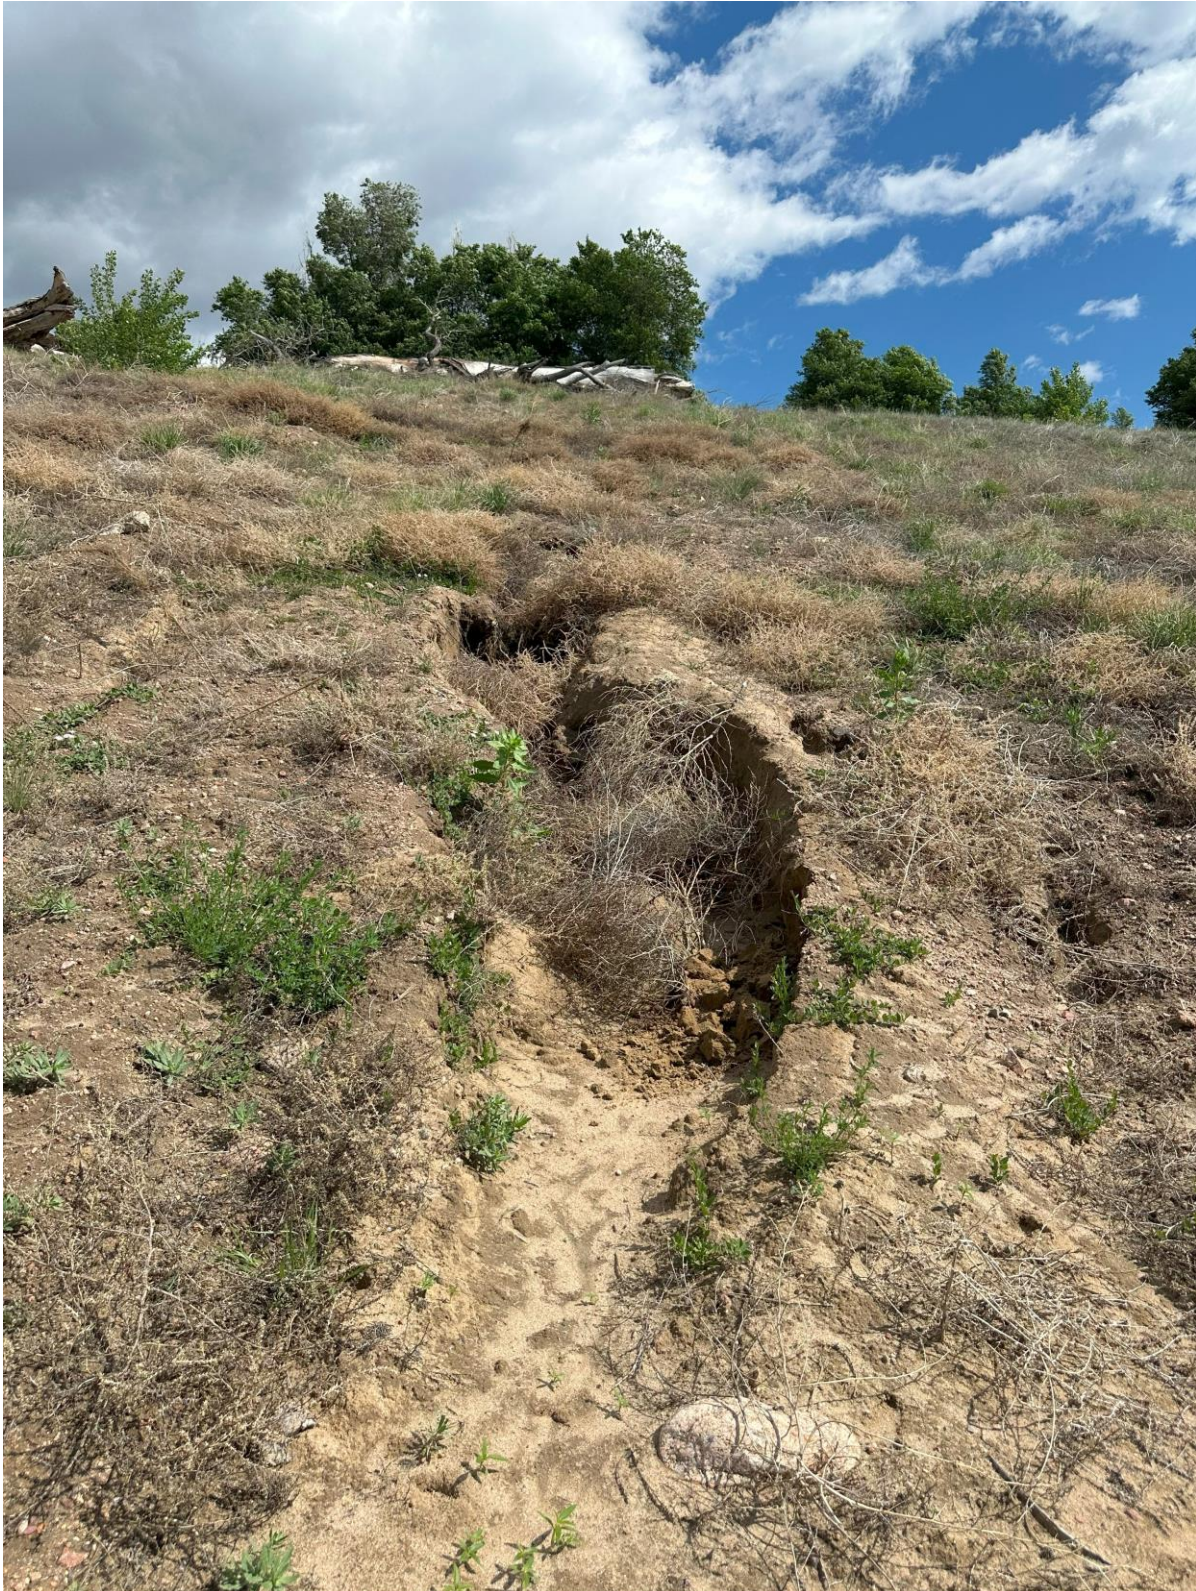
Photo 20. Erosion gully in buttress

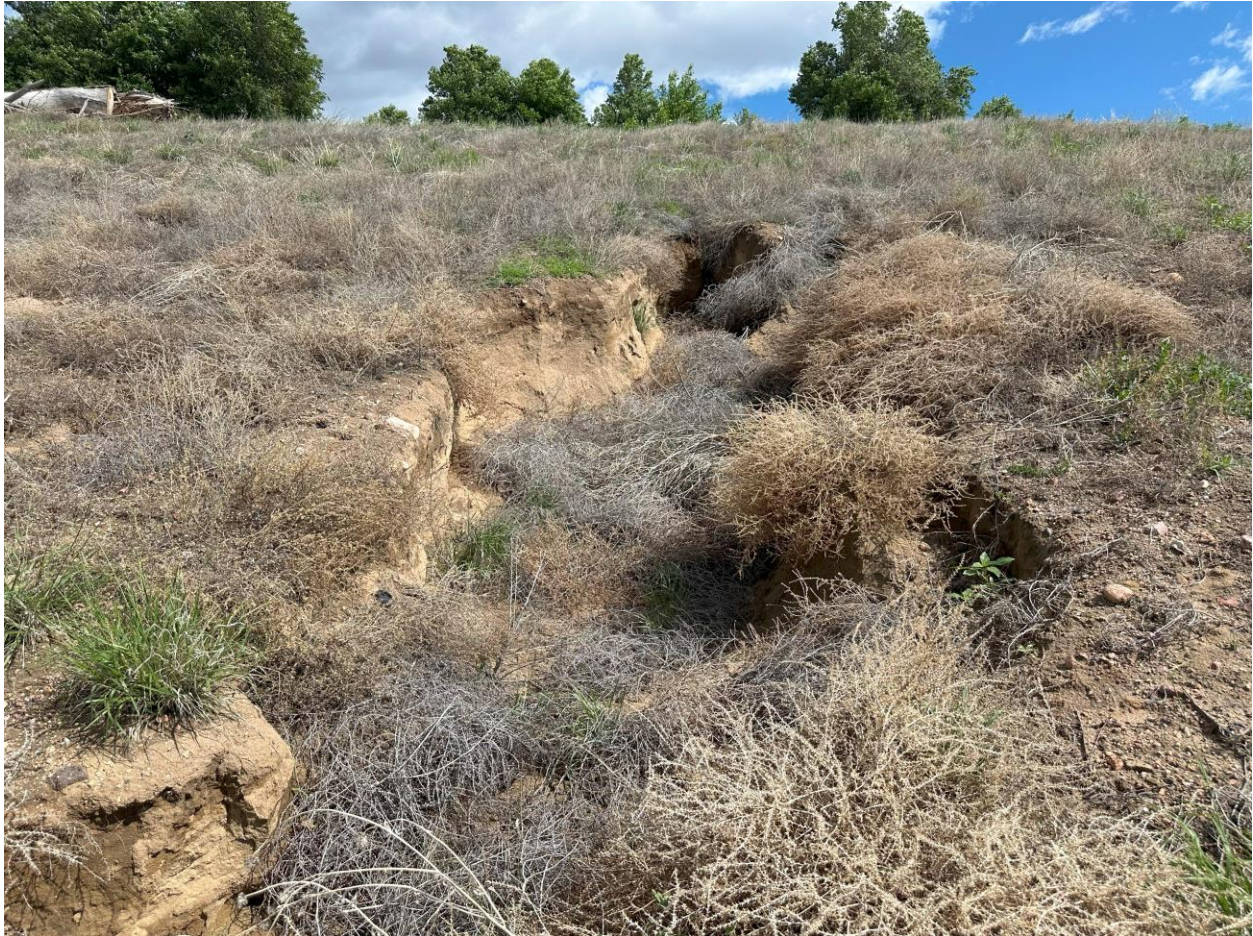
Photo 21. Erosion gully in buttress

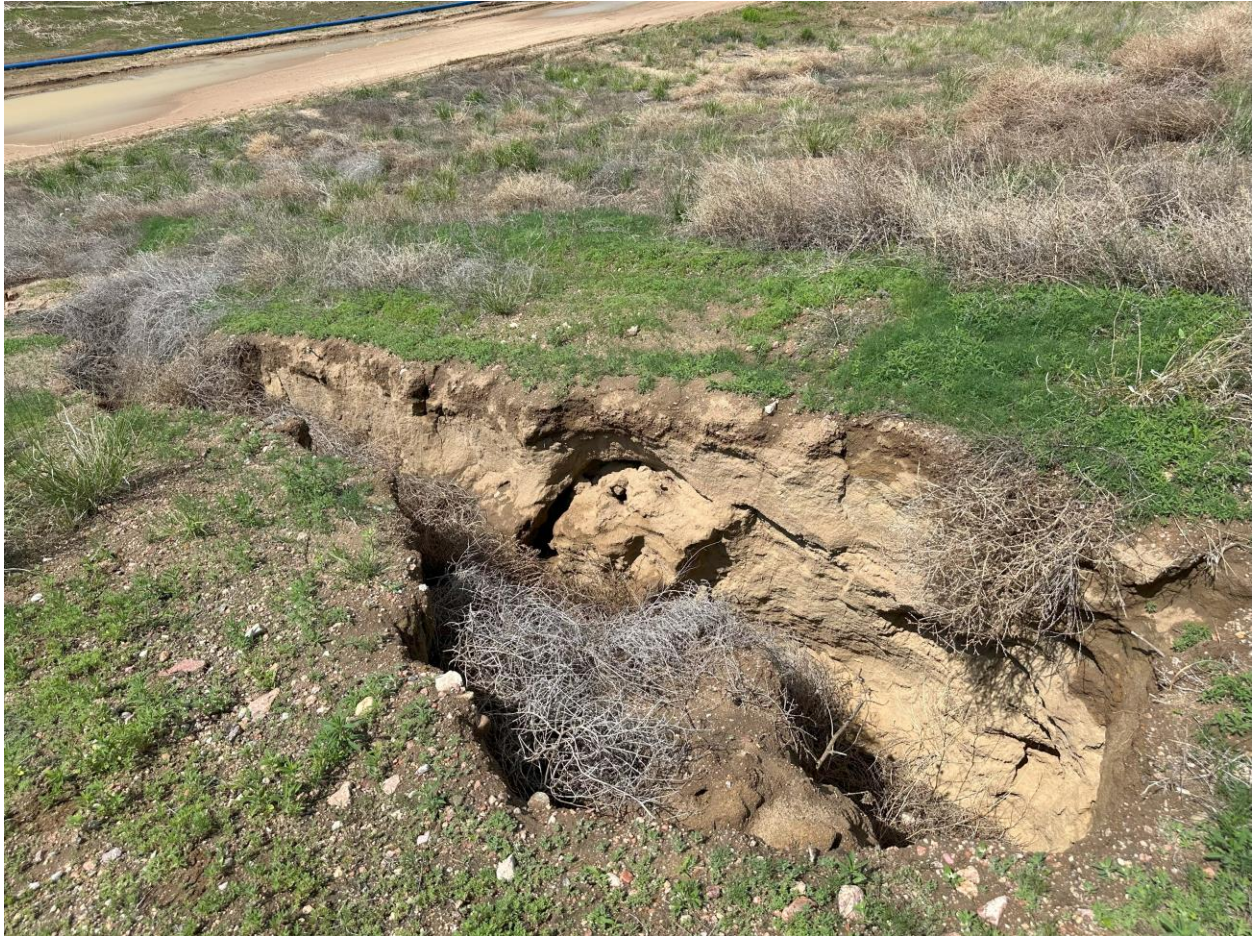
Photo 22. Erosion gully in buttress

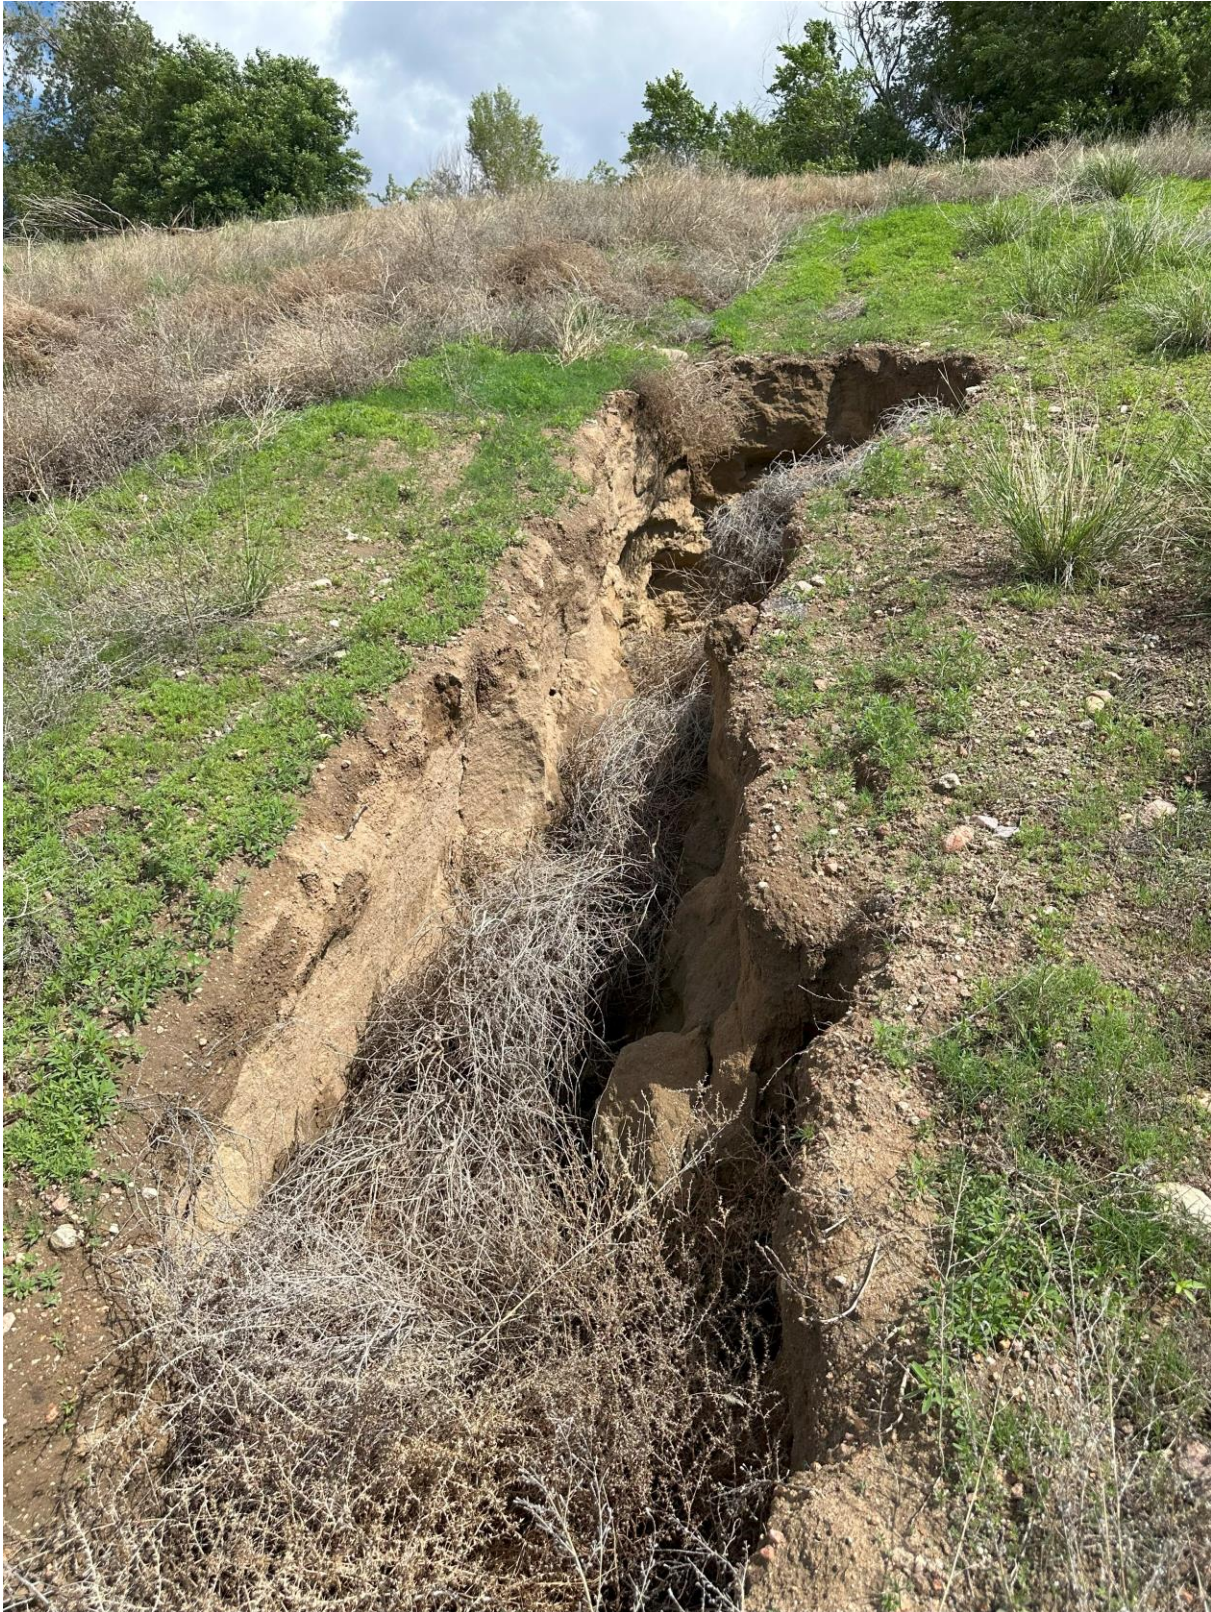
Photo 23. Erosion gully in buttress
