May 7, 2025 (rev 06/02/2025)

**Re: M-1977-573 - West Pueblo Pit – TR07 Request Letter**

**Exhibit F**  
**Reclamation Plan Map**

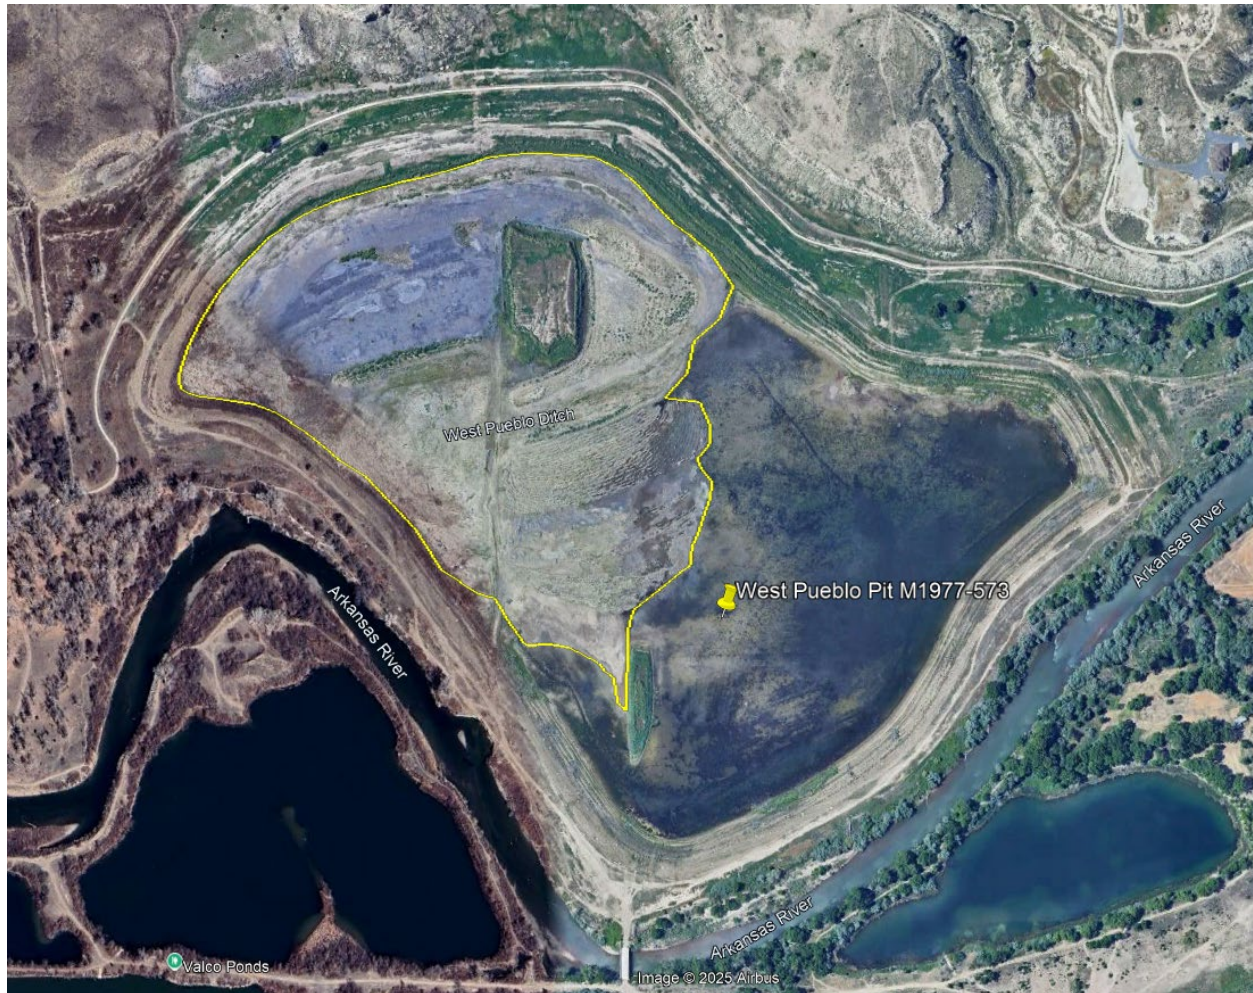
The northern part of the Pit contains a large quantity of imported fill that was deposited in the Pit during the construction of facilities associated with Colorado Springs Utilities' Southern Delivery System (SDS) project. AGRA has estimated the quantity of this material to be about 270,000 CY of soil removed from the site of the Juniper Pump Station located near Pueblo Dam. These soils, while difficult to characterize thoroughly without detailed soils testing, which has not been performed by AGRA, are believed to consist of overburden, coarse sands and gravels, and processed sedimentary rock such as shale which underlies much of the region as bedrock.

There is also a significant unquantified amount of limestone boulders that may also be from SDS related excavations, although this is uncertain. This deposit is located just south of the fills. No classification of this rock has been performed but a visual inspection has been performed, and the rock appears to range in gradation from large boulders to small cobbles, with most rocks being angular in shape. Approximately 600 CY of this rock was recently used as riprap for emergency repairs along the Arkansas River at the west side of parcel boundary. These repairs will be discussed in more detail in the section below.

**Figure 1. Overview of West Pueblo Pit, Showing Approximate Location of Imported Fills.**

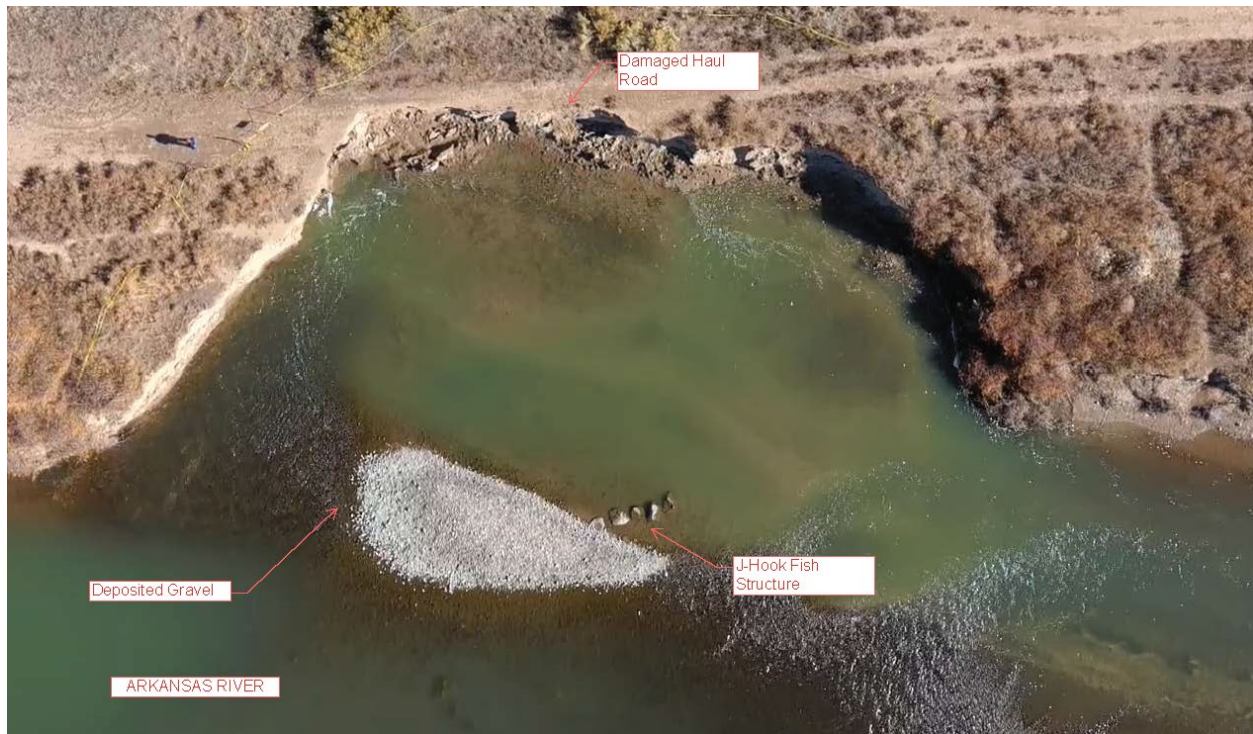
The second issue addressed by this TR is a section of localized scour along the Arkansas River at the western property boundary. The river has created a large scour hole as the result of a malfunctioning rock fish structure placed in the river near the river’s edge. AGRA and Colorado Parks and Wildlife (CPW), the two property owners affected by this erosion, have been collaborating on a solution to this problem. This solution consists of slope grading and riprap placement to protect against further erosion.

The Arkansas River flows along the western and southern side of the Pit. At the Pit's western edge, the river has created a large scour hole and has eroded into the property and across the property line, destroying a haul road that is actively used by pedestrians recreating in the area.

Figure 2 below shows an overview of the scour hole and shows the cause of the erosion and the damage that has been sustained on AGRA's property as a result.

**Figure 2. Overview of The Scour Hole at West Pueblo Pit, Showing Cause of Erosion and Damaged Areas.**

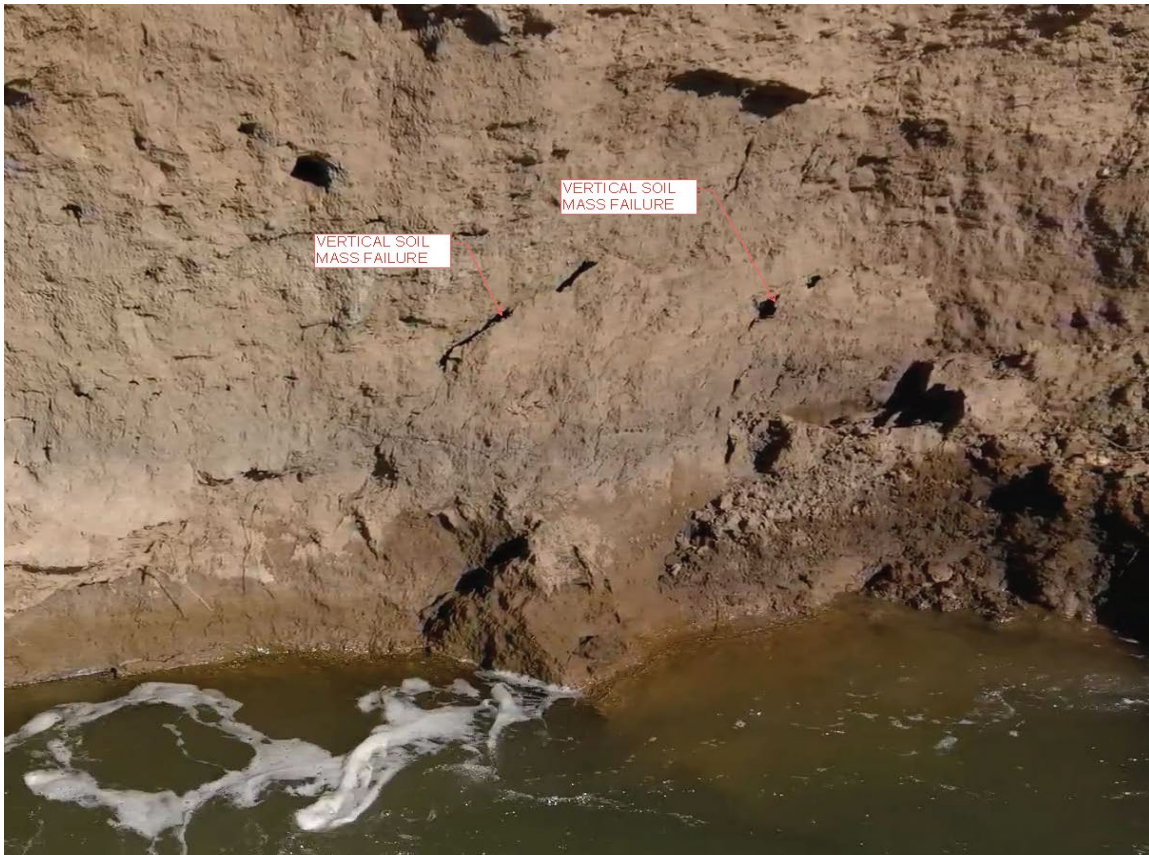
Figure 3 below shows an example of the vertical bank caving that was occurring due to saturated soils, before emergency repairs were completed.

**Figure 3. A Close-Up View of the Damaged Bank, Showing Where the Bank Is Failing Vertically.**

Anticipating higher flows during spring runoff and high release rates from Pueblo Dam, AGRA and CPW pursued emergency repairs to ensure that no further damage would ensue and that the Pit would not be breached. A local contractor was engaged and hired to perform site grading and riprap placement along the bank to adequately protect it from higher flows. Approximately 600 CY of riprap present on the Pit floor was removed by the contractor and placed on the bank, after grading the bank slope back to an approximate 2:1 slope. Figure 4 shows the finished repairs.

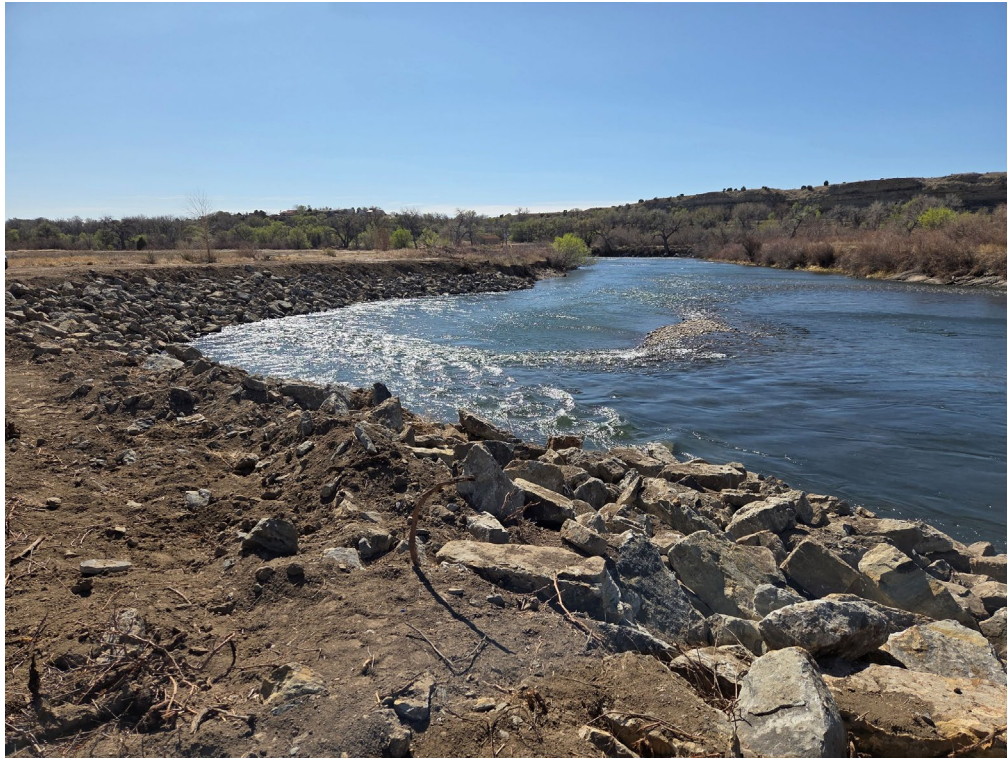
Figure 4. A View of Completed Bank Repairs at the West Pueblo Pit, April 2<sup>nd</sup>, 2025.

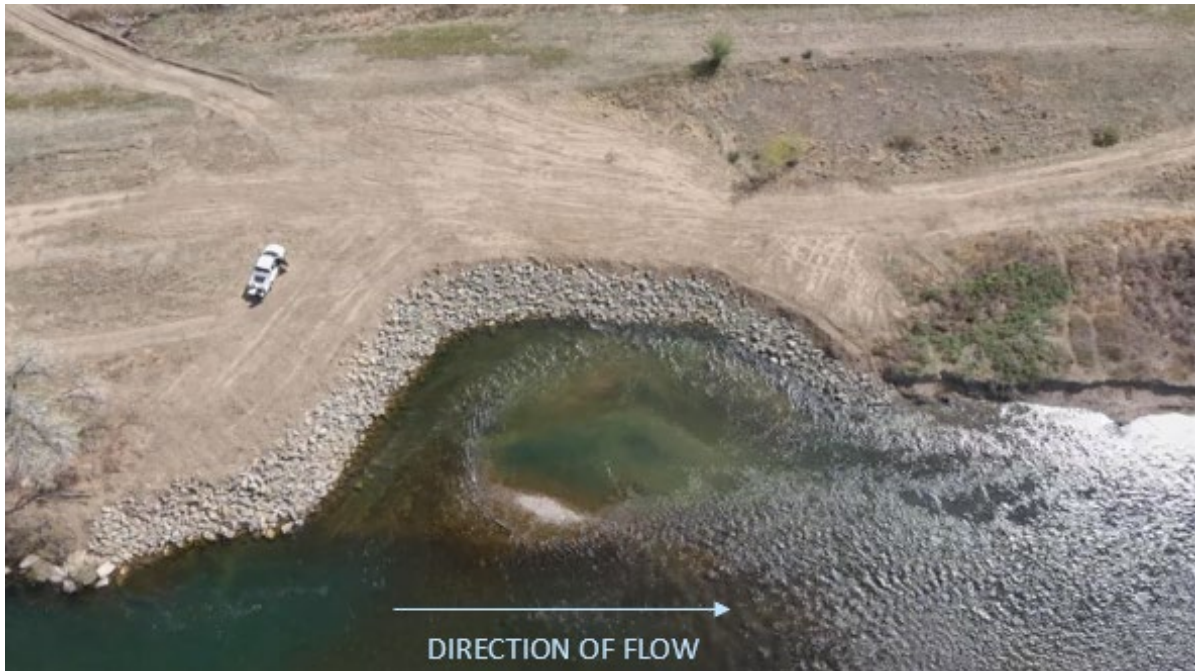
Figure 5. An Overview of Completed Bank Repairs at the West Pueblo Pit, April 25<sup>th</sup>, 2025.
