**MINERALS PROGRAM INSPECTION REPORT**  
**PHONE: (303) 866-3567**

<b>MINE NAME:</b> Duckworth Pit	<b>MINE/PROSPECTING ID#:</b> M-2003-091	<b>MINERAL:</b> Sand and gravel	<b>COUNTY:</b> Weld
<b>INSPECTION TYPE:</b> Monitoring	<b>WEATHER:</b> Clear	<b>INSP. DATE:</b> June 10, 2025	<b>INSP. TIME:</b> 12:00
<b>OPERATOR:</b> Martin Marietta Materials, Inc.	<b>OPERATOR REPRESENTATIVE:</b> Julie Mikulas	<b>TYPE OF OPERATION:</b> 112c - Construction Regular Operation	
<b>REASON FOR INSPECTION:</b> Normal I&E Program	<b>BOND CALCULATION TYPE:</b> Complete Bond	<b>BOND AMOUNT:</b> \$60,900.00	
<b>DATE OF COMPLAINT:</b> NA	<b>POST INSP. CONTACTS:</b> None	<b>JOINT INSP. AGENCY:</b> None	
<b>INSPECTOR(S):</b> Patrick Lennberg	<b>INSPECTOR'S SIGNATURE:</b>

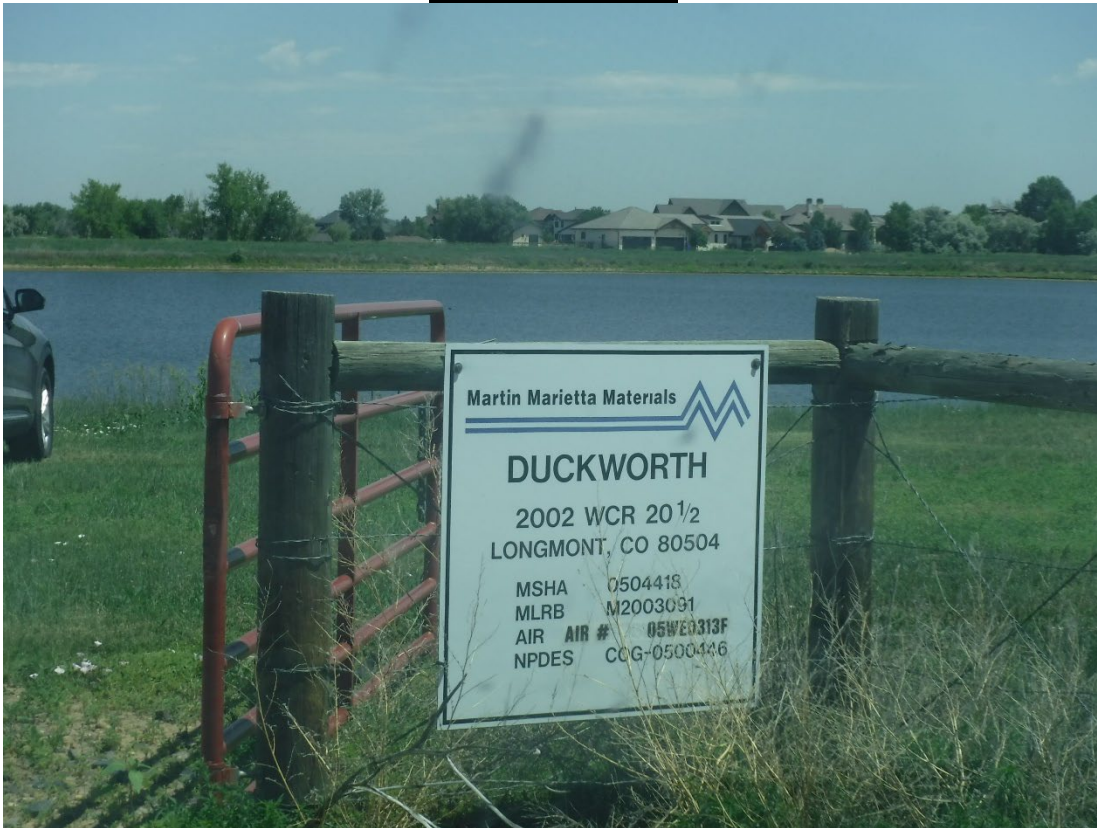
The site is 112c Construction Materials permit for 56.5 acres. The permit area is in Weld County, approximately 2 miles southwest of Del Camino. The site is accessed to the north of Weld County Road (WCR) 20.5 about 0.5 miles west of the intersection of WCR 20.5 and Co Rd 7. The post-mining land use for this site is developed water resources. The permit area and affected lands are owned by the Operator. A mine sign was posted along the primary mine entrance as required by Rule 3.1.12.

**Photo 1:** Mine sign at primary mine entrance

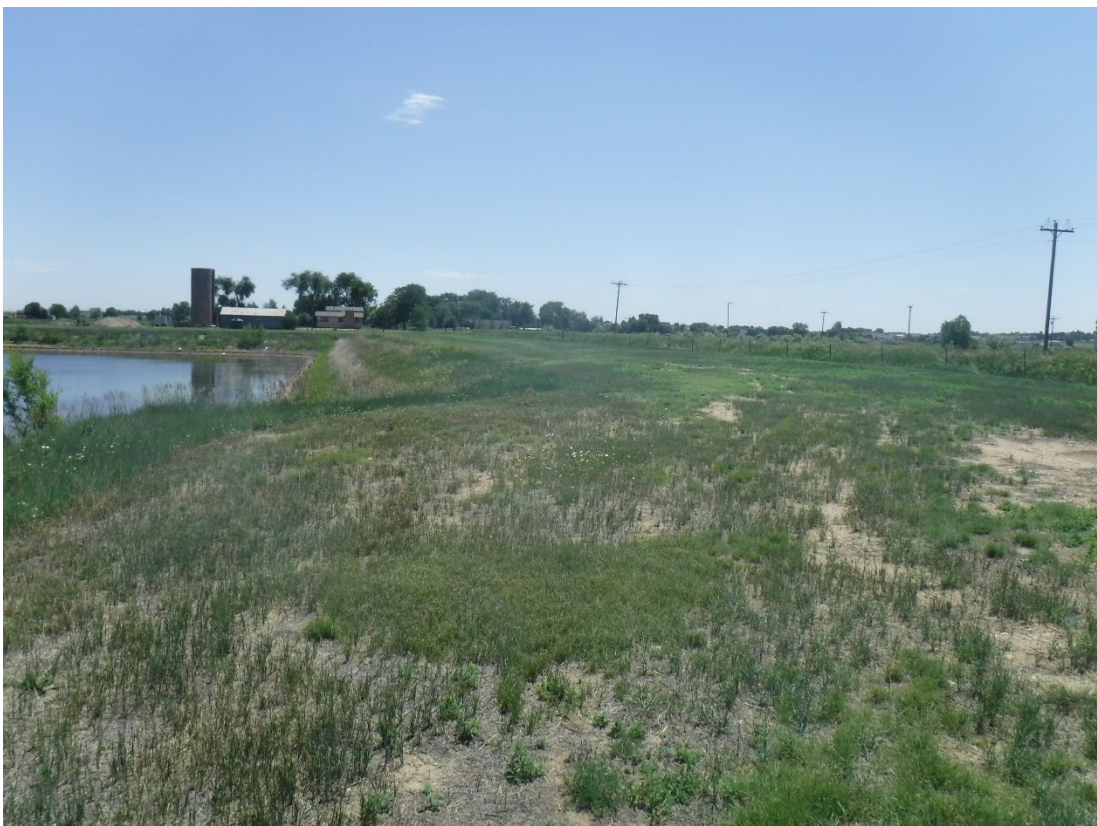
**Photo 2:** Looking east from the sw corner of western pond

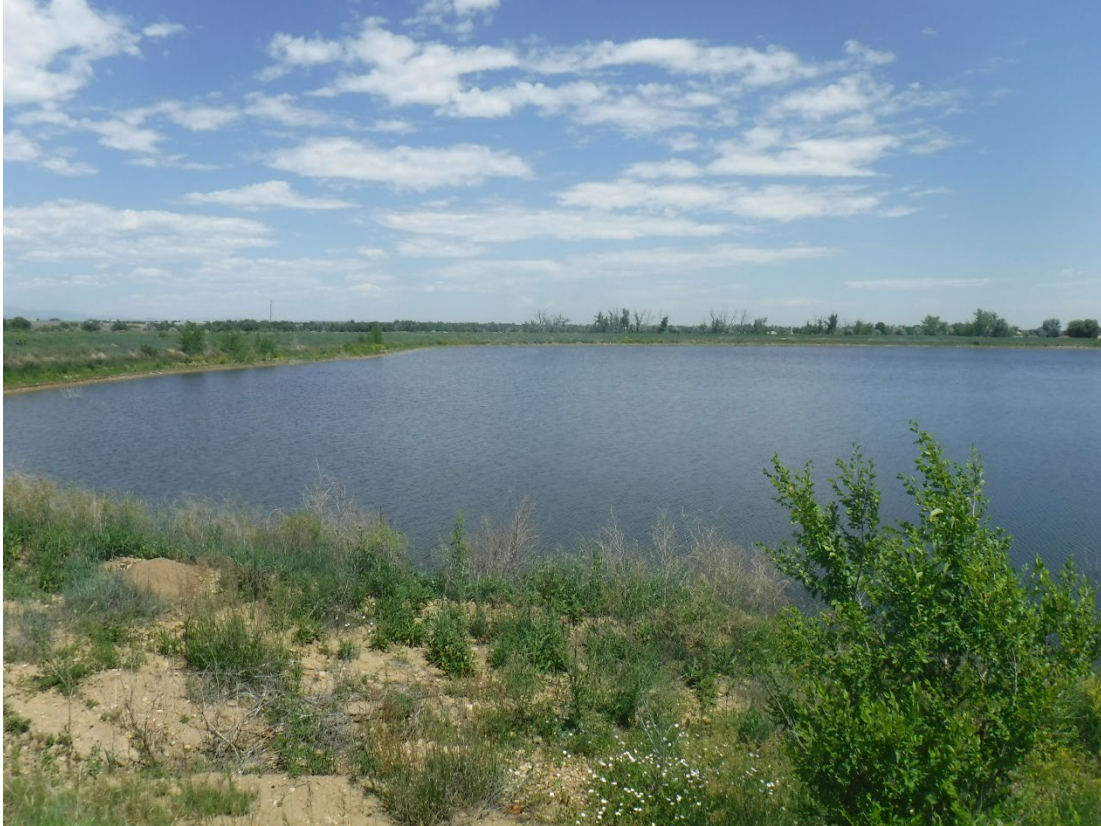
**Photo 3:** Looking north across the western portion of the western pond

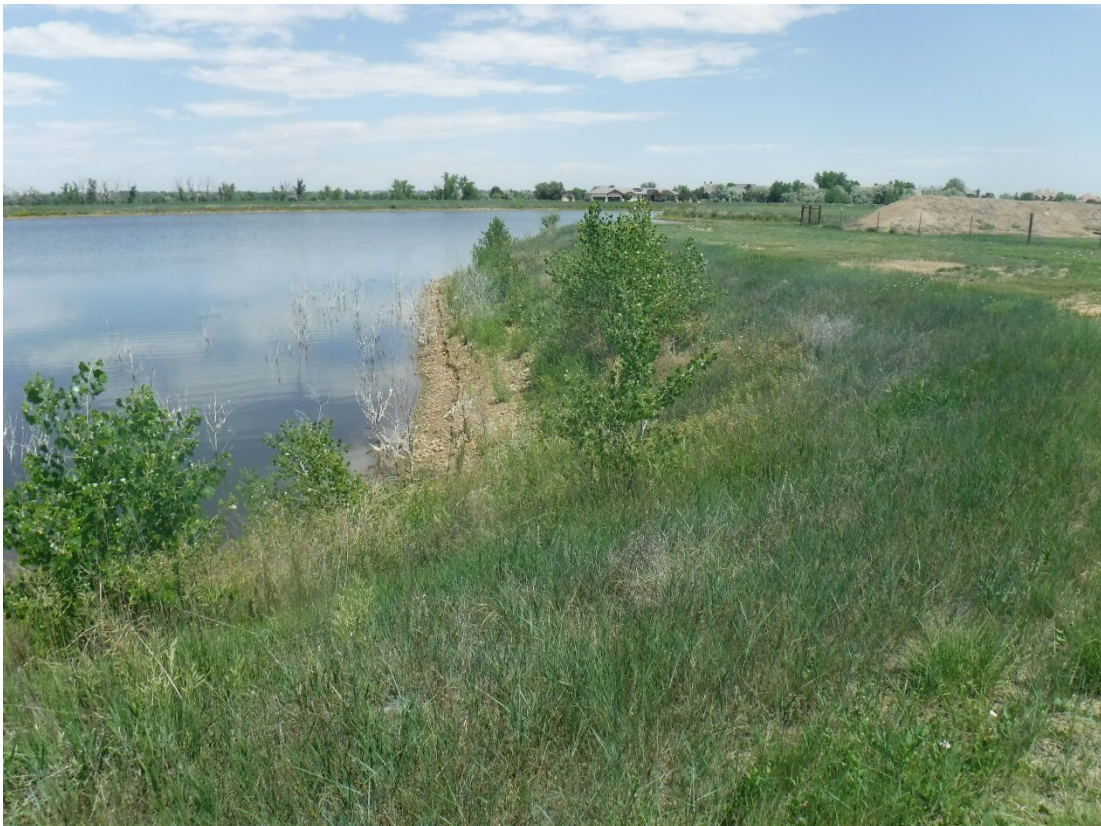
**Photo 4:** Looking north across the eastern portion of the western pond

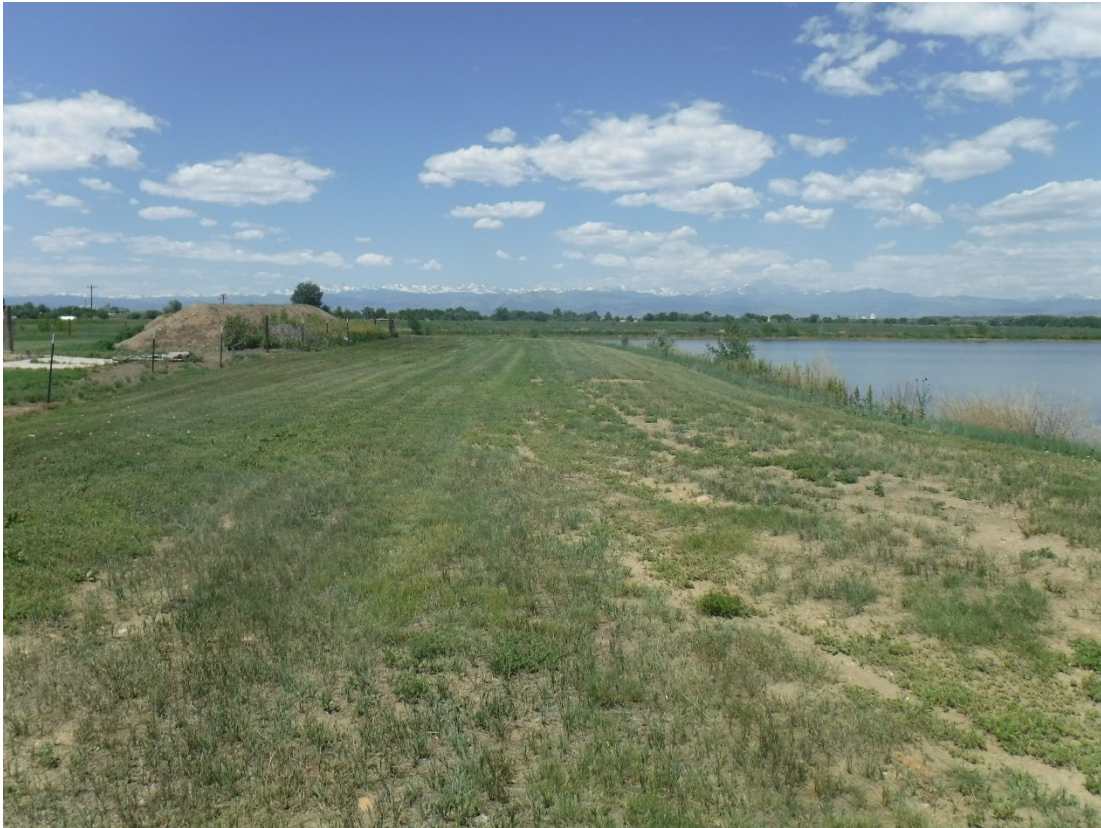
The site was not active at the time of inspection and has been in final reclamation since about 2016. In 2023 the reservoirs were filled during a free river period. Since the last inspection desirable grass species have become well established. There are some annual weed species located throughout the permitted area, but the site is not acting as a source for these species. During the AM-1 application process the Operator provided a demonstration that the side slopes of the reservoirs are at a 3H:1V grade. The slopes are also well vegetated and there were no signs of excessive erosion. The lining of the ponds was approved by the Division of Water Resources on November 28, 2016.

**Photo 5:** Typical vegetation established along the eastern banks of the western pond

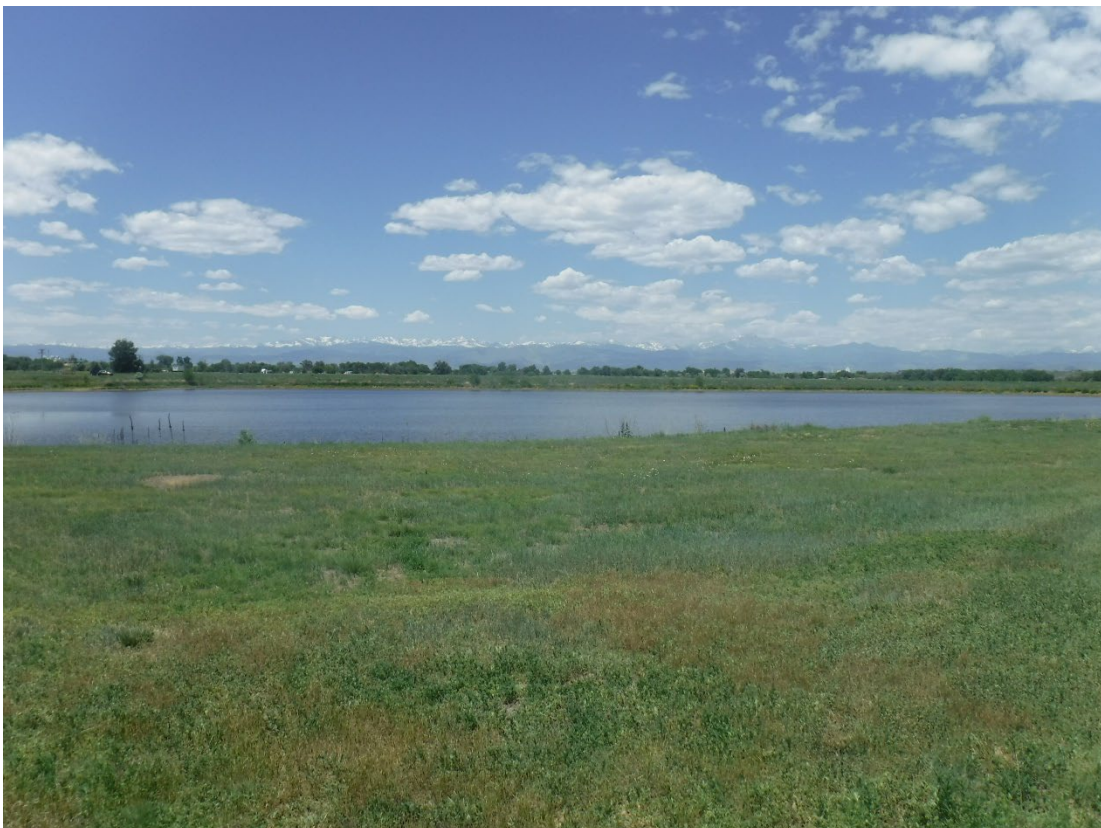
**Photo 6:** Looking west across the western pond

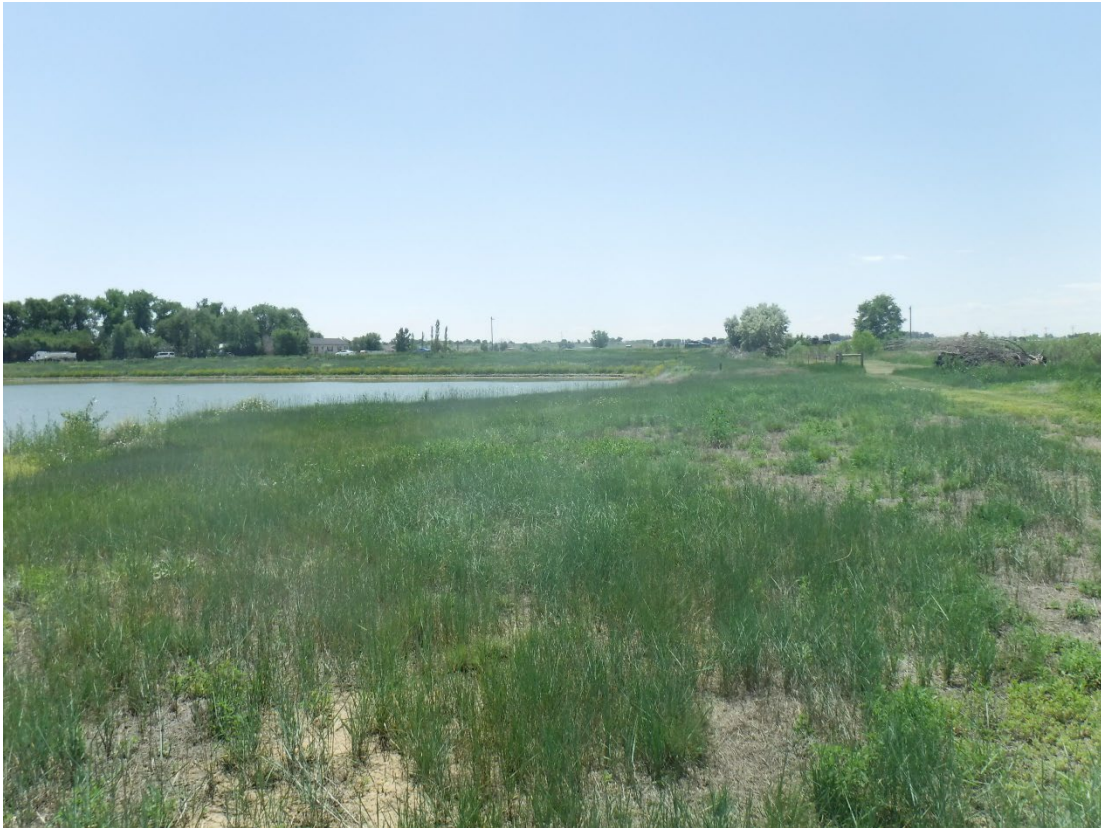
**Photo 7:** Looking south along the western shoreline of the eastern pond

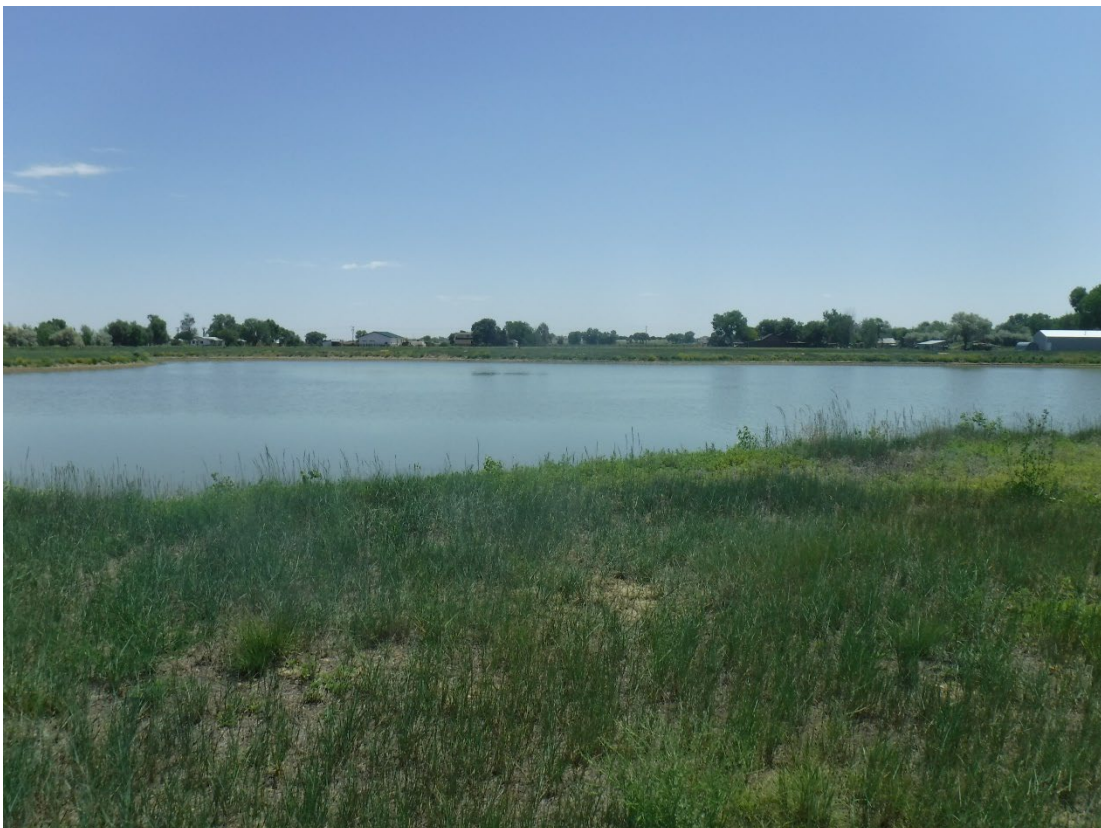
**Photo 8:** Looking east across the eastern pond

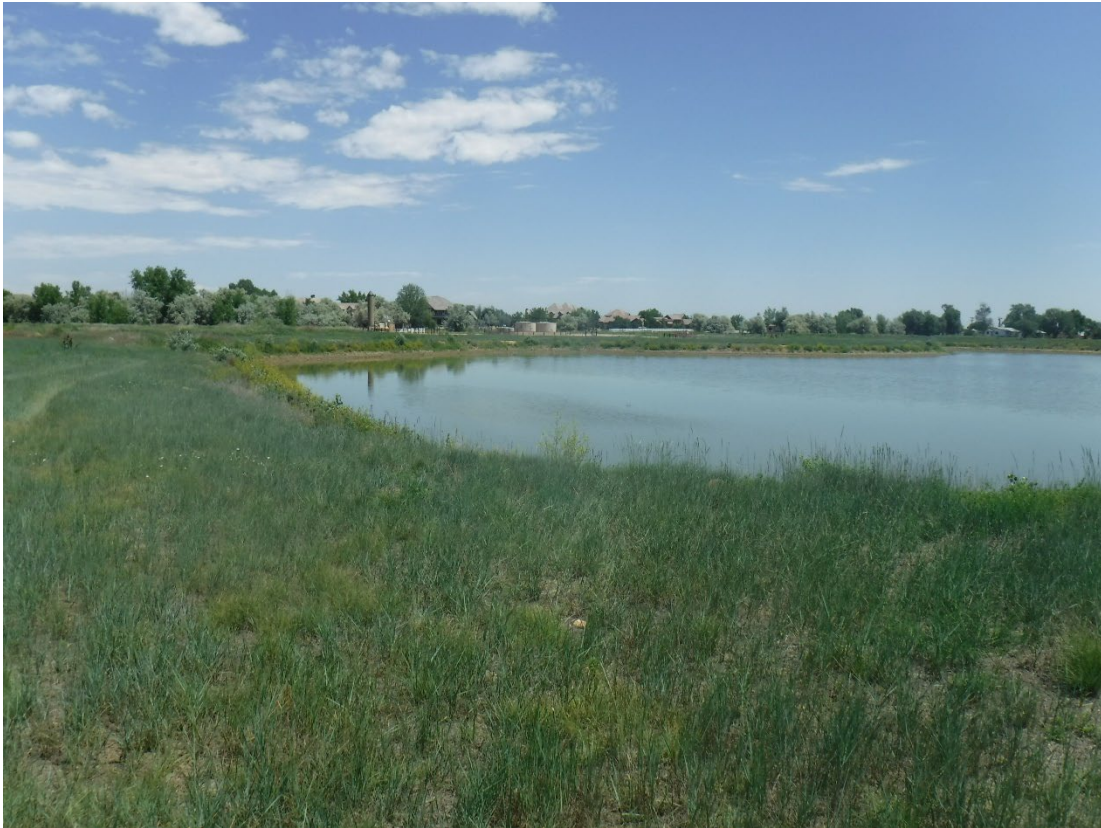
**Photo 9:** Looking east across the northern shoreline of the eastern pond

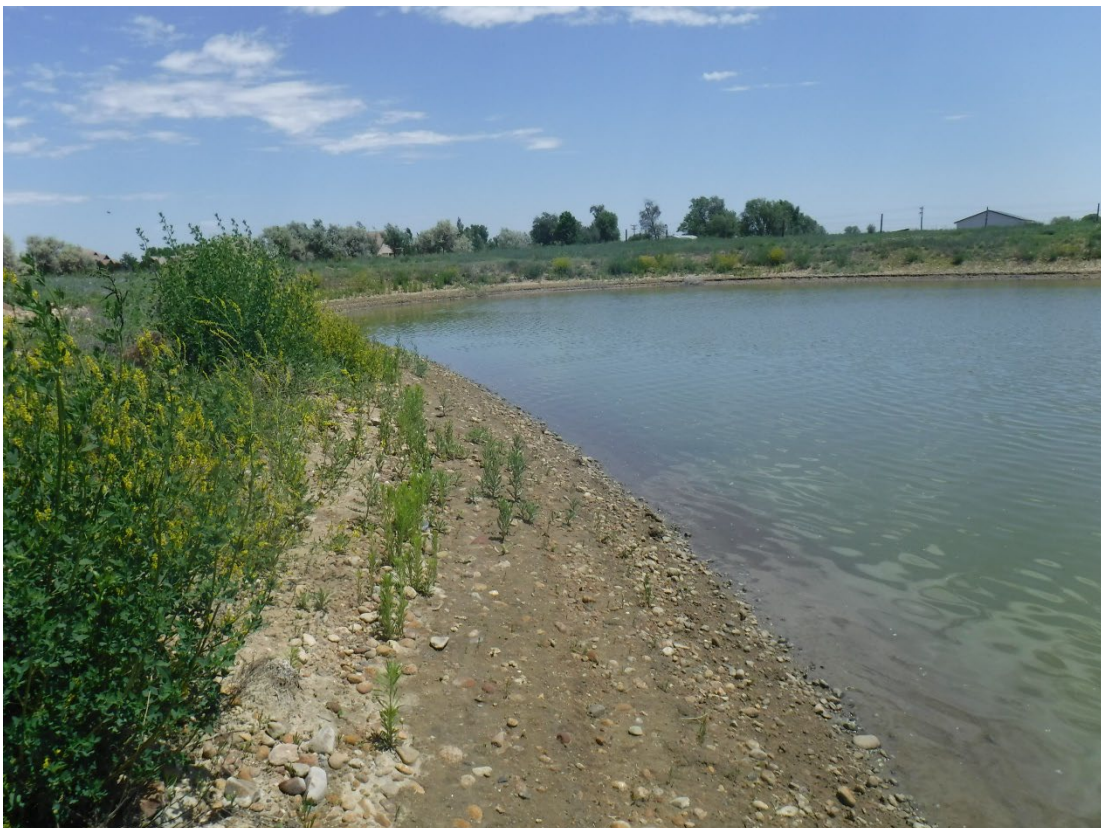
**Photo 10:** Typical shoreline conditions of the eastern pond
