MINERALS PROGRAM INSPECTION REPORT
PHONE: (303) 866-3567

MINE NAME: McKenna Limestone Quarry	MINE/PROSPECTING ID#: M-2000-039	MINERAL: Limestone (general)	COUNTY: Huerfano
INSPECTION TYPE: Surety-Related Inspection	WEATHER: Clear	INSP. DATE: May 20, 2025	INSP. TIME: 12:52
OPERATOR: Delhur Industries, Inc.	OPERATOR REPRESENTATIVE: None	TYPE OF OPERATION: 110c - Construction Limited Impact

REASON FOR INSPECTION: Surety Related	BOND CALCULATION TYPE: Complete Bond	BOND AMOUNT: \$17,100.00
DATE OF COMPLAINT: NA	POST INSP. CONTACTS: None	JOINT INSP. AGENCY: None
INSPECTOR(S): Amber M. Gibson	INSPECTOR'S SIGNATURE:

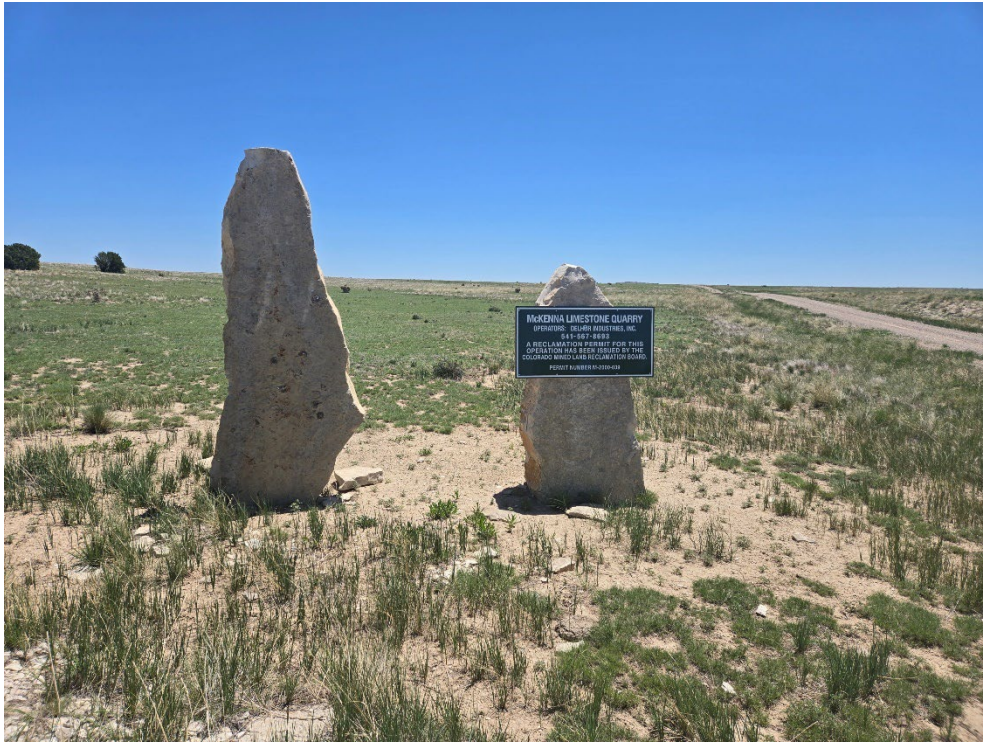
As a result of the Division's 2024 inspection, the Operator has since replaced the mine sign at the entrance to the site. The mine sign is in compliance with Rule 3.1.12(1). Upon re-inspecting the site, the inspector did not

Photo 1: New mine sign located at the site entrance.

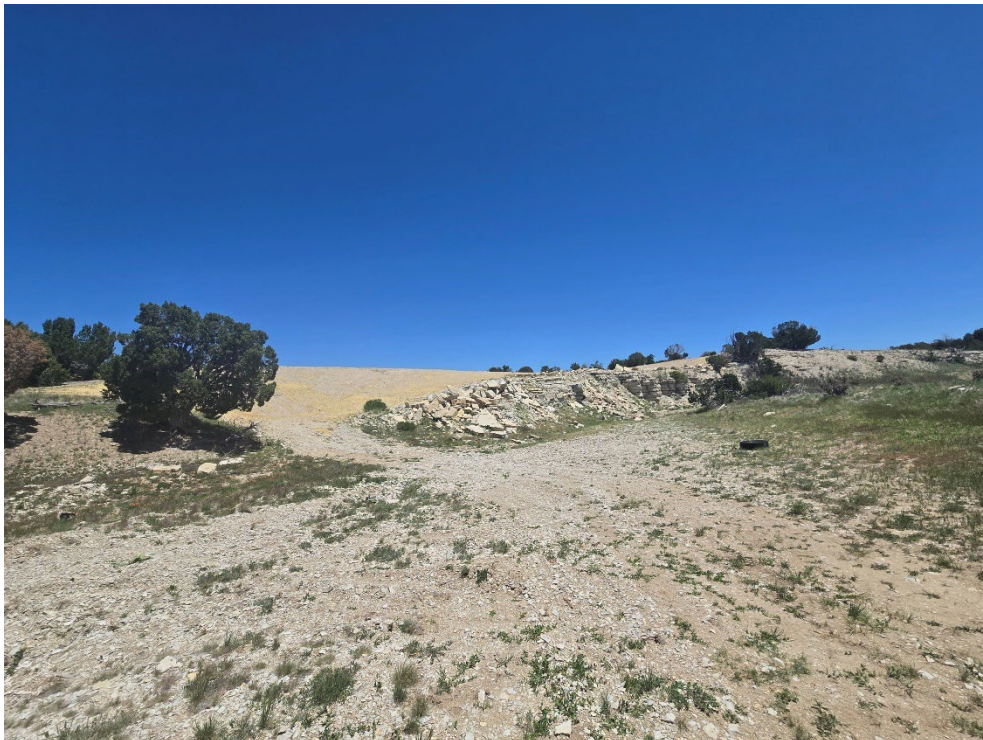
Photo 2: Looking at the recently reclaimed area, standing on the access road outside of the mining area. The wall on the west side of the permit area is a natural berm and is approved to stay to help protect the adjacent arroyo from stormwater runoff from the pit.

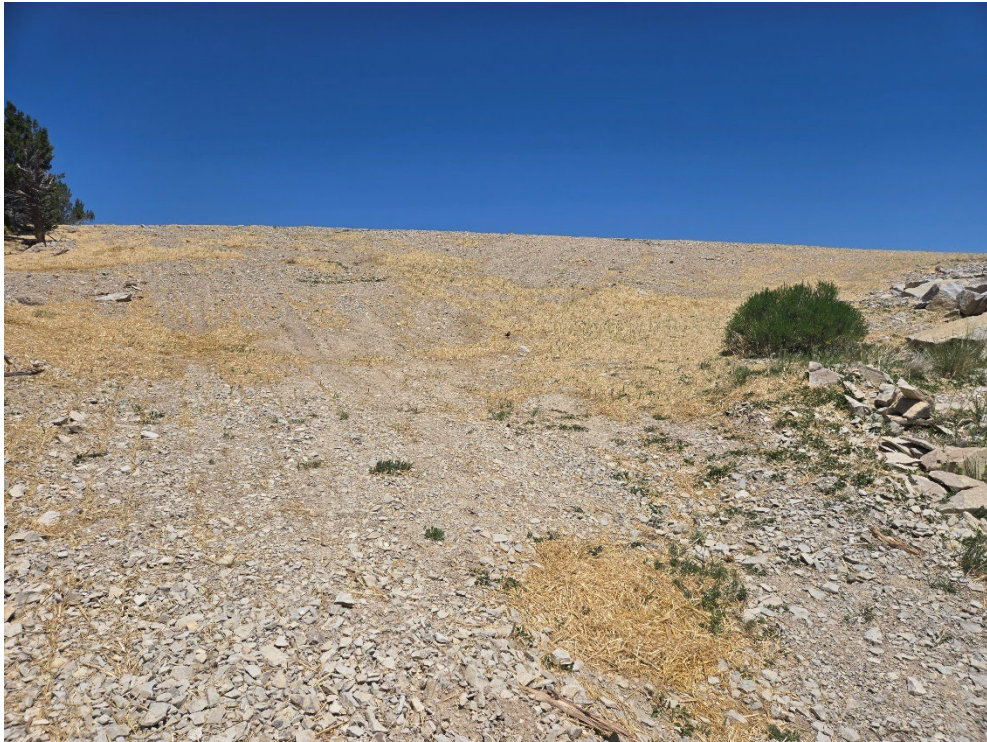
Photo 3: Looking northeast from the western permit boundary.

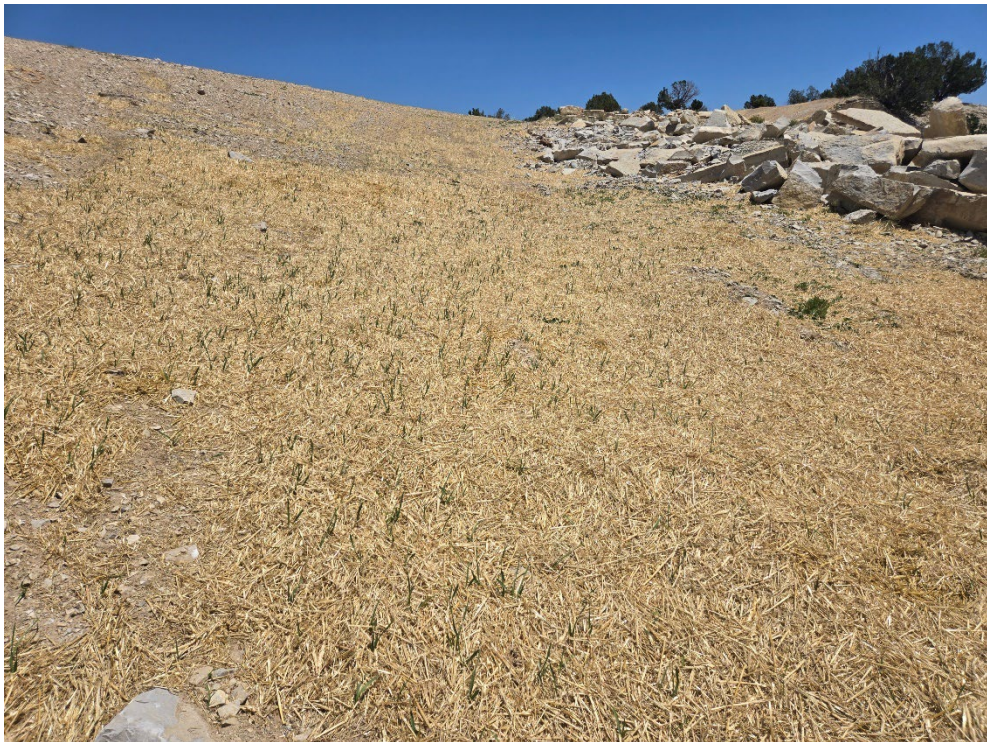
Photo 4: Looking at a recently mulched area along the natural berm lining the arroyo where some vegetation has begun to sprout.

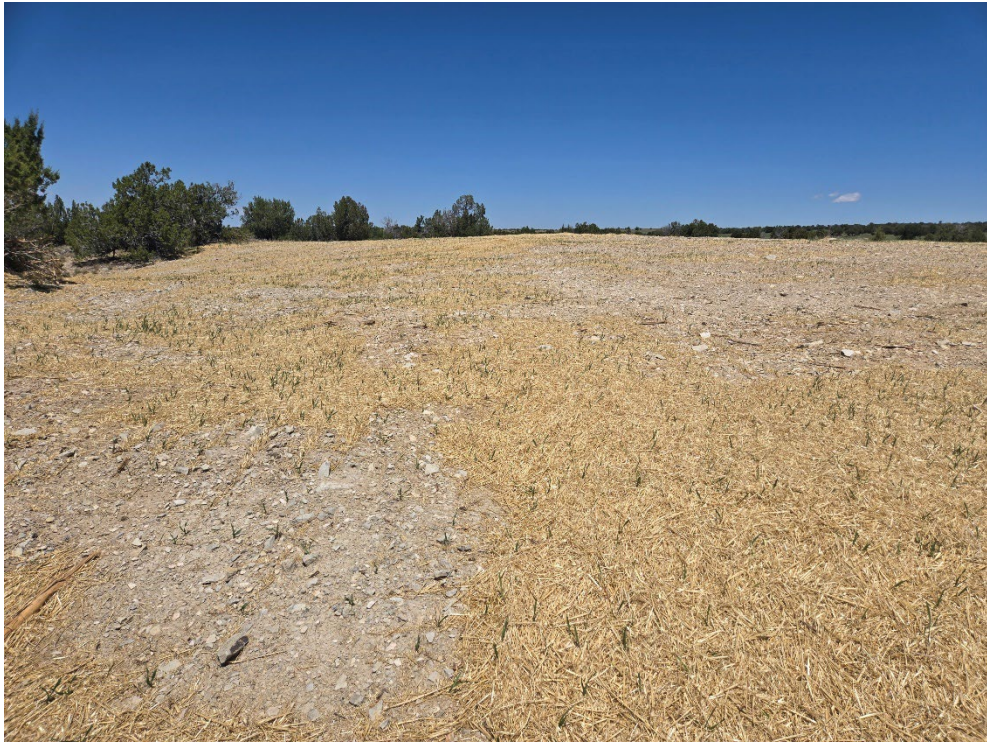
Photo 5: Looking across the backfilled, graded, topsoiled, mulched, and seeded area on the east side of the permit.

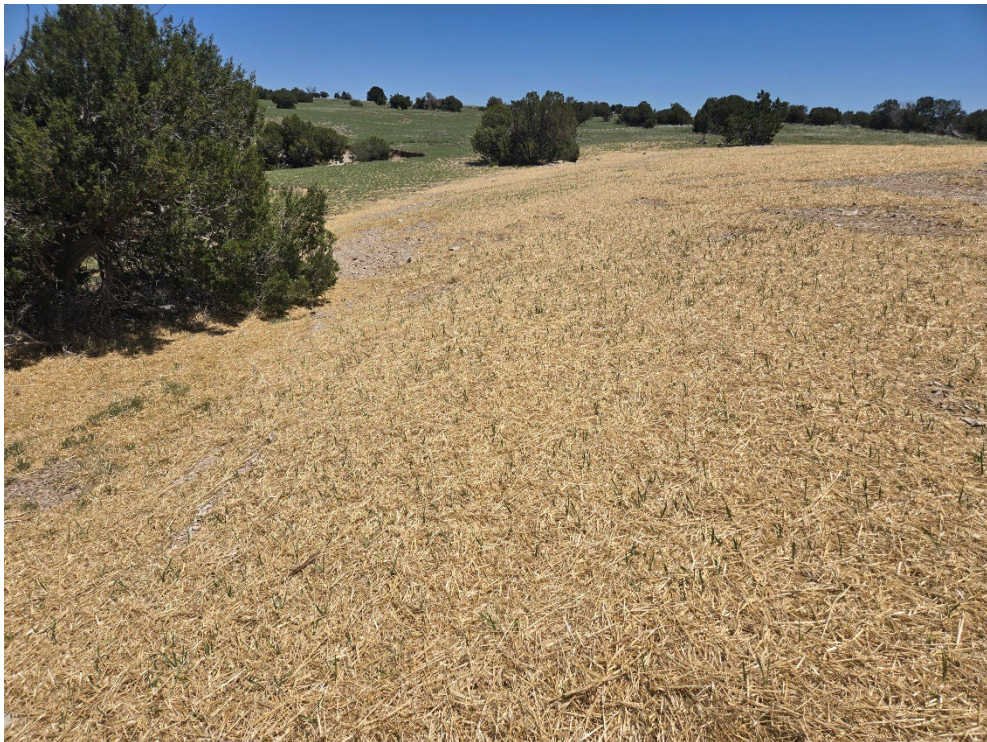
Photo 6: Looking across the backfilled, graded, topsoiled, mulched, and seeded area on the north side of the permit.

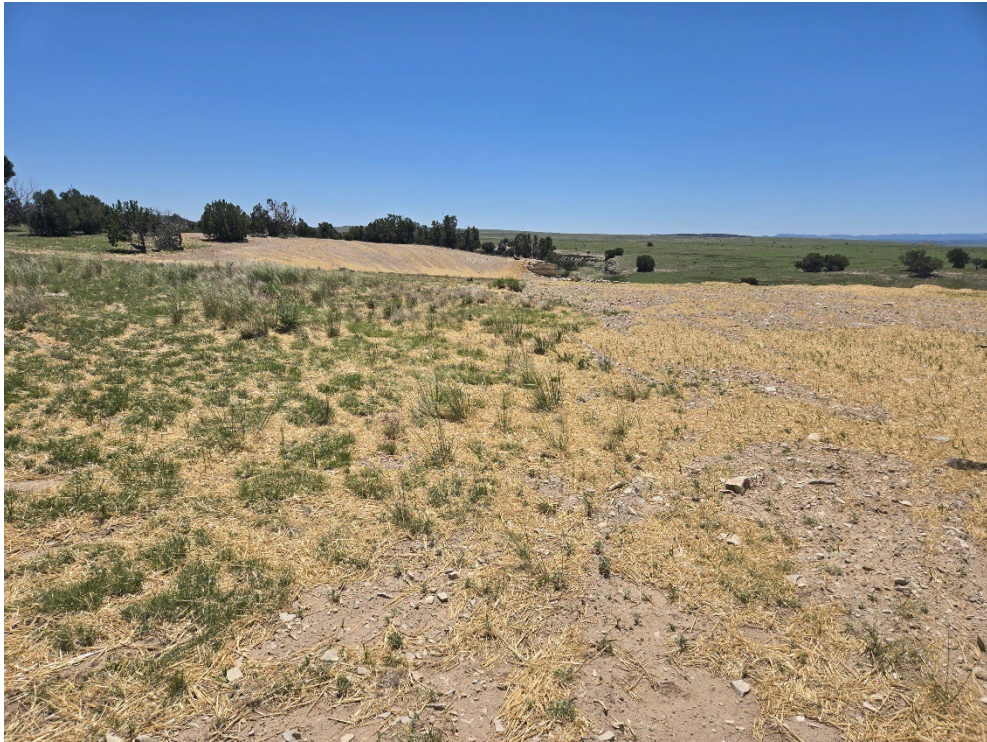
Photo 7: Looking south across the reclaimed disturbance.

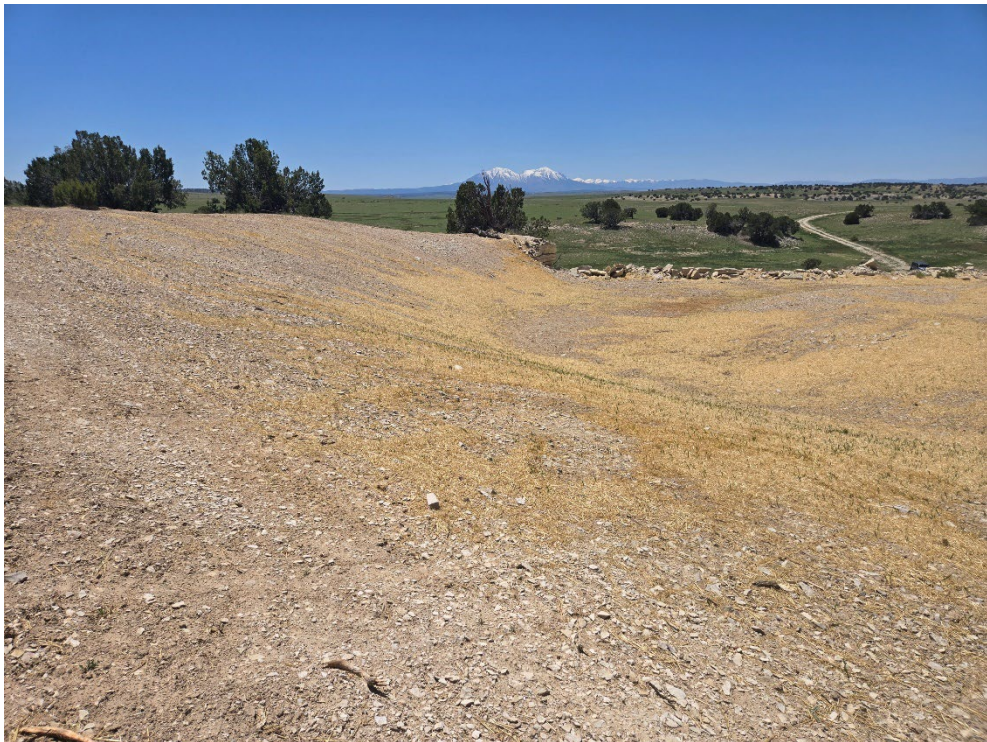
Photo 8: Looking west along the reclaimed highwall on the south side of the permit.

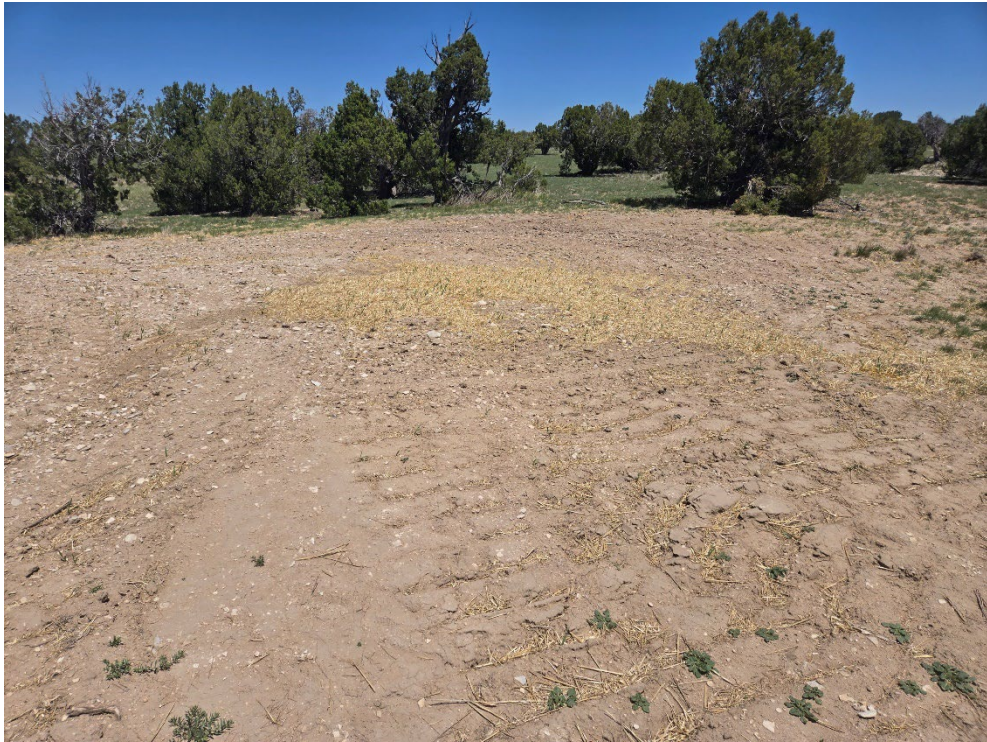
Photo 9: Looking southeast at some reclaimed disturbance on the southeast side of the permit.

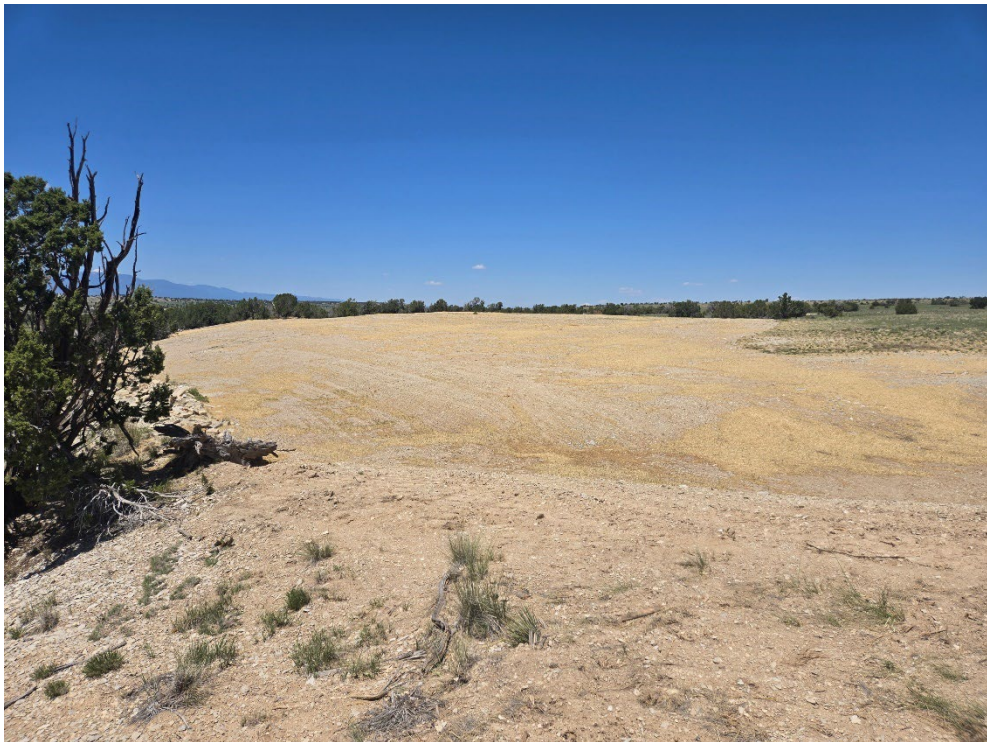
Photo 10: Looking across the reclaimed areas from the south side of the permit.

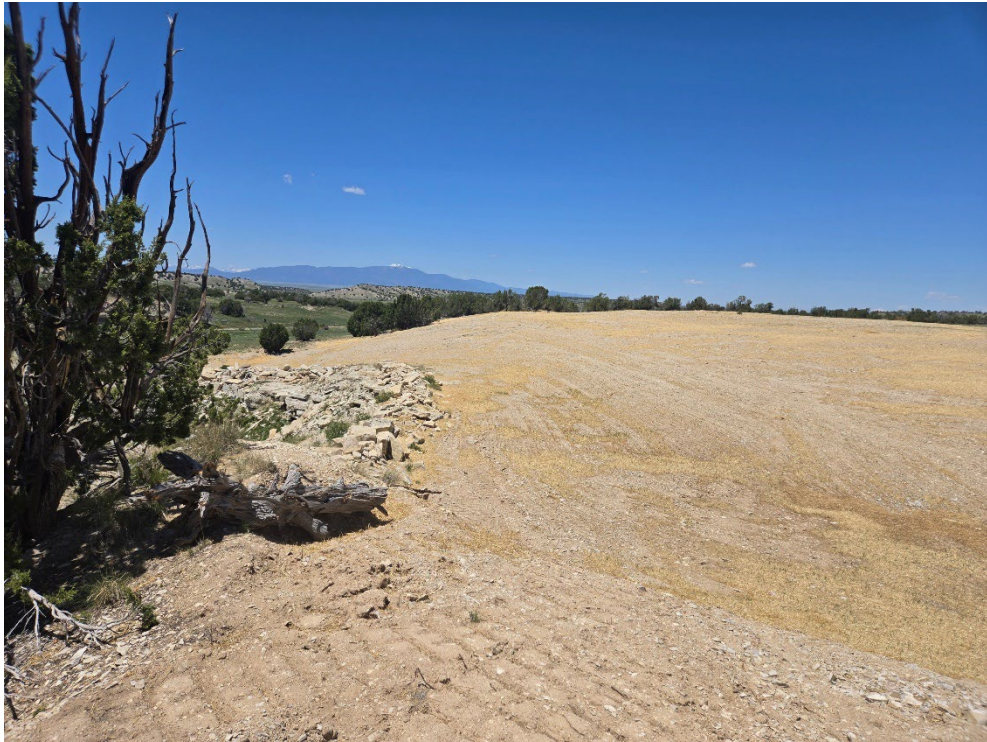
Photo 11: Looking across the reclaimed areas from the south side of the permit. Pictured again is the natural arroyo shown in Photo 2 above.

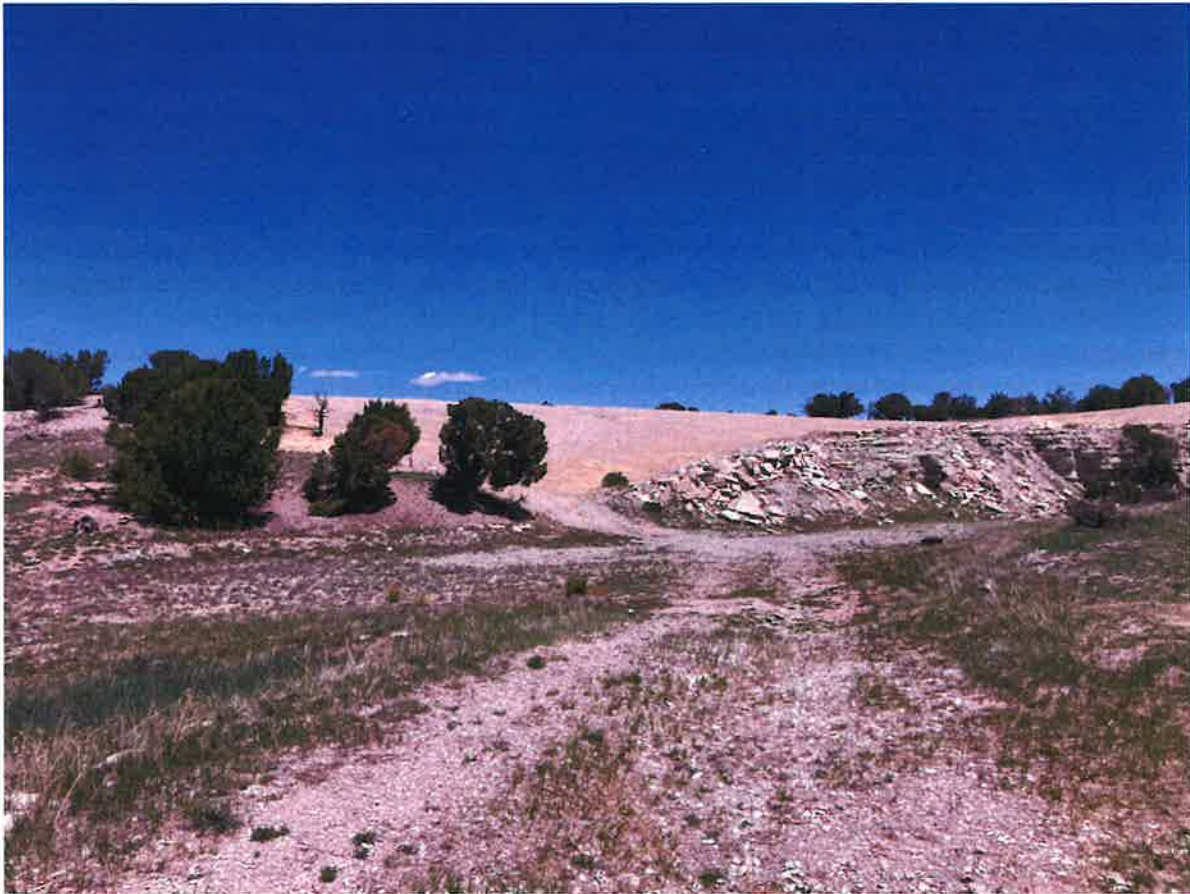
Photo: Looking NE from access road, west side of site

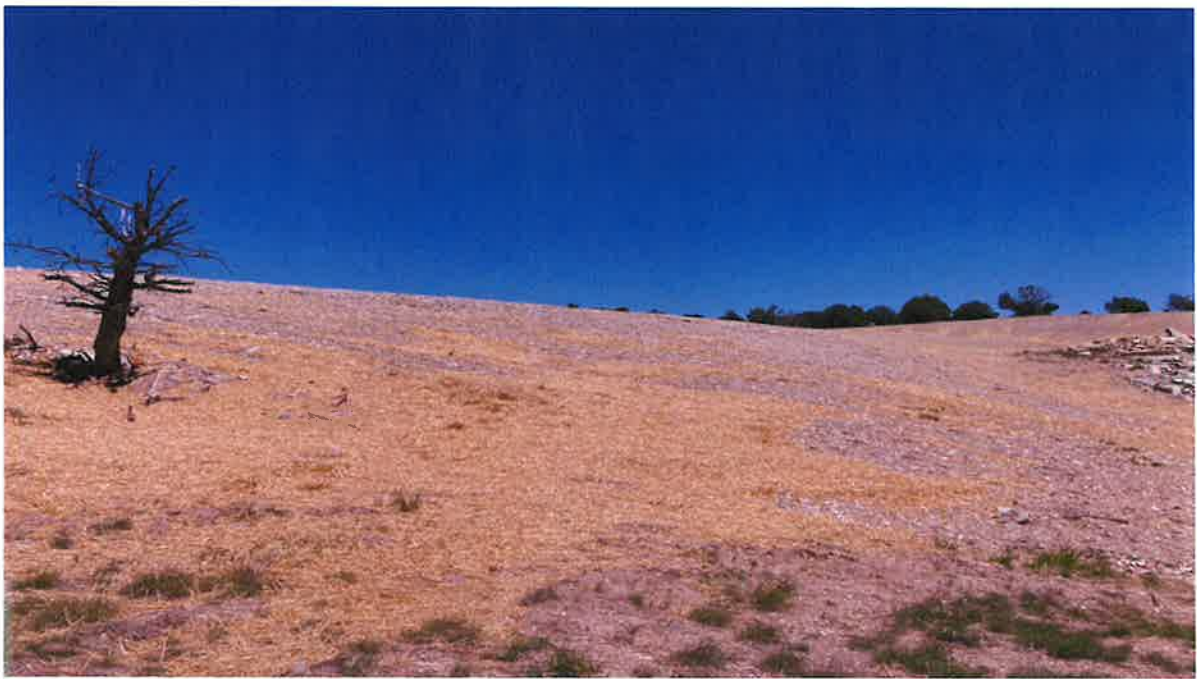
Photo: Looking east from SW corner

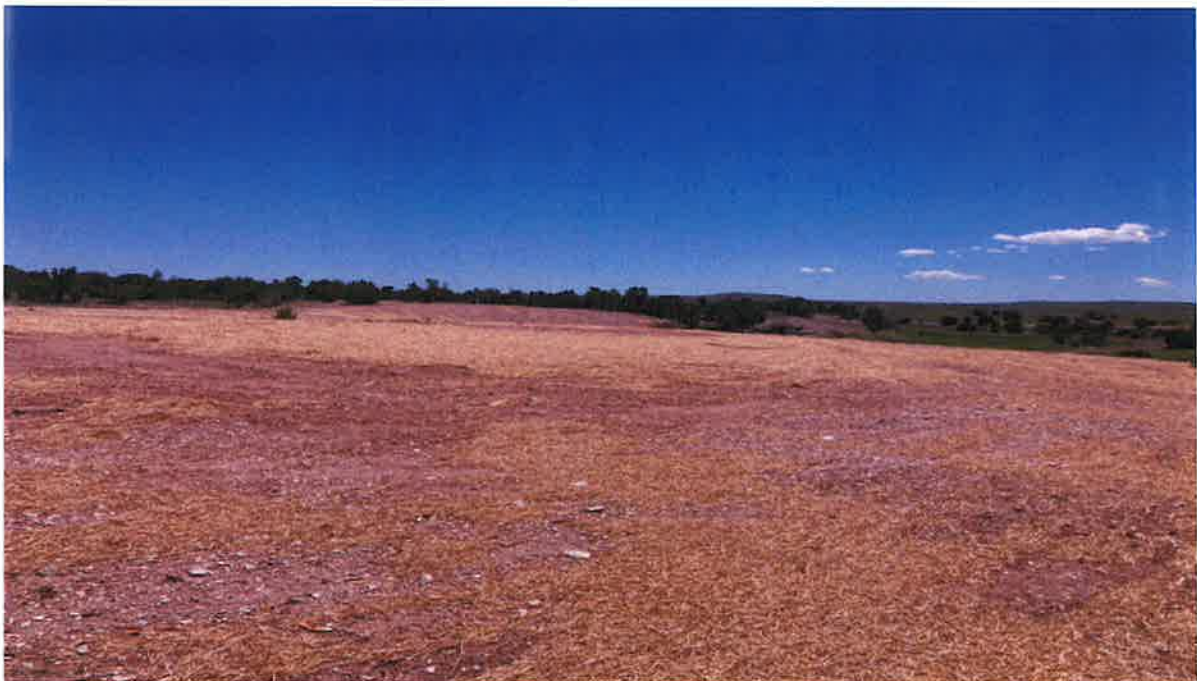
Photo: Looking south from north side

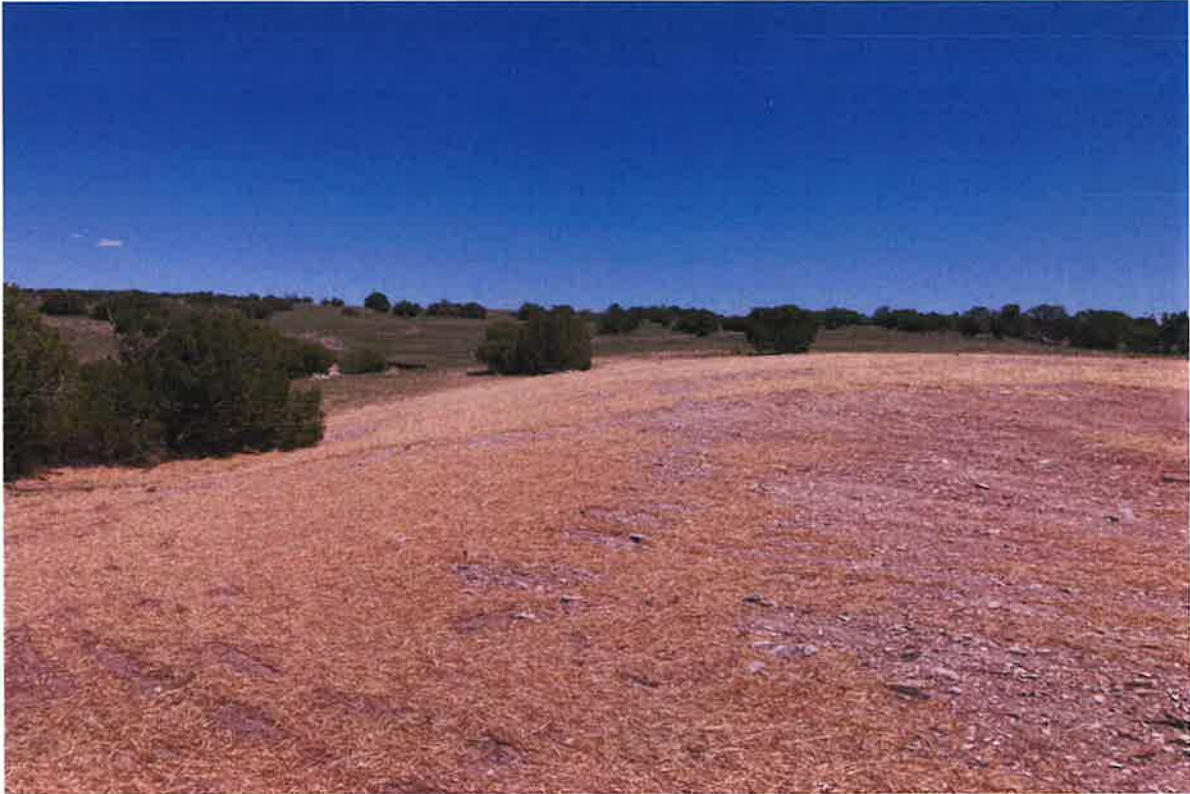
Photo: Taken from NE corner looking SE

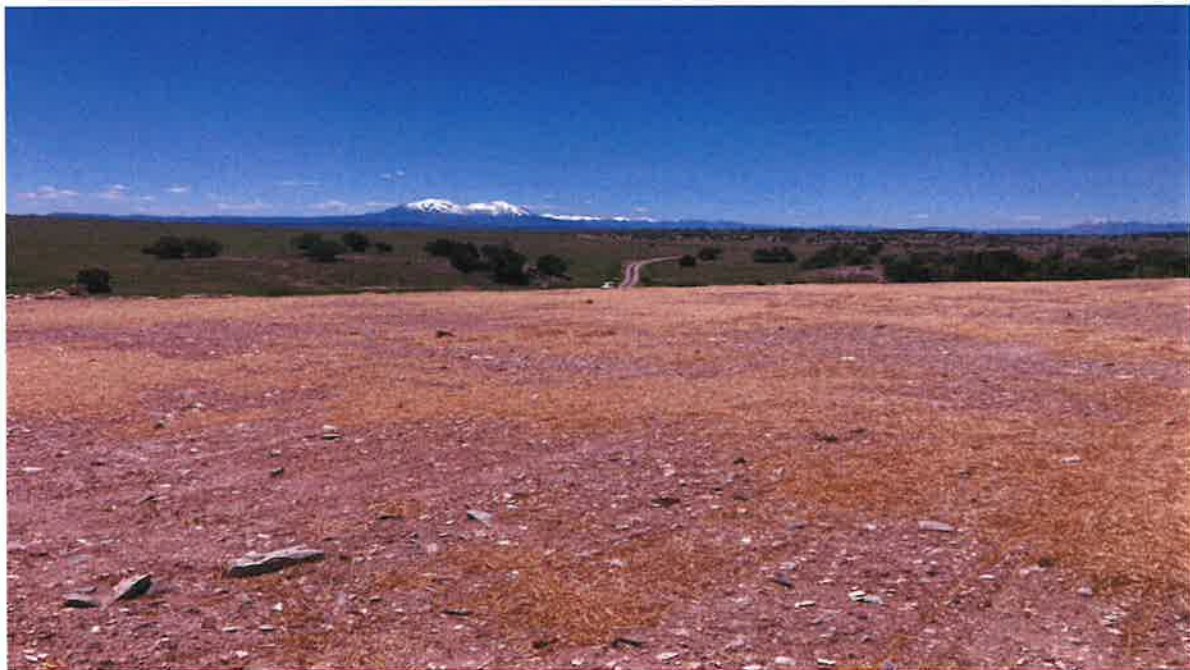
Photo: Looking west from east side
