**MINERALS PROGRAM INSPECTION REPORT**  
**PHONE: (303) 866-3567**

<b>MINE NAME:</b> Cresson Project	<b>MINE/PROSPECTING ID#:</b> M-1980-244	<b>MINERAL:</b> Gold and silver	<b>COUNTY:</b> Teller
<b>INSPECTION TYPE:</b> Monitoring	<b>WEATHER:</b> Windy	<b>INSP. DATE:</b> May 28, 2025	<b>INSP. TIME:</b> 09:30
<b>OPERATOR:</b> Cripple Creek & Victor Gold Mining Company	<b>OPERATOR REPRESENTATIVE:</b> Brian Doering	<b>TYPE OF OPERATION:</b> 112d-3 - Designated Mining Operation	
<b>REASON FOR INSPECTION:</b> Normal I&E Program	<b>BOND CALCULATION TYPE:</b> None	<b>BOND AMOUNT:</b> \$319,158,980.00	
<b>DATE OF COMPLAINT:</b> NA	<b>POST INSP. CONTACTS:</b> None	<b>JOINT INSP. AGENCY:</b> None	
<b>INSPECTOR(S):</b> Hunter Ridley Ben Hammar	<b>INSPECTOR'S SIGNATURE:</b>

### **Schist Island**

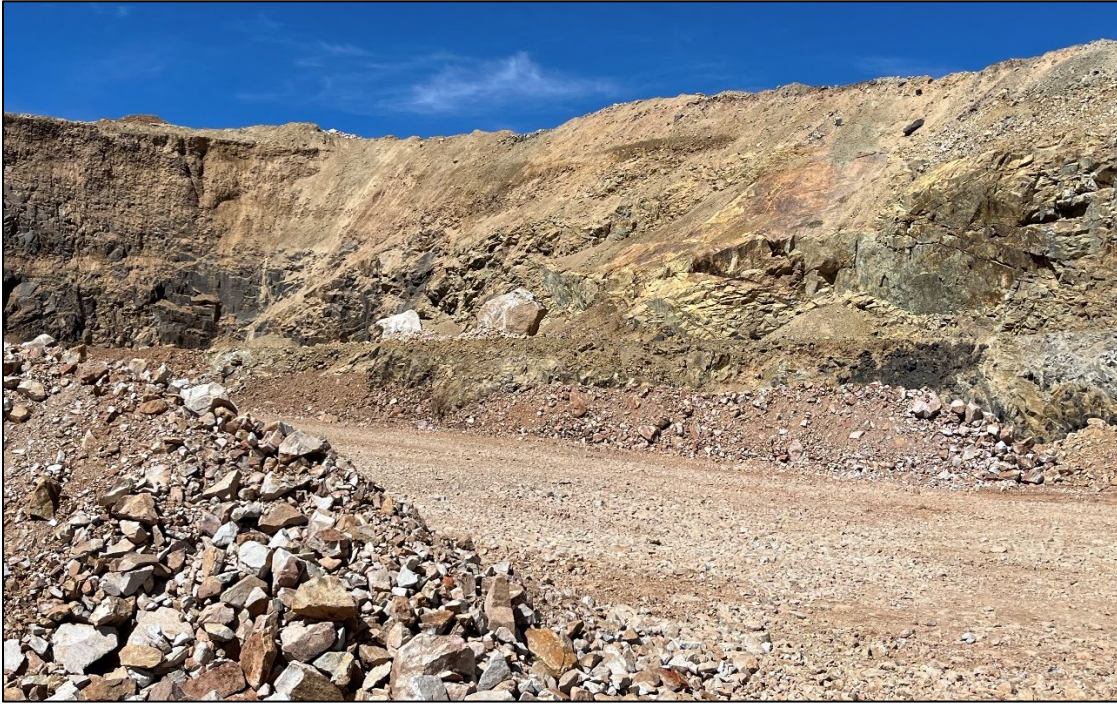
The Schist Island was viewed from ground level in the active backfill area. The low compaction backfill is mainly situated to the south and east and the high compaction area to the north, both compaction areas are being added to simultaneously. The Division attempted to inspect Schist Island from above at a southwester overlook, but a scheduled blast halted all truck traffic from entering the pit for ~45 minutes. NewFields representatives were present at the time of inspection. Division representatives inspected the low compaction area (facing south) from afar and watched several rounds of haul trucks dump onto the low compaction area while a dozer pushed material to the face of the dump (Photo 2). All material observed during this time appeared to be within the low compaction specification of 5 feet or less in two out of 3 dimensions. The Division also walked up to the face of the low compaction zone and measured several larger pieces of material to ensure compliance with the specifications. All material observed in the low compaction zone was found to be in compliance with the specifications. Two larger, out of spec. boulders had been put aside prior to the Division's inspection for further crushing before placement in the backfill area (Photo 1).

**Photo 1: Two large boulders had been separated from the low compaction zone in preparation for further break up / crushing to reduce their size to fit required fill specifications.**

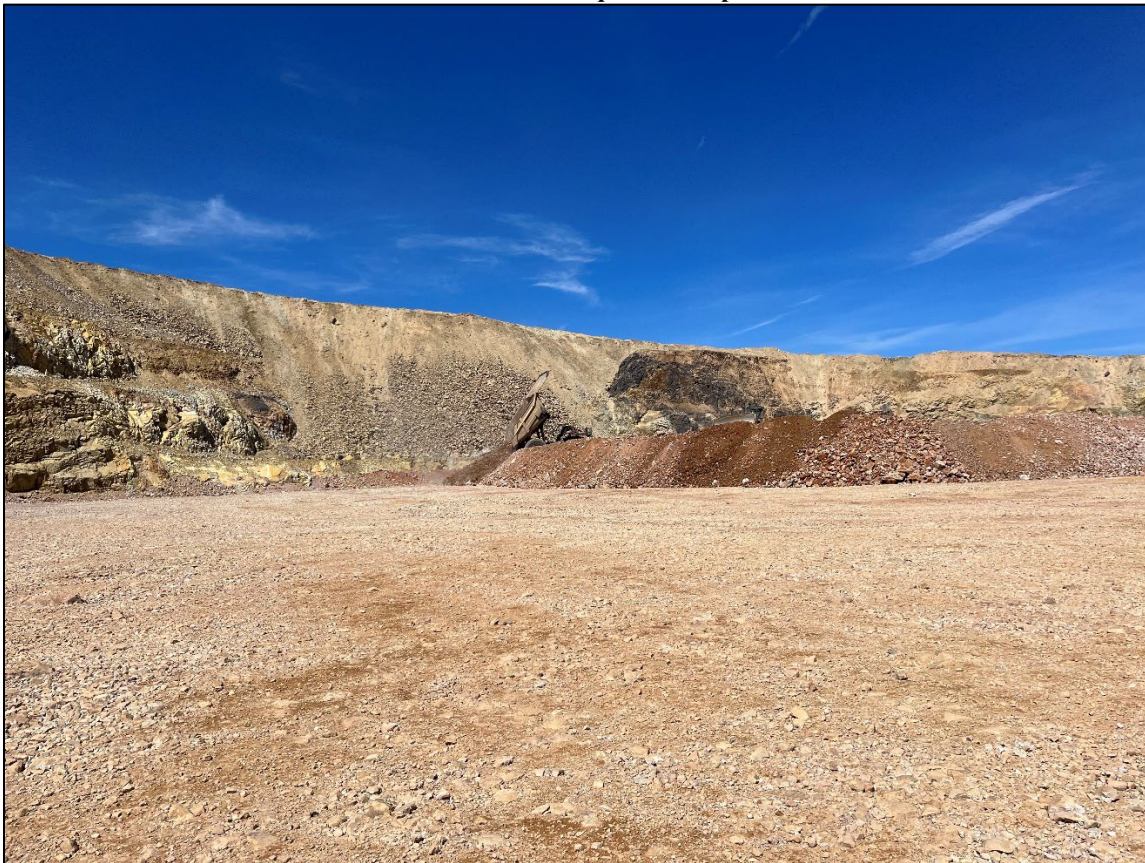
**Photo 2: View west of the low compaction dump face, dump and doze operations were active during the inspection.**

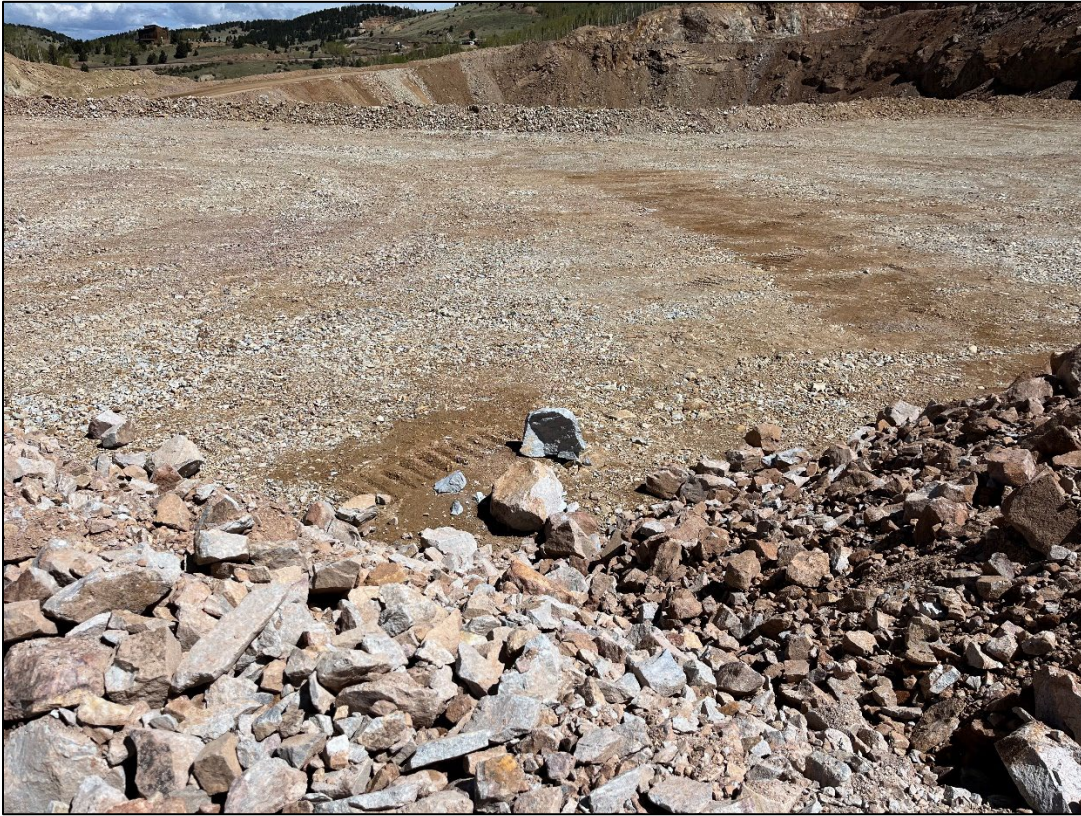
**Photo 3: View looking down onto the dump face of the high compaction zone in the northern backfill area.**

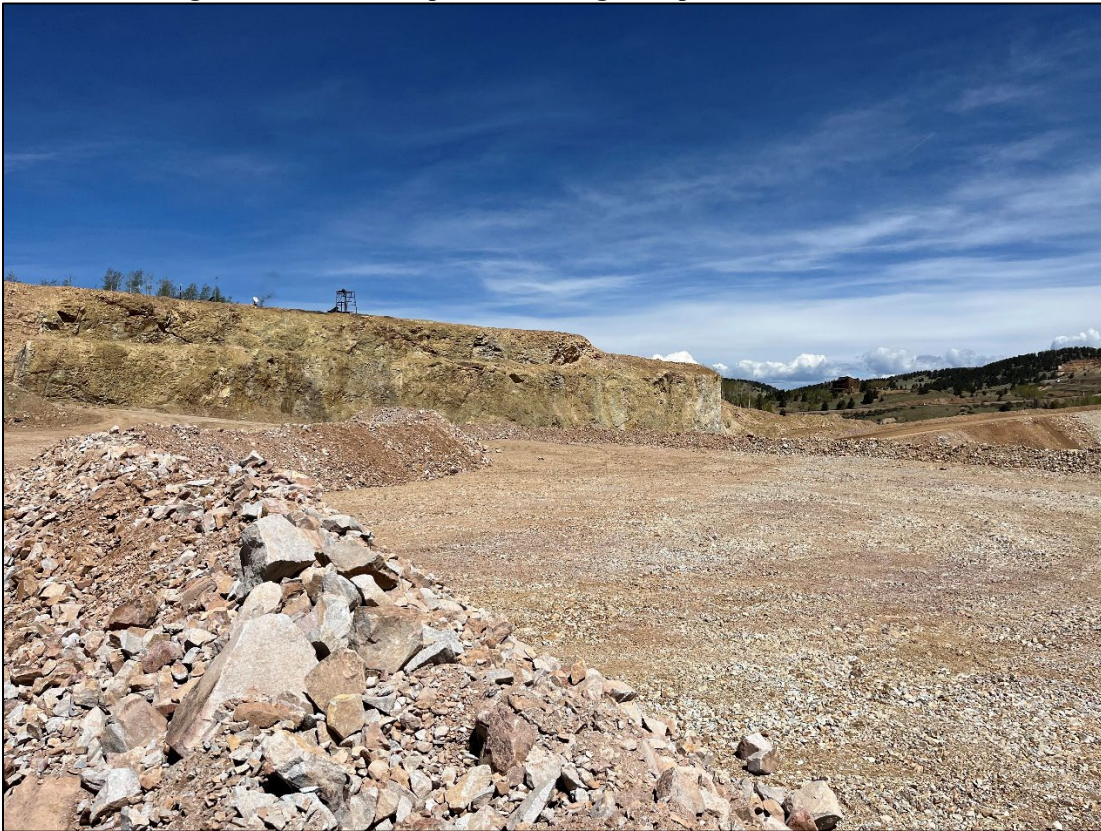
**Photo 4: View looking northwest along the dump face in the northern end of the backfill area.**

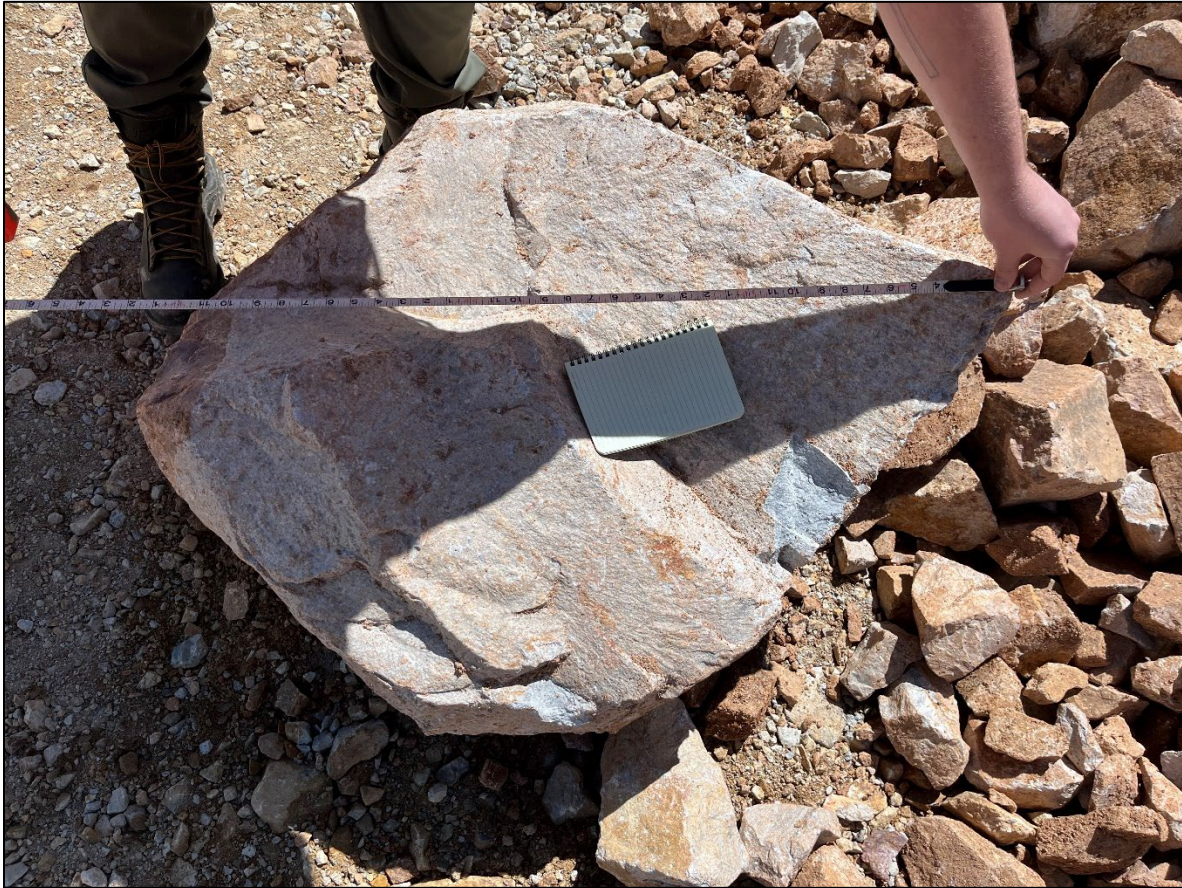
**Photo 5: Material measured in the area shown in Photos 4 and 12. Measured 3'3" by 2'6".**

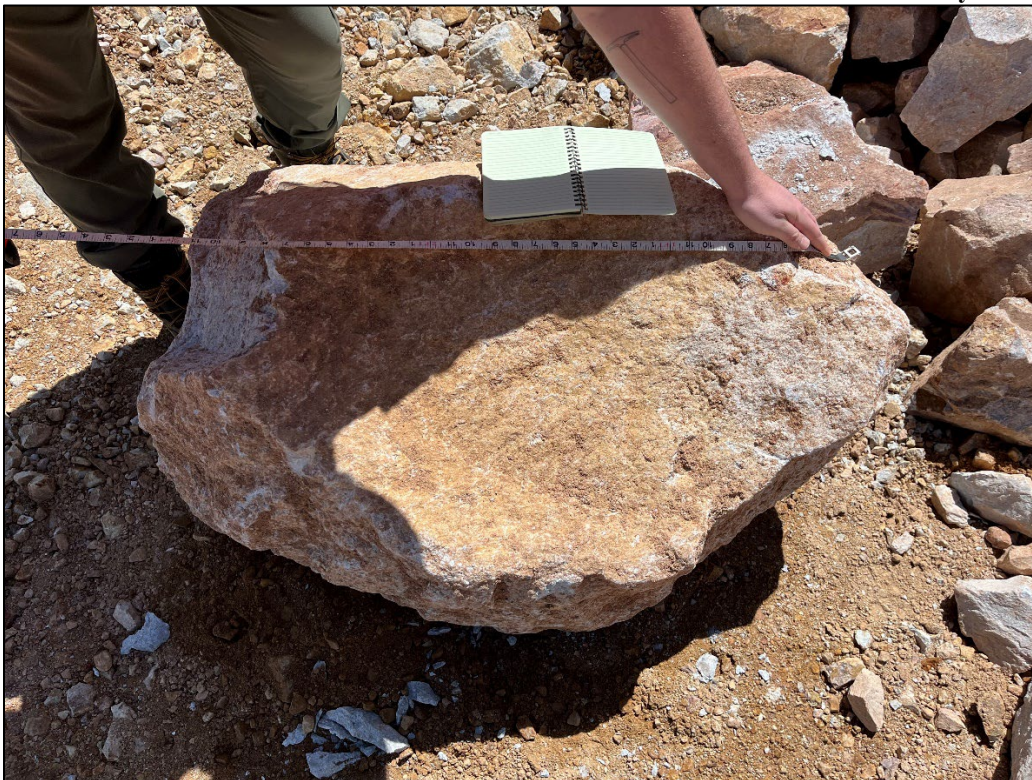
**Photo 6: Material measured in the area shown in Photos 4 and 12. Measured 3'4" by 2'6".**

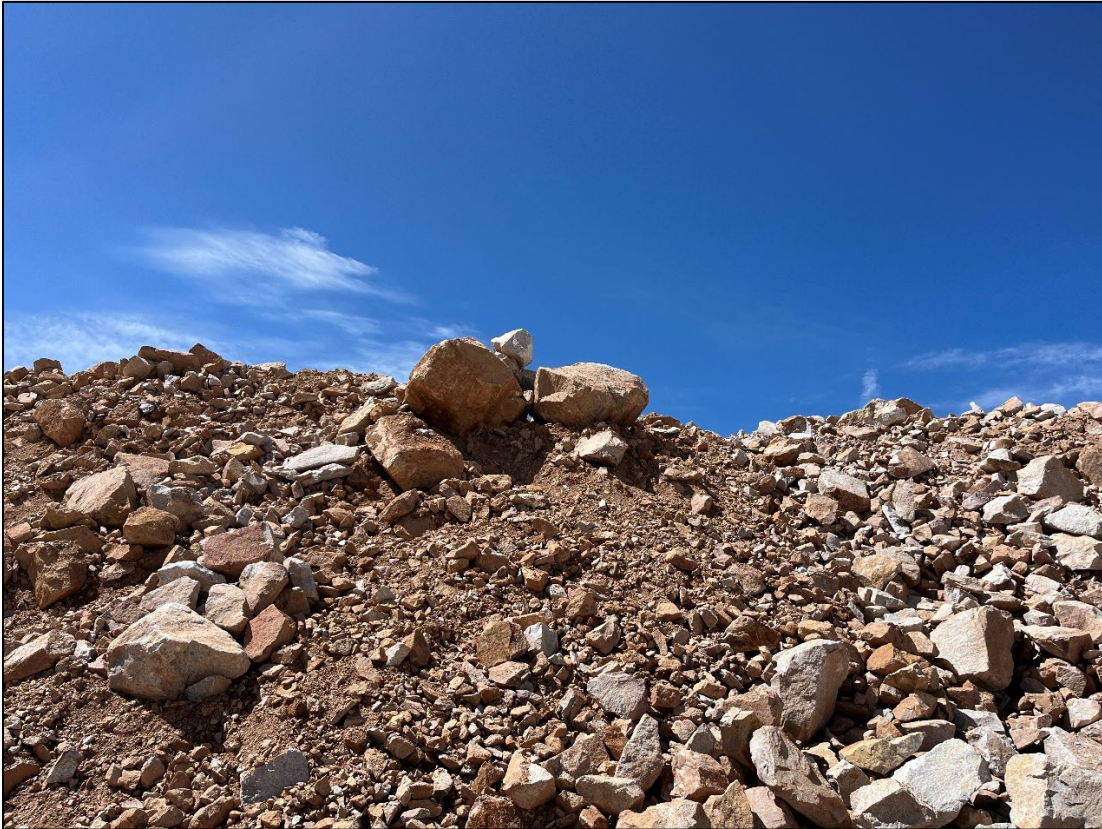
**Photo 7: Large rock in the same Photos 4 and 12 area, unable to be measured but similar in size to rocks in Photos 5, 6, 8, 9, 10.**

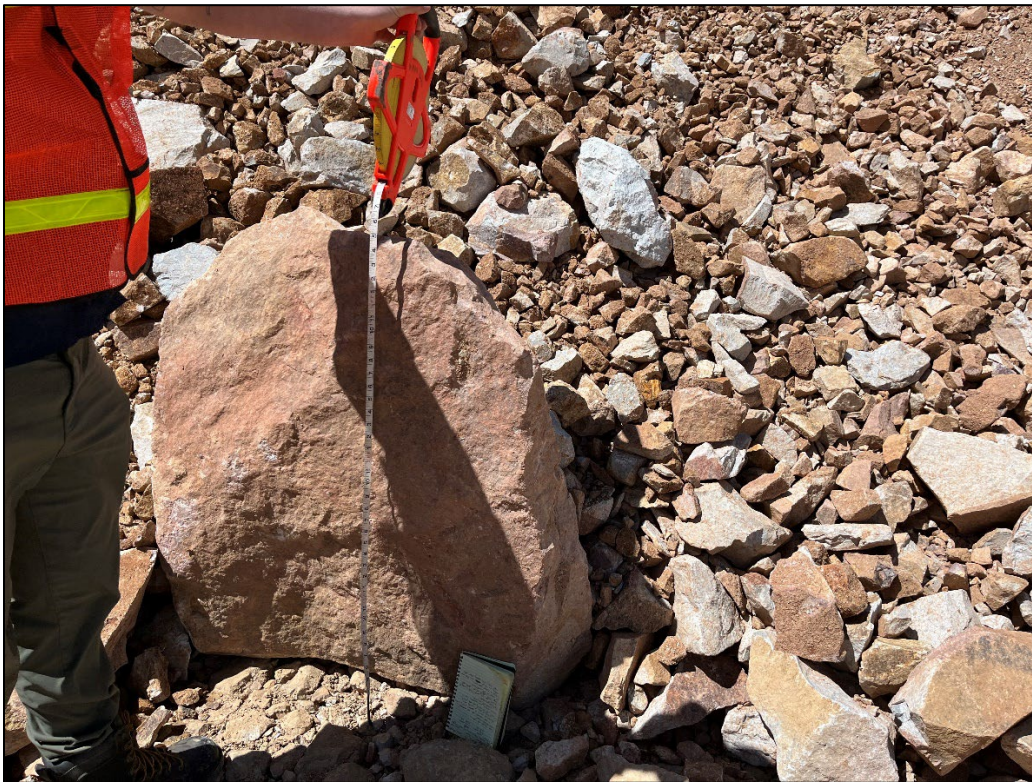
**Photo 8: Material measured in the area shown in Photos 4 and 12. Measured 3'6" by 3'9".**

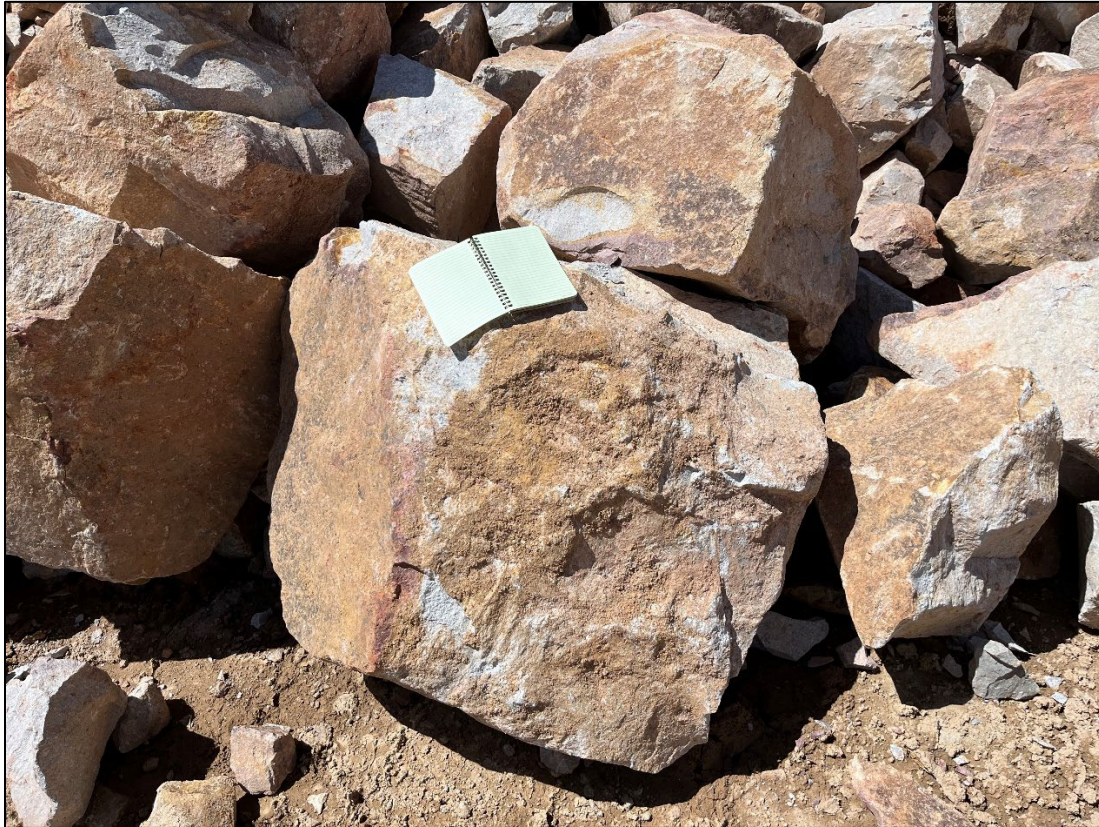
**Photo 9: Material measured in the area shown in Photos 4 and 12. Measured 3'2" by 2'6".**

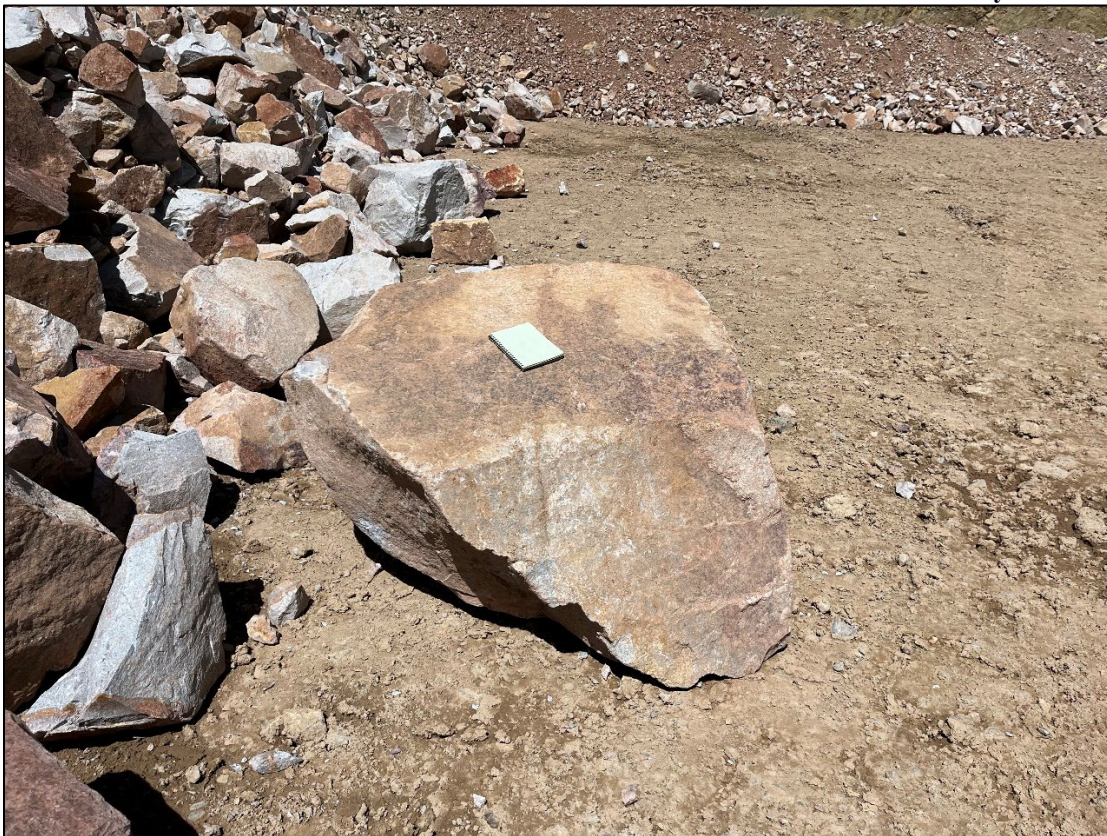
**Photo 10: Material measured in the area shown in Photos 4 and 12. Measured 4'9" by 2'6".**

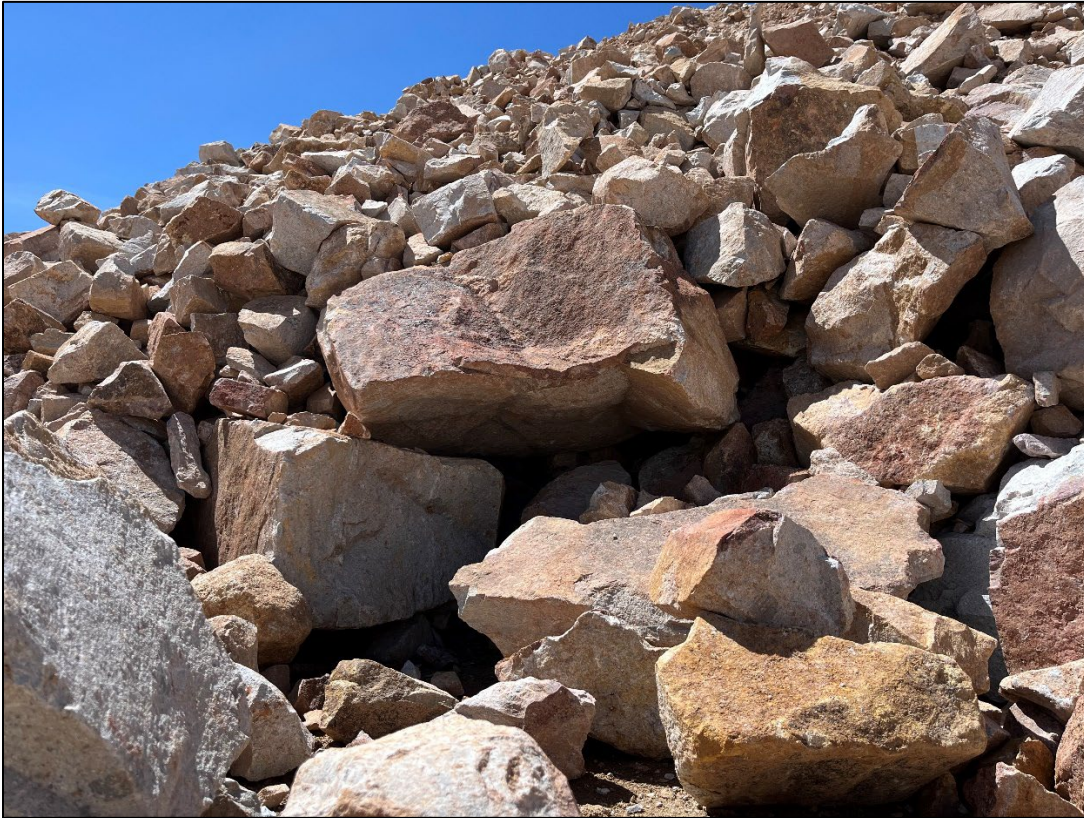
**Photo 11: Large rock in the same Photos 4 and 12 area, unable to be measured but similar in size to rocks in Photos 5,6,8, 9, 10.**

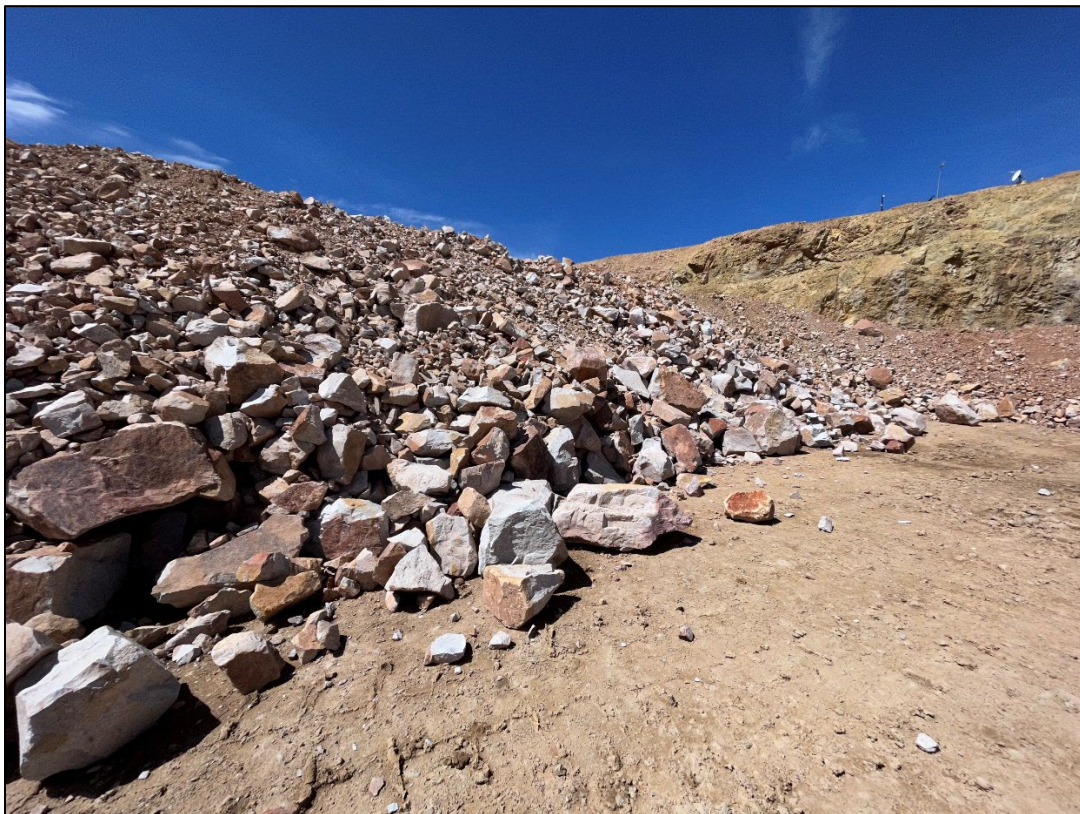
The Division then walked north in the backfill area to inspect the high compaction zone. While CC&V currently conducts their own quality control for the low compaction zone, NewFields is in charge of quality control for the high compaction zone. Tyler, with NewFields, reconfirmed that each 5 foot lift is signed off by one of their staff before the next lift begins. The Division noted that there were many pieces of material in this area that appeared to be slightly or well above the 2 foot maximum specification limit for the high compaction zone. Therefore, the Division inspected the entire length of the northern face (Photo 4), documenting the size of ~8 large boulders. These are shown in Photos 3 through 12. About  $\frac{3}{4}$  of this northern face contained material that is compliant with the high compaction specifications. At the western end is where the Division found a collection of larger boulders (Photo 12). NewFields could not determine in the field whether or not the large boulders observed were in or outside of the official line for the high compaction zone. The Division asked that Mr. Doering confirm this with a survey and provide the Division with the updated information. If the material observed *was* in the high compaction zone, the Division informed CC&V representatives that they would need to remove such material prior to dumping the next lift. The Division received an email from Mr. Doering on June 5, 2025. The report provided is attached below and shows that the large boulders observed were *not* within the high compaction zone.

**Photo 12: View southwest of the dump face where large rocks were observed and measured. In general, this area holds many larger rock fragments that are likely not within high compaction specifications.**

- 1. Confirm whether or not 2ft+ boulders were within the high compaction zone.**
  - a. The 2ft+ boulders identified during the inspection were surveyed for their precise location. The surveyed locations were compared to the zone of high compaction, and shown to be outside of that zone.*
  - b. **Attachment 1** identifies the boulder locations as well as the high and low compaction zones for the relevant lift elevations.*
- 2. If 2ft+ boulders are within the high compaction zone, remove them from the zone and document the process.**
  - a. Because the 2ft+ boulders were outside of the low and high compaction zones, the boulders were not removed.*

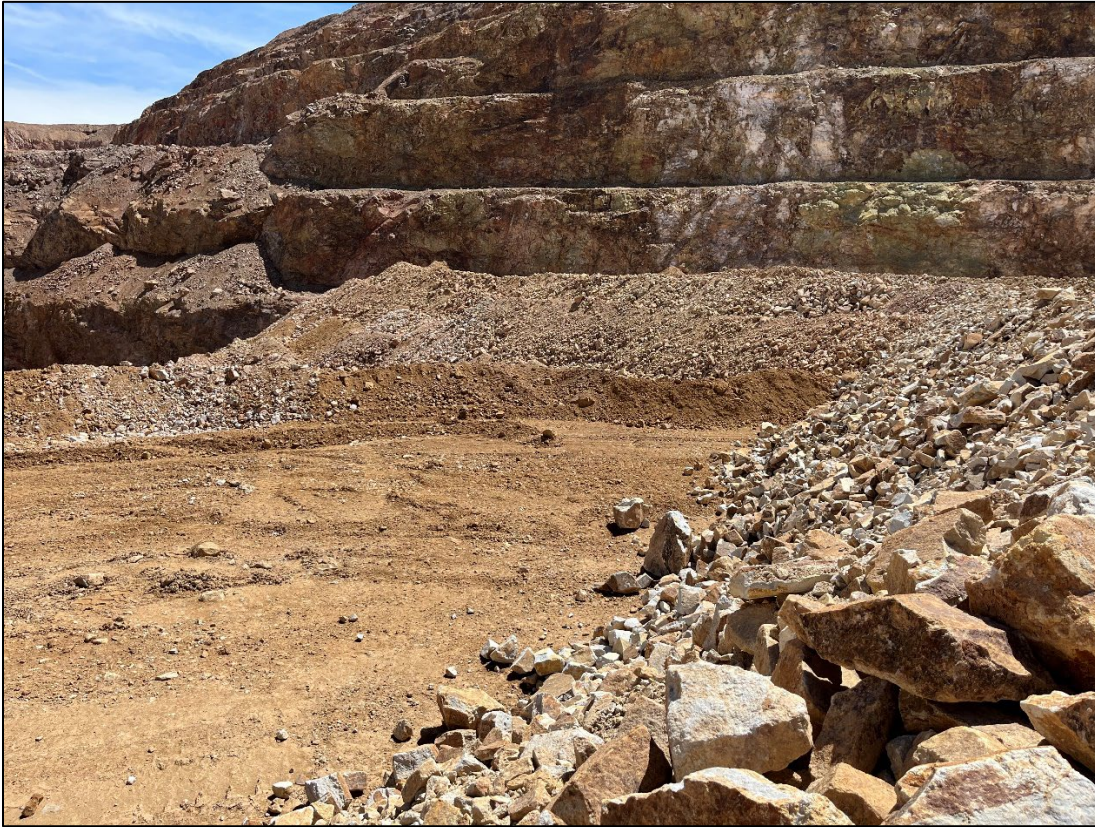
**Photo 13: View northwest of the northern end of the fill area, looking towards the low compaction zone.**

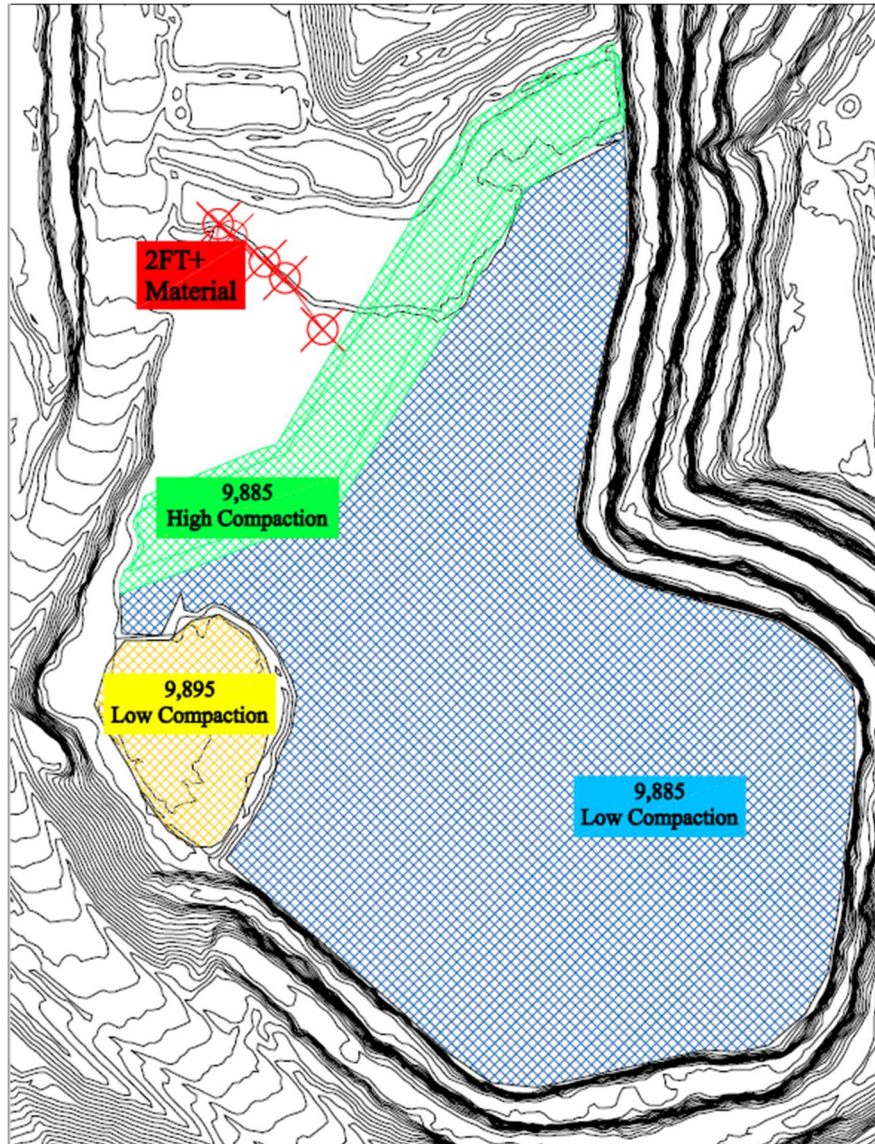
## Attachment 1

The blue and yellow areas highlight the current low compaction lifts. Green highlights the high compaction zone including the 9,875 to the 9,885 elevations. The > 2ft boulders identified during the May 28<sup>th</sup> inspection were surveyed and are identified with the red icons, outside both the high and low compaction zones.
