### MINERALS PROGRAM INSPECTION REPORT

<b>MINE NAME:</b> Cottonwood Pit	<b>MINE/PROSPECTING ID#:</b> M-1988-042	<b>MINERAL:</b> Sand and gravel	<b>COUNTY:</b> Weld
<b>INSPECTION TYPE:</b> Monitoring	<b>WEATHER:</b> Clear	<b>INSP. DATE:</b> June 10, 2025	<b>INSP. TIME:</b> 11:15
<b>OPERATOR:</b> Martin Marietta Materials, Inc.	<b>OPERATOR REPRESENTATIVE:</b> Julie Mikulas	<b>TYPE OF OPERATION:</b> 112c - Construction Regular Operation	
<b>REASON FOR INSPECTION:</b> Normal I&E Program	<b>BOND CALCULATION TYPE:</b> Complete Bond	<b>BOND AMOUNT:</b> \$421,700.00	
<b>DATE OF COMPLAINT:</b> NA	<b>POST INSP. CONTACTS:</b> None	<b>JOINT INSP. AGENCY:</b> None	
<b>INSPECTOR(S):</b> Patrick Lennberg	<b>INSPECTOR'S SIGNATURE:</b>

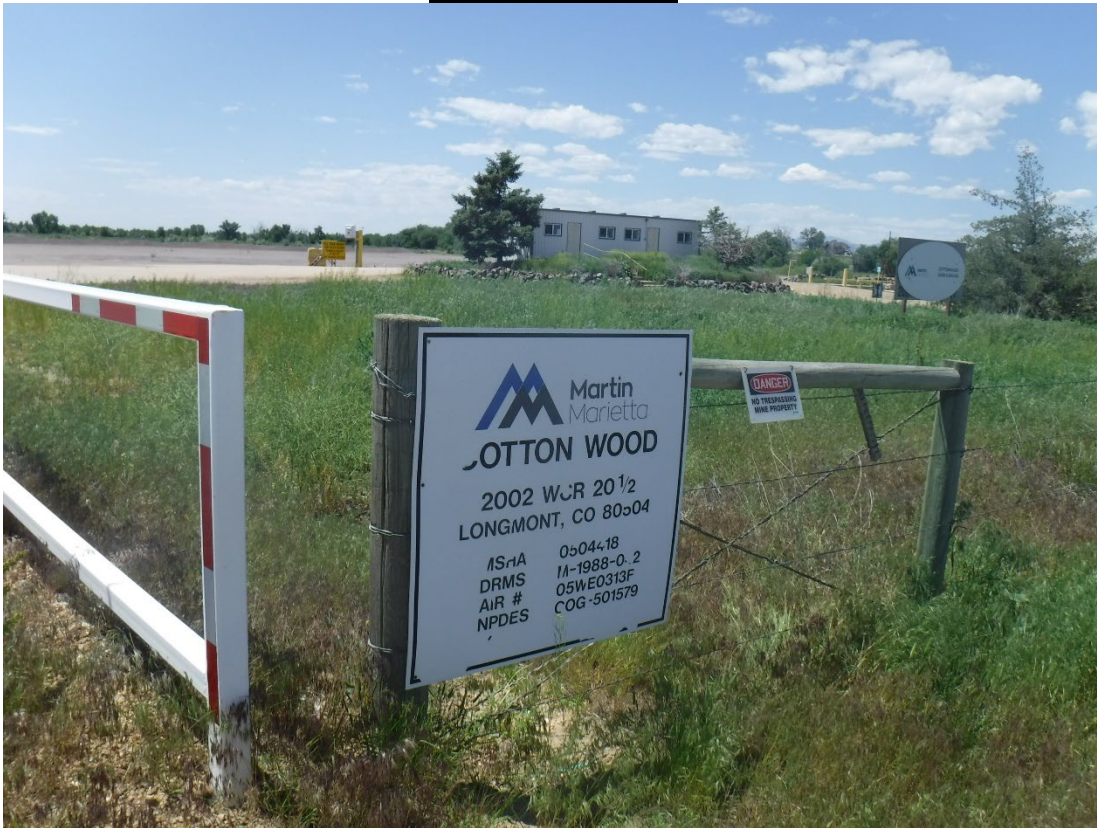
**Photo 1:** Mine sign at primary mine entrance

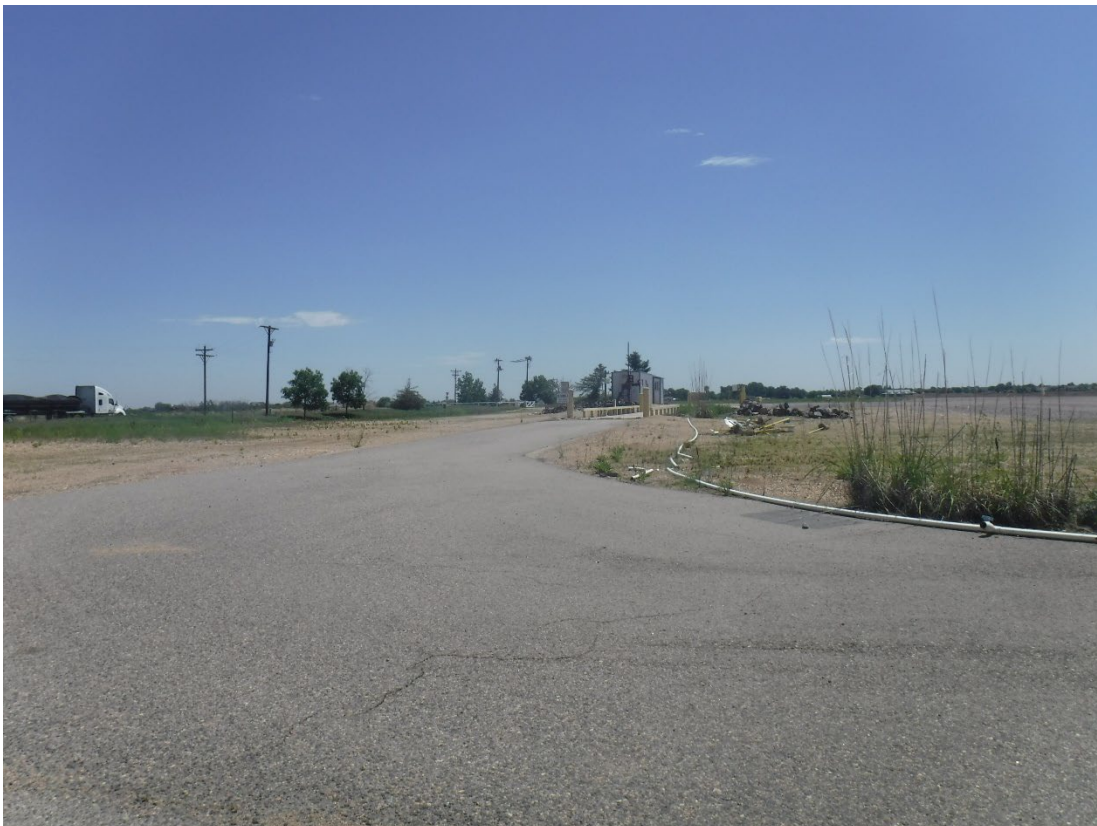
**Photo 2:** Portable scale and house

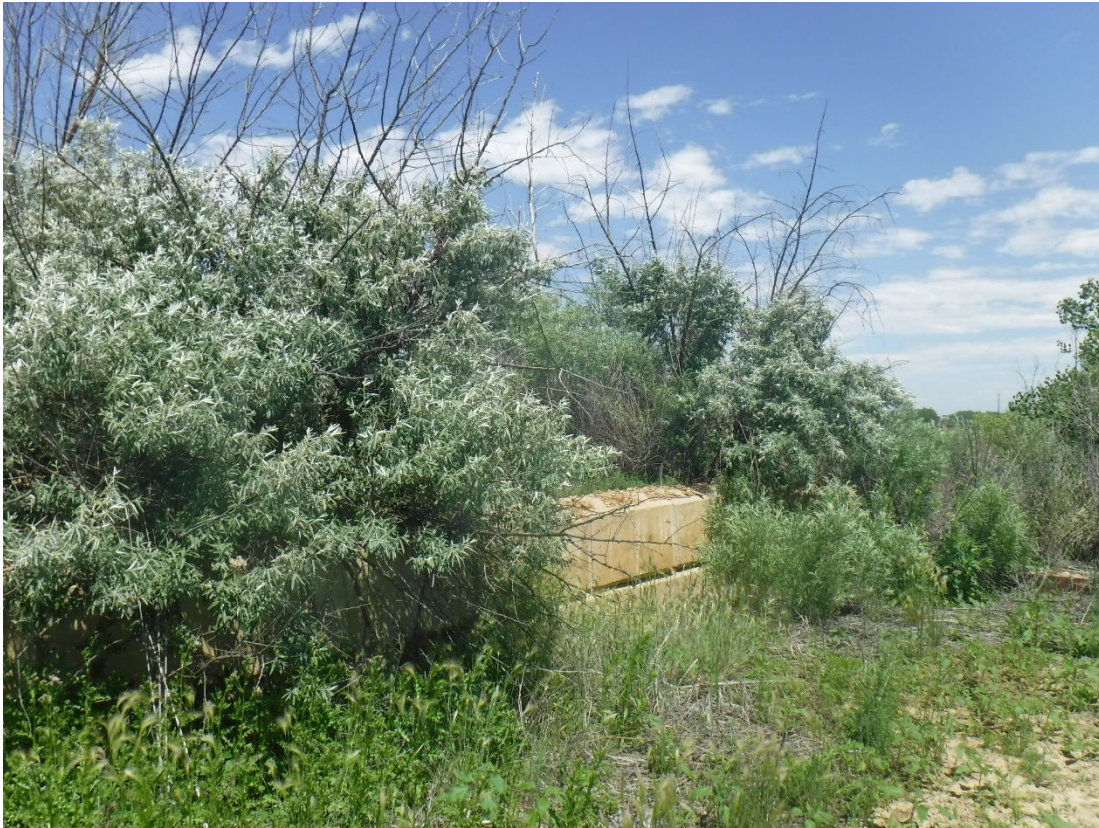
**PROBLEM:** There are state-listed noxious weeds present on site. This is a problem for failure to employ weed control methods for state listed noxious weed species within the permitted area, and to reduce the spread of weeds to nearby areas as required by Section 3.1.10 (6) of the rule.

During the inspection the Division noted many Russian Olive trees and Tamarisk (salt cedar) trees throughout the permit area. These are Colorado List B noxious weed species. The Division is citing this as a problem for failure to implement the currently approved Weed Control and Management Plan.

**Photo 3:** Established Russian Olive Trees adjacent to the scales

**CORRECTIVE ACTIONS:** Implement approved weed control plan and provide proof to the Division that this has been done by the corrective action date.

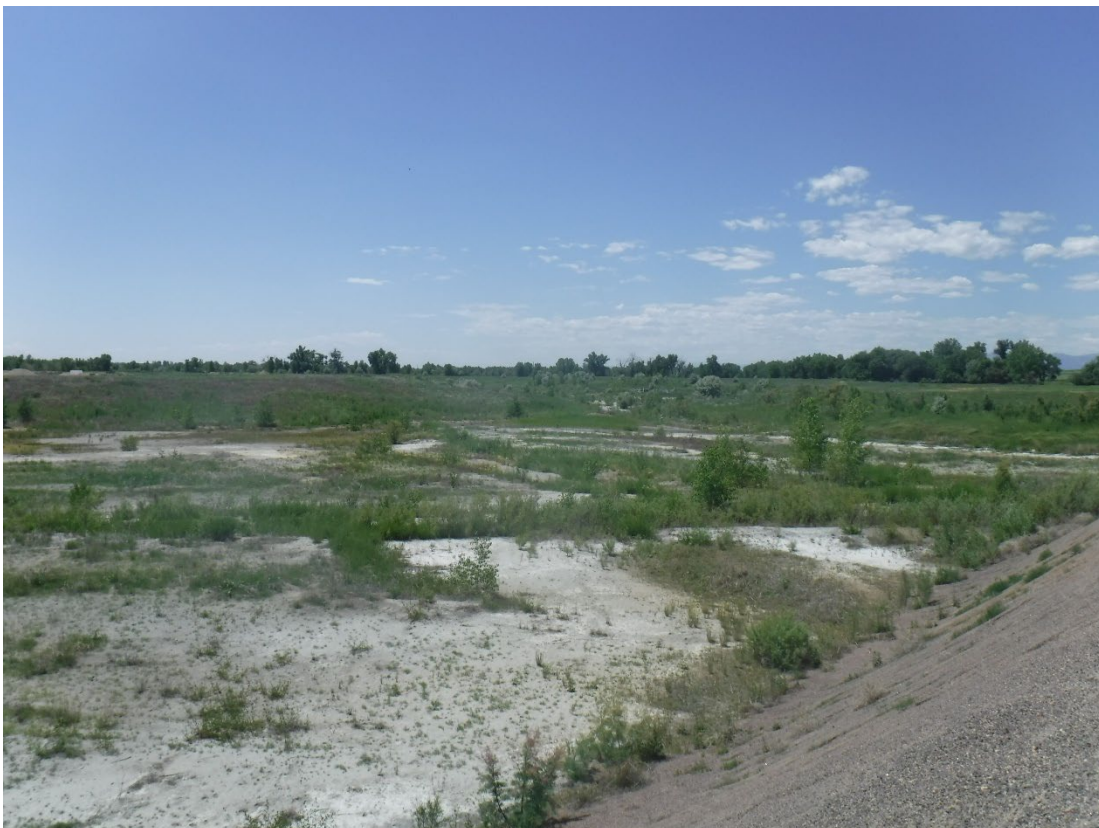
**Photo 4:** Looking from the CW5 backfill area across the pond to the southwest, note Russian and Salt Cedar trees

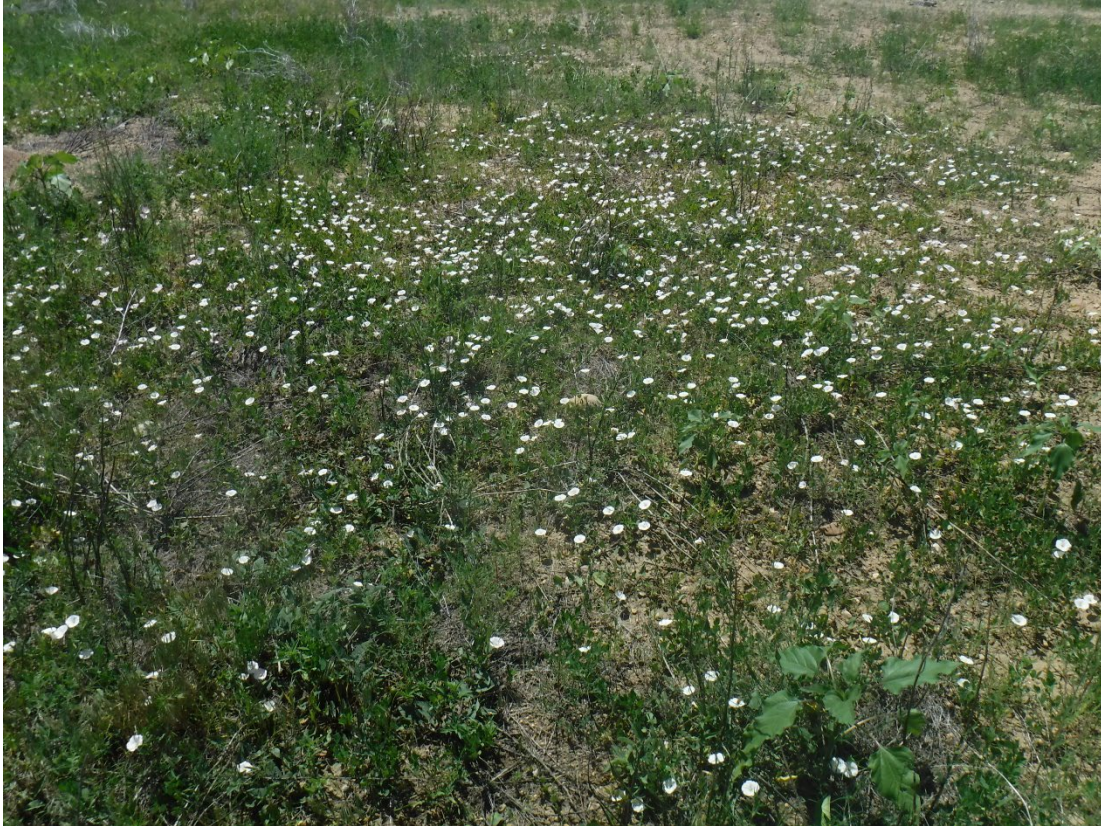
**Photo 5:** Typical bindweed infestation onsite

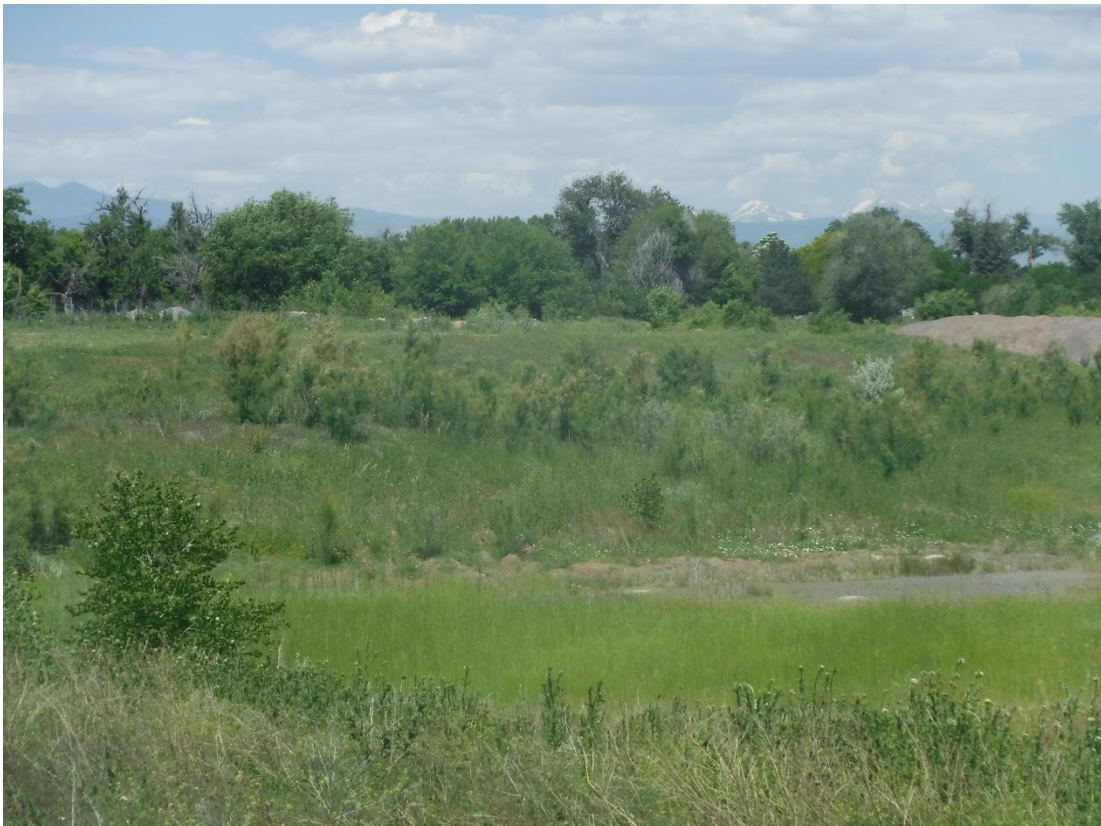
**Photo 6:** Typical Salt Cedar infestation onsite

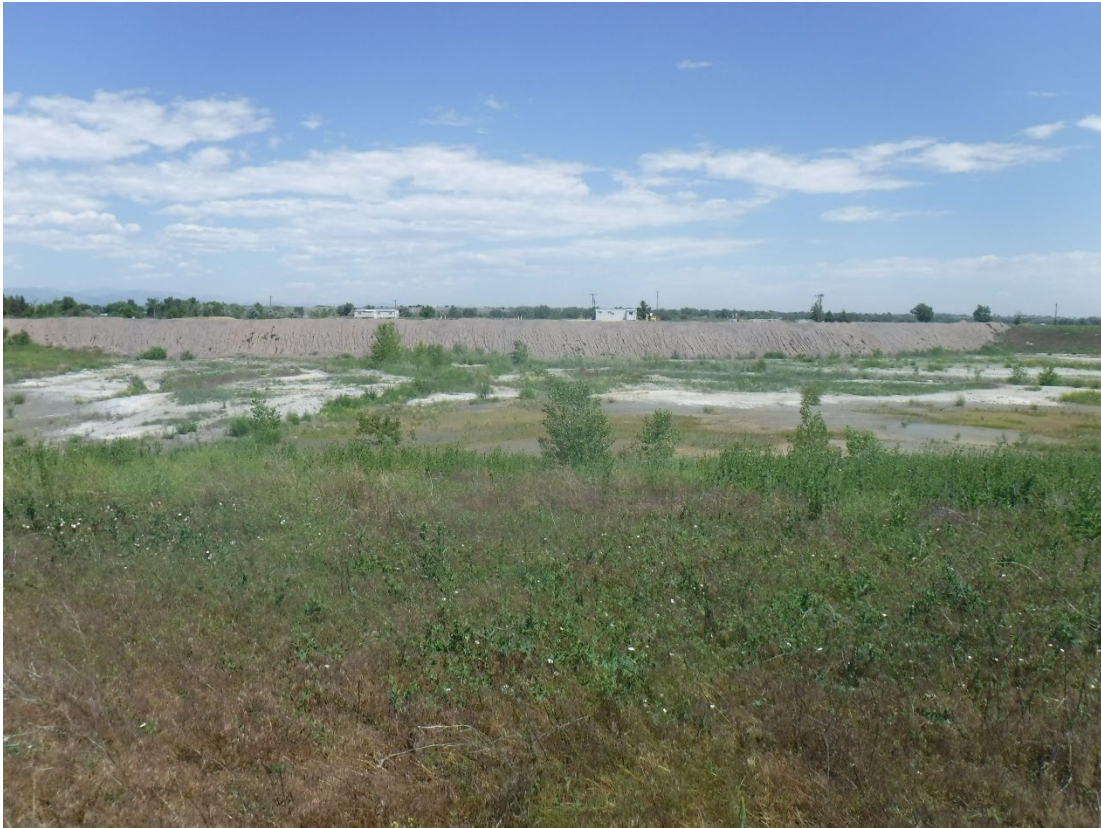
**Photo 7:** The advancing backfilling face of CW5

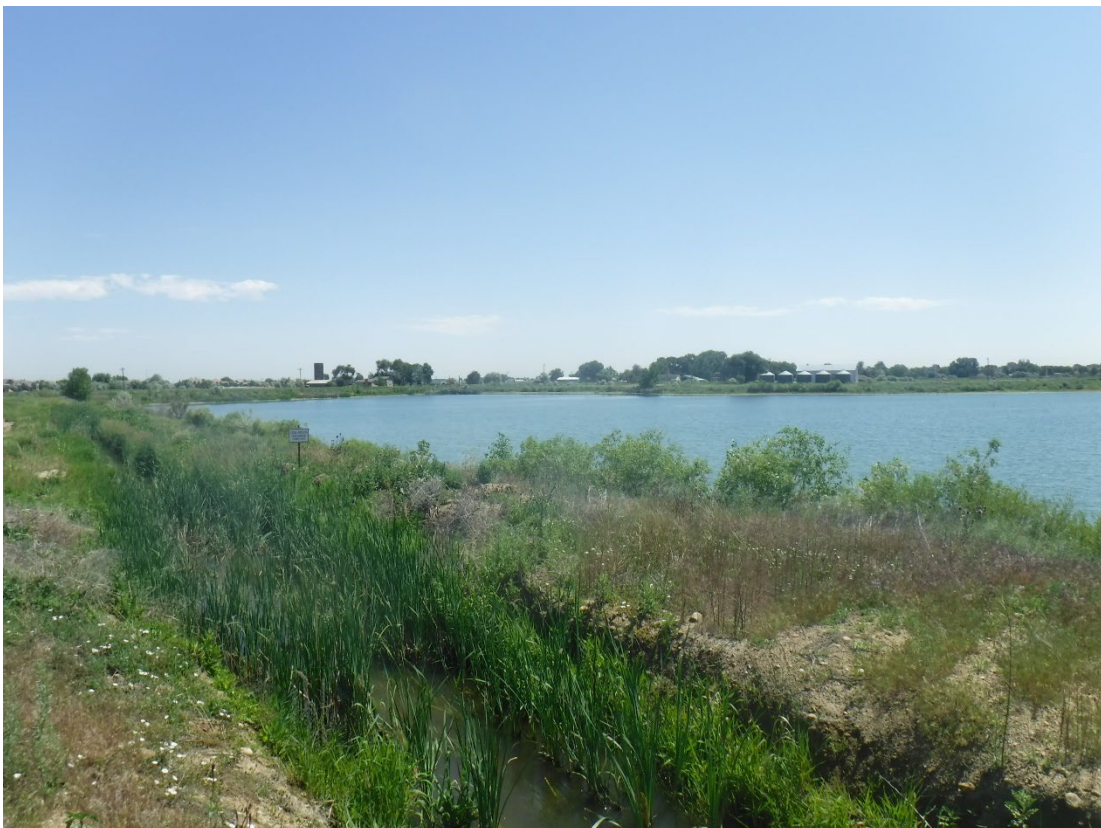
**Photo 8:** Reclaimed CW4 area

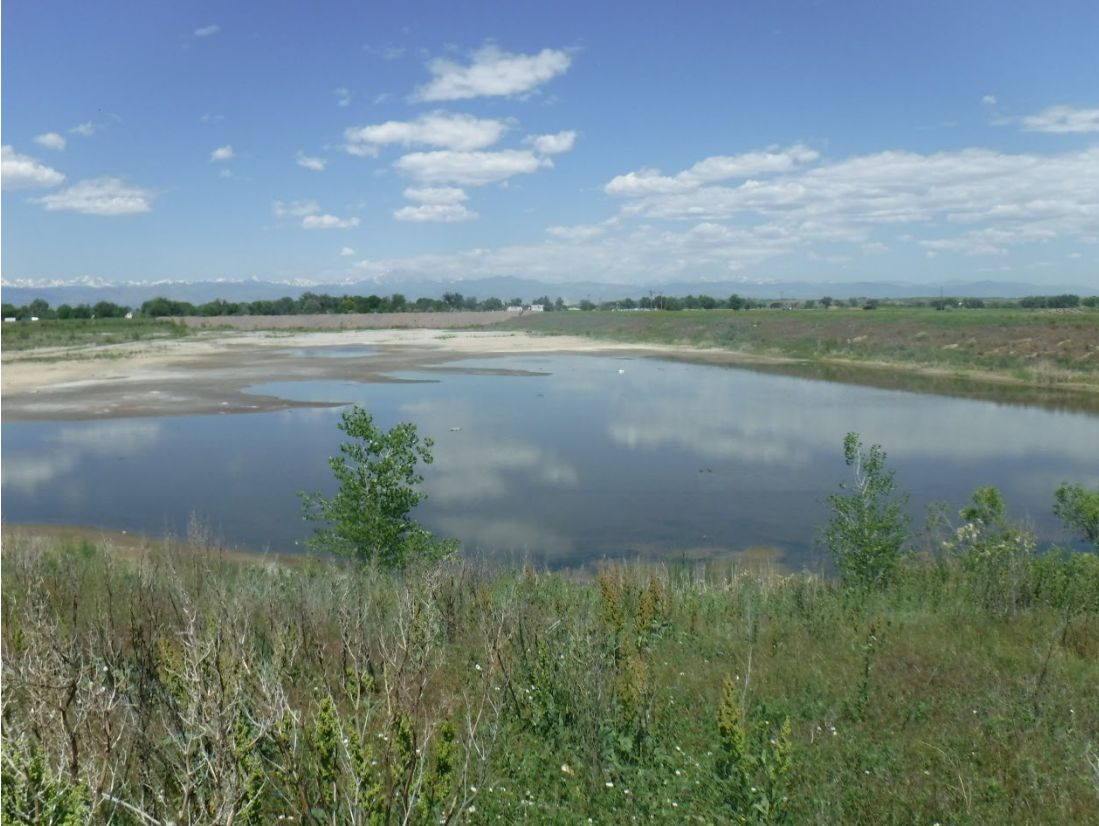
**Photo 9:** Looking west across the CW5 area

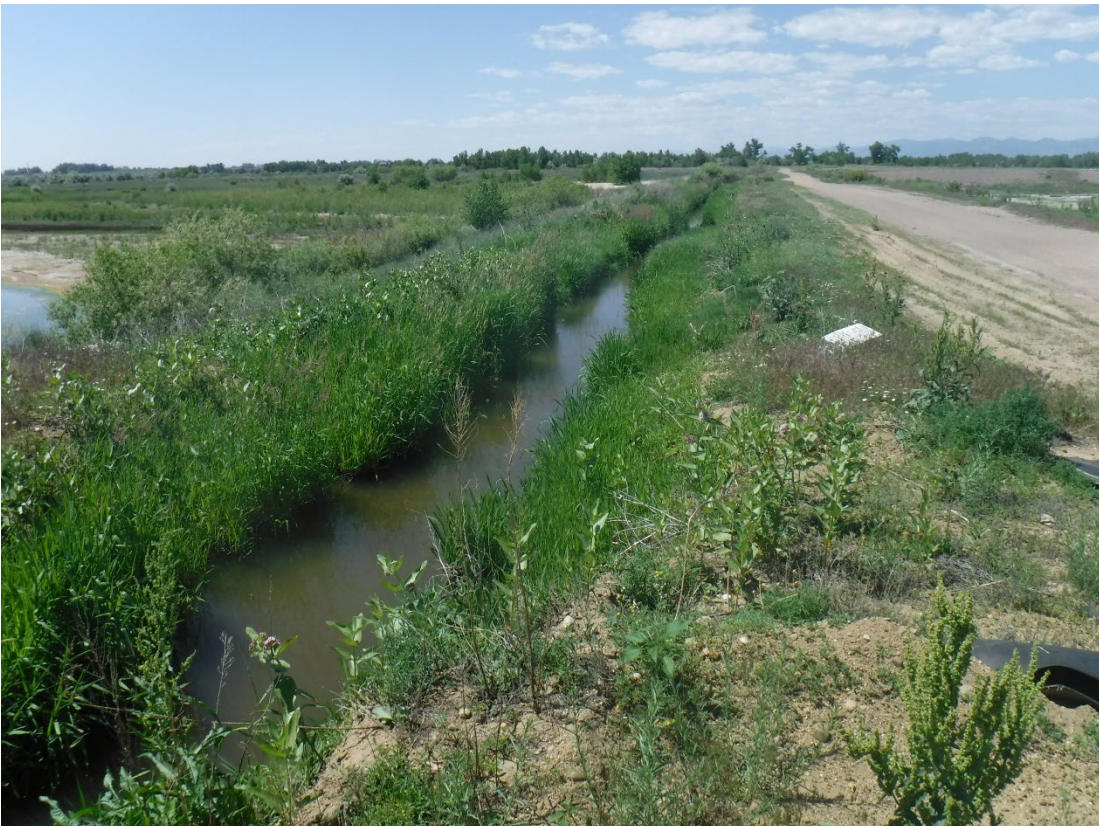
**Photo 10:** Irrigation ditch crossing through the site
