MINERALS PROGRAM INSPECTION REPORT
PHONE: (303) 866-3567

MINE NAME: Climax Mine	MINE/PROSPECTING ID#: M-1977-493	MINERAL: Molybdenum	COUNTY: Lake
INSPECTION TYPE: Monitoring	WEATHER: Clear	INSP. DATE: June 9, 2025	INSP. TIME: 10:00
OPERATOR: Climax Molybdenum Company, Climax Mine	OPERATOR REPRESENTATIVE: Alex Ungers and Paul Weber	TYPE OF OPERATION: 112d-3 - Designated Mining Operation	
REASON FOR INSPECTION: Normal I&E Program	BOND CALCULATION TYPE: None	BOND AMOUNT: \$284,783,656.00	
DATE OF COMPLAINT: NA	POST INSP. CONTACTS: DRMS	JOINT INSP. AGENCY: None	
INSPECTOR(S): Amy Yeldell	INSPECTOR'S SIGNATURE:

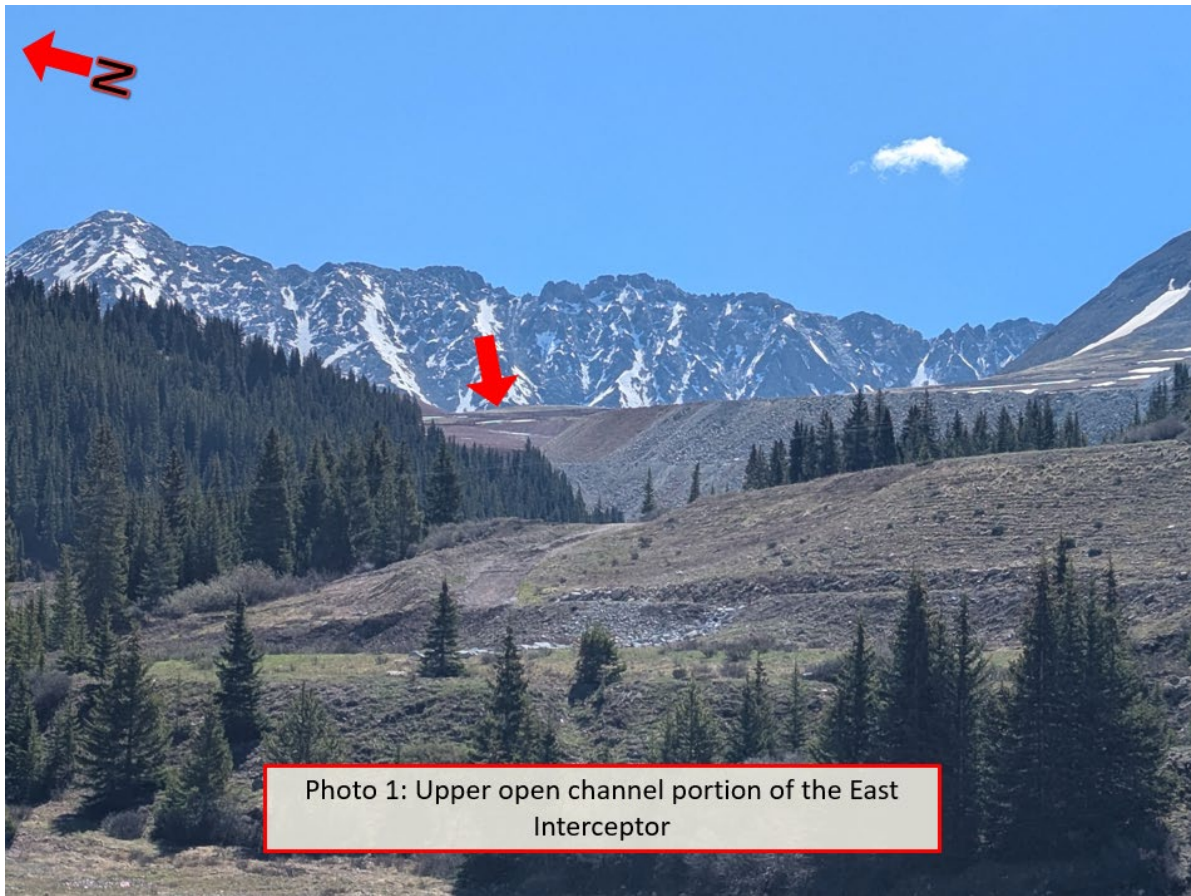
The East Interceptor begins at the McNulty OSF. The East Interceptor flows from the south to the north. It recently has been extended to wrap around the back side (northeast) of the OSF. The Division was unable to access the upper portion of the East Interceptor due to snow cover (Photo One). The newly constructed portion above McNulty OSF is open channel. The East Interceptor then crosses under Highway 91 on the northwest side of McNulty OSF and then generally runs alongside the highway. It transitions from being open channel to piped when it's on the west side of Highway 91. It is then open channel again near the SDP (Photo Two). The East Interceptor ultimately reports to Clinton Reservoir.

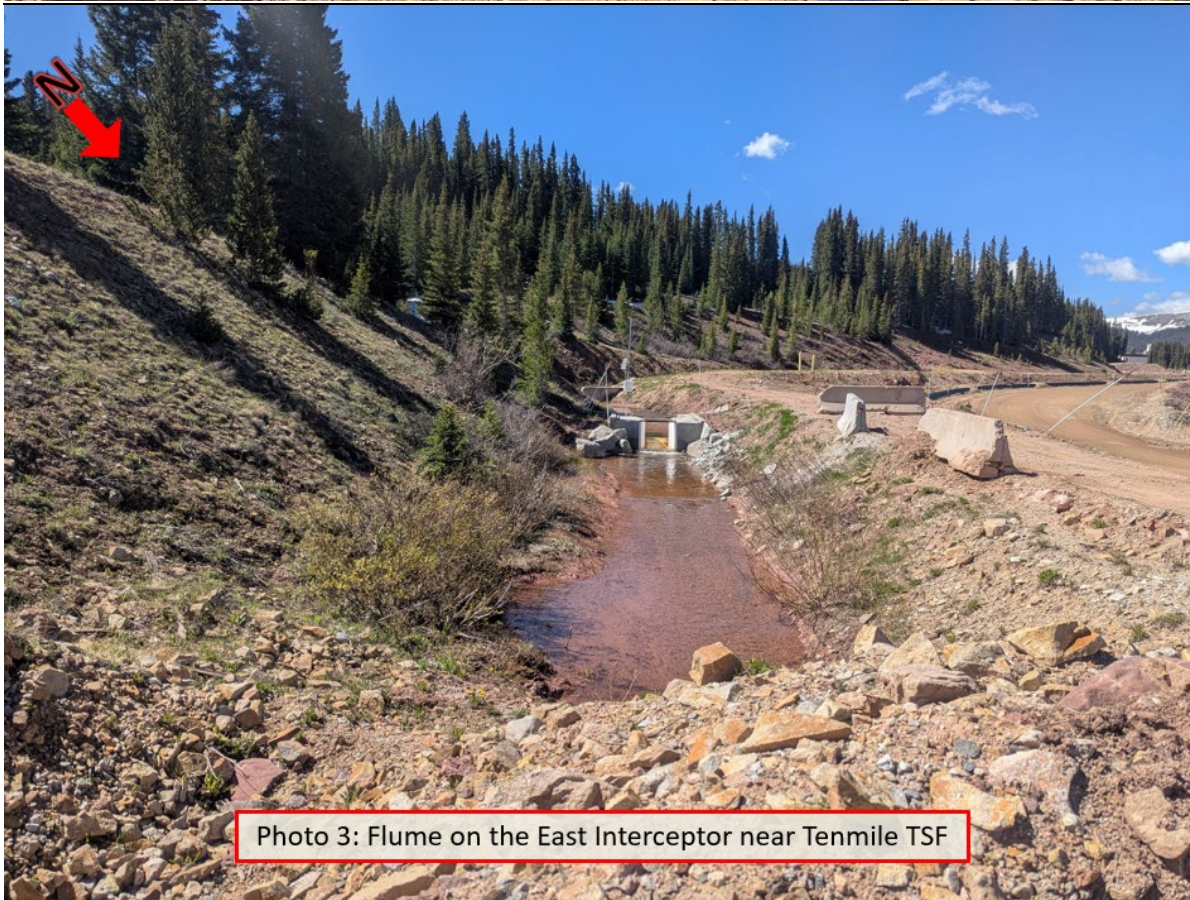
The lower portion of the east interceptor is scheduled to be replaced. Currently it is made of corrugated steel pipe which is deteriorating. It will be replaced with HDPE. Open portions of the East Interceptor appeared to be clean with no signs of sedimentation. All flumes and culverts observed were free of obstructions (Photo Three).

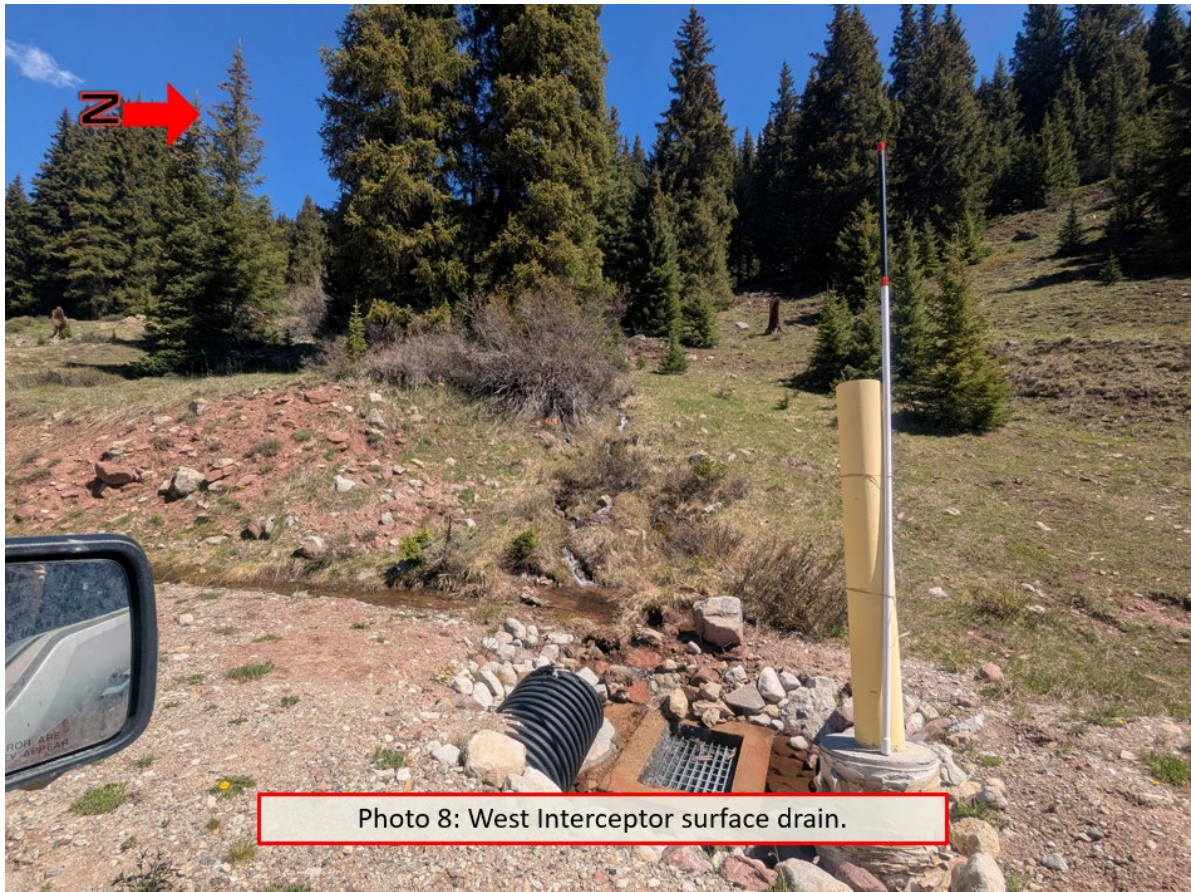
After Searle Gulch the West Interceptor resumes being piped with periodic surface drains to add additional surface flows (Photo Eight). Tucker Creek is that last major water input source prior to the West Interceptor going to the mixing zone. At the confluence Tucker Creek is the right and West Interceptor is the left side (Photo Nine).

Photo 8: West Interceptor surface drain.

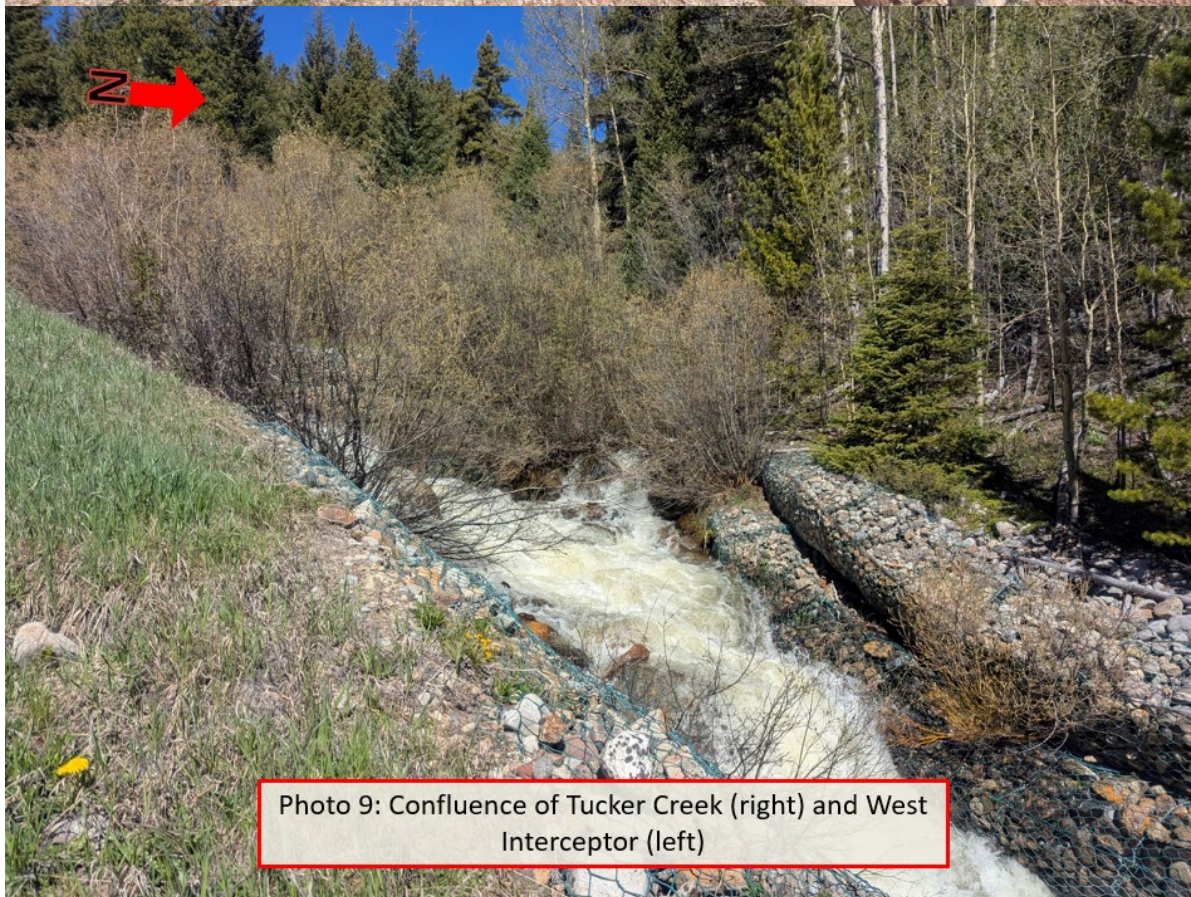
Photo 9: Confluence of Tucker Creek (right) and West Interceptor (left)

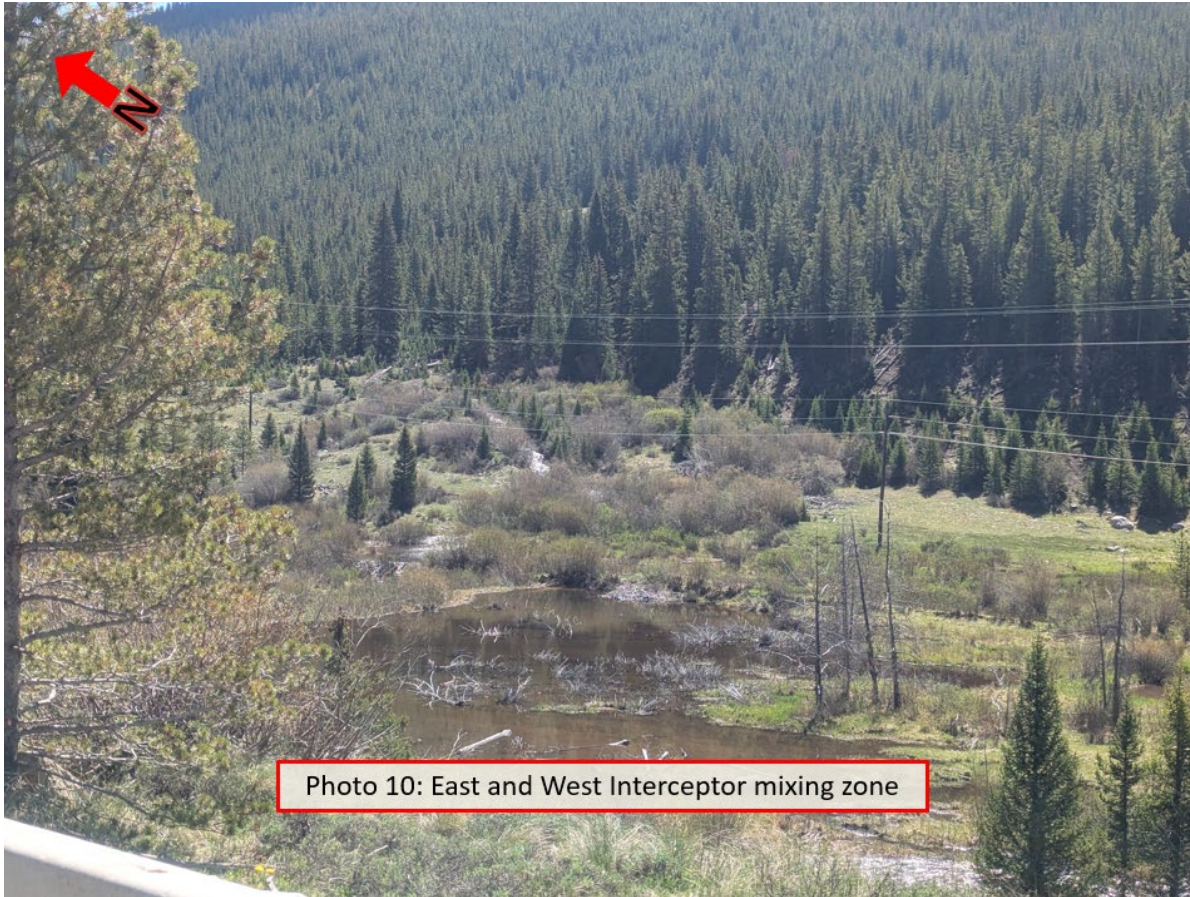
The East and West interceptors converge at the Mixing zone which is just before Property Line Flume (outfall 001A) (Photo Ten).

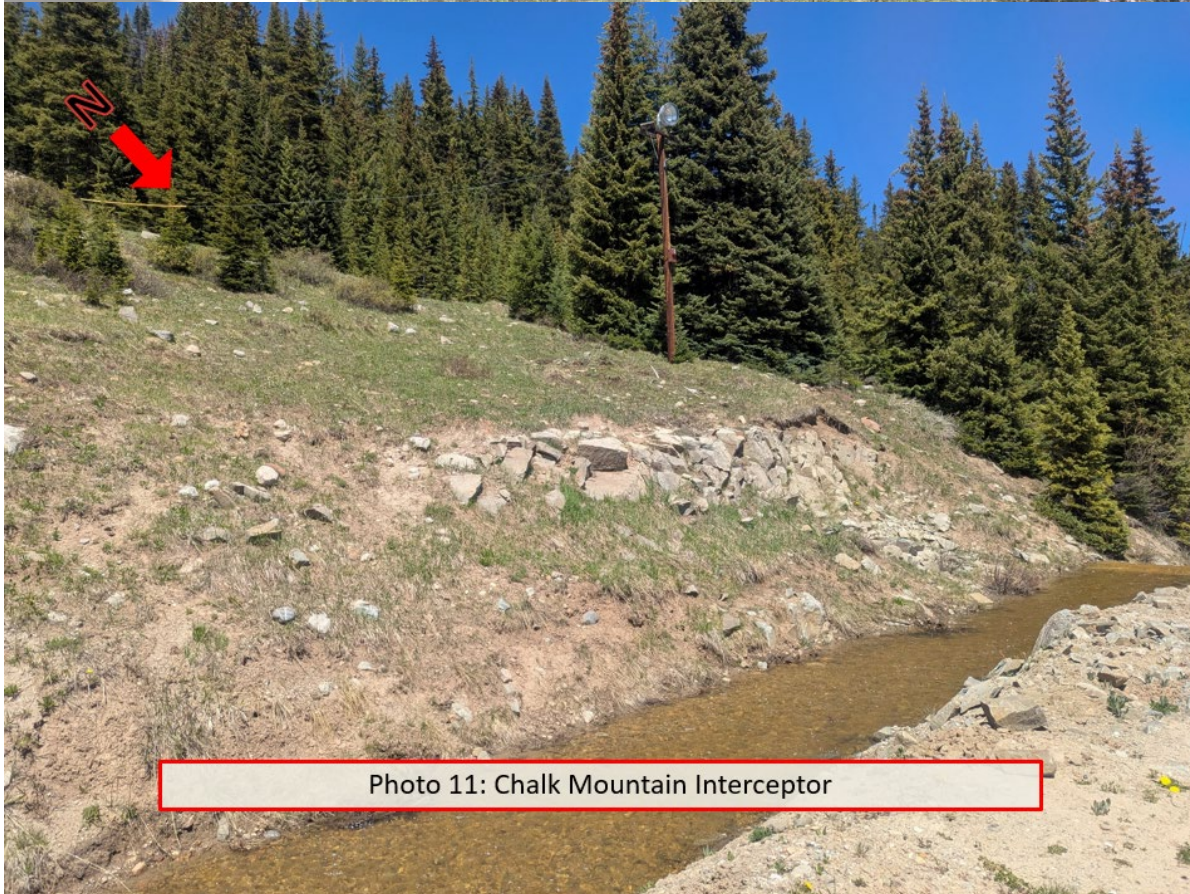
The Chalk Mountain interceptor is located on the south side of the mine and consists of an open channel (Photo Eleven). It begins near the top of Fremont Pass on the west side of Highway 91 flowing north. Near Buffers Lake it begins to part from the highway and flows from east to west. Chalk Mt interceptor then discharges into the East Fork of the Eagle River. Water observed was clean with no visible sedimentation. No obstructions were observed in the Chalk Mountain Interceptor.
