**MINERALS PROGRAM INSPECTION REPORT**  
**PHONE: (303) 866-3567**

<b>MINE NAME:</b> Dick Casey Concr Pit	<b>MINE/PROSPECTING ID#:</b> M-1978-349	<b>MINERAL:</b> Sand and gravel	<b>COUNTY:</b> Garfield
<b>INSPECTION TYPE:</b> Monitoring	<b>WEATHER:</b> Clear	<b>INSP. DATE:</b> May 27, 2025	<b>INSP. TIME:</b> 08:30
<b>OPERATOR:</b> Oldcastle SW Group, Inc. dba United Compas County	<b>OPERATOR REPRESENTATIVE:</b> Jesse Farmer	<b>TYPE OF OPERATION:</b> 112c - Construction Regular Operation	
<b>REASON FOR INSPECTION:</b> Normal I&E Program	<b>BOND CALCULATION TYPE:</b>	<b>BOND AMOUNT:</b> \$515,991.00	
<b>DATE OF COMPLAINT:</b> NA	<b>POST INSP. CONTACTS:</b> None	<b>JOINT INSP. AGENCY:</b> None	
<b>INSPECTOR(S):</b> Todd Jesse	<b>INSPECTOR'S SIGNATURE:</b>

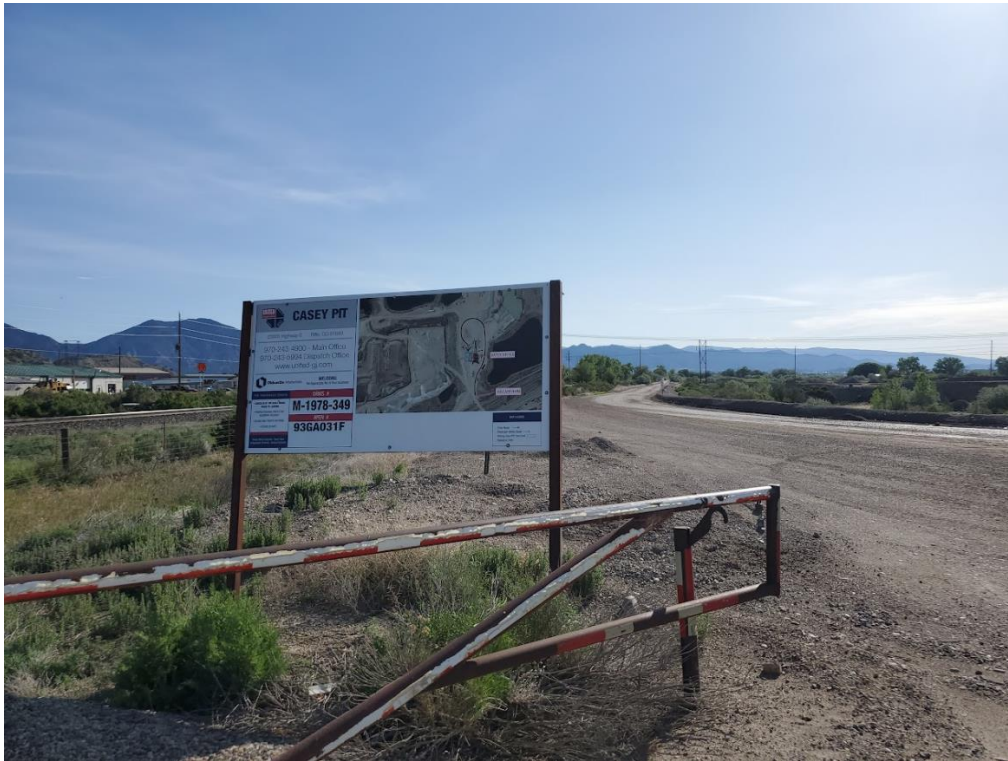
The mine identification sign and boundary markers are in place and in compliance with Rule 3.1.12. The sign is posted by the entrance to site. The permit boundary is marked with fence line and posts that are easily identifiable as well as earthen berms

Photo 1: View to the east of proper mine ID signage at entrance to the site. Boundary fence can be seen in the background.
