TRAPPER MINING INC.
CRAIG, COLORADO

HORSE GULCH FILL
QUARTERLY FILL CERTIFICATION

Horse Gulch Fill Quarterly Inspection Report

Second Quarter 2025

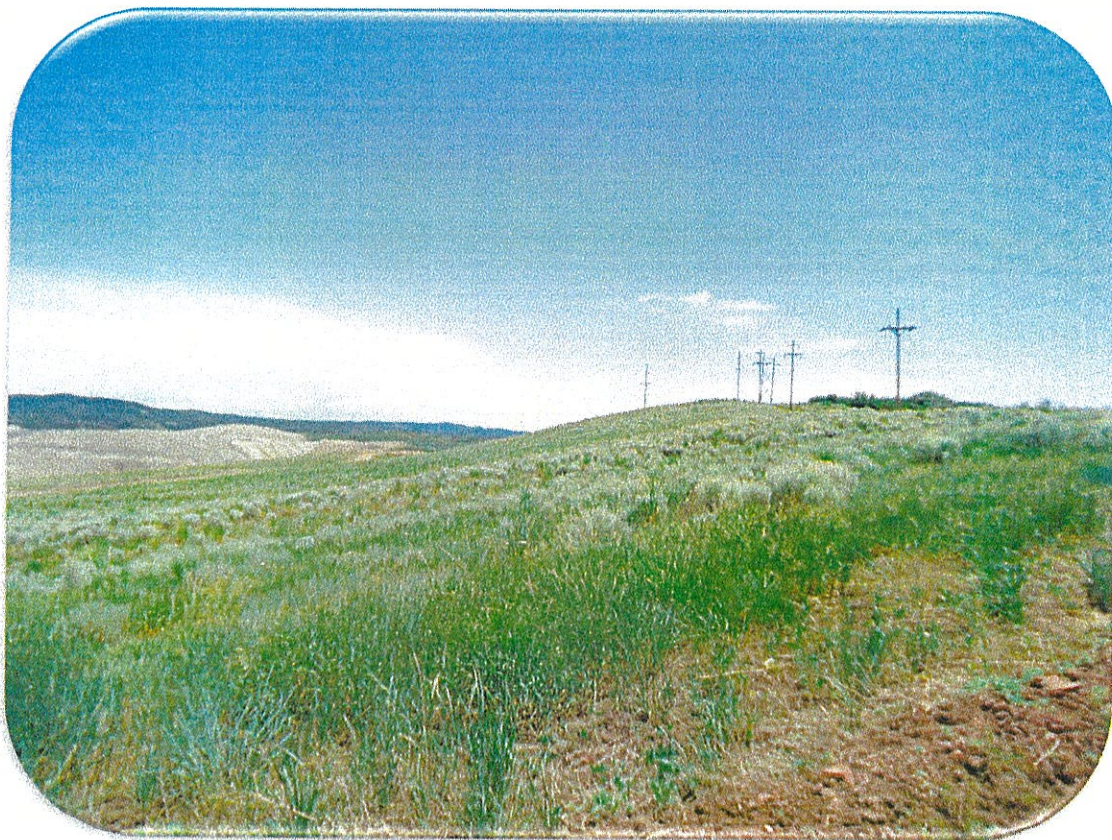
No appearances of instability, structural weakness, or other hazardous conditions were observed. Both the southeast side of the fill and the northeast side of the fill were inspected this quarter (Photographs 1 and 2). The area where cracks were detected on the top south portion of the dump during the first quarter of 2013 inspection was checked. There was no additional cracking found.

Photograph 1: North-east Side Looking South (6/17/2025)

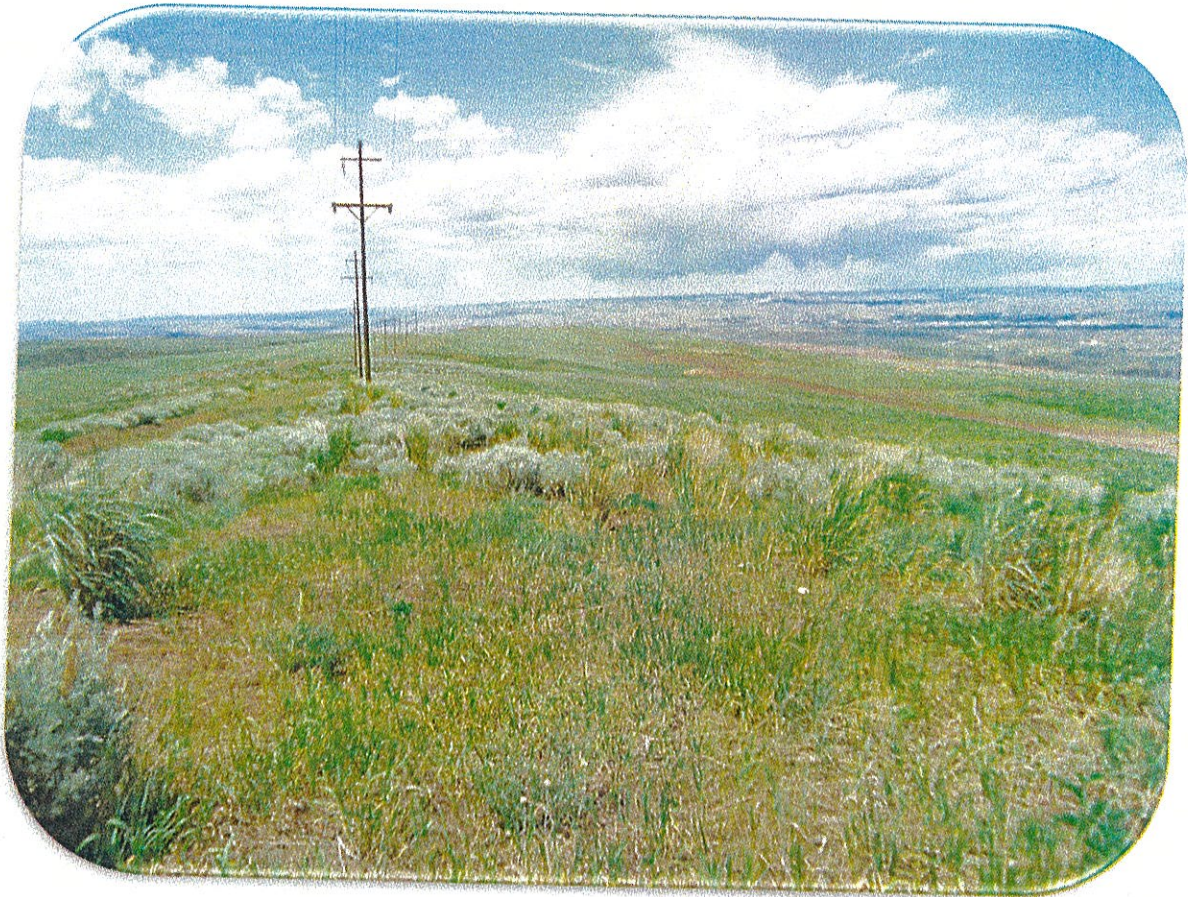
Photograph 2: South Side Looking North (6/17/2025)

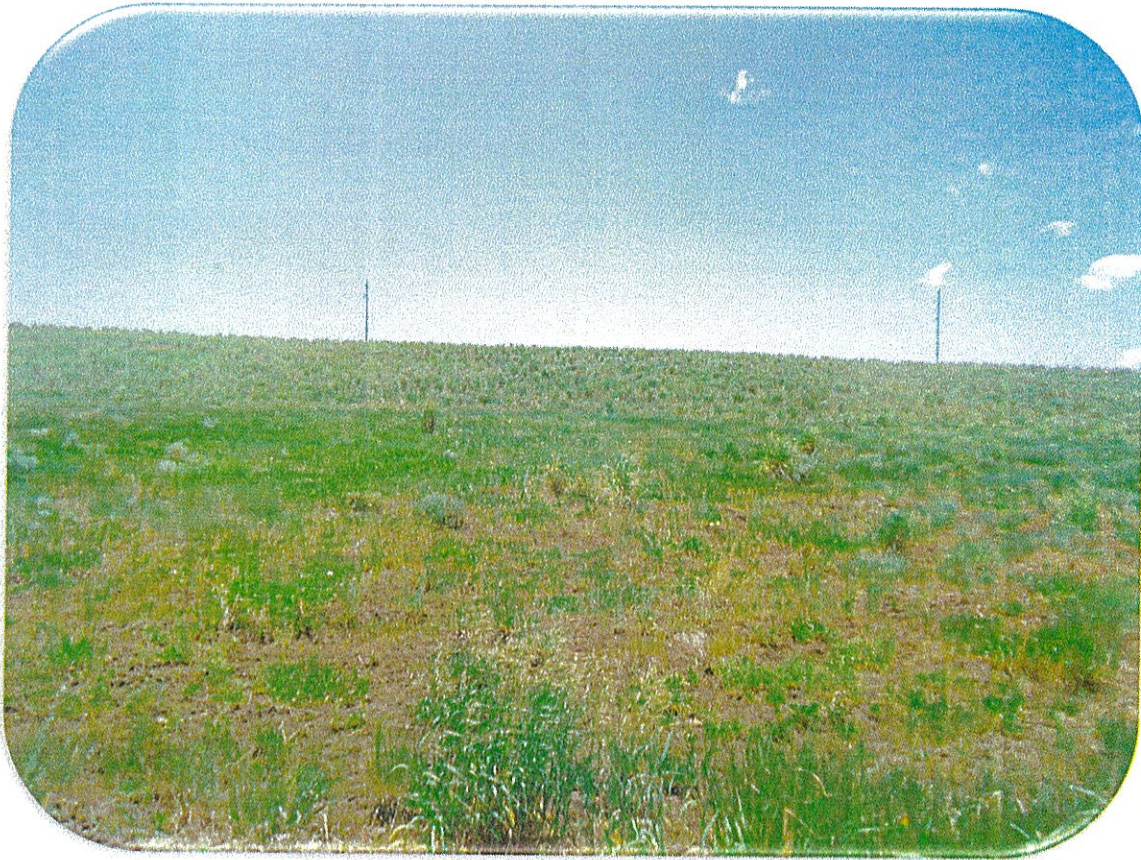
Photograph 3 depicts the east facing slope of the fill.

Photograph 3: East Side of the Fill Looking North-west (6/17/2025)
