Keenesburg Mine inspection report

Permit Number: C-1981-028 Mine Name: Keenesburg Strip Mine Operator: Coors Energy Company Operator Address: Mr. Ben Moline	County: Weld Operation Type: Surface Permit Status: Permanent Cessation Ownership: Private			
P.O. Box 4030	Operator Representative Present:			
Golden, CO 80402	operator representative resents			
Golden, CO 80402	None			
Operator Representative Signature: (Field Issuance Only)

Inspection Start Date: June 20, 2025 Inspection Start Time: 08:00 Inspection End Date: June 20, 2025 Inspection End Time: 09:00			Inspection Type: Coal Partial Inspection Inspection Reason: Normal I&E Program Weather: Clear	
Joint Inspection Agency:		Joint Inspection Contacts:		
None				
Post Inspection Agency:		Post Inspection Contacts:		
None				
Inspector(s):	Inspector's Signature: Sign		Signature Date:	
Robert Zuber, P.E.	Phot D. The			
				6/20/2025

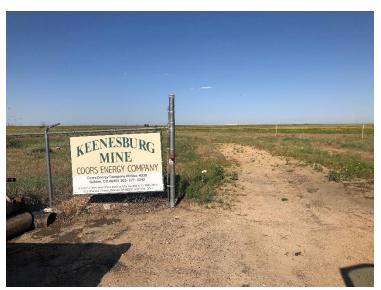
The entrance sign was in place and contained the necessary information. Boundary markers were observed on the east, south, and north sides of the site.

Entrance sign

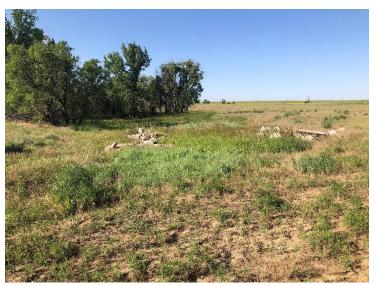
Sediment Pond 2 and the Dugout Pond contained no visible water; both ponds have large amounts of vegetation on their bottoms. Neither was discharging during the inspection, and there were no signs that the ponds had discharged recently. No problems were observed.

Spillway of the Dugout Pond

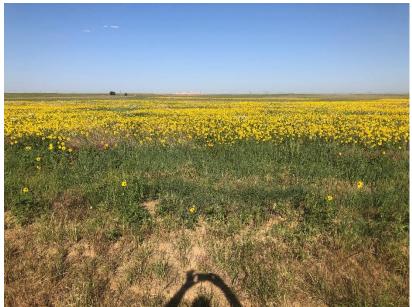
Sunflowers were prevalent in some areas (Areas 25 and 34), and Indian ricegrass (Achnatherum hymenoides, aka Oryzopsis hymenoides) was prevalent in other areas (Areas 36 and 38, and the reclaimed road south of Area 25). Area 37 contained large amounts of both of these species. Indian ricegrass is in the seed mix for this permit.

Sunflowers in Area 25

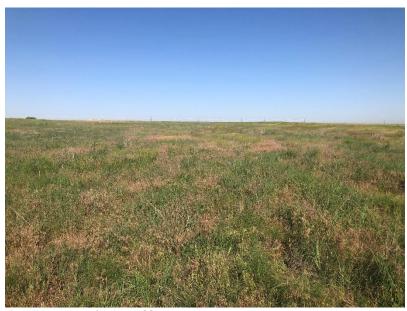
Excellent cover in Area 33

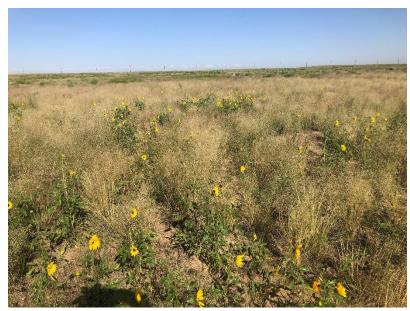
Sunflowers and Indian ricegrass in Area 37

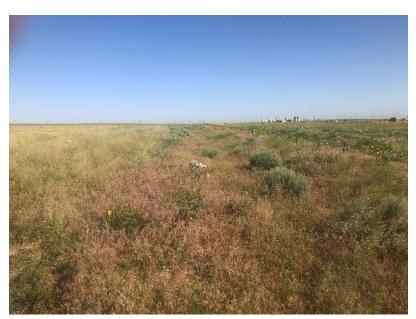
The ditch along the northern border of the site, which drains to Sediment Pond 2, was functioning.

North boundary, looking northwest
