MINERALS PROGRAM INSPECTION REPORT
PHONE: (303) 866-3567

MINE NAME: Red Rock Pit	MINE/PROSPECTING ID#: M-1978-315	MINERAL: Sand and gravel	COUNTY: Routt
INSPECTION TYPE: Monitoring	WEATHER: Clear	INSP. DATE: May 14, 2025	INSP. TIME: 09:30
OPERATOR: Peabody Williams Fork Mining, LLC	OPERATOR REPRESENTATIVE: Mike Howard	TYPE OF OPERATION: 112c - Construction Regular Operation	
REASON FOR INSPECTION: Normal I&E Program	BOND CALCULATION TYPE: Complete Bond	BOND AMOUNT: \$37,143.00	
DATE OF COMPLAINT: NA	POST INSP. CONTACTS: None	JOINT INSP. AGENCY: None	
INSPECTOR(S): Brock Bowles	INSPECTOR'S SIGNATURE:

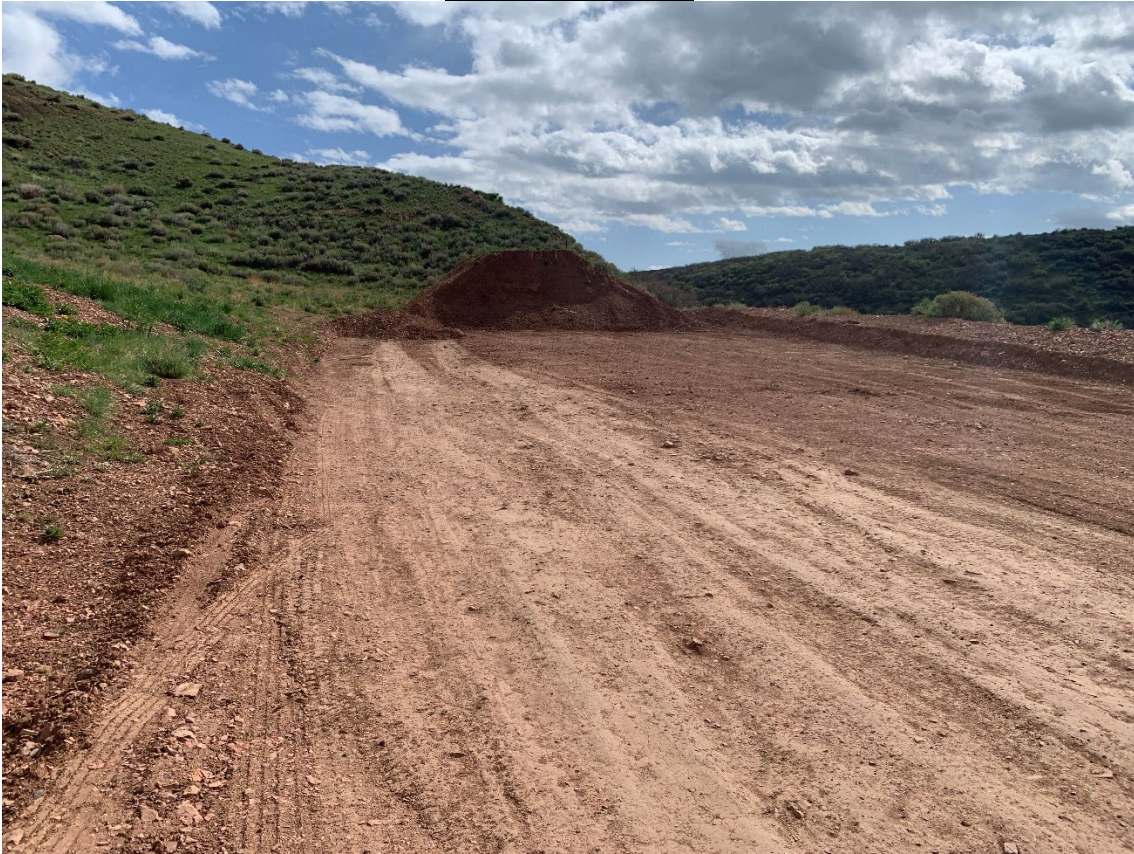
The mining operation is along the west side of CR 53 and approximately 6 acres are currently disturbed. Overburden material and large rocks are placed on the west side of the mined area, against the hillside. A stockpile is located on the northern end of the mined area and is approximately 20 feet high, 60 feet wide and 80 feet long (photo 1).

Photo 1 – Stockpile on north end of pit area. Photo facing north with CR 53 is on right side below the berm

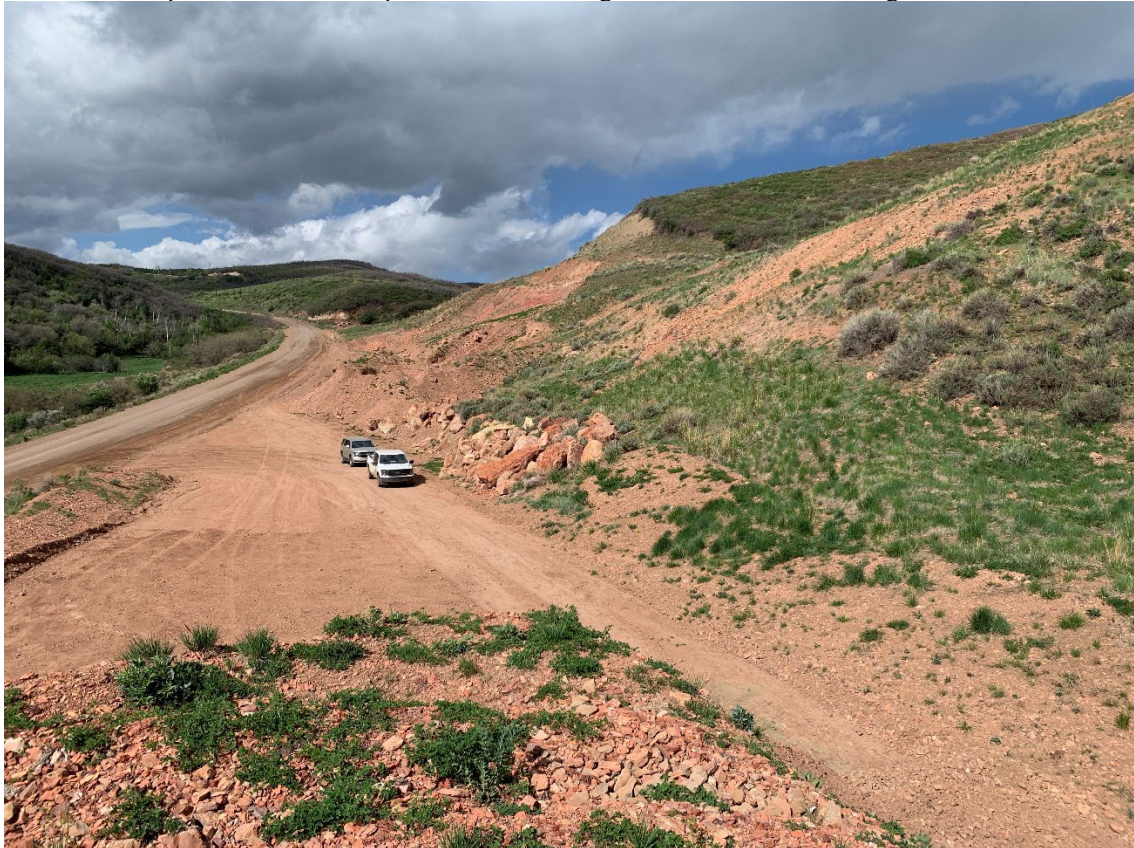
The hillside slopes on the west side of the excavated area are sloped between 1h:1v and 2h:1v as approved in the permit application (photo 2). They appear to be stable at this time.

Photo 2 – Mined area looking south. CR 53 on left.

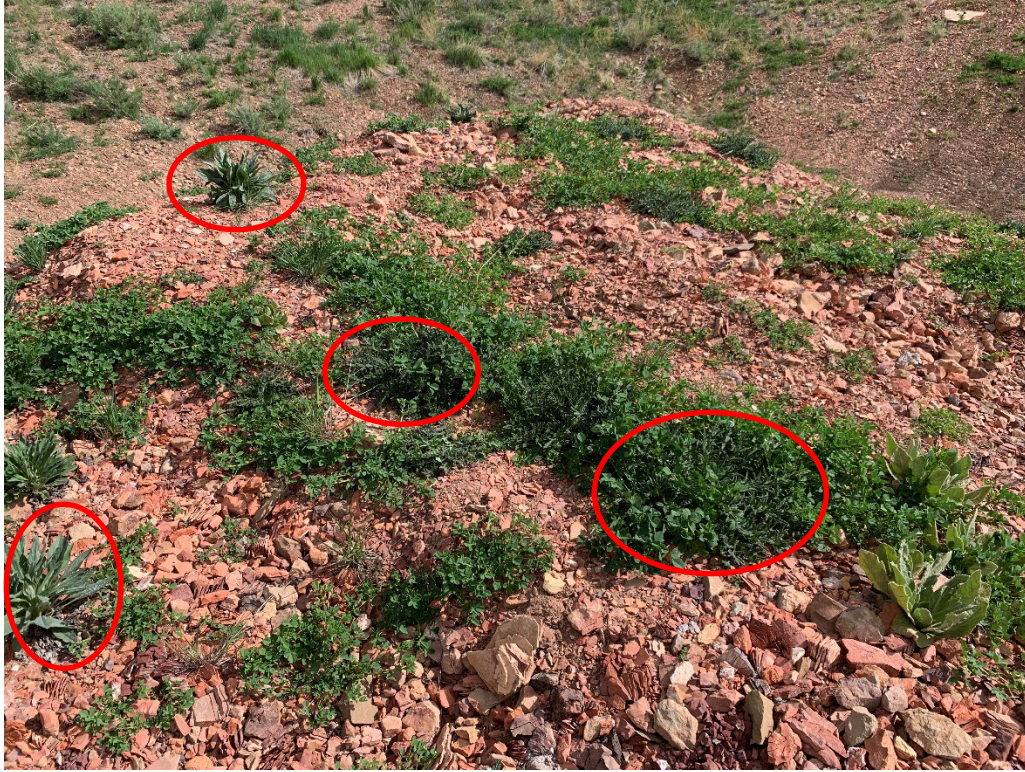
Several houndstongue and bull thistle plants were seen on and around the stockpile and need to be treated (photo 3).

Photo 3- Houndstongue and thistle plants on stockpile.
