**MINERALS PROGRAM INSPECTION REPORT**  
**PHONE: (303) 866-3567**

<b>MINE NAME:</b> Cresson Project	<b>MINE/PROSPECTING ID#:</b> M-1980-244	<b>MINERAL:</b> Gold and silver	<b>COUNTY:</b> Teller
<b>INSPECTION TYPE:</b> Monitoring	<b>WEATHER:</b> Windy	<b>INSP. DATE:</b> May 19, 2025	<b>INSP. TIME:</b> 09:00
<b>OPERATOR:</b> Cripple Creek & Victor Gold Mining Co.	<b>OPERATOR REPRESENTATIVE:</b> Brian Doering, Paulina Barrella	<b>TYPE OF OPERATION:</b> 112d-3 - Designated Mining Operation	
<b>REASON FOR INSPECTION:</b> Normal I&E Program	<b>BOND CALCULATION TYPE:</b> None	<b>BOND AMOUNT:</b> \$319,158,980.00	
<b>DATE OF COMPLAINT:</b> NA	<b>POST INSP. CONTACTS:</b> None	<b>JOINT INSP. AGENCY:</b> None	
<b>INSPECTOR(S):</b> Patrick Lennberg	<b>INSPECTOR'S SIGNATURE:</b>

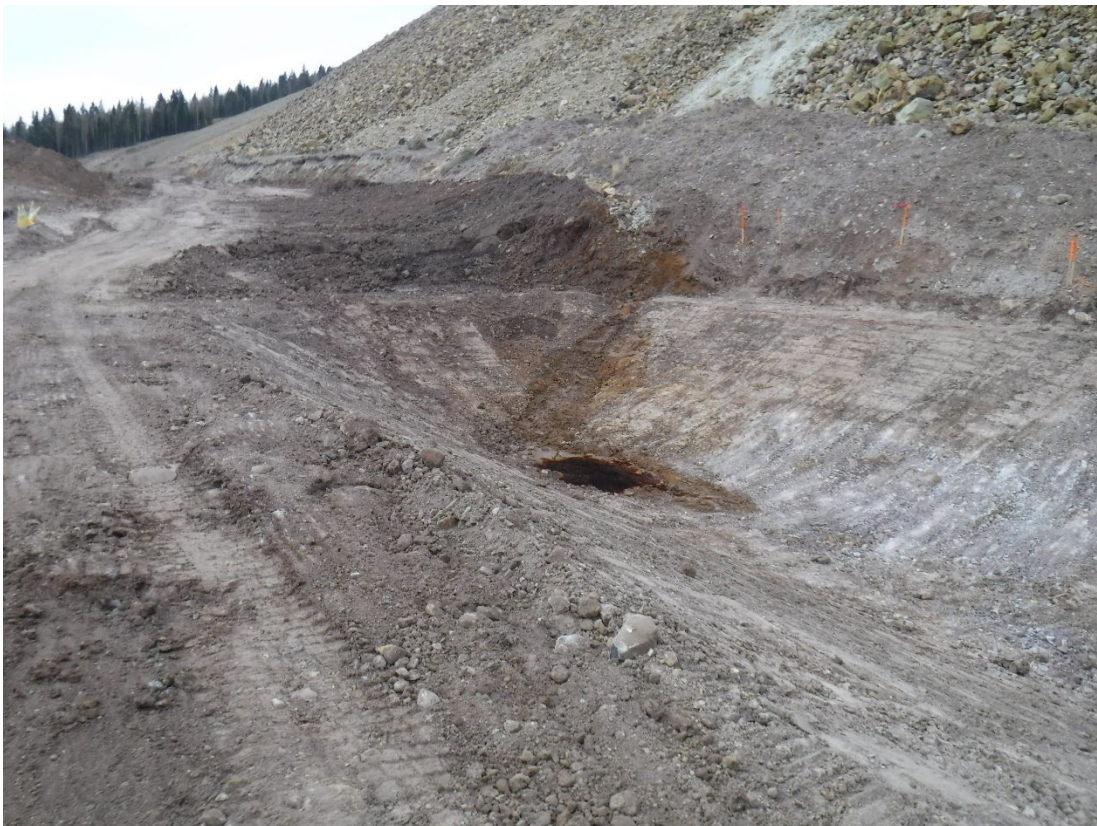
The Division inspected the Grassy Valley Seep collection improvements and basin construction. The Division observed that the basins had been constructed but not yet lined with the geomembrane liner. Lining of the basins and ditches was not scheduled to begin until the beginning of June and work was being done to ensure the subgrade was at the correct elevations. In the Seep 1 collection area, the most southern basin, the collection ditch had been shortened by ~75 feet due to safety concerns for excavation equipment. However, the ditch still extends beyond where the seep area is actively expressing or where there are signs of seepage.

**Photo 1:** Seep 1 basin

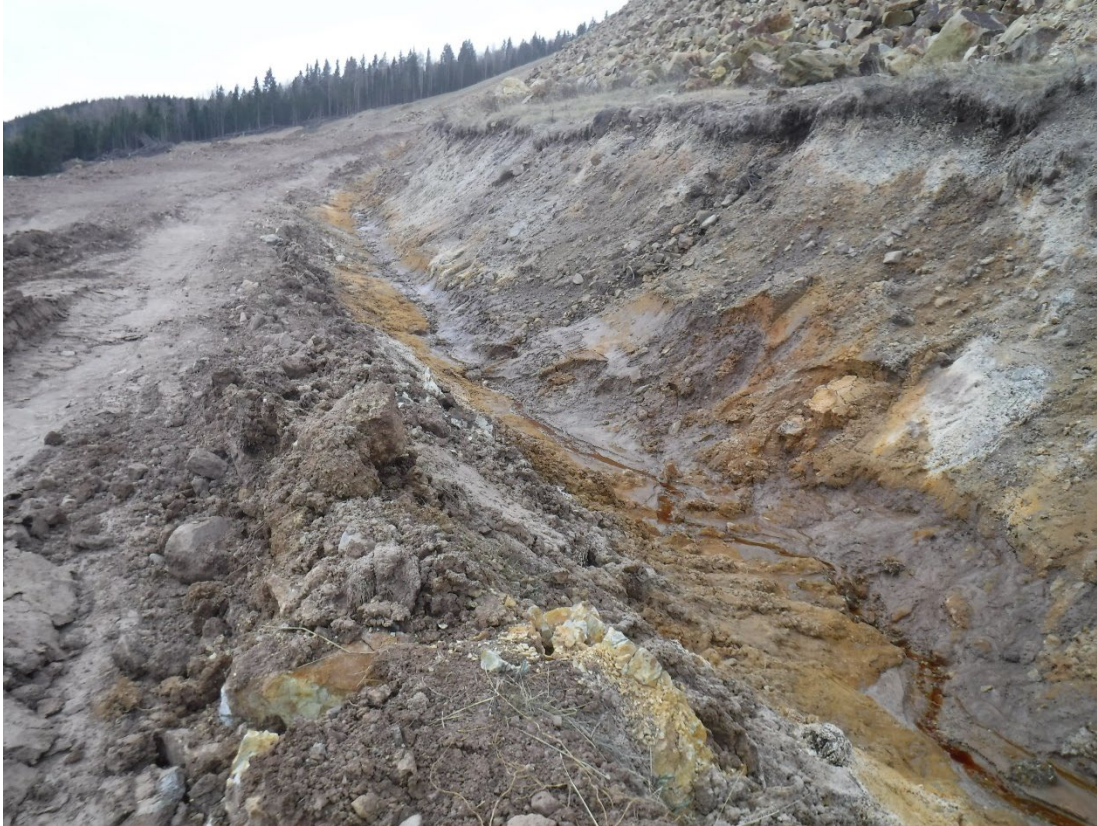
**Photo 2:** Seep 1 water in drainage ditch leading to Seep 1 Basin

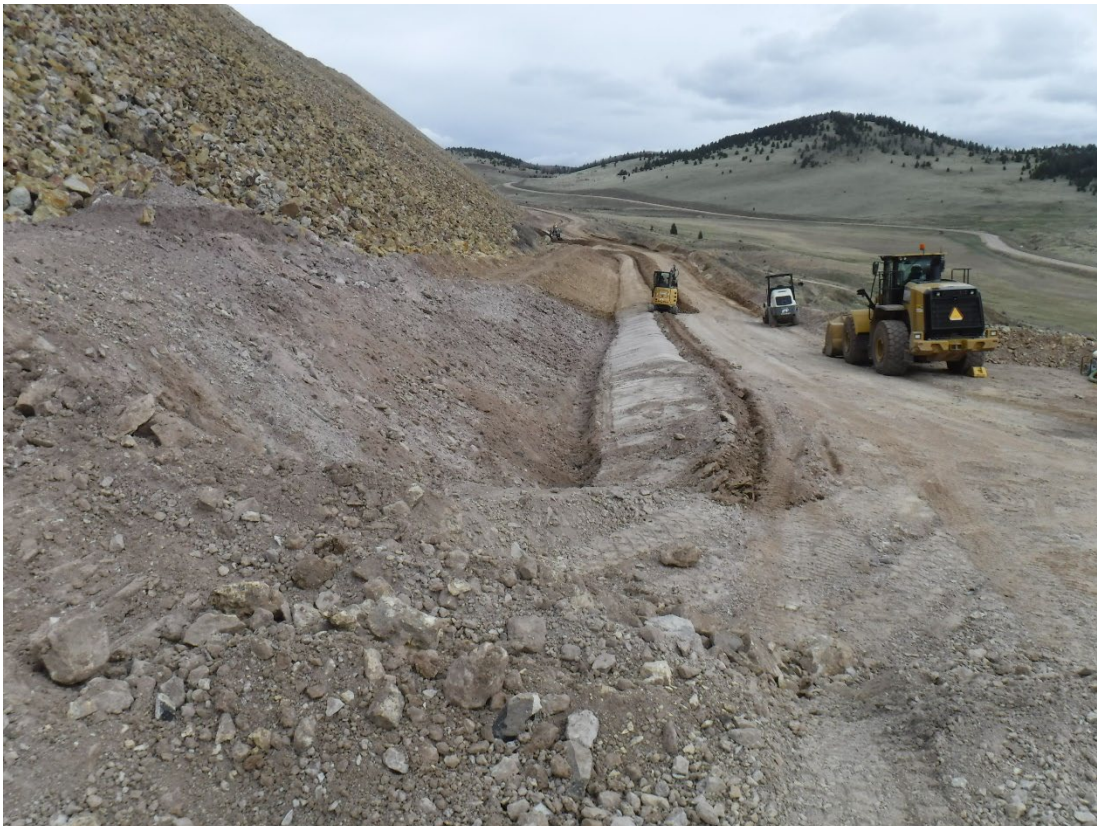
At the Seep 3/4 collection basin they were finish grading the basin and excavating the anchor trench, extending to the south, in preparation for the liner. The collection trench to the north of the basin has been excavated and was collecting seep water from near the area of Seep 3. Seep 3 does not have a collection basin to be constructed but a collection trench will convey seepage to the Seep 3/4 Basin

**Photo 3:** Looking north along the collection trench leading to Basin 3/4

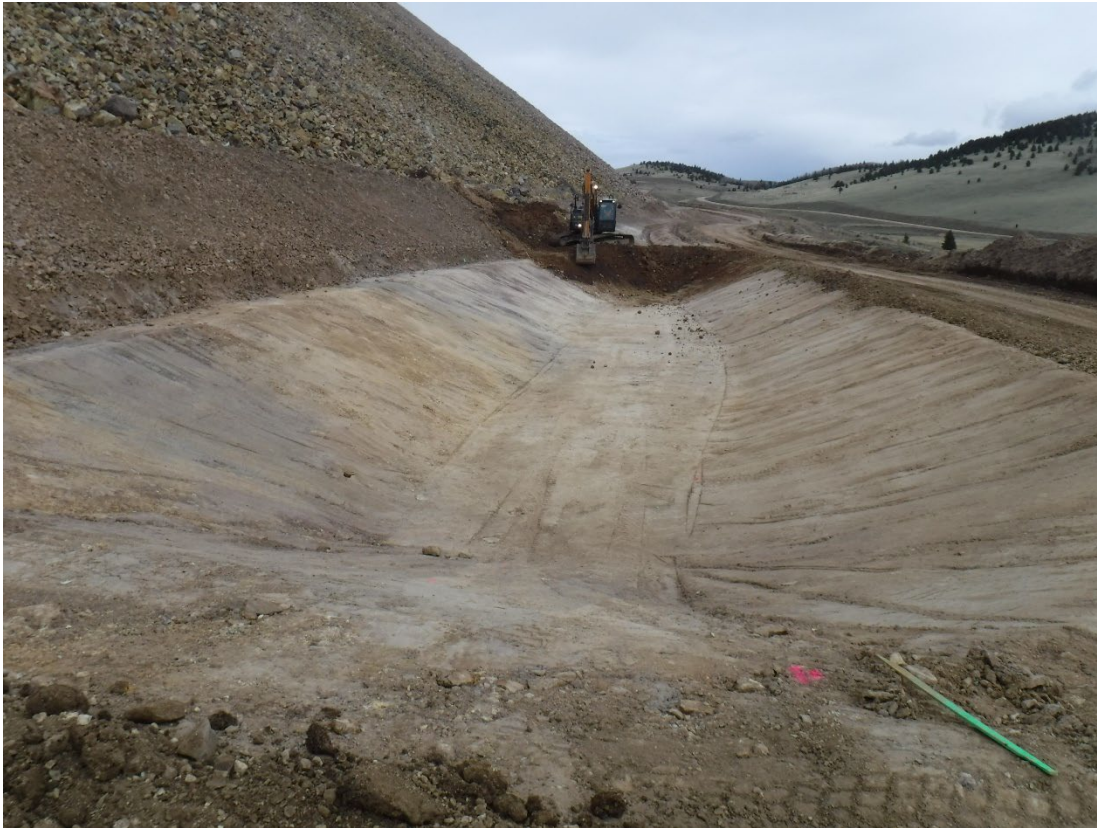
**Photo 4:** Seep collection Basin 3/4

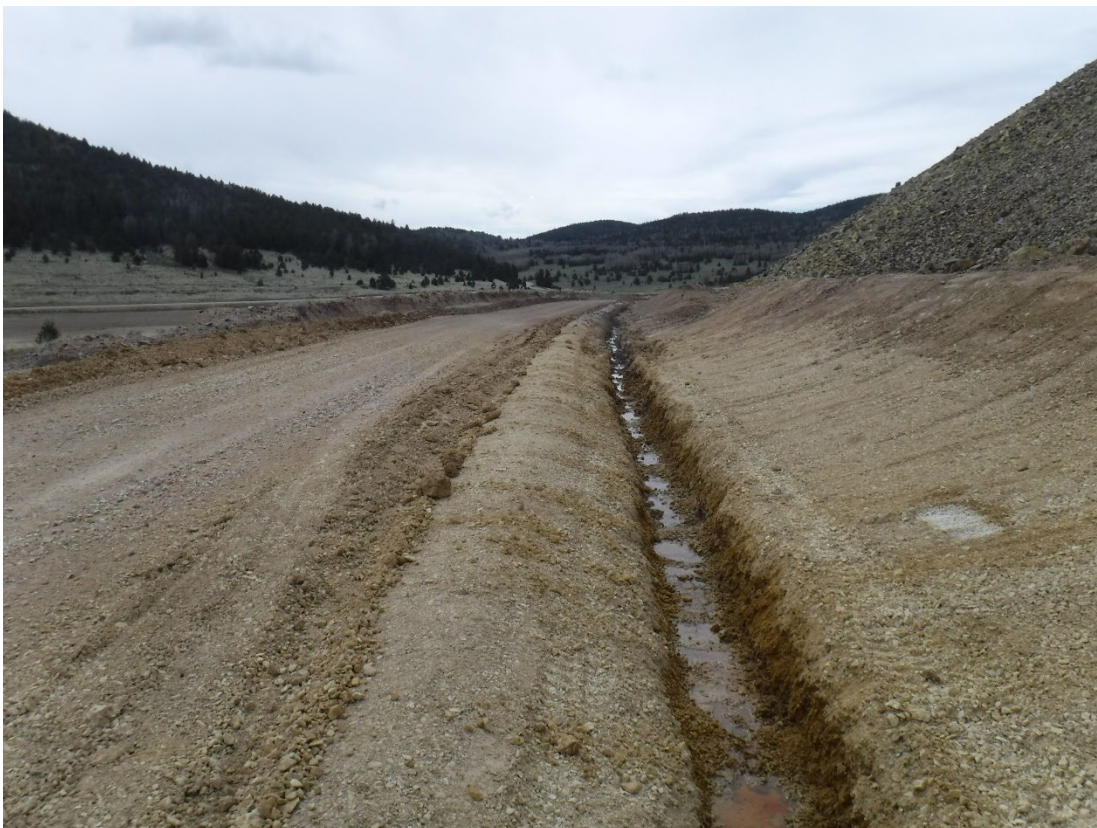
**Photo 5:** Seep collection trench near the Seep 3 area draining to Basin 3/4

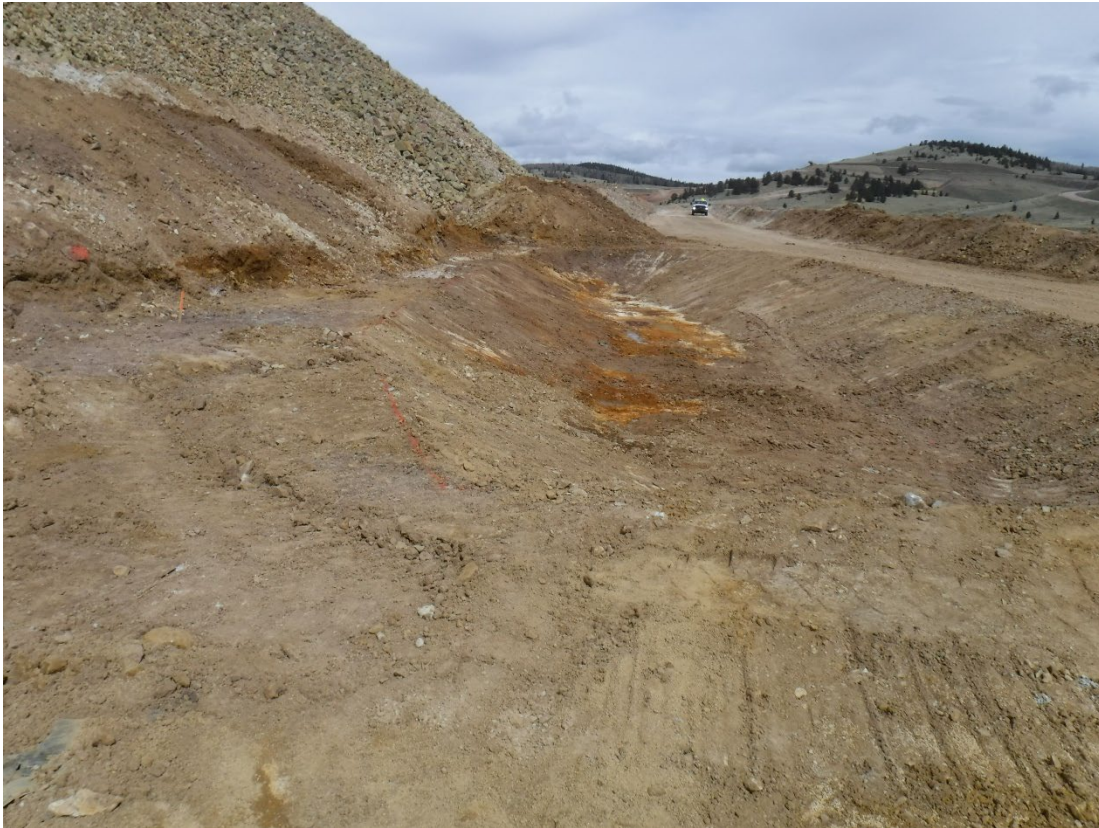
The Seep 2 collection basin was graded and there was seep water that was collecting in the bottom of the basin. In the exposed ECOSA toe there was evidence liner associated with leach facility that was located in the area.

**Photo 6:** Seep Collection Basin 2 for Seep 2

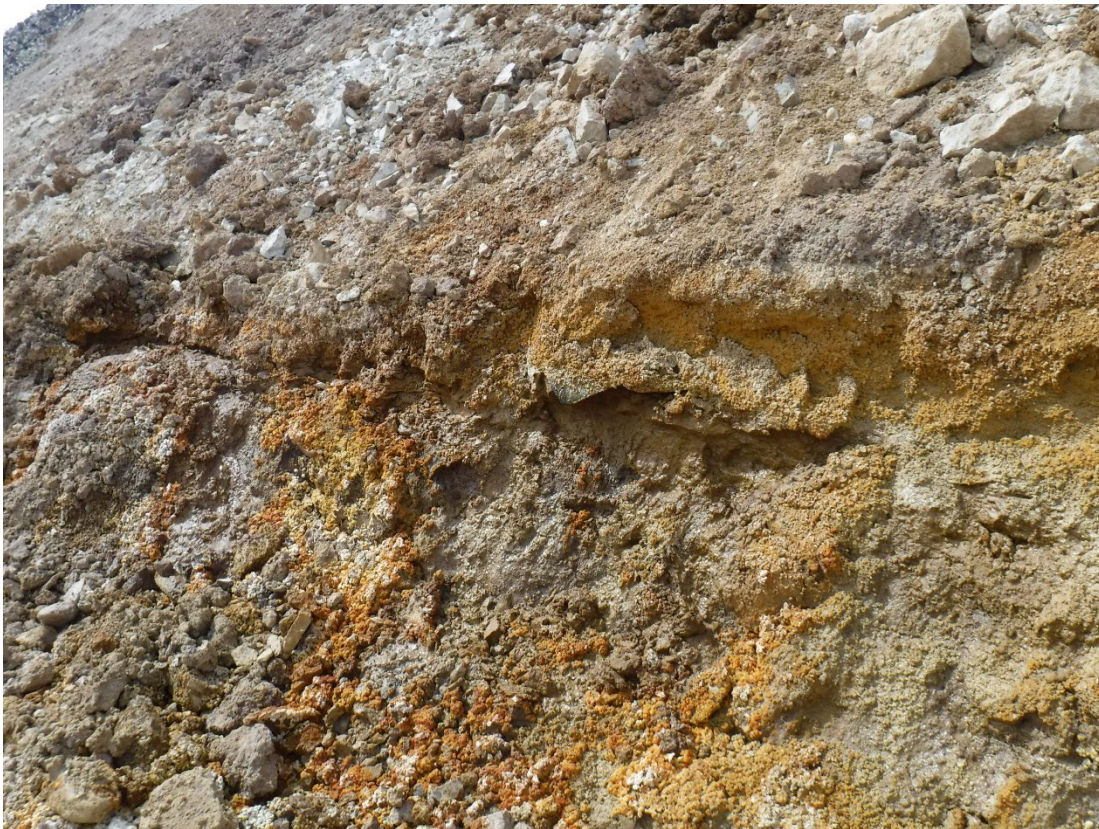
**Photo 7:** Seep 2 from ECOSA

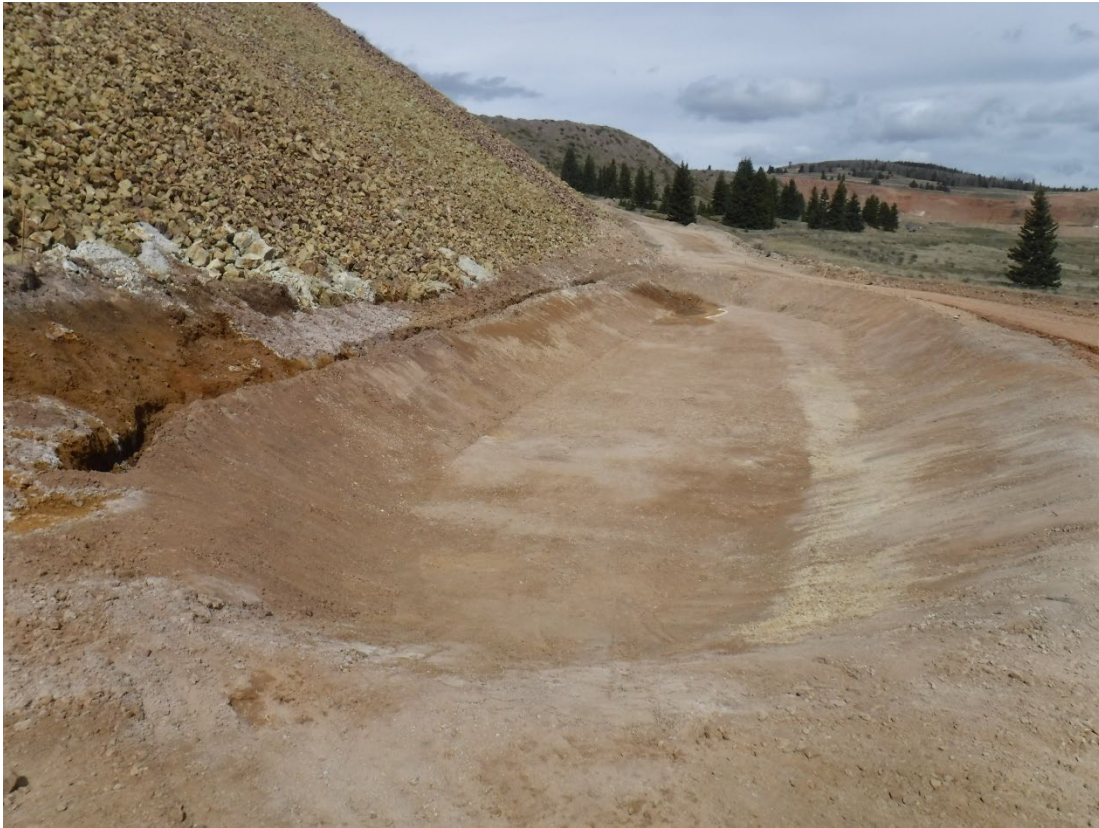
The Seep 5 collection basin, the most northerly basin, had been graded and it too was collecting seep water.

**Photo 8:** Seep Collection Basin 5

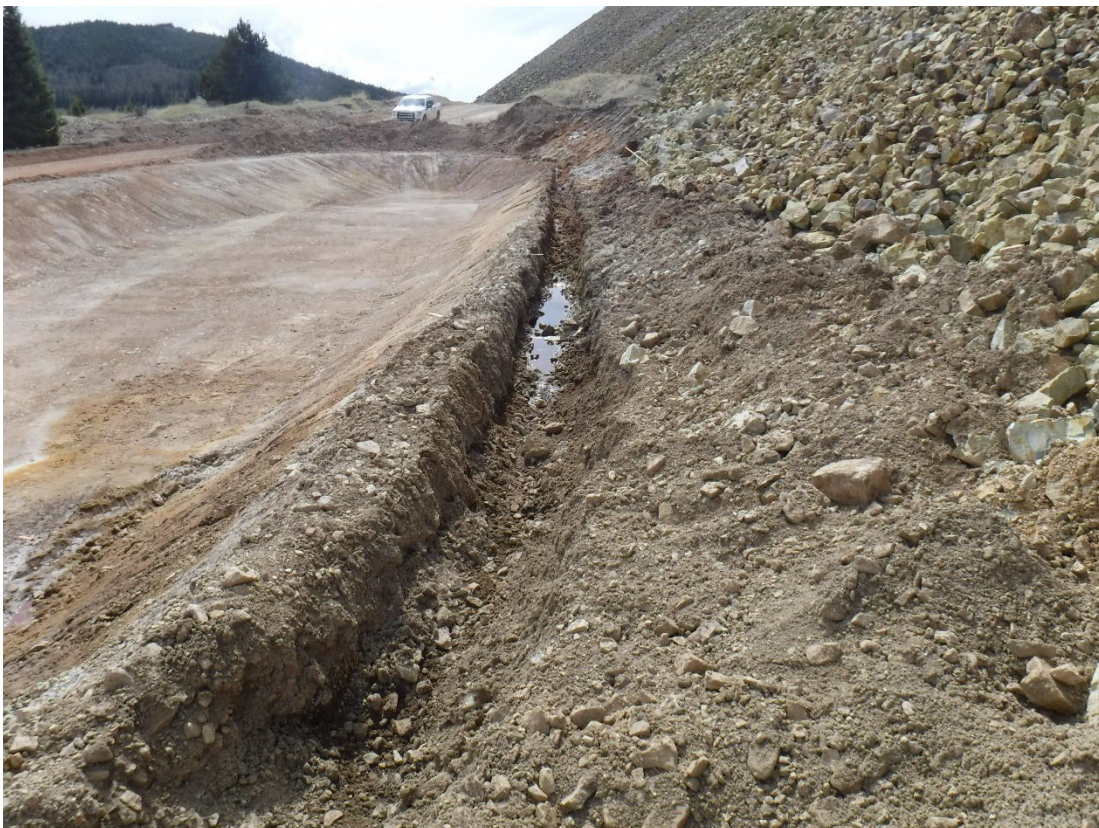
**Photo 9:** Seepage in the anchor trench

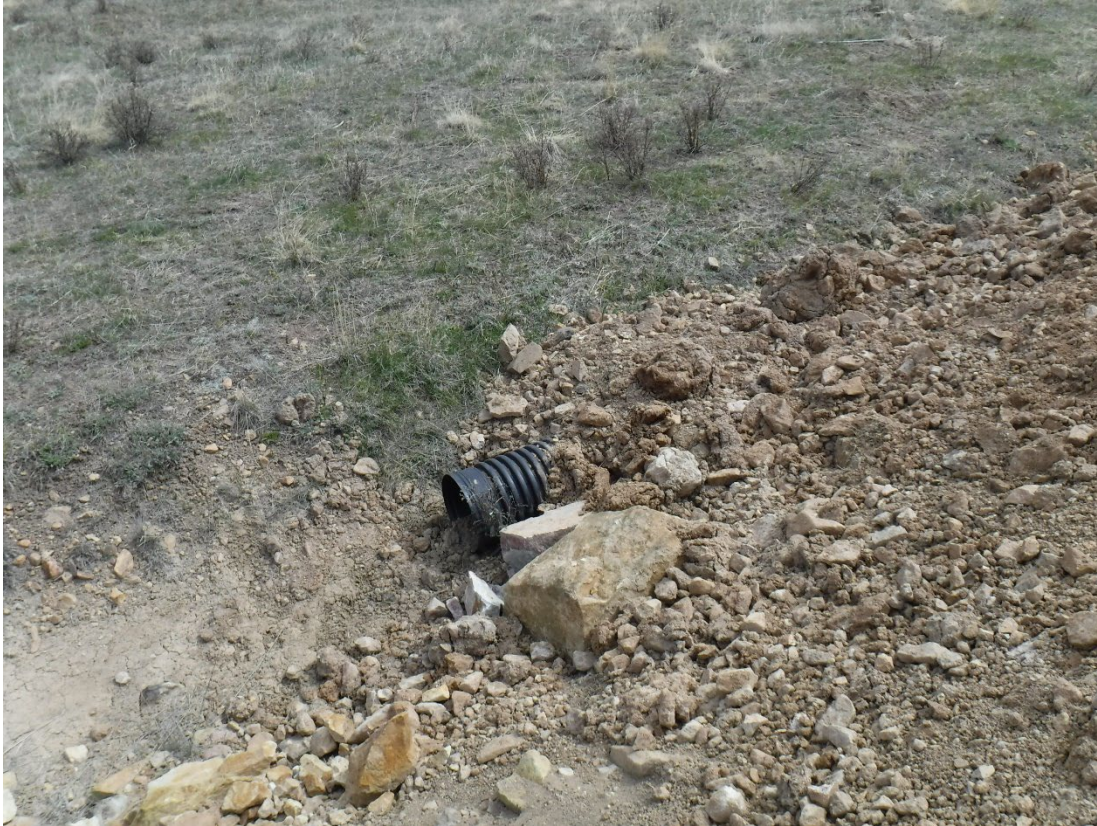
**Photo 10:** Corrugated pipe for drainage around road realignment for Seep Collection Basin 5

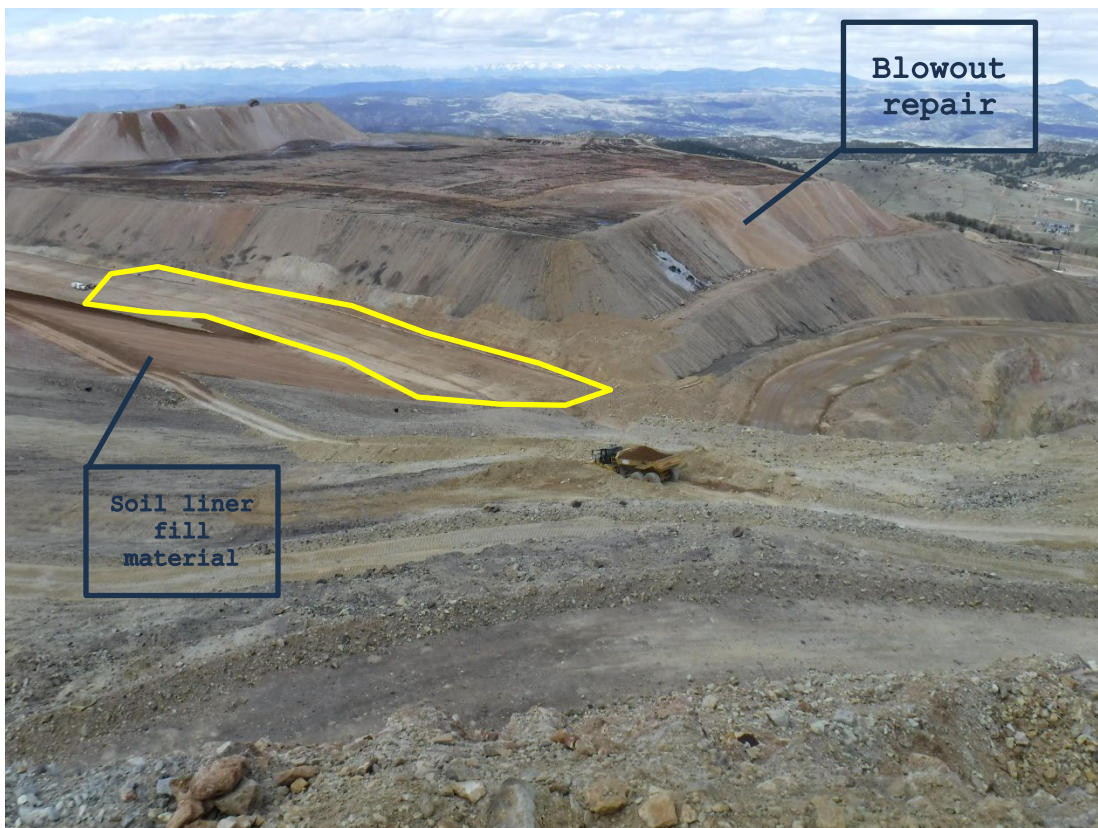
The Division observed the area where the Operator would like permission to stack ore material in a downhill manner. Stacking ore in this manner is not approved by the Division. However, the Operator believes stacking ore in a downhill manner with the shallow grade, ~3%, will not adversely affect the liner. If the Division does not allow ore stacking in this manner the Operator will have to use a contractor and typical construction equipment to move the estimate 100,000 cubic yards of material to level area enough for haul trucks to be

**Photo 11:** VLF2 Phase 3 area, yellow outlined area is downhill stacking area

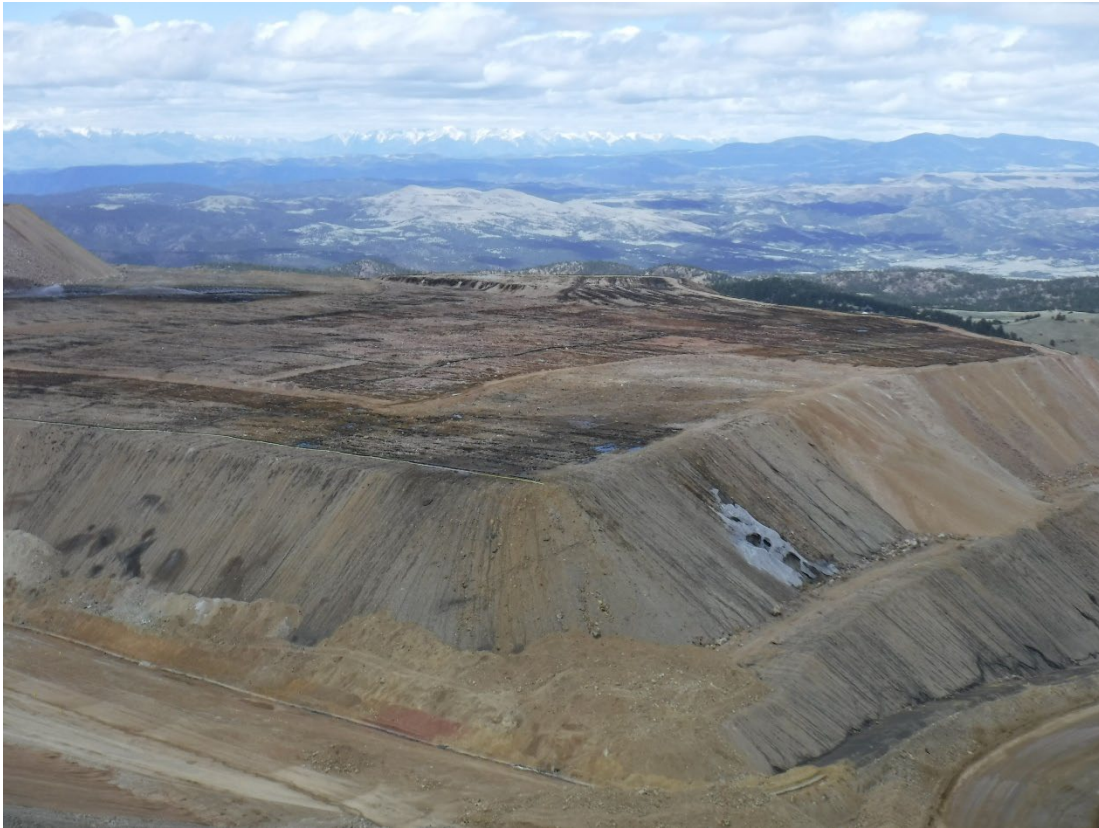
While in this area the Division observed the blowout repair VLF2 Phase 2A at the 10,300 elevation that was discussed in February 20<sup>th</sup> inspection report. The repair had been completed in the weeks prior to the inspection. Additionally, the Operator was stacking ore material on the 10,400 elevation and the Division observed minor pooling areas on the 10,350 elevation.

**Photo 12:** Minor areas of ponding and blowout repair

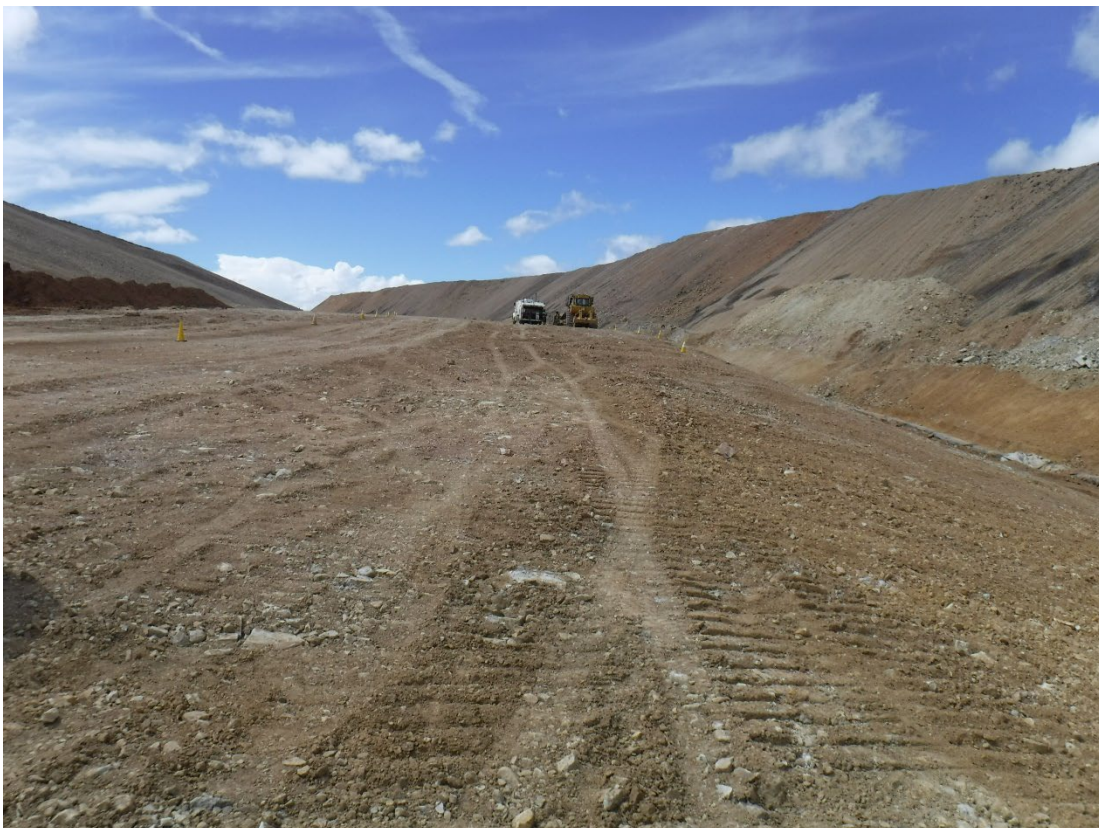
**Photo 13:** Downhill stacking area

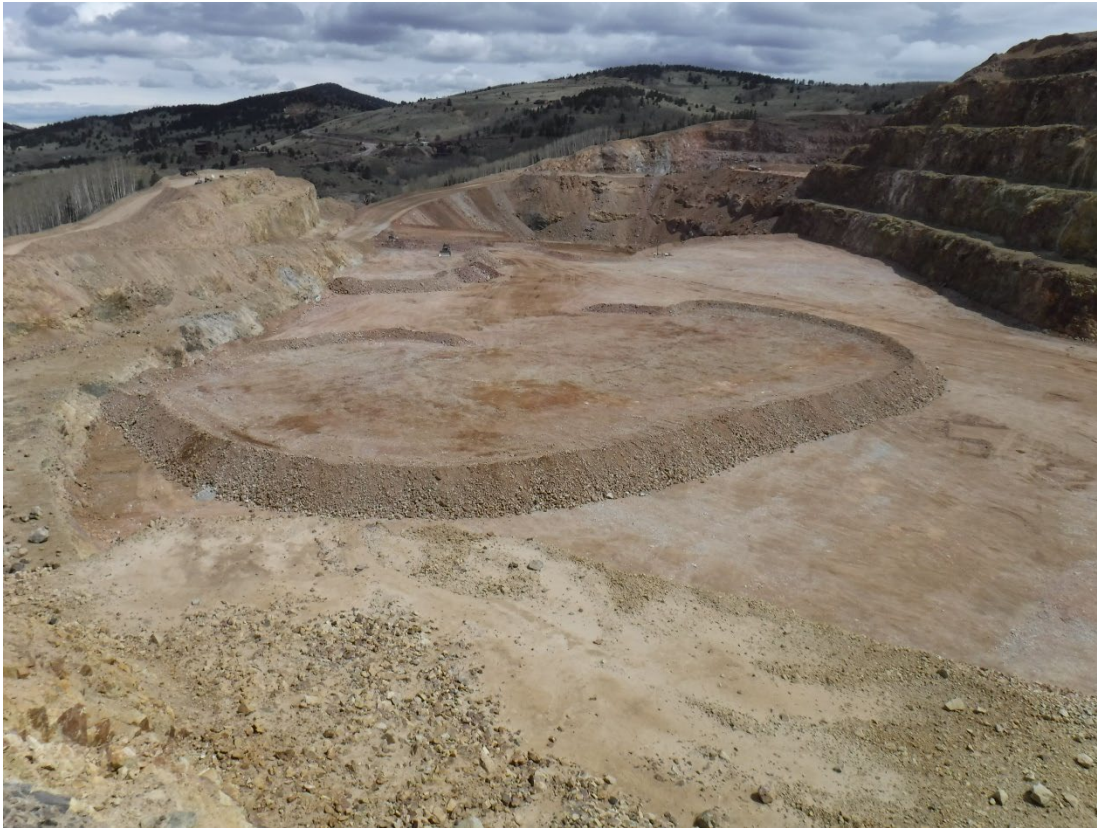
The Schist Island Backfill area was observed from the overview area and from ground level as material was being placed. The Operator was placing material in two locations, the low compaction face and an area of high compaction. The low compaction area can have material placed in 10-foot lifts and material placed needs to meet the specification of 5 feet or less in two out of 3 dimensions. The high compaction area material specification is 2 feet or less in two out of 3 dimensions. During the April inspection the Division observed over-sized material being placed in the low compaction area. During this inspection the Division observed what appeared to be oversized material being placed and proceeded to ground level where the material was being placed. Observing some of the material that had been placed on the high compaction lift it was determined that oversized material had been placed, specifically a boulder that was well over 5 feet in multiple dimensions. NewFields personnel informed the operations manager, and they observed the boulder that had been placed. The manager directed a dozer working in the area to remove the boulder and resize it by running over it and crushing it to smaller sizes that meet the specification. While personnel were observing the face a haul truck loaded with out of spec material attempted to dump material but was instructed not to dump. The haul truck was redirected to dump in area between the high and low compaction lifts in an isolated area. It was the Operators intent to either re-size the material or haul the material away and not used for backfilling. NewFields stated they had excess personnel onsite that could observe the material being placed met the required specifications for the specific lifts. Later, during the inspection, the Division noted hearing radio traffic that indicated NewField's personnel were observing the backfilling activities. The oversized material was theorized to be caused by where the material was being blasted, which was near a road.

**Photo 14:** Two areas of Schist Island backfilling

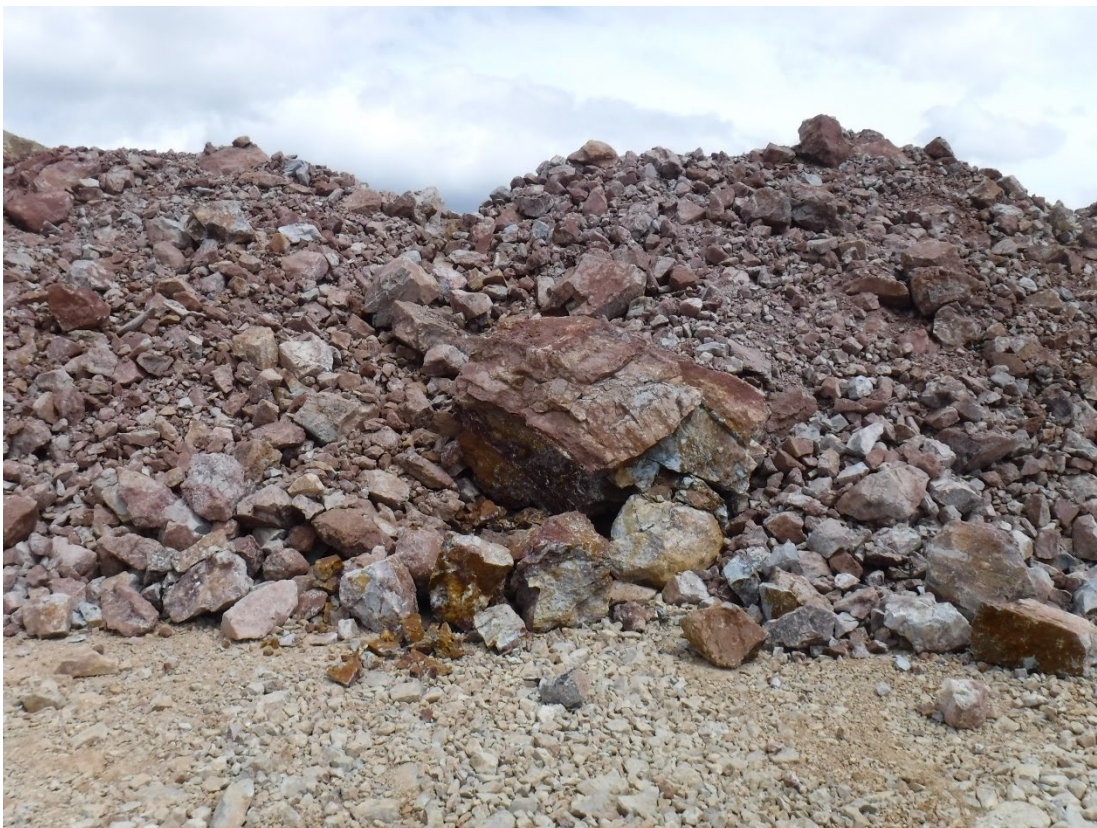
**Photo 15:** Boulder, 5-foot +, high compaction area

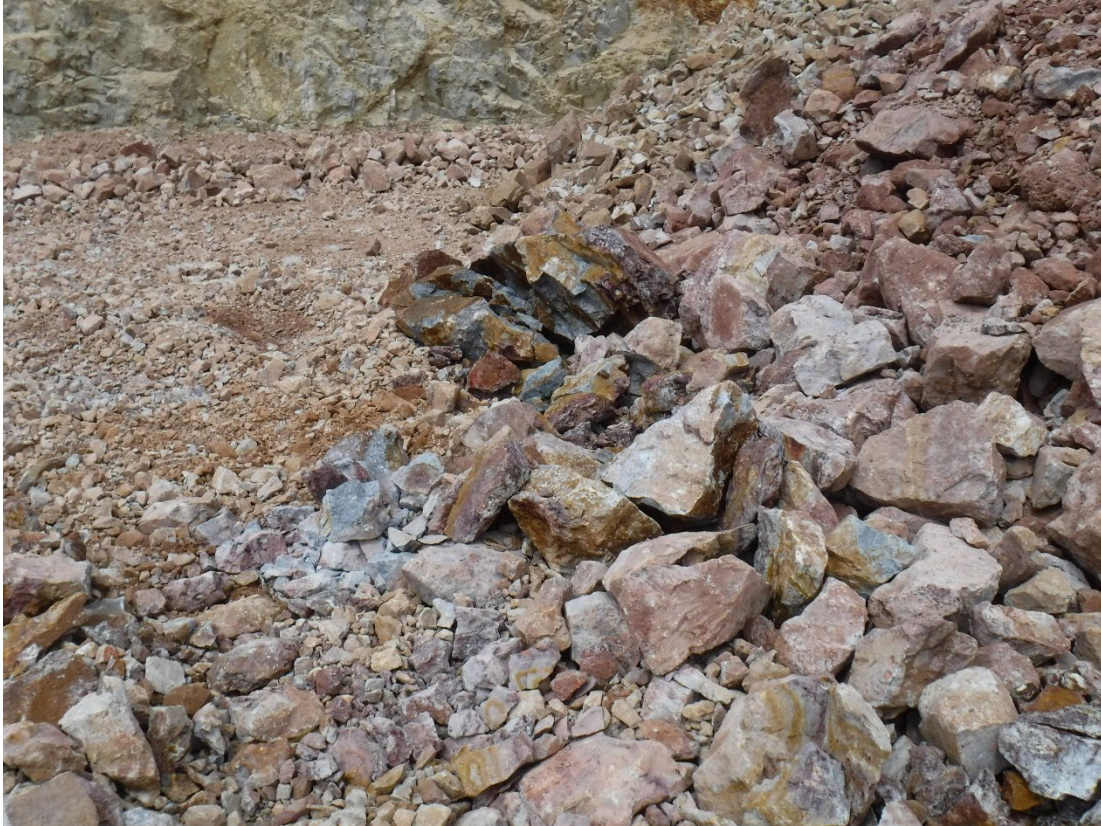
**Photo 16:** Boulder, after being processed by dozer

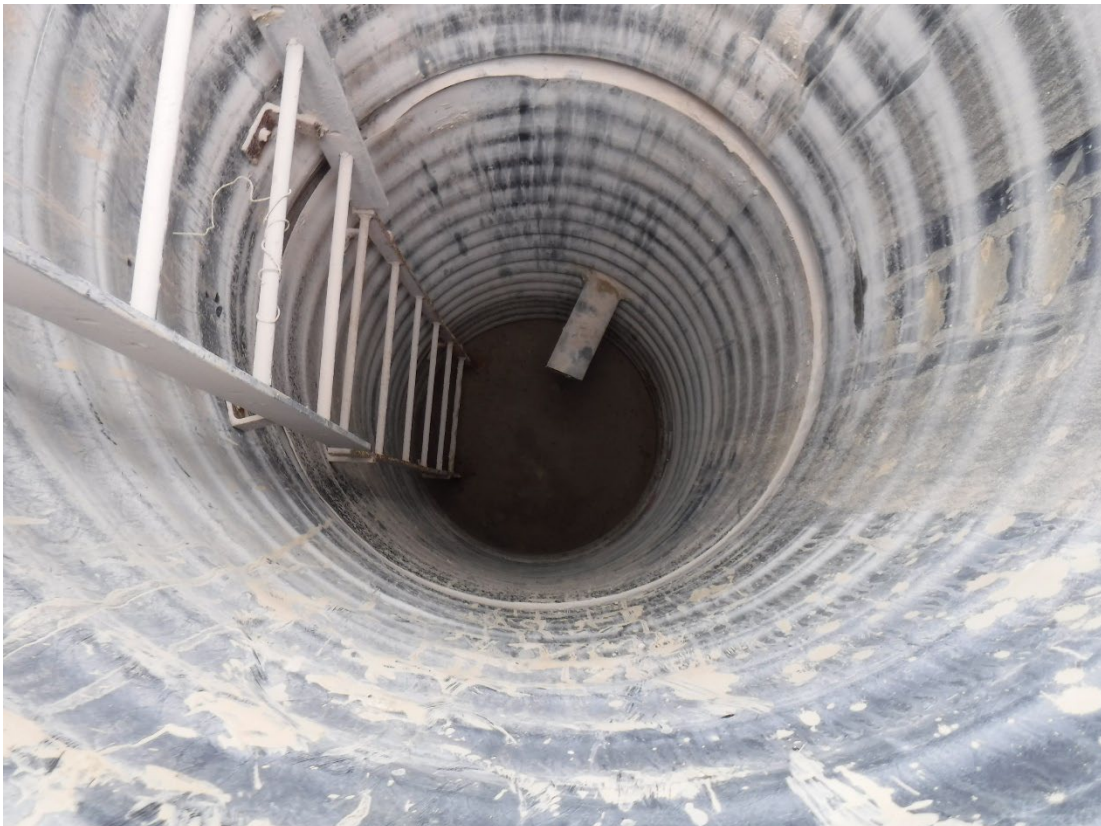
**Photo 17:** LDS 12

The Division observed leak detection sumps 12, 13, 14 and 15. Sumps 12 and 13 were dry, 14 was wet on the floor of the sump but not sufficient to be pumped, and 15 had approximately 2 feet of water at the bottom of it. The Operator stated that water in this sump is from recent rain events in the area and not VLF leakage. The Operator will sample the water and pump it out according to the approved protocol.
