DRMS's SL 8 Inspection Seneca IIW

Division of Reclamation,
Mining and Safety

5 June 2025

Permit Number: C1982057 Mine Name: Seneca IIW Mine Operator: Seneca Property LLC Operator Address: Ms Miranda Kawcak 29515 Routt County Road No. 27 Oak Creek, CO 80467	County: Routt Operation Type: Surface Permit Status: Permanent Cessation Ownership: Private Operator Representative Present: Miranda Kawcak
Operator Representative Signature: (Field Issuance Only) This report was issued electronically from the Divisions' Denver Office.

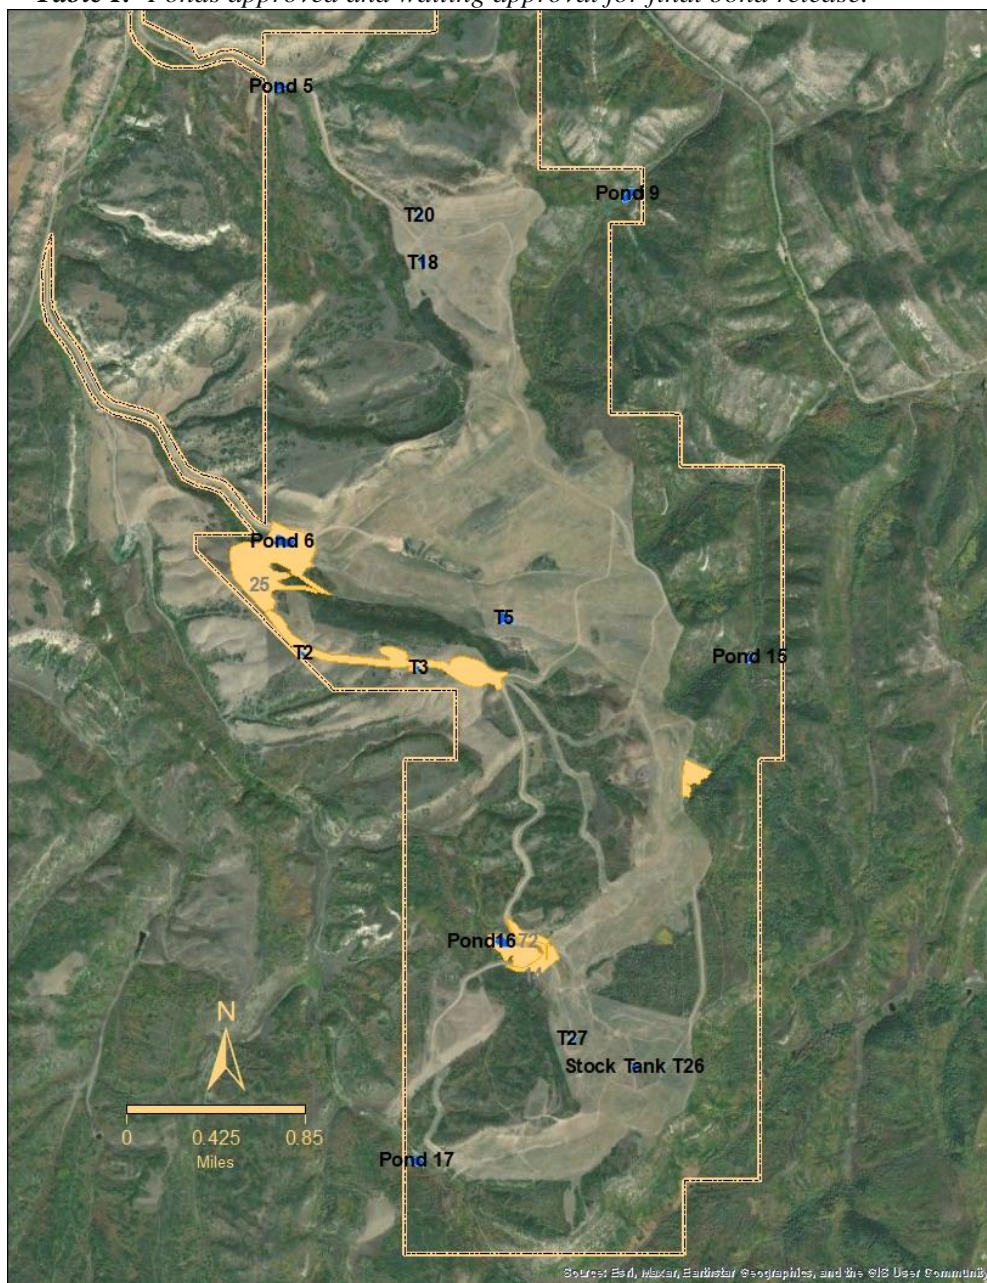
Map I: Parcels requested for release are located as shown on the map above.
Both private, Federal and State surface areas are included in the proposed release.

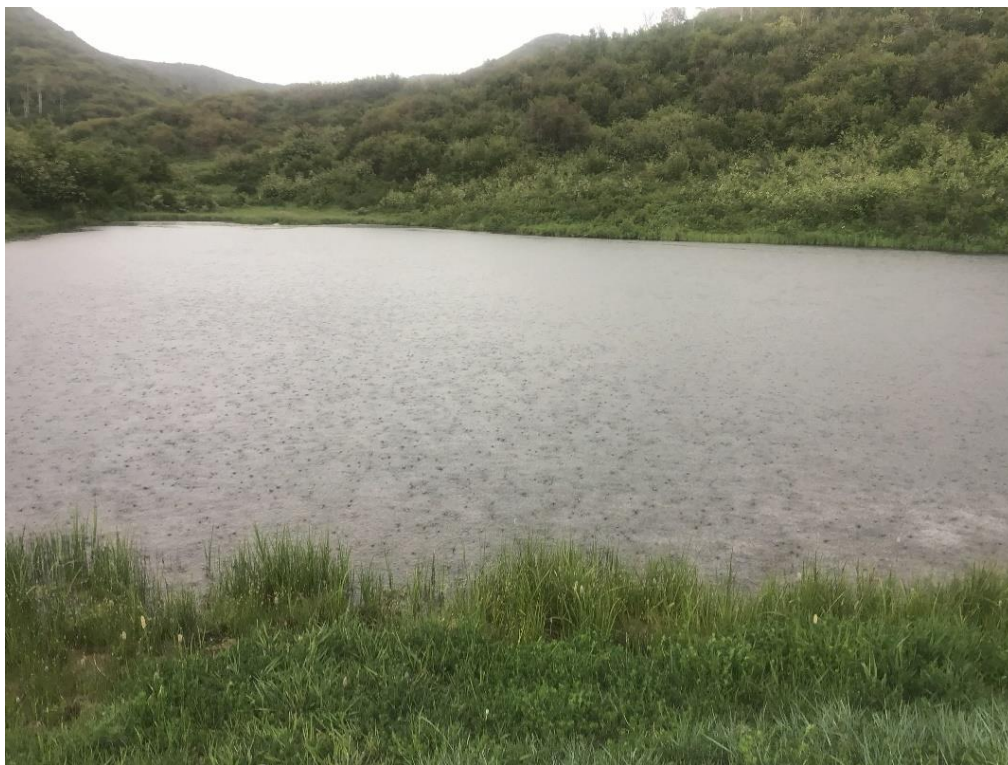
Photo1: Pond 17, slightly turbid.

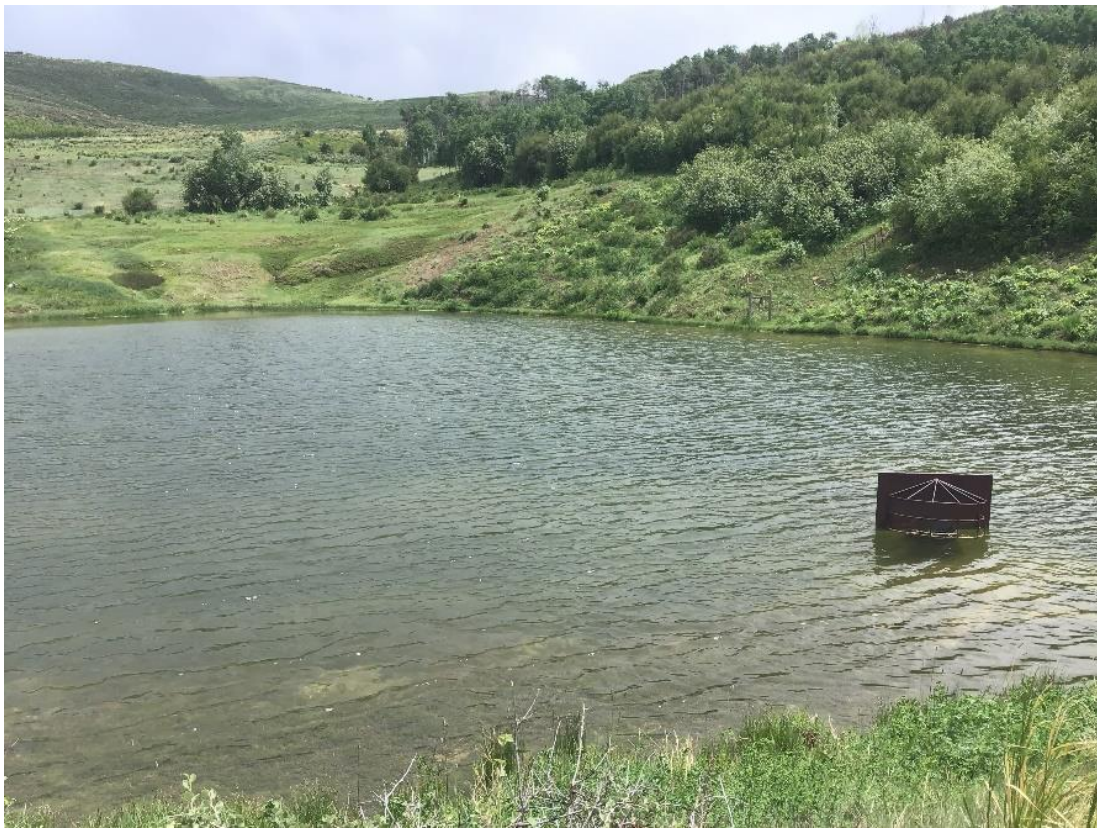
- Pond 5 held water at the time of inspection.
- Pond 6, was discharging clear water at the time of inspection.
- Pond 15 held slightly turbid water and was discharging at the time of inspection.
- Pond 16 was receiving inflow from the spring fed system above and was discharging clear water at the time of inspection. Vegetation was well established on banks and a growth of whitetop was prevalent on the north bank. The white top along the north bank requires remediation.
- Pond 17 was discharging at the time of inspection.

Photo2: Pond 16 discharging clear water. There is a growth of whitetop along the north bank of the pond.

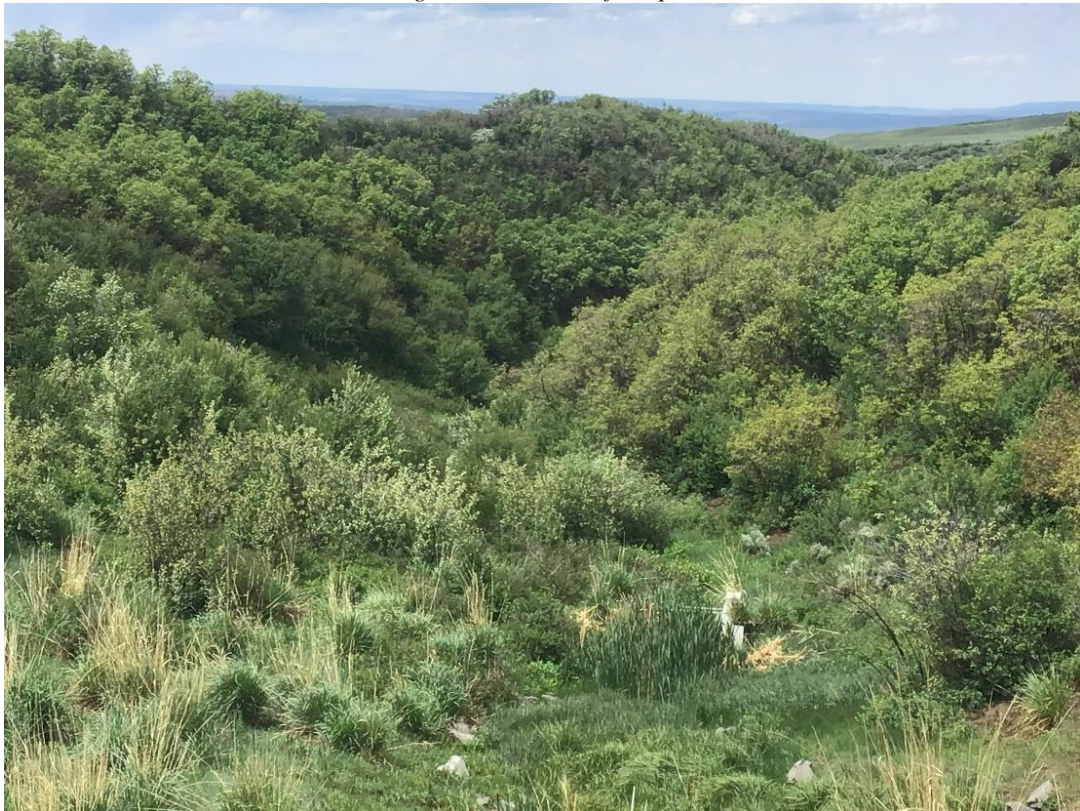
Photo 3: Pond 16 drainage way, functioning properly..

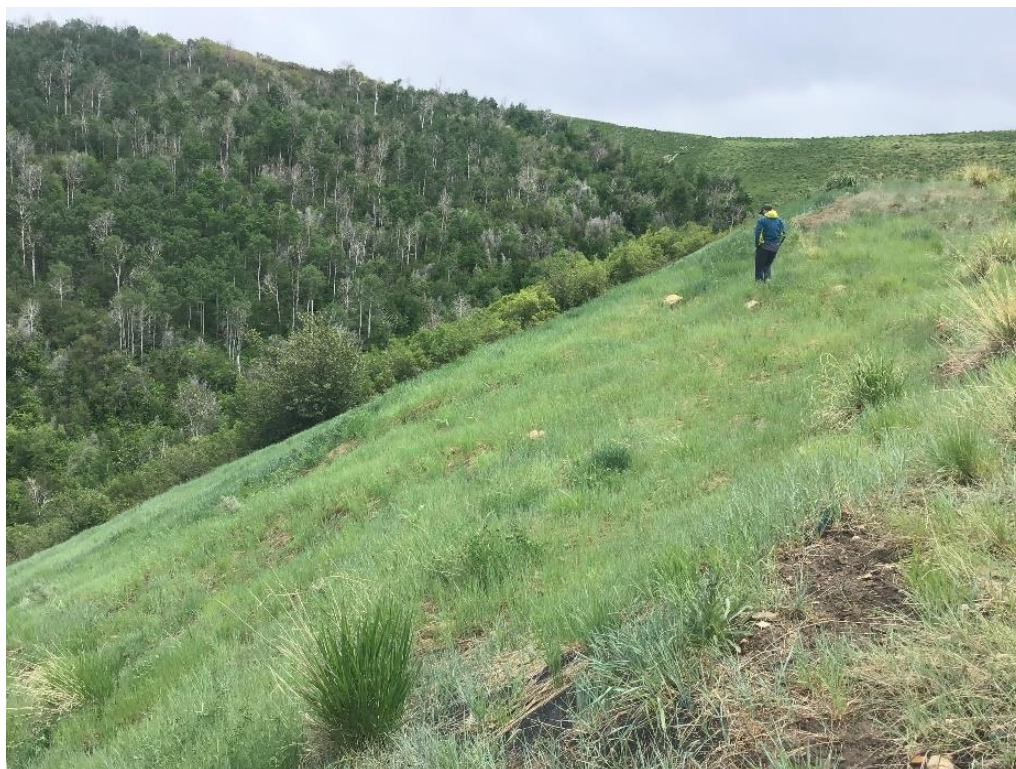
The site, in the past, has experienced soil movement in the form of slumps and slides. At the time of inspection no evidence of recent new movement was observed and historic slide areas appeared stable.

Photo 4: Steep slide slope above pond 15 exhibiting stable and well established vegetation comprised of a mix of grasses and forbs. The slide has been remediated, and the area has been stable for years.

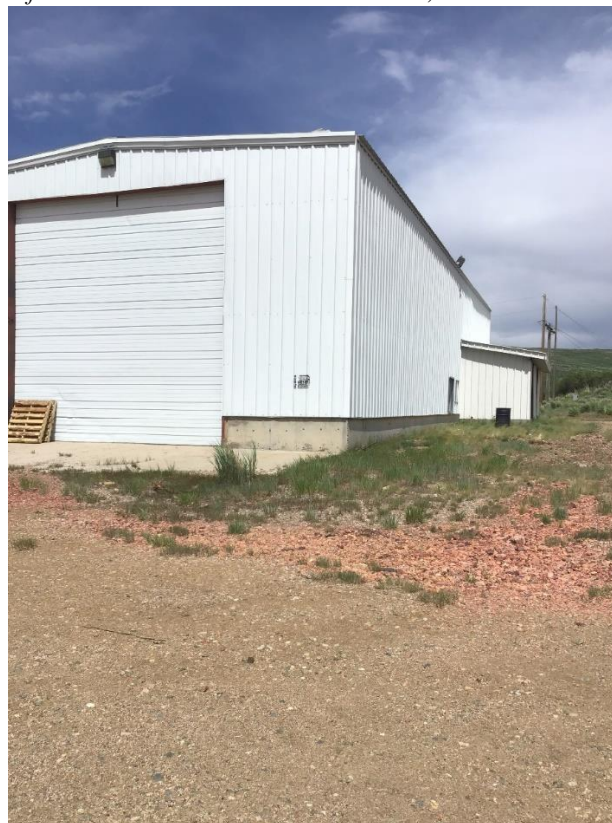
Photo5: The Shop, a permanent facility.

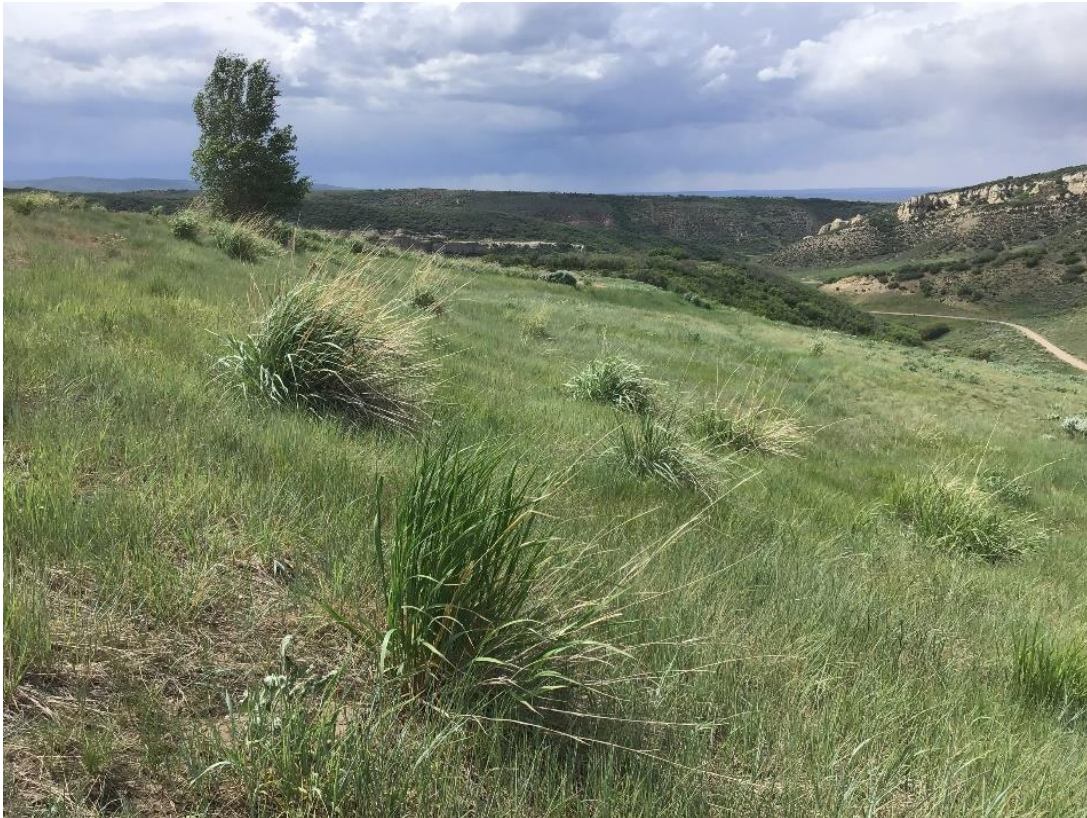
Photo 6: Vegetation on the slope below the shop comprised of various grasses and forbs.

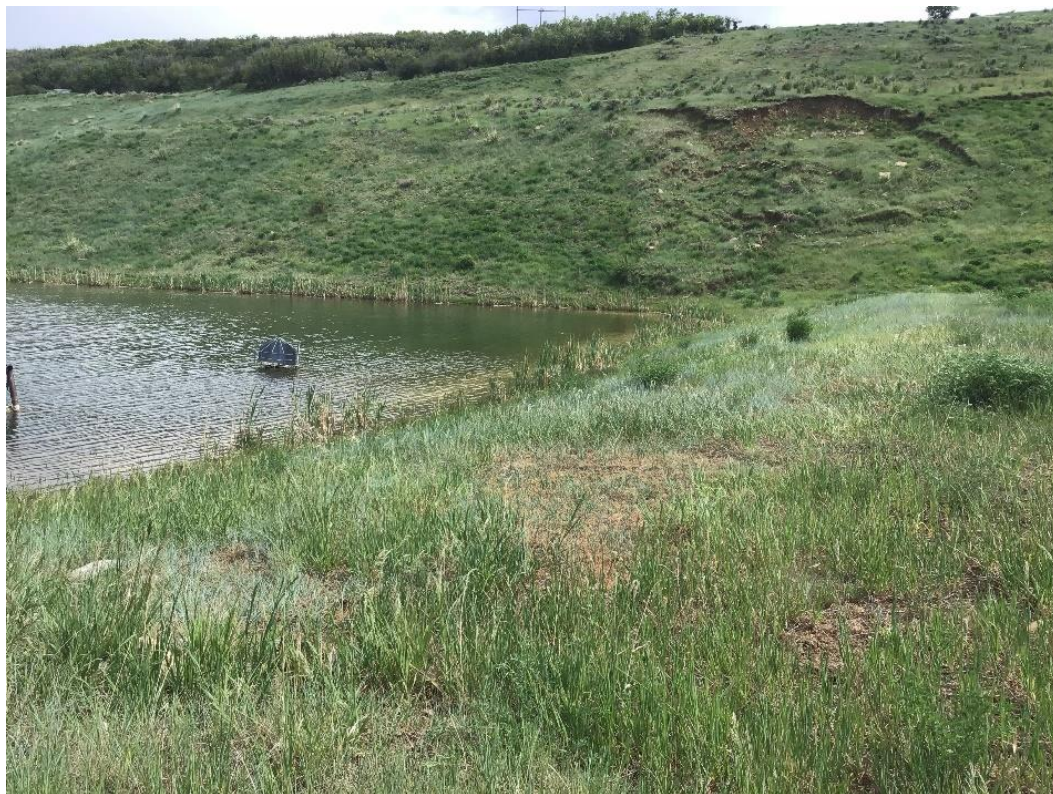
Photo 7: Pond 6 and associated slump. The slump has been stable and slowly revegetating over the years.

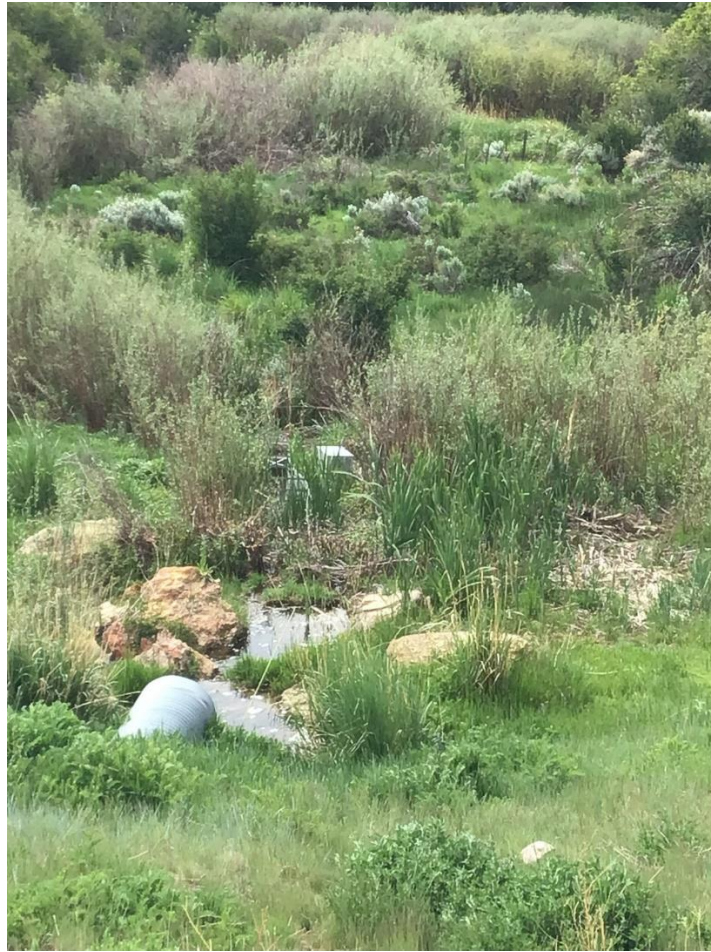
Photo 8: Pond 6 drainage way and discharge culvert discharging clear water.

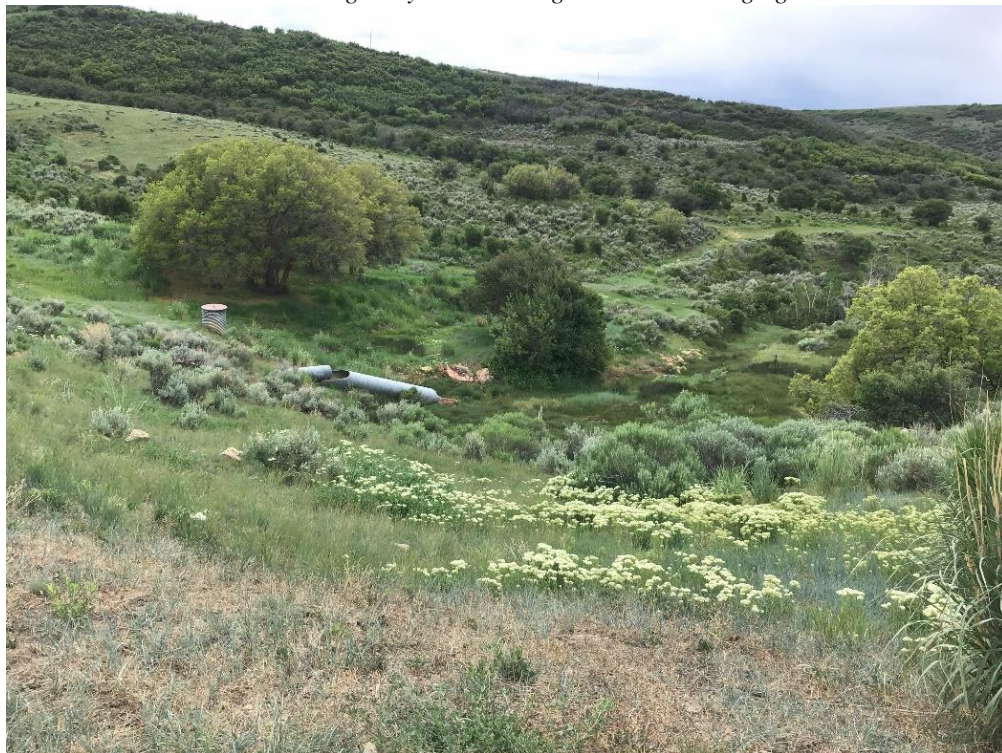
Photo 9: Pond 5 drainage way and discharge culvert, a small area of whitetop is present.

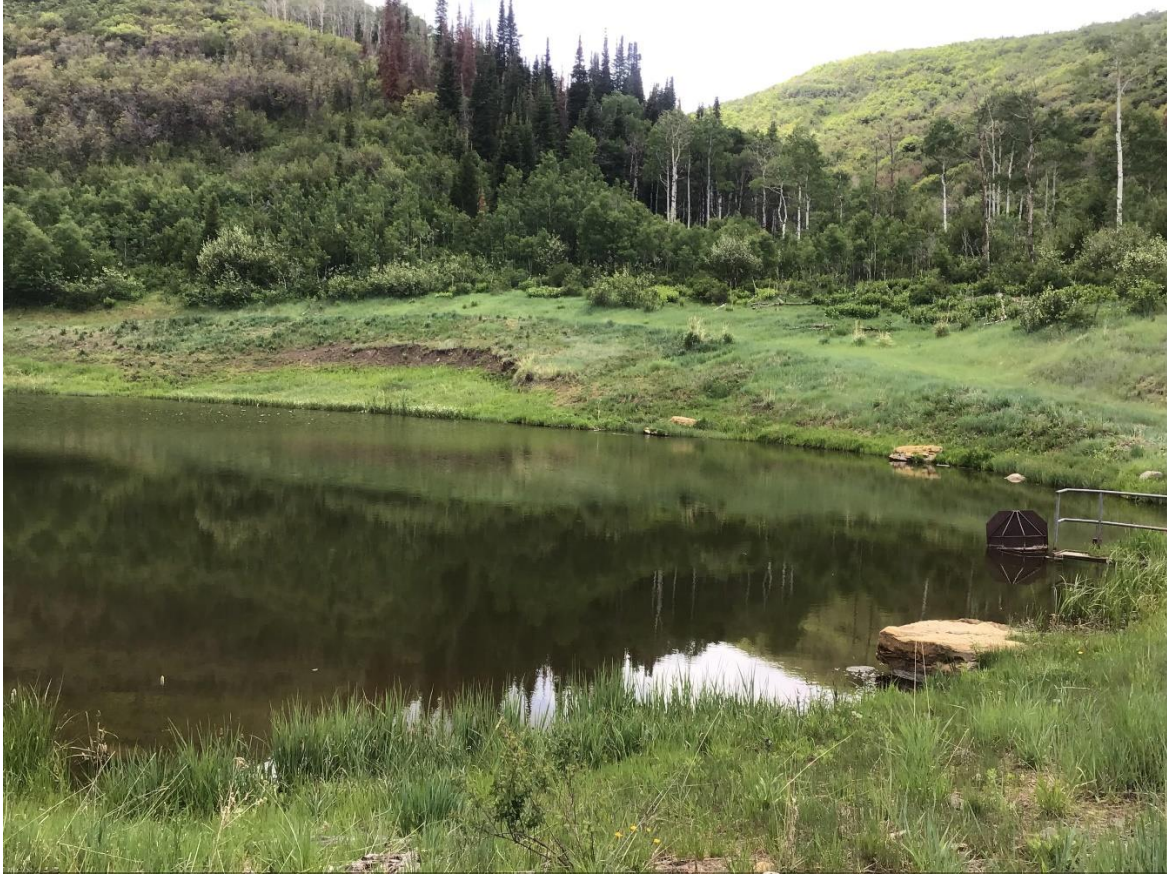
Photo 10: Pond 15, discharging slightly turbid water.

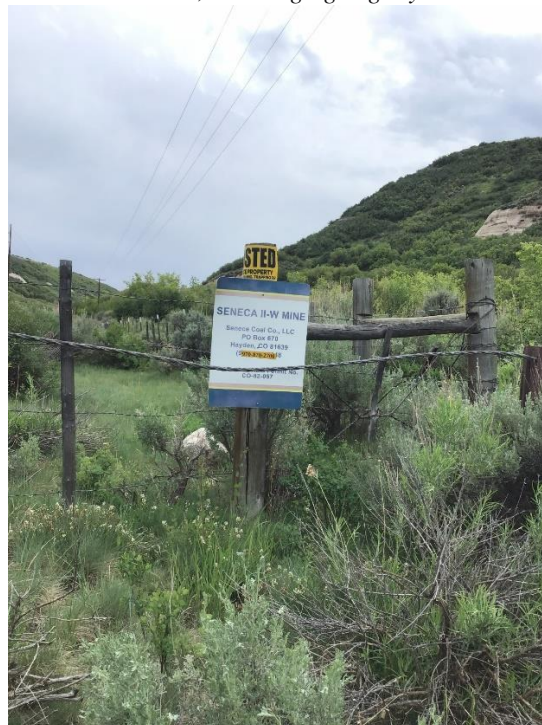
Photo 11: Seneca IIW mine ID sign at the main entrance from the county road.
