STATE OF
COLORADO

June Inspection Report

Permit Number: C-1981-018 Mine Name: Deserado Mine Operator: Blue Mountain Energy, Inc Operator Address: Mr Kurtis Blunt 3607 County Road 65 Rangely, CO, 81648	County: Moffat, Rio Blanco Operation Type: Underground Permit Status: Active Ownership: Private
	Operator Representative Present: Kurt Blunt
Operator Representative Signature: (Field Issuance Only)

Inspection Start Date: June 11, 2025 Inspection Start Time: 10:30 Inspection End Date: June 11, 2025 Inspection End Time: 13:30		Inspection Type: Coal Complete Inspection Inspection Reason: Normal I&E Program Weather: Clear	
Joint Inspection Agency: None		Joint Inspection Contacts: NA	
Post Inspection Agency: None		Post Inspection Contacts: NA	
Inspector(s): Todd Jesse	Inspector's Signature:

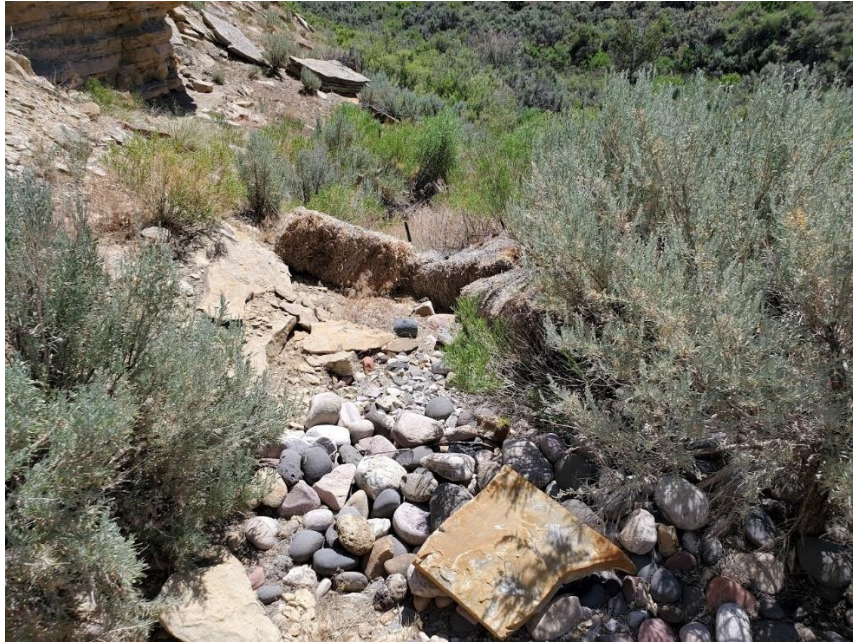
The explosives storage area for the Deserado Mine is located at the southern end of the main facilities area. The storage consists of a pad with a storage bunker for the explosives. The cut and fill slope of the pad was stable with no erosional features. Runoff from the pad is directed to an outlet at the southern end of the pad and passes down a channel through straw bales. The bales appear to be in good condition and functioning as designed (Photo 1)

Photo 1: View to the east of bales in pad drainage.

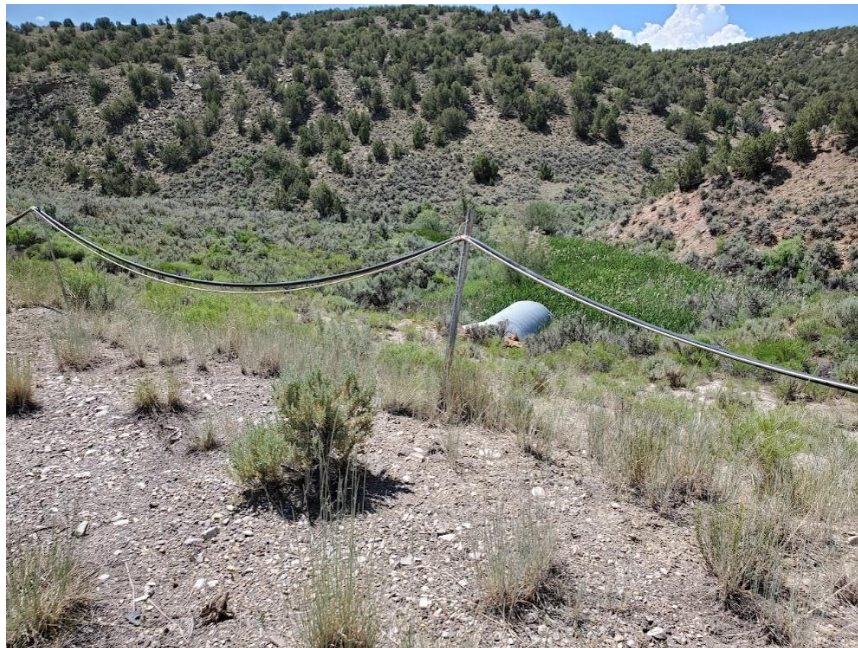
There are three ponds located in the main facilities area: the DP-1 Pond, the PP-1 Pond and the PP-2 Pond. The DP-1 Pond is located on the southern part of the lower facilities bench. DP-1 collects all runoff from the from the three facilities benches. The outlet structure was clear of debris and the pond was discharging at the time of inspection. The embankments appear stable with well-established vegetative cover (Photo 2). The emergency spillway has minor amounts of vegetation but still appears to be able to convey water and is well armored. There were no erosional concerns identified. The PP-1 Pond is located on the middle bench of the facilities area near the prep plant. The pond held minor amounts of water and was well below the discharge level (Photo 3). There were no erosion or stability issues identified in the PP-1 Pond. The PP-2 Pond is located on the upper facilities bench. The outlet structure was in good condition with no vegetation obscuring the outlet (Photo 4). Water diversion ditches throughout the main facilities area were unobstructed and stable.

Photo 2: View to the southeast of DP-1 embankment.

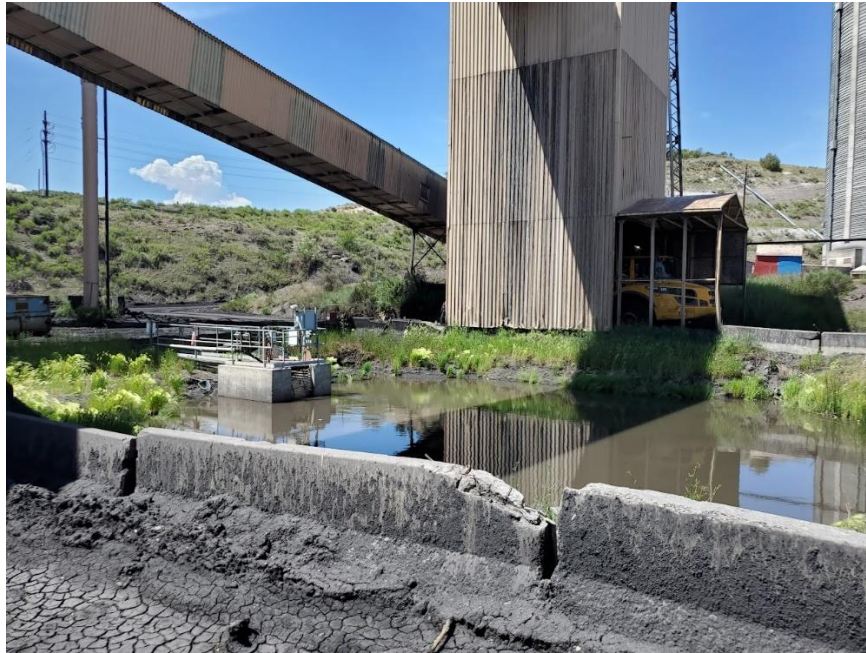
Photo 3: View to the southwest of PP-1 pond

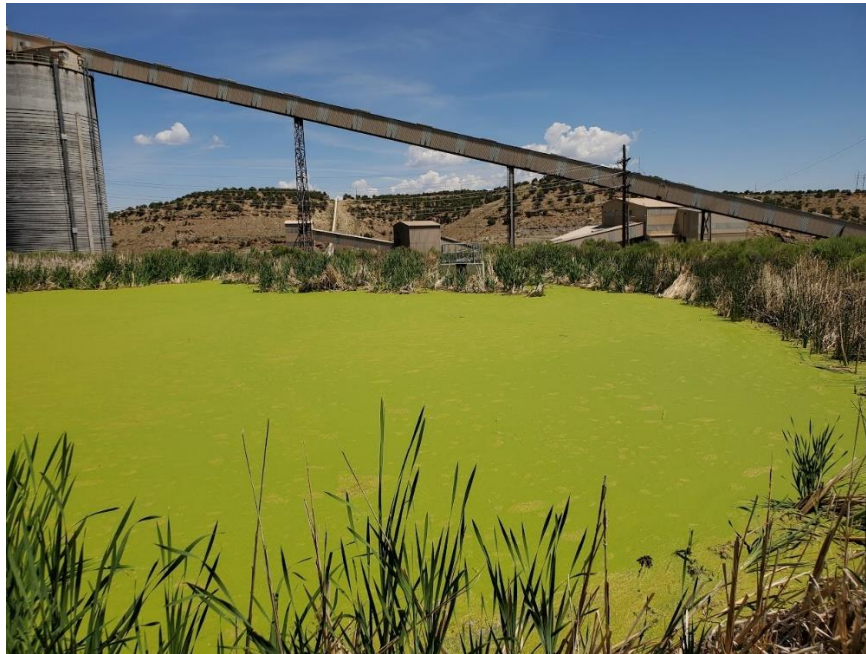
Photo 4: View to the north of outlet of PP-2 Pond and outlet.

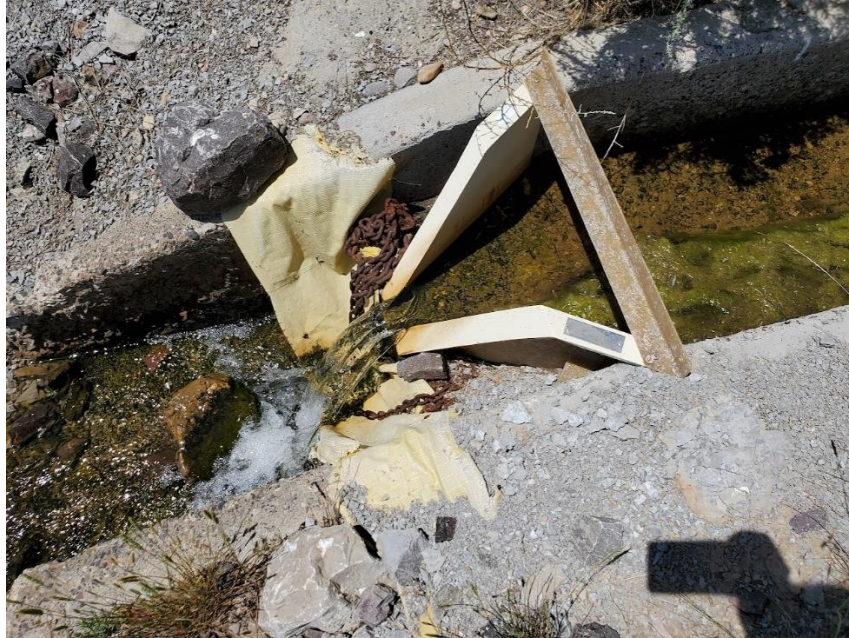
The B Seam Dewatering System No. 1 was active during the inspection. Cells were impounding water. There was well established vegetation on the embankments of the cells. The cells were stable with no erosional or other stability features noted. The Last Chance Pond was discharging approximately 25 gpm at the time of the inspection (Photo 5).

Photo 5: View to the south of Last Chance Pond discharge.

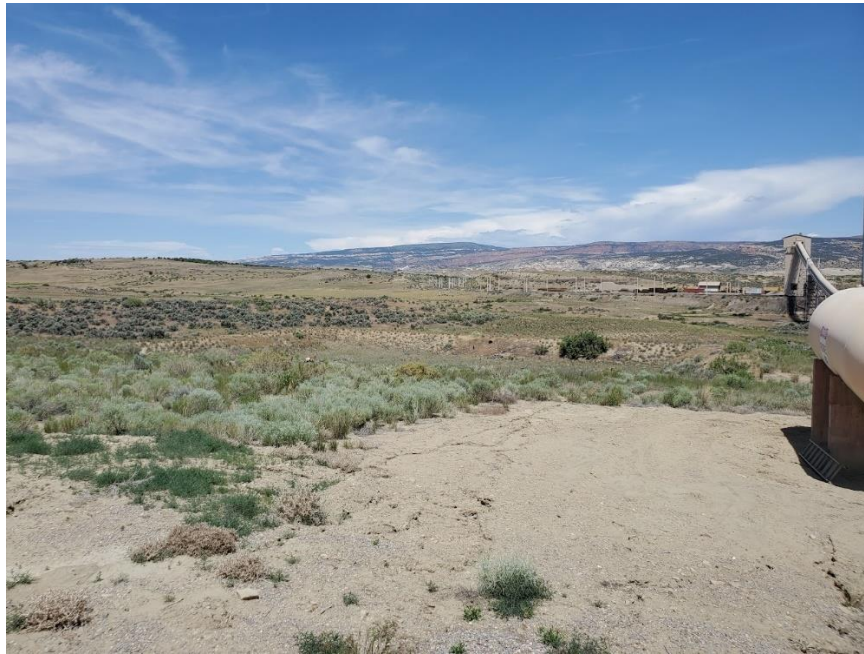
The SS-2 Pond is located at the northwestern base of the Slot Storage Facility. The pond was dry at the time of the inspection. The embankments of the pond were well vegetated and stable with no indications of erosion (Photo 6).

Photo 6: View to the north of SS-2 pond.

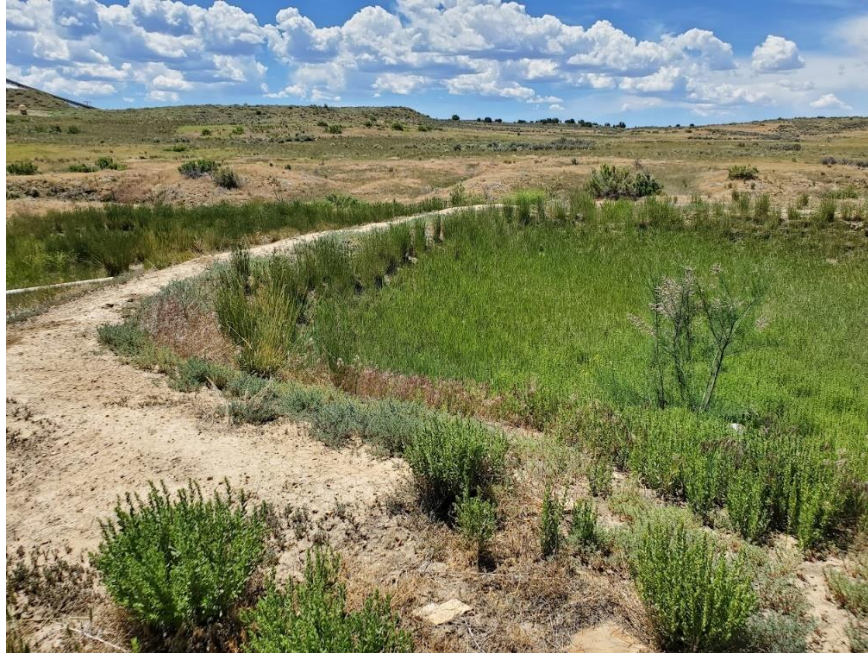
The RS-1 Sump and the RR-1 Pond are located at the south side of the Rail Loadout. The RS-1 Sump was dry (Photo 7). There were no indications of erosion. The RR-1 Pond was dry. The embankments of the pond seem stable. The erosion feature on the northern embankment that has been noted in previous inspection reports does not appear to have grown in size (Photo 8). The Rail Loadout Storage South Ditch has minor amounts of vegetative debris but does not appear obstructed and is able to convey water.

Photo 7: View to the south of the rail sump

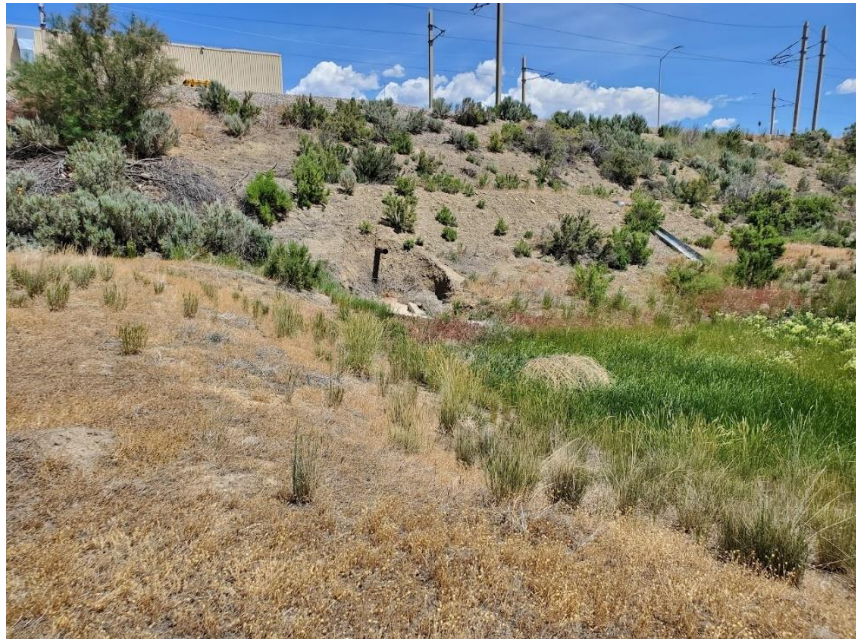
Photo 8: View to the north of erosion scar on RR-1 Pond.

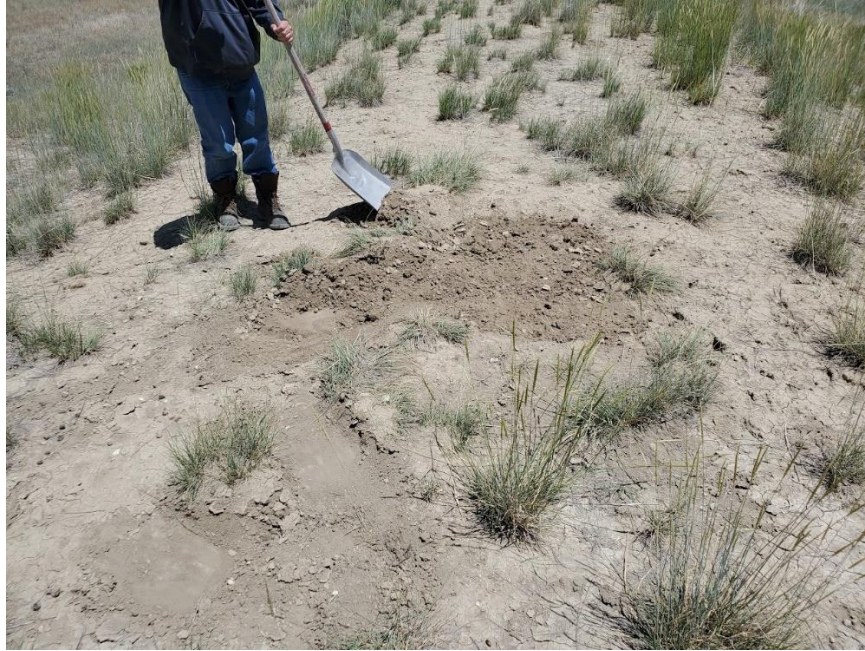
Two ponds are located at the northern base of Refuse Pile RP-2/3/4. The RP -2/3 Pond is located on the pile's northeast corner. The Pond consists of three cells – the upper cells were holding water at the time of the inspection. The channels above the ponds appear clear of debris. No erosional features were noted on the embankments of the conveyance ditches. The trash rack was clear of debris. The RP-4 Pond is located at the northwest base of the pile. The pond was dry during the inspection. The outlet for the RP-4 Pond is capped with a trash rack. The outlet was clear of debris. Animal burrows were noted in the embankments of the RP-4 Pond and were filled during the inspection (Photo 9).

Photo 9: View to the east of filled animal burrow on embankment of RP-4 Pond

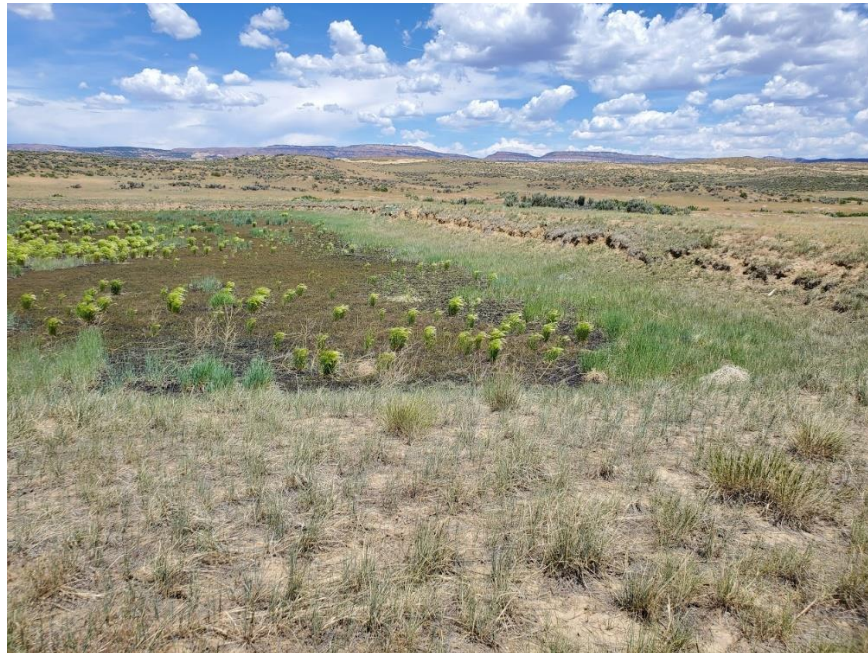
Pond RP-5 is located at the northern base of the RP-5a Refuse Pile. The pond was dry at the time of the inspection. The embankments of the ponds were vegetated and seemed stable (Photo 10). No indications of erosion were observed. The outlet was clear of obstructions.

Photo 10: View to the north of embankment of RP-5 Pond.

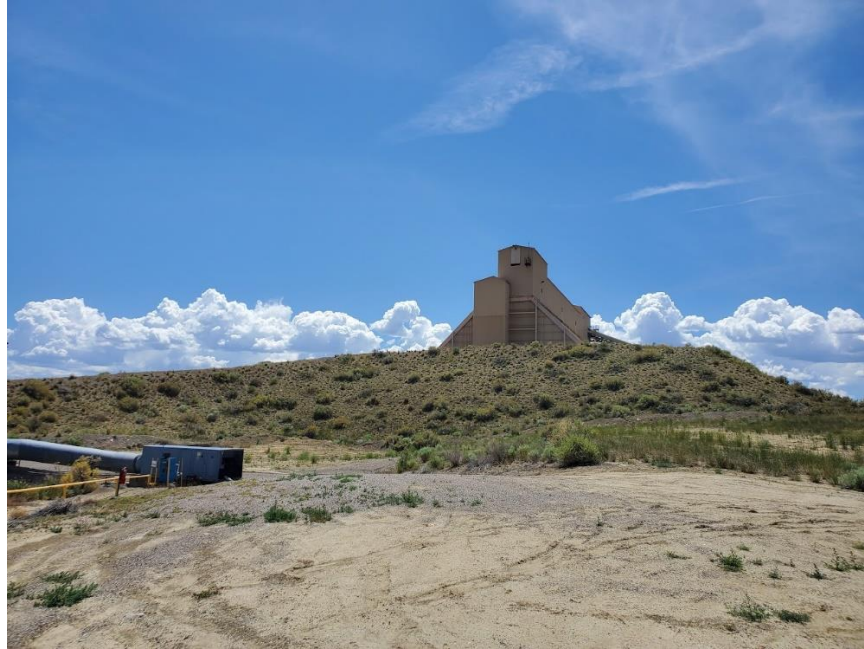
The Slot Storage Facility is located just to the south of the rail loadout. The pad that surrounds the Slot Storage is in good condition with a berm to control erosion. Equipment that was kept on the pad has been cleaned and organized. There were no erosional features noted on the embankments below the slot storage building (Photo 11).

Photo 11: View to the south of embankments of slot storage facility.

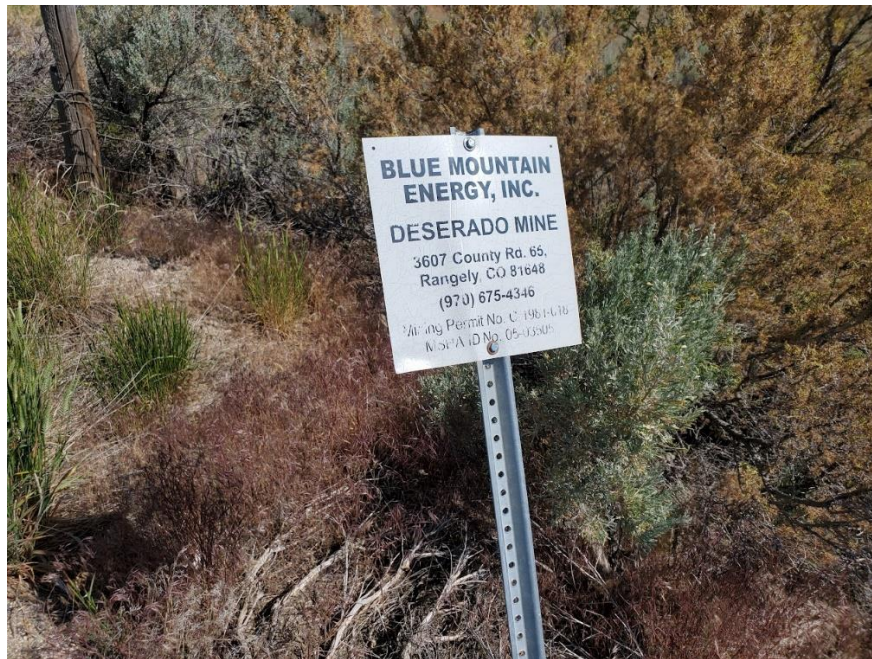
A mine identification sign was observed to be posted on the right-hand side of CR-65 as the county road enters the permit boundary. The sign was placed in an unobstructed location and the text was easily legible. Information on the sign contained the mine permit number, permittee name and contact information (Photo 12)

Photo 12: View to the northwest of mine ID sign at entrance to the permit boundary.
