Division of Reclamation,  
Mining and Safety

### PERMIT INFORMATION

<b>Permit Number:</b> C-1981-012 <b>Mine Name:</b> New Elk Mine <b>Operator:</b> New Elk Coal Company, LLC <b>Operator Address:</b> 12250 Highway 12 Weston, CO 81091	<b>County:</b> Las Animas <b>Operation Type:</b> Underground <b>Permit Status:</b> <b>Suspended</b> <b>Ownership:</b> Private
	<b>Operator Representative Present:</b>  None
<b>Operator Representative Signature: (Field Issuance Only)</b>

### INSPECTION INFORMATION

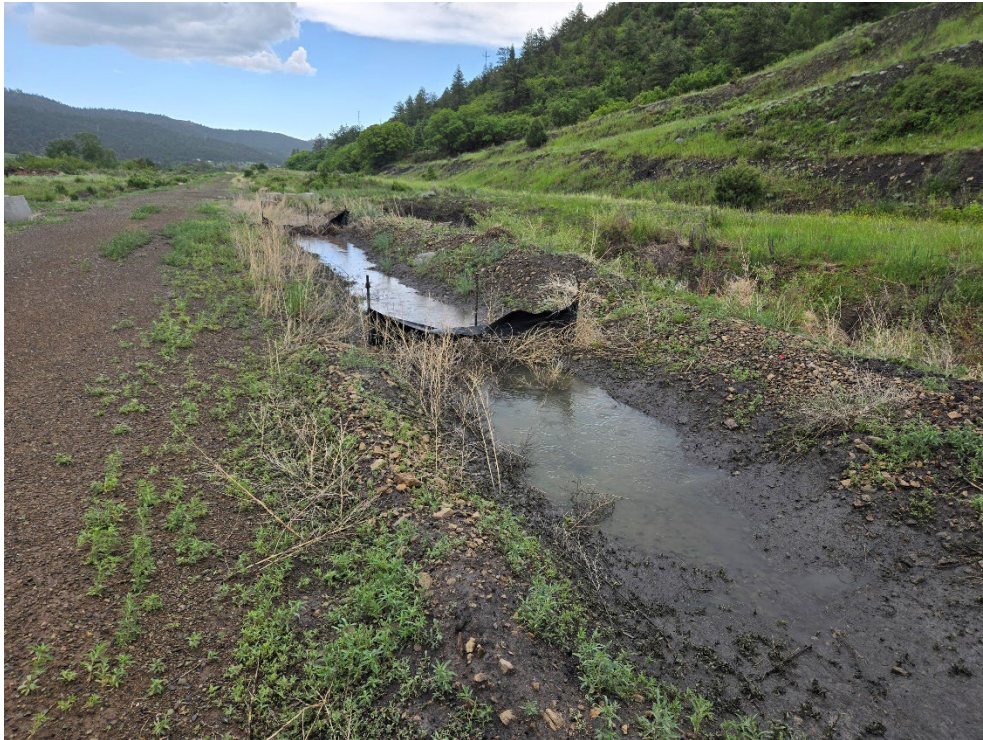
2. (January 2024 report) **The silt fences along the road in the SAE south of Pond 007 are damaged and need to be repaired.**

*Photo 1: Silt fences within S.A.E, south of Pond 007a. The area experienced a lot of rainfall recently and it was raining at the time of the inspection.*

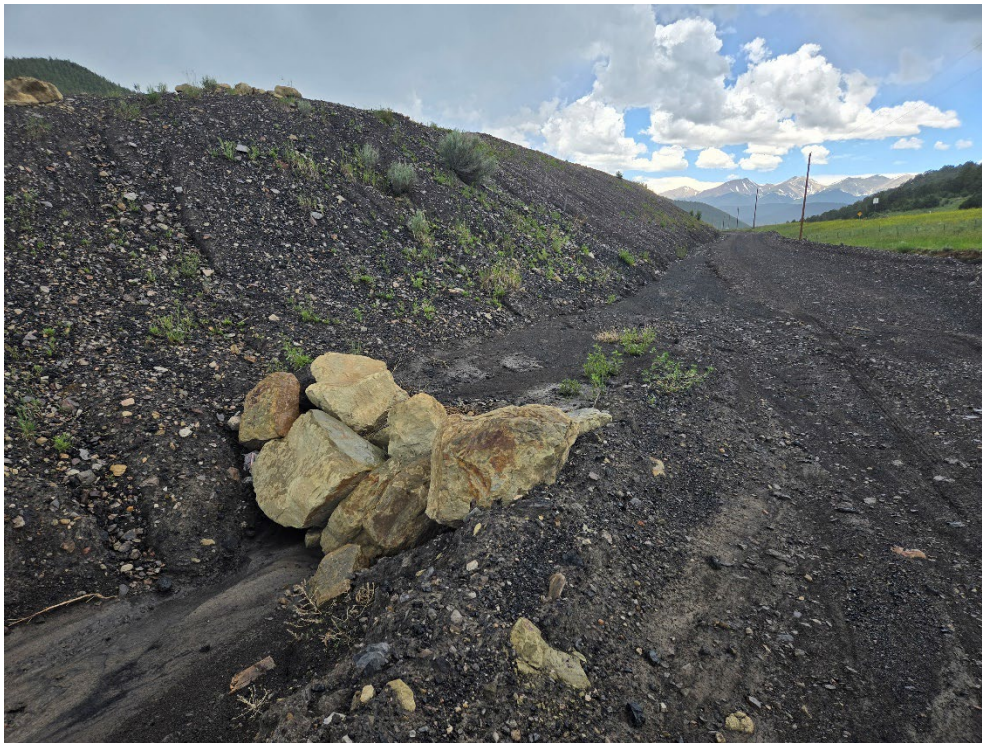
6. (October 2024 report) The check dams along the north side of the sediment basin at DWDA #2 have filled with sediment. **The Operator shall clean the check dams of sediment and ensure that the sediment control structures are functioning appropriately.**

*Photo 2: Looking west at the check dams on the north side of DWDA #2 leading to the sediment basin.*

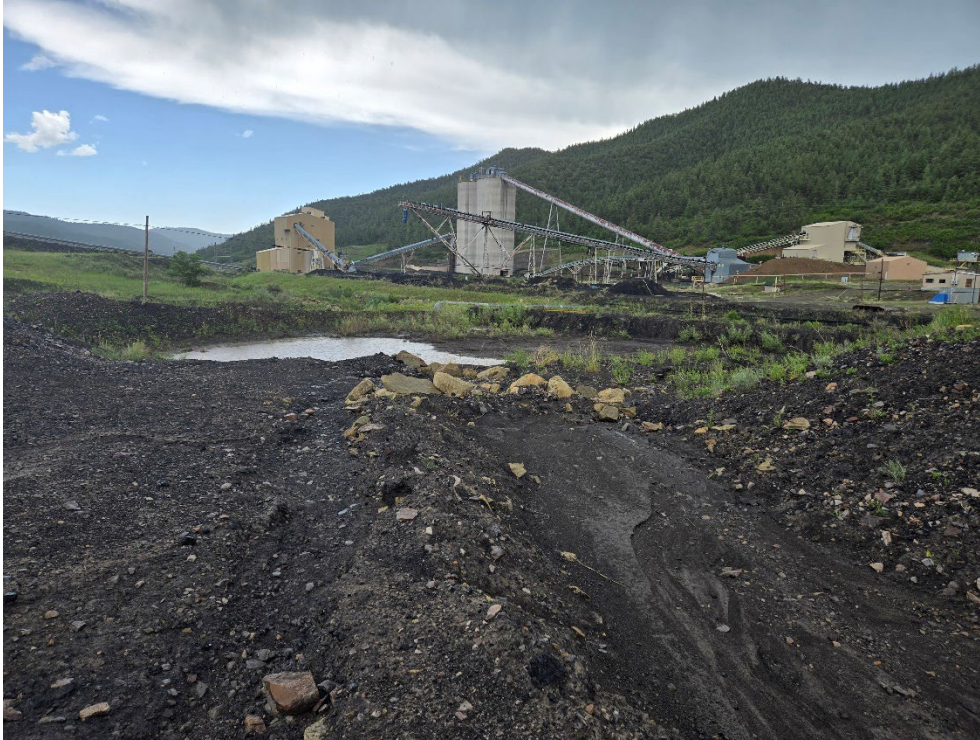
*Photo 3: Looking east at the check dams on the north side of DWDA #2 leading to the sediment basin.*

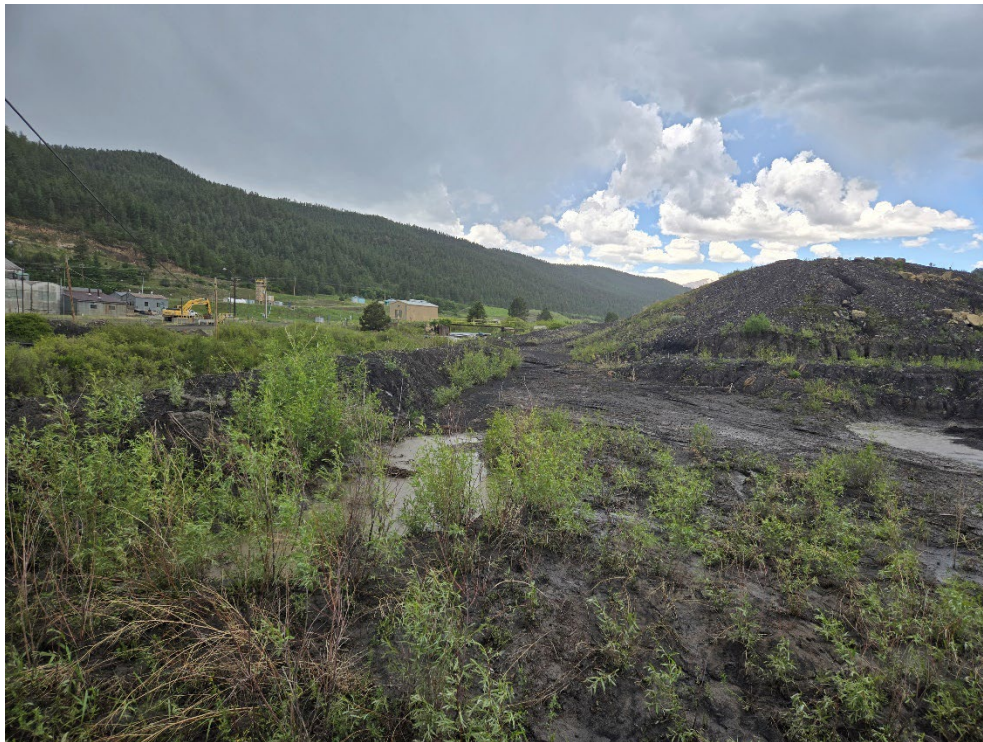
- The sediment basin at the east end of DWDA #2 held water at the time of the inspection.
- The sediment basin and sediment drying area on the north and west sides of DWDA #2 held some water at the time of the inspection (Photo 4). All water appeared to be contained within the bermed areas round DWDA #2.
- No signs of erosion were observed along the slopes of DWDA #1. The slopes appear to be well vegetated and stable.
- Ditch D3 on the west and south side of DWDA #1 held some water at the time of the inspection. The berm on the outside of D3 appeared to be intact with no observed erosional areas (Photo 5).
- Ditch D2 on the northside of DWDA #1 held water at the time of the inspection (Photo 6).
- **See outstanding maintenance items 6 and 8.**

*Photo 4: Looking east along the bermed areas around DWDA #2.*

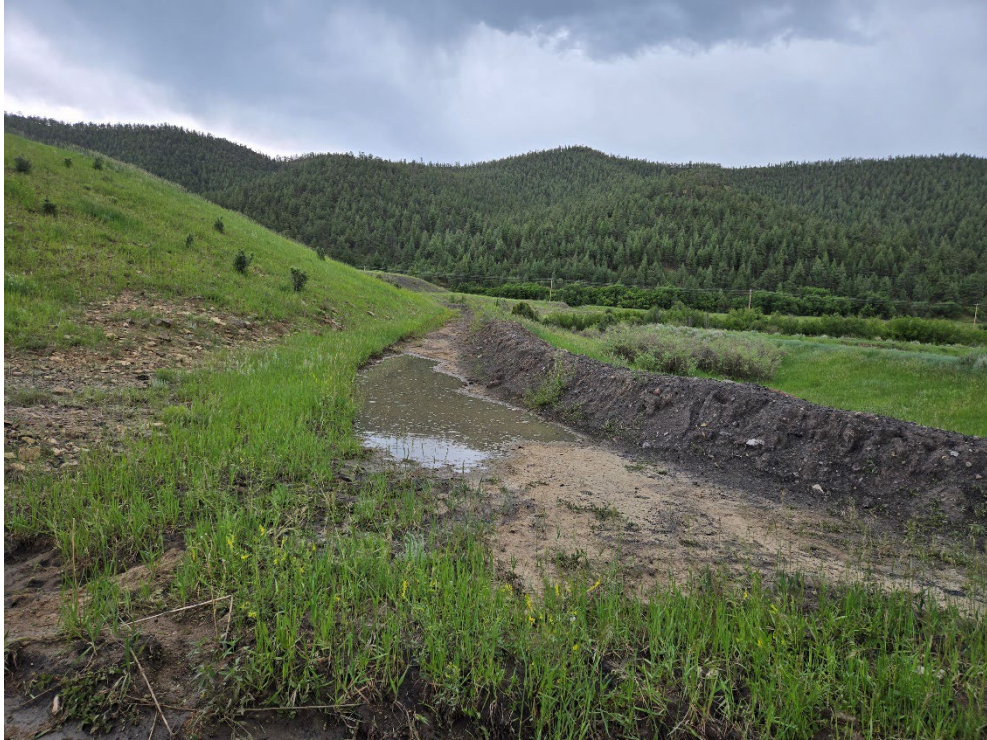
*Photo 5: Looking south along D3.*

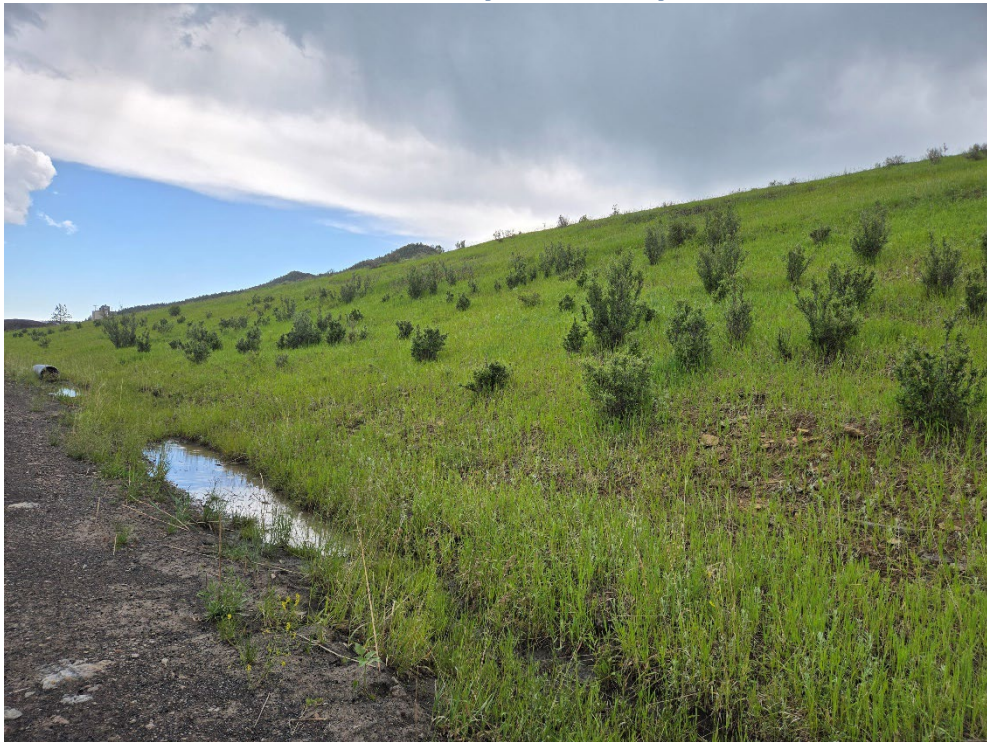
8. (October 2024 report) Areas along D2, located to the north of DWDA #1, have begun to fill with sediment. Some erosion along the road leading to Pond 004A was also observed. **The Operator shall clean this ditch and stabilize the road.**

*Photo 6: Looking east along D2 on the north side of DWDA #1.*

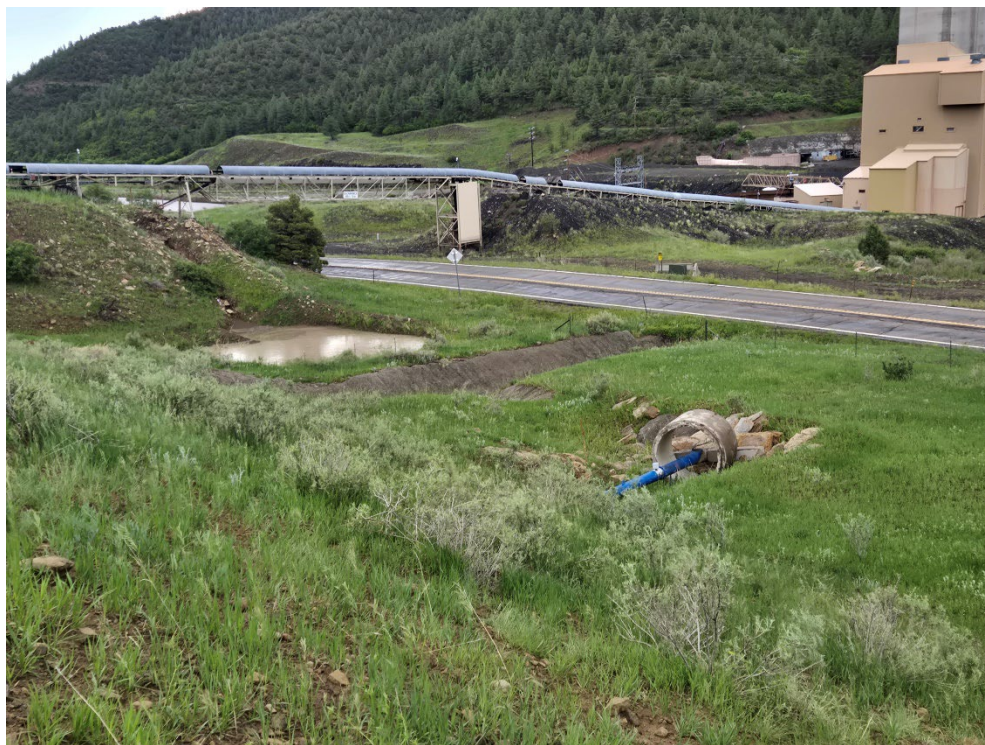
- Containment area #5 contained water at the time of the inspection. The area had recently experienced rainstorms and it was raining at the time of the inspection (Photo 7). The containment area was still below capacity, but water is nearing the tops of the embankment. There is a ditch that leads to the Pond 08 emergency spillway if the water in the containment were to the embankment.

*Photo 7: Containment area #5.*

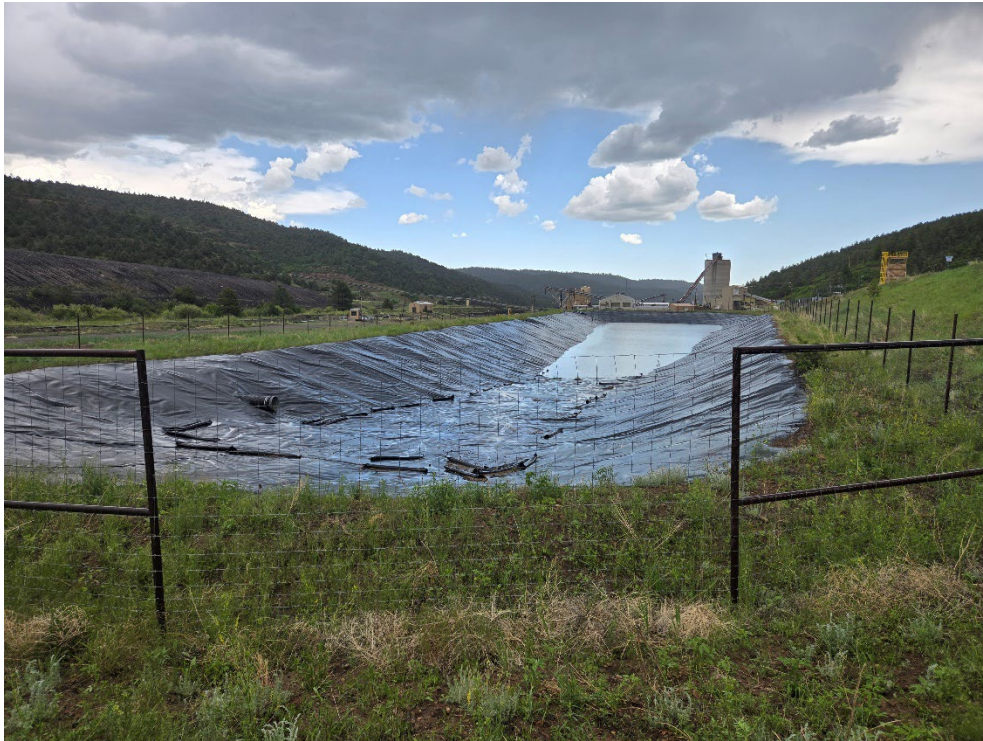
- Pond 001A held some water at the time of the inspection. No tears were observed in the pond lining (Photo 8).
- Pond 004A contained some water, located within the southeast corner, at the time of the inspection (Photo 9). The Division walked along the embankment on the south side of the pond and no structural issues were observed.
- Pond 006A contained some water at the time of the inspection. The banks of the pond appeared to be stable (Photo 10).

*Photo 8: Pond 001A.*

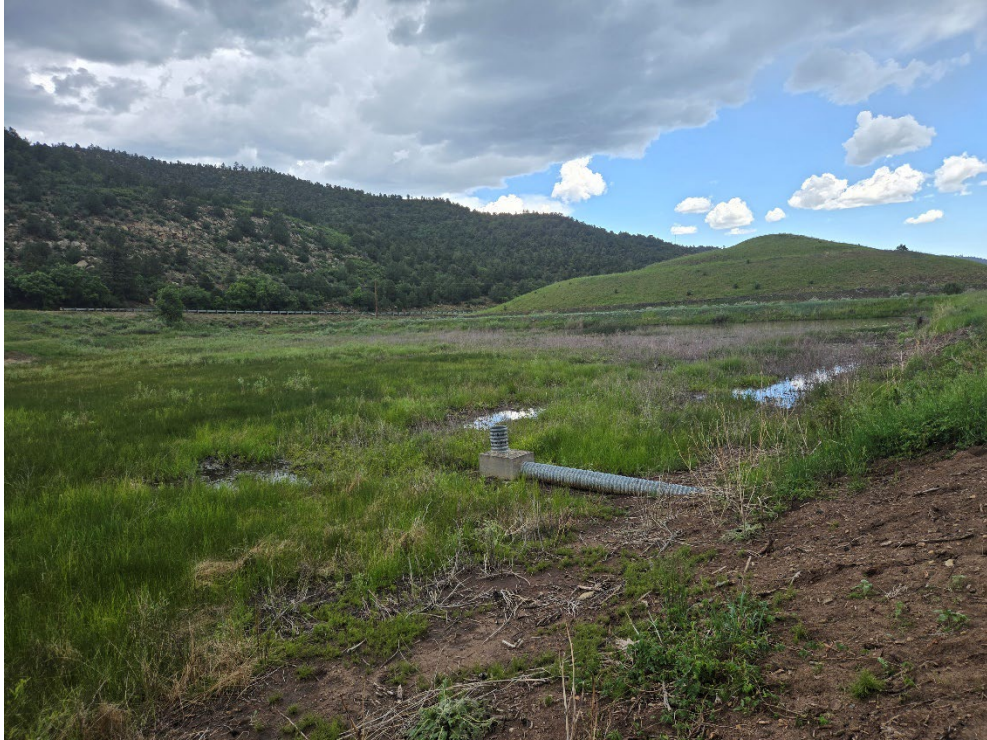
*Photo 9: Pond 004A.*

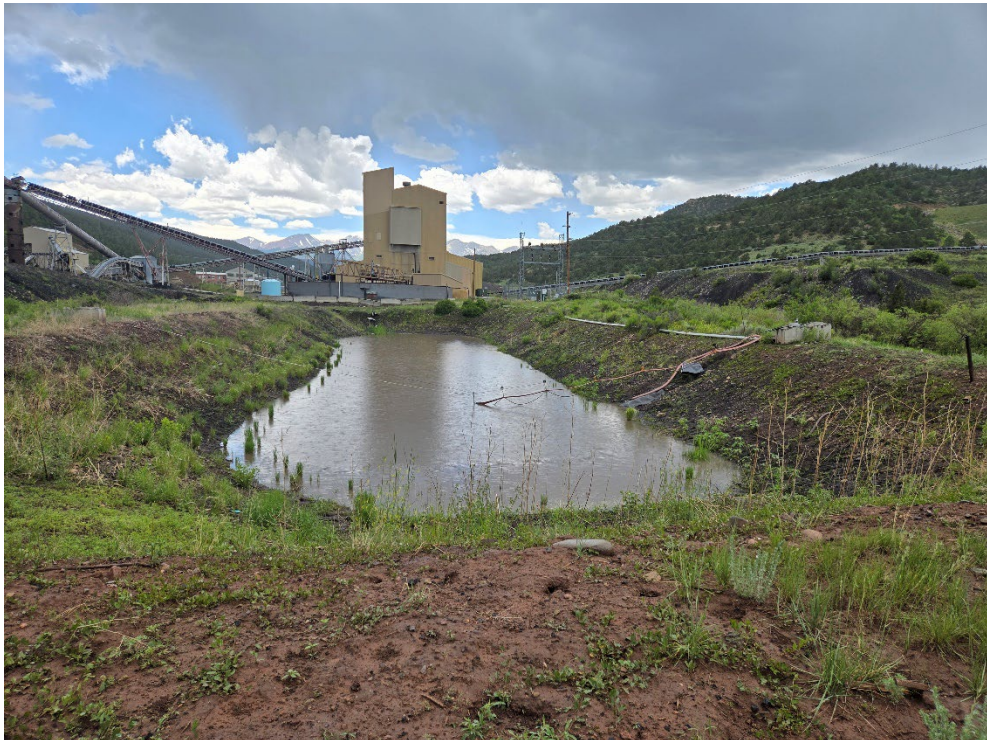
*Photo 10: Pond 006A.*

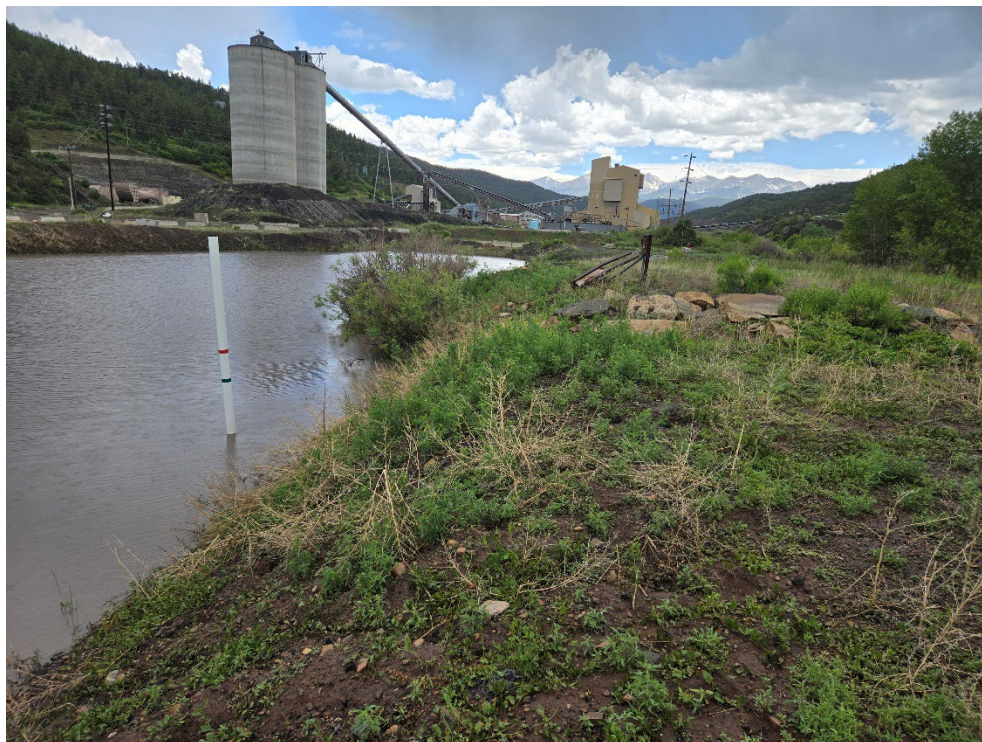
- The water was high in Pond 007A at the time of the inspection but had plenty of capacity before reaching the blue marker on the white PVC pipe (Photo 11). The water was above all of the holes on the principal spillway, but the pond was not discharging (Photos 11 and 12). The banks appeared stable and the emergency spillway was clear.
- Pond 08 contained some water at the time of the inspection and was below its capacity. The spillways appeared clear, and the banks were stable. The Division walked along the south facing side of the south bank and it appeared stable. Pond 08 was not discharging.

*Photo 11: Water in Pond 007a compared to the capacity indicators on the white PVC pipe.*

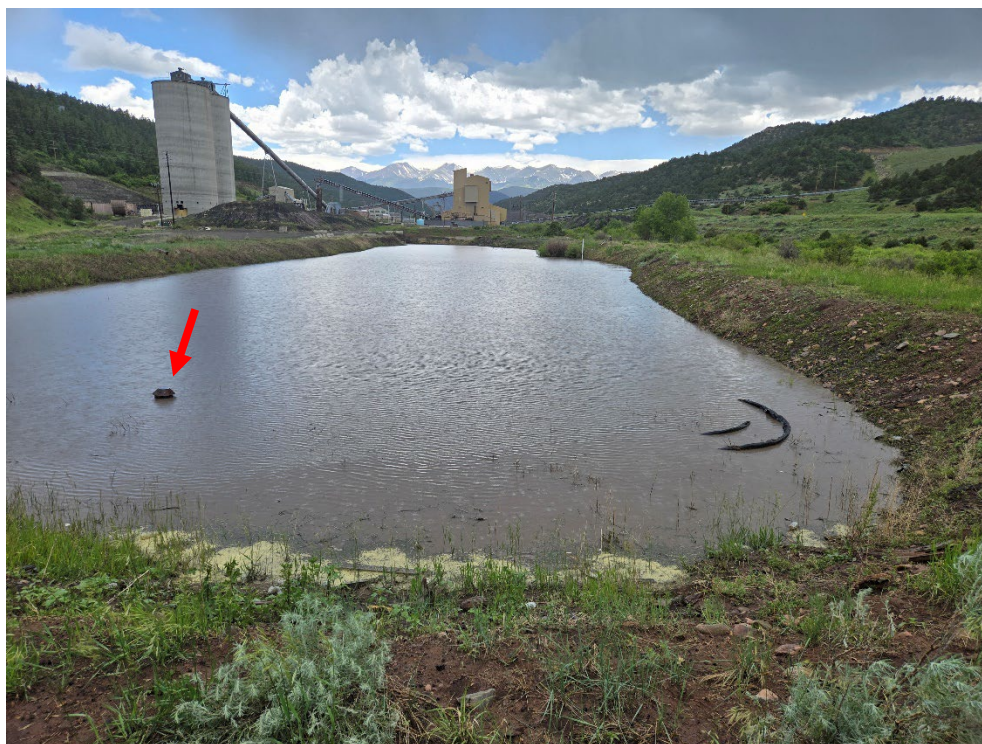
*Photo 12: Pond 007A. The arrow points to the top of the principal spillway.*

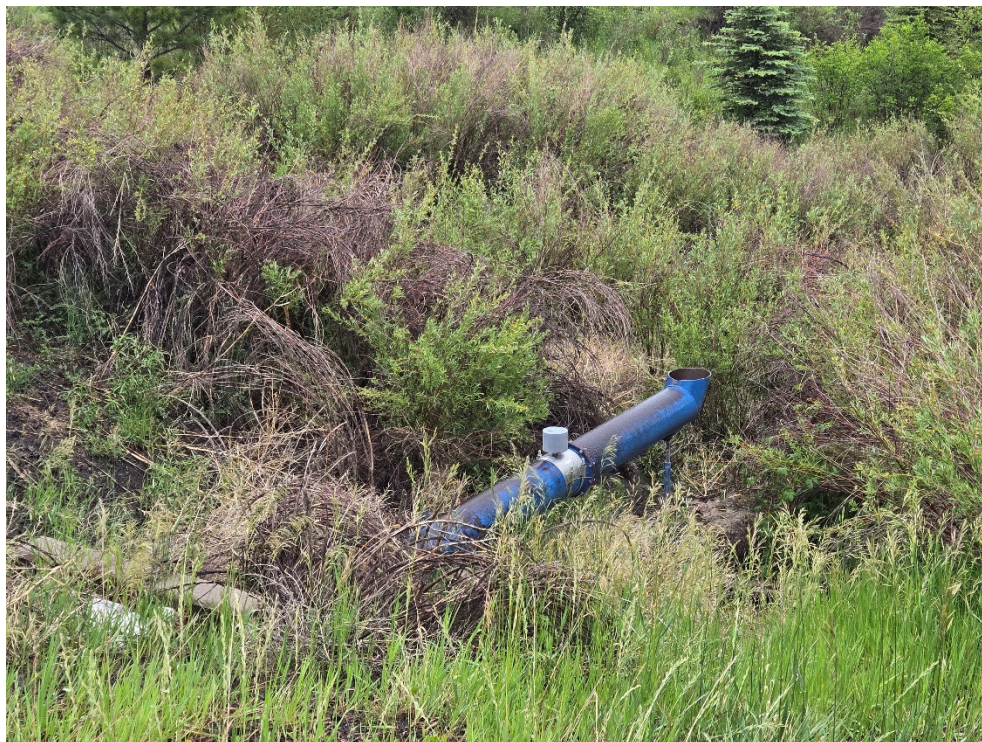
*Photo 13: Principal spillway outlet for Pond 007a. Not discharging during the inspection.*

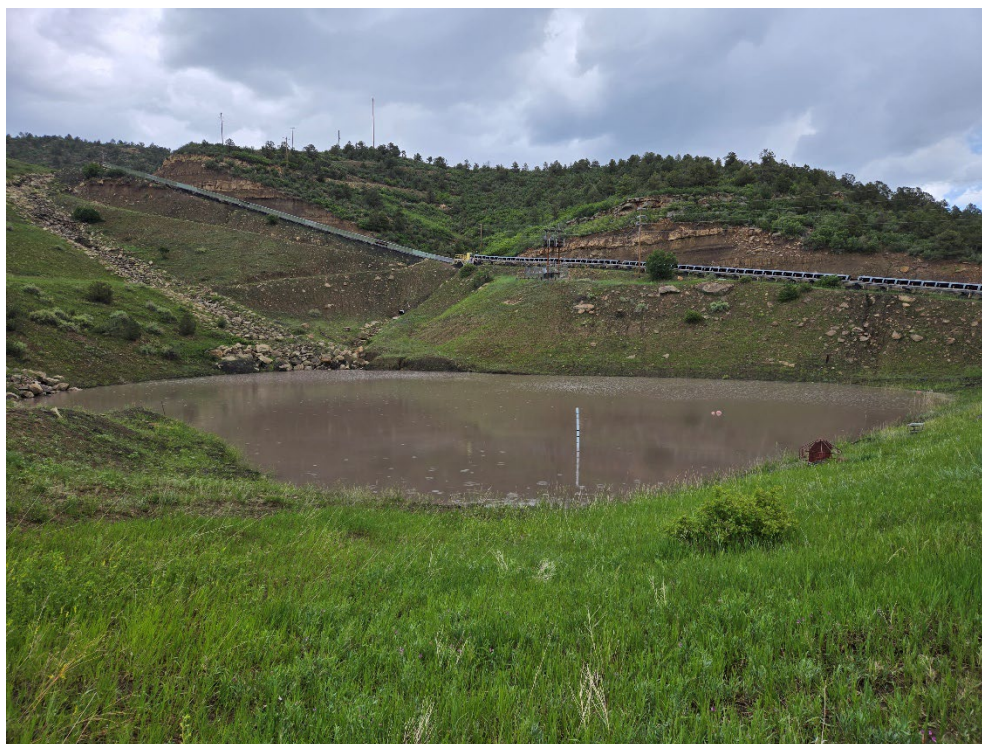
*Photo 14: Pond 08.*

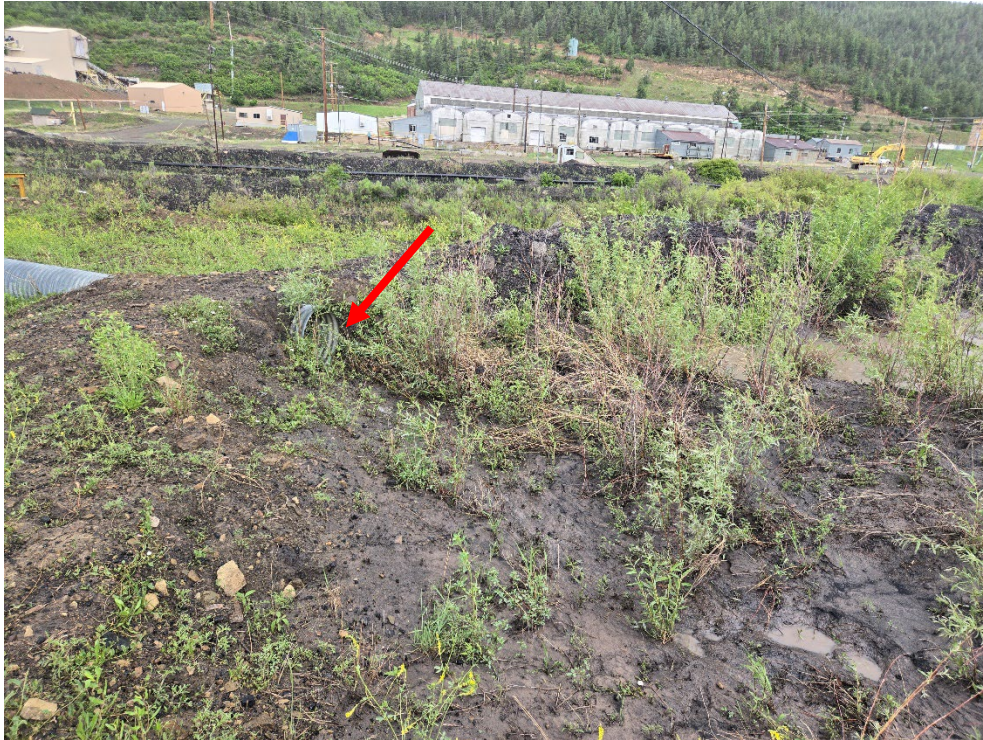
- The inlet for culvert C13, located within the sediment basin for DWDA #2, was clear of obstructions (Photo 15).

*Photo 15: Arrow points to the inlet for C13.*
